18.0 Spook, Wyoming, Disposal Site

The Spook, Wyoming, Uranium Mill Tailings Radiation Control Act (UMTRCA) Title I Disposal Site was inspected on July 14, 2021. No changes were observed on the land surface of the disposal cell. Perimeter sign P5 was observed to be delaminating and will be replaced, but inspectors found no cause for a follow-up or contingency inspection. Groundwater monitoring is not required.

Figure 18-1. 2021 Annual Inspection Drawing for the Spook, Wyoming, Disposal Site

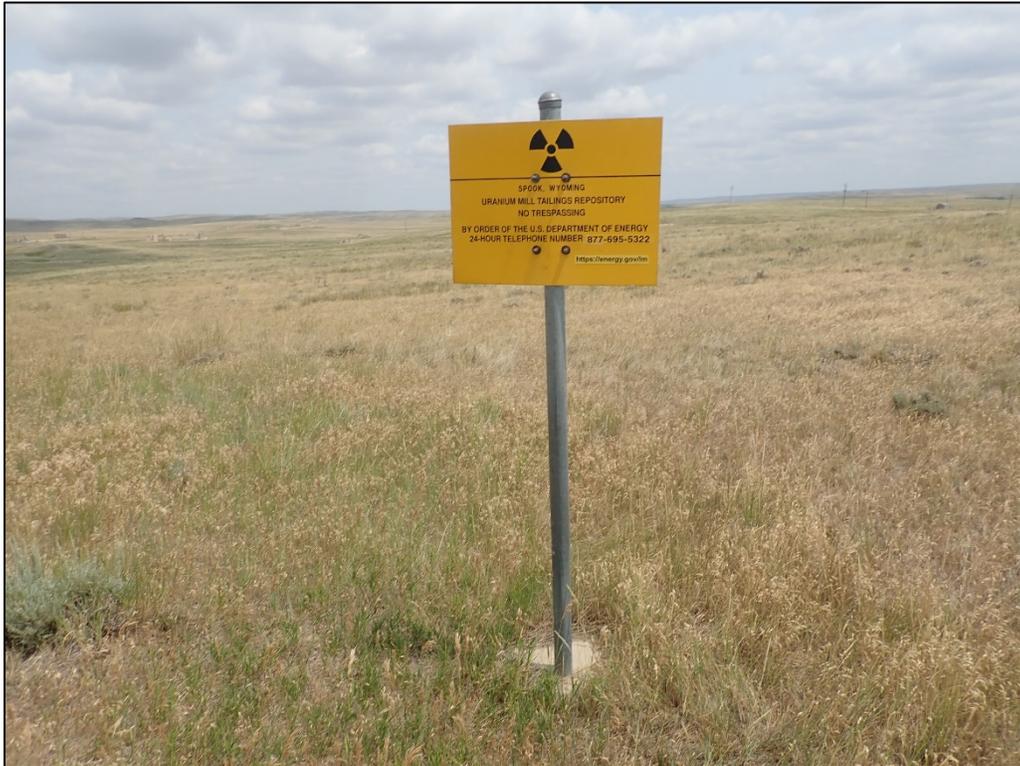
PL-1. Entrance Sign

Access to the site is from Wyoming Highway 95 from Glenrock or Wyoming Highway 93 from Douglas to Converse County Road 31 and onto Hornbuckle Ranch Road. Site access is maintained through perpetual easements across the Hornbuckle ranch. The graded, hardpack road to the site is maintained by the ranch. The entrance sign is mounted on a steel post set in concrete (PL-1). No maintenance needs were identified.

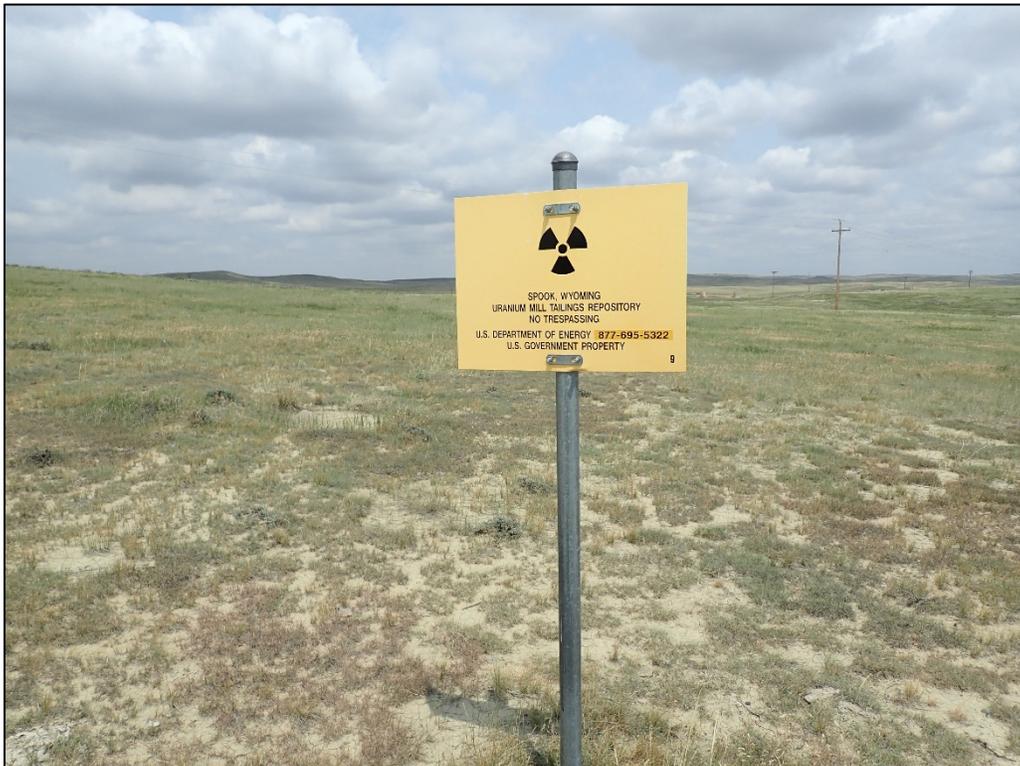
PL-2. Perimeter Sign P9

There are 10 perimeter signs (PL-2), attached to steel posts set in concrete, positioned around the site outside the unfenced property boundary. Perimeter sign P5 shows signs of weathering and is delaminating. The sign will be replaced during the next annual inspection. No other maintenance needs were identified.

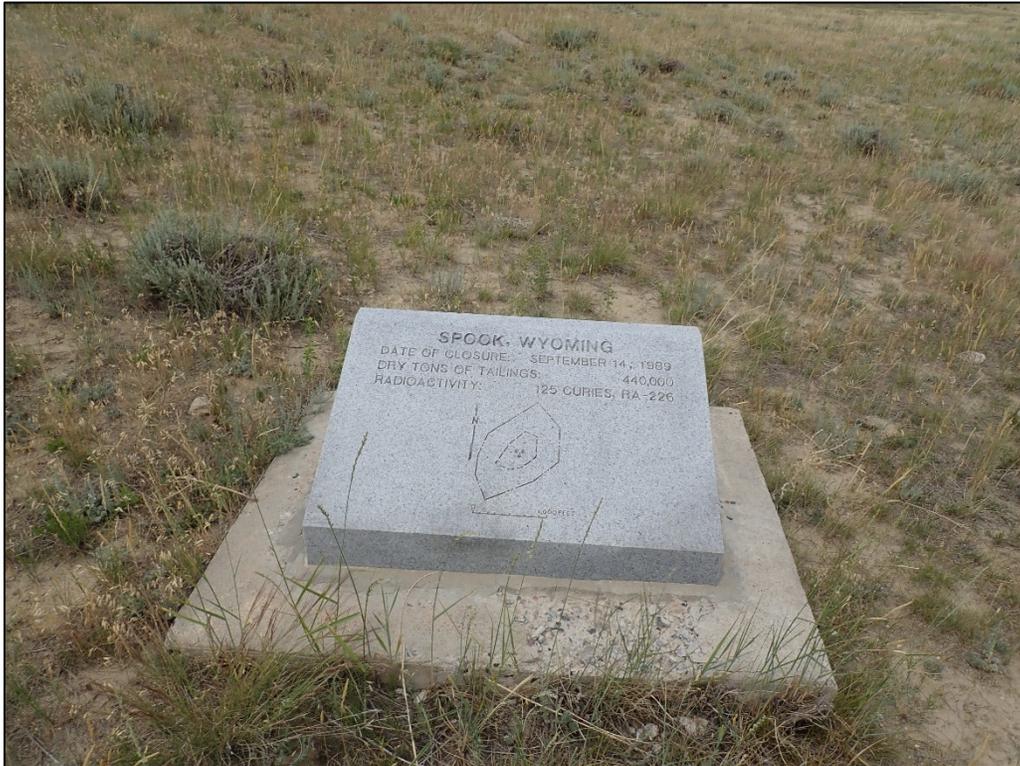
PL-3. Site Marker SMK-1

The site has two granite site markers. Site marker SMK-1 is at the south side of the disposal cell (PL-3). Its concrete base is damaged due to spalling but is stable; there were no apparent changes from the previous year. Site marker SMK-2 is at the north side of the disposal cell. No maintenance needs were identified.

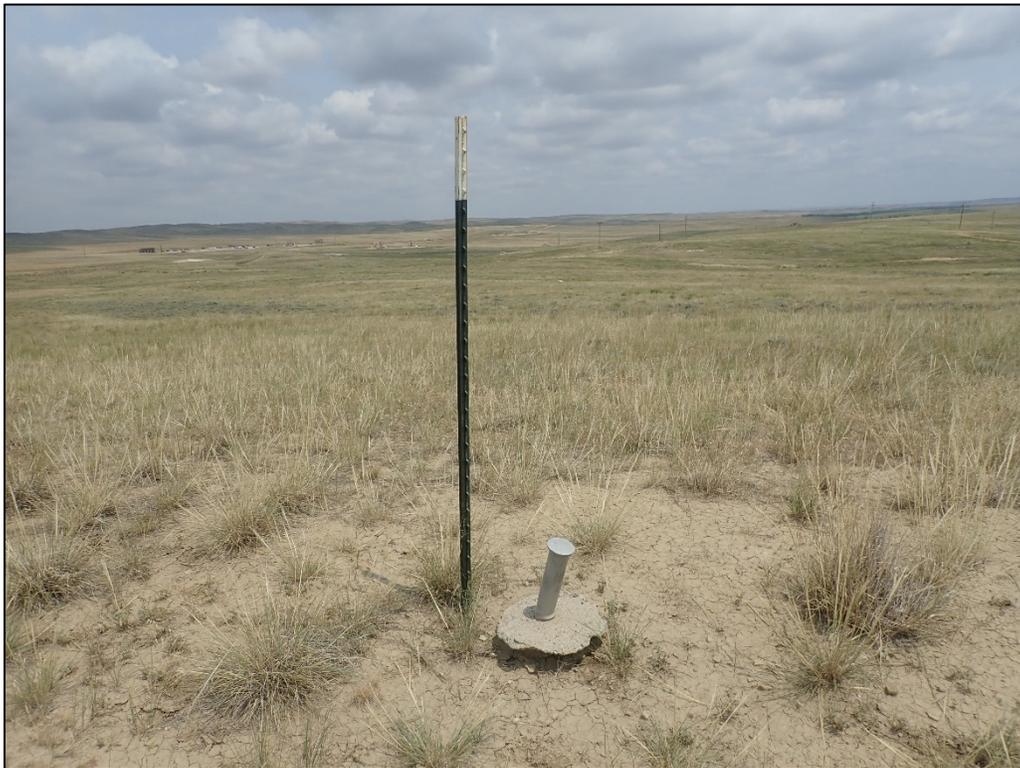
PL-4. Boundary Monument BM-6

The site has three survey monuments and eight boundary monuments. Boundary monument BM-6 is bent but stable (PL-4). The boundary monuments and a survey monument, as well as the perimeter signs, are outside the property boundary. The owner of the surrounding property (Hornbuckle ranch) is aware that the monuments are on his property, but he is not concerned. Therefore, the survey and boundary monuments and perimeter signs will remain at their current locations.

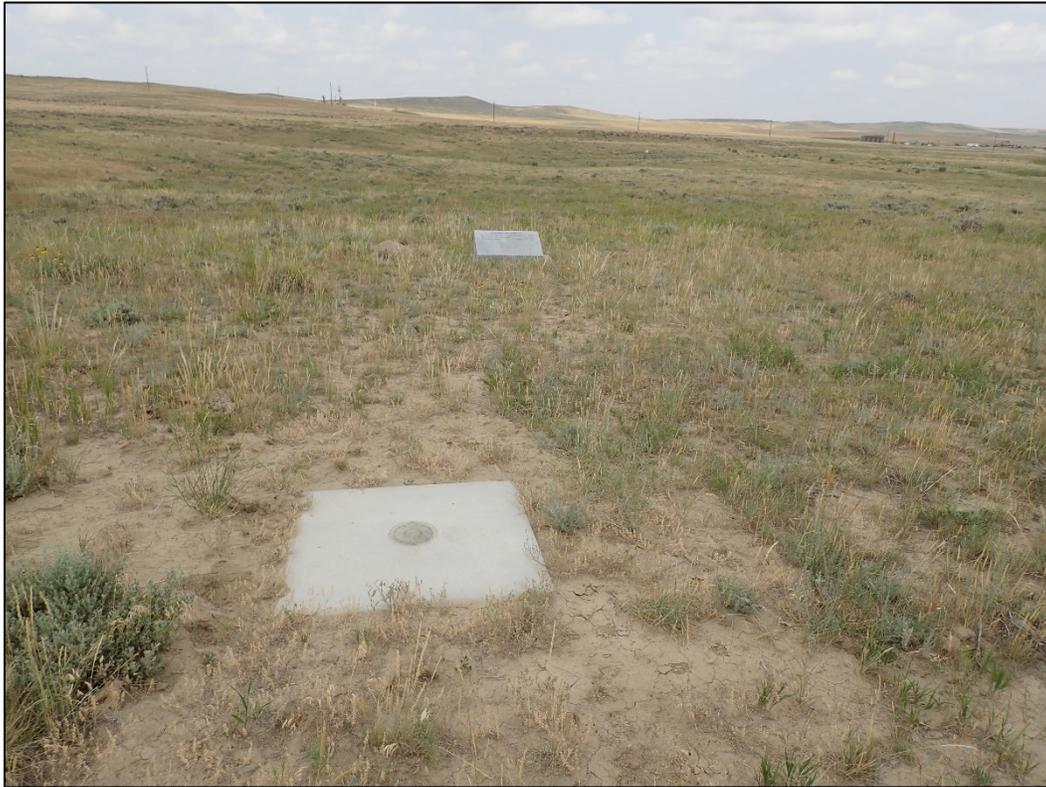
PL-5. Quality Control Monument QC-3 and Site Marker SMK-2

Four aerial survey quality control monuments were installed in 2019 following the site inspection (PL-5). The quality control monument locations are shown in Figure 18-1. No maintenance needs were identified.
