## 18.0 Spook, Wyoming, Disposal Site

### 18.1 Compliance Summary

Figure 18-1. 2022 Annual Inspection Drawing for the Spook, Wyoming, Disposal Site

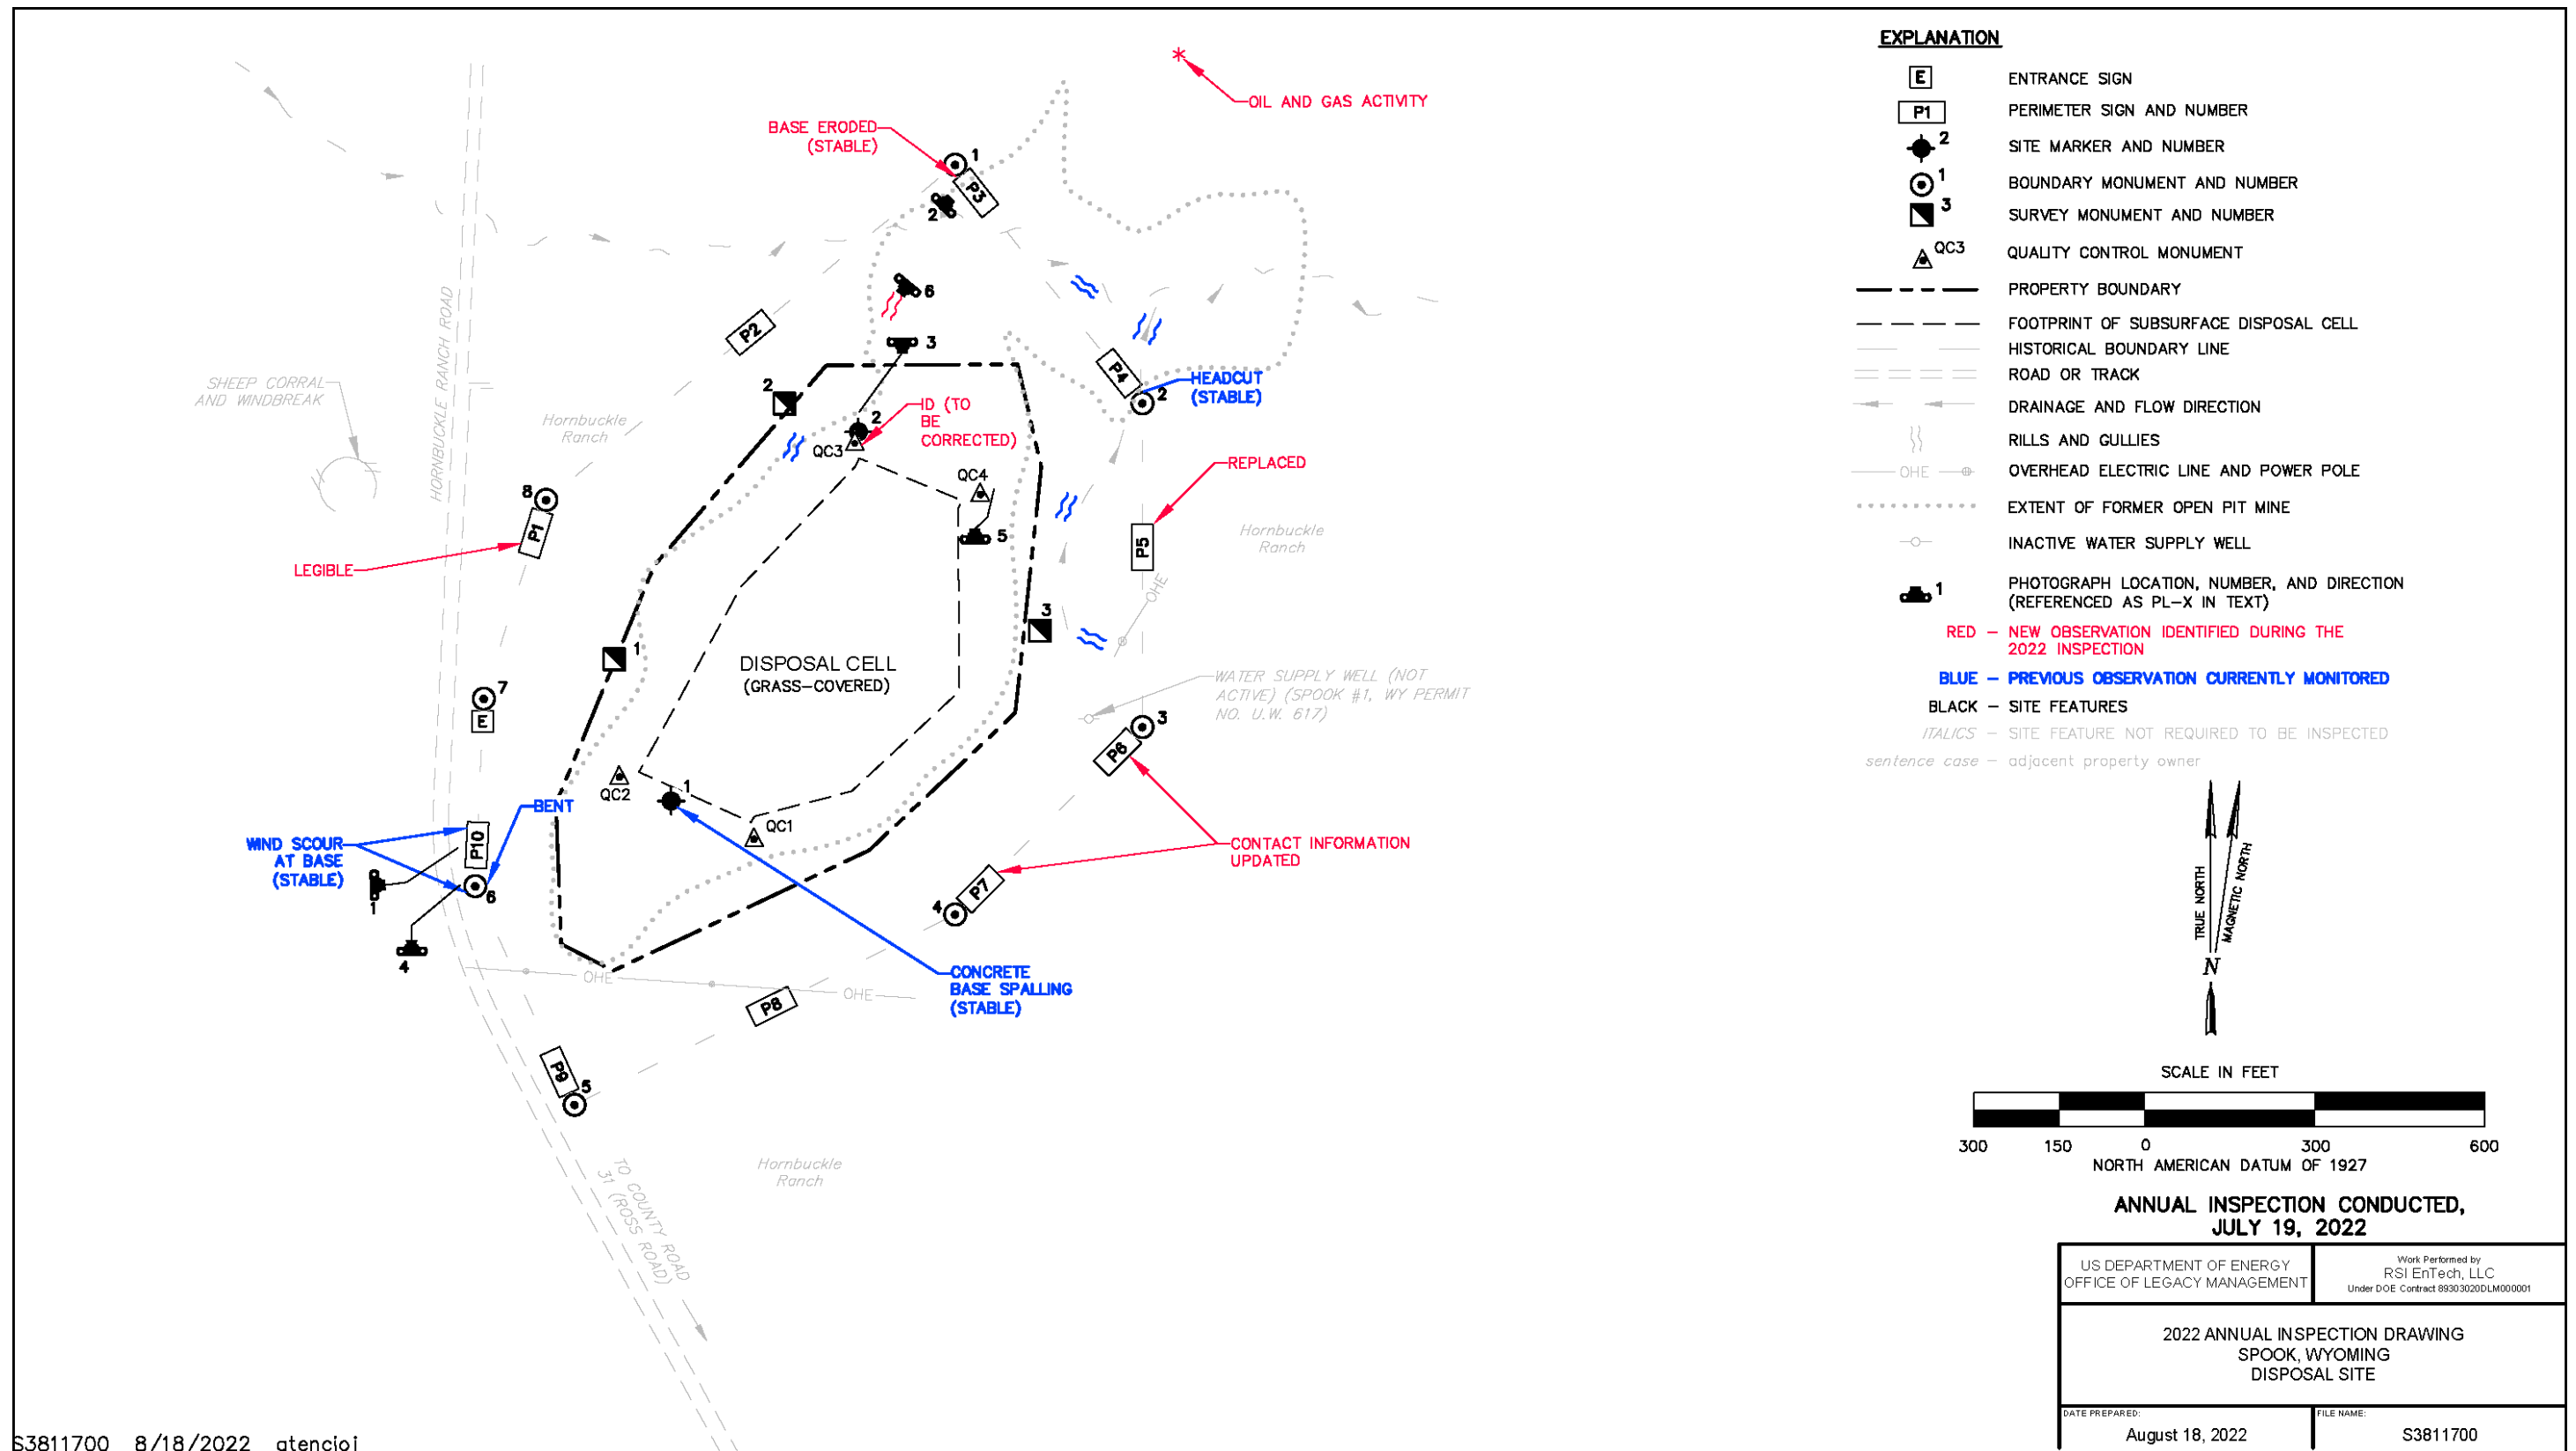
Figure 18-1 shows the locations of site features, including site surveillance features and inspection areas, in black and gray font. Some site features that are present but not required to be inspected are shown in italic font. Observations from previous inspections that are currently monitored are shown in blue, and new observations identified during the 2022 annual inspection are shown in red. Inspection results and recommended maintenance activities associated with site surveillance features are described in the following subsections. Photographs to support specific observations are noted in the text and in Figure 18-1 by photograph location (PL) numbers. The photographs and photograph log are presented in Section 18.10.

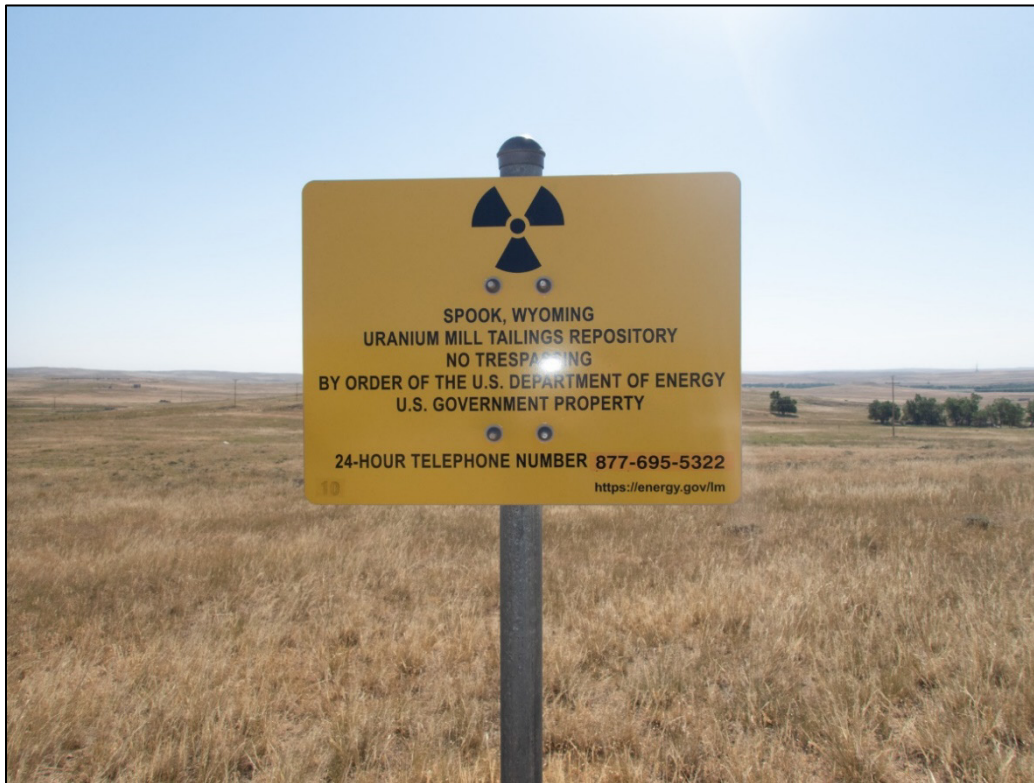
There are 10 perimeter signs (PL-1) attached to steel posts set in concrete and positioned around the site outside the unfenced property boundary. The 2021 inspection noted that perimeter sign P5 showed signs of weathering and was delaminating. The sign was replaced after the 2022 inspection. Perimeter sign P1 is plastic and warped but still legible. Soil around the concrete base of perimeter sign P3 is eroded but remains stable (PL-2). The phone numbers on perimeter signs P6 and P7 were updated during the inspection. No other maintenance needs were identified.

*PL-1. Perimeter Sign P10*

Inspectors updated the contact information listed on perimeter signs P6 and P7 during the inspection. Following the inspection, perimeter sign P5 was replaced. The label on quality control monument QC-3 will be corrected before the next inspection.

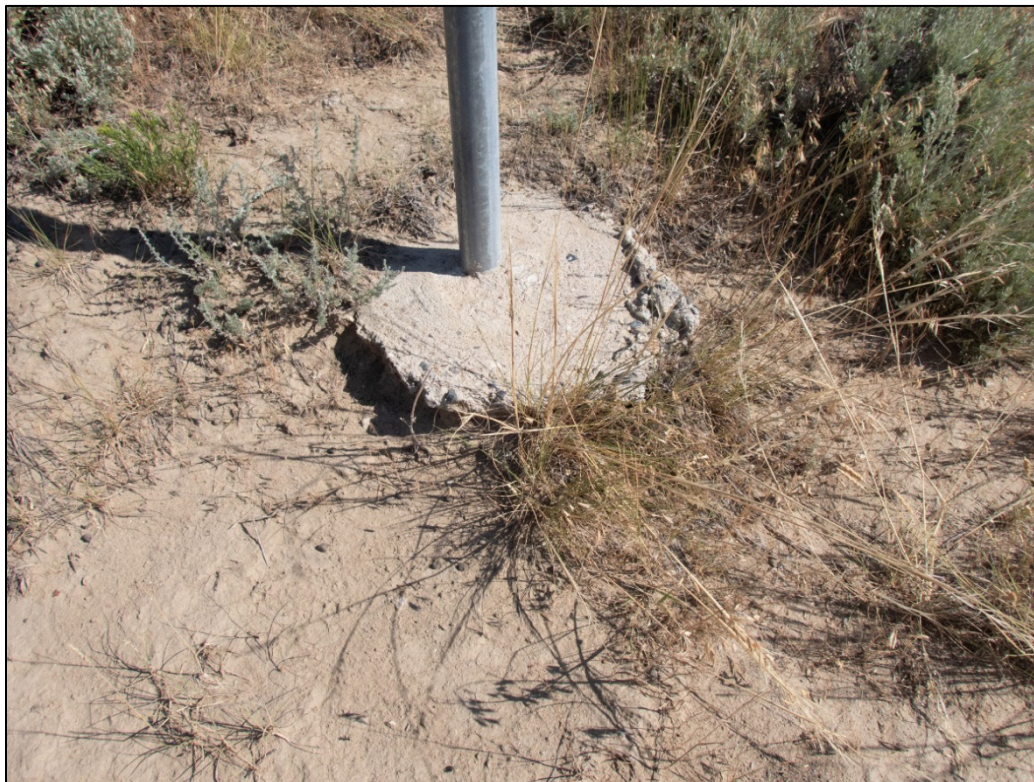
*PL-2. Erosion Around Base of Perimeter Sign P3*

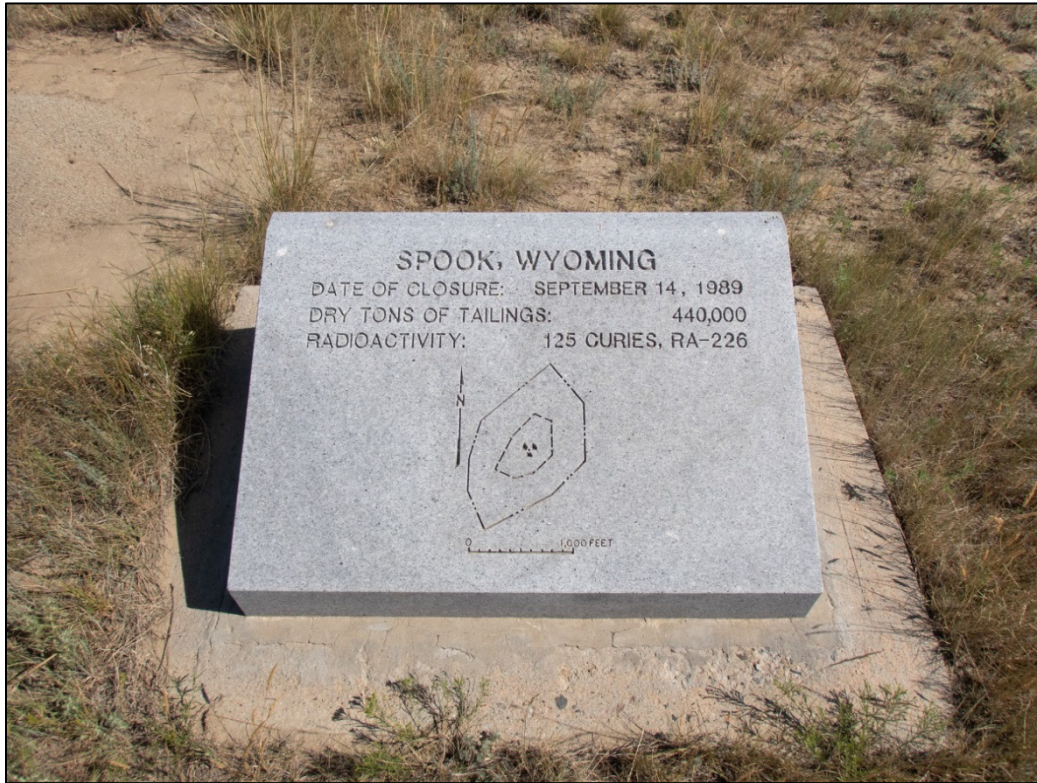
The site has two granite site markers. Site marker SMK-1 is at the south side of the disposal cell. Its concrete base is damaged due to spalling but is stable; there were no apparent changes from the previous year. Site marker SMK-2 is at the north side of the disposal cell (PL-3). No maintenance needs were identified.

*PL-3. Site Marker SMK-2*

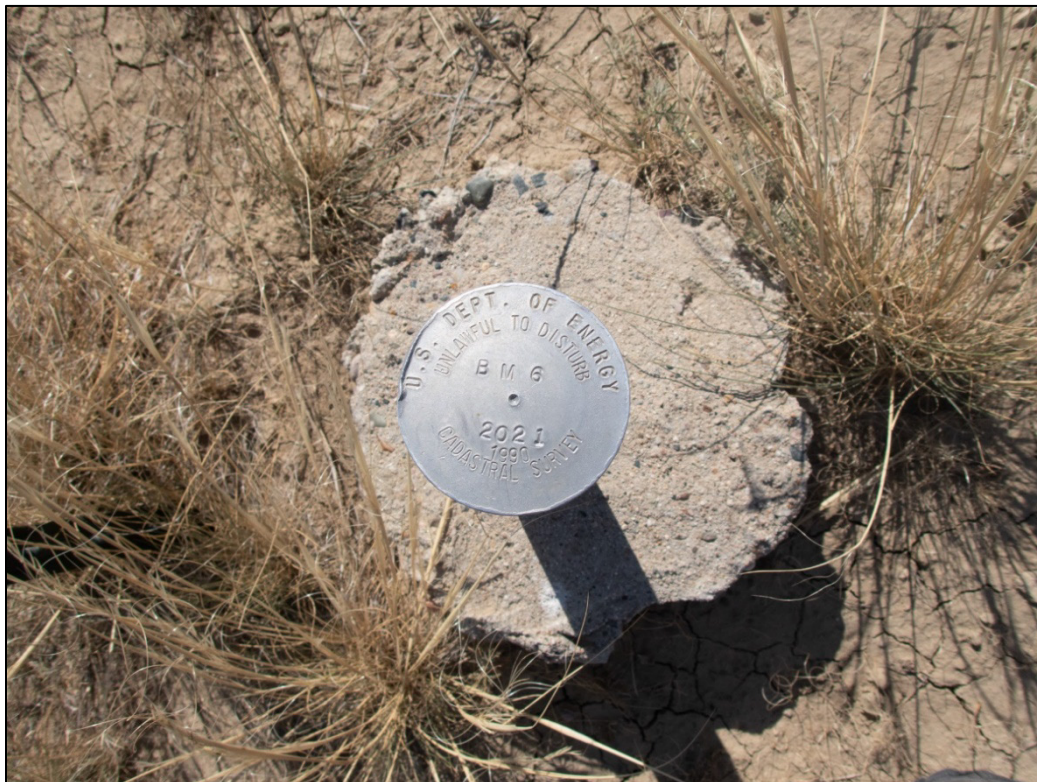
The site has three survey monuments and eight boundary monuments. Boundary monument BM-6 is bent and the base is eroded but stable (PL-4). The boundary monuments and a survey monument, as well as the perimeter signs are outside the property boundary. The owner of the surrounding property (Hornbuckle Ranch) is aware that the monuments are on his property, but he is not concerned. Therefore, the survey and boundary monuments and perimeter signs will remain at their current locations. No maintenance needs were identified.

*PL-4. Boundary Monument BM-6*

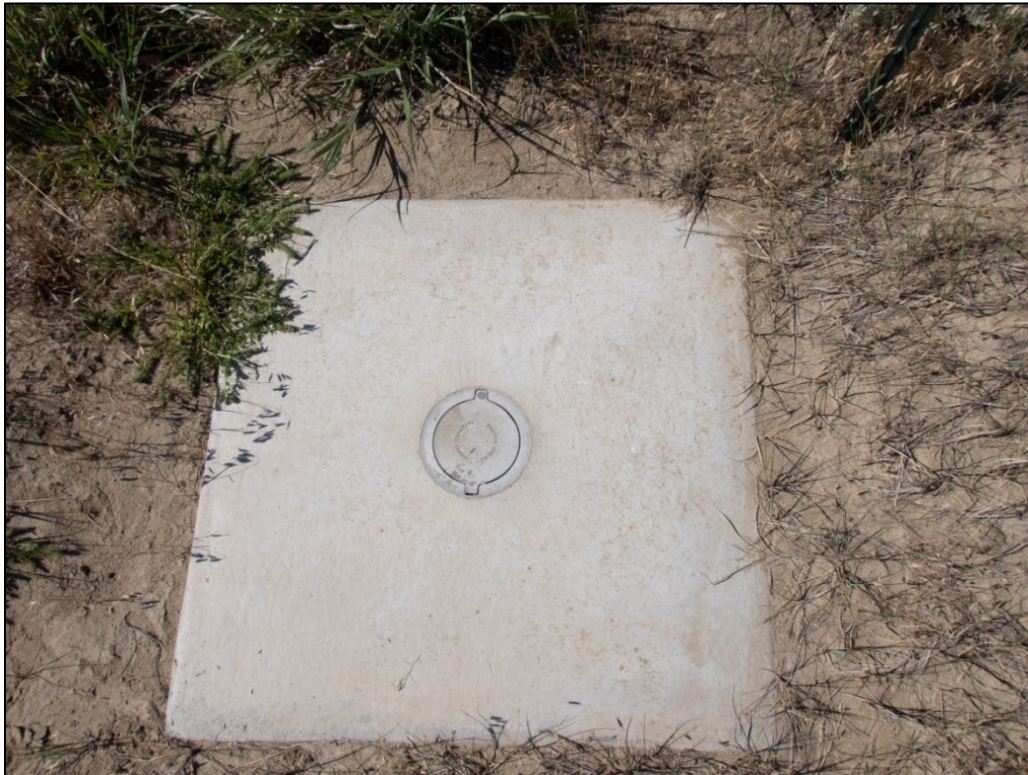
Four aerial survey quality control (QC) monuments were inspected (PL-5). The cap for quality control monument QC-3 was stamped as QC-1. The cap will be renumbered before the next annual inspection. No other maintenance needs were identified.

*PL-5. Quality Control Monument QC-4*

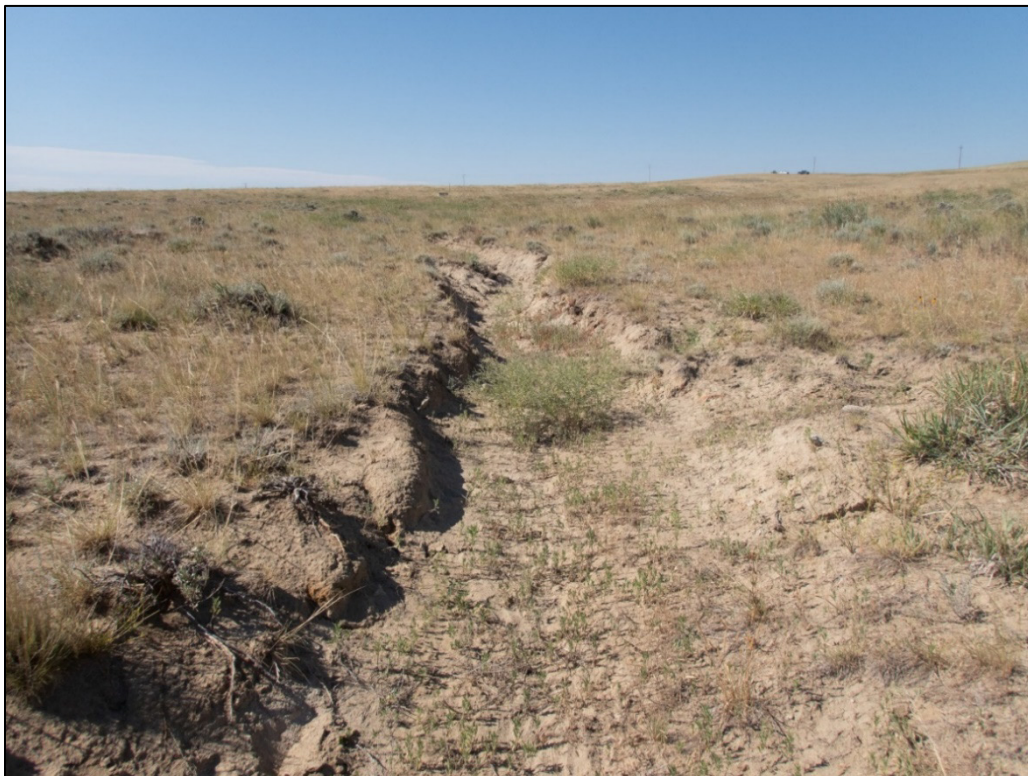
The area beyond the site boundary for a distance of 0.25 mile was visually observed for erosion, changes in land use, or other phenomena that might affect the long-term integrity of the site. No such impacts were observed. Several minor rills and gullies are near the site and appear to be stable. One minor gully was noted north of the disposal site, which was not identified in previous inspections (PL-6). This gully appeared to be stable and had established vegetation. None of the erosion areas are harming the function of the disposal cell cover or other site features and are not a concern at this time. Inspectors will continue to monitor these erosion areas.

*PL-6. Erosional Gully, Previously Unreported*
