19.0 Tuba City, Arizona, Disposal Site

19.1 Compliance Summary

Figure 19-1. 2021 Annual Inspection Drawing for the Tuba City, Arizona, Disposal Site

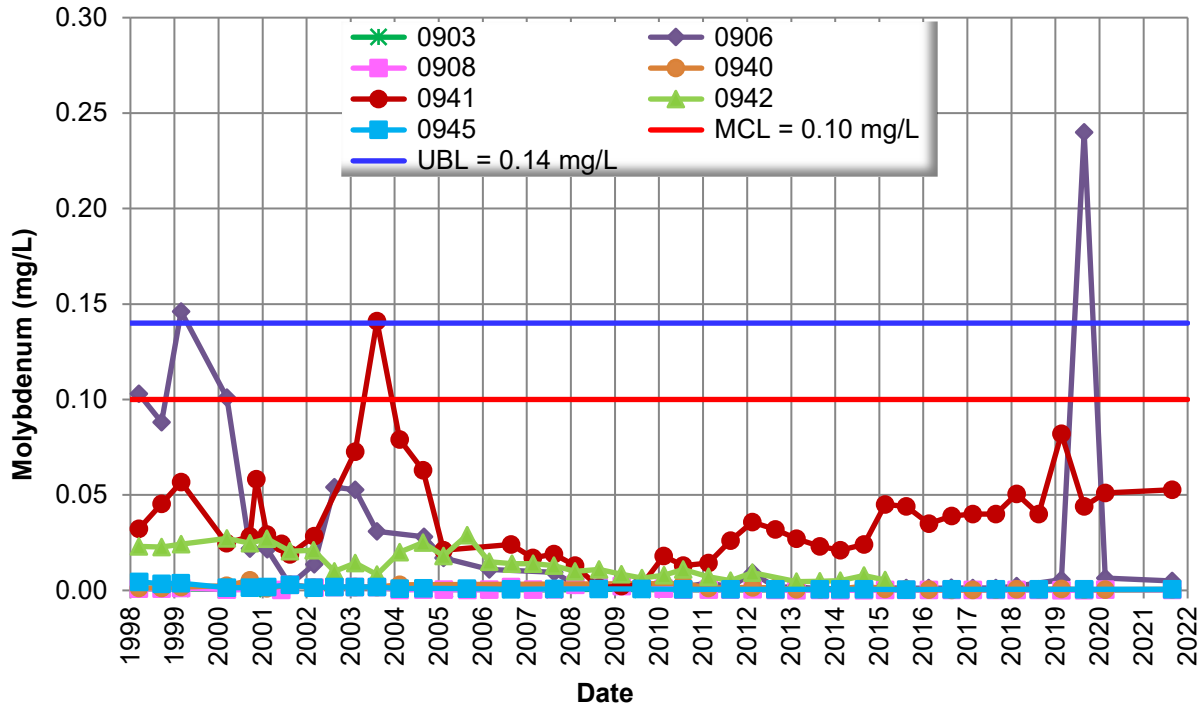
Figure 19-3. Molybdenum in Groundwater at the Tuba City, Arizona, Disposal Site

Since 2004, molybdenum concentrations have been below both the 0.10 milligram per liter (mg/L) MCL and the 0.14 mg/L UBL in all LTSP evaluative wells except well 0906 in August 2019 (Figure 19-3). Molybdenum concentrations in the westernmost downgradient well 0908 and in distal downgradient well 0903 (approximately 1250 feet south of the site perimeter) continue to be comparable to concentrations in background well 0945. Well 0906 exceeded the UBL for molybdenum in August 2019 for the first time since 1999. The UBL exceedance in well 0906 was measured during the 2019 pumping campaign. Molybdenum in well 0906 decreased below the MCL in February 2020 and remained below the MCL in August 2021.

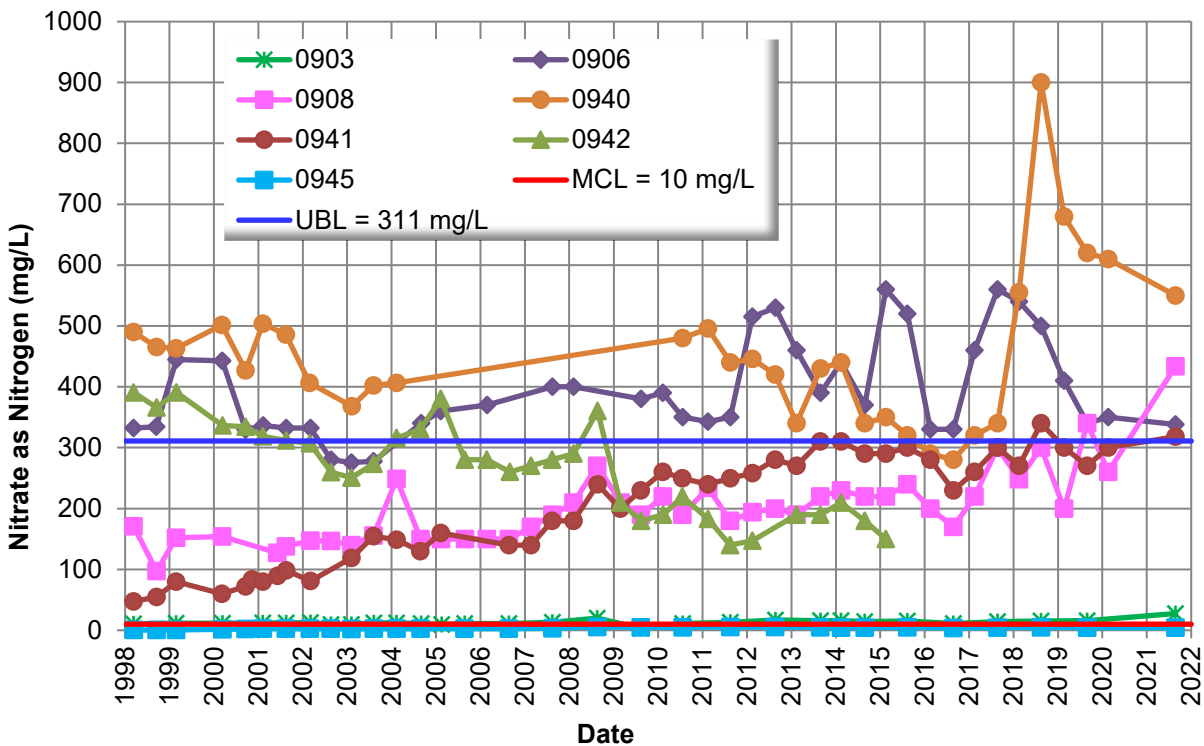
Figure 19-4. Nitrate in Groundwater at the Tuba City, Arizona, Disposal Site

Nitrate concentrations have historically exceeded the 10 mg/L MCL in all LTSP evaluative wells except background well 0945 (Figure 19-4). Exceedances of the 311 mg/L UBL were observed at compliance wells 0906 (338 mg/L), 0908 (434 mg/L), 0940 (550 mg/L), and 0941 (318 mg/L) in August 2021. Nitrate concentrations in distal downgradient well 0903 have regularly exceeded the MCL since 2004 but remained below the UBL in 2020.

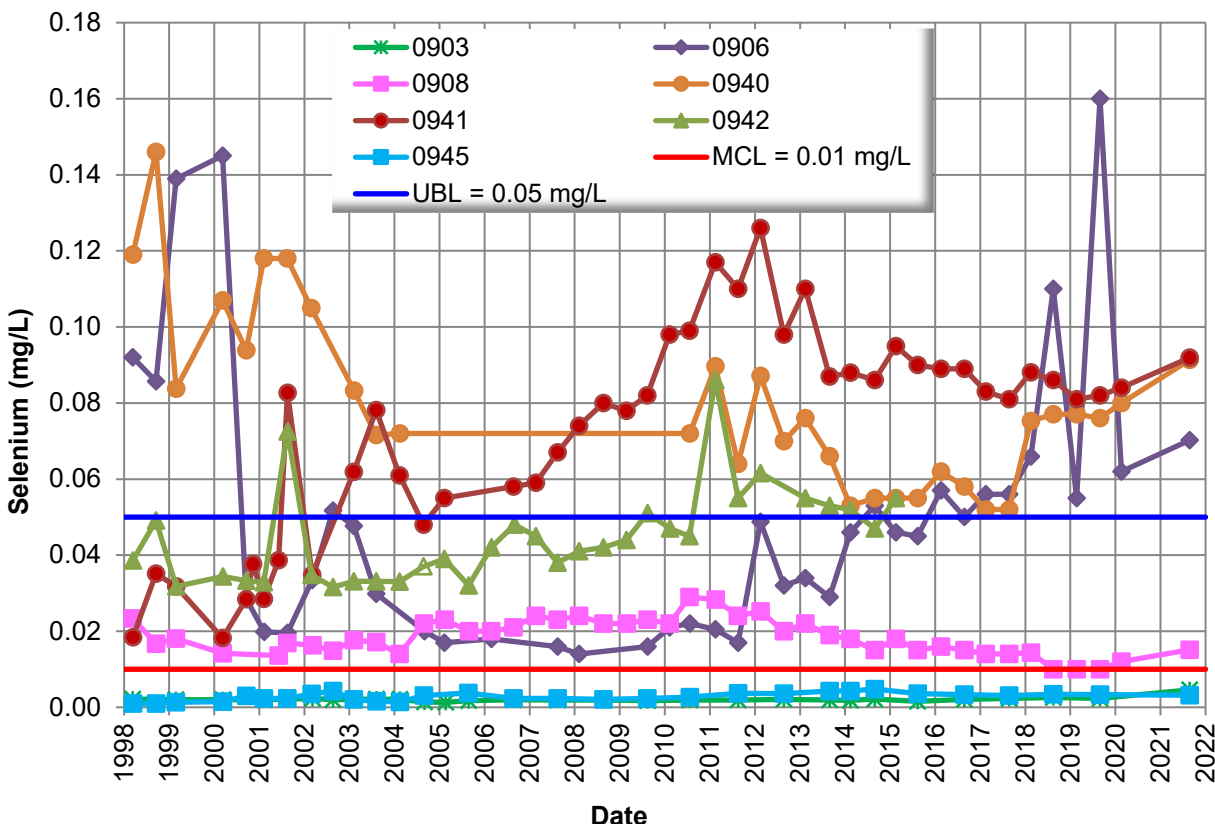
Figure 19-5. Selenium in Groundwater at the Tuba City, Arizona, Disposal Site

Selenium concentrations have historically exceeded the 0.01 mg/L MCL in all LTSP evaluative wells except background well 0945 and distal well 0903 (Figure 19-5). Concentrations in well 0908 exceeded the UBL for selenium in 1997 and have since remained at or slightly above the 0.01 mg/L MCL since August 2018. Selenium concentrations in well 0942 exceeded the UBL in February 2015, and that well has not been sampled since. Concentrations continued to exceed the 0.05 mg/L UBL in wells 0906, 0940, and 0941, all of which are immediately downgradient of the disposal cell. Selenium concentrations increased in well 0941 from 0.018 mg/L in 1998 to 0.09 mg/L in 2021. Selenium concentrations in distal downgradient well 0903 have consistently been below both the UBL and the MCL and, since late 2004, below levels measured in background well 0945.

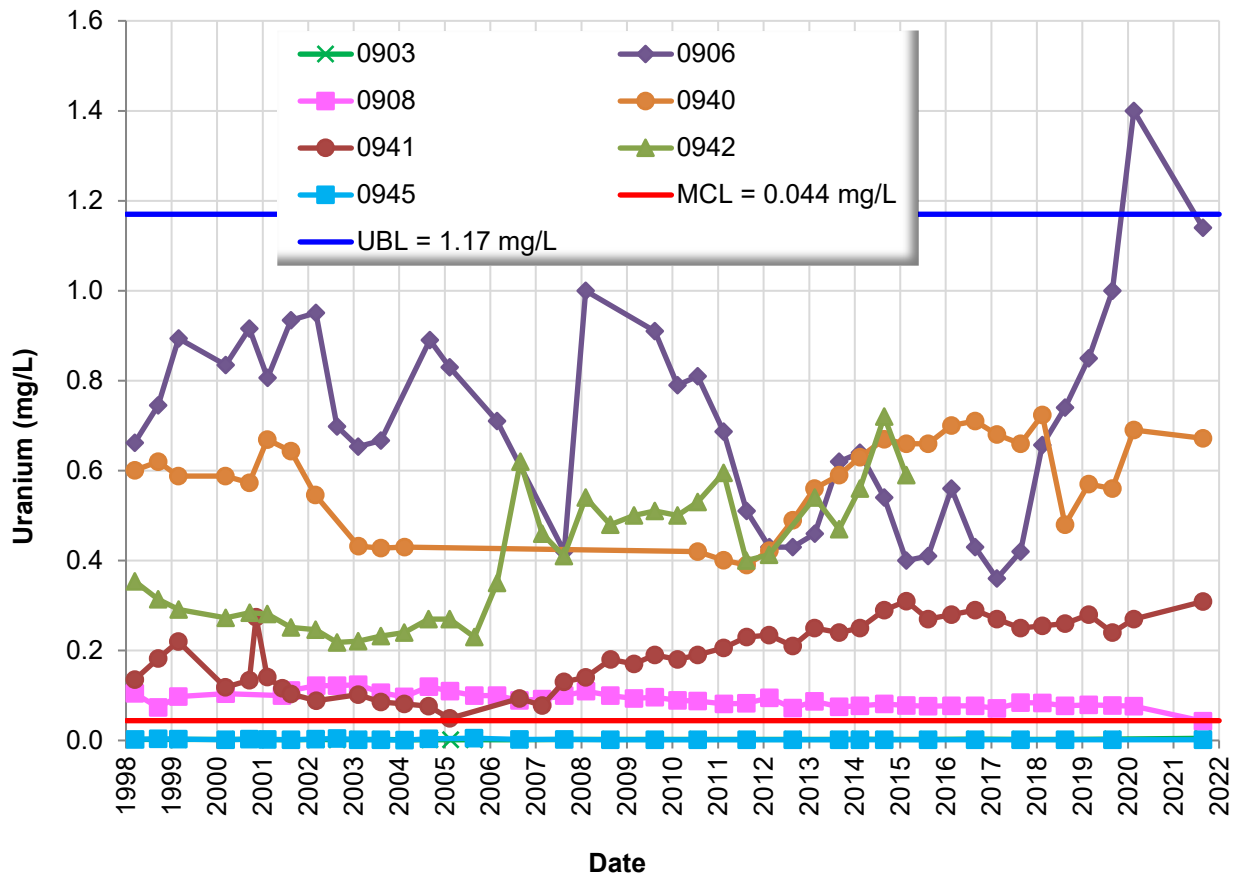
Figure 19-6. Uranium in Groundwater at the Tuba City, Arizona, Disposal Site

Uranium concentrations have historically exceeded the 0.044 mg/L MCL in all compliance wells except for distal downgradient well 0903 and background well 0945, both of which have always been below the MCL (Figure 19-6).

Uranium concentrations in central downgradient well 0941 have gradually increased since 2005 from 0.05 mg/L to 0.31 mg/L. Concentrations in well 0906 have more recently increased from 0.36 mg/L in February 2017 to 1.4 mg/L in February 2020, above the 1.17 mg/L UBL, then to 1.14 mg/L in August 2021, just below the UBL. Uranium concentration in well 0908 decreased to 0.043 mg/L, just below the MCL, in August 2021; this was the first time uranium concentrations were below the MCL in this well since evaluative monitoring began.

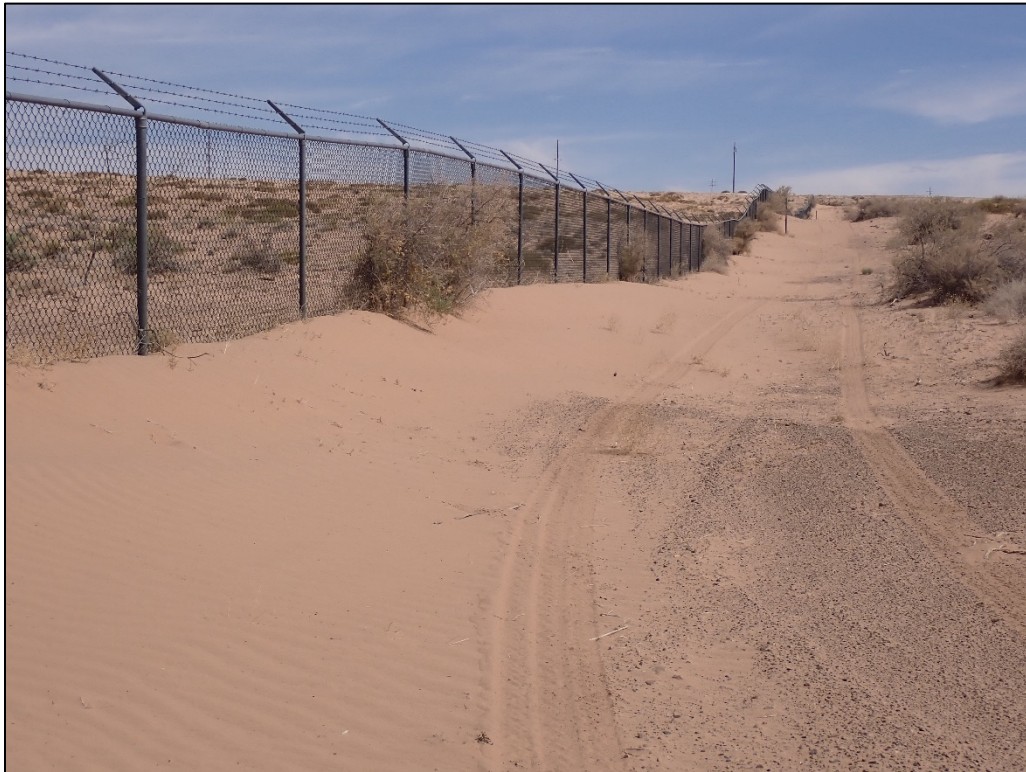
A chainlink perimeter fence encloses the site. Windblown sand continues to accumulate along the western perimeter fence and road (PL-1). The sand accumulation is not of concern at this time. Inspectors found several areas of accumulated tumbleweeds along the eastern fence line that will be cleared to reduce a potential fire hazard once Navajo Nation travel restrictions are lifted.

PL-1. Windblown Sand Accumulation Along Western Perimeter Fence

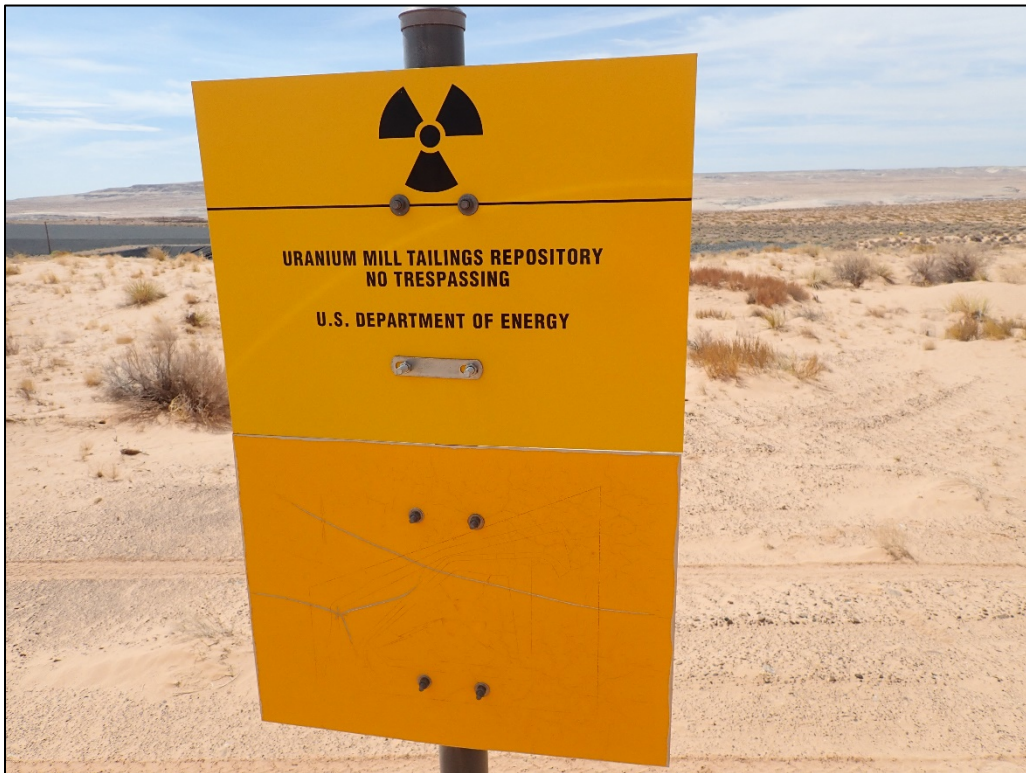
Thirty pairs of perimeter signs, designated P1 through P30, are attached to steel posts set in concrete directly inside and along the perimeter fence. One of the sign pairs is textual, and the other is pictorial. All were legible and stable, with the exception of pictorial signs P6, P7, and P24, which are faded and cracked (PL-2, PL-3, and PL-4); these observations were reported in 2020, but the signs cannot be replaced until travel to the Navajo Nation is approved.

PL-2. Faded and Cracked Pictorial Perimeter Sign P6

- Replacement of the P6, P7, and P24 pictorial perimeter signs.
- Investigation of tire tracks on the disposal cell top.

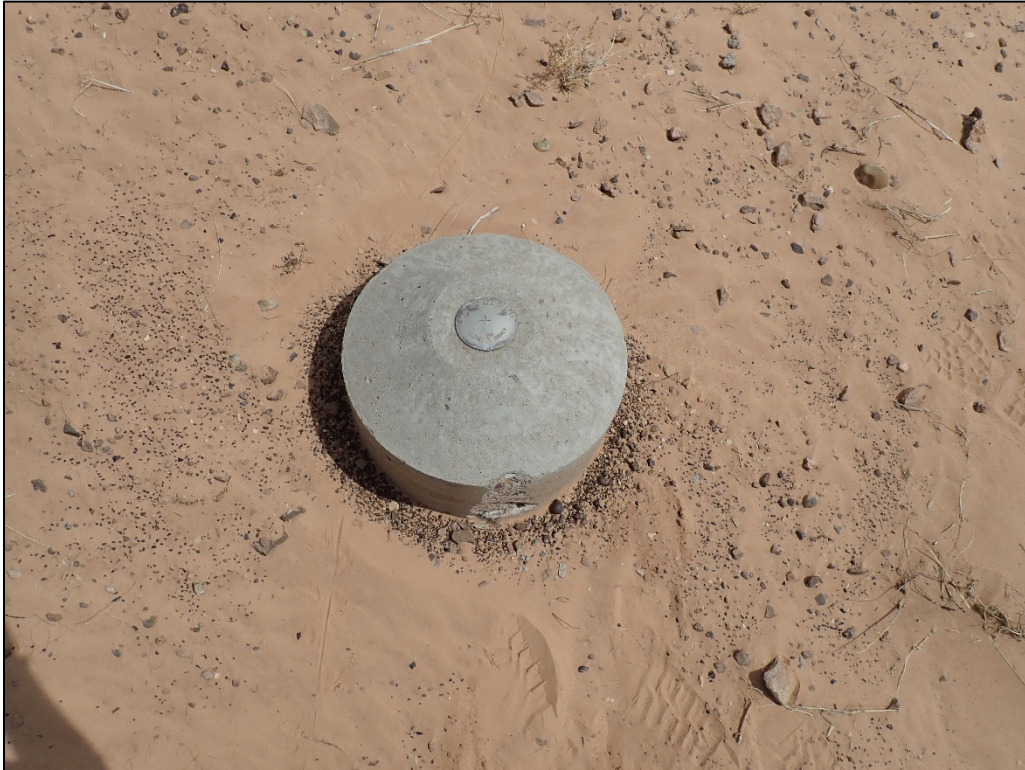
One boundary monument and three combined survey and boundary monuments delineate the corners of the site. Combined survey and boundary monuments SM/BM-1 and SM/BM-3 tend to get covered with windblown sand and are marked with steel T-posts. Boundary monument SM/BM-3 was found in this condition during the inspection and was cleared and exposed for visual detection during the inspection (PL-7). All other survey and boundary monuments were located and in good condition. No other maintenance needs were identified.

PL-3. Combined Survey Monument/Boundary Monument SM/BM-2

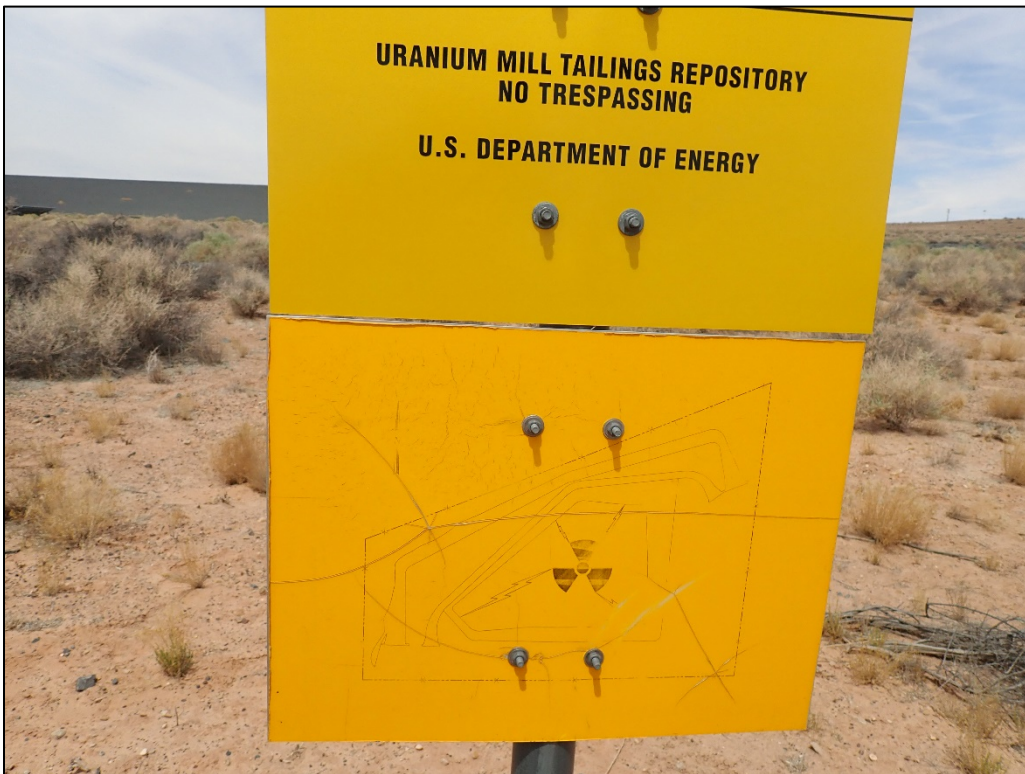
PL-4. Faded and Cracked Pictorial Perimeter Sign P24

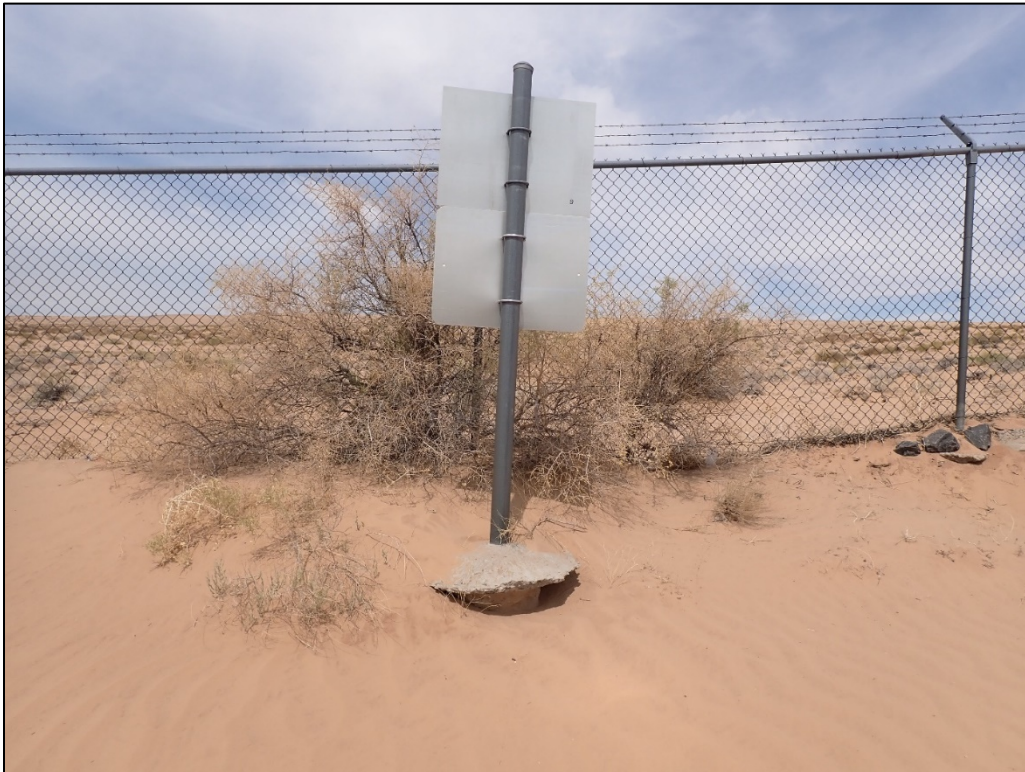
PL-5. Exposed Concrete Base of Perimeter Sign P9

- Removal of tumbleweeds along the fence near perimeter sign P26.
- Repair of the gap beneath the fence near perimeter signs P16 and P28.
- Repair of the eroding base on perimeter sign P9.
- Replacement of two caution signs near perimeter sign P12.
- Repair of animal burrows under the fence line near perimeter signs P20 and P25.
- Removal of trash and debris by perimeter sign P9.

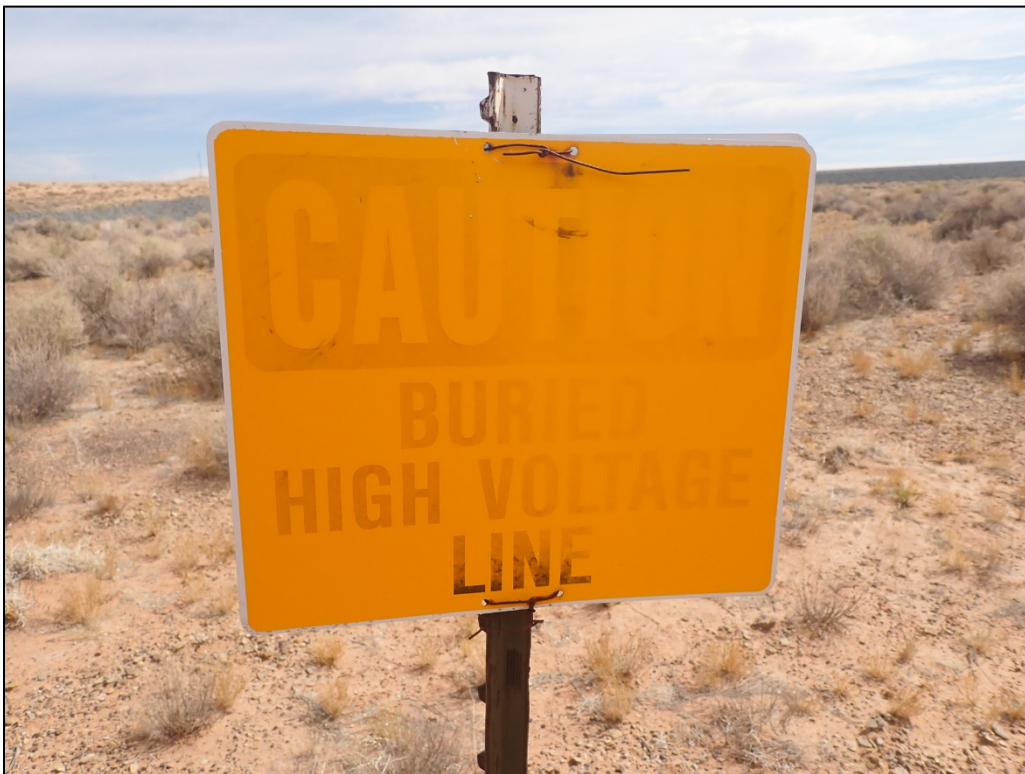
The erosion reported in 2020 under the fence near perimeter sign P16 has developed into a significant gap under the fence; a similar gap was also observed near perimeter sign P28. Animal burrows under the fence line near perimeter signs P20 and P25 identified in the 2020 inspection are still in need of repair. Perimeter sign P9 is being undercut by wind erosion (PL-5). Two faded signs warning of high voltage near perimeter sign P-12 were identified in the 2020 inspection. These maintenance tasks will be conducted once travel restrictions to the Navajo Nation are lifted (PL-6).

PL-6. Faded Caution Sign for Buried High Voltage Line

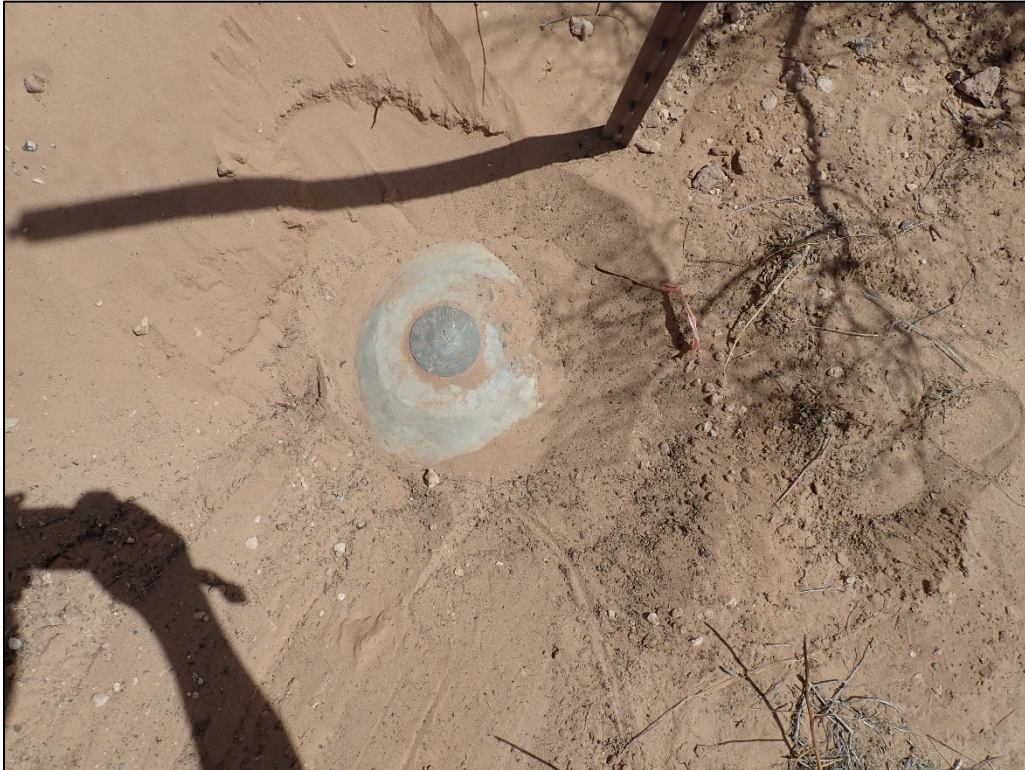
PL-7. Combined Survey Monument/Boundary Monument SM/BM-3

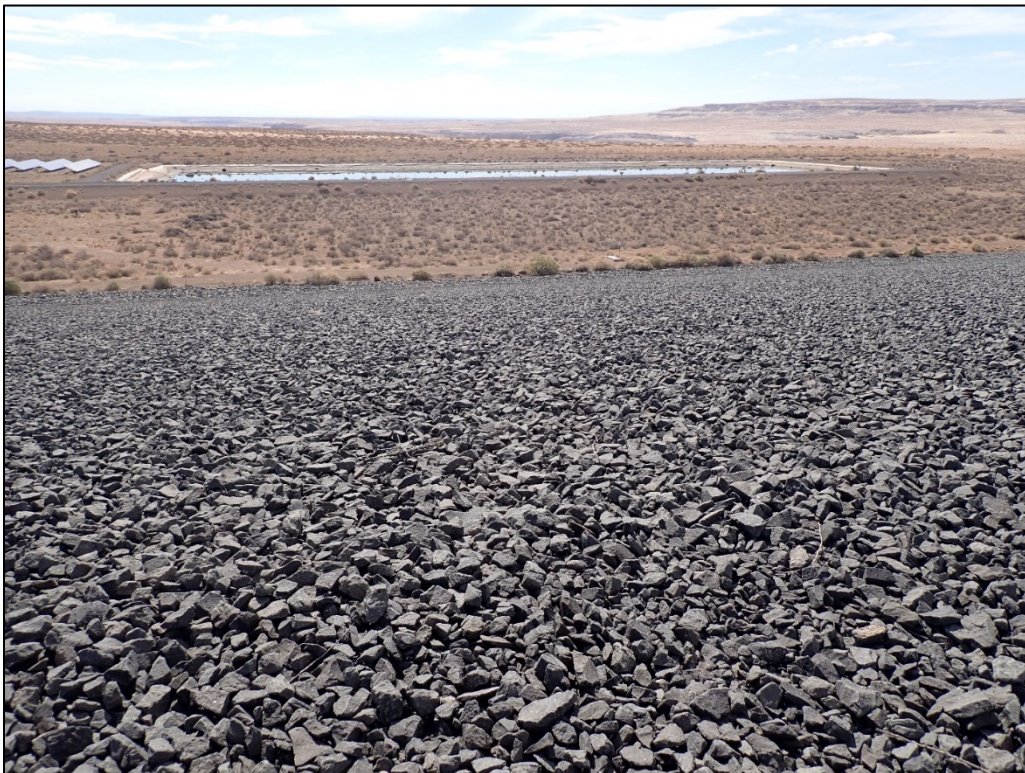
The disposal cell, completed in 1989, occupies 50 acres. The disposal cell is armored with riprap to control erosion and deter animal and human intrusion (PL-8). Inspectors detected parallel depressions from possible tire tracks on the cell top (PL-9). These will be investigated and mapped once travel restrictions are lifted. There was no evidence of erosion, settling, slumping, or other modifying process on the disposal cell.

PL-8. Disposal Cell Top Slope

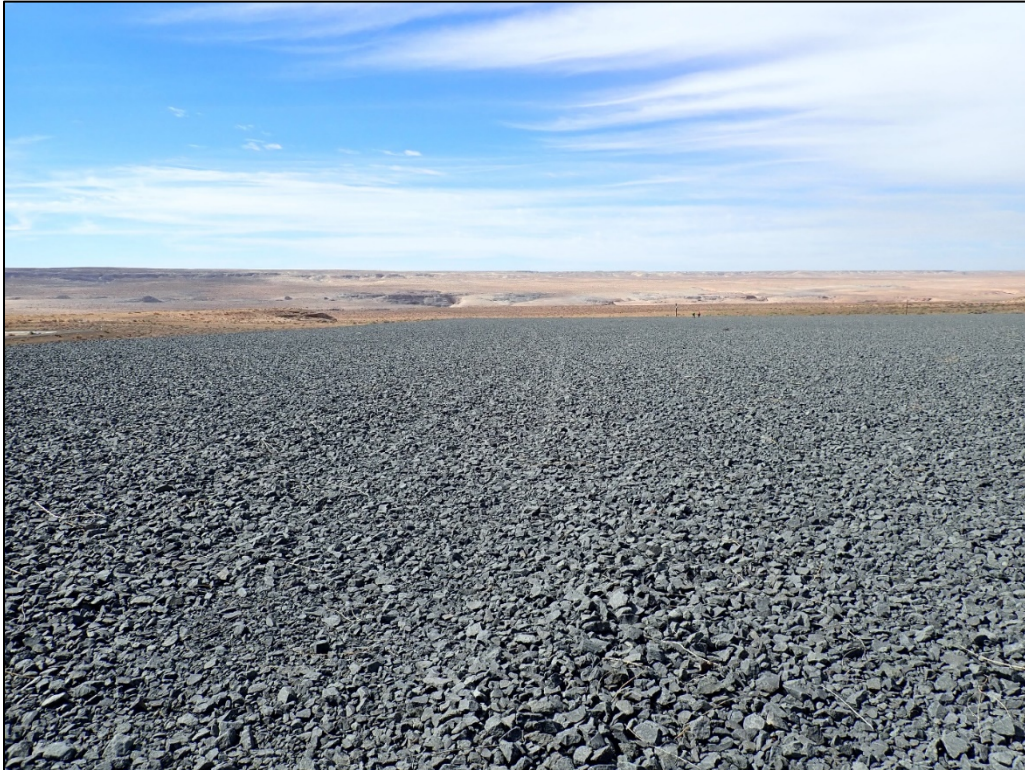
PL-9. Tire Tracks on Disposal Cell Top

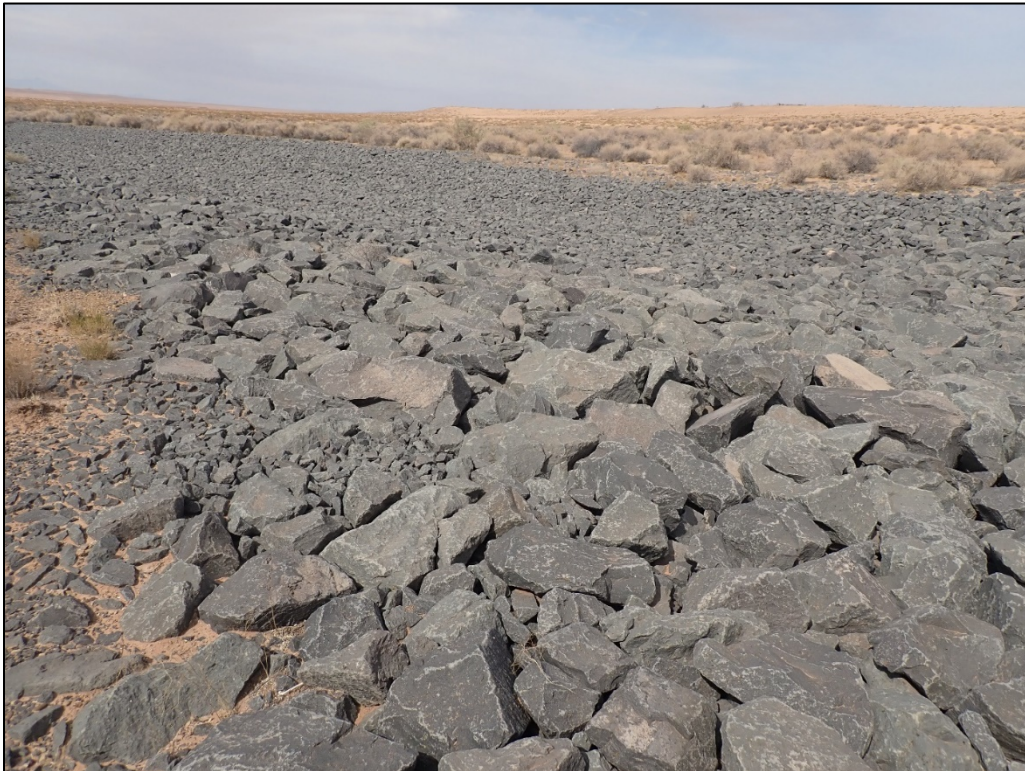
The disposal cell is protected from stormwater runoff by a disposal cell apron ditch and a diversion channel, both of which are armored with riprap and located along the north and northwest sides of the disposal cell. Windblown sand and vegetation accumulate in the apron ditch and the diversion channel (PL-10) along the north and northwest sides of the disposal cell. This sand deposition and associated vegetation establishment have not adversely affected the performance of these structures. No evidence of recent or past water flows was observed in the apron ditch or the diversion channel.

PL-10. Minor Sedimentation and Plant Growth in Mouth of South Apron Ditch

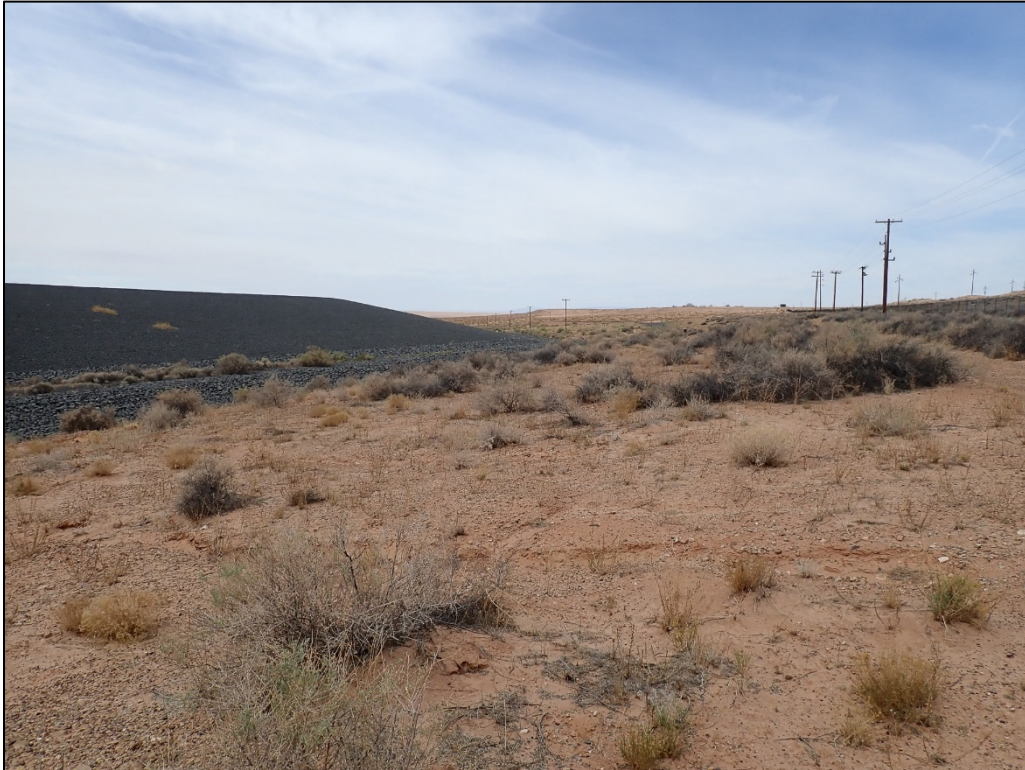
Inspectors noticed that much of the vegetation in reclaimed areas around the disposal cell appeared to be dormant or dead. This is likely the result of a prolonged drought in the region (<https://www.epa.gov/climate-indicators/southwest>). No action is necessary at this time.

PL-11. Drought-Stricken Vegetation in Reclaimed Area

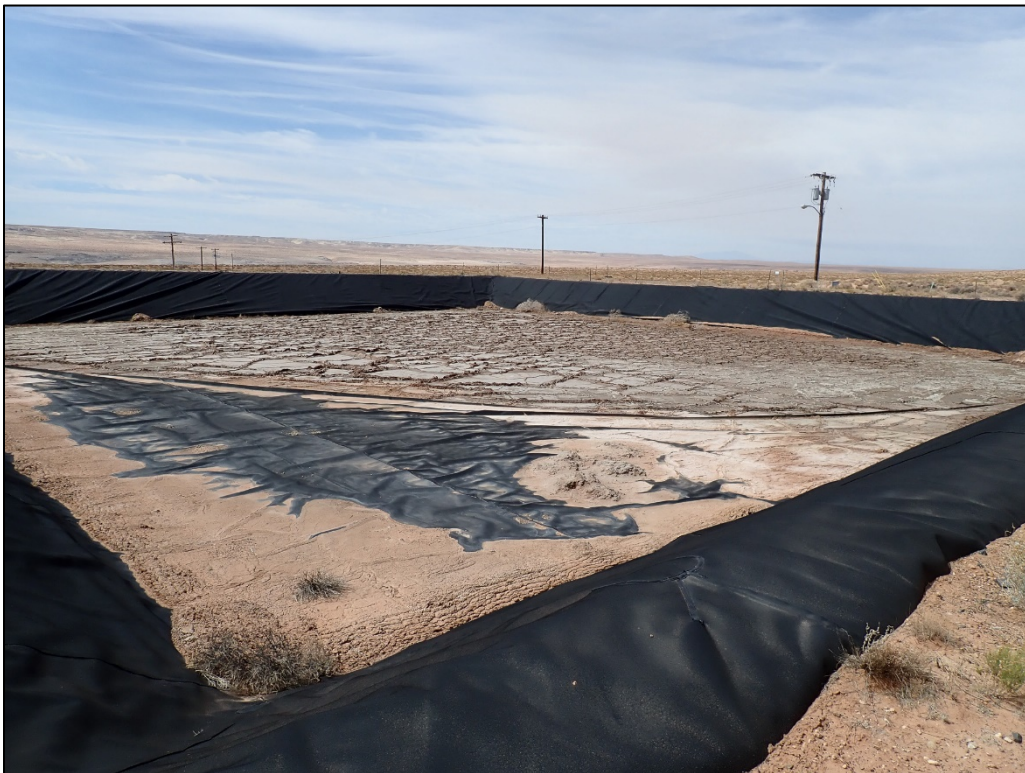
The remaining evaporation pond, filled minimally with windblown sand and evaporites, is retained as a backup for the main evaporation pond on the east side of the site (PL-12). The steel cable and caution signs surrounding the pond were in good condition. The high-density polyethylene liner was in good condition. The plastic geofabric that stabilizes the south-facing slope of the pond remains exposed. No repairs of the geofabric are needed at this time, as it remains mostly buried and continues to stabilize the slope. Inspectors will continue to monitor this area. No maintenance needs were identified.

PL-12. Evaporites and Windblown Sand in Inactive Evaporation Pond
