19.0 Tuba City, Arizona, Disposal Site

19.1 Compliance Summary

The Tuba City, Arizona, Uranium Mill Tailings Radiation Control Act (UMTRCA) Title I Disposal Site was inspected on May 17, 2022. No significant changes were observed on the disposal cell or in the associated drainage features. Inspectors identified maintenance needs but found no cause for a follow-up inspection.

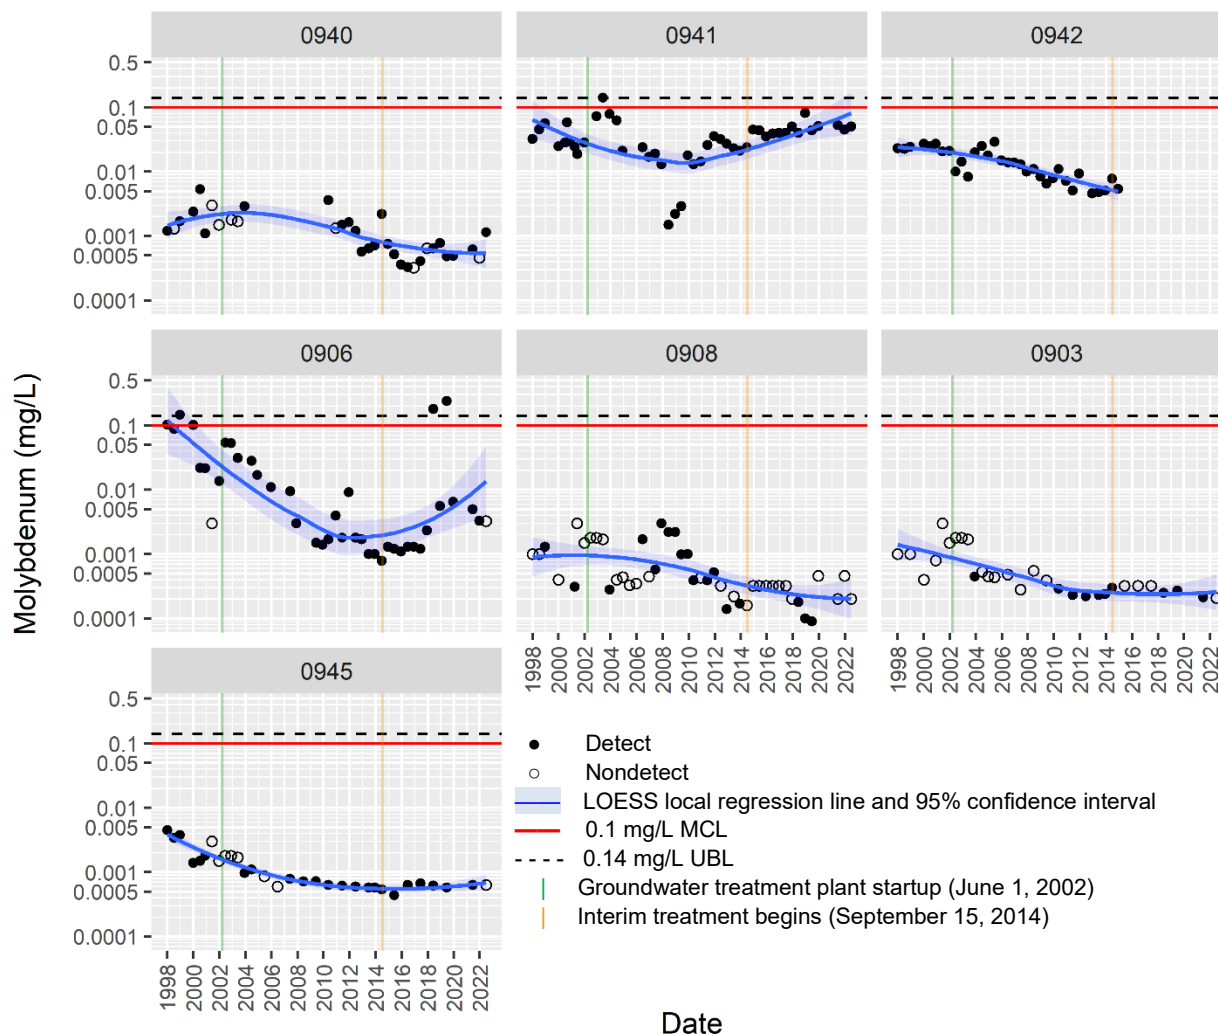
Figure 19-3. Time-Concentration Plots of Molybdenum in Groundwater at the Tuba City, Arizona, Disposal Site

Since 2004, molybdenum concentrations have been below both the 0.10 milligram per liter (mg/L) MCL and the 0.14 mg/L UBL in all LTSP evaluative monitoring wells except well 0906 in August 2019 (Figure 19-3). Overall, molybdenum concentrations have been highest in well 0941, averaging about 0.04 mg/L. Concentrations in this well have increased since 2015 but are still below the UBL (most recent result of 0.05 mg/L). Molybdenum concentrations in wells 0940, 0908, and 0903 have been comparable to concentrations in background well 0945. In August 2019, the molybdenum concentration in well 0906 (0.18 mg/L) exceeded the UBL for the

first time since 1999. Concentrations declined the following February but then exceeded the UBL again in August 2019 (0.24 mg/L). Both UBL exceedances coincided with the pumping campaigns. Molybdenum concentrations in well 0906 have since declined to levels well below both the MCL and the UBL (≤ 0.007 mg/L). The most recent (August 2022) was below the detection limit value (<0.003 mg/L).

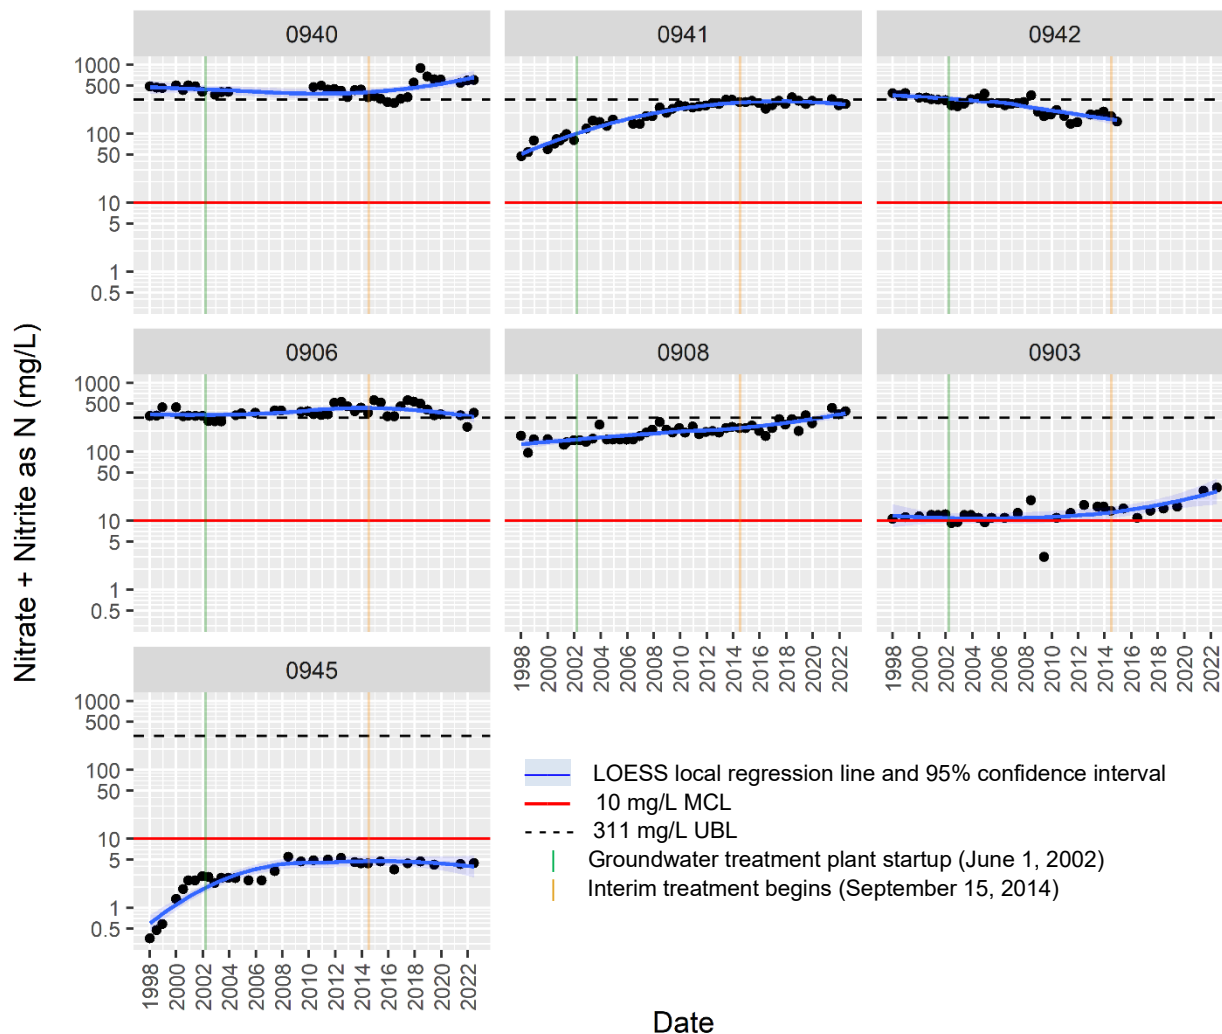
Figure 19-4. Time-Concentration Plots of Nitrate in Groundwater at the Tuba City, Arizona, Disposal Site

Nitrate (+ nitrite as nitrogen [N]) concentrations have historically exceeded the 10 mg/L MCL in all LTSP evaluative wells except background well 0945 (Figure 19-4). The 311 mg/L UBL has been exceeded in all downgradient evaluative monitoring wells except southernmost well 0903, approximately 1250 feet south of the site perimeter. The UBL has been exceeded consistently in wells 0940 and 0906, but only recently (in the last several years) in wells 0941 and 0908. Nitrate

concentrations in well 0941 exceeded the UBL twice, first in August 2018 (340 mg/L) and again (slightly) in August 2021 (318 mg/L); the most recent (August 2022) result was 270 mg/L.

In westernmost well 0908, nitrate exceeded the 311 mg/L UBL for the first time in August 2019. Levels have remained elevated since August 2021, when the maximum concentration of 434 mg/L was detected. Nitrate concentrations in southernmost downgradient well 0903, although regularly exceeding the MCL since 2004, have remained below the UBL. However, results have slightly increased since about 2014, with the maximum result (30.1 mg/L) detected in August 2022. In summary, in 2022, the UBL was exceeded in three compliance monitoring wells: 0940 (590–605 mg/L), 0906 (370 mg/L), and 0908 (350–391 mg/L).

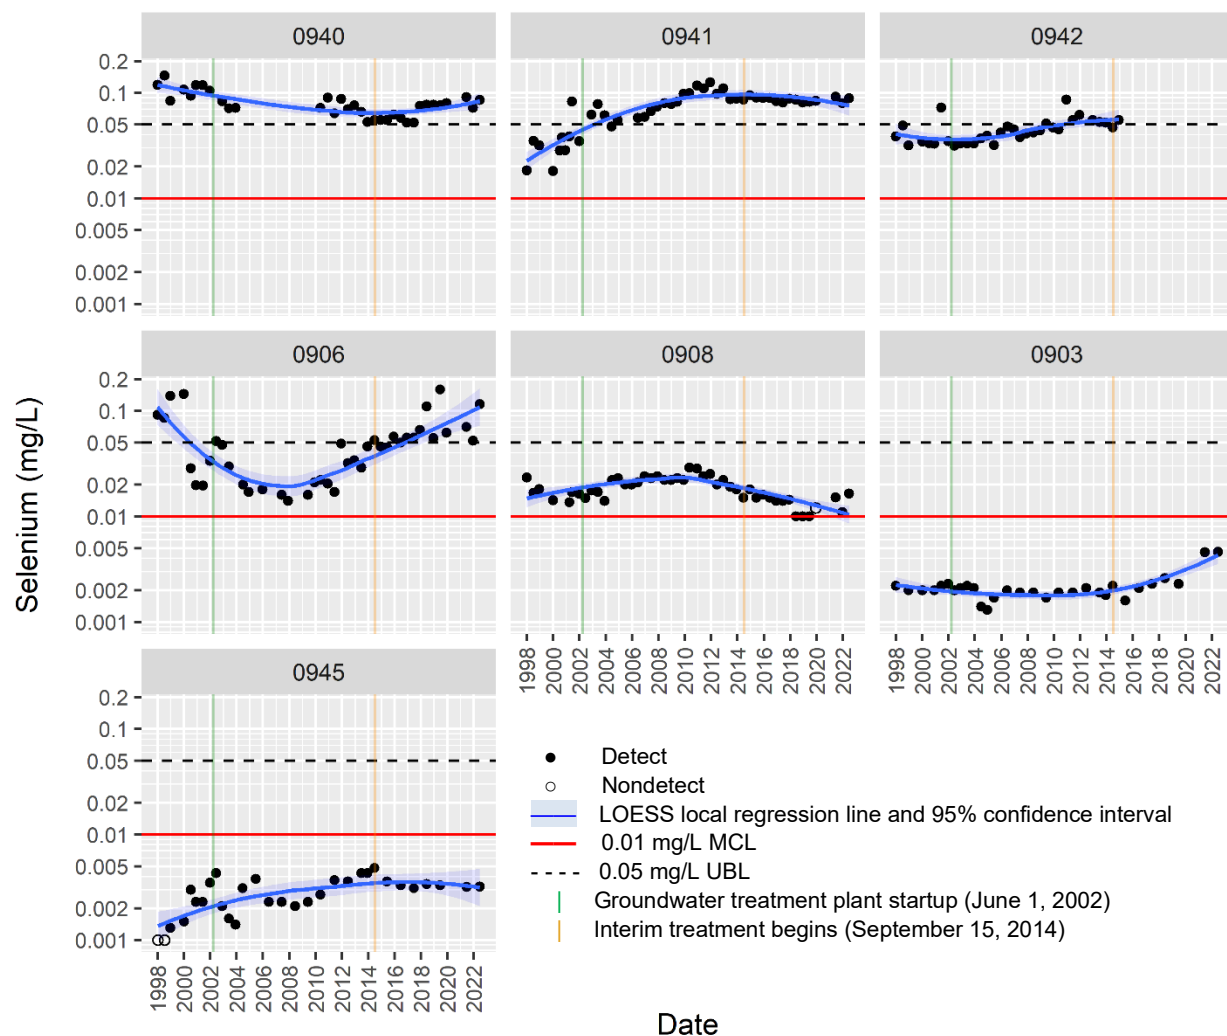
Figure 19-5. Time-Concentration Plots of Selenium in Groundwater at the Tuba City, Arizona, Disposal Site

Selenium concentrations have historically exceeded the 0.01 mg/L MCL in all LTSP evaluative wells except background well 0945 and distal well 0903 (Figure 19-5). The 0.05 mg/L UBL has been exceeded consistently in wells 0940 and 0941, immediately downgradient of the disposal cell, since 1998 and 2005, respectively. Selenium concentrations in both wells have been stable, however, averaging about 0.07 mg/L and 0.09 mg/L (respectively) since 2010; the most recent results were 0.085 and 0.089 mg/L. Since 2018, the highest selenium concentrations have been measured in well 0906. After declining from 0.15 mg/L in 2000 to 0.014 mg/L in 2008, concentrations have since increased; the most recent result was 0.12 mg/L (Figure 19-5). The increase in selenium concentrations in well 0906 since 2009 correlates with the time that average annual cumulative extraction rates dropped from 80 to 35 gallons per minute (gpm) due to intermittent shutdowns of the groundwater treatment plant for maintenance (DOE 2020).

Selenium concentrations in well 0908 have been consistently at or above the 0.01 mg/L MCL but remain below the 0.05 mg/L UBL since 1998 (the most recent result was 0.017 mg/L). Selenium concentrations in southernmost downgradient well 0903 have consistently been below both the UBL and the MCL. Concentrations have increased slightly in recent years, however, from 0.0016 mg/L in 2015 to 0.0046 mg/L in August of 2021 and 2022.

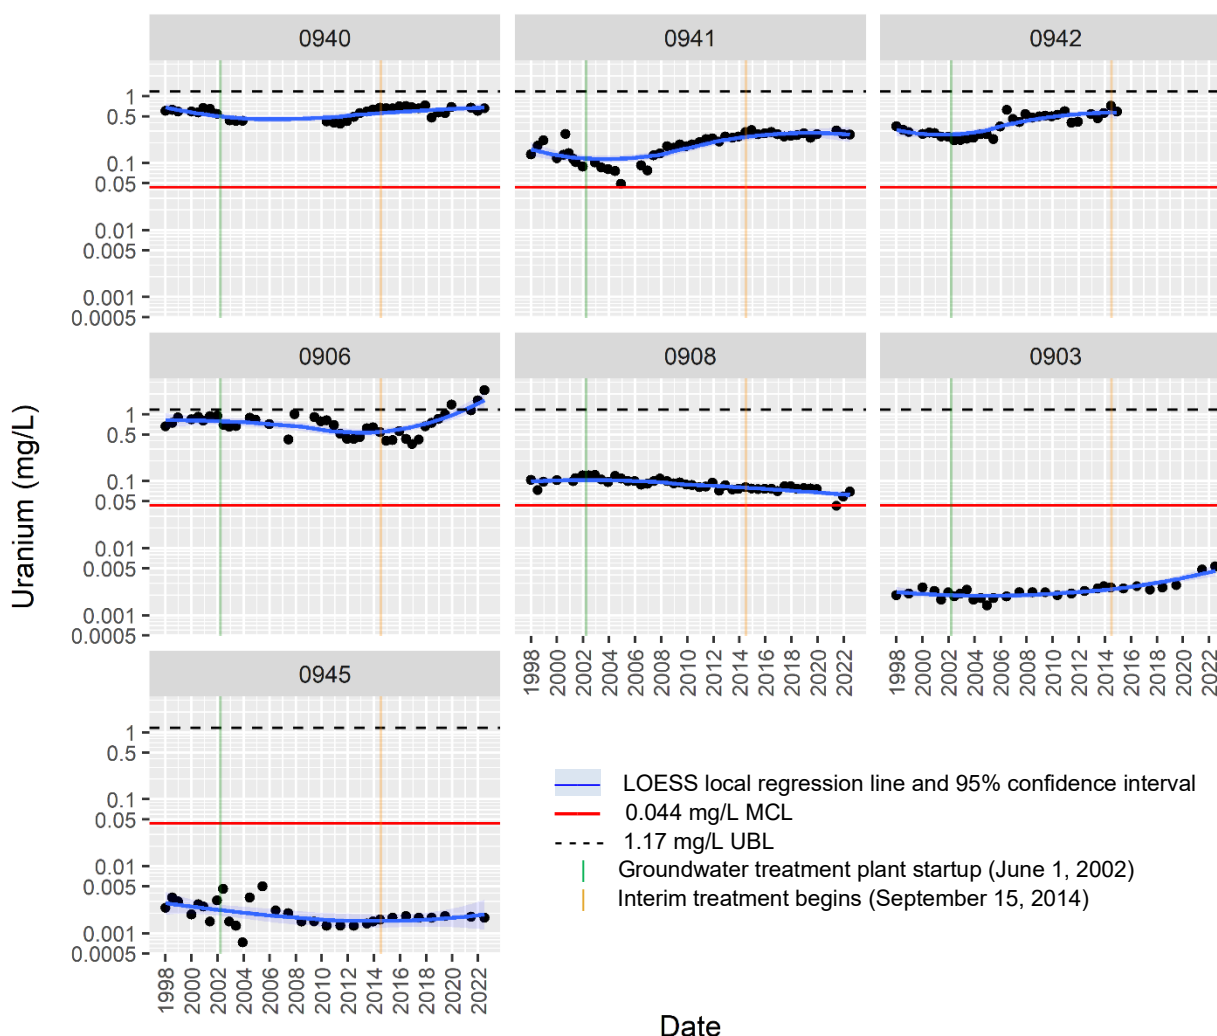
Figure 19-6. Time-Concentration Plots of Uranium in Groundwater at the Tuba City, Arizona, Disposal Site

Uranium concentrations have historically exceeded the 0.044 mg/L MCL in all downgradient compliance wells except for distal downgradient well 0903 and a single (August 2021) measurement in well 0908 (Figure 19-6). The 1.17 mg/L UBL has not been exceeded except for recent measurements in well 0906. Uranium concentrations in this well increased from 0.36 mg/L in February 2017 to 1.4 mg/L in February 2020. Following a slight decline in August 2021, concentrations increased again, to 1.6 mg/L in February 2022 and (a historical maximum) 2.3 mg/L in August 2022. Uranium concentrations in well 0908 exhibit a slight decreasing trend, with the most recent results (0.07–0.08 mg/L) just slightly exceeding the 0.044 mg/L MCL. In contrast, increasing uranium concentration trends are apparent in wells 0906 and 0903 (refer to DOE 2022b for a detailed evaluation). Although below both the MCL and the UBL, the most recent uranium concentration in well 0903 is the highest result on record for this well at 0.0054 mg/L.

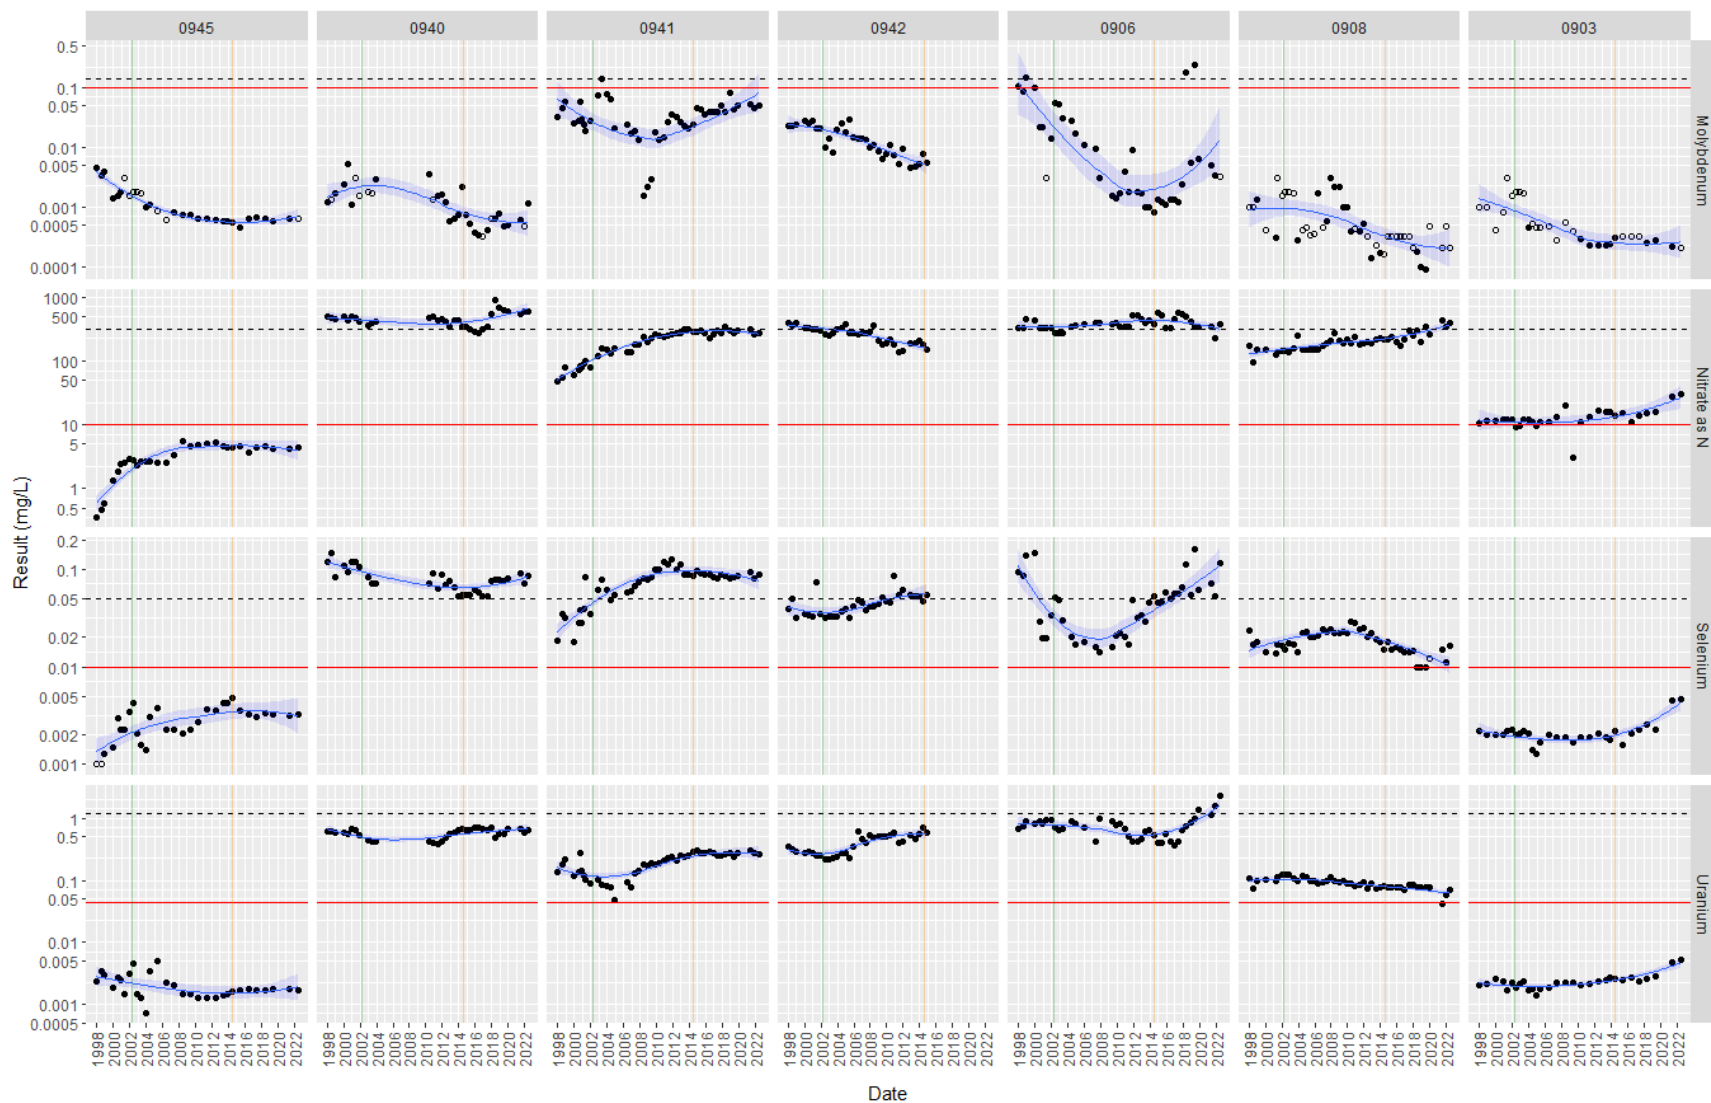
Figure 19-7. Summary of Historical Evaluative Monitoring Results at the Tuba City, Arizona, Disposal Site (1998–2022)

In summary, analytical results from the 2022 evaluative monitoring effort indicate that groundwater quality in downgradient wells is still degraded relative to background concentrations in upgradient well 0945 (Figure 19-7). The only exceptions to the latter are molybdenum concentrations in wells 0908 and 0903, that are comparable to background. Apart from a few historical results for well 0906, molybdenum concentrations in all downgradient wells have been below the corresponding MCL of 0.1 mg/L. Nitrate concentrations have recently increased in several site wells, with the 311 mg/L UBL currently exceeded in wells 0940, 0906, and 0908. Selenium concentrations currently exceed the 0.05 mg/L UBL in wells 0940, 0941, and 0906 and have increased significantly in well 0906 since 2008. Except for recent measurements in well 0906, uranium concentrations have been below the 1.17 mg/L UBL in all evaluative monitoring wells. Increases in uranium and molybdenum concentrations in well 0906 starting around 2014 correlate with the timing of the groundwater treatment plant shutdown, after which, the site began operating under interim treatment with an average annual cumulative extraction rate of 7 gpm. Analysis of water quality trending and progress of the groundwater remedy are reported in the site-specific remedy performance reports for the Tuba City site (DOE 2020; DOE 2022b).

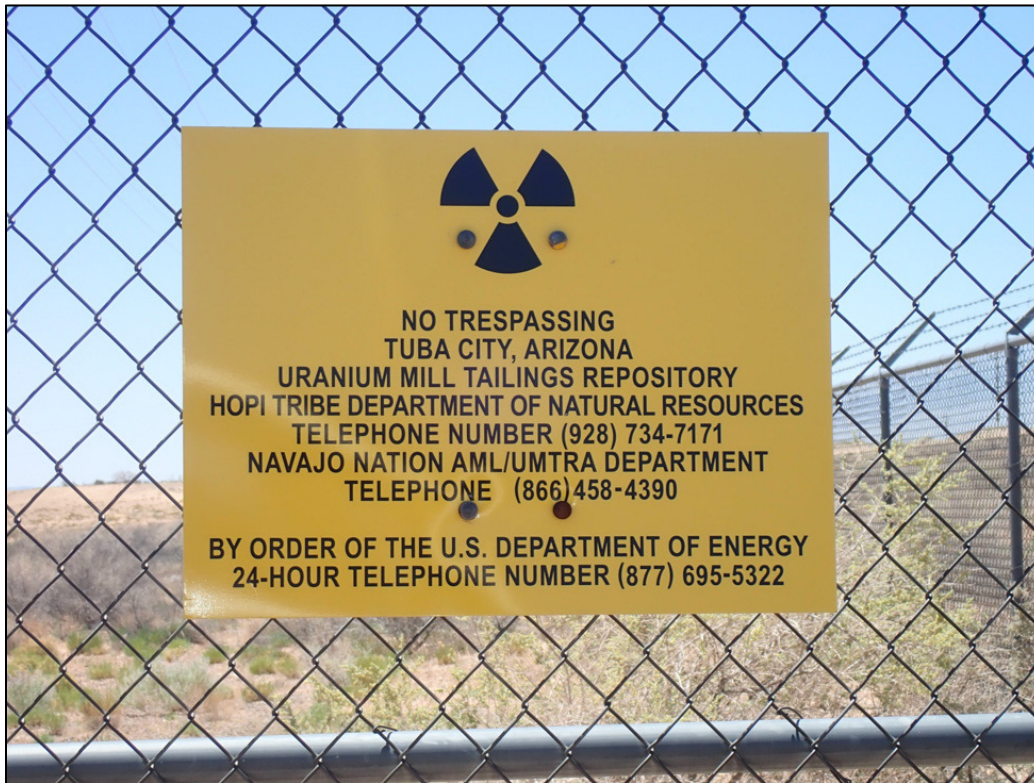
Entrance signs are posted on the main highway gate, near the entrance gate, and on two vehicle gates (No. 1 and No. 2). Vehicle Gate No. 3, in the northeast corner of the site, purposefully does not have a sign. An informational sign exists on the main entrance gate (PL-1). No maintenance needs were identified.

PL-1. Entrance Sign

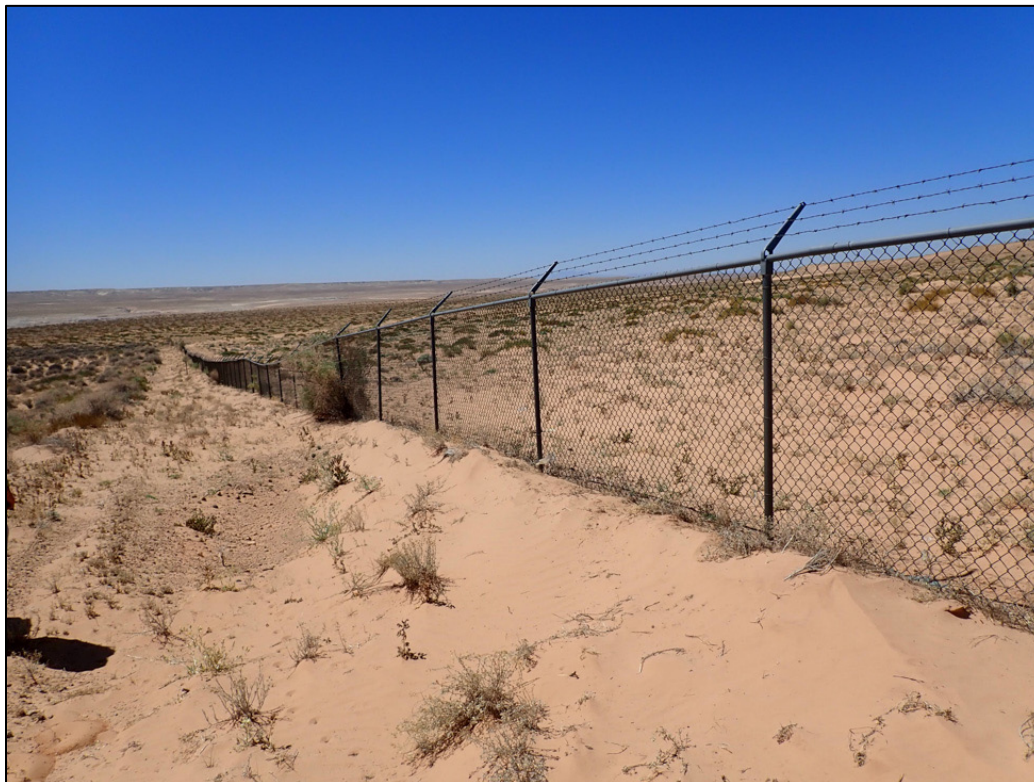
A chainlink perimeter fence encloses the site. Windblown sand and tumbleweeds regularly accumulate along the perimeter fence line and road (PL-2 and PL-3) resulting in several gaps under the fence (PL-4). These areas will be repaired before the next inspection. Trash and debris have accumulated around perimeter sign P9 and were removed following the inspection.

PL-2. West Perimeter Fence with Sand Deposition

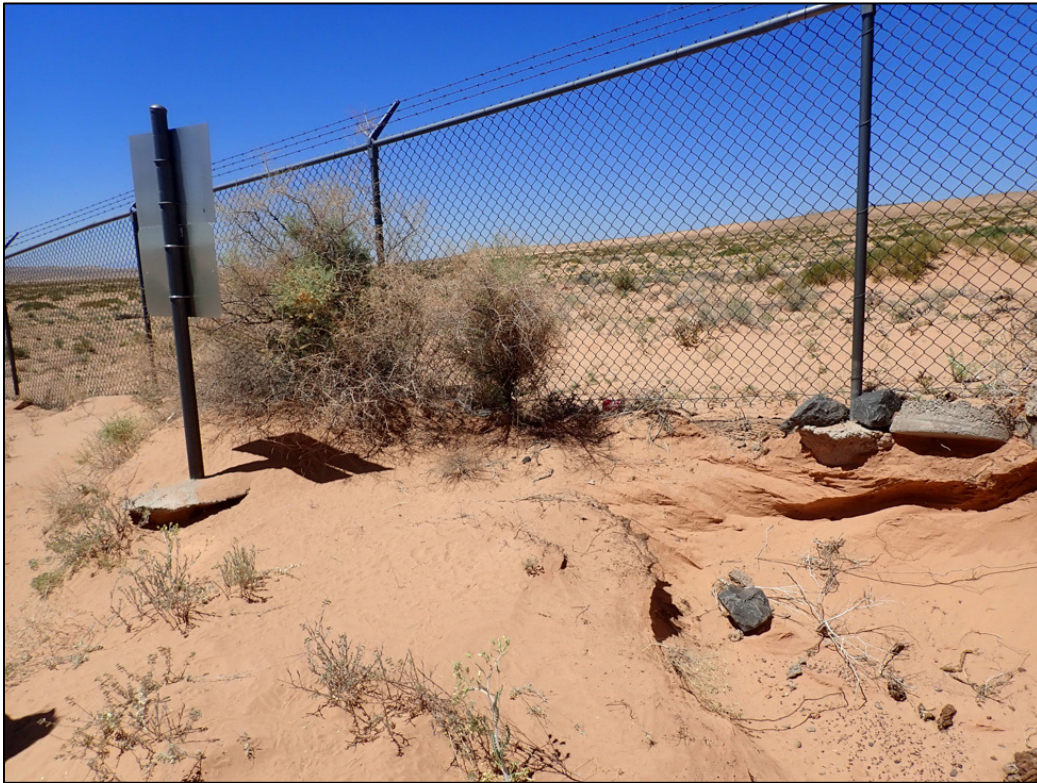
PL-3. Vegetation and Debris on Fence near Perimeter Sign P9

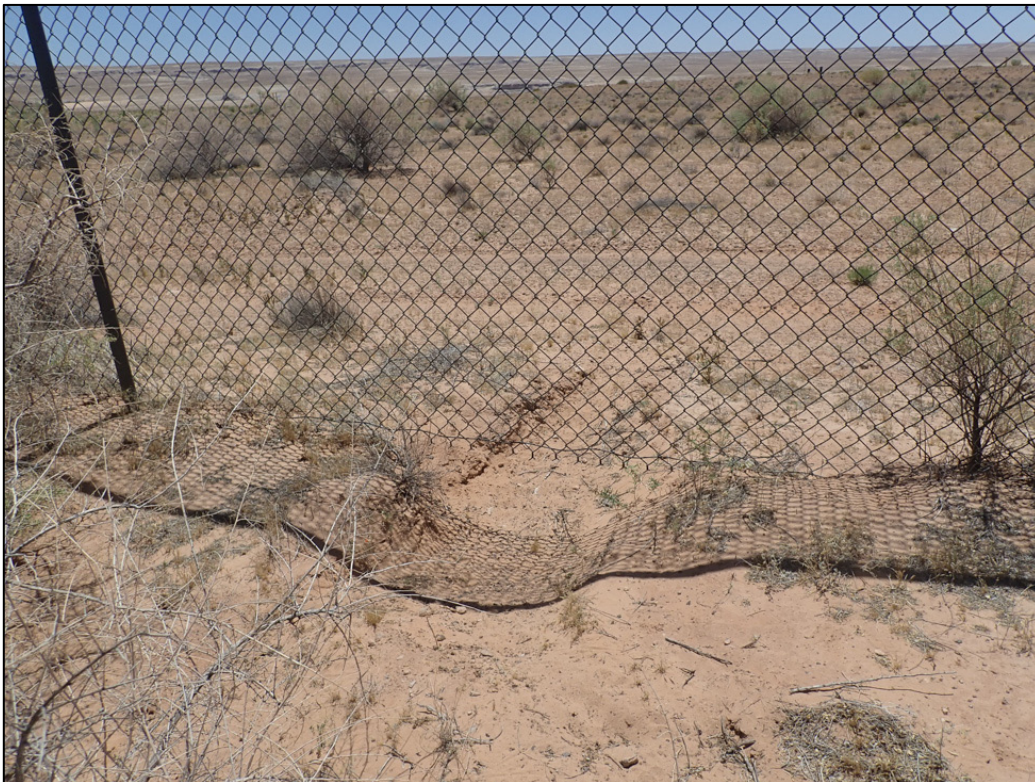
PL-4. Gap Under Perimeter Fence near Perimeter Sign P9

- Treatment of the vegetation on the side slopes of the disposal cell
- Replacement of two caution signs near perimeter sign P12
- Repair of the gap in the fence near perimeter sign P9
- Implementation of habitat enhancements to reduce potential fire hazards at the site

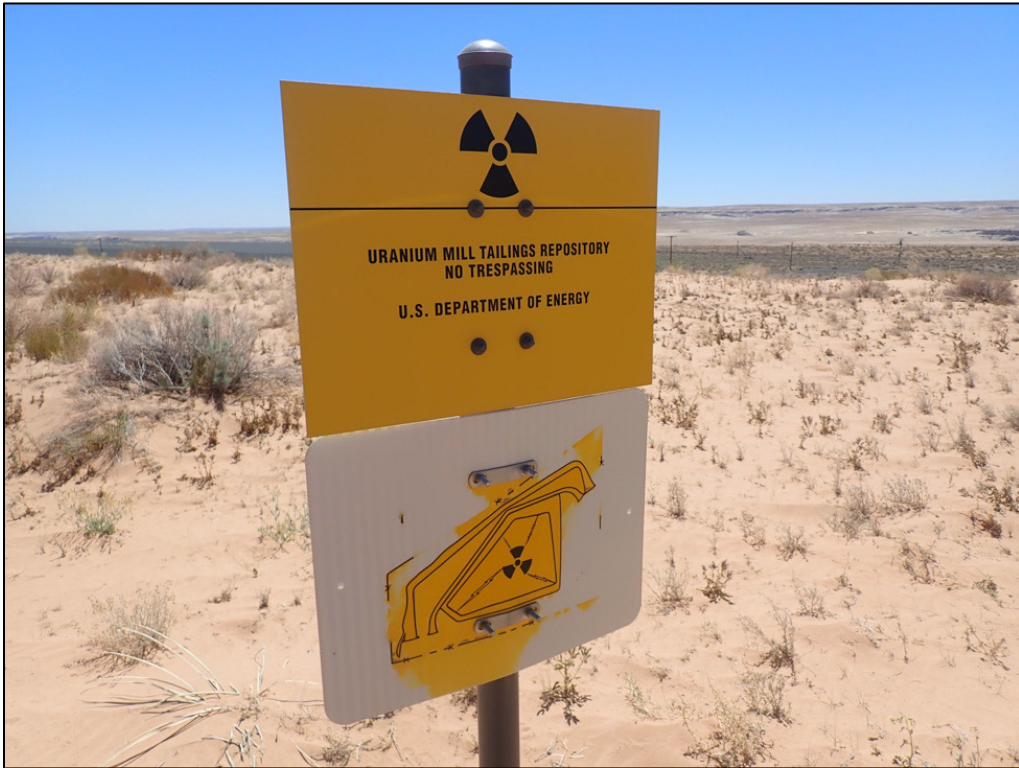
Thirty pairs of perimeter signs, designated P1 through P30, are attached to steel posts set in concrete directly inside and along the perimeter fence. One of the sign pairs is textual, and the other is pictorial. Pictorial signs P6, P7 (PL-5), P8, P9, and P24 and textual sign P22 were damaged and were replaced following the inspection. In previous years, perimeter sign P9 was reported to be undercut by wind erosion and was repaired following the inspection. Two faded signs warning of high voltage near perimeter sign P12 need to be replaced. No other maintenance needs were identified.

PL-5. Perimeter Sign P7; Pictorial Sign Damaged

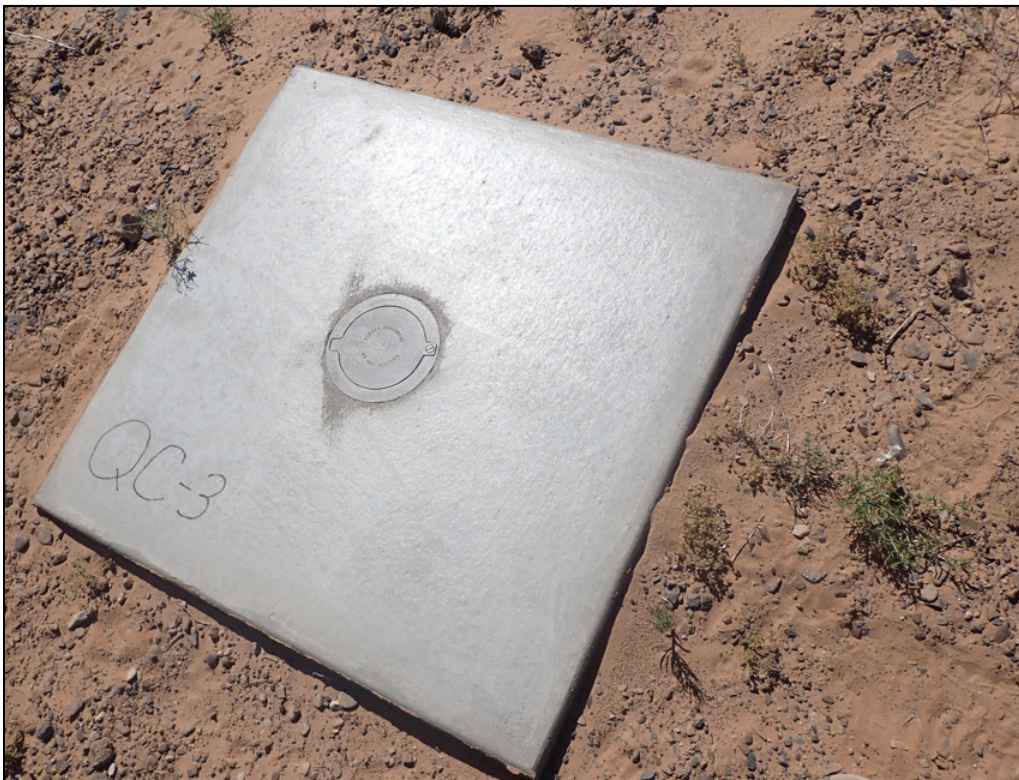
Five aerial survey quality control (QC) monuments were installed before the 2022 inspection as identified in Figure 19-1. All were located and in good condition (PL-6). No maintenance needs were identified.

PL-6. Quality Control Monument QC-3

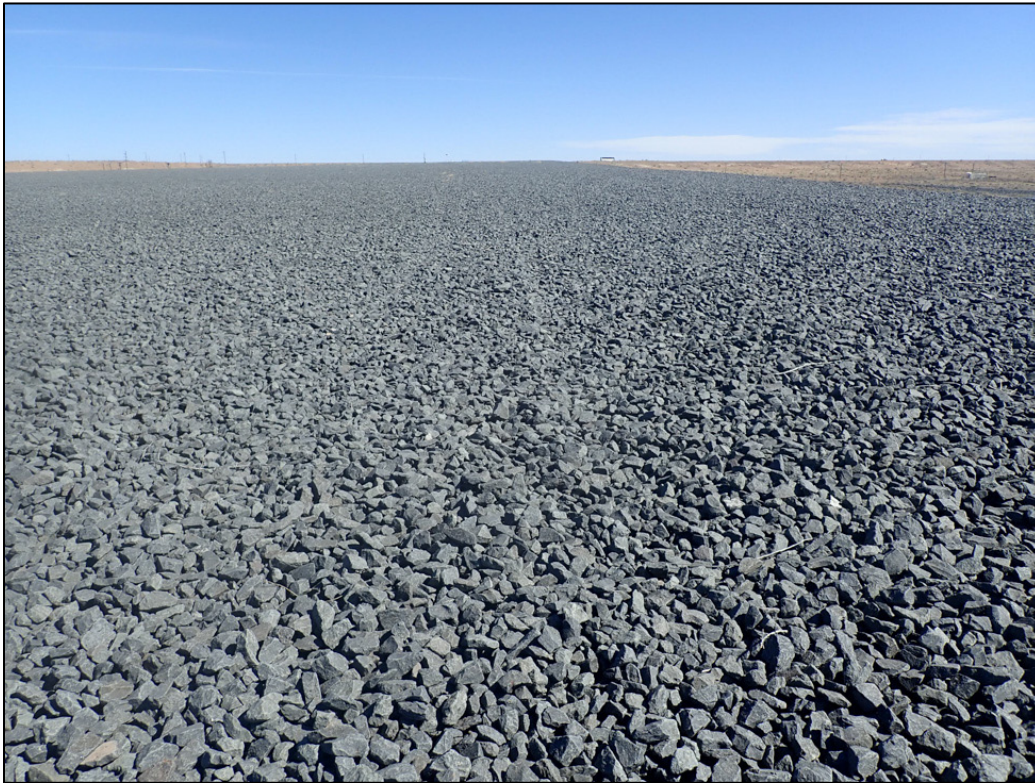
The disposal cell, completed in 1989, occupies 50 acres. The disposal cell is armored with riprap to control erosion and deter animal and human intrusion. Inspectors confirmed parallel tracks on the top slope of the disposal cell (PL-7) reported in previous annual reports. This area will continue to be monitored. There was no evidence of erosion, settling, slumping, or other modifying processes on the disposal cell.

PL-7. Parallel Tracks Visible on Top of Disposal Cell

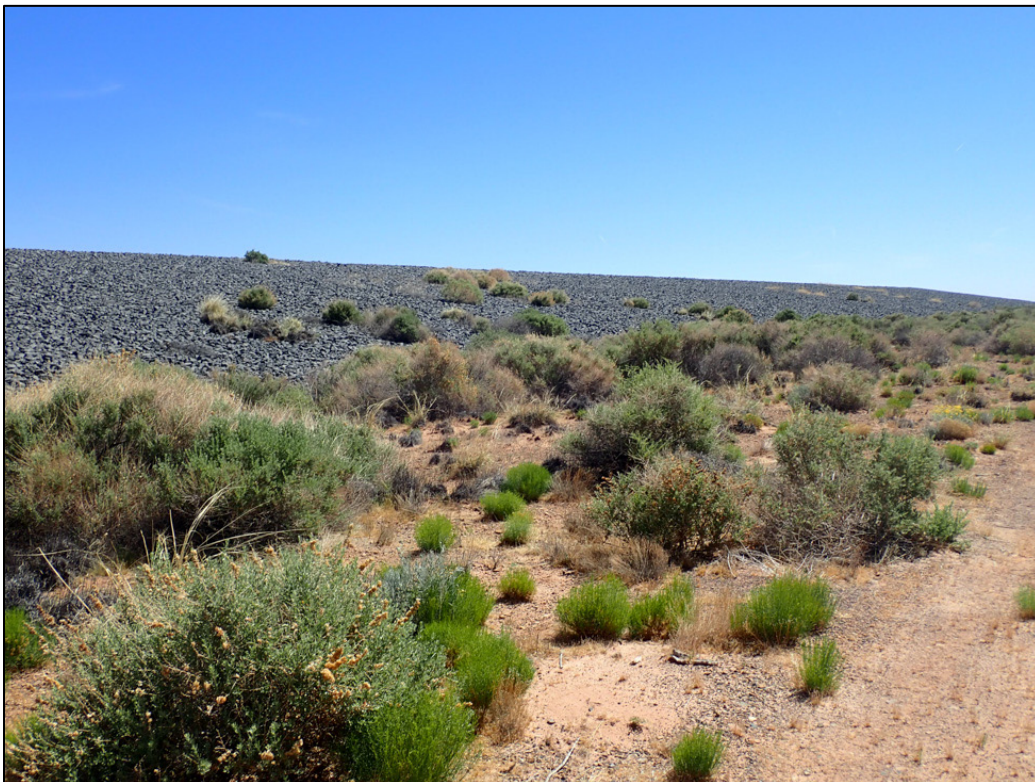
In accordance with the LTSP, deep-rooted vegetation is controlled to prevent potential penetration of the radon barrier. Windblown sediments continue to accumulate on the rock-covered surfaces, providing a favorable environment for plant growth. Periodic spot-application of herbicide has been effective in controlling deep-rooted vegetation growth on the disposal cell cover. No deep-rooted shrubs were observed on top of the disposal cell, but some shrubs have become established on the side slopes (PL-8). This area will continue to be monitored. No other maintenance needs were identified.

PL-8. Vegetation on South Slope of Disposal Cell

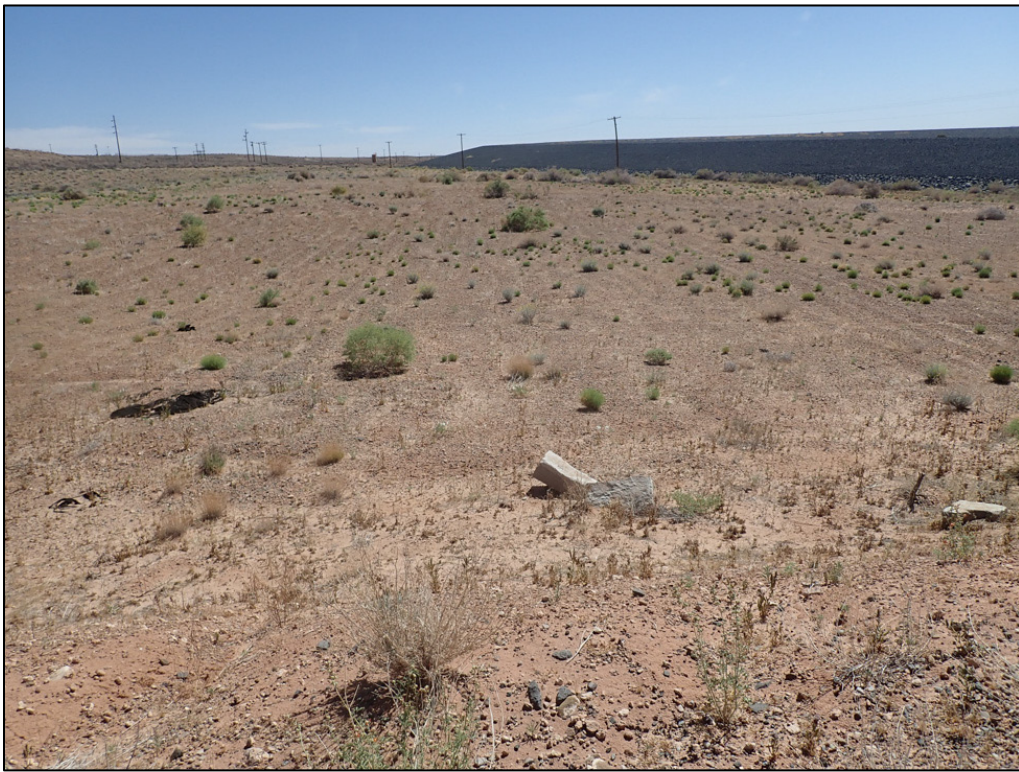
Two of the three evaporation ponds near the northwest side of the disposal cell were removed in 2007. The area was reclaimed and seeded with a native seed mix in 2007 and again in 2013. Perennial vegetation is establishing in these areas (PL-9).

PL-9. Revegetated Area of Former Evaporation Ponds

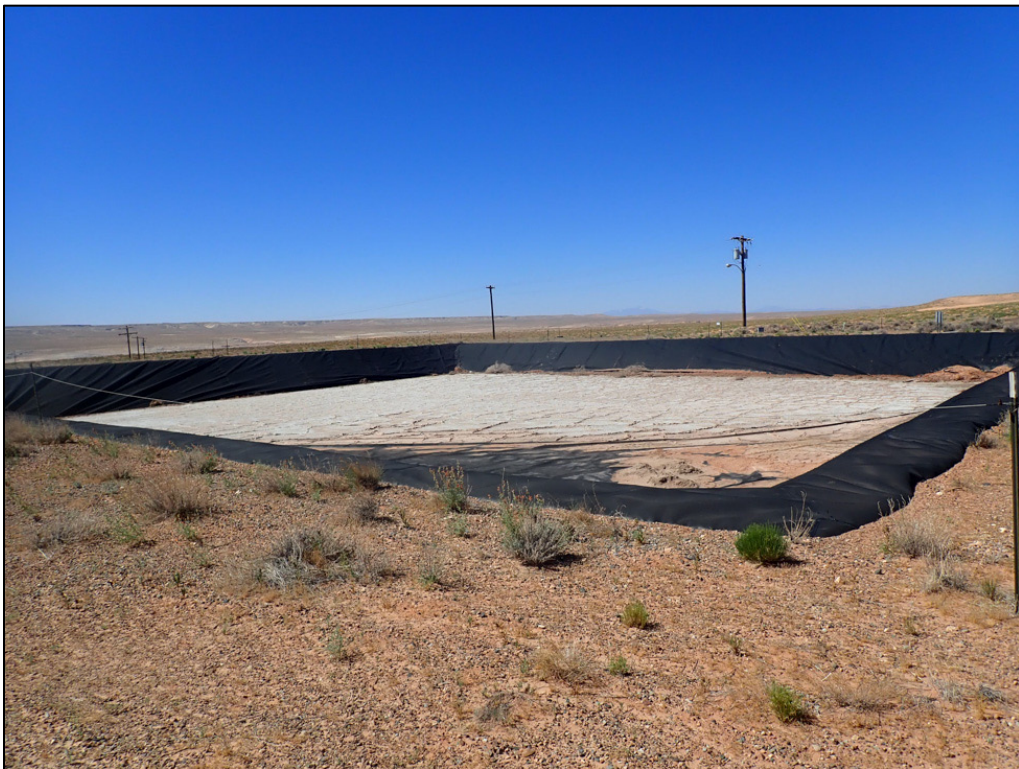
The remaining historical evaporation pond, containing windblown sand and evaporites (PL-10), is retained as a backup for the main evaporation pond on the east side of the site. The steel cable and caution signs surrounding the pond and the high-density polyethylene liner were intact. The plastic geofabric that stabilizes the south-facing slope of the pond remains exposed. No repairs of

the geofabric are needed at this time, as it remains mostly buried and continues to stabilize the slope. Inspectors will continue to monitor this area. No other maintenance needs were identified.

PL-10. Inactive Evaporation Pond
