## 19.0 Tuba City, Arizona, Disposal Site

### 19.1 Compliance Summary

The Tuba City, Arizona, Uranium Mill Tailings Radiation Control Act (UMTRCA) Title I Disposal Site was inspected on May 2, 2023. No significant changes were observed on the disposal cell or in the associated drainage features. Inspectors identified maintenance needs but found no cause for a follow-up inspection.

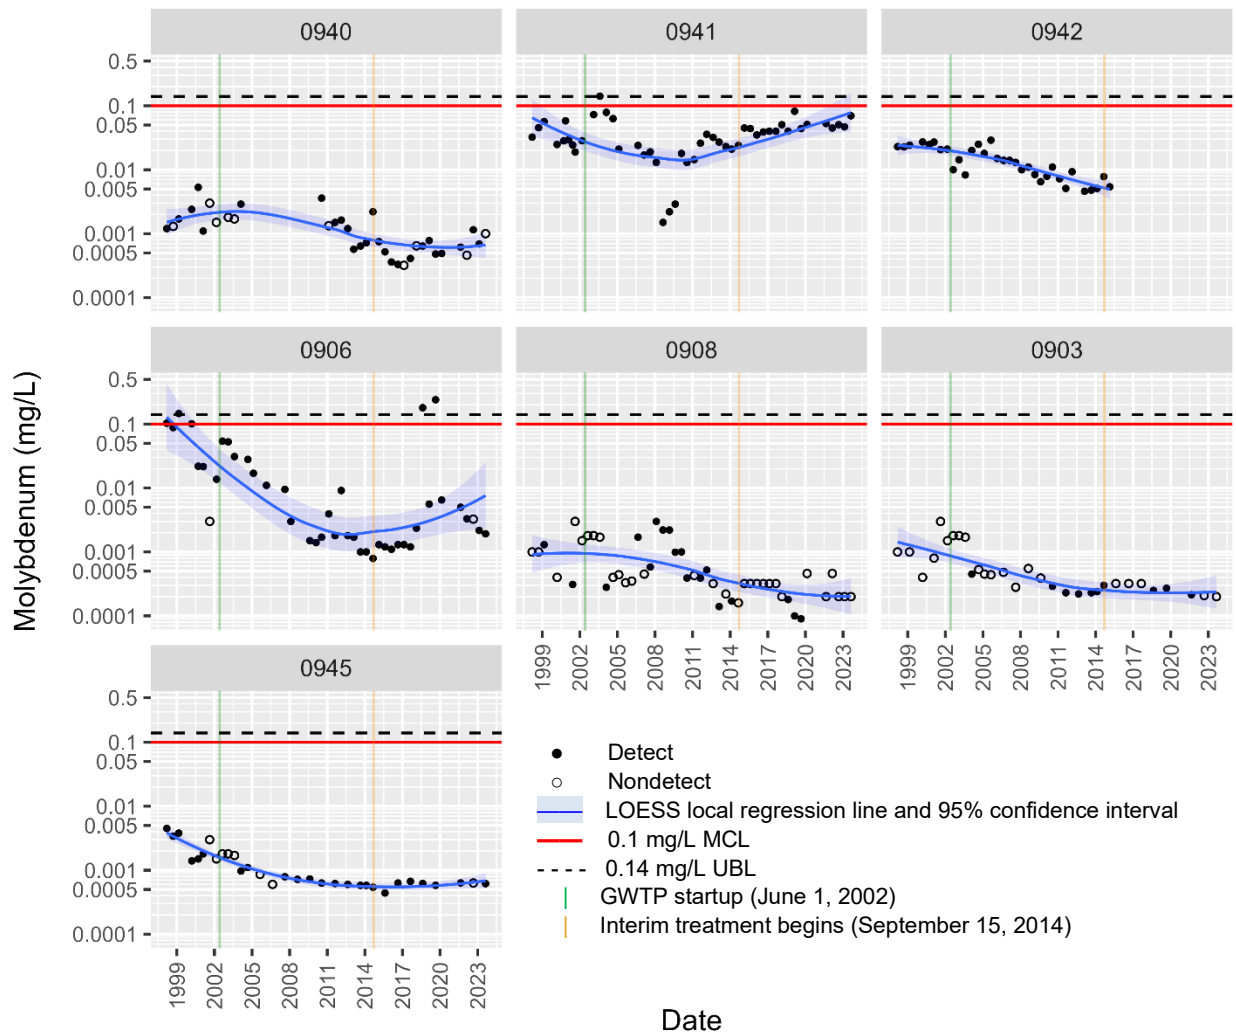
*Figure 19-3. Time-Concentration Plots of Molybdenum in Groundwater at the Tuba City, Arizona, Disposal Site, 1998–2023*

Since 1998, molybdenum concentrations have been mostly at or below the 0.14 milligram per liter (mg/L) UBL, and in most cases the 0.1 mg/L MCL, in all LTSP evaluative monitoring wells (Figure 19-3). The few exceptions apply to well 0906: 0.15 mg/L in February 1999 and 0.18–0.24 mg/L in 2018–2019. The latter spikes coincide with the short-duration, high-intensity pumping campaigns. Although a statistically significant decreasing trend is found for the 1998–2023 time frame (Table 19-4), molybdenum concentrations in well 0906 have been increasing since 2015 (Figure 19-3). That trend is not statistically significant, however (Table 19-5), and the most recent result, 0.0019 mg/L, is well below both the UBL and the MCL. Molybdenum concentrations in well 0941 have increased since 2015, accounting for the statistically significant trend overall, and are approaching the MCL (most recent result of 0.070 mg/L). Molybdenum concentrations in wells 0940, 0908, and 0903 have been comparable to concentrations in background well 0945. Most results for wells 0908 and 0903 have been below detection limits (Figure 19-3) (Table 19-4).

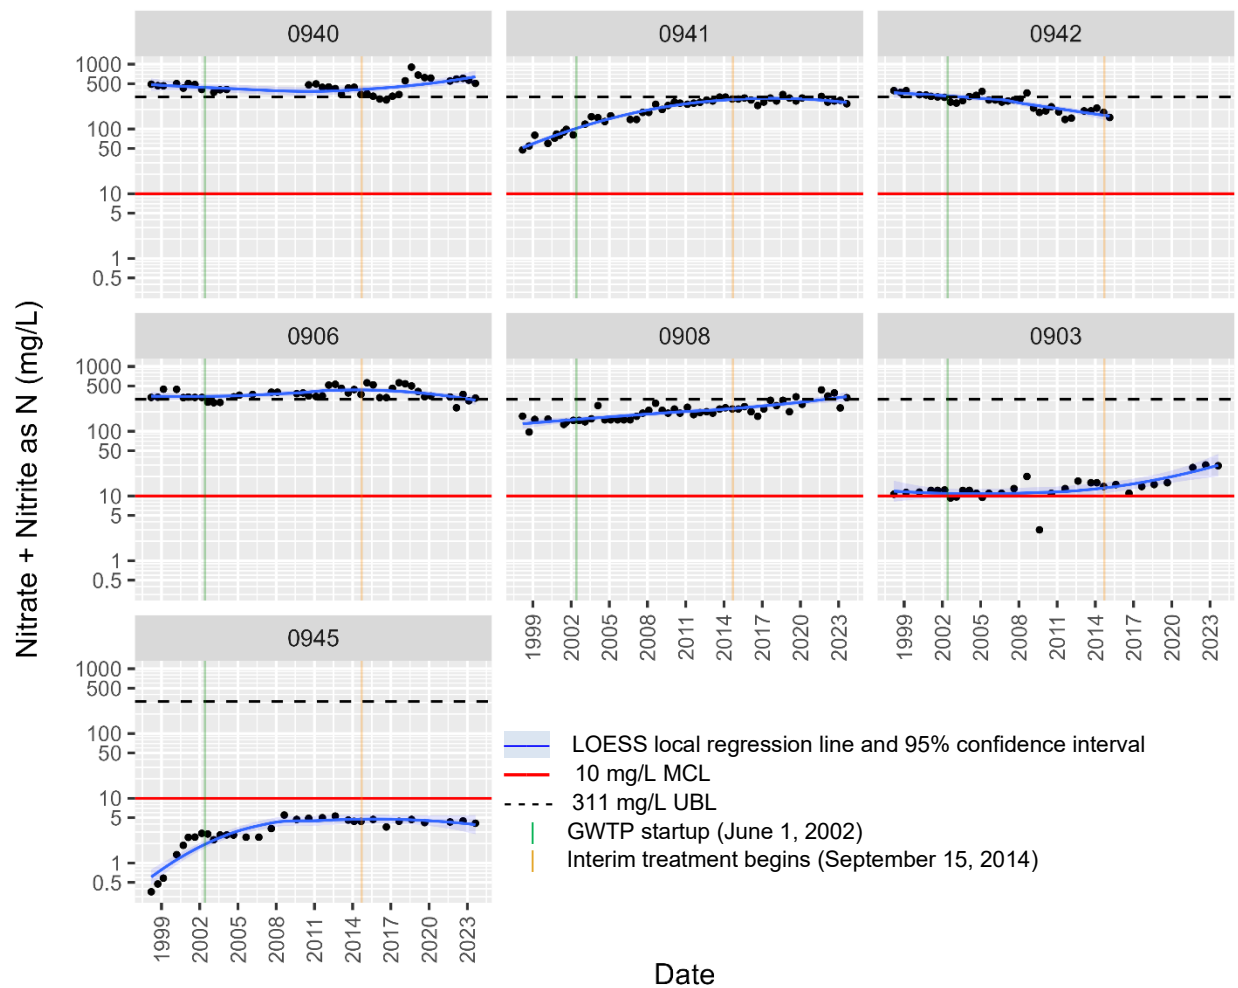
Figure 19-4. Time-Concentration Plots of Nitrate (as N) in Groundwater at the Tuba City, Arizona, Disposal Site, 1998–2023

Nitrate (+ nitrite as nitrogen [N]) concentrations have historically exceeded the 10 mg/L MCL in all LTSP evaluative wells except background well 0945 (Figure 19-4). The 311 mg/L UBL has been exceeded in all downgradient evaluative monitoring wells except southernmost well 0903, approximately 1250 feet south of the site perimeter. Mann-Kendall trend analysis for 1998–2023 indicates statistically significant increasing nitrate concentration trends in four of the six wells currently monitored: wells 0903, 0908, 0941, and background well 0945 (Table 19-4). For the 2015–2023 period, however, trends remain statistically significant only for wells 0903 and 0908 (Table 19-5). The UBL has been exceeded fairly consistently in wells 0940 and 0906, but only recently (2018–2023) in wells 0941 and 0908. In 2023, the UBL was exceeded in wells 0906 (325 mg/L), 0908 (329 mg/L), and 0940 (505–565 mg/L). Nitrate concentrations in southernmost downgradient well 0903, although regularly exceeding the 10 mg/L MCL since 2004, have remained below the UBL. However, results have increased in the last several years, with the maximum result (30.1 mg/L) detected in August 2022. The most recent (August 2023) nitrate result for well 0903 is 29.3 mg/L.

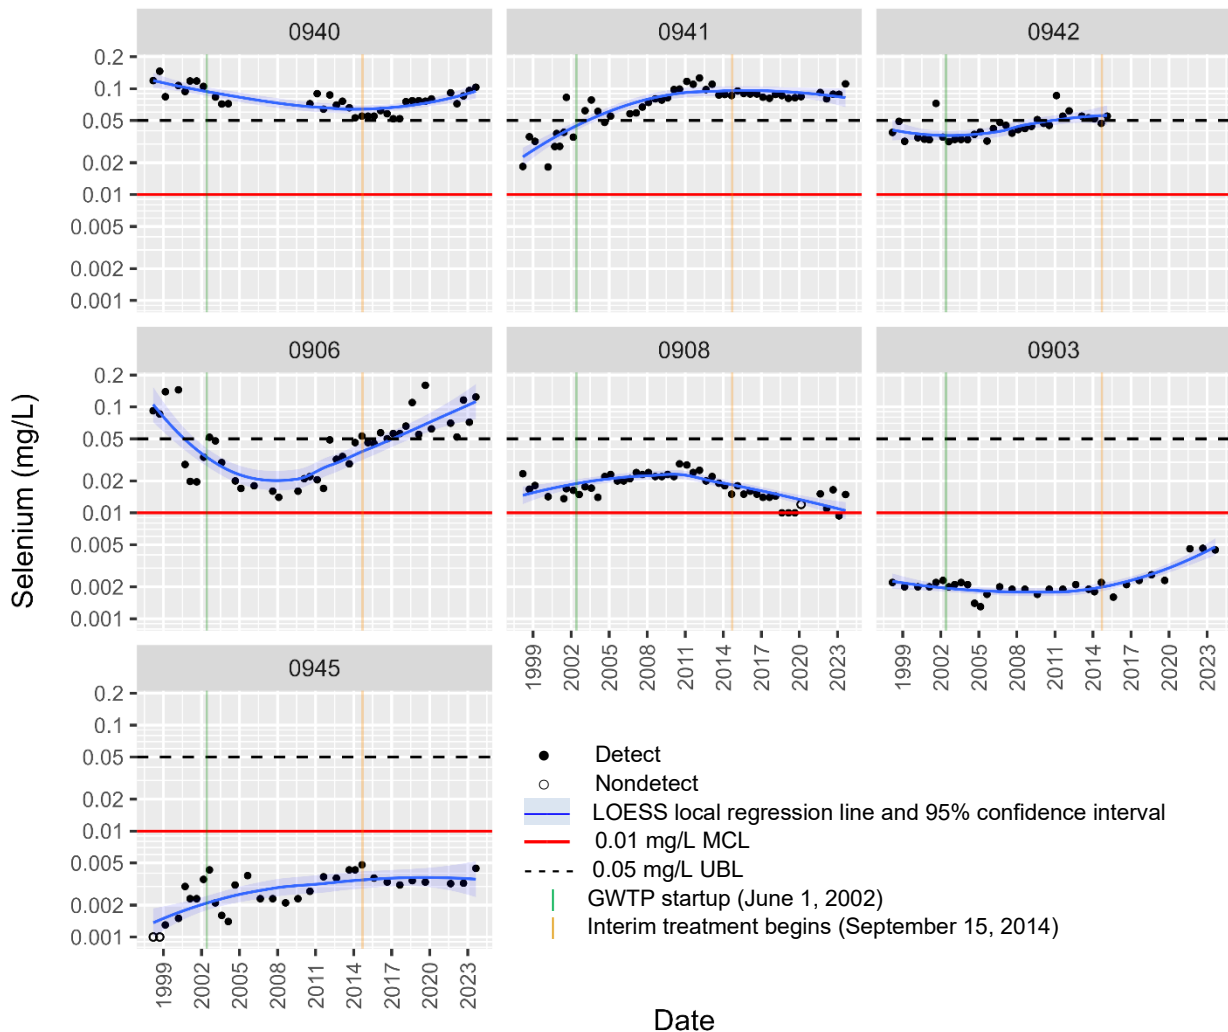
Figure 19-5. Time-Concentration Plots of Selenium in Groundwater at the Tuba City, Arizona, Disposal Site, 1998–2023

Selenium concentrations have historically exceeded the 0.01 mg/L MCL in all non-background evaluative monitoring wells except southernmost well 0903 (Figure 19-5). The 0.05 mg/L UBL has been exceeded consistently in wells 0940 and 0941, immediately downgradient of the disposal cell, since 1998 and 2005, respectively. Since 2018, the highest selenium concentrations have been measured in well 0906. After declining by an order of magnitude between 2000 and 2008 (from 0.15 to 0.014 mg/L), concentrations have since increased; the most recent result was 0.12 mg/L. This increase in selenium concentrations in well 0906 since 2009 correlates with the period when average annual cumulative extraction rates dropped from 80 to 35 gallons per minute (gpm) due to intermittent shutdowns of the GWTP (DOE 2020). Mann-Kendall trend analysis for 1998–2023 indicates statistically significant increasing trends in wells 0906 and 0941, but for the more recent period (2015–2023), two additional wells (0940 and 0903) show significant increasing trends (Table 19-4 and Table 19-5).

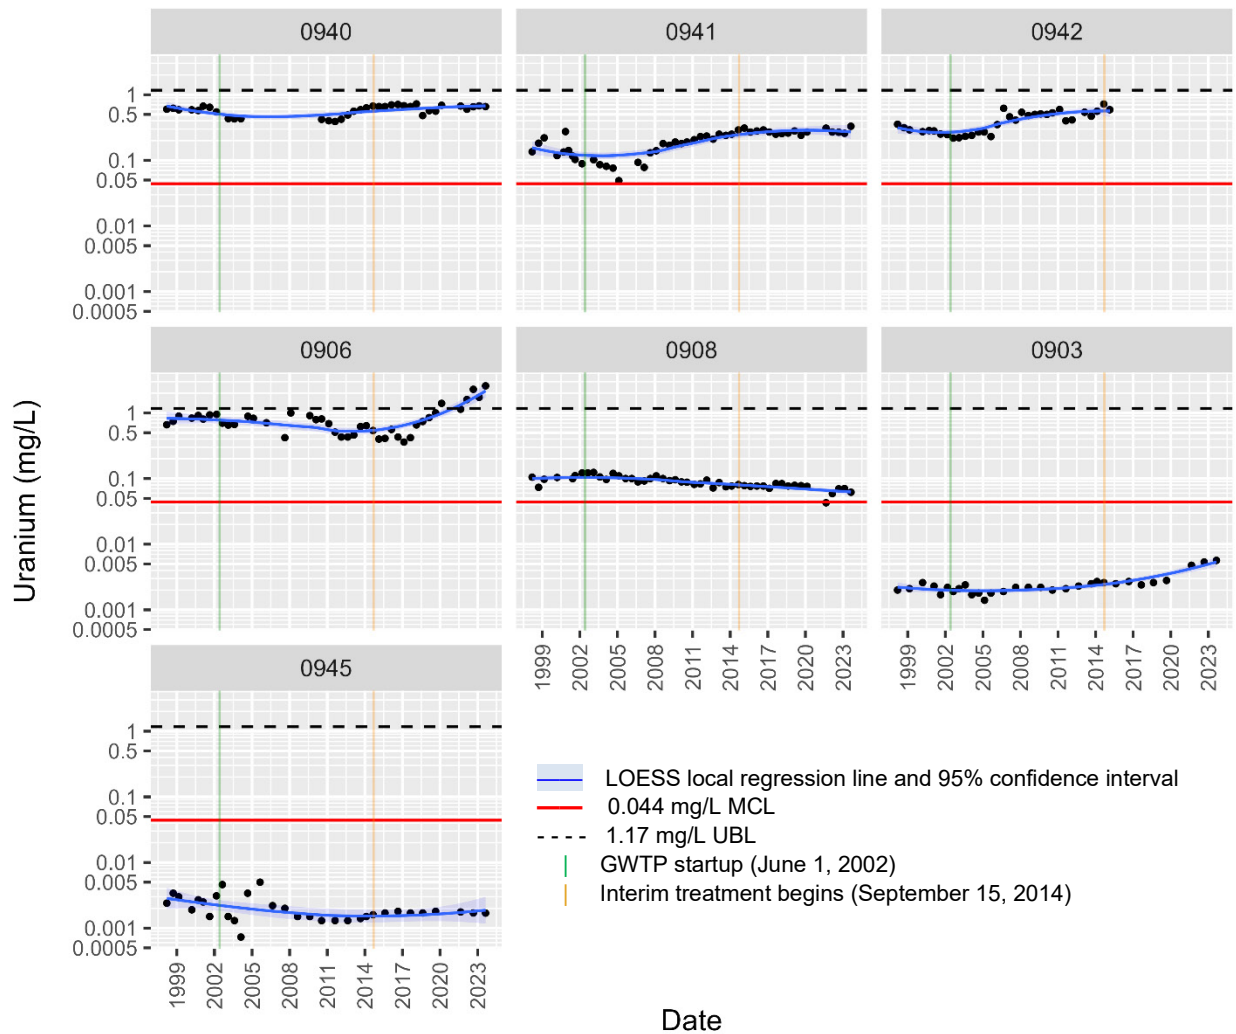
*Figure 19-6. Time-Concentration Plots of Uranium in Groundwater at the Tuba City, Arizona, Disposal Site, 1998–2023*

Uranium concentrations have historically exceeded the 0.044 mg/L MCL in all downgradient compliance wells except for well 0903 and a single (August 2021) measurement in well 0908 (Figure 19-6). The 1.17 mg/L UBL has not been exceeded except for recent measurements in well 0906. Uranium concentrations in well 0906 exceeded the UBL for the first time in February 2020 and have since increased to 2.59 mg/L (a historical maximum) in August 2023. Mann-Kendall trend analysis for 1998–2023 indicates statistically significant increasing nitrate concentration trends in three of the six wells currently monitored: wells 0903, 0940, and 0941. For 2015–2023, the statistically significant increasing trend for downgradient well 0903 continues, and a significant increasing trend was also found for well 0906 (Table 19-5), in contrast to the previous stable trend (Figure 19-6). Although still below both the MCL and the UBL, the most recent (August 2023) uranium concentration in well 0903 is the highest result on record for this well at 0.0057 mg/L.

A detailed evaluation of the recent increasing concentration trends in these wells is provided in the 2019–2021 groundwater remedy performance update (DOE 2022). Well 0908 is the only well with a significant decreasing uranium concentration trend (Table 19-4, Table 19-5). The most recent result (0.062 mg/L) slightly exceeds the 0.044 mg/L MCL.

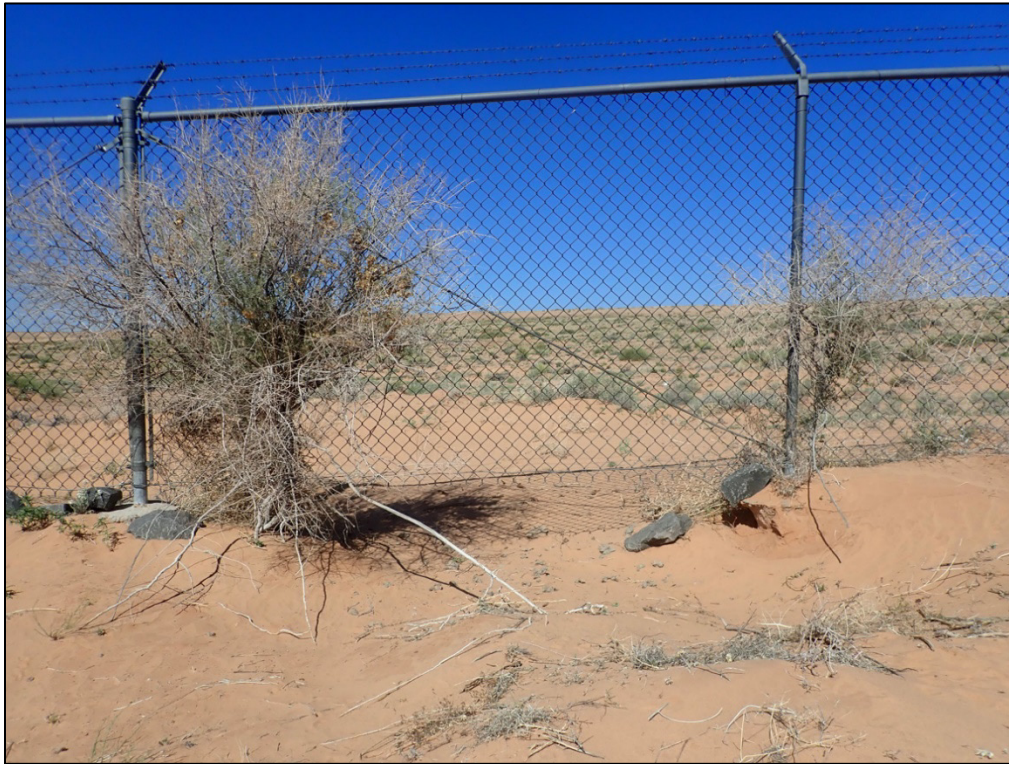
A chainlink perimeter fence encloses the site. Windblown sand and tumbleweeds regularly accumulate along the perimeter fence line. Wind scouring also occurs, which results in gaps under the fence (PL-1). Also noted are several gaps under the fence from animal access (PL-2). These areas will be repaired before the next inspection. A sediment deposition gage was installed before the annual inspection. It should be read every year to quantify sand deposition (PL-3). Trash and debris have accumulated outside the fence near perimeter sign P9 (P-4). The debris will be removed following the inspection.

*PL-1. Gap Under Fence near Perimeter Sign P9*

- Repair the eroding base at perimeter signs P4, P9, and P10
- Remove the trash and debris near perimeter sign P9
- Repair the animal access areas along the eastern and southern perimeter fence

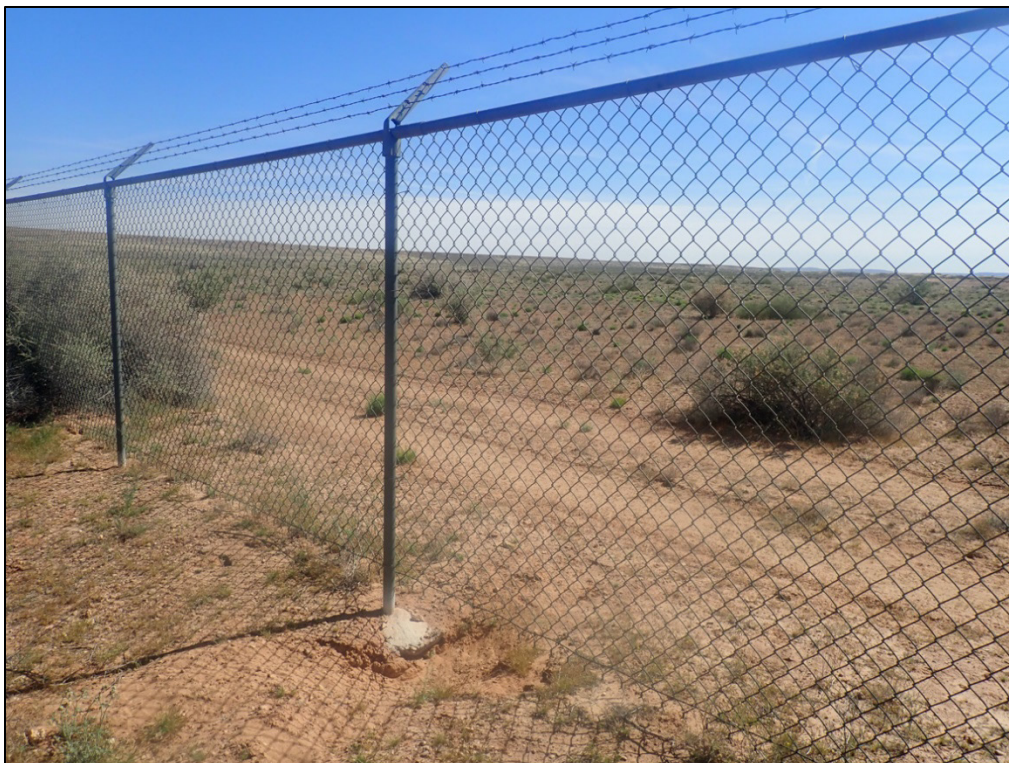
*PL-2. Gap Created by Animals Under Fence Between Perimeter Signs P21 and P22*

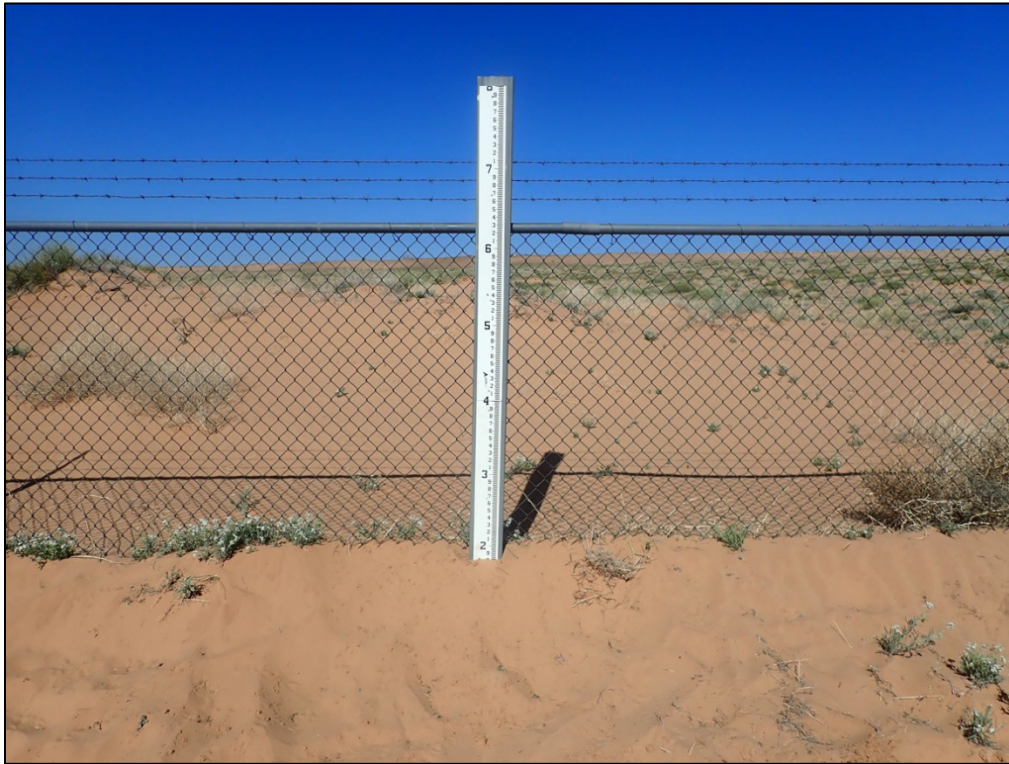
*PL-3. Sediment Deposition Gage Between Perimeter Signs P9 and P10*

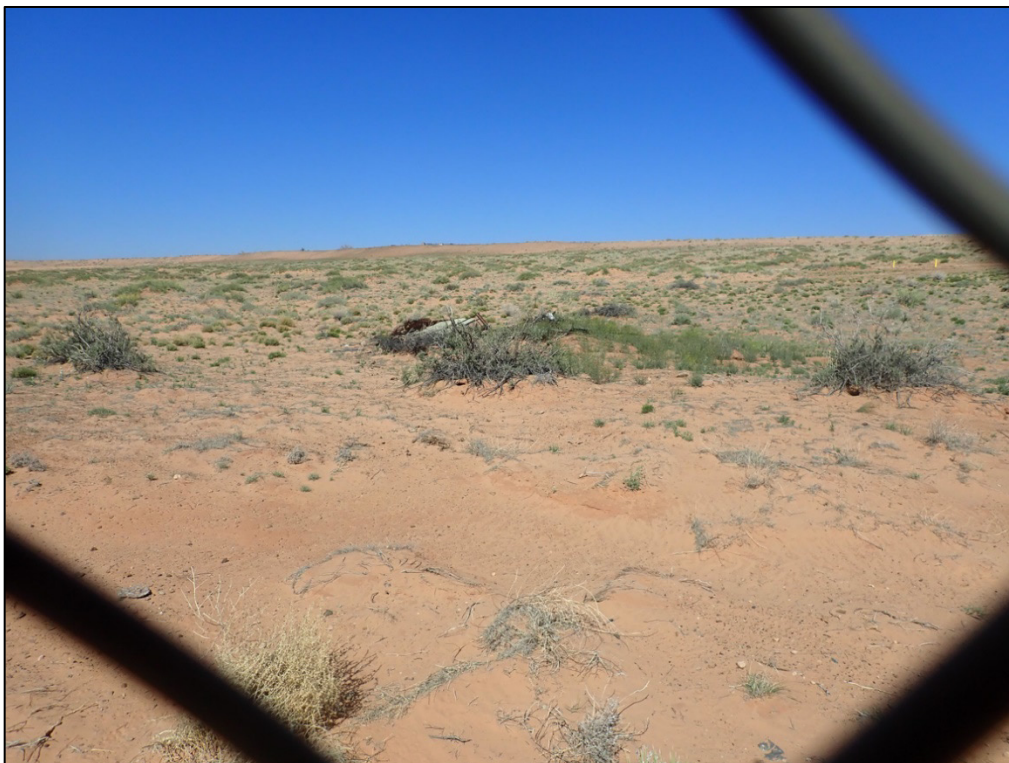
*PL-4. Debris near Perimeter Sign P9*

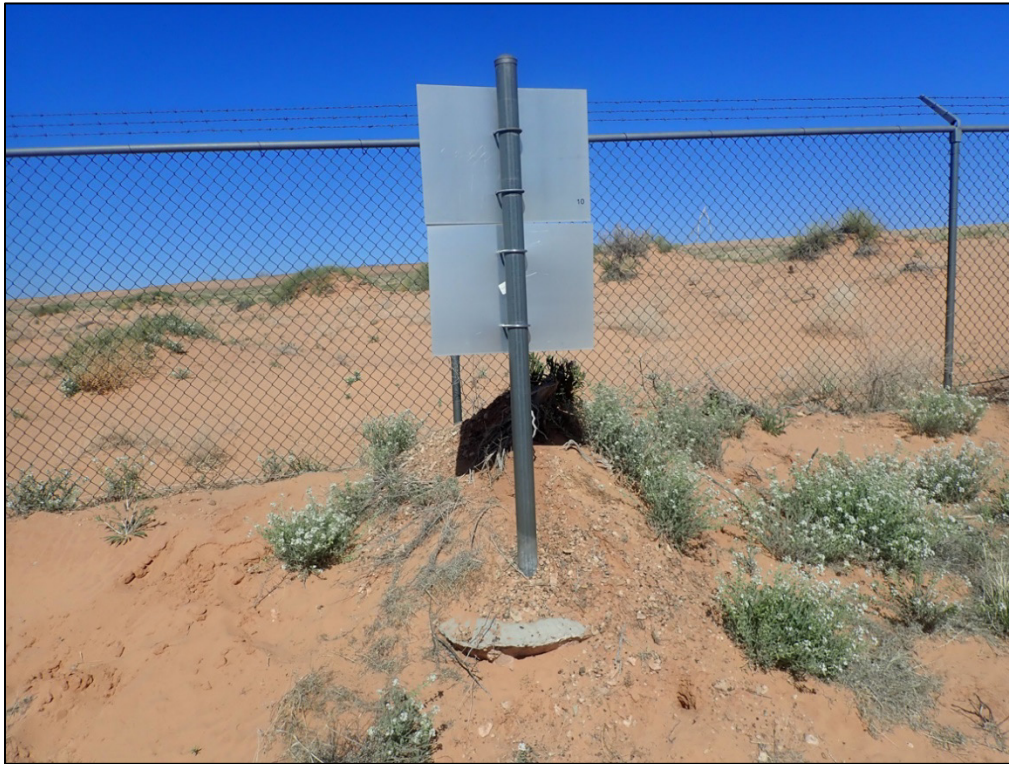
Thirty pairs of perimeter signs, designated P1 through P30, are attached to steel posts set in concrete directly inside and along the perimeter fence. One of the sign pairs is textual, and the other is pictorial. The base of perimeter signs P4, P9, and P10 were undercut by wind erosion and will be repaired following the inspection (PL-5). Two faded signs that warn of high voltage near perimeter sign P12 were replaced before the inspection. No other maintenance needs were identified.

*PL-5. Erosion Under Base of Perimeter Sign P10*

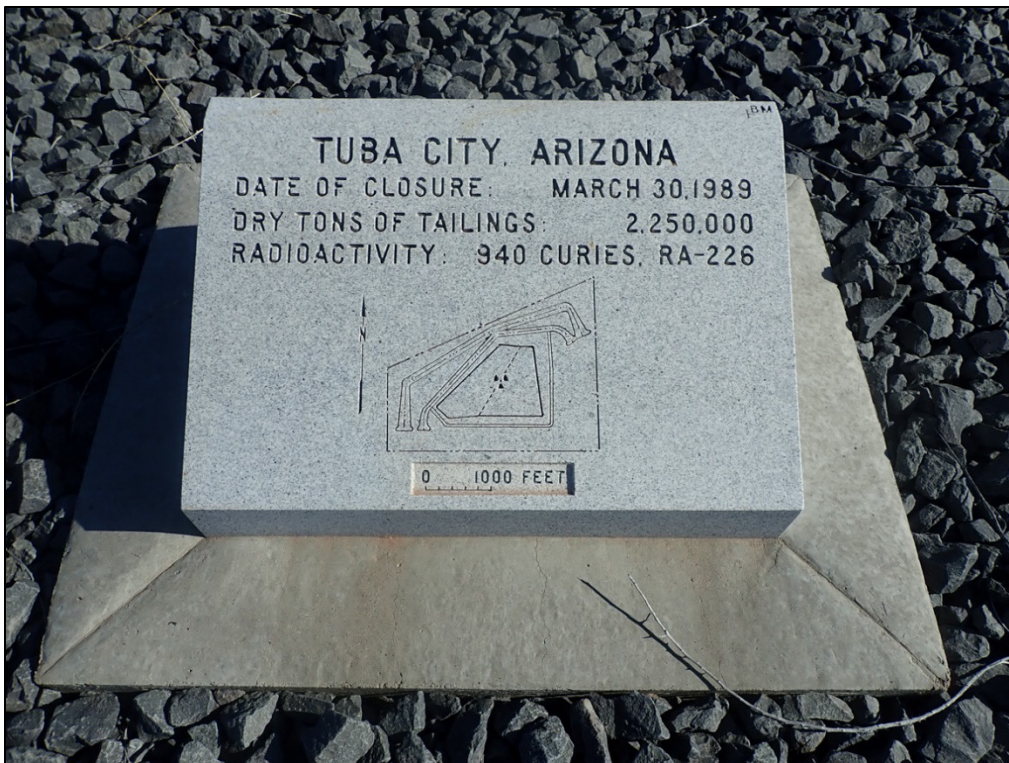
The site has two granite site markers. Site marker SMK-1 is just inside the entrance gate, and site marker SMK-2 is on the top slope of the disposal cell (PL-6). No maintenance needs were identified.

*PL-6. Site Marker SMK-2*

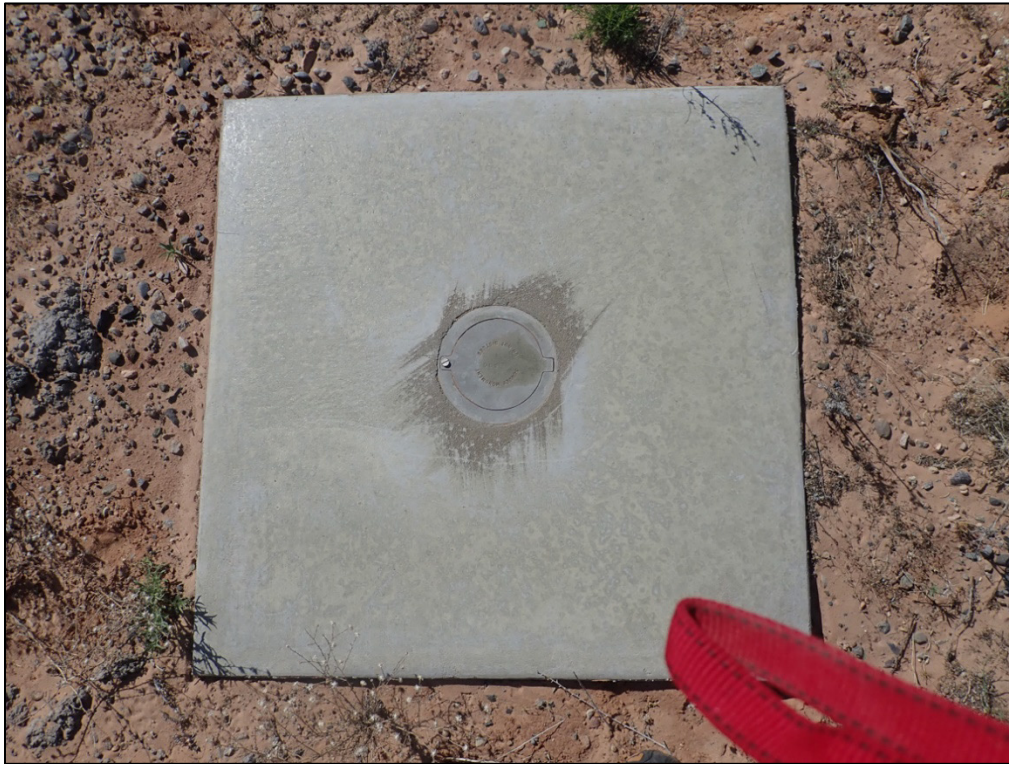
Five aerial survey quality control monuments were located and in good condition (PL-7). No maintenance needs were identified.

*PL-7. Quality Control Monument QC-2*

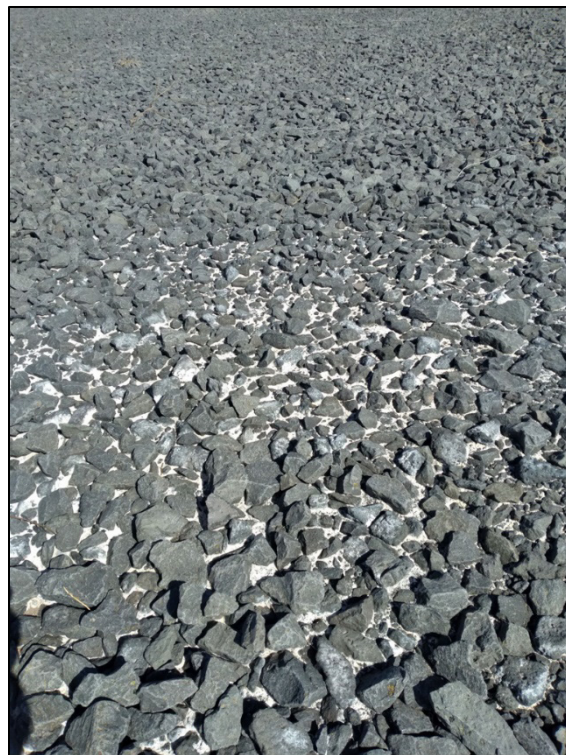
The disposal cell, completed in 1989, occupies 50 acres. The disposal cell is armored with riprap to control erosion and deter animal and human intrusion. Inspectors confirmed parallel tracks on the top slope of the disposal cell that were reported in previous annual reports. An evaporative mineral, caused by water pooling and subsequent evaporation, on top of windblown deposited sediment within riprap matrixes was noted on the top of the disposal cell (PL-8). These areas will continue to be monitored. There was no evidence of erosion, settling, slumping, or other modifying processes on the disposal cell.

*PL-8. Evaporative Minerals on Top Slope of Disposal Cell*

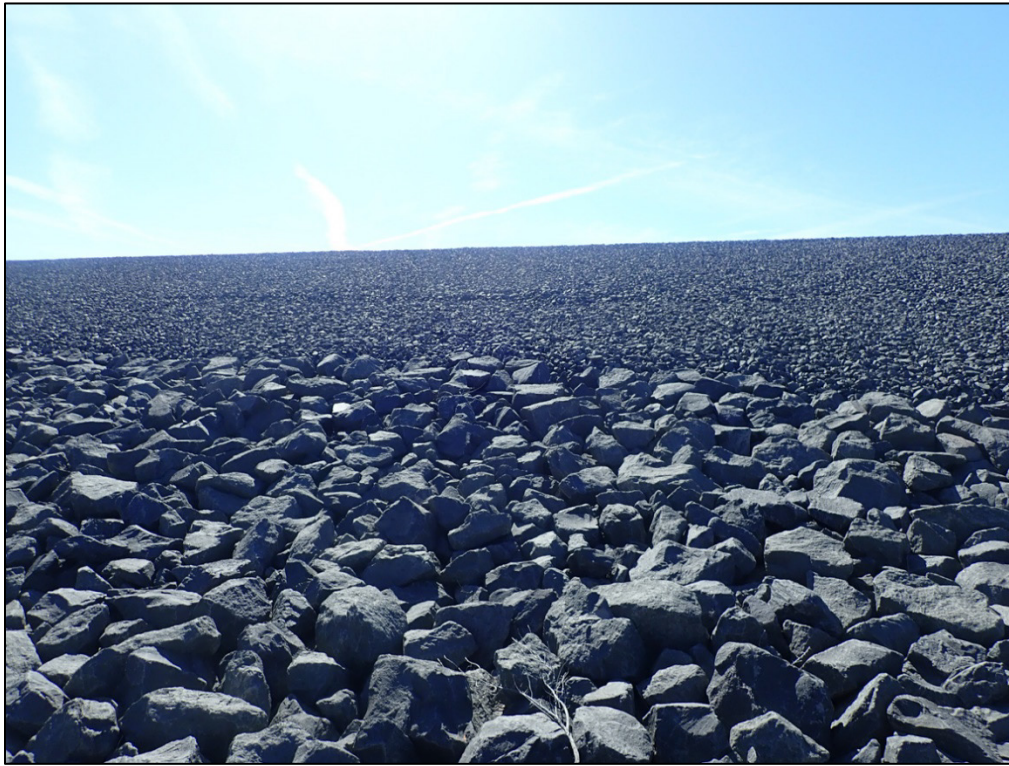
The riprap-covered side slopes were in good condition. There were visible horizontal channels along the southwest slopes (PL-9). The channels are most likely formed from surface flow from melting snow cover or precipitation, or both. These features do not currently pose a threat to the integrity of the disposal cell; however, continued monitoring is recommended to ensure that erosion features do not create any problems that could undermine the soil and rock interface or the rock side slope below.

*PL-9. Horizontal Lines on West Slope of Disposal Cell*

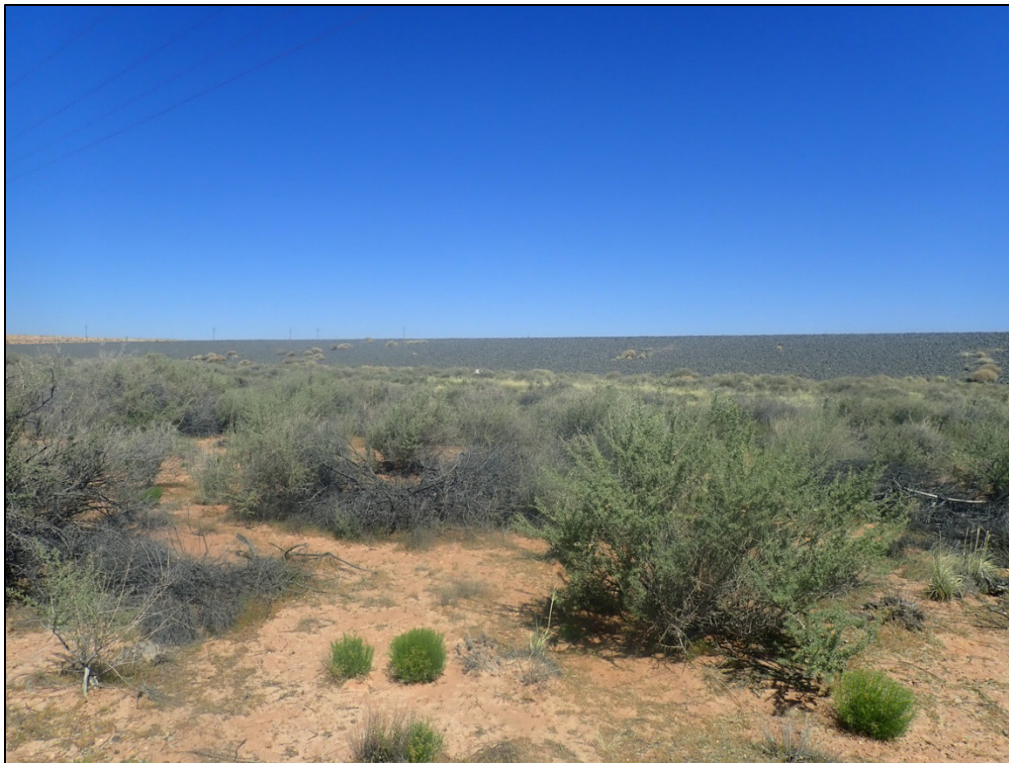
In accordance with the LTSP, deep-rooted vegetation is controlled to prevent potential penetration of the radon barrier. Windblown sediments continue to accumulate on the rock-covered surfaces, providing a favorable environment for plant growth. Periodic spot application of herbicide has been effective in controlling deep-rooted vegetation growth on the disposal cell cover. No deep-rooted shrubs were observed on top of the disposal cell, but some shrubs have become established on the side slopes (PL-10), as noted in previous inspections. This area will continue to be monitored. No maintenance needs were identified.

*PL-10. Vegetation on South Slope of Disposal Cell*

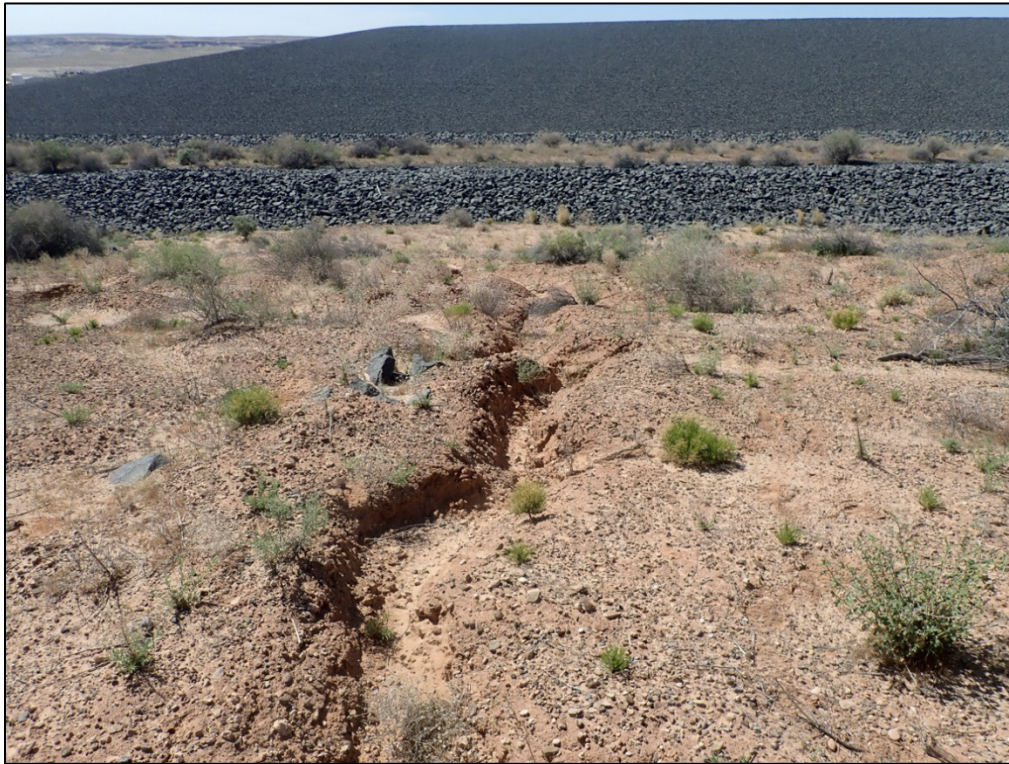
The north slope above the diversion channel consists of noncohesive sandy soil and is subject to erosion from stormwater runoff. Erosion repair conducted in this area in 2013 reduced the rate of erosion and subsequent soil deposition in the channel. Some erosion and deposition continue near the northeast corner of the diversion channel—an erosion gully and soil accumulation were observed (PL-11). Erosion will be monitored, and erosion control repairs will be performed as needed.

*PL-11. Erosion Gully and Soil Accumulation in Diversion Ditch North of Disposal Cell*
