## 2.0 Burrell, Pennsylvania, Disposal Site

The Burrell, Pennsylvania, Uranium Mill Tailings Radiation Control Act (UMTRCA) Title I Disposal Site was inspected on October 29, 2024. No changes were observed on the disposal cell or in the associated drainage features. Inspectors identified minor maintenance needs but found no cause for a follow-up inspection.

Figure 2-1. 2024 Annual Inspection Drawing for the Burrell, Pennsylvania, Disposal Site

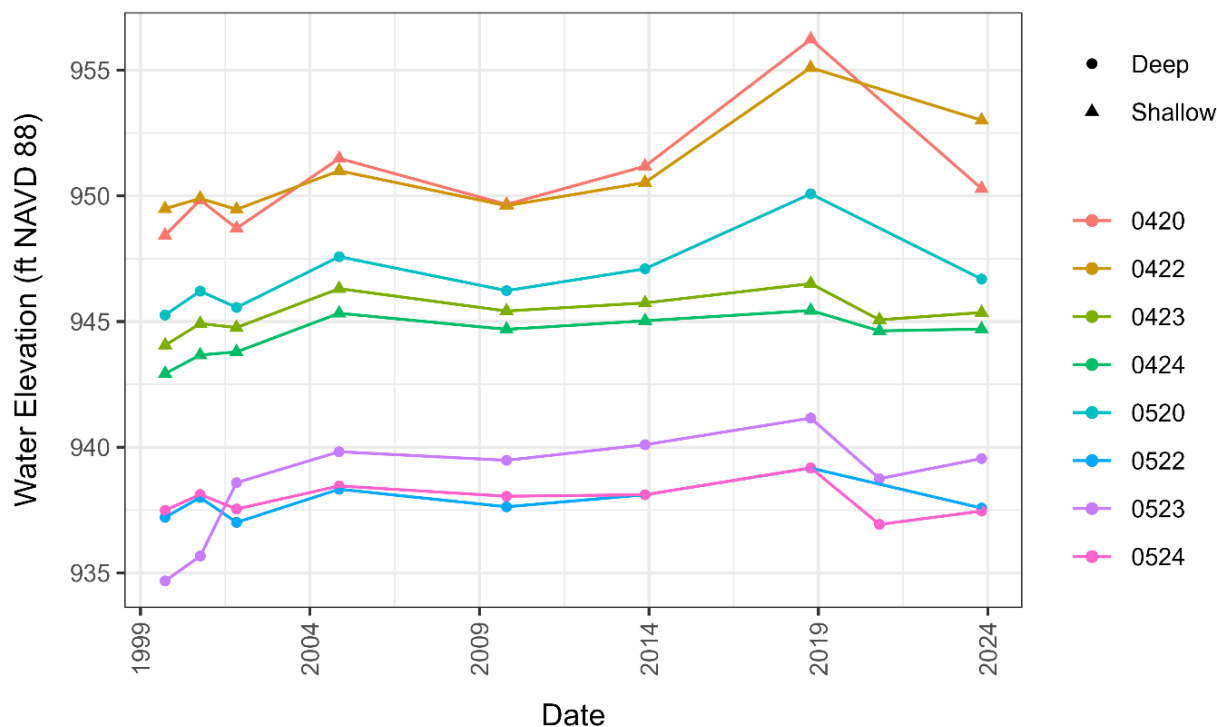
Figure 2-3. Hydrographs for Monitoring Wells at the Burrell, Pennsylvania, Disposal Site, 1999–2023

Initial (1987–1999) groundwater elevation measurements at the site indicated seasonal variations of up to 3–4 ft (DOE 2000). Routine measurements since 1999 (most taken in the fall) indicate that water elevations have been relatively stable in most wells as shown in Figure 2-3.

Mann-Kendall trend analysis indicates no statistically significant trends in water levels except for deep well 0523, where water levels have increased approximately 5 ft since 1999.

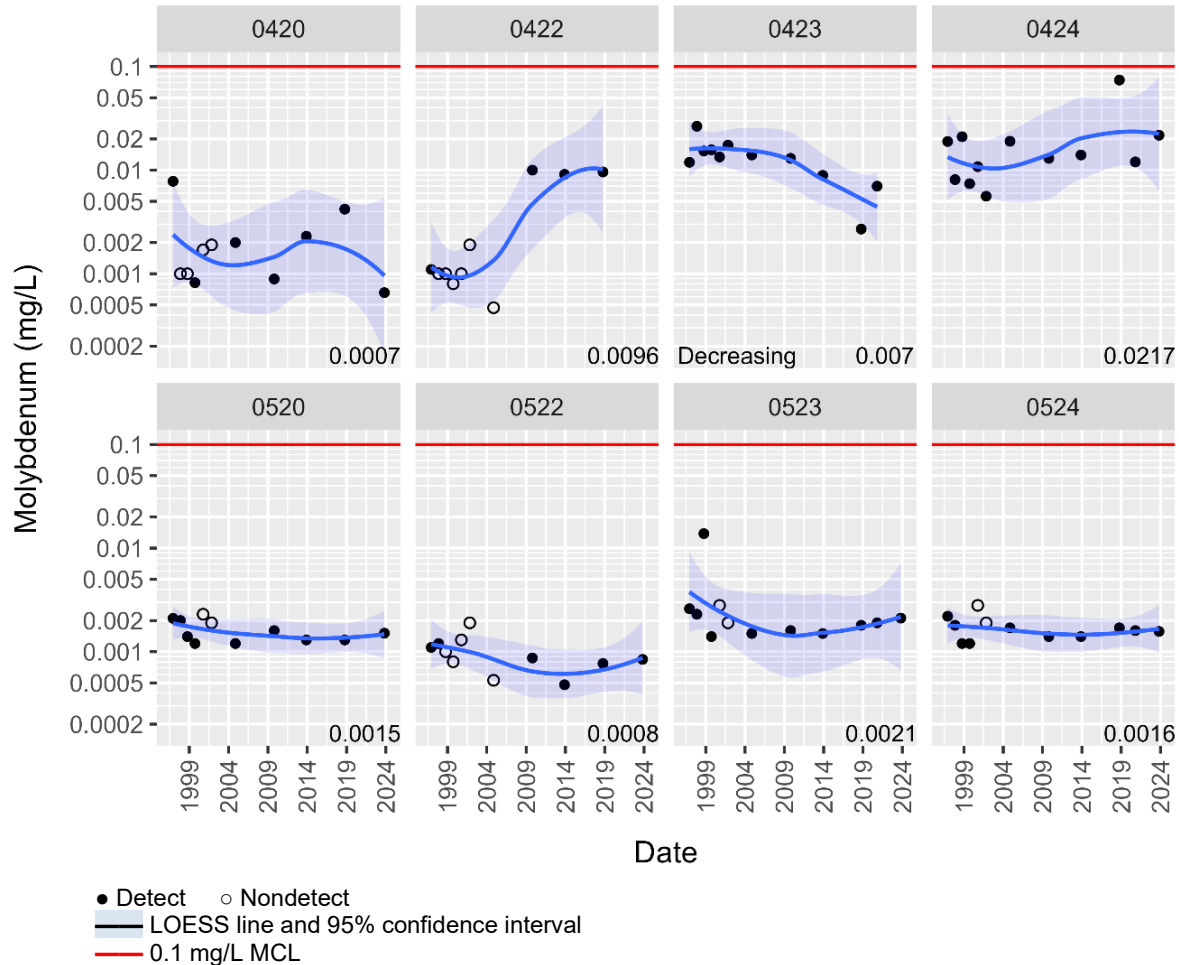
Figure 2-4. Molybdenum Concentrations in Groundwater at the Burrell, Pennsylvania, Disposal Site

Molybdenum concentrations in all wells remain below the 0.1 milligram per liter (mg/L) MCL, with all trends now stable or decreasing (Figure 2-4). The 0.074 mg/L result for well 0424 in 2018 prompted the 2020 nonroutine sampling event given concerns that the MCL could soon be exceeded. However, the two most recent molybdenum results for this well (0.012 and 0.022 mg/L in 2020 and 2023, respectively) are consistent with pre-2018 results.

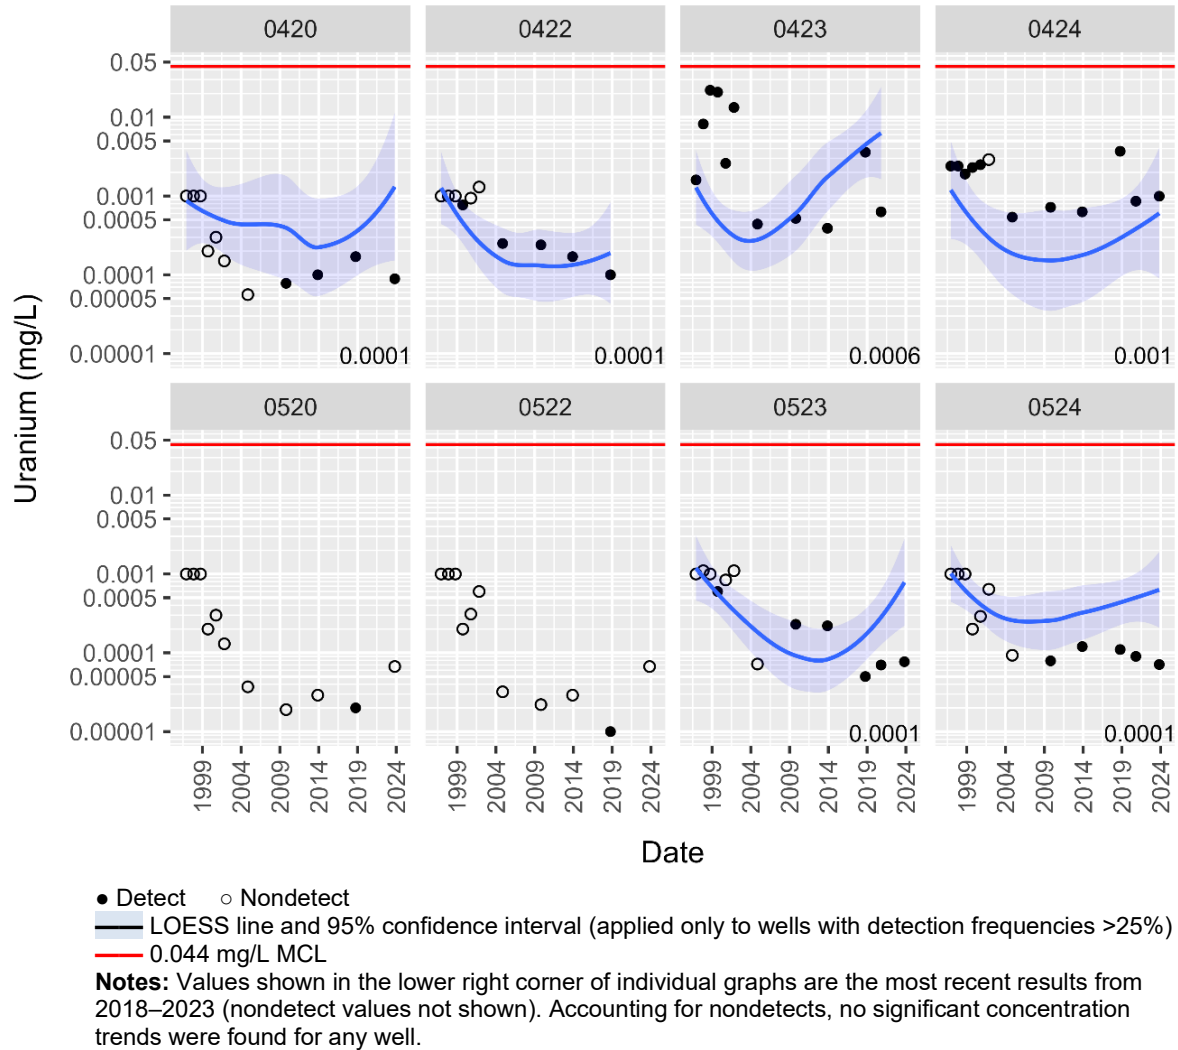
Figure 2-5. Uranium Concentrations in Groundwater at the Burrell, Pennsylvania, Disposal Site

Based on the most recent (2018–2023) results, uranium concentrations in all wells are  $\leq 0.001$  mg/L, which is well below the 0.044 mg/L MCL (Figure 2-5). Most results for deeper wells (shown in the bottom row of figure) have been below the laboratory detection limit. Despite the apparent decreasing uranium concentration trend in deep wells, none of these trends are statistically significant because of the high proportion of nondetects.

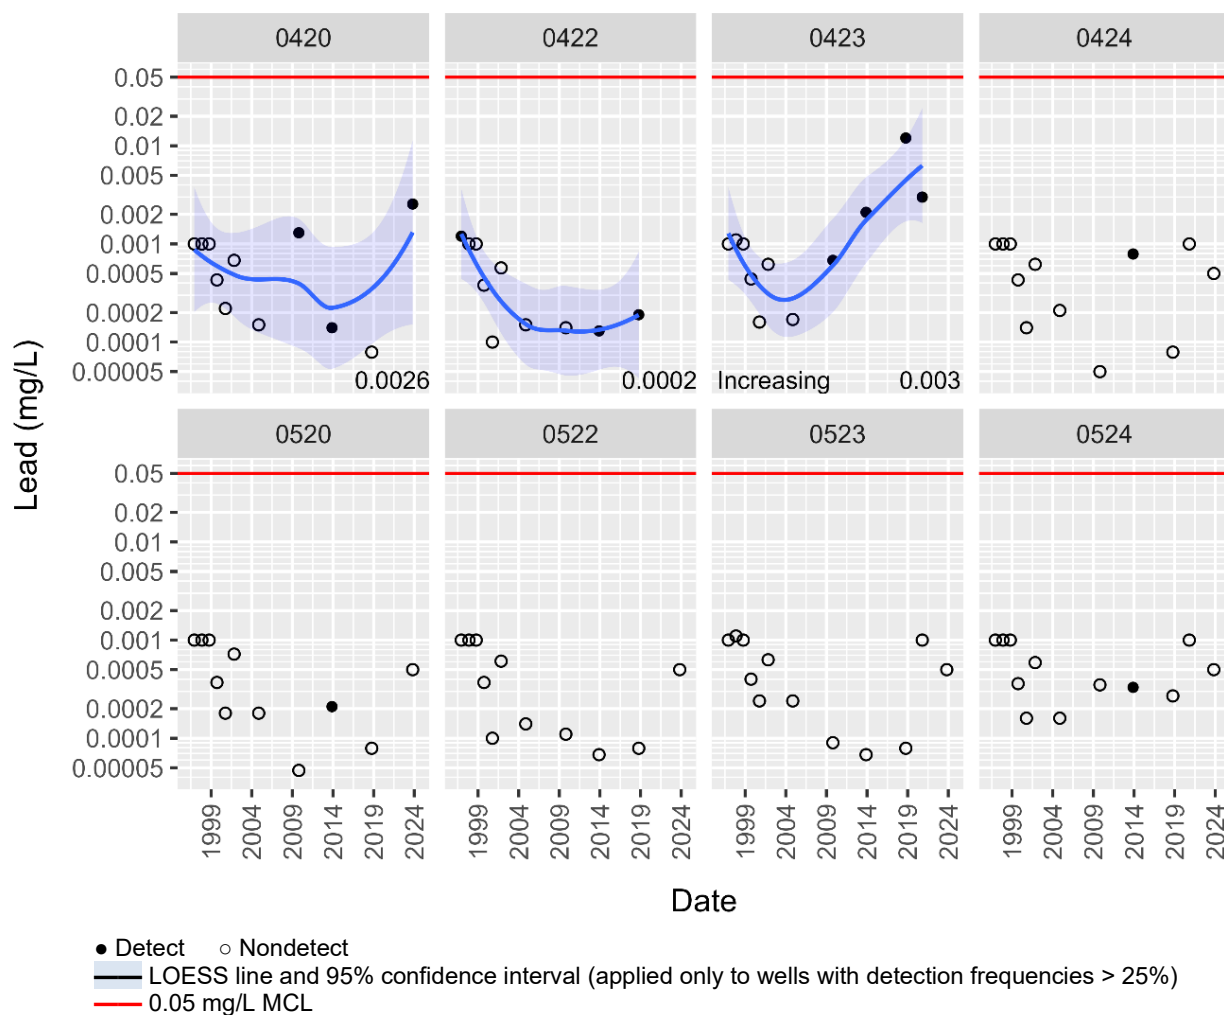
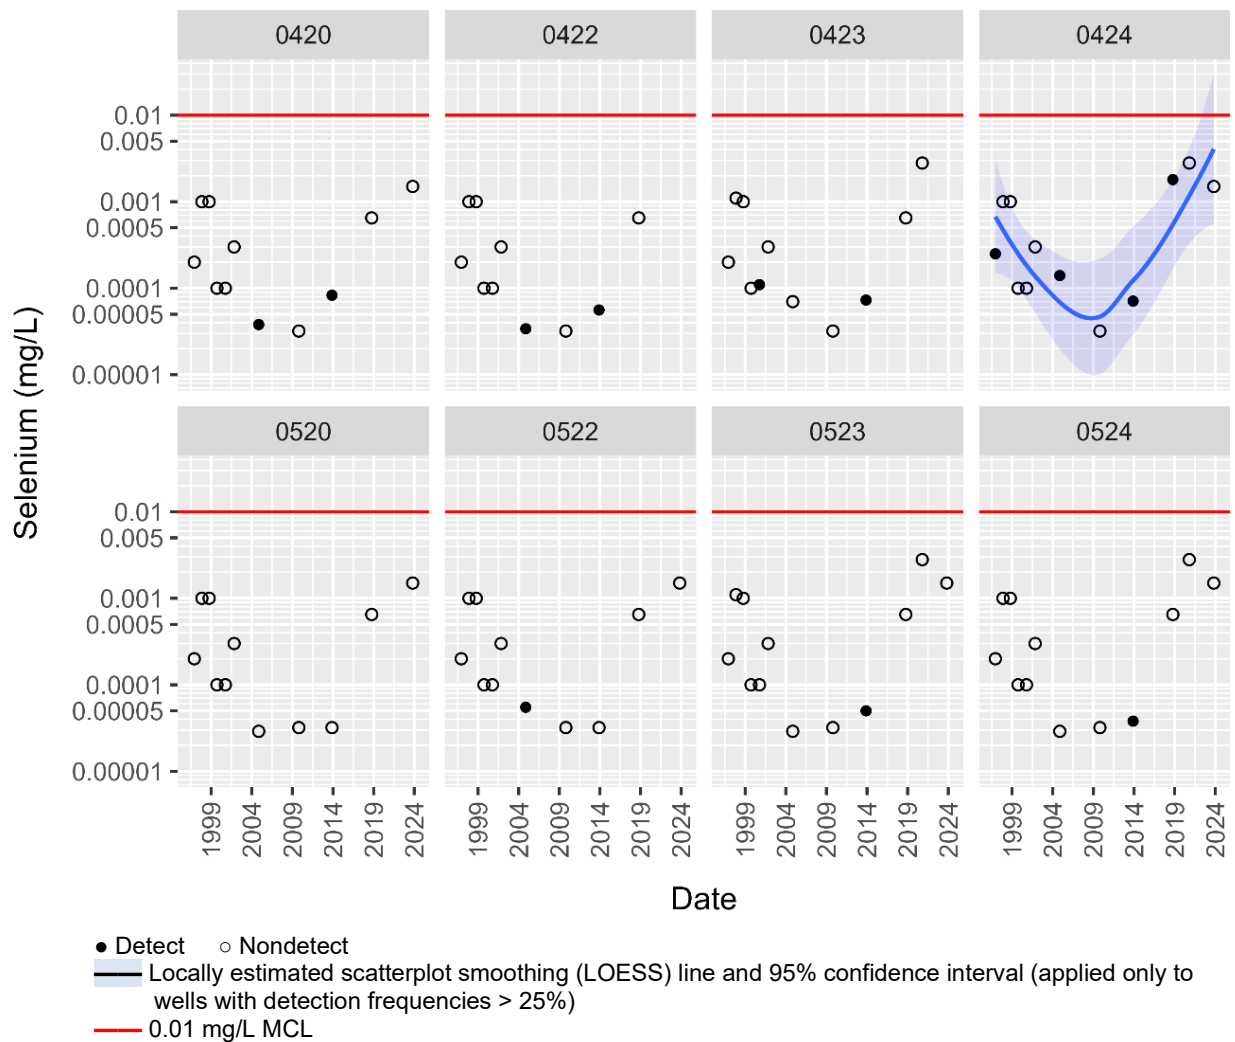
Figure 2-6 and Figure 2-7 plot temporal data for lead and selenium, showing the high proportion of nondetects (about 86%) for both analytes across the monitoring well network. Lead concentrations have been consistently below the MCL and, with few exceptions, below detectable levels in deep wells (Figure 2-6). The statistically significant increasing trend found for well 0423 reflects the increase from 0.0007 mg/L (2009) to 0.012 mg/L in 2018. The most recent (2020) result, 0.003 mg/L, is more than 1 order of magnitude below the 0.05 mg/L MCL. Similar observations apply to selenium; the most recent results (2018–2023) were all below the detection limit as shown in Figure 2-7.

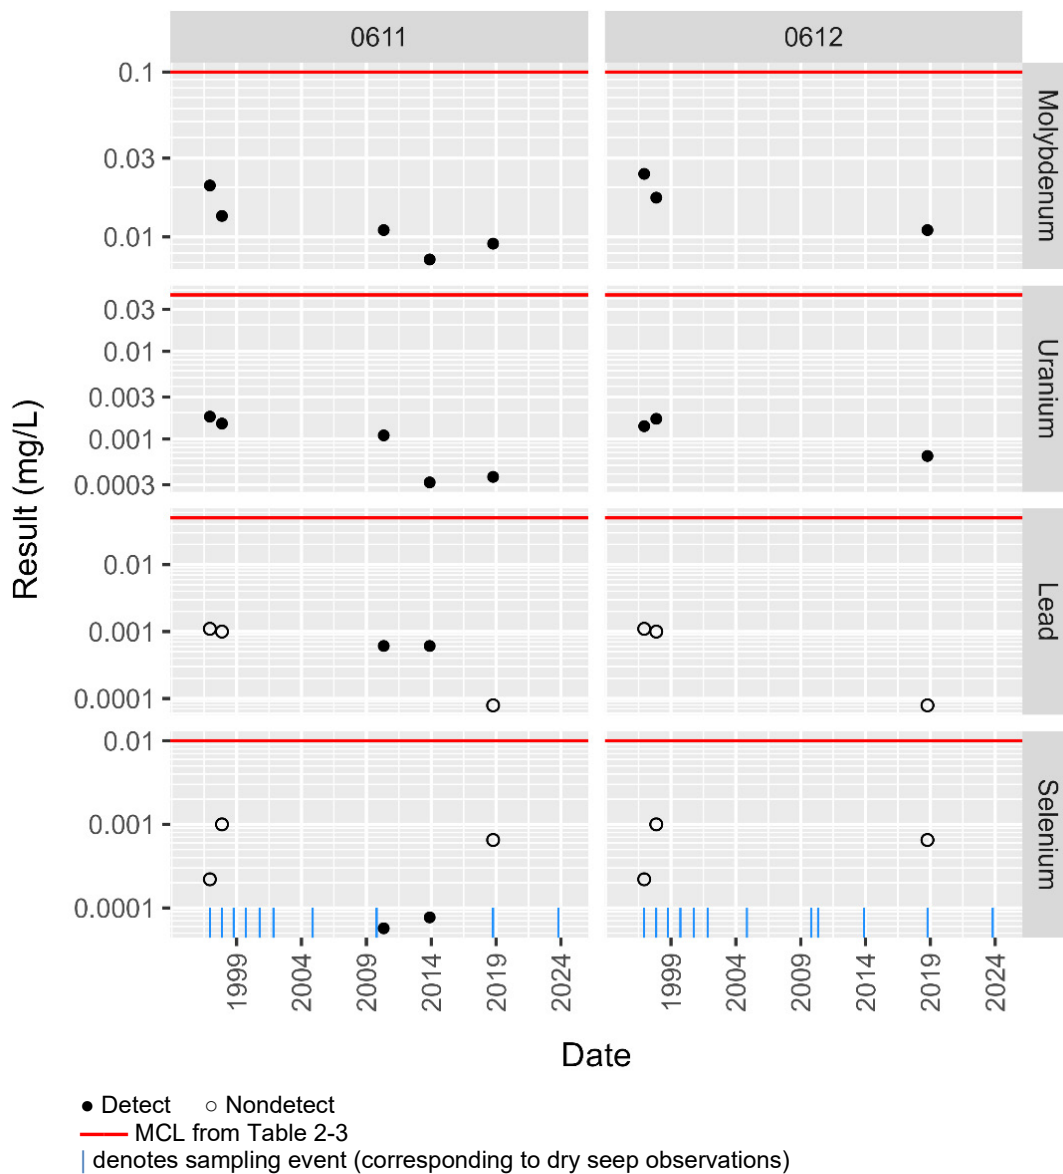
Figure 2-8. Historical Results for Seep Locations, Burrell, Pennsylvania, Disposal Site

Seeps 0611 and 0612 have typically been dry. As shown in Figure 2-8, when it has been possible to collect samples at these locations, concentrations of target analytes have been consistently below the corresponding MCLs and often below detection limits.

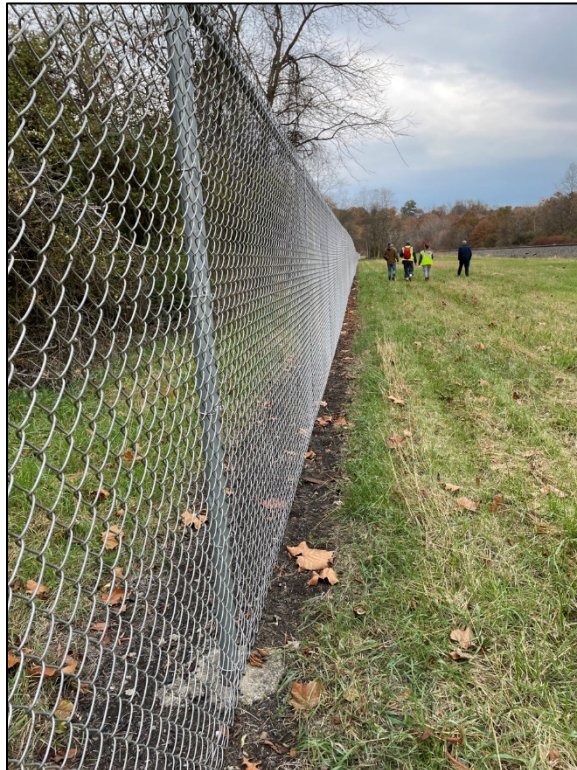
A chainlink security fence encloses the disposal cell and drainage features. The site herbicide subcontractor keeps the fence line clear of vegetation, which should prolong the life of the security fence (PL-1). In 2023, trees felled by strong winds damaged the fence, compromising its integrity. Repairs were completed following the 2023 inspection. The upper rail of the fence along the southern boundary is bent in a few areas, but the fence remains serviceable, and repairs

*PL-1. Fence Line*

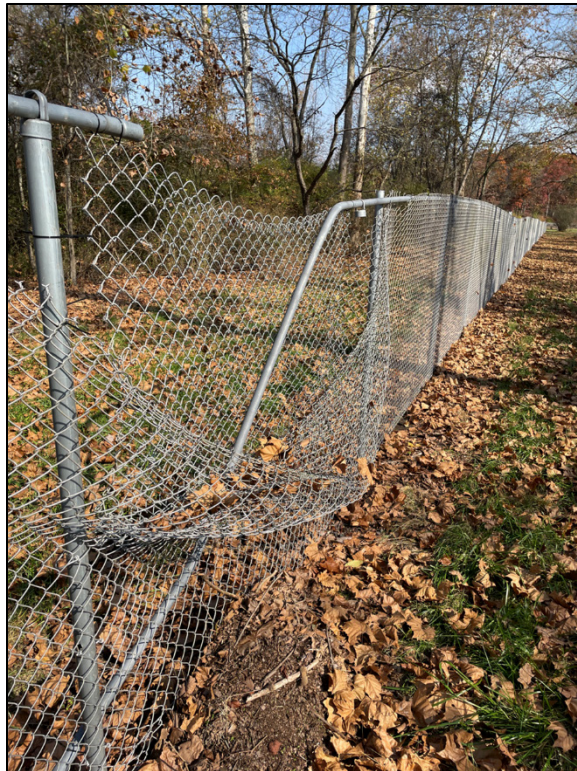
are not required at this time. A large tree fell on the fence in 2024. Temporary repairs were made to the fence (PL-2). DOE plans to wait until summer 2025 to make permanent repairs. This decision was based on the observed adequacy of the temporary repairs and the late time of year. If winter and spring storms further damage the fence, repairs can be made all at once.

*PL-2. Temporary Fence Repair*

- Boundary monument BM-4 was not located. It is believed to be covered by grass. Efforts will be made during the 2025 annual inspection to locate boundary monument BM-4.
- Telephone numbers on some site perimeter signs were outdated. Stickers with updated phone numbers were placed on the perimeter signs near the entrance gates. The rest of the perimeter signs will be updated in 2025.
- Damaged fence from downed tree was temporarily repaired, and further repairs are planned for 2025.

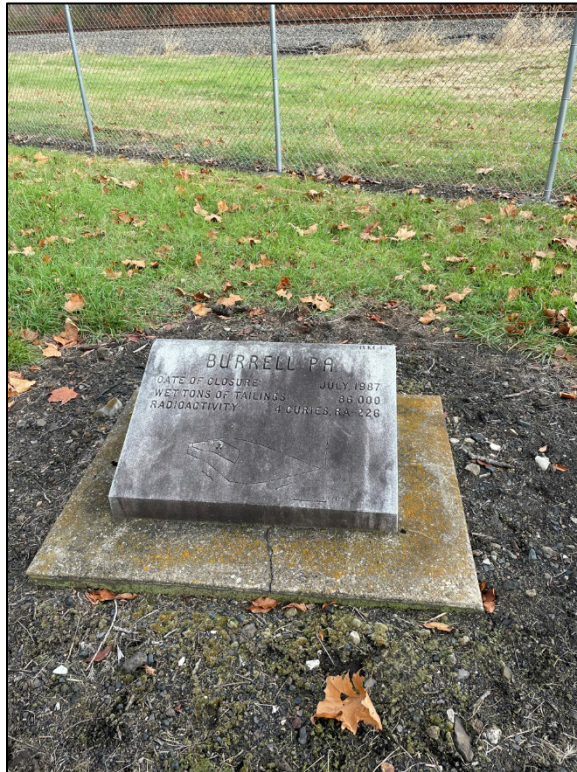
The site has one granite site marker just inside the main entrance gate. The concrete pad is cracked but remains functional. The surface of the site marker is stained but remains legible (PL-3). No maintenance needs were identified.

*PL-3. Site Marker*

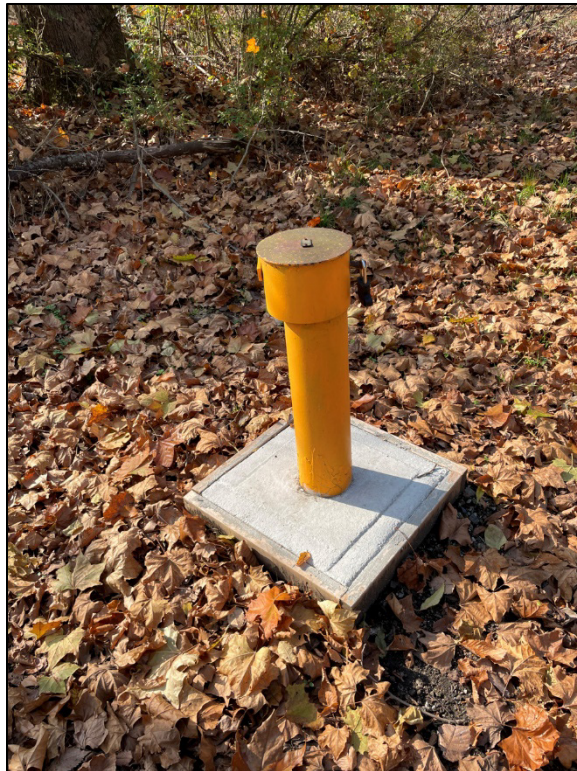
In 2024, concrete well pads were installed at the two remaining wells that lacked them (wells 0424 and 0524) (PL-4 and PL-5). Also in 2024, repairs were made to cracked well pads 0422 and 0522 (PL-6). All well pads are now in good condition. All wellhead protectors that were observed during the annual inspection were locked and undamaged. New locks were installed at all of the monitoring wells in 2023.

*PL-4. New Well Pad at Well 0424*

- Well pads were installed at wells 0424 and 0524
- Cracks were repaired in existing well pads for monitoring wells 0422 and 0522

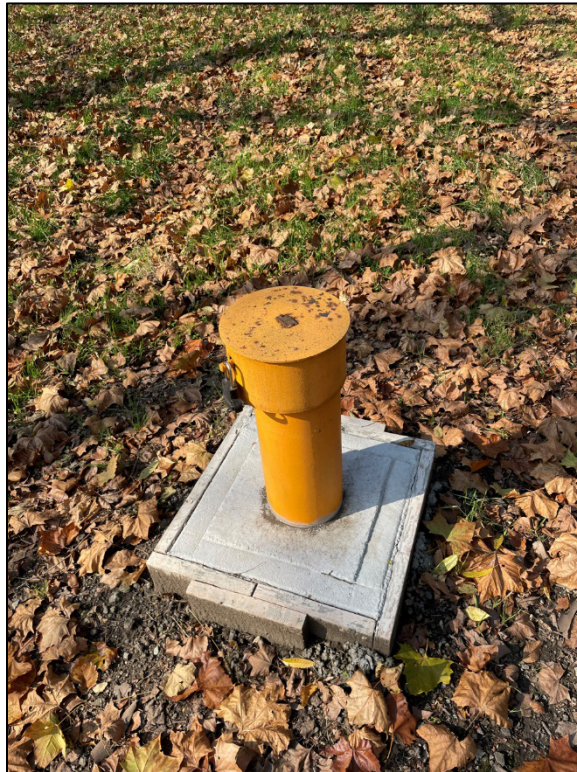
*PL-5. New Well Pad at Well 0524*

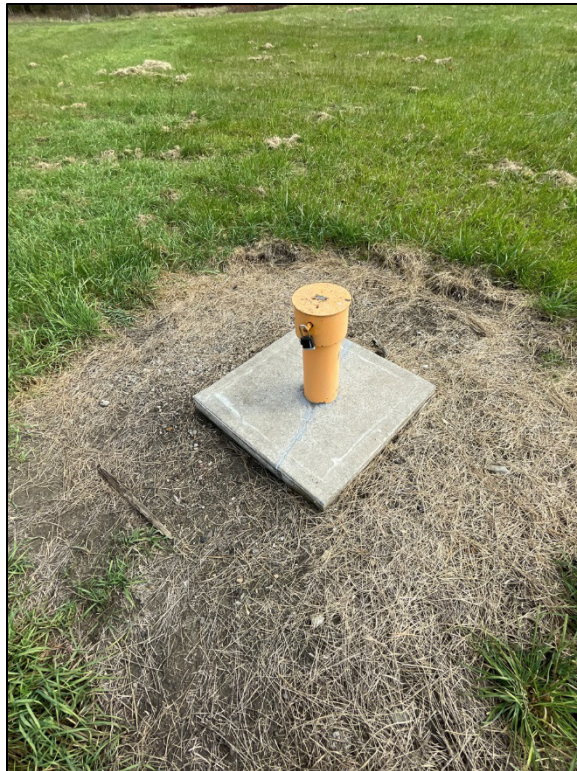
*PL-6. Crack Repaired at Well Pad of Monitoring Well 0422*

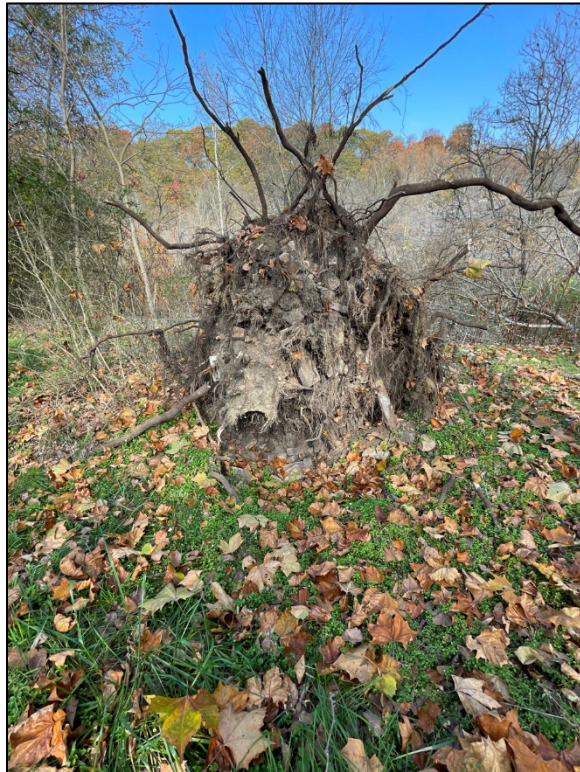
Woody vegetation on the disposal cell cover that has been growing since 2000 has progressed to the point that trees are becoming tall enough to create concern that one could fall (e.g., die or be blown down). A fallen tree could create a large root ball and perhaps impact or expose the underlying clay layer of the cell cover. A windstorm in 2024 downed several large trees that were not located on the disposal cell. The size of the root balls on these downed trees illustrates the disposal cell cover concern (PL-7). DOE will work with NRC to develop a path forward to address the trees on the disposal cell cover, considering the potential root ball concern.

*PL-7. Large Root Ball on Downed Tree*
