# 1.0 Bluewater, New Mexico, Disposal Site

## 1.1 Compliance Summary

The site, approximately 9 miles northwest of Grants, New Mexico, was inspected September 10–11, 2020. The annual inspection, which routinely occurs in March, was delayed by coronavirus-related travel restrictions. The inspection was conducted by J. Cario, N. Keller, and D. Traub of the Legacy Management Support (LMS) contractor. B. Tsosie (LM site manager), B. Frazier (LM), and A. Rheubottom (New Mexico Environment Department [NMED]) attended the inspection. The purposes of the inspection were to confirm the integrity of visible features at the site, identify changes in conditions that might affect conformance with the LTSP, and determine the need, if any, for maintenance or additional inspection and monitoring.

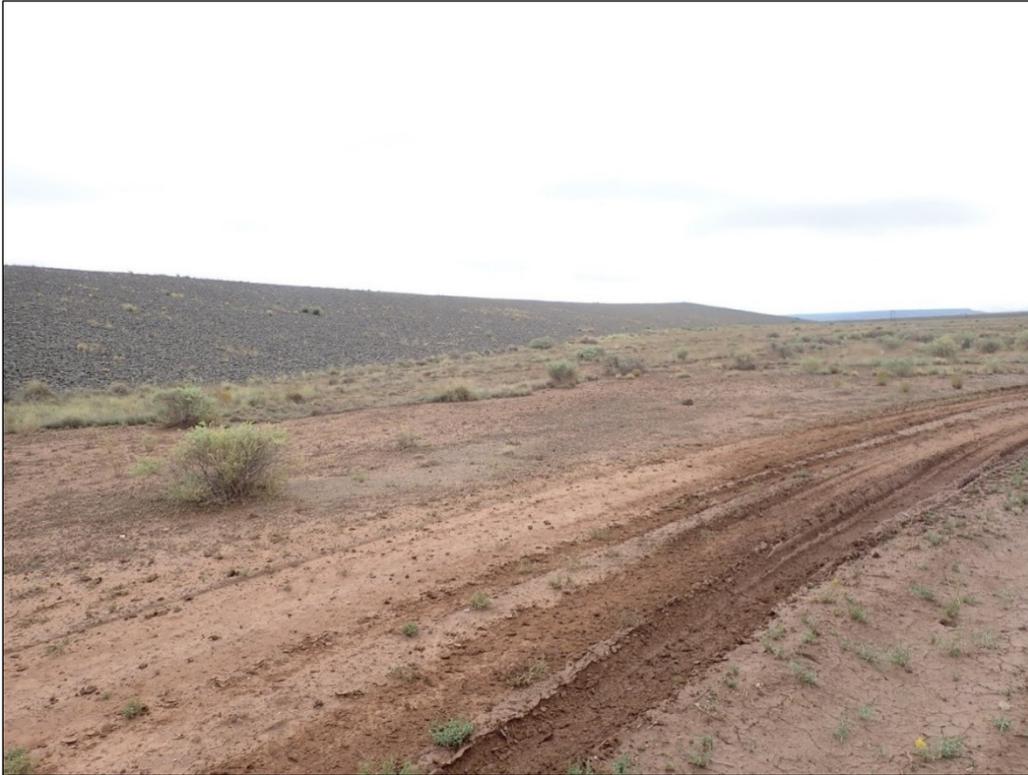
Interior roads used to access LM assets consist of a dirt track covered at places with crushed basalt (PL-1). The roads are susceptible to erosion and are repaired when they become impassable. Erosion on the road northwest of the main tailings disposal cell continues to be an issue. In 2017 riprap was added to repair a gully intersecting this section of the road. Additional erosion was noted along the road paralleling the northern perimeter of the site. LM is planning to repair the roads in 2021 through the interagency agreement with USACE. Vegetation was also overgrown along the road paralleling the north perimeter of the site, which LM cut back in a subsequent visit in September 2020. No other maintenance needs were identified.

*PL-1. Access Road and West Side Slope of the Main Tailings Disposal Cell*

Inspectors also identified the need to repair erosion along the interior road. This work is proposed for 2021.

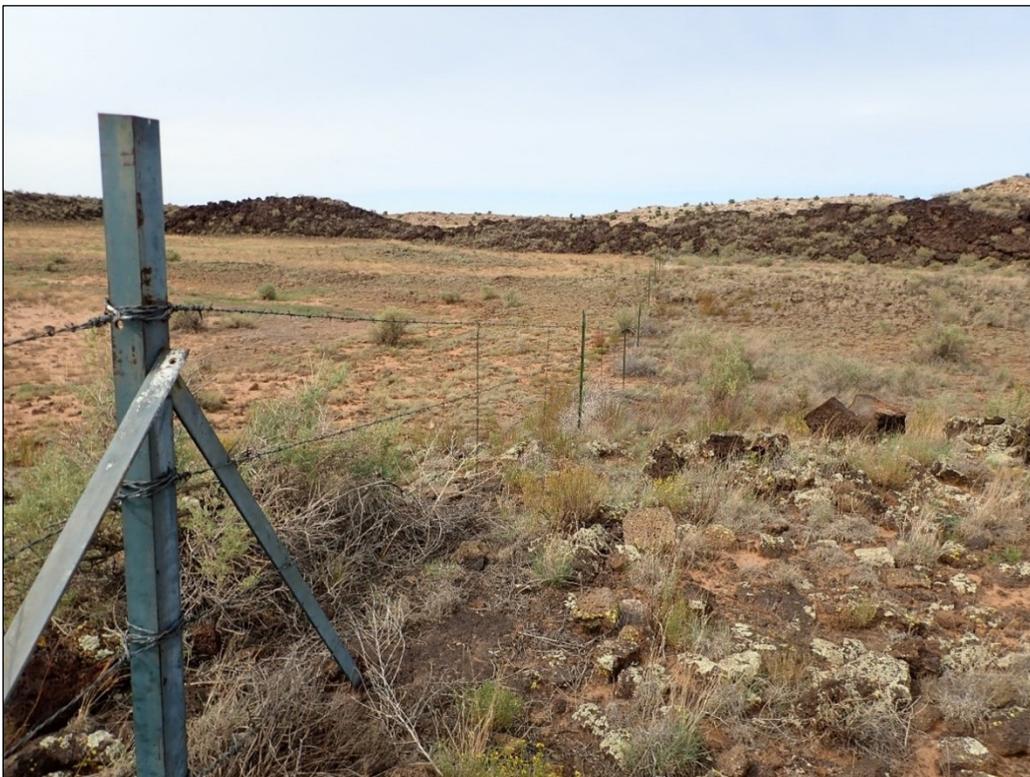
A four-strand barbed-wire fence encloses the site to facilitate land management by LM, which retains a local subcontractor to periodically check the site perimeter fence and remove trespassing cattle (PL-2). Minor fence repairs are conducted as needed. Numerous sections of the fence are in remote areas of the site and cannot be observed from site access roads. Inspectors observed the gullies paralleling the perimeter fence northwest of the main tailings disposal cell, which were identified in the 2019 inspection. No significant changes were observed. Inspectors will continue to monitor this area for damage to the perimeter fence.

*PL-2. Fence Line Near Boundary Monument BM-4*

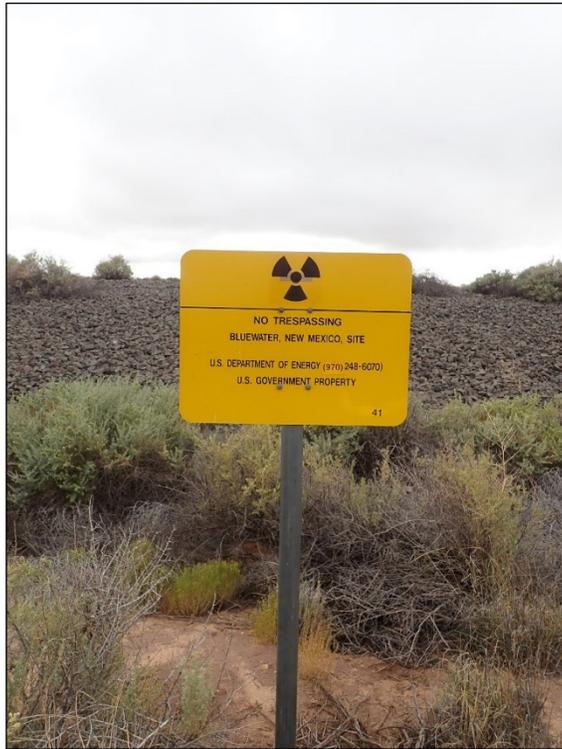
Fifty-five perimeter signs (warning and no-trespassing signs) are mounted on steel posts along the site boundary and around the main and carbonate tailings disposal cells (PL-3). Perimeter signs P3 and P10 have bullet hole damage but are legible. The base of perimeter sign P16 was loose, though immediate maintenance is not required. Inspectors will continue to monitor the condition of the sign. No other maintenance needs were identified.

*PL-3. Perimeter Sign P41*

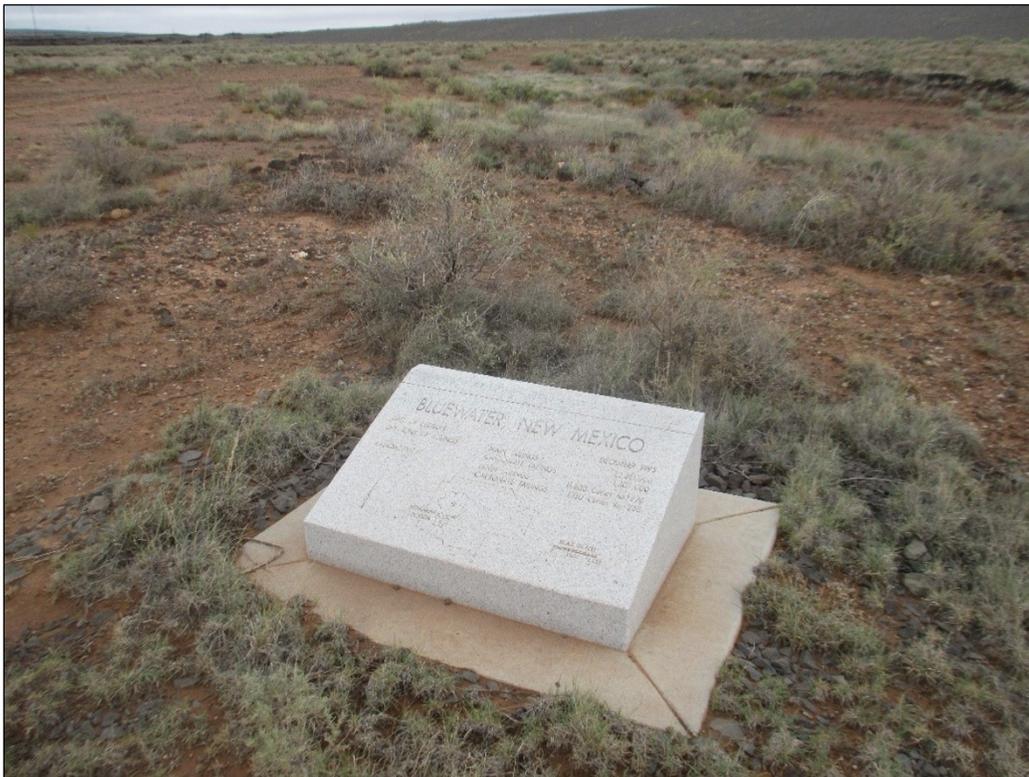
The site has one granite site marker between the southwest corner of the main tailings disposal cell and the northwest corner of the carbonate tailings disposal cell (PL-4). No maintenance needs were identified.

*PL-4. Site Marker*

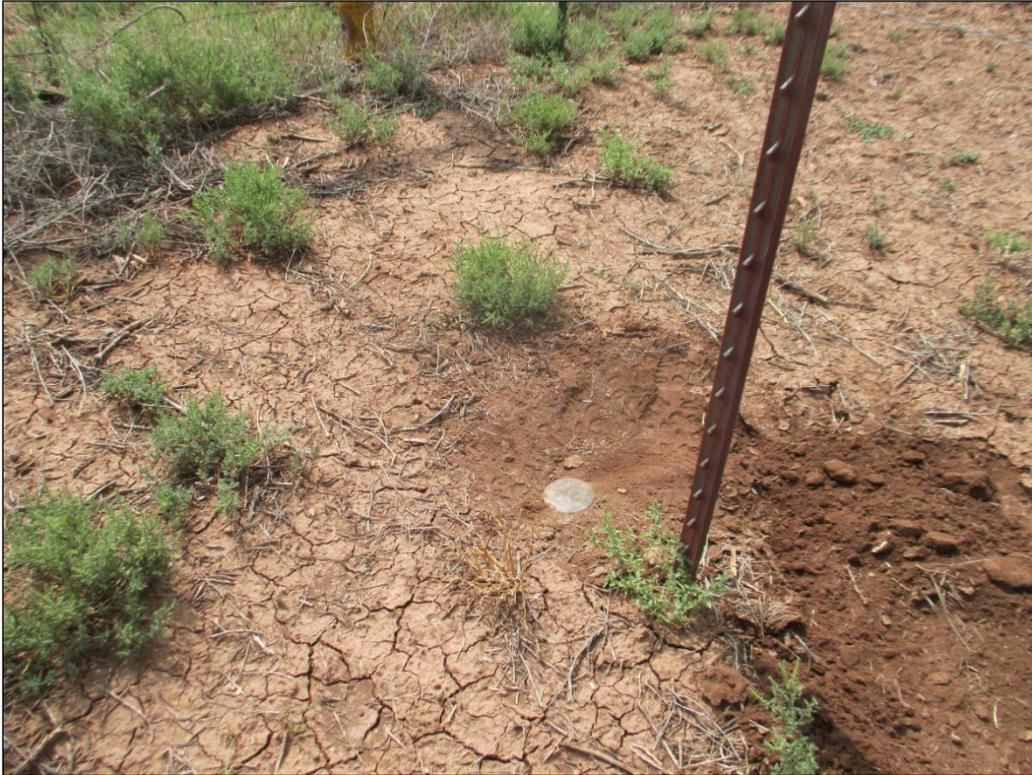
Twenty-four boundary monuments define the site boundary (PL-5). These monuments are typically inside the perimeter fence and several feet inside the true corner or boundary line. Some monuments become covered by drifting sand, and metal T-posts have been driven at those locations to help inspectors find them. Other monuments are in remote sections of the site and cannot be observed from site access roads. All boundary monuments were inspected either during the 2020 inspection or in a subsequent maintenance trip at the end of September 2020. No maintenance needs were identified.

*PL-5. Boundary Monument BM-20*

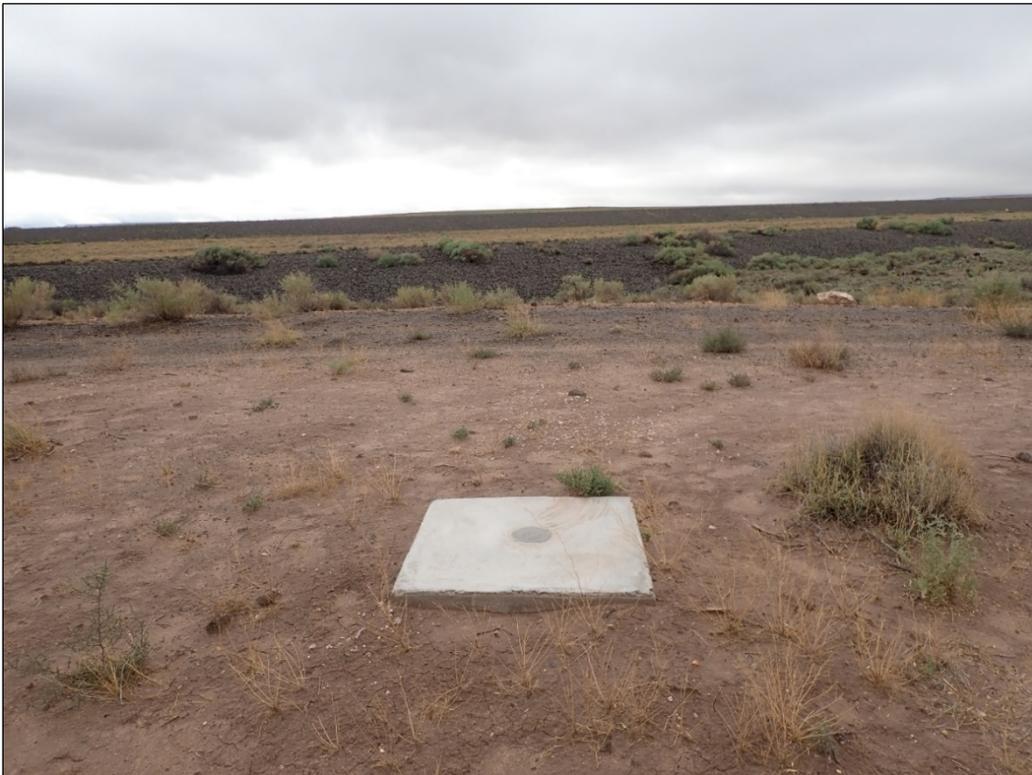
Thirteen aerial survey quality control (QC) monuments, installed in 2019, were inspected during the 2020 annual inspection (PL-6). No maintenance needs were identified.

*PL-6. Quality Control Monument QC12*

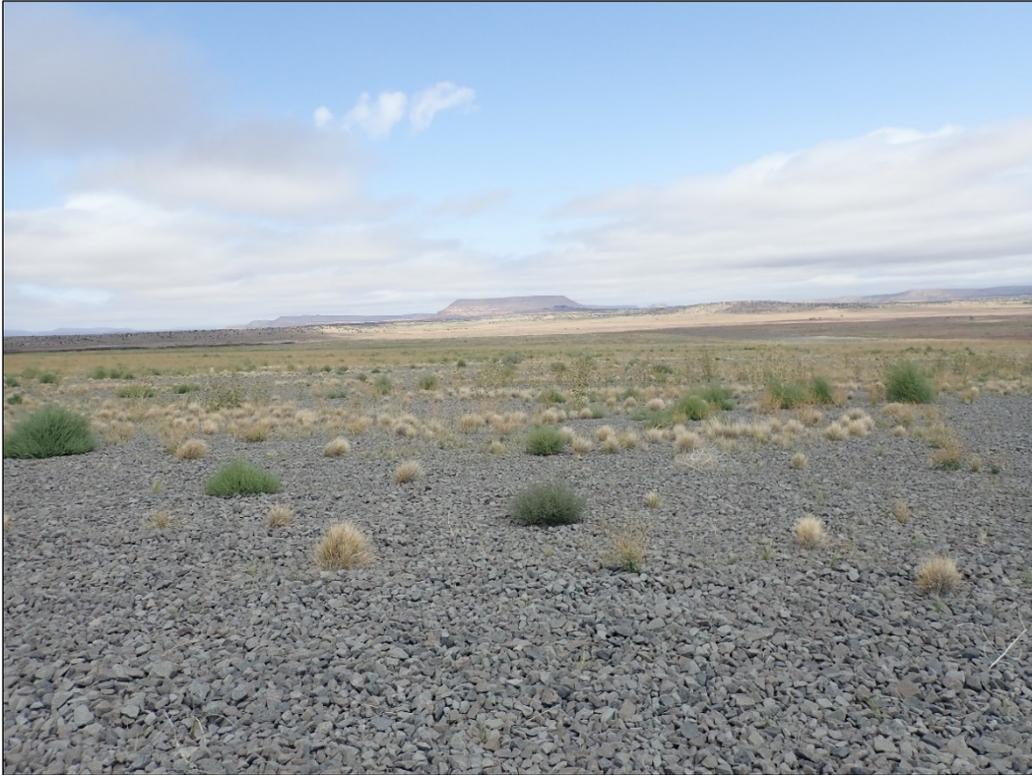
Plant encroachment (by annual weeds, perennial grasses and forbs, and scattered perennial shrubs) continues on the main tailings disposal cell top and side slopes (PL-7). Siberian elm saplings on the top slope are managed to prevent the establishment of trees that could damage the main tailings disposal cell cover materials. Several were identified and flagged to be treated during a subsequent vegetation management trip.

*PL-7. Main Tailings Disposal Cell Top Slope*

- Management of Siberian elm saplings on the top slope of the main tailings disposal cell
- Treatment of noxious weeds

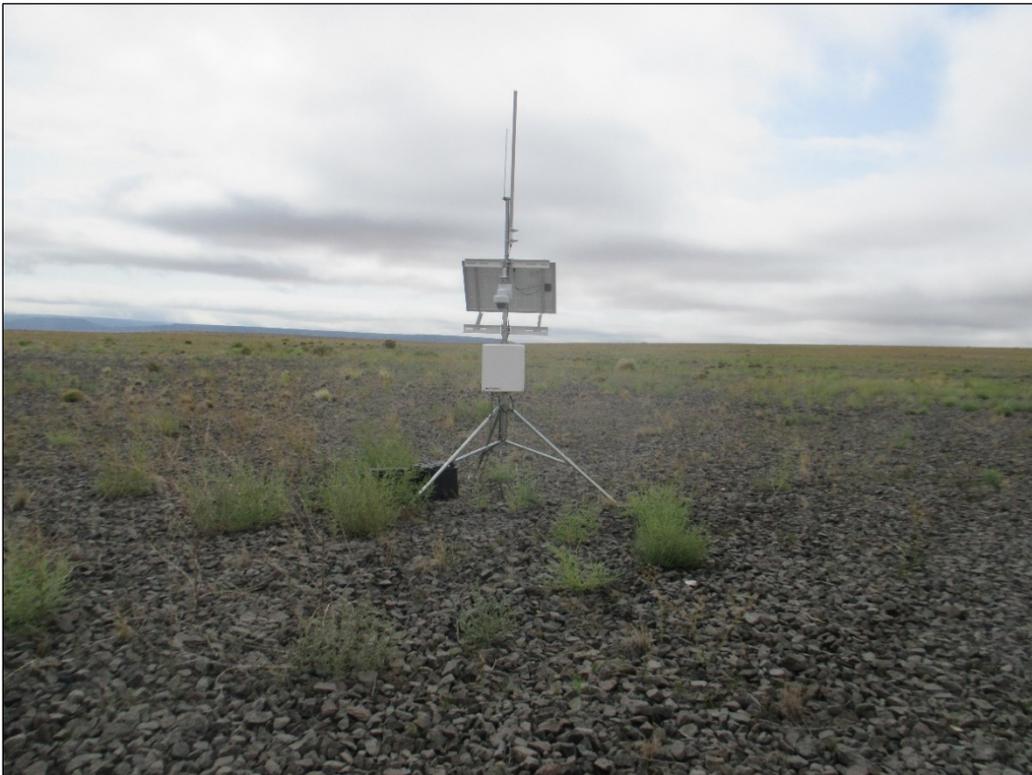
Ponds often develop in the depressions after rainfall and occasionally coalesce into one large pond after a series of rainstorms. The area of depressions is monitored continuously using a remotely operated webcam to detect the presence of ponded water (PL-8). No ponding was observed on the main tailings disposal cell during the inspection. No algae were present during the inspection even though algae have been noted in previous reports.

*PL-8. Main Tailings Disposal Cell Webcam*

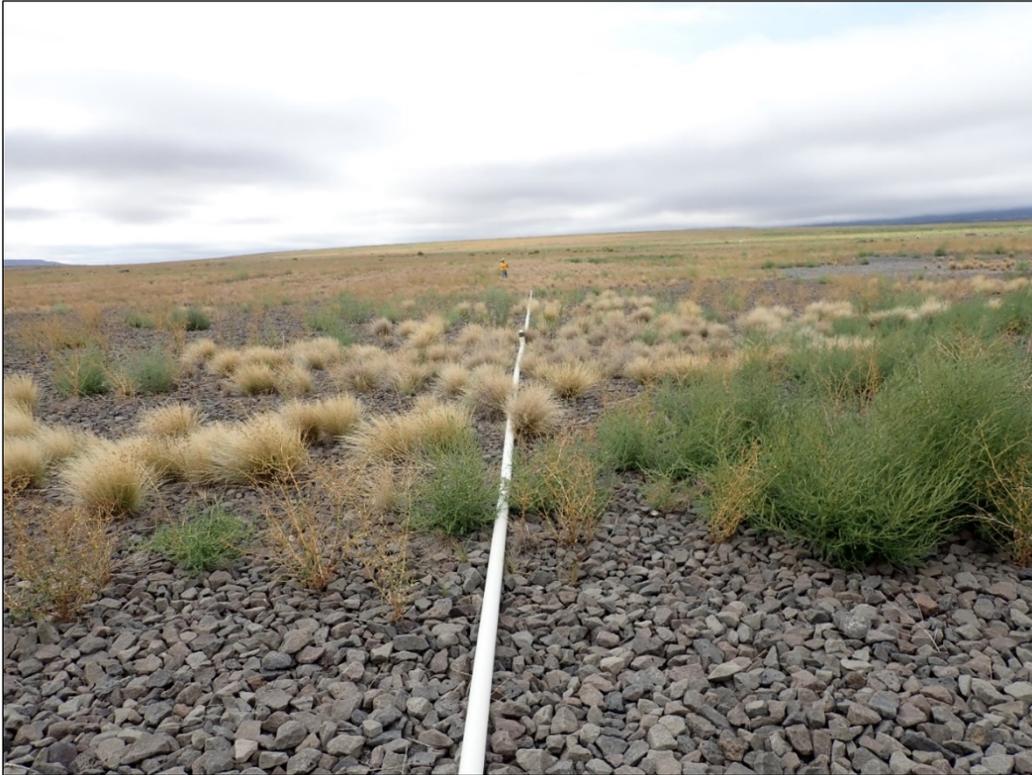
A 2-inch-diameter siphon was installed in fall 2015 to dewater as much of the ponded water as possible (PL-9). The siphon is manually started when the webcam indicates that a large pond has developed. The intent is to avoid potential erosion of the main tailings disposal cell cover materials if the pond surface reaches an elevation high enough to spill over the disposal cell's north side slope. Water would start to spill at the lowest point along the north edge of the top slope, and that could initiate erosion at that spot. LM entered into an interagency agreement with USACE in October 2019 to design a repair to the depressions and ensure continued positive drainage from the main tailings disposal cell. NRC will be involved in reviewing designs as they are developed and will concur upon the final design before construction.

*PL-9. Siphon on the Top Slope of the Main Tailings Disposal Cell*

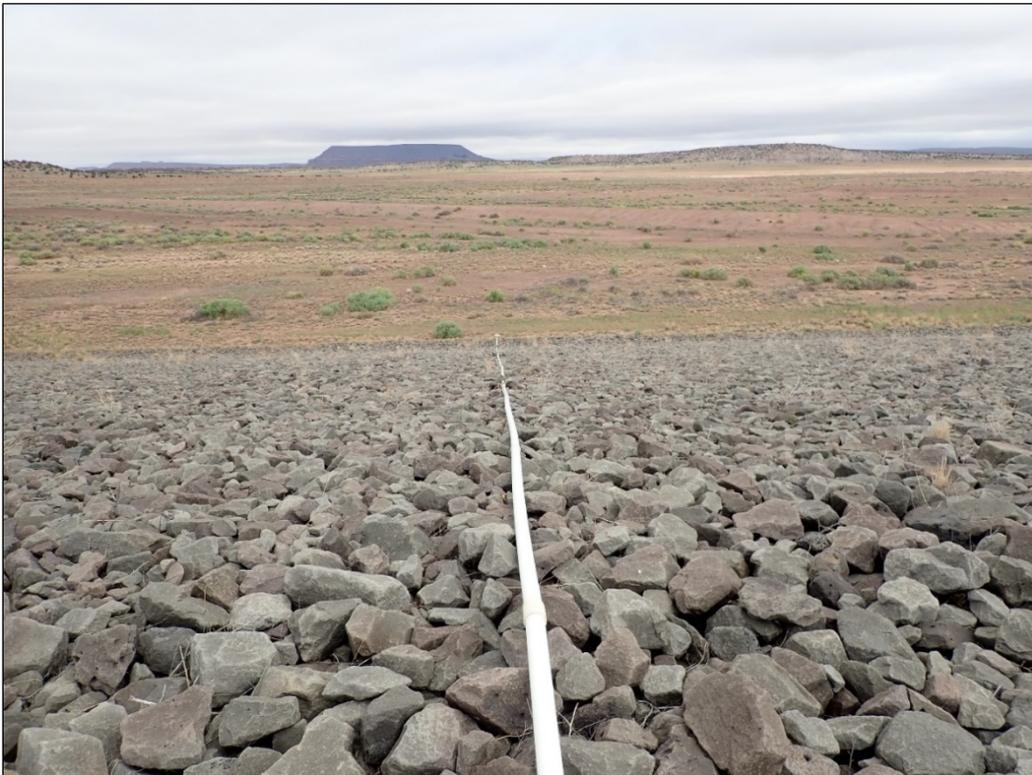
The siphon is usually operated at least once a year, and it successfully removes nearly all the water; the remaining water evaporates. All the water cannot drain from one location because of the unevenness of the depressions. The siphon was not operated in 2020 because of minimal ponded water. When operated, the siphon discharges water at a rate of approximately 100 gallons per minute at the toe of the north side slope where runoff water was intended to discharge (PL-10). The discharged water ponds over a large area north of the main tailings disposal cell and eventually dissipates through infiltration into soil and through evaporation. The discharged water does not flow off the site.

*PL-10. Siphon on North Side Slope of the Main Tailings Disposal Cell*

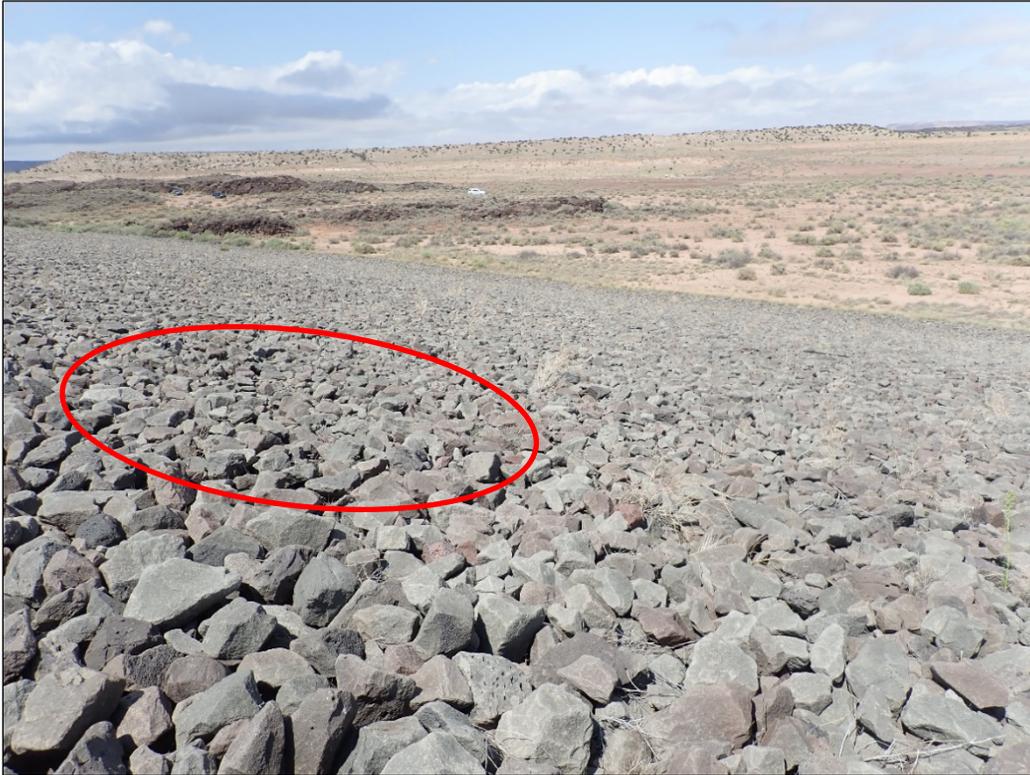
The side slopes and toe of the main tailings disposal cell were inspected for signs of erosion or sediment deposition. An area of minor depression was observed on the south side slope during the 2018 annual inspection and was observed from the base of the main tailings disposal cell during the 2020 annual inspection, but it could not be identified from the top slope. An additional area of potential settlement was observed on the north side slope (PL-11). The side slopes will continue to be observed for depressions and will be evaluated using lidar. During the 2019 annual inspection, minor rills with a maximum depth of 6 inches were observed at the base of the east side slope; minor rills with a maximum depth of 8 inches were observed at the base of the main tailings disposal cell south bench. The rills did not appear to increase in depth or extent. A linear desiccation crack was observed along the base of the east side slope (PL-12). LM will continue to monitor the rills and crack for potential impact to the main tailings disposal cell and south bench area. No sediment deposits were present along the toe. No maintenance needs for the side slopes or acid tailings and south bench disposal areas were identified.

*PL-11. Potential Settlement on the North Side Slope of the Main Tailings Disposal Cell*

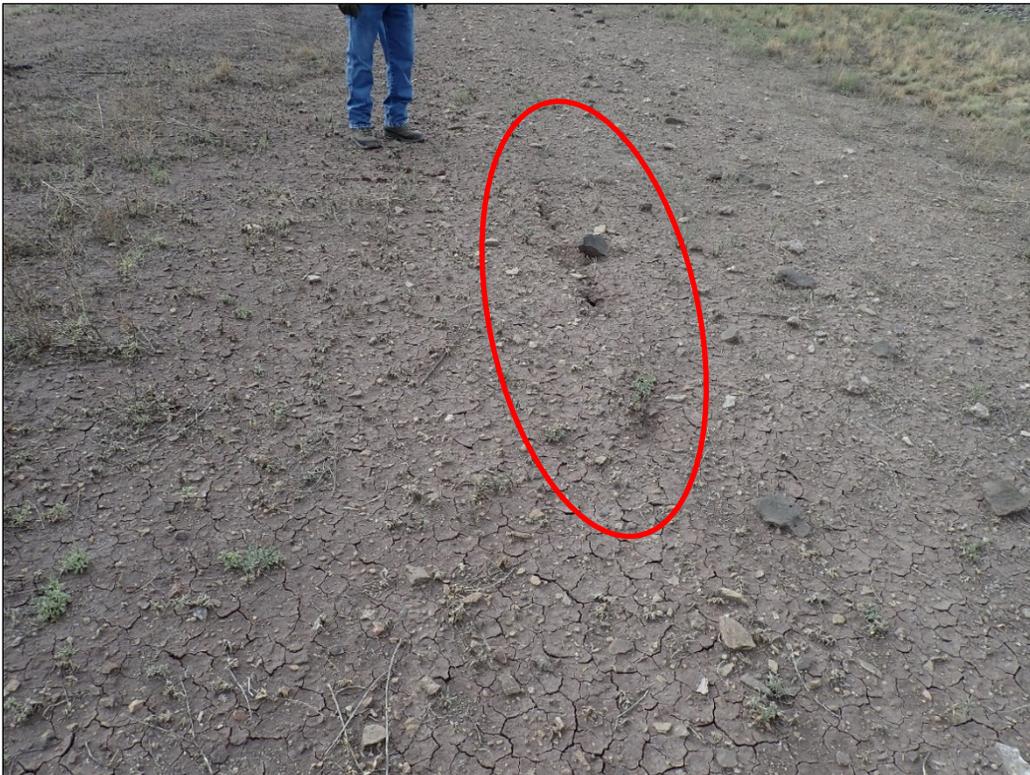
*PL-12. Linear Desiccation Crack*

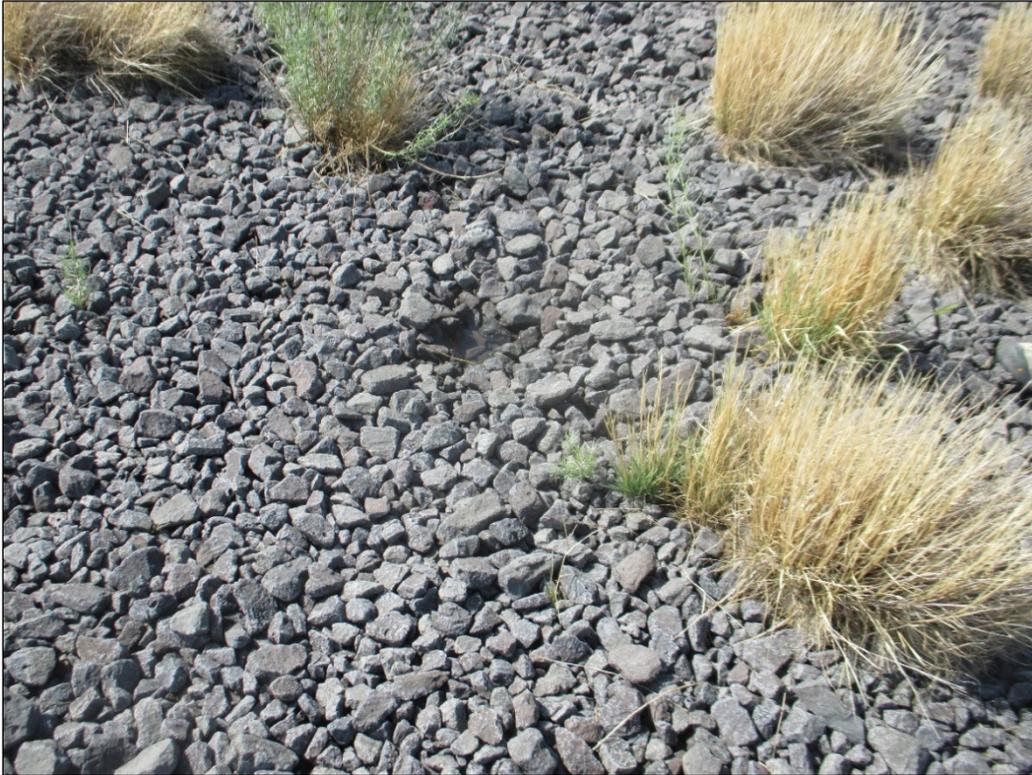
The 54-acre carbonate tailings disposal cell is south of the main tailings disposal cell. Basalt riprap covers the top and side slopes of the carbonate tailings disposal cell. The top, for the most part, slopes gently eastward. The carbonate tailings disposal cell includes extensions to the northwest and southeast. A very shallow depression exists on the northwest extension, and rainfall runoff occasionally ponds at this location; minor ponding was observed in the depression during the 2020 inspection (PL-13). This depression does not appear to be enlarging but will continue to be visually inspected and evaluated using periodic lidar survey results. An additional wet area was observed along the north toe slope (PL-14); this is believed to be a topographic low point. Annual weeds, perennial grasses, and scattered woody shrubs were present on the carbonate tailings disposal cell and its extensions. Siberian elm saplings are periodically treated with herbicide; no saplings were observed during the inspection. No maintenance needs were identified.

*PL-13. Ponded Water Near Shallow Depression on the Northwest Extension of the Carbonate Tailings Disposal Cell*

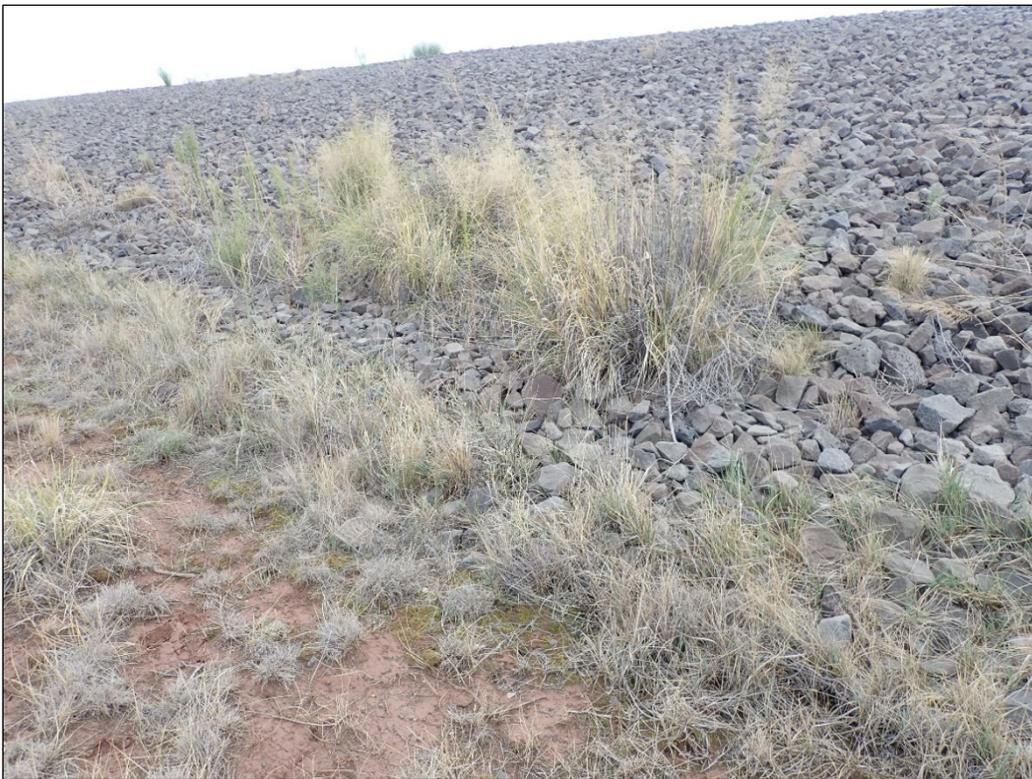
*PL-14. Wet Area Near North Toe Slope of the Carbonate Tailings Disposal Cell*

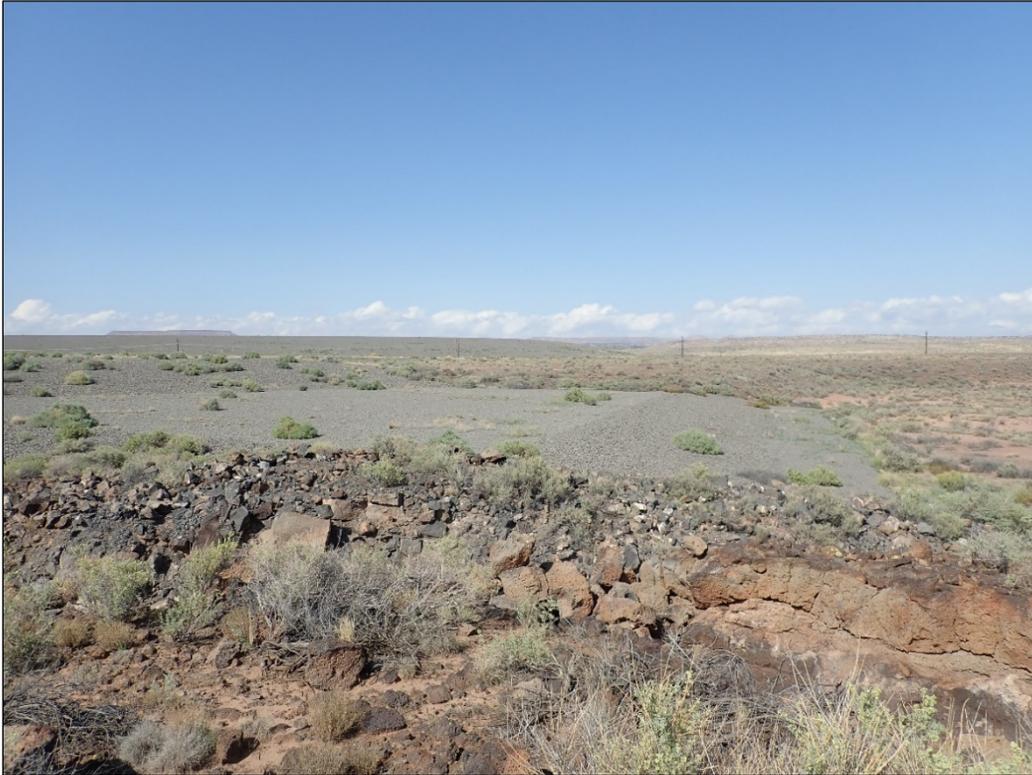
The 2-acre asbestos disposal area is a bowl-like feature just south of the carbonate tailings disposal cell. The north, west, and south side slopes of this feature are covered by limestone riprap; the bottom of the bowl (the asbestos cell cover) is covered with grass (PL-15). The depressions repaired in May 2018 were observed, and no changes were apparent. LM observed the depression identified during the 2019 annual inspection on the north side slope; no changes were apparent. LM will continue to observe the depression and make repairs as necessary. No immediate maintenance needs were identified.

*PL-15. Asbestos Disposal Area*

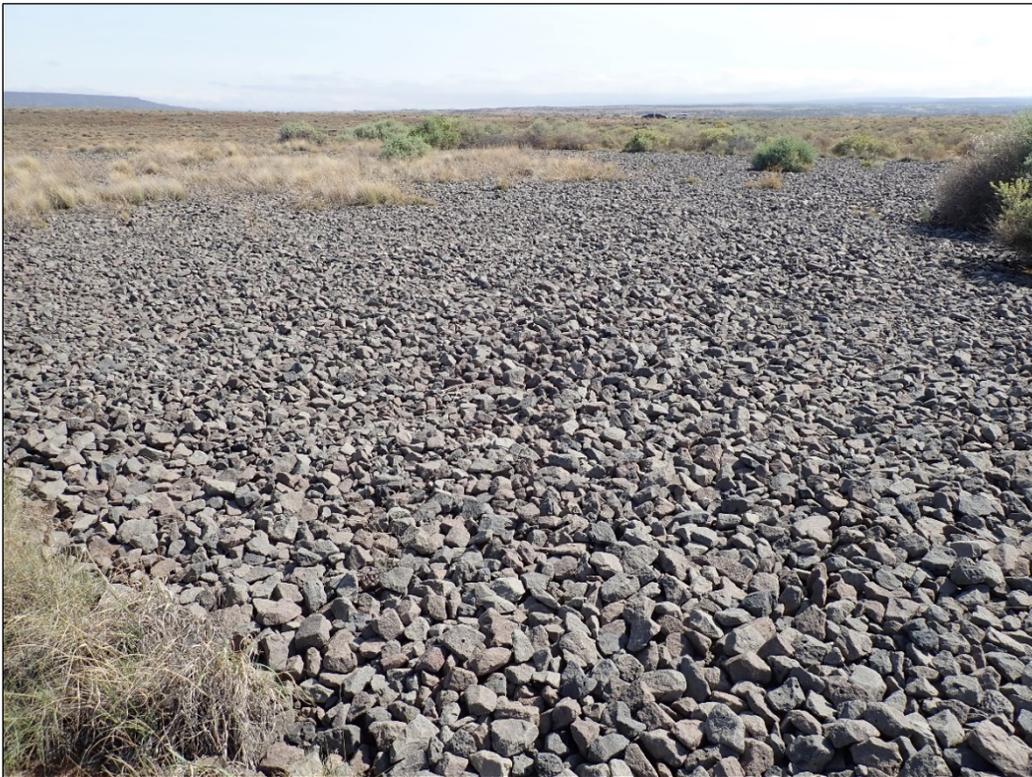
An 11-acre grass-covered disposal area is south of the asbestos disposal area. A small riprap-covered PCB cell (less than 1 acre) is within the disposal area (PL-16). Two grass-covered dumps, totaling about 2 acres, are east of the carbonate tailings disposal cell (PL-17). Inspectors observed the fill material settled into the basalt in an area at the southern interface of the east dump; it was first identified during the 2019 annual inspection (PL-18). No changes were apparent. LM will continue to observe the settlement and make repairs as necessary. No immediate maintenance needs were identified.

*PL-16. PCB Disposal Area*

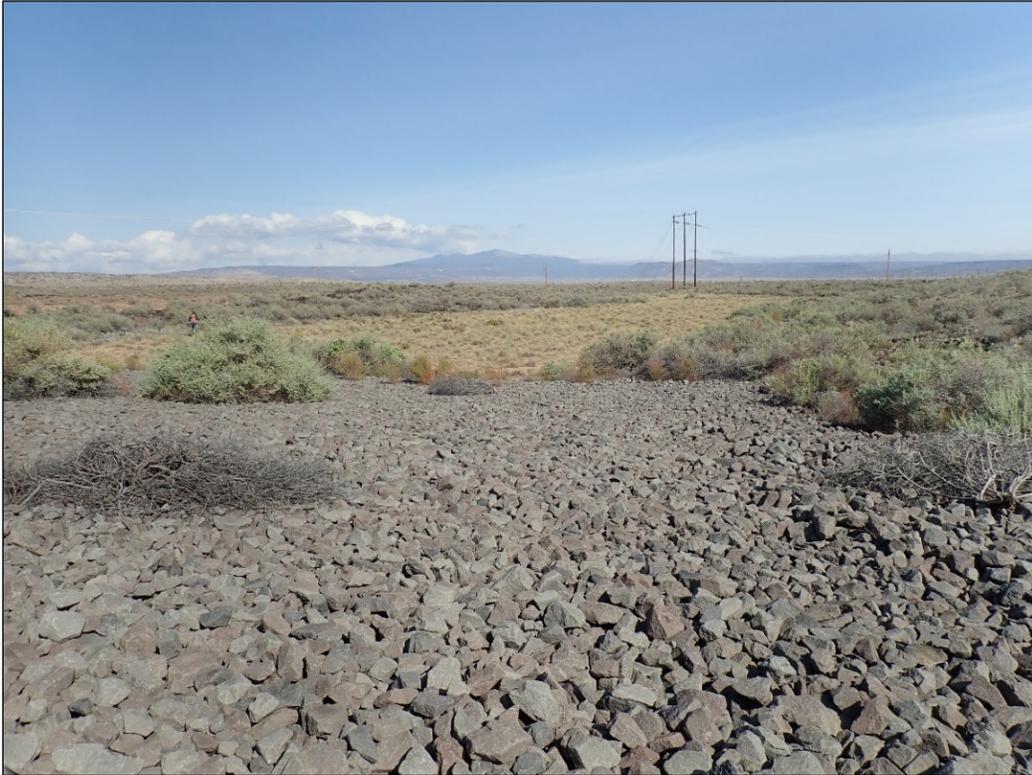
*PL-17. East Dump*

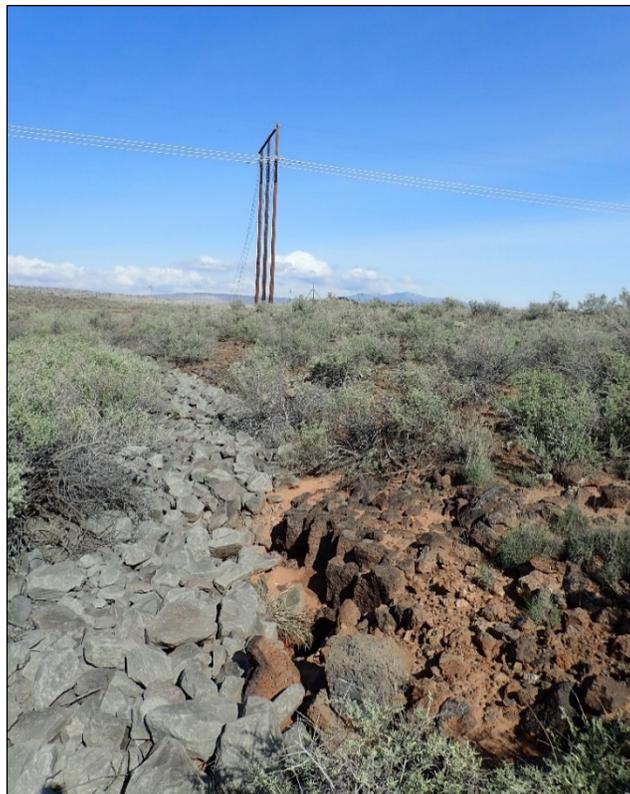
*PL-18. Settlement in Fill Covering Basalt at the Interface of the East Dump Cover*

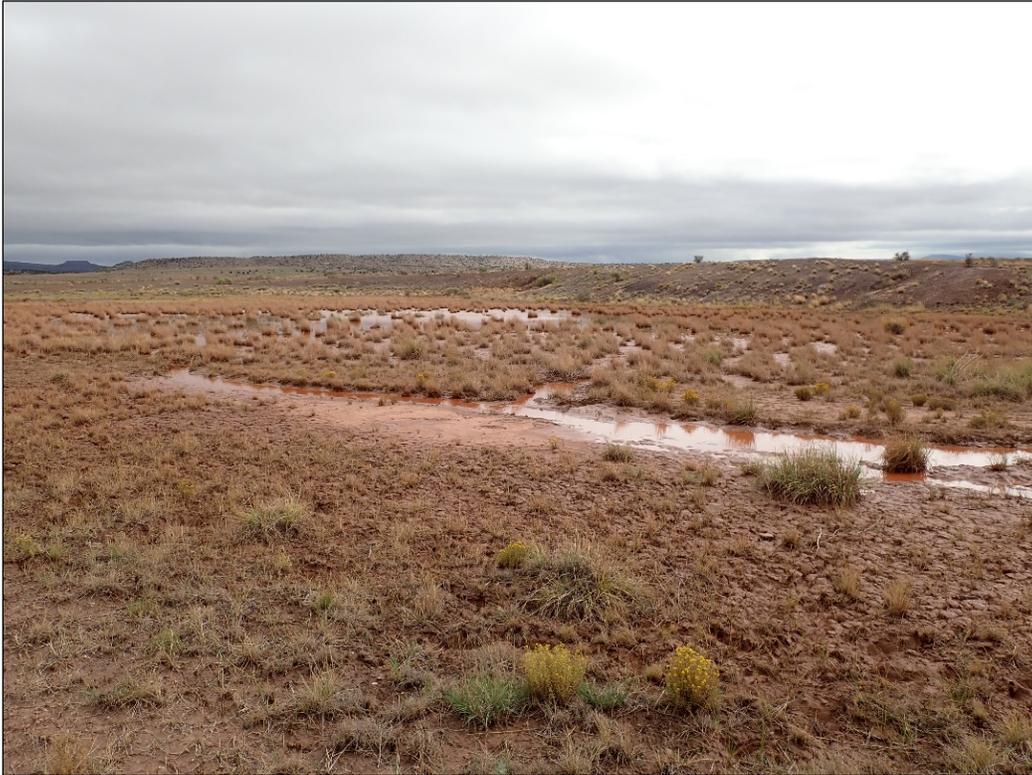
Small ephemeral ponds often form in an area along the east side of the main tailings disposal cell and in other low spots following storms. The areas of ponding are far enough from the main tailings disposal cell to not impact it. The ponded areas were wet during the inspection (PL-19).

*PL-19. Wet Ephemeral Ponds*
