2.0 Edgemont, South Dakota, Disposal Site

2.1 Compliance Summary

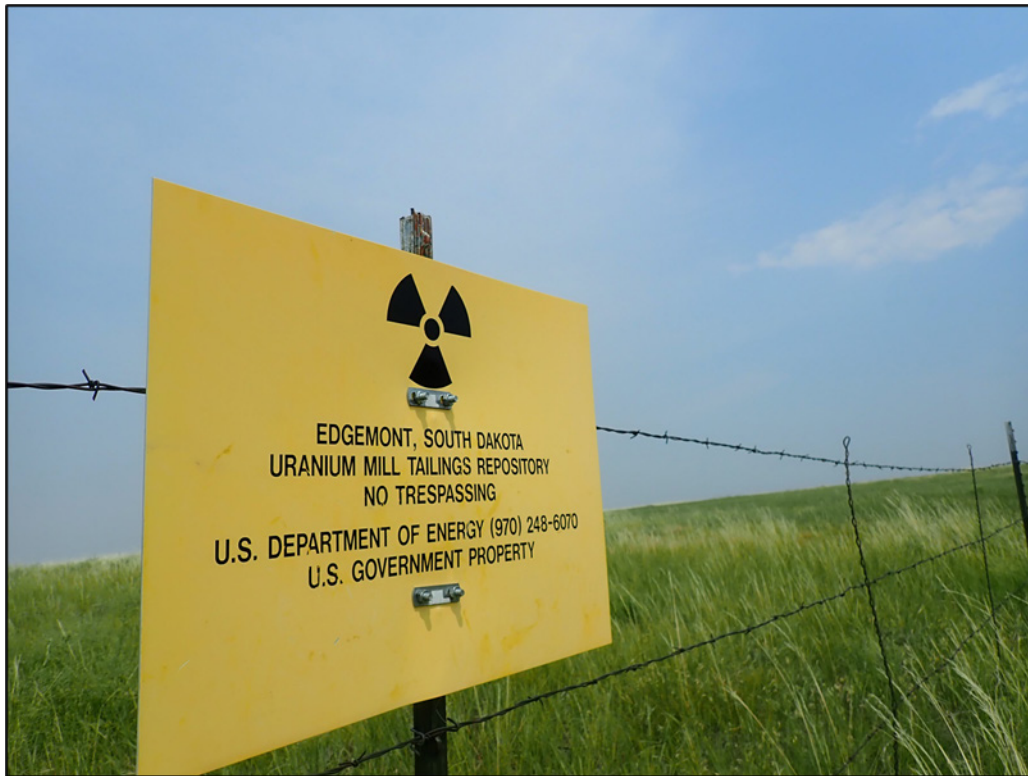
A four-strand barbed-wire fence encloses the site, truncating at the southeast corner to allow livestock access to a preexisting stock pond. Two perimeter signs are attached to the perimeter fence (PL-1). No maintenance needs were identified.

PL-1. Perimeter Sign P2

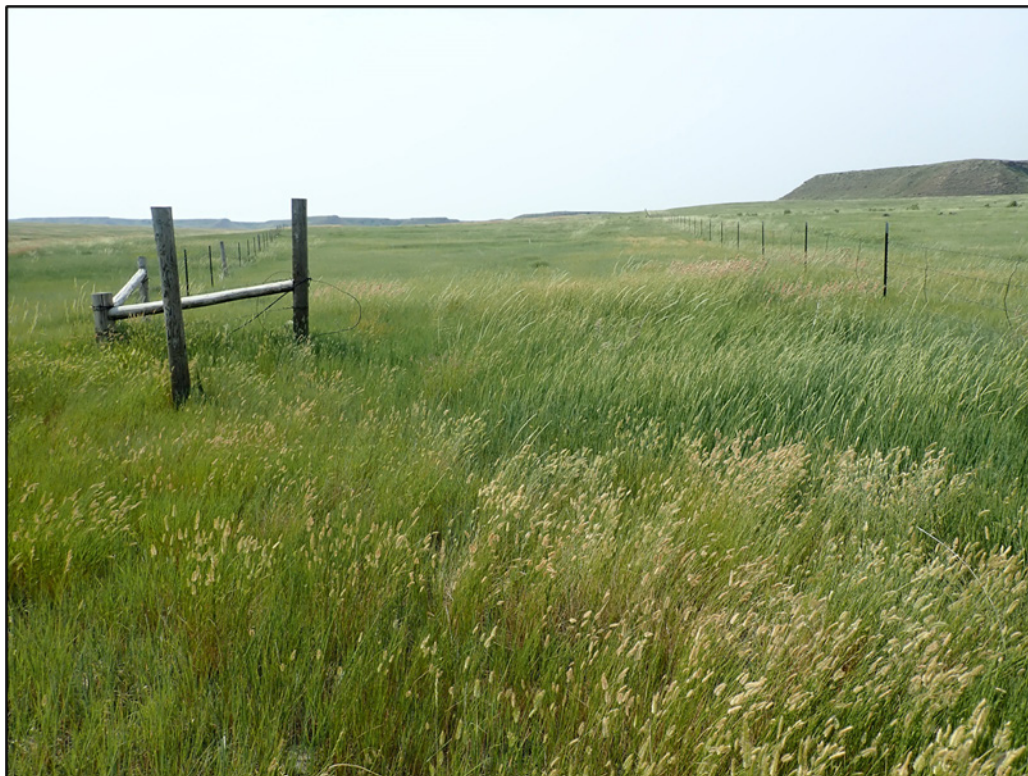
The grazing licensee monitors site security and maintains the perimeter fence. The licensee proposed removing the unmaintained interior fence that was installed to prevent grazing during vegetation establishment following closure of the disposal cell (PL-2). The LM site manager concurred with this proposal, as this fence is no longer required. The fence will be removed by the grazing licensee.

PL-2. View Along Western Fence Line

The grazing licensee will remove the unmaintained interior fence. A new entrance sign was mailed to the grazing licensee and installed (PL-9). No other maintenance needs were identified.

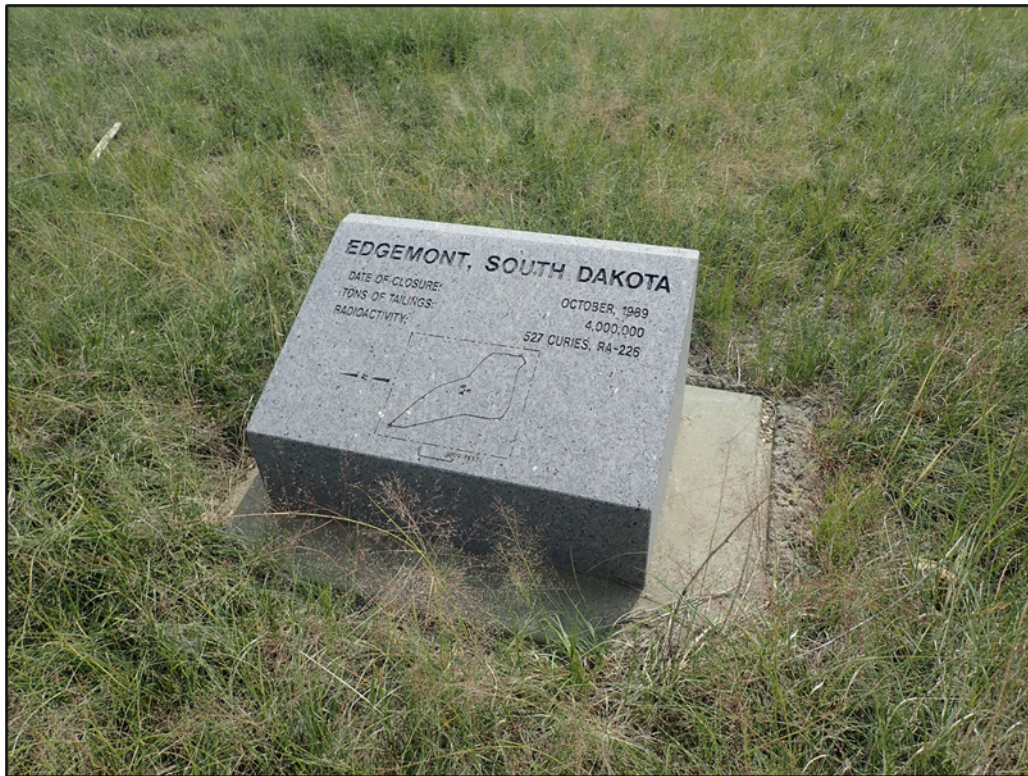
One granite site marker is present just inside the entrance gate (PL-3). No maintenance needs were identified.

PL-3. Granite Site Marker

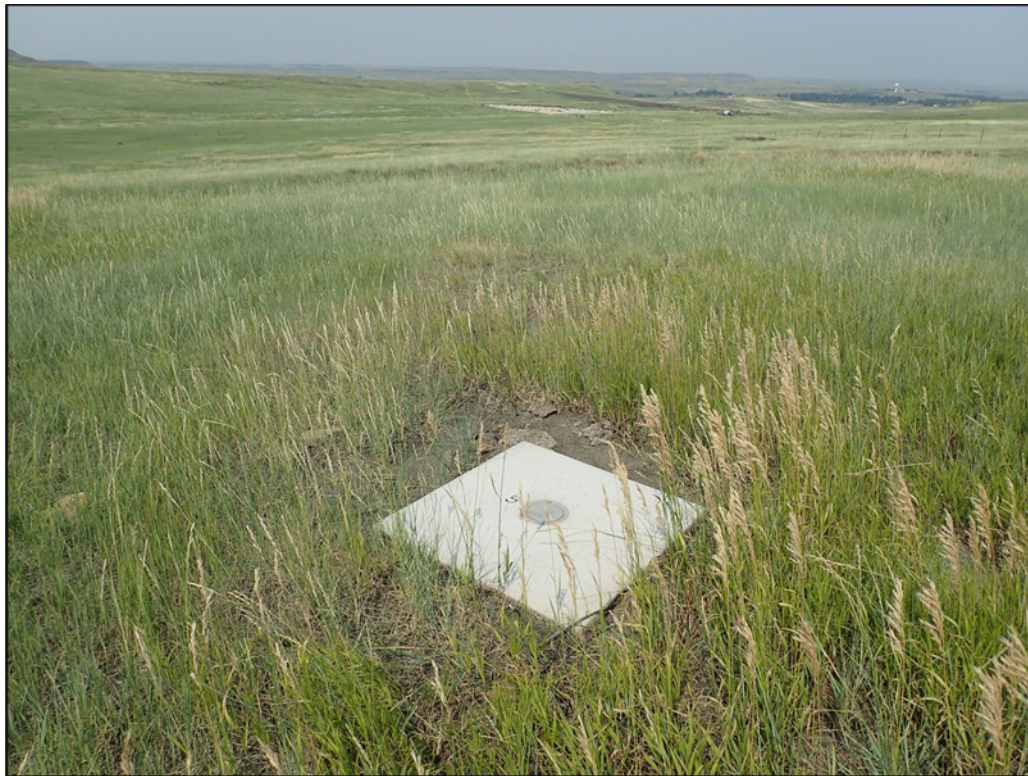
Seven aerial survey quality control monuments, installed in 2019, were inspected during the 2021 annual inspection (PL-4). No maintenance needs were identified.

PL-4. Quality Control Monument QC-5

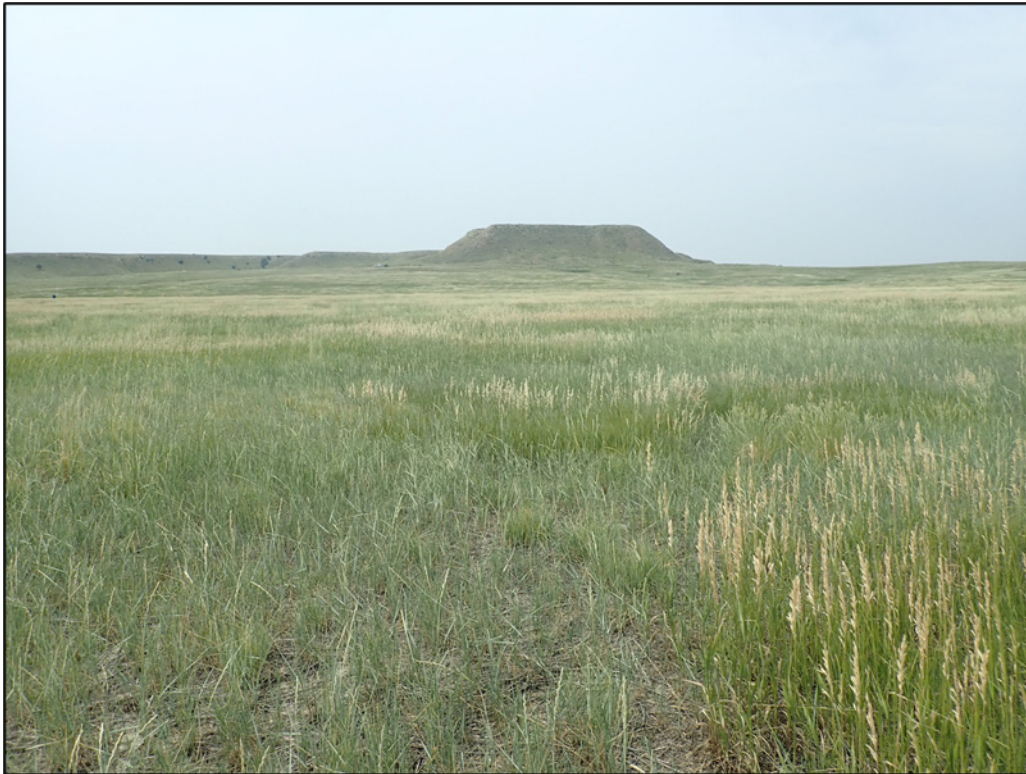
The grass-covered disposal cell, completed in 1989, occupies 100 acres (PL-5). No signs of erosion, settling, or other modifying processes were found that could affect its integrity. No maintenance needs were identified.

PL-5. Vegetated Disposal Cell Top Slope

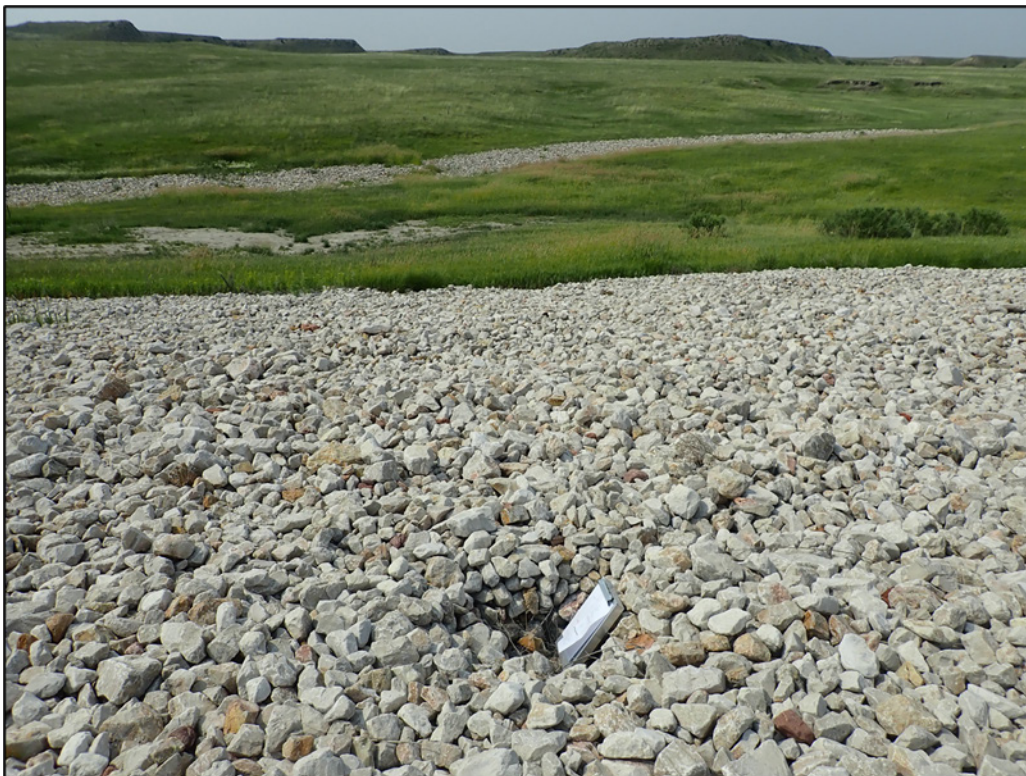
The face of the containment dam, the steepest man-made slope onsite, is armored with riprap. Two small depressions, approximately 2 feet in diameter, were observed on the containment dam (PL-6; PL-7). Since this was the first time these depressions were observed, inspectors documented the location of the depressions with a GPS unit and inspected the areas around the depressions to look for evidence of sediment mobilization or other process that would explain the formation of the depressions. No evidence of sediment deposition, human intervention, or other modifying process was observed. The depressions do not threaten the integrity or performance of the disposal cell, and monitoring of the depressions will continue during annual inspections and subsequent aerial surveys. Grasses and annual weeds were growing in the riprap in several places. These plants do not threaten the stability or function of the containment dam.

PL-6. Small Depression #1 on Disposal Cell Side Slope

A baseline aerial survey was conducted August 8–10, 2021. The purpose of the survey was to establish updated site topography for comparison with future aerial surveys to better understand and quantify changes to the site, including monitoring the depressions observed on the containment dam side slope.

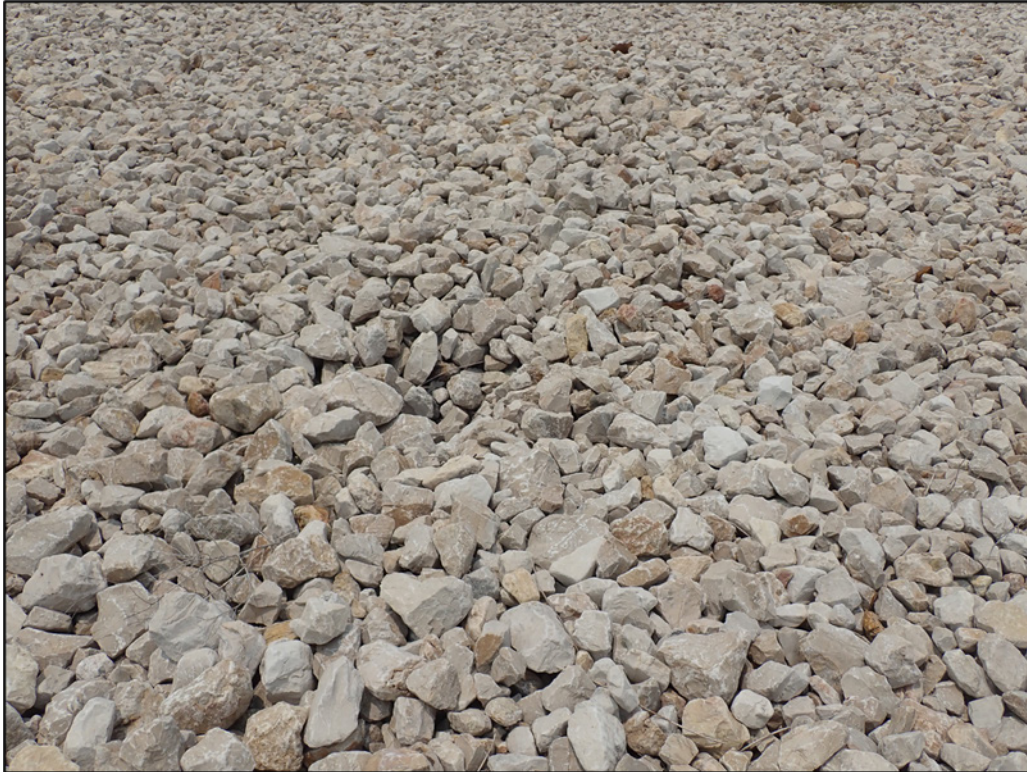
PL-7. Small Depression #2 on Disposal Cell Side Slope

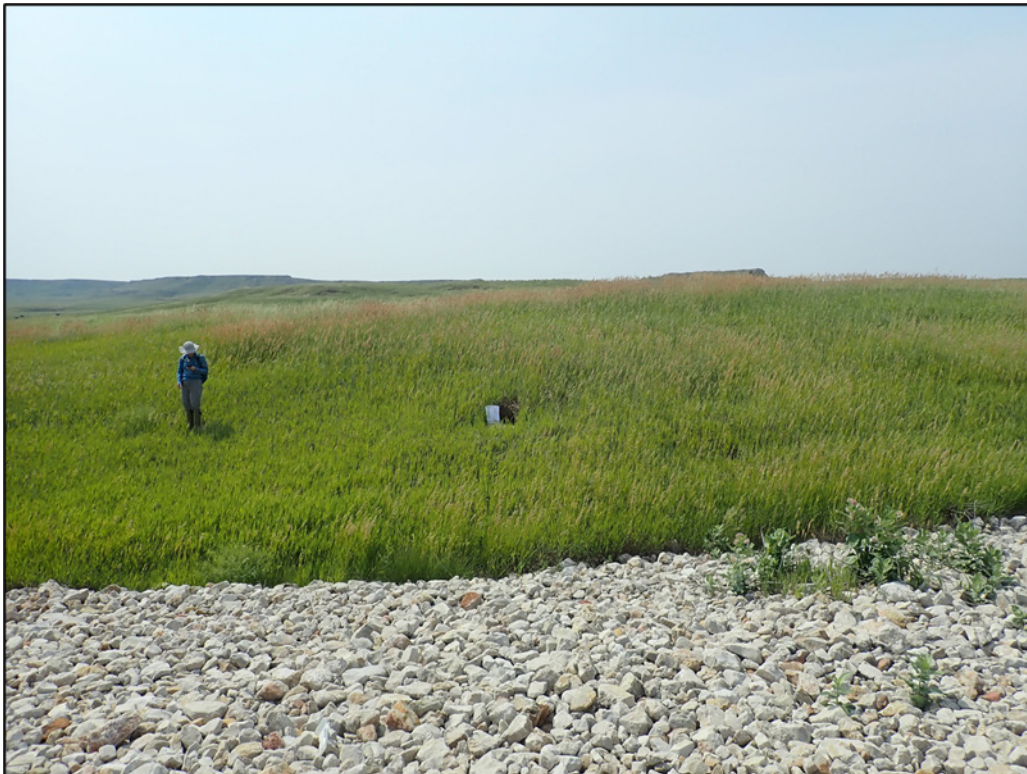
outside the northwest corner of the property that is riprap armored to prevent headward erosion onto the site—was visually observed for erosion, changes in land use, or other phenomena that might affect the long-term integrity of the site. An animal burrow was observed adjacent to the riprap-armored drainage channel but does not impact the functionality of the channel (PL-8). The balance of the site consists of undisturbed areas covered with native shrubs, grasses, and forbs and formerly disturbed areas covered primarily with seeded grasses and annual weeds. Some minor erosional features are present on steep slopes in an area isolated from the disposal cell; these features were stable. No maintenance needs were identified.

PL-8. Animal Burrow Adjacent to Toe of Armored Disposal Cell Side Slope

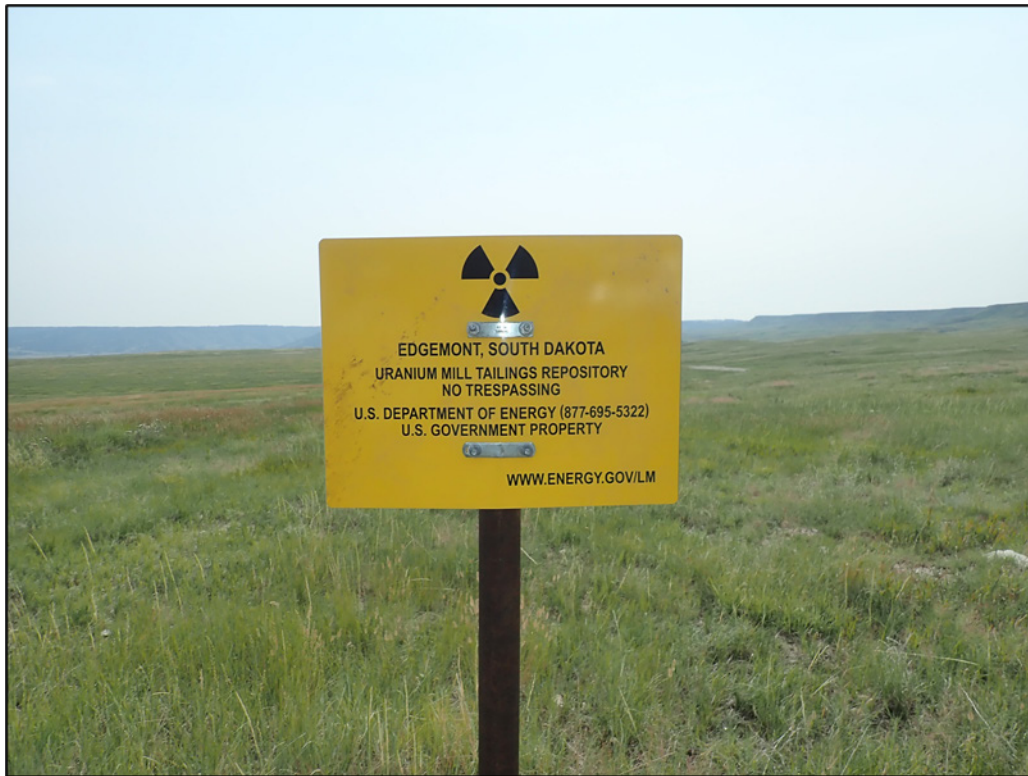
Access to the site is from Fall River County Road 6N. The entrance sign, which is mounted on a steel post set in concrete, was missing and was subsequently replaced by the grazing licensee. The tubular metal entrance gate was secured by a locked chain and was intact. The perimeter fence features three additional wire gates at the following locations: (1) the northwest corner of the property, (2) approximately 700 feet north of the southeast corner, and (3) the southeast corner of the site. All gates were closed and intact. No maintenance needs were identified.

PL-9. Entrance Sign
