4.0 Maybell West, Colorado, Disposal Site

4.1 Compliance Summary

The Maybell West, Colorado, Uranium Mill Tailings Radiation Control Act (UMTRCA) Title II Disposal Site (site) was inspected on September 2, 2021. Depressions observed during previous inspections on the top of the disposal cell and ancillary cell were revisited in 2021. The dimensions of Depressions No. 1, No. 2, and No. 3 appeared to be approximately the same size when compared to measurements made in 2020. The small depressions on the ancillary cell did not appear to change since the 2020 inspection. None of the depressions threaten the integrity or performance of the disposal cells; monitoring of the depressions will continue, including aerial surveys that can detect small changes in depression size. No changes were observed in associated drainage features.

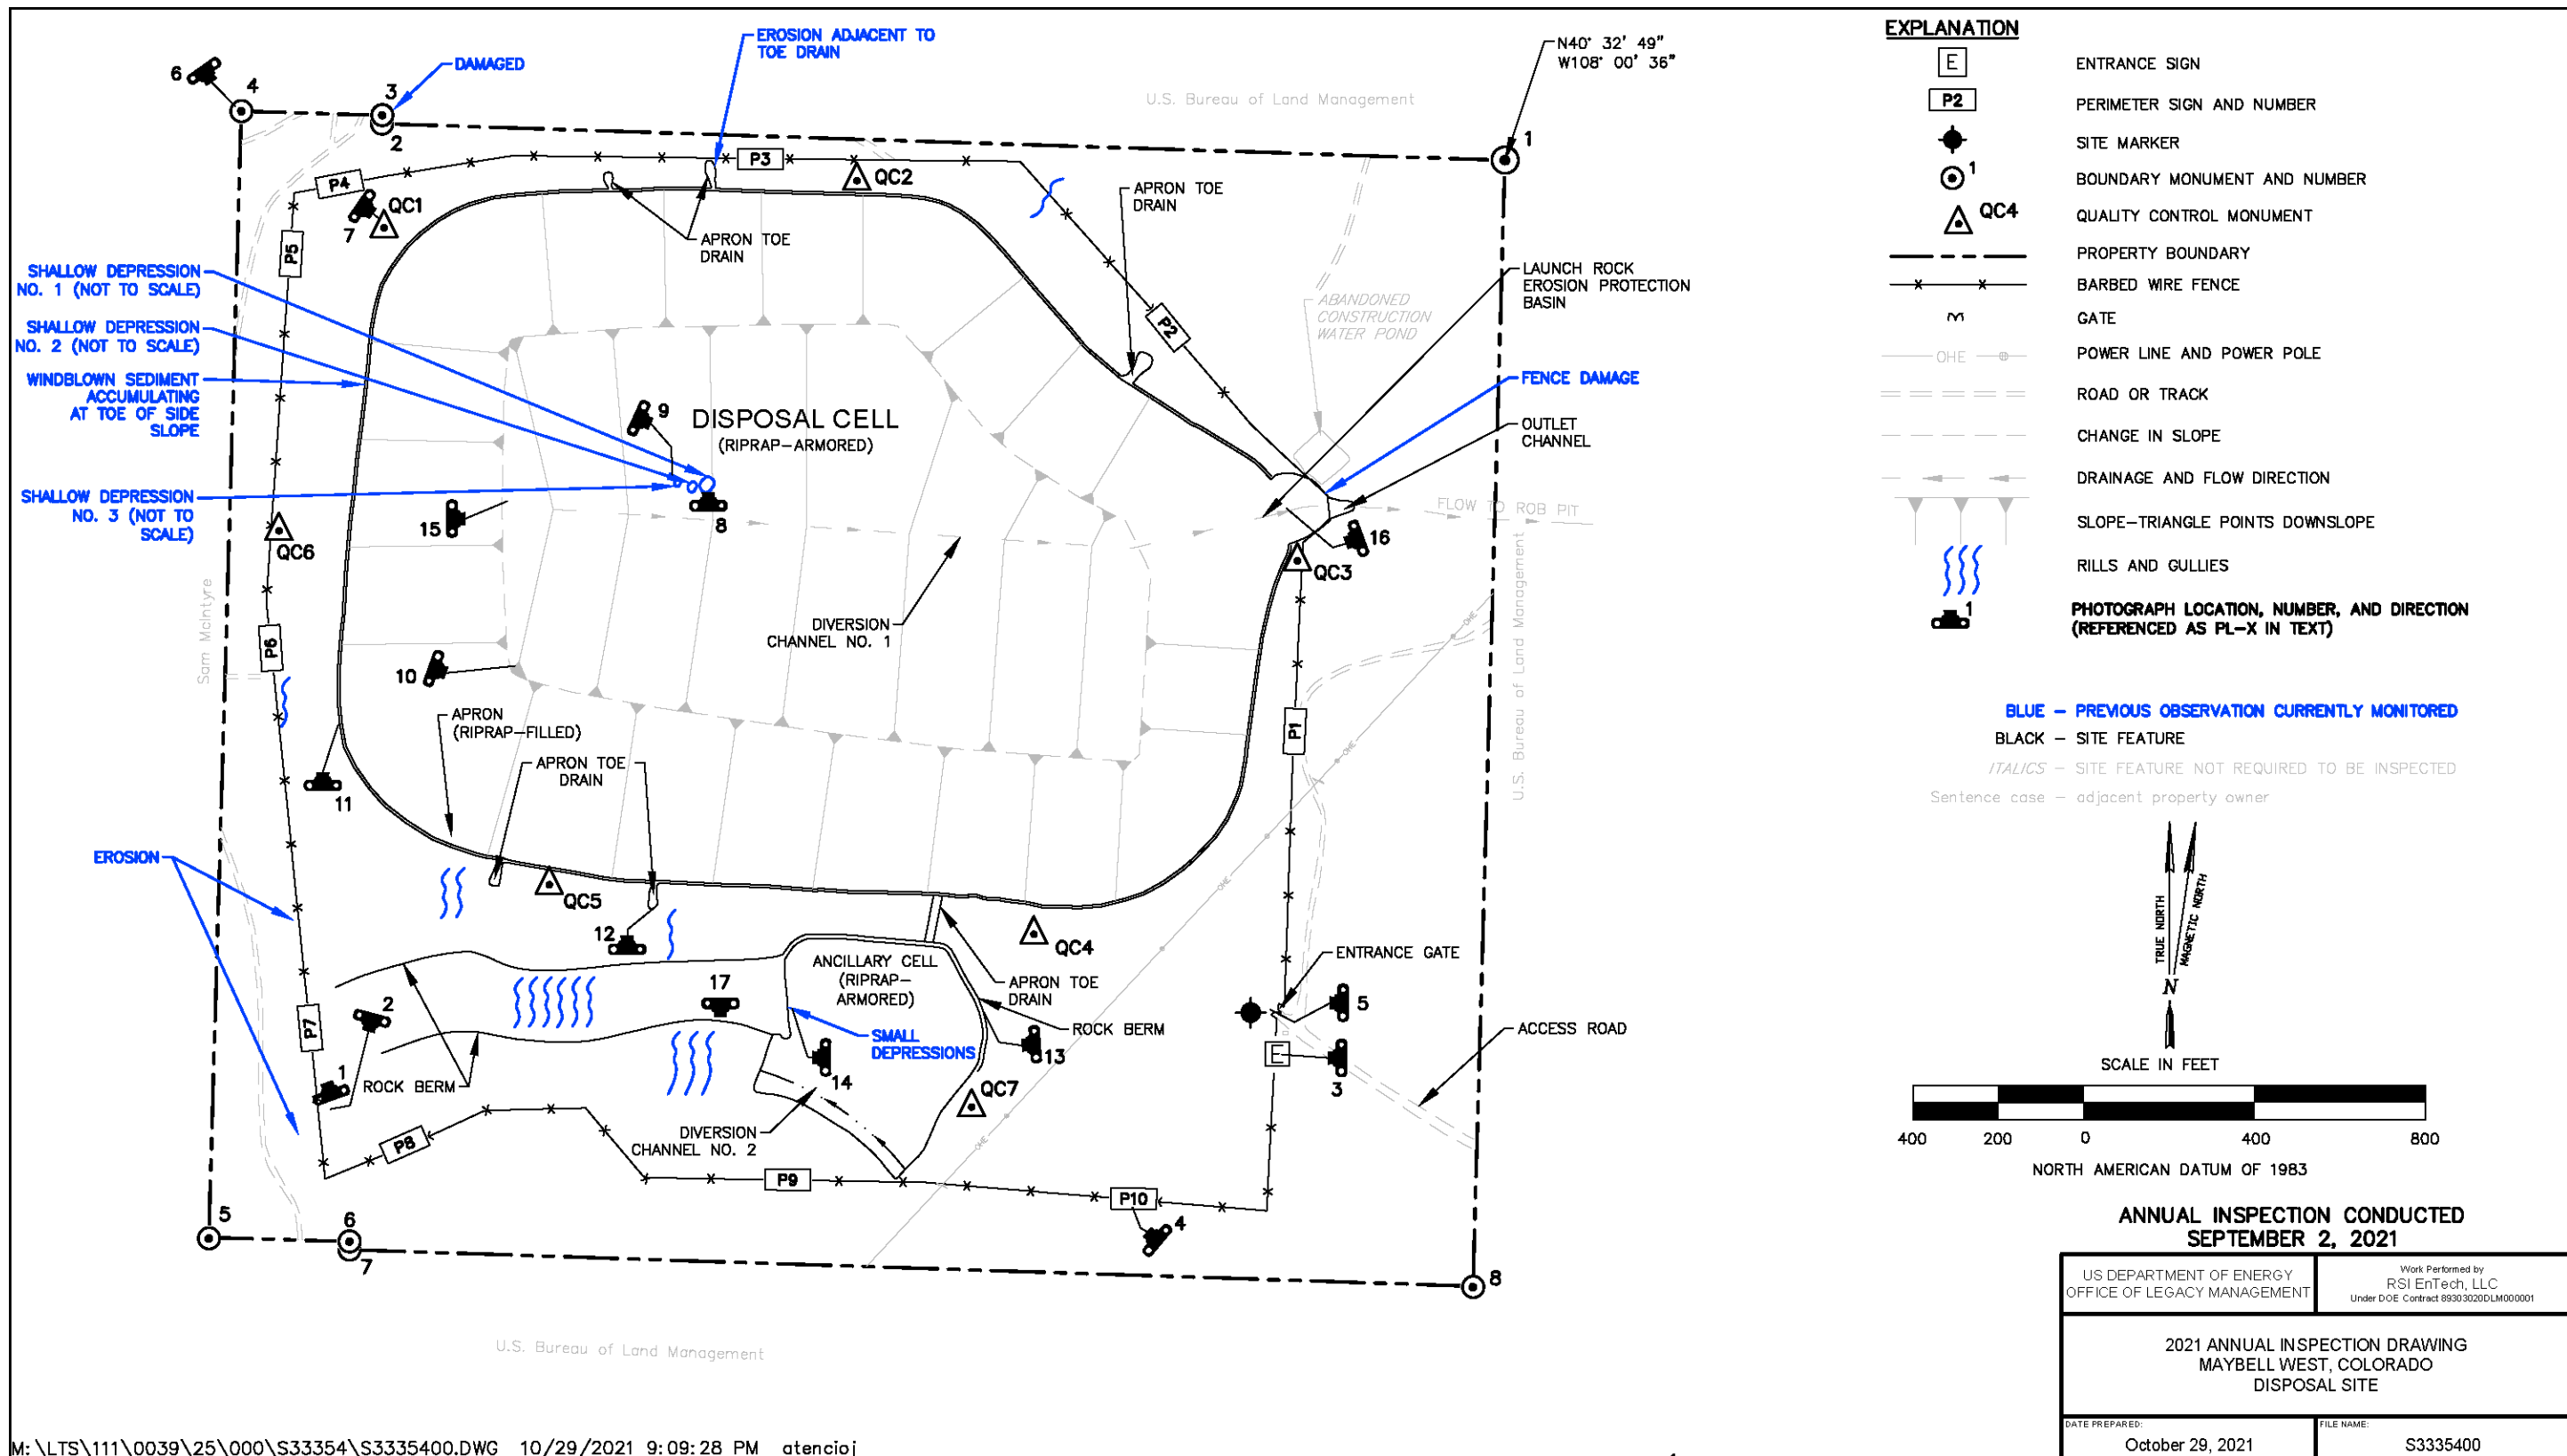
Figure 4-1. 2021 Annual Inspection Drawing for the Maybell West, Colorado, Disposal Site

Figure 4-1 shows the locations of site features, including site surveillance features and inspection areas, in black and gray font. Site features that are present but not required to be inspected are shown in italic font. Observations from previous inspections that are currently monitored are shown in blue type. No new observations were identified in the 2021 annual inspection. Inspection results and recommended maintenance activities associated with site surveillance features are included in the following subsections. Photographs to support specific observations are identified in the text and in Figure 4-1 by photograph location (PL) numbers. The photographs and photograph log are presented in Section 4.9.

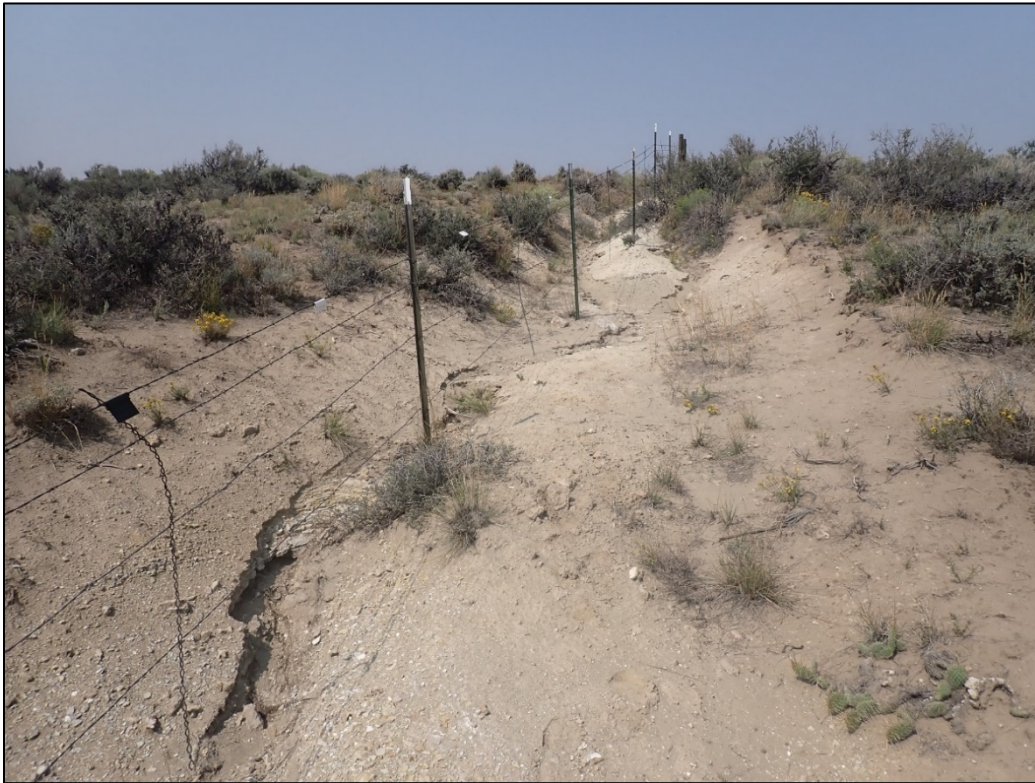
Gullies were observed west of Diversion Channel No. 2, and slight rilling under the northern and southwestern perimeter fence was also observed. None of this erosion threatens the integrity of the main disposal cell, ancillary cell, or associated surface water diversion structures; monitoring of this erosion will continue. No new observations or maintenance needs were identified for 2021. Inspectors identified no cause for a follow-up inspection. Groundwater monitoring is not required at the site.

PL-1. Erosion Under the Perimeter Fence Southwest of the Disposal Cell

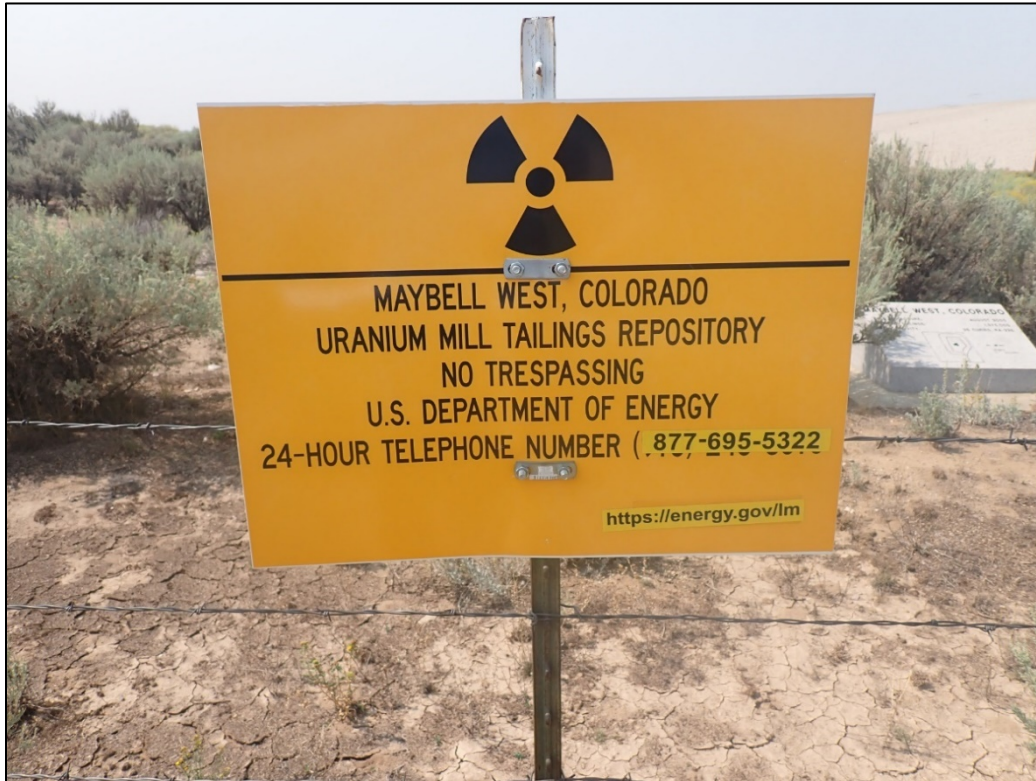
The entrance sign is mounted on a metal T-post directly south of the entrance gate (PL-3). Ten warning or perimeter signs are mounted on metal T-posts around the site (PL-4). No other maintenance needs were identified.

PL-3. Site Entrance Sign

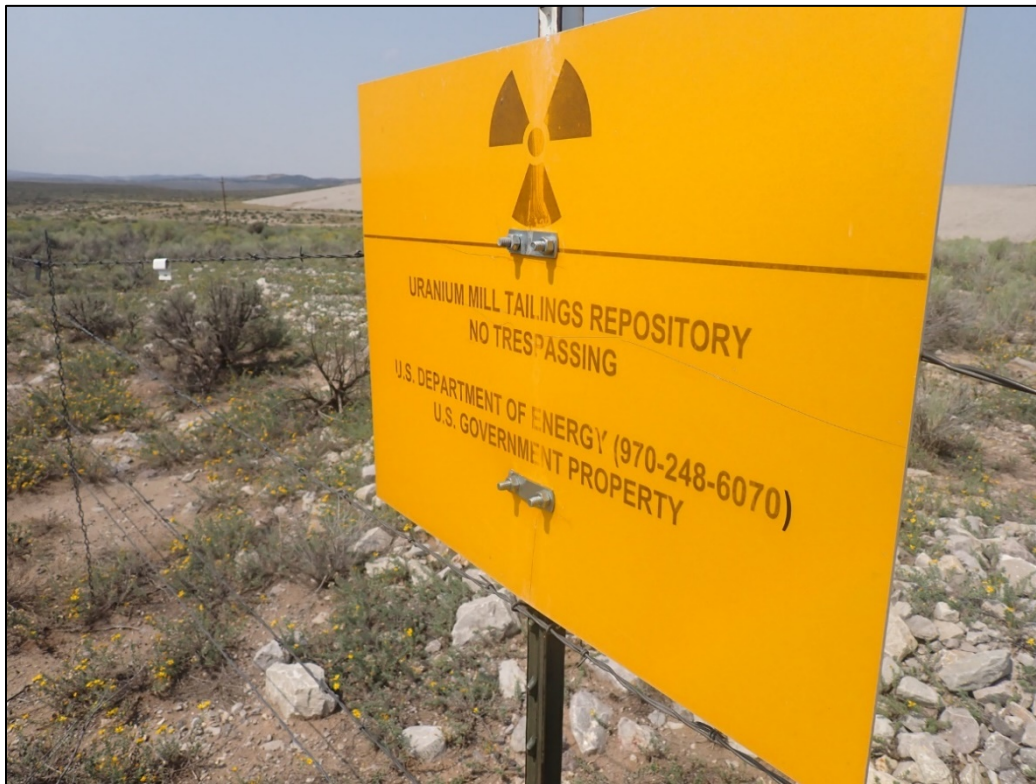
PL-4. Perimeter Sign P-10

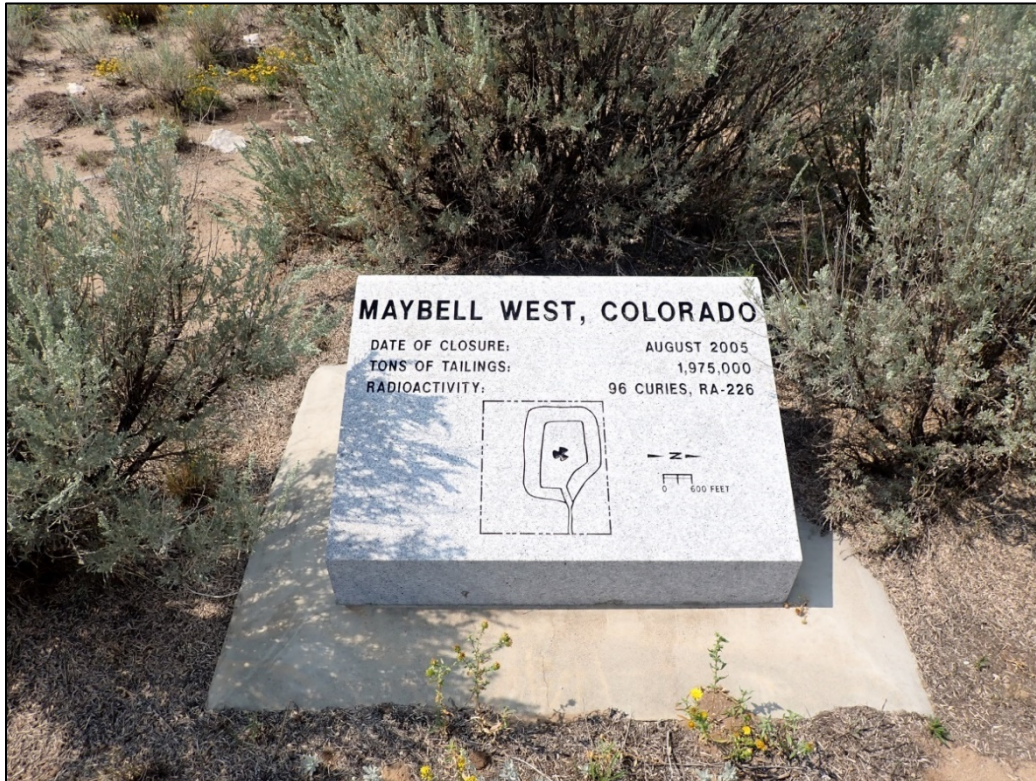
The site has one granite site marker near the entrance gate (PL-5). No maintenance needs were identified.

PL-5. Site Marker

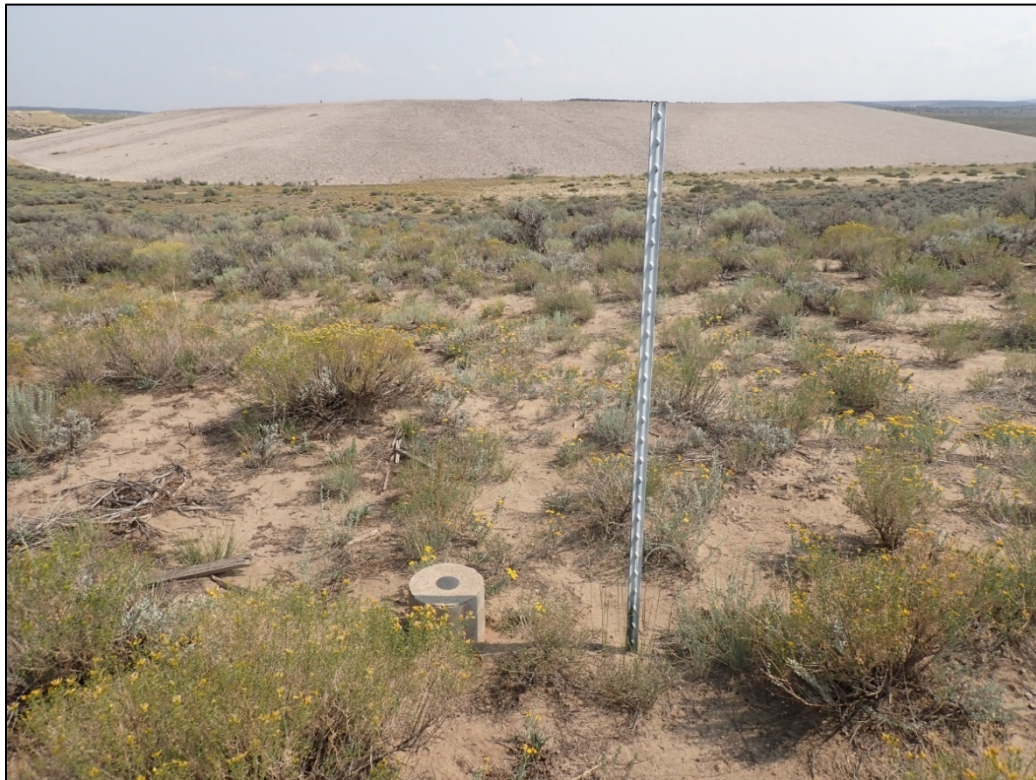
Eight boundary monuments are on the site boundary outside the fenced area (PL-6). Four of the monuments are at the property corners, and the other four define an approximate 20-foot offset along the north and south boundaries where the private land that LM acquired in fee adjoins the BLM withdrawal area on the western portion of the site. Boundary monuments BM-3 and BM-6 (capped pieces of rebar) define the two 20-foot offsets. Boundary monument BM-3 was first observed to be bent during the 2017 annual inspection; since then attempts to straighten the monument were not successful; however the monument is still in place. No additional maintenance needs were identified.

PL-6. Boundary Monument BM-4

Boundary monument BM-3 is damaged and will need to be repaired or replaced but continues to delineate the property. No other maintenance needs were identified.

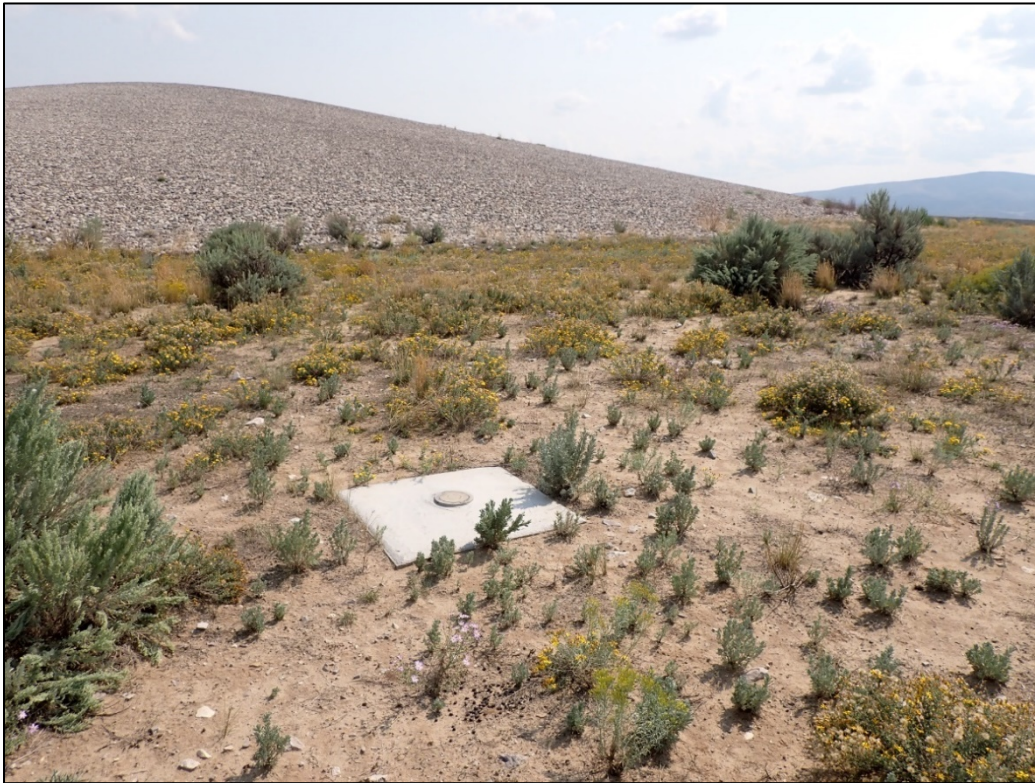
Seven aerial survey quality control (QC) monuments, installed in 2018, were inspected during the 2021 inspection (PL-7). No maintenance needs were identified.

PL-7. Quality Control Monument QC-1

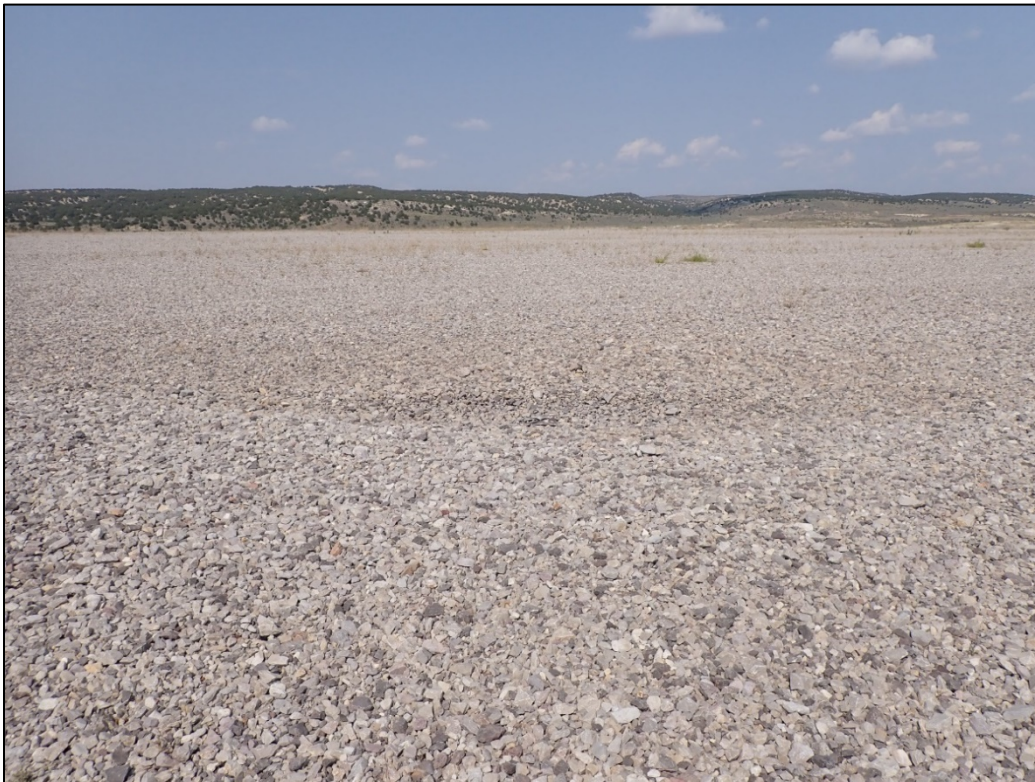
The disposal cell is on the reclaimed site of a former heap leach processing area. The top slope of the riprap-armored disposal cell occupies about 60 acres of the site. The top of the disposal cell showed no signs of significant erosion, settling, or other modifying processes that would affect the cell's integrity. However, three small shallow depressions have been observed (just north of Diversion Channel No. 1) since the site transitioned to DOE in 2010. These depressions appear to be the result of settlement of the underlying materials since completion of the disposal cell. Depression No. 1 was discovered during the initial annual inspection in 2010 (PL-8). A second smaller and shallower depression (Depression No. 2) was first noted just west of the first depression during the 2016 annual inspection. A third, depression (Depression No. 3 [PL-9]) was first observed during the 2018 annual inspection. All three depressions appeared during the 2021 inspection to be approximately the same size as observed during the 2020 annual inspection. Measurements taken annually vary by the methodology employed (i.e., using a handheld tape measure), and the individual taking the measurements.

No standing water was observed in any of the depressions during the inspection. These depressions currently do not threaten the integrity or performance of the disposal cell. No maintenance needs were identified.

PL-8. Shallow Depression No. 1

All three depressions will continue to be measured during annual inspections to determine if additional, more significant settlement is occurring. The comparison of 2018 baseline aerial survey data with data from future aerial surveys will help LM measure and monitor the depressions. The next aerial survey is anticipated to take place in summer 2022.

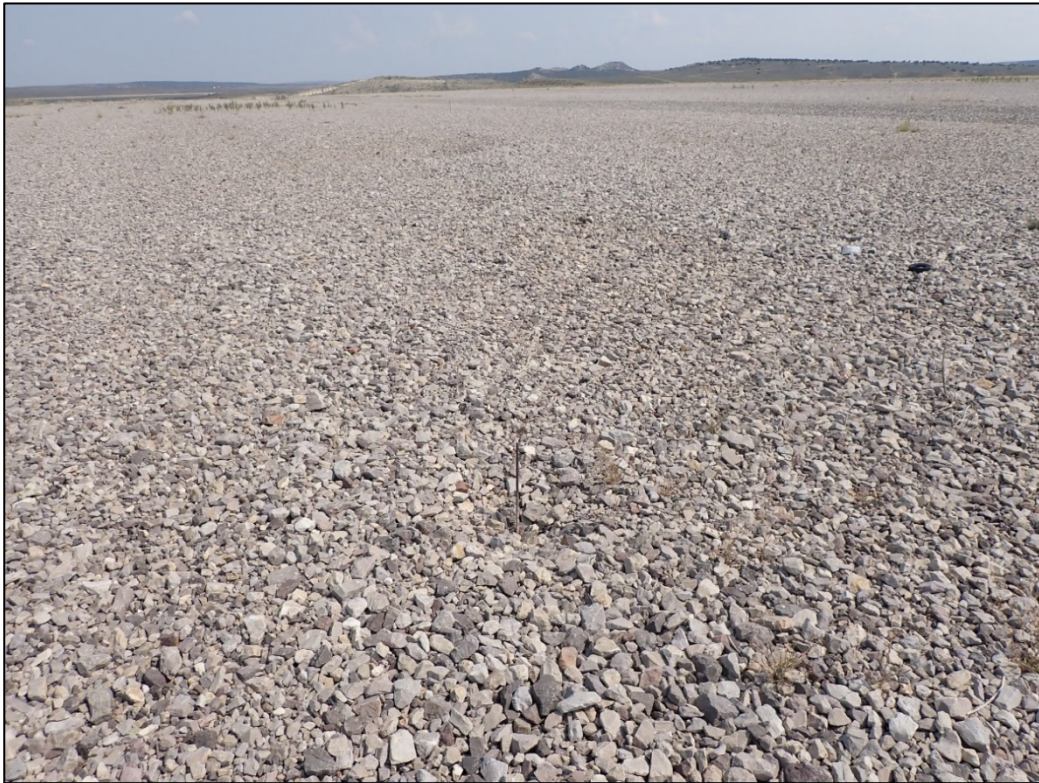
PL-9. Shallow Depression No. 3

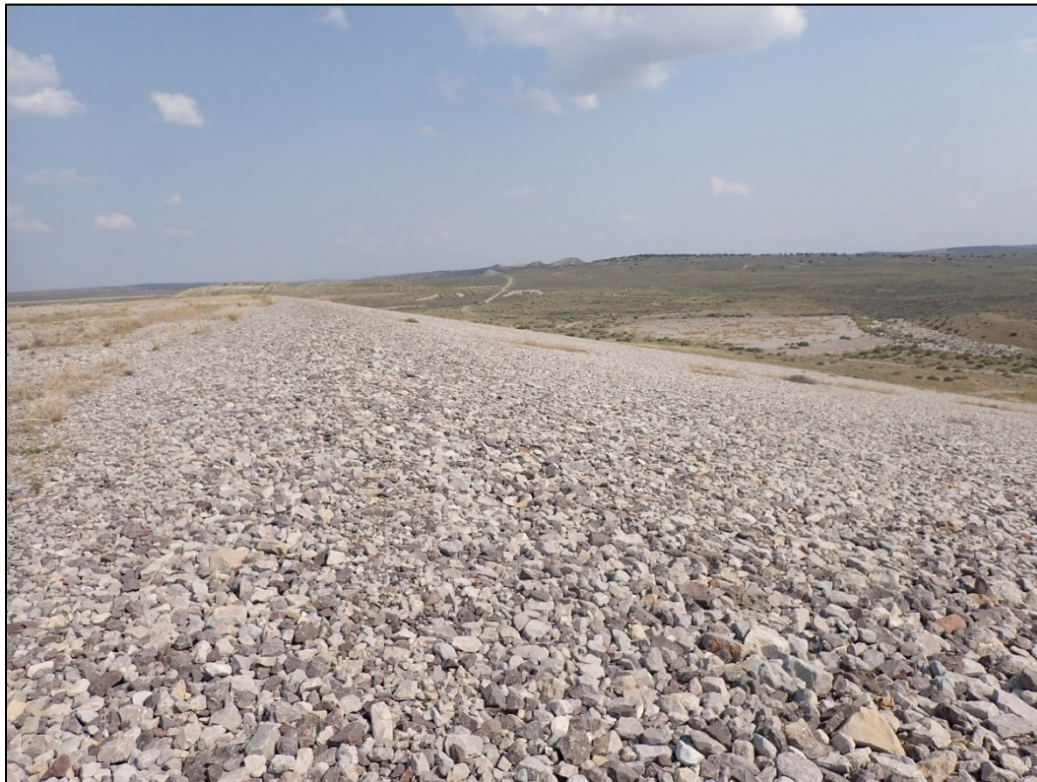
The disposal cell was designed to control surface water runoff resulting from a probable maximum flood event. The side slopes of the disposal cell were constructed with a 20% slope and are covered with a 1-foot-thick layer of riprap (PL-10). Minor sediment accumulation observed in the toe drain apron below the northwest side slope appears to be windblown (PL-11), and there was no evidence of side slope instability, erosion, or settlement. This area of sediment accumulation will continue to be monitored to ensure the toe drain and side slope are functioning properly.

PL-10. View Southeast of Southern Disposal Cell Side Slope

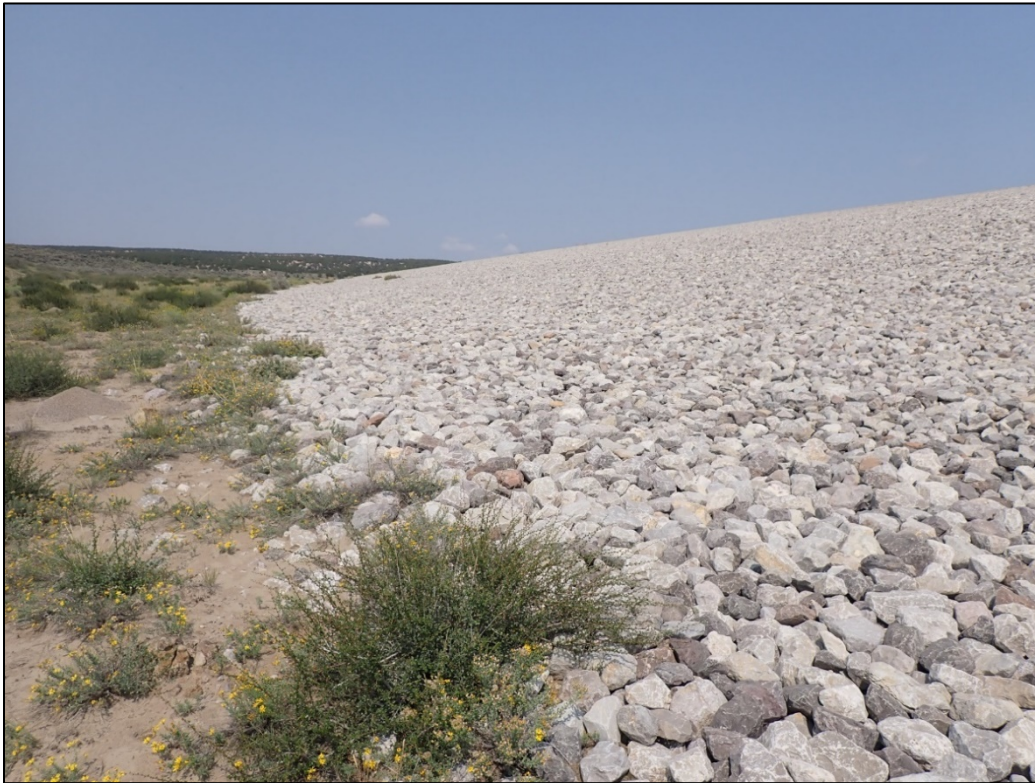
PL-11. Windblown Material Along Western Toe Slope of Disposal Cell

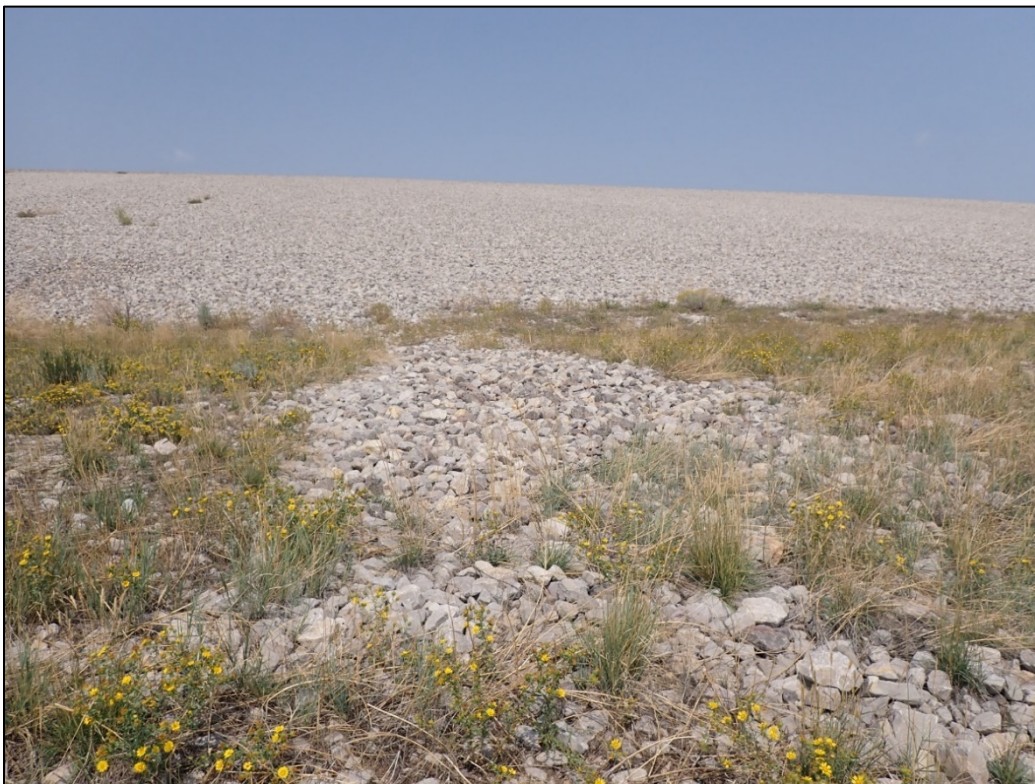
Surface water runoff from the side slopes is conveyed by an apron at the toe of the slope to six riprap-armored toe drains (PL-12) at low points in the apron. The apron and toe drains are constructed channels filled with riprap. Minor erosion has occurred adjacent to a toe drain along the north side of the disposal cell, but that has not impacted the performance of the toe drain. No maintenance needs were identified.

PL-12. Apron Toe Drain on the South Side of Disposal Cell

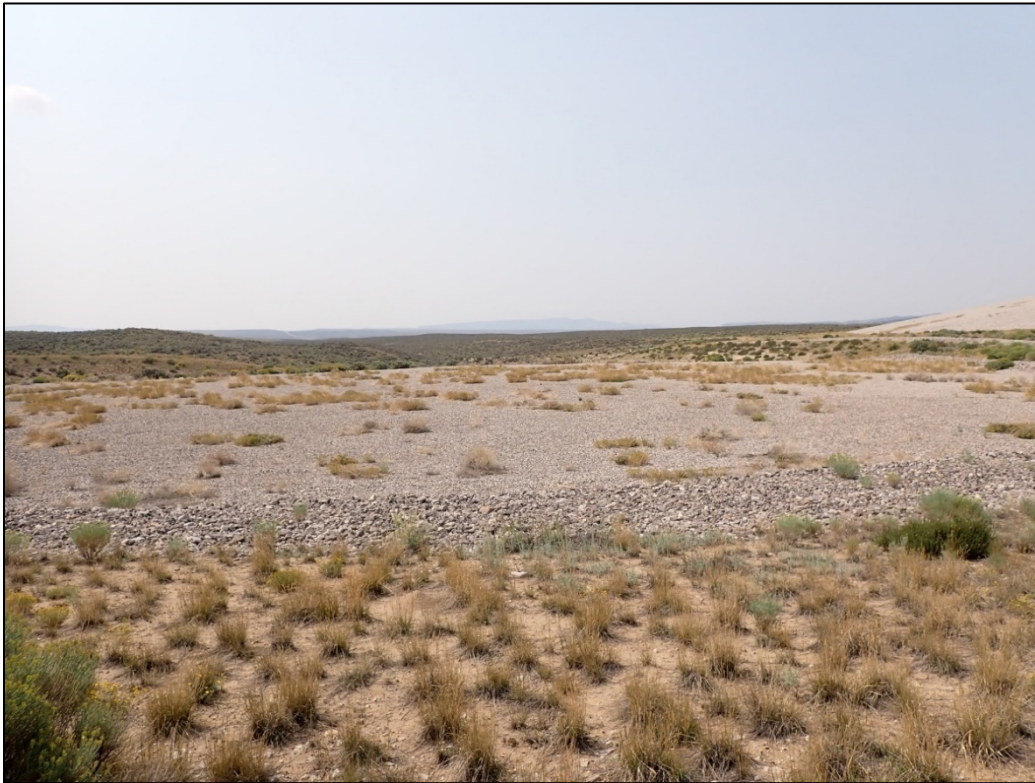
The ancillary cell (PL-13) was constructed to contain waste materials associated with the reclaimed evaporation pond area. It slopes gently toward the southwest. A rock berm wraps around its eastern and northern sides to protect it from surface water runoff. Small depressions observed on the west end of the ancillary cell top slope are not impacting the performance of the cell, but it will continue to be monitored (PL-14). Various species of plants were present on the top slope of the ancillary cell. Noxious weeds were also treated during the July 27, 2021, noxious weed treatment event.

PL-13. View West of Ancillary Cell Top Slope

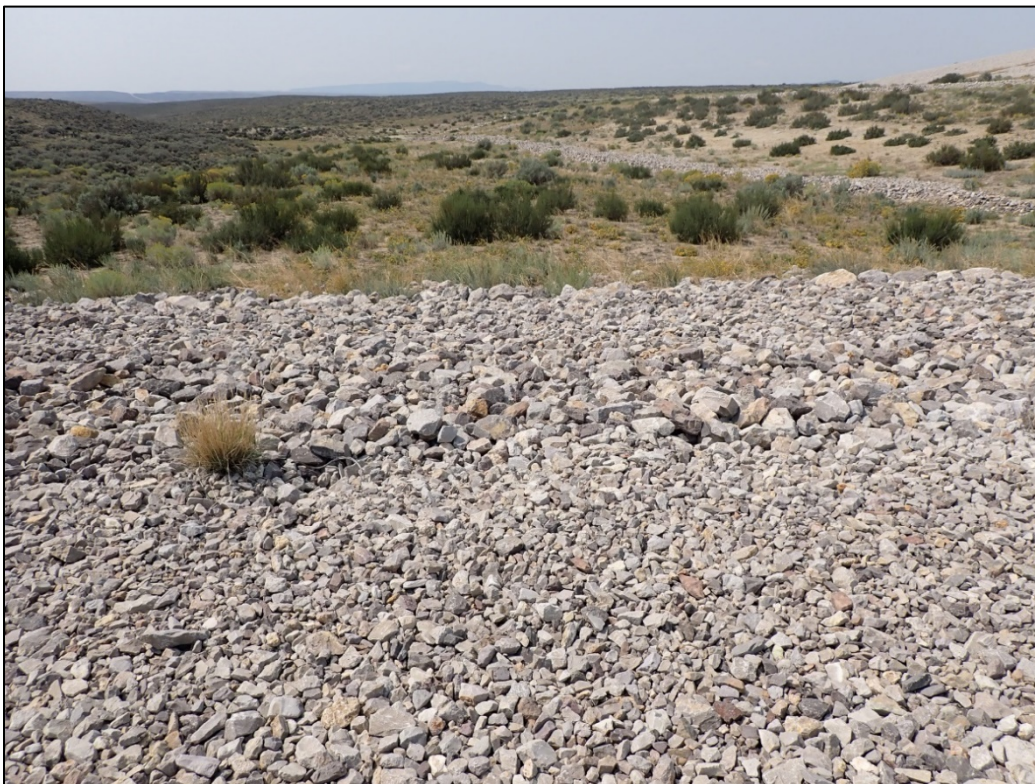
PL-14. Small Depressions on Ancillary Cell Top Slope

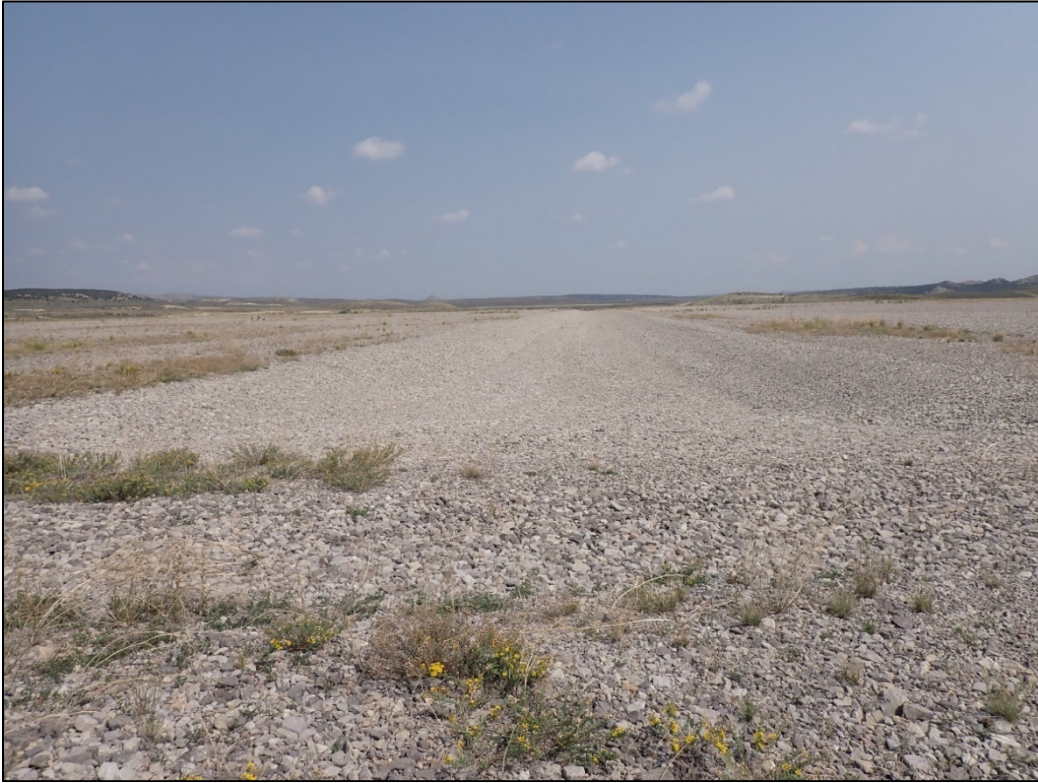
Final surface conditions at the site include a combination of rock armoring and contouring to achieve the surface water drainage control and erosion protection necessary to satisfy the design longevity requirements. The top slope of the disposal cell was designed to drain surface water runoff to the center and into riprap-armored Diversion Channel No. 1 (PL-15), which is graded toward and then down the east side slope of the disposal cell. Surface water runoff ultimately discharges into Rob Pit east of the site. An erosion protection structure, referred to as the Launch Rock Erosion Protection Basin (PL-16), was constructed at the outfall of Diversion Channel No. 1 to protect the disposal cell from headcutting that may occur from the deep channel that runs into Rob Pit. Diversion Channel No. 2 runs along the south side of the ancillary cell to convey surface water runoff away from the ancillary cell. The diversion channels and outlet channel of the Launch Rock Erosion Protection Basin continue to function as designed.

PL-15. View East of Diversion Channel No. 1

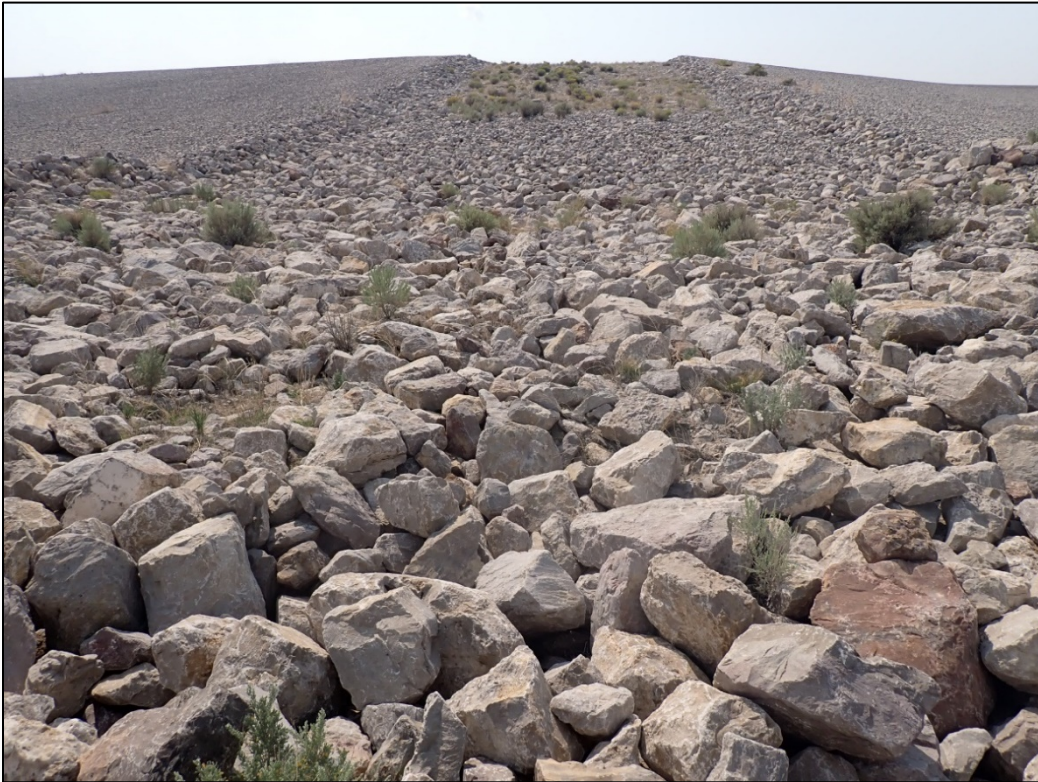
PL-16. View Southwest of the Launch Rock Erosion Protection Basin

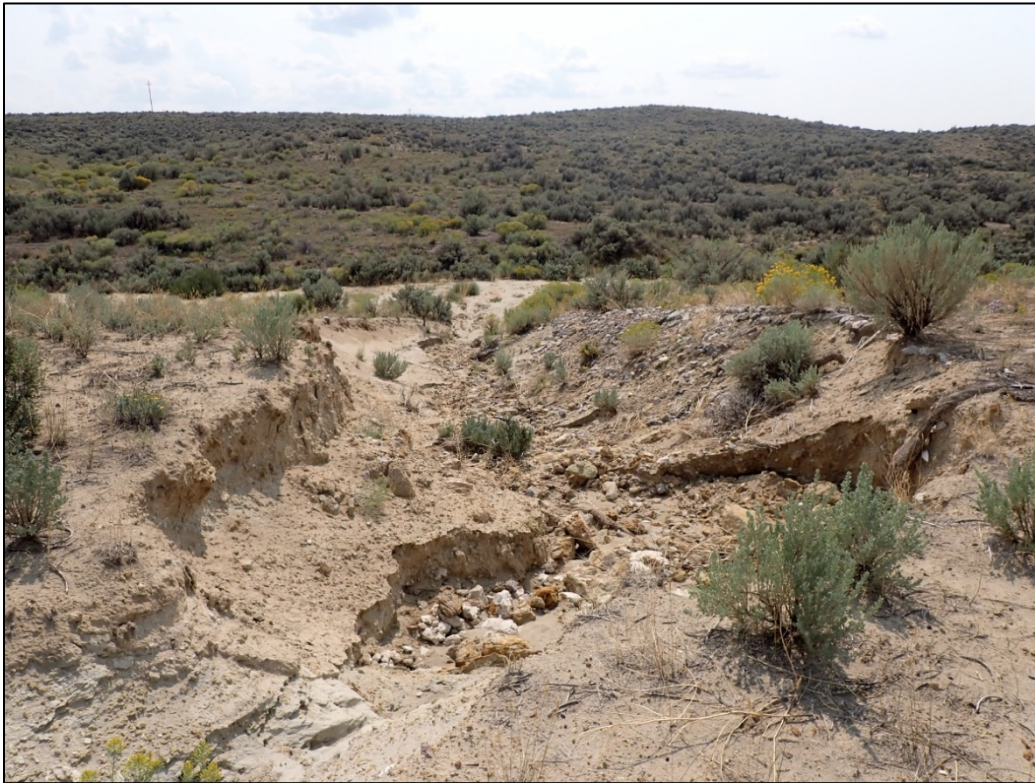
The rock berm that runs along the northern edge of the ancillary cell continues west across the slope south of the disposal cell to protect against erosion. Several gullies and rills have developed on this south slope but do not threaten the integrity of the disposal cell (PL-17). The gullies will continue to be monitored and repaired as needed. The rock berm effectively controls headcutting from these gullies and protects the disposal cell. No maintenance needs were identified.

PL-17. Erosion South of Rock Berm Near Diversion Channel No. 2
