5.0 Sherwood, Washington, Disposal Site

5.1 Compliance Summary

The Sherwood, Washington, Uranium Mill Tailings Radiation Control Act (UMTRCA) Title II Disposal Site (site) was inspected June 9, 2021. The disposal cell, containment dam, and associated drainage features were functioning as designed. Inspectors identified one missing perimeter sign, which was replaced during the subsequent groundwater sampling event in July 2021. No additional maintenance needs or cause for a follow-up inspection were identified.

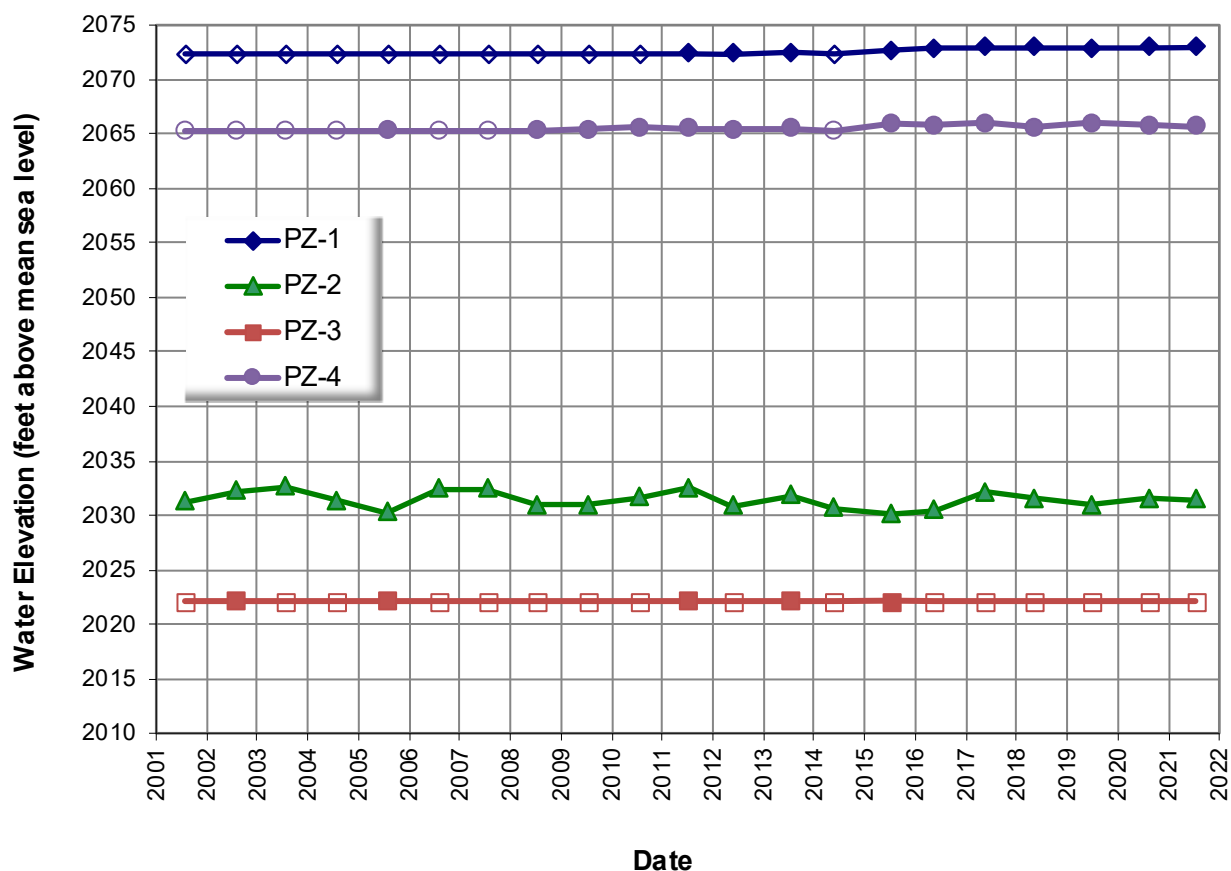
Figure 5-2. Sherwood, Washington, Disposal Site Piezometer Water Elevations

Measurements of water levels in four piezometers atop the containment dam are collected during the annual groundwater sampling events as part of the annual dam inspection. These annual measurements, collected since the piezometers were installed in 2000, provide a direct means of determining moisture conditions in the containment dam. Steadily increasing water levels in any of the piezometers could indicate a potential problem with the dam’s performance. Measurements collected July 13, 2021—provided in Table 5-2, Figure 5-2, and the attached *Dam Inspection Checklist*—do not indicate an increase in water levels. Variations in the amount of water in the four piezometers are thought to be seasonal responses to precipitation. The minor

amount of water in piezometer PZ-2 is the result of a small, perched lens of water that exists because of localized differences in permeability. While the lateral extent of the lens is unknown, it is estimated, based on water levels in piezometer PZ-2 and monitoring wells 4 and 10, that more than 200 ft of unsaturated material is beneath the piezometer PZ-2 perched zone. Based on the recent water levels observed in the piezometers and monitoring wells, the containment dam is considered to be unsaturated.

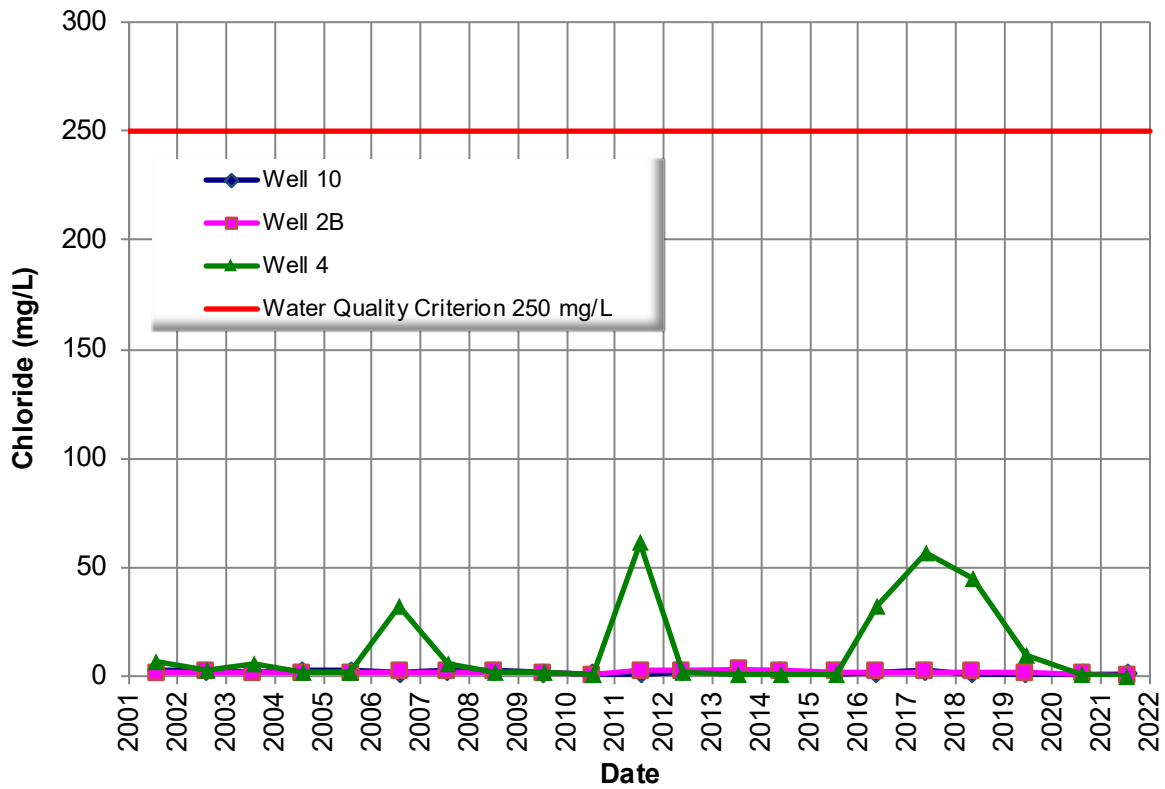
Figure 5-4. Chloride Concentrations at the Sherwood, Washington, Disposal Site

Time-concentration plots of chloride and sulfate for the three monitoring wells are shown in Figure 5-4 and Figure 5-5, respectively. Occurrences of slightly elevated chloride levels in well 4 correspond with the higher sulfate levels measured at the same location. Water elevations for each of the monitoring wells are shown in Figure 5-6 and Figure 5-7. Groundwater occurs in two hydrostratigraphic units: (1) the alluvium that lies on top of the bedrock surface and (2) the conductive bedrock, including weathered bedrock in the upper portion and unweathered or competent bedrock below. Monitoring well 10 is completed in the alluvium, and wells 2B and 4 are completed in the bedrock. Absolute values of water table elevations reported in Figure 5-6 and Figure 5-7 differ slightly from those in previous reports, but the trends are the same. The reason for the offset is the recent transformation of vertical datum from National Geodetic Vertical Datum of 1929 to North American Vertical Datum of 1988 in LM's environmental database.

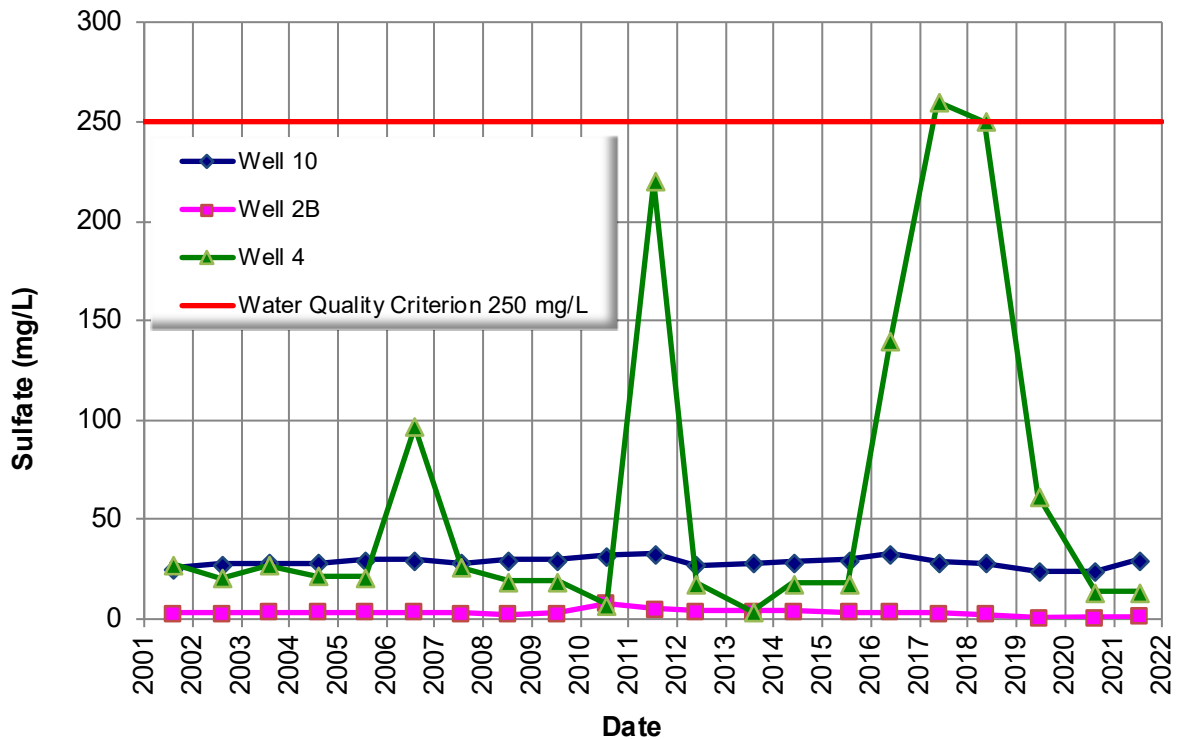
Figure 5-5. Sulfate Concentrations at the Sherwood, Washington, Disposal Site

Increases in water table height in wells 2B and 4 correspond with the elevated levels of chloride and sulfate measured in well 4 in 2006 and 2011 and from 2016 to 2018. As stated by WDOH in the February 2000 *Sherwood Uranium Mill Project, Technical Evaluation Report, Monitoring and Stabilization Plan Supplement* (WDOH 2000), "One of the downgradient point-of-compliance wells, well 4, has seasonal variation in water quality, represented by late spring and summer peaks that are consistent with annual infiltration and the rise in static water levels. This seasonal trend has been evaluated closely and ground water monitoring increased as established by the MSP [Monitoring and Stabilization Plan]." Annual precipitation totals measured in Spokane, Washington, show a correlation with the increased sulfate and chloride concentrations. Years with higher precipitation totals are also years with higher sulfate concentrations.

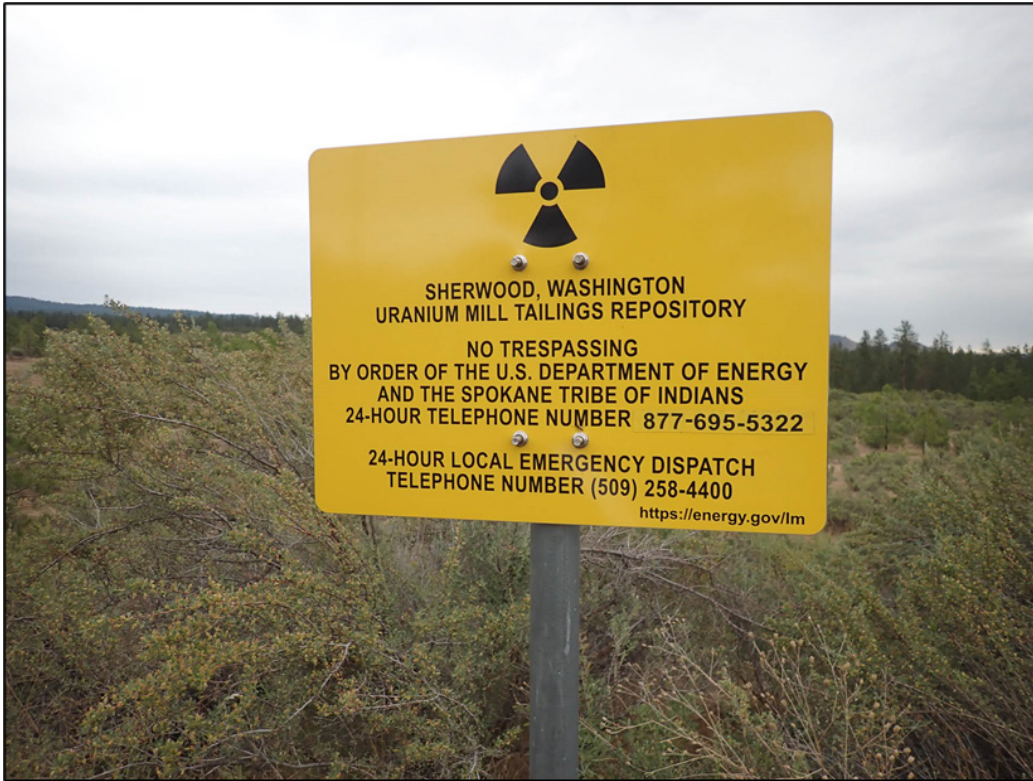
PL-1. Perimeter Sign P6

There are six warning or perimeter signs, attached to steel posts set in concrete, positioned along the site boundary at likely access points around the site (PL-1). Perimeter sign P2 was missing and was replaced during the subsequent groundwater sampling event in July 2021. No additional maintenance needs were identified.

Perimeter sign P2 was identified as missing and was replaced during the subsequent groundwater sampling event in July 2021. No additional routine maintenance needs were identified.

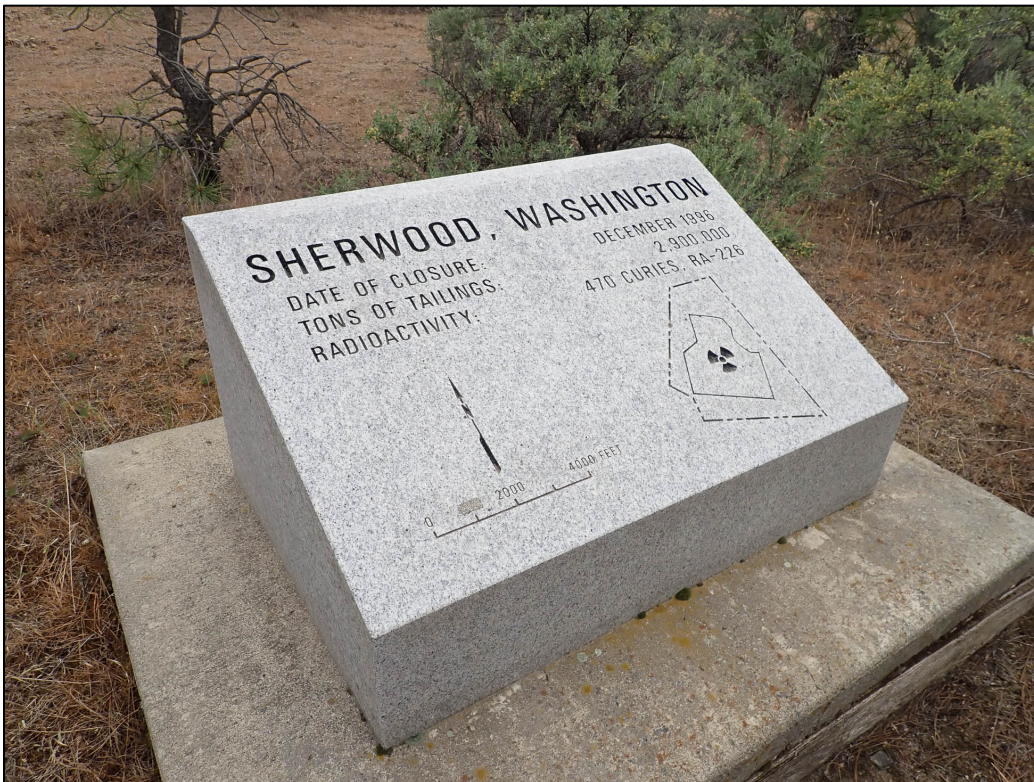
PL-2. Granite Site Marker

There is one granite site marker on the southwest side of the site where the access road lies closest to the site boundary (PL-2). No maintenance needs were identified.

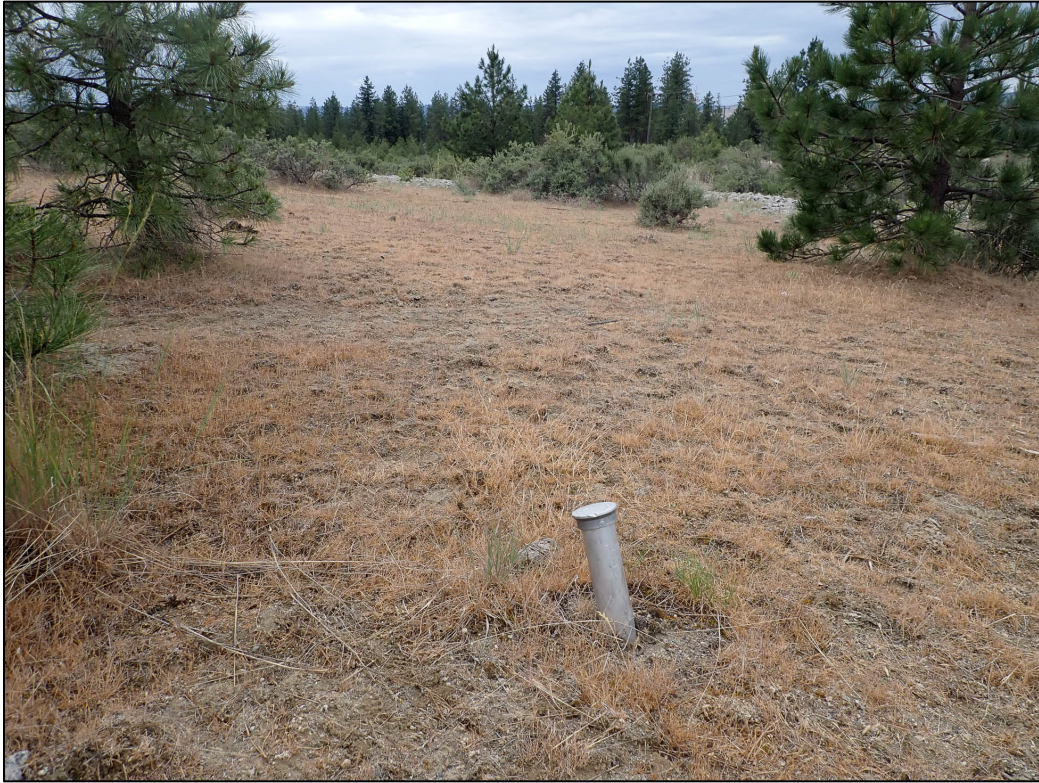
PL-3. Boundary Monument BM-3A

Six boundary monuments set in concrete define the site boundary. Because surrounding vegetation has made it difficult to locate some of the monuments, metal T-posts were installed at each monument location (PL-3). All boundary monuments were inspected. No maintenance needs were identified.

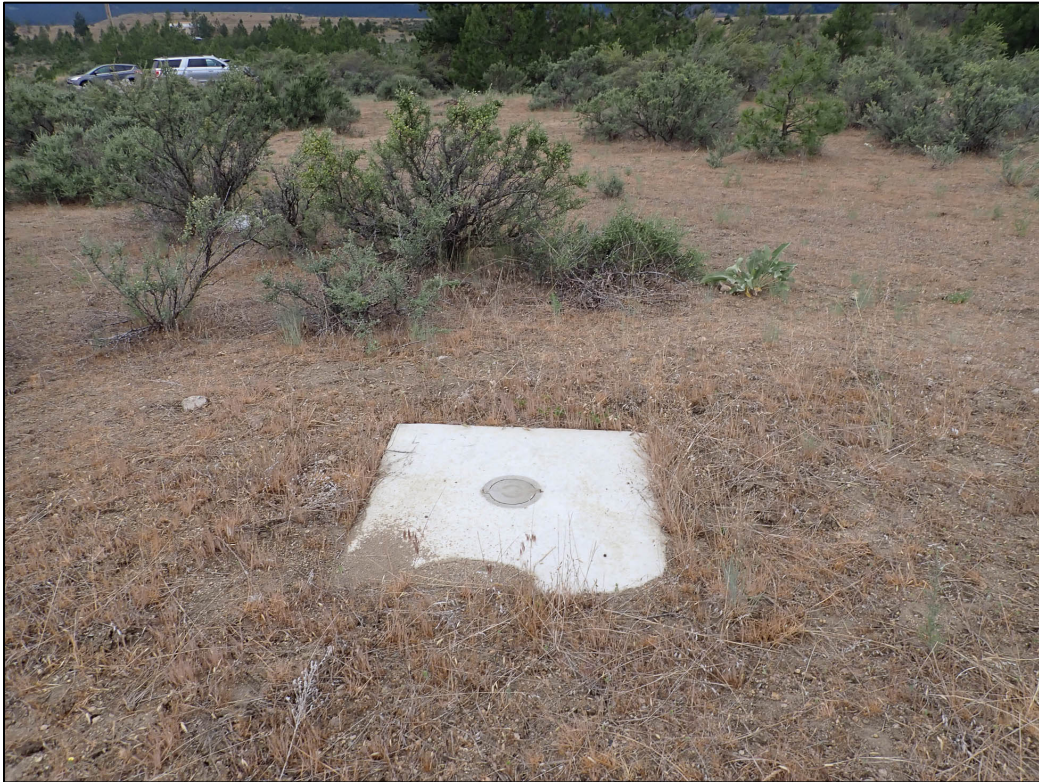
PL-4. Quality Control Monument QC-1

Eight aerial survey quality control (QC) monuments, installed in 2019, were inspected during the 2021 inspection (PL-4). A baseline aerial survey was conducted in October 2021. No maintenance needs were identified.

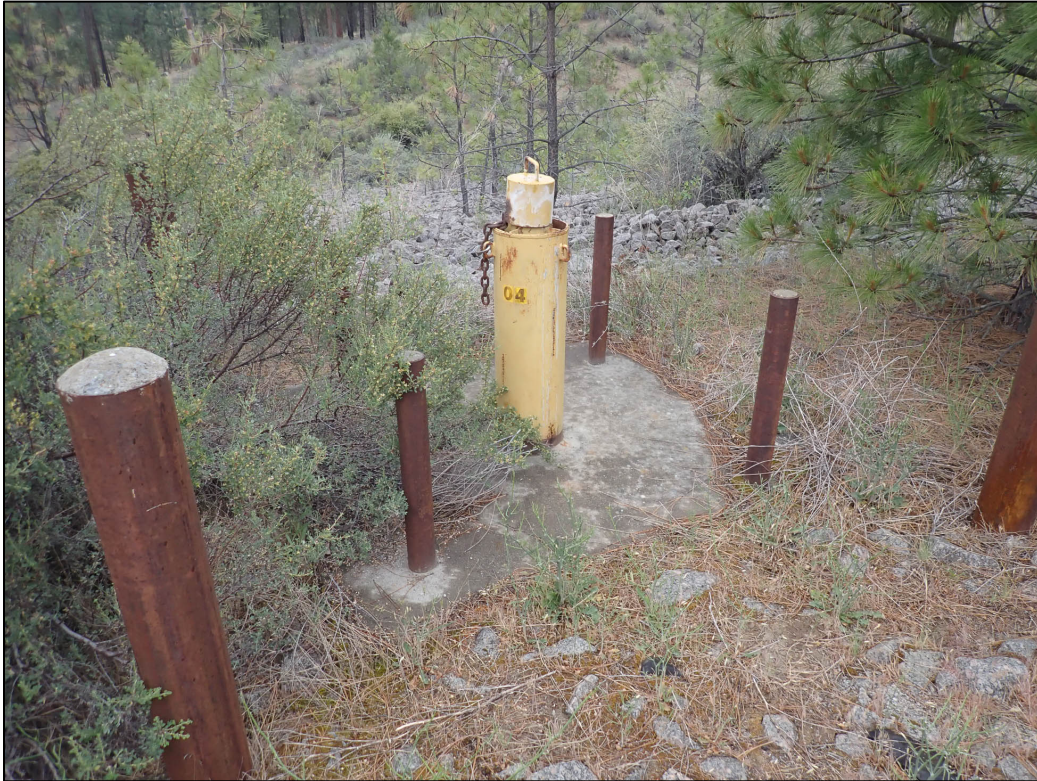
PL-5. Monitoring Well 4

The site groundwater monitoring network consists of monitoring wells 2B, 4, and 10 (PL-5). As part of the dam safety inspection program, four piezometers, designated piezometers PZ-1 through PZ-4, were installed in November 2000 along the crest of the containment dam at a depth equivalent to the base of the dam. All piezometers and wellhead protectors were undamaged and locked. No maintenance needs were identified.

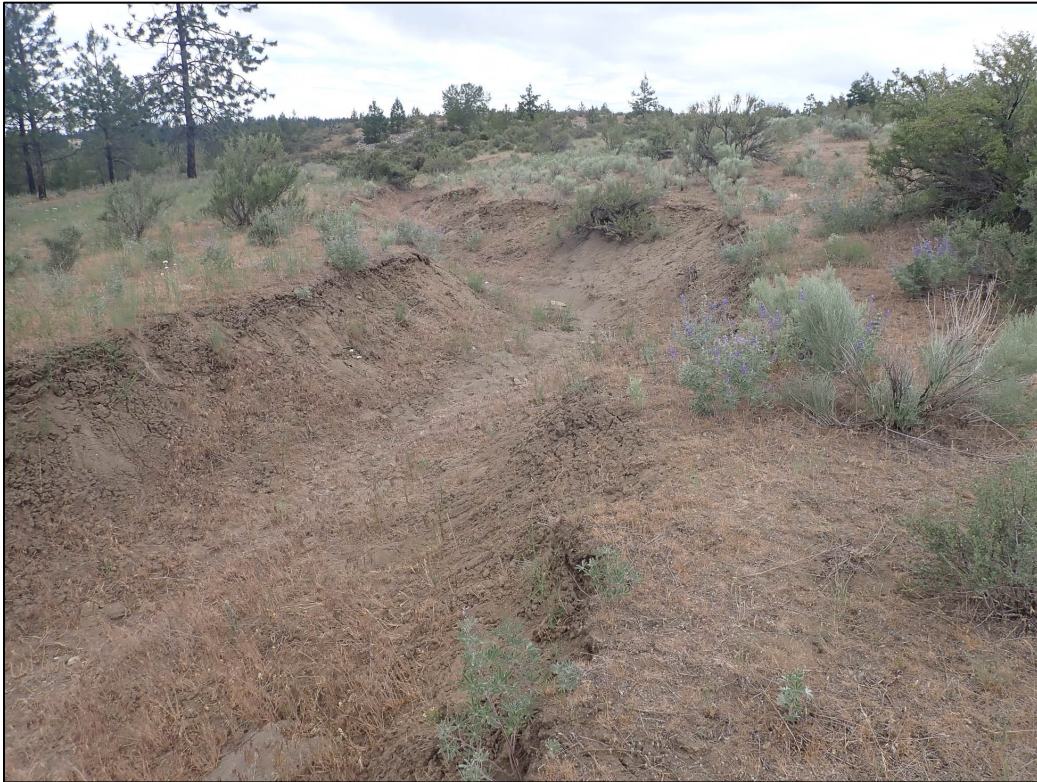
A gully offsite, downgradient of the riprap-armored swale near perimeter sign P1, was first observed in 2009. The gully is photographed periodically to monitor its development (PL-6). Although erosion continues to occur because of site drainage, the gully is not impacting site features or access but will continue to be monitored. Additionally, minor erosion was identified during the 2021 inspection adjacent the two-track on the southeast side of the cell near perimeter sign P2 (PL-7). The erosion areas are not impacting site features or access and will continue to be monitored. No maintenance needs were identified.

PL-6. Gully Downgradient of Riprap-Armored Swale Near Perimeter Sign P1

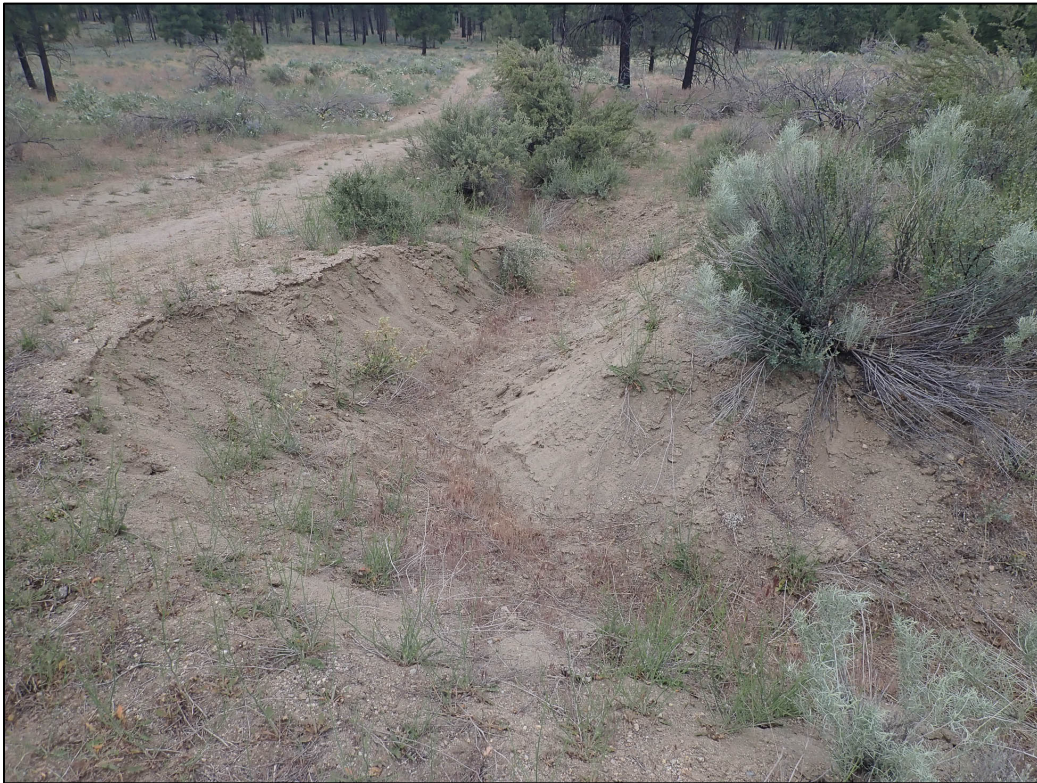
PL-7. Gully Near Perimeter Sign P2 (Stable)

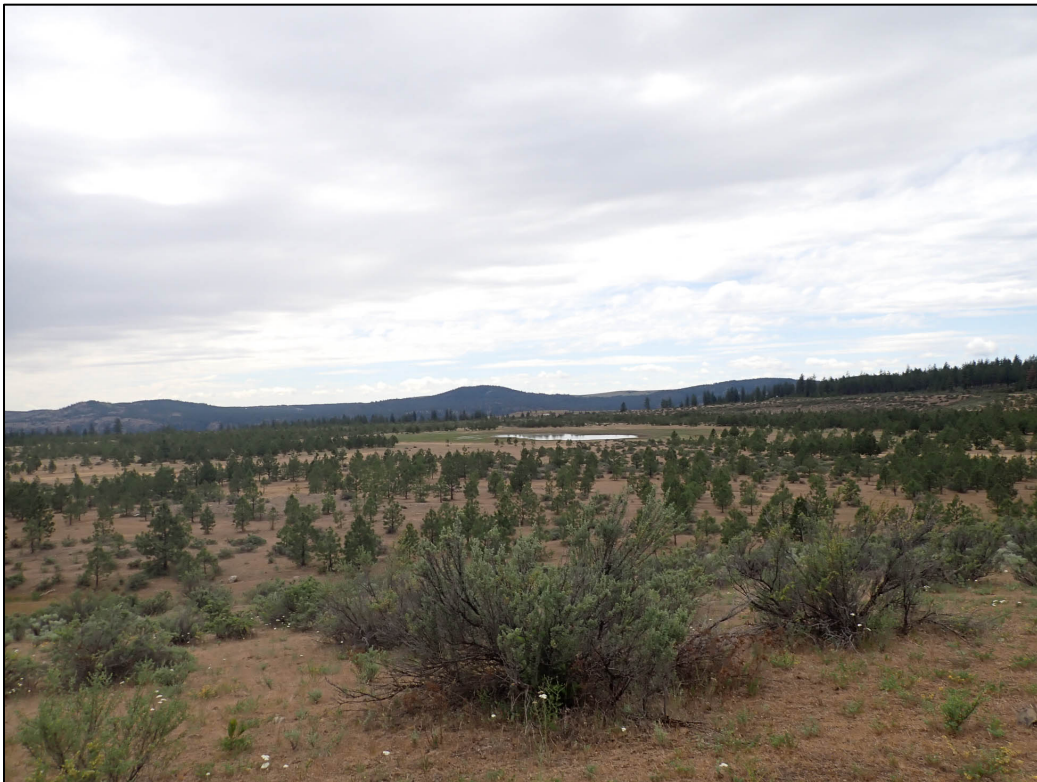
PL-8. Disposal Cell

The disposal cell, completed in 1996, occupies 100 acres. The cover consists of 12 to 20 ft of uncompacted soils. During site reclamation, the surface was seeded and planted with native shrubs, forbs, grasses, and trees (PL-8).

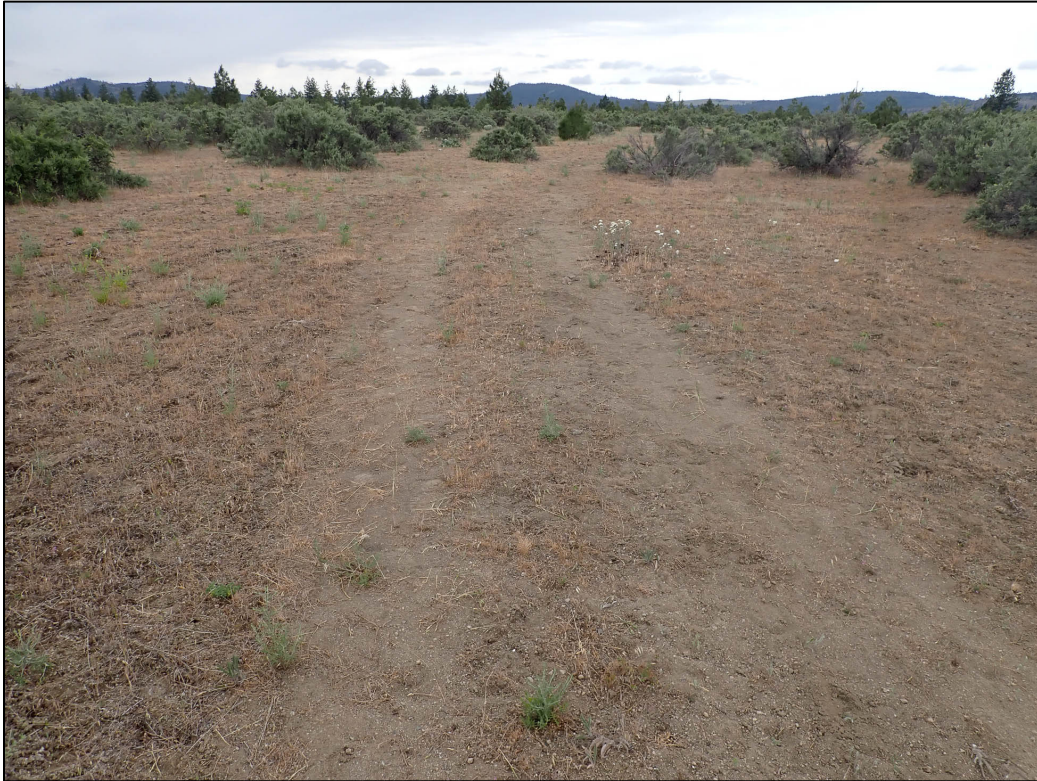
Evidence of vehicle travel was identified on the southwest side of the disposal cell. Minor vehicle tracks were observed from the road intersection near perimeter sign P5 to the edge of Pond 1 (PL-9). The area will continue to be monitored, and strategies to prevent unnecessary vehicle traffic on the cell will be evaluated in consultation with Spokane tribal leadership.

PL-9. Evidence of Vehicle Tracks to Disposal Cell Pond 1

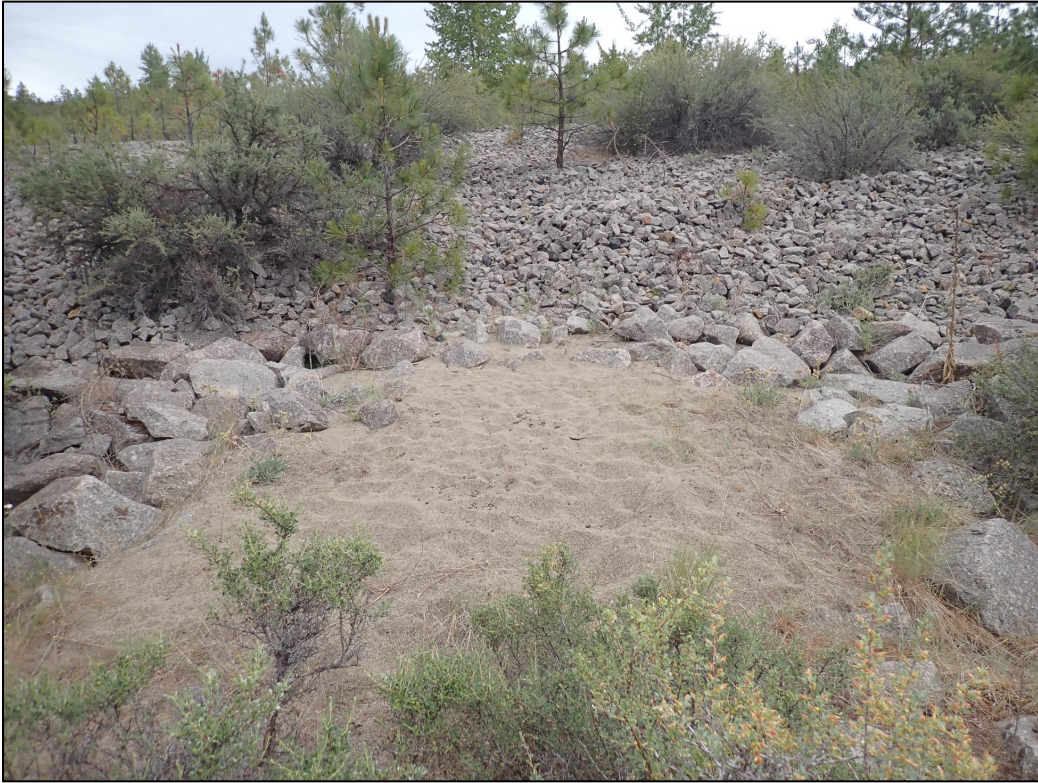
During the 2016 annual inspection, one location at the base of the rock-covered containment dam face was found to have a deposit of sand that had washed out from underneath the rock cover, as evidenced by a shallow rock-filled erosion feature upgradient of the deposit (Figure 5-1). A subsequent follow-up inspection and evaluation identified that the sandy material was the same as natural undisturbed material nearby. During reclamation, this area of the site was used as a source for fill material used to contour the area below the toe of the containment dam. Review of original reclamation and as-built drawings showed that the toe of the containment dam is upslope from the area of erosion, which was confirmed during the follow-up investigations. Therefore, it was concluded that the sand deposit location is in a portion of the dam defined as the outslope in the construction completion report and does not impact the containment dam (DOE 2018b).

The sand deposit location was examined during the inspection, and there was no apparent change in the deposit or the upgradient erosion feature (PL-11). The area will be visually monitored during future inspections and by periodic aerial remote sensing surveys. Repair options will be evaluated and implemented, in consultation with NRC, if the erosion area increases such that the containment dam could be affected.

PL-11. Sand Deposit at Toe of Containment Dam Outslope
