2.0 Edgemont, South Dakota, Disposal Site

The Edgemont, South Dakota, Uranium Mill Tailings Radiation Control Act (UMTRCA) Title II Disposal Site was inspected on July 20, 2022. No changes were observed in the disposal cell or drainage features. Inspectors identified no maintenance needs or cause for a follow-up inspection. Groundwater monitoring is not required at the site.

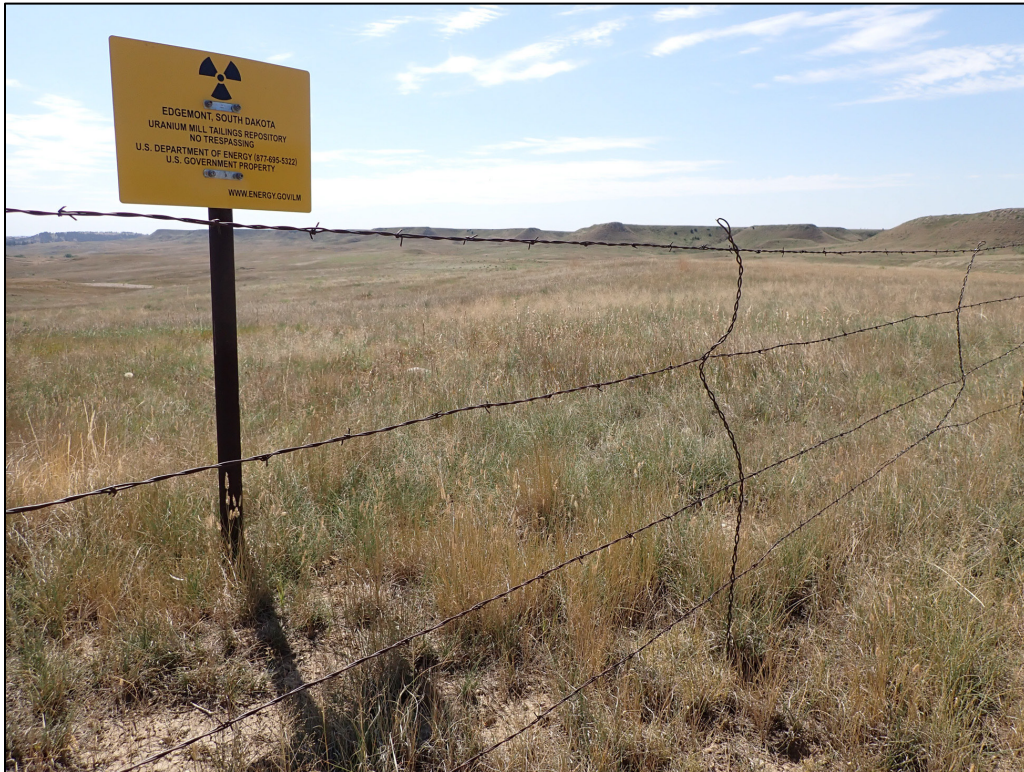
Access to the site is from Fall River County Road 6N. The entrance sign, which is mounted on a steel post set in concrete, was in good condition (PL-1). The tubular metal entrance gate was secured by a locked chain and was intact. The entrance gate lock was replaced with a new lock during the 2022 annual inspection. The perimeter fence features three additional wire gates at the following locations: (1) the northwest corner of the property, (2) approximately 700 feet north of the southeast corner, and (3) the southeast corner of the site. All gates were closed and intact. No maintenance needs were identified.

PL-1. Entrance Sign and Property Boundary Fence

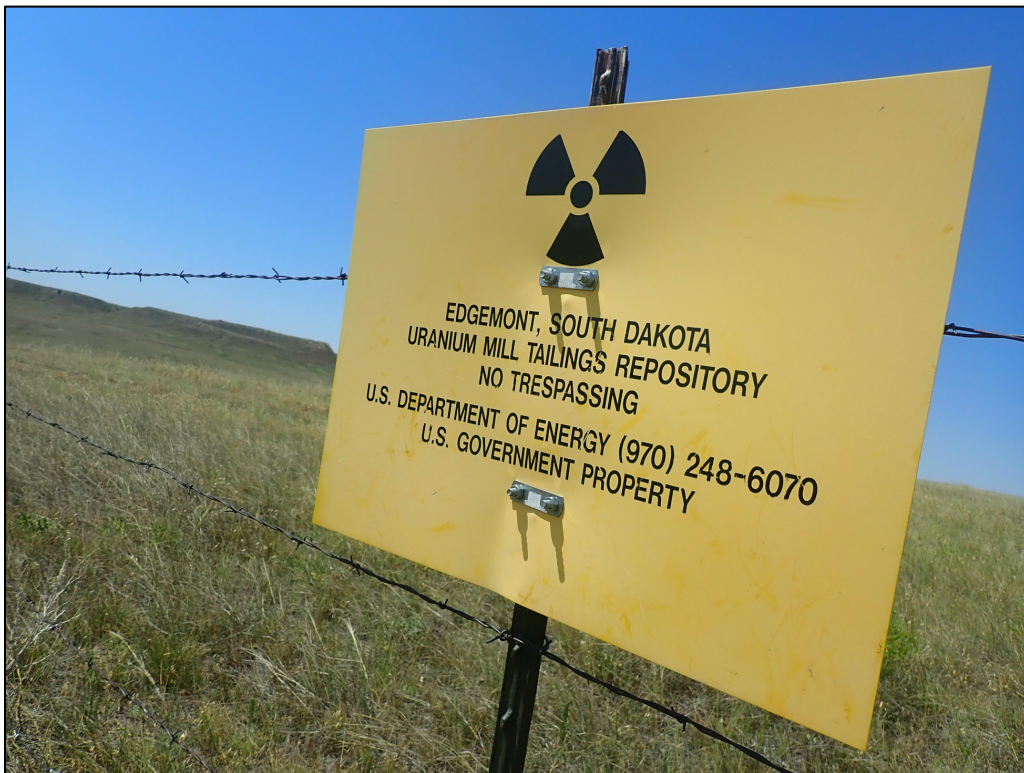
A four-strand barbed-wire fence encloses the site, truncating at the southeast corner to allow livestock access to a preexisting stock pond. Two perimeter signs are attached to the perimeter fence (PL-2). No maintenance needs were identified.

PL-2. Perimeter Sign P2

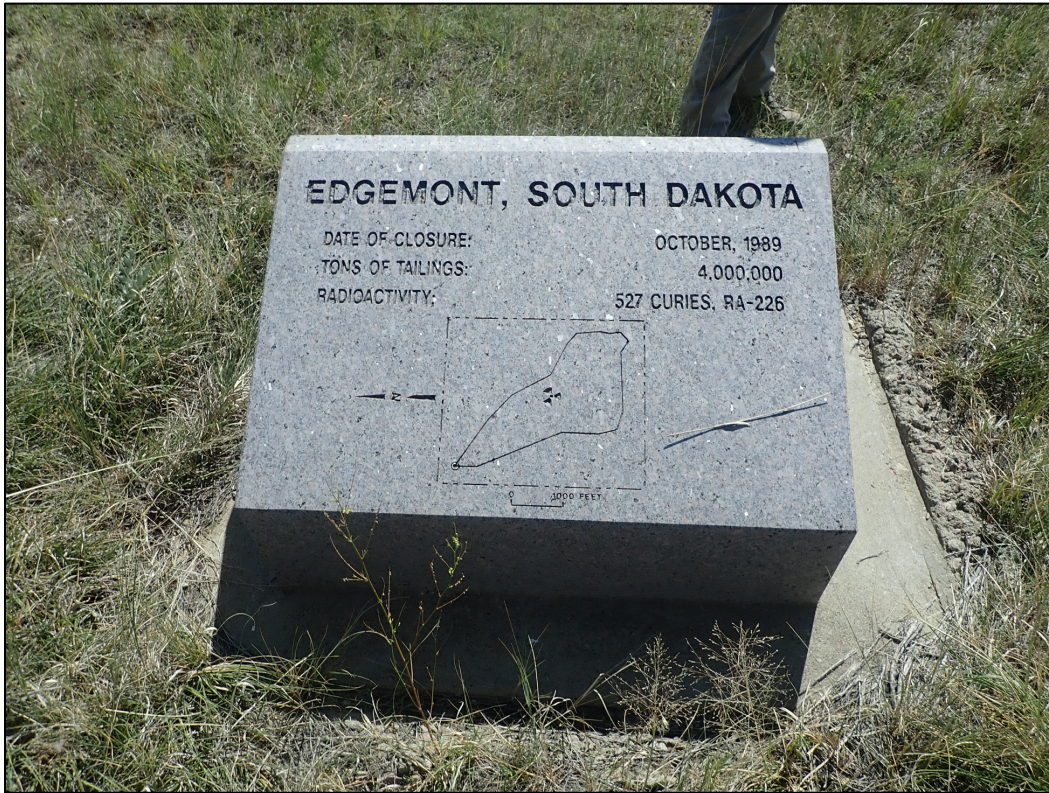
One granite site marker is just inside the entrance gate (PL-3). No maintenance needs were identified during the inspection.

PL-3. Granite Site Marker

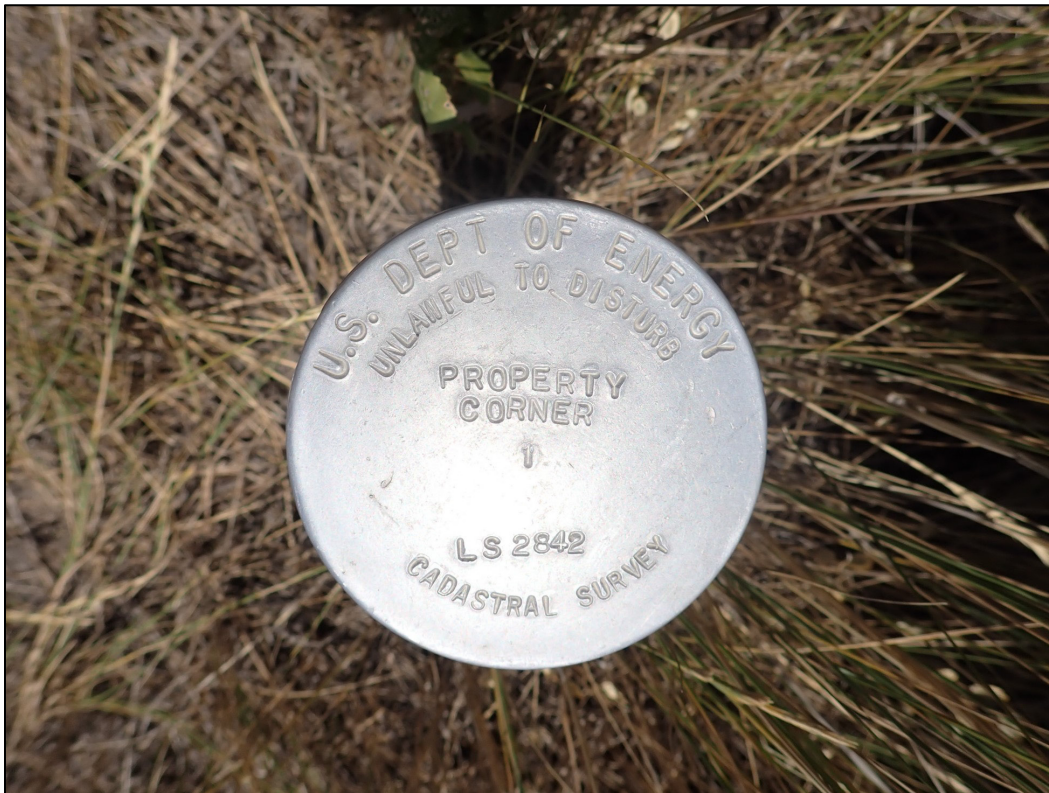
Boundary monuments are at each of the property's four corners (PL-4). No maintenance needs were identified.

PL-4. Boundary Monument BM-1

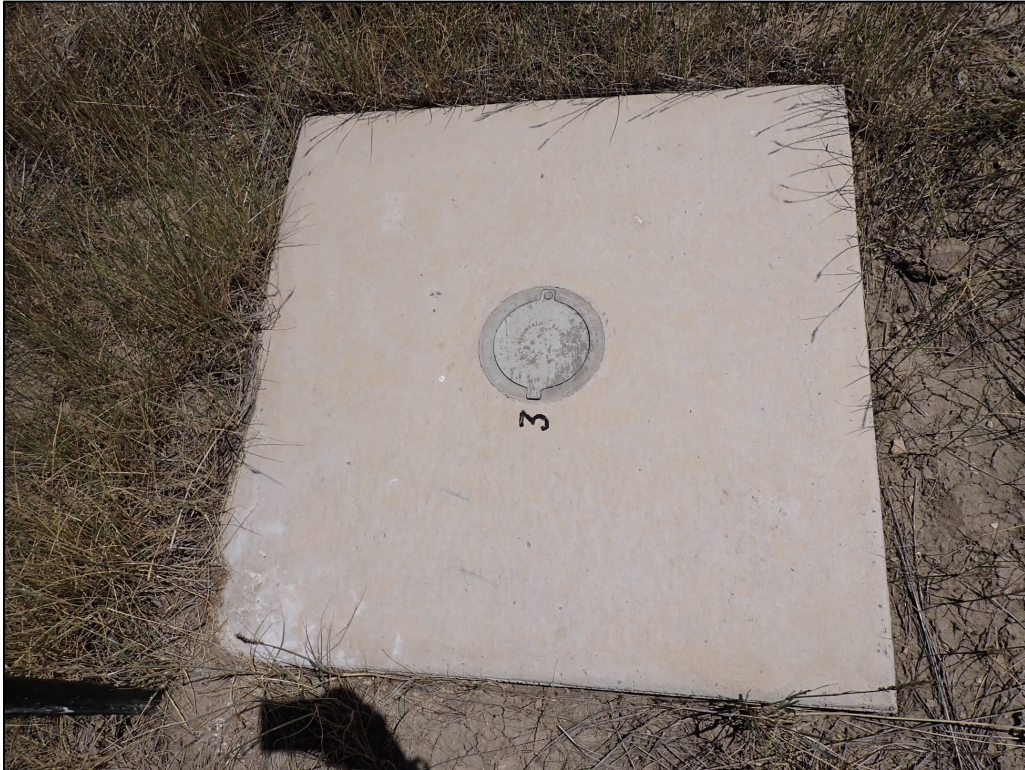
LM installed seven aerial survey quality control monuments in 2019 and conducted a baseline aerial survey in 2021. The quality control monuments were inspected during the 2022 annual inspection (PL-5). No maintenance needs were identified.

PL-5. Quality Control Monument QC-3

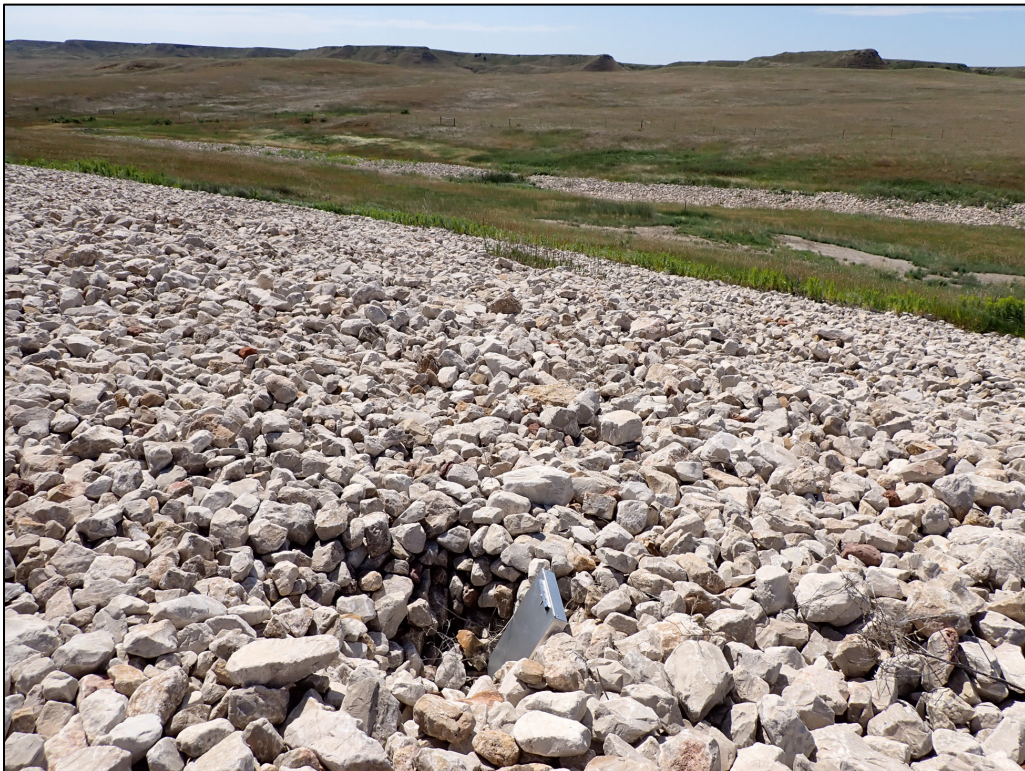
The face of the containment dam is armored with riprap. Two small depressions, approximately 2 feet in diameter, were observed on the containment dam during the 2021 annual inspection. No evidence of sediment deposition, human intervention, or other modifying processes were observed near the depressions. No changes to the two depressions were identified in the 2022 annual inspection (PL-6) and the depressions do not threaten the integrity or performance of the disposal cell. Monitoring of the depressions will continue during annual inspections and subsequent aerial surveys. Grasses and annual weeds were growing in the riprap in several places. These plants do not threaten the stability or function of the containment dam.

PL-6. Small Depression Number One

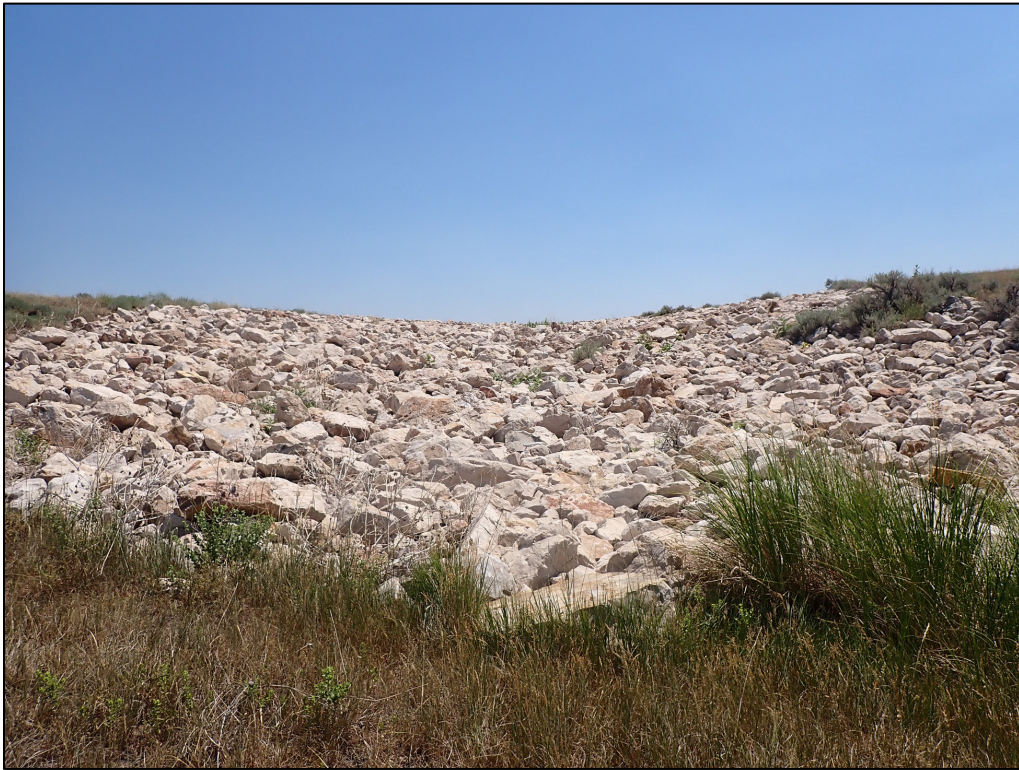
The site is surrounded by private land used primarily for grazing and wildlife habitat. The area approximately 0.25 mile beyond the site boundary—including a surface drainage area just outside the northwest corner of the property that is riprap armored to prevent headward erosion onto the site—was visually observed for erosion, changes in land use, or other phenomena that might affect the long-term integrity of the site (PL-7). No such changes were identified.

PL-7. Surface Drainage—Dry

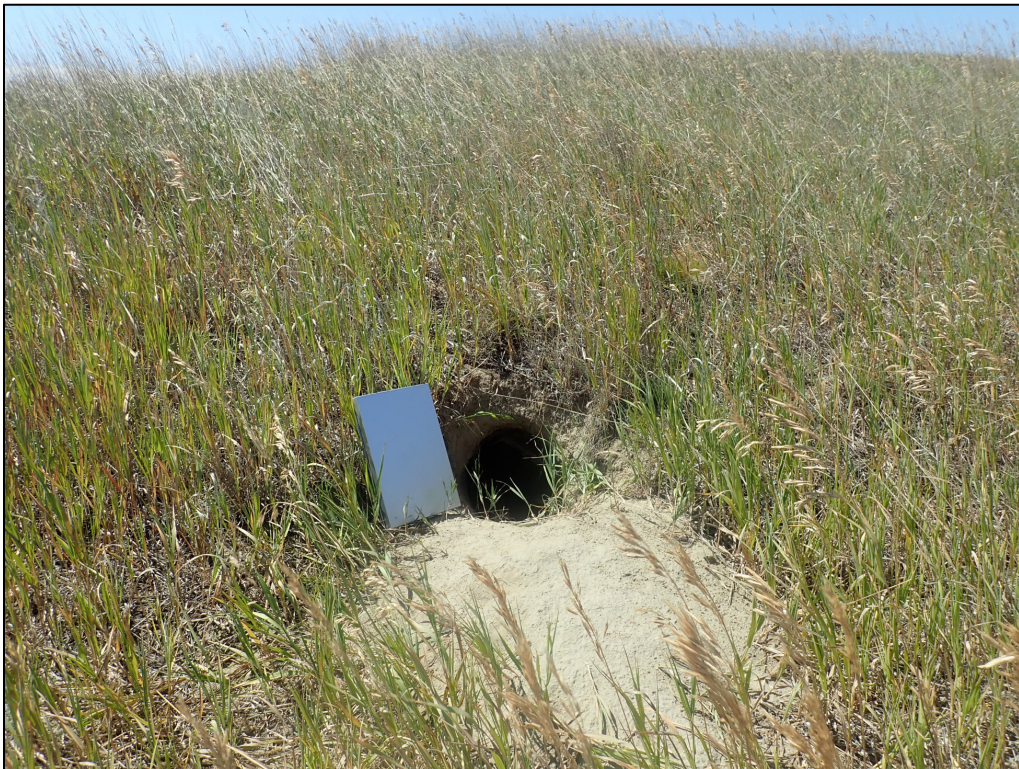
The balance of the site consists of undisturbed areas covered with native shrubs, grasses, and forbs and formerly disturbed areas covered primarily with seeded grasses and annual weeds. Animal burrows observed between the riprap-armored west diversion channel and the

containment dam are not impacting the functionality of the disposal cell or drainage features (PL-8). Some minor erosional features are on steep slopes in an area isolated from the disposal cell; these features were stable. No maintenance needs were identified.

PL-8. Animal Burrow Adjacent to Toe of Armored Containment Dam Side Slope
