## 4.0 Maybell West, Colorado, Disposal Site

### 4.1 Compliance Summary

Figure 4-1. 2022 Annual Inspection Drawing for the Maybell West, Colorado, Disposal Site

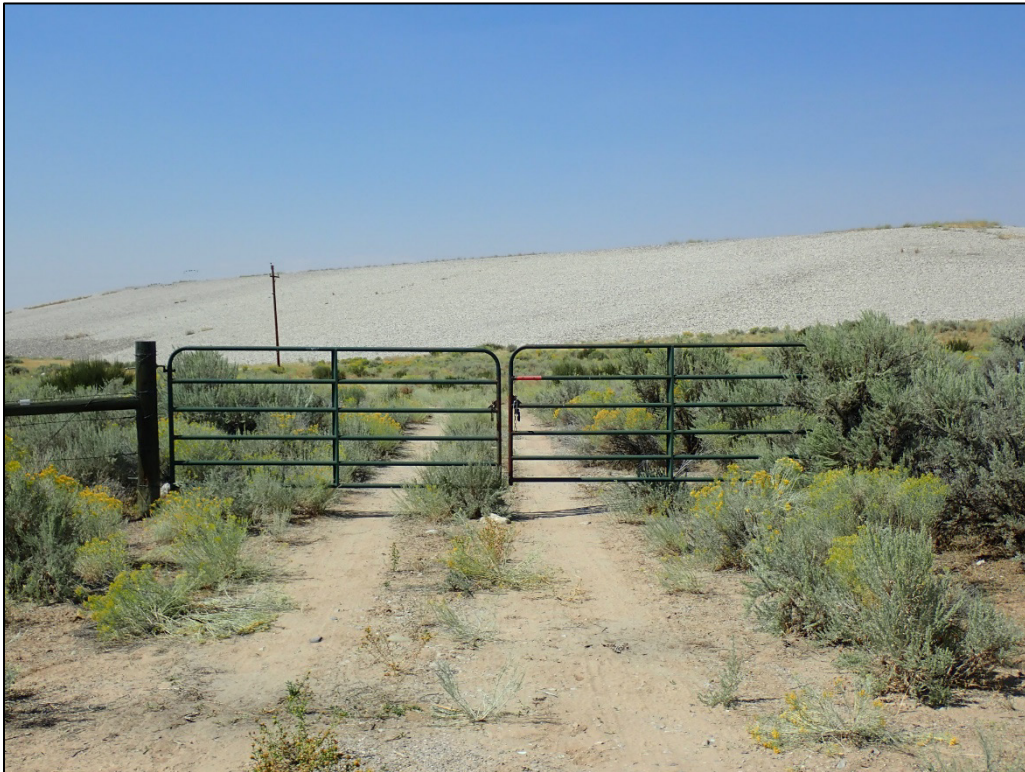
The access road was passable, and no maintenance needs were identified. The entrance gate (PL-1), a standard tubular metal stock gate, is near the southeast corner of the site. A new lock was installed to replace the old lock. No maintenance needs were identified.

*PL-1. Entrance Gate*

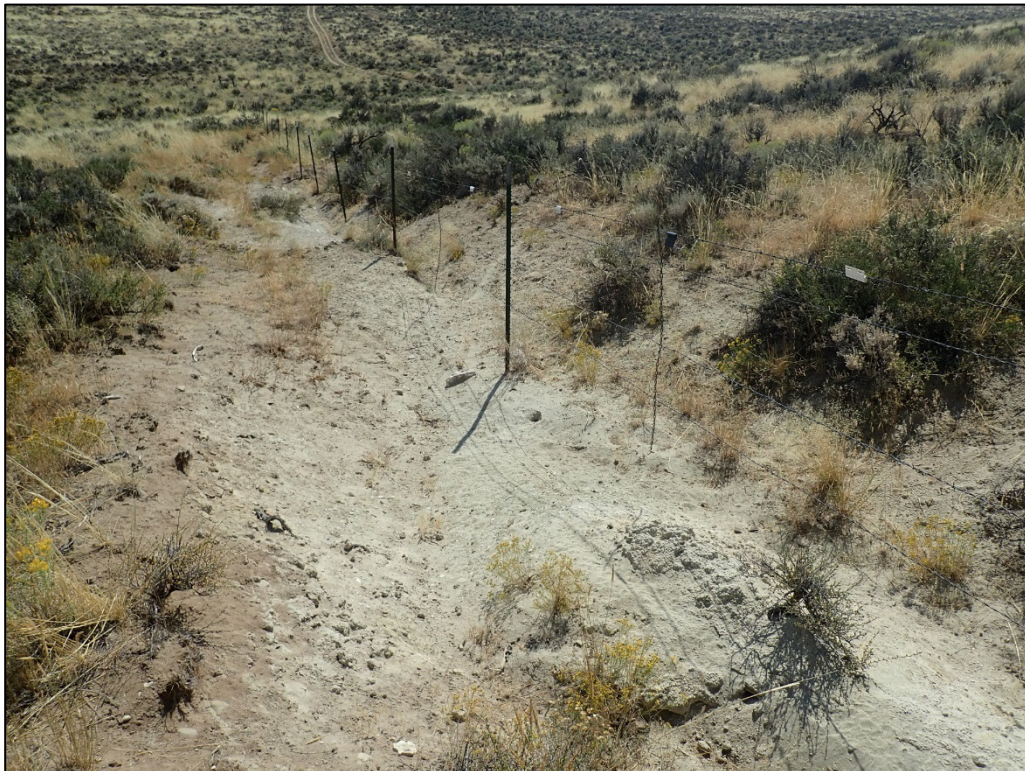
*PL-2. Erosion Under Perimeter Fence Southwest of Disposal Cell*

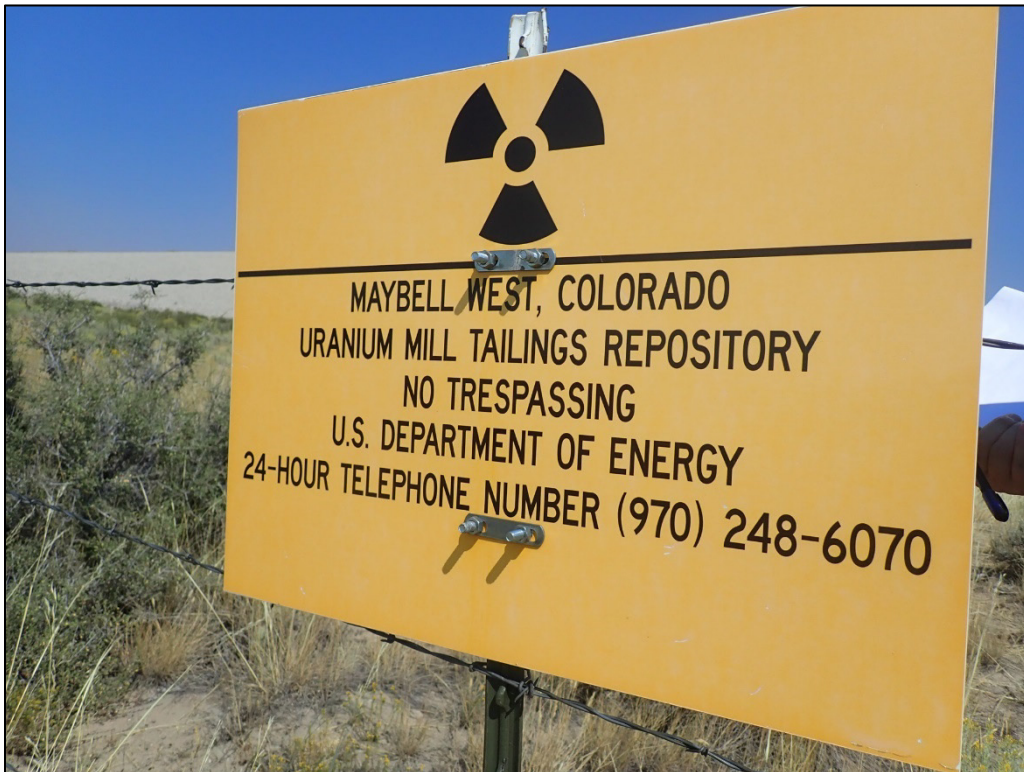
The entrance sign is mounted on a metal T-post directly south of the entrance gate. It was missing during the inspection. A generic perimeter sign was hung in its place and will be replaced with the site-specific new entrance sign during the 2023 inspection. Ten warning or perimeter signs are mounted on metal T-posts around the site (PL-3). No other maintenance needs were identified.

*PL-3. Perimeter Sign P7*

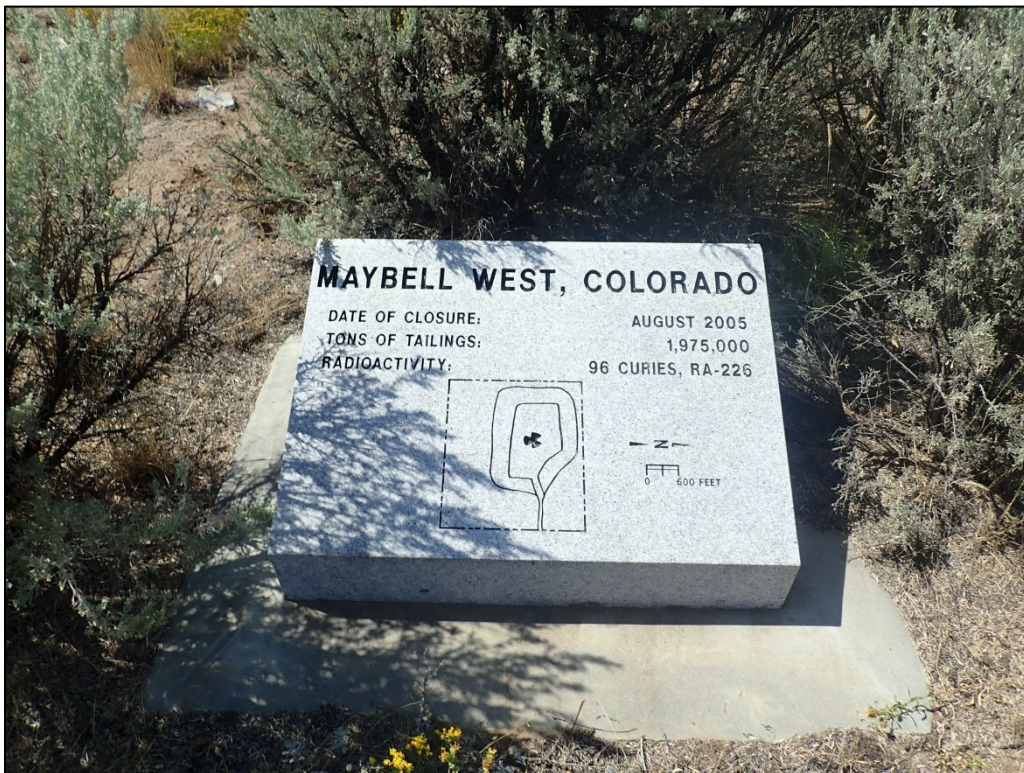
The site has one granite site marker near the entrance gate (PL-4). There is minimal cracking in the cement at the base of the site marker (PL-5). It does not affect the integrity of the marker. No maintenance needs were identified.

*PL-4. Granite Site Marker*

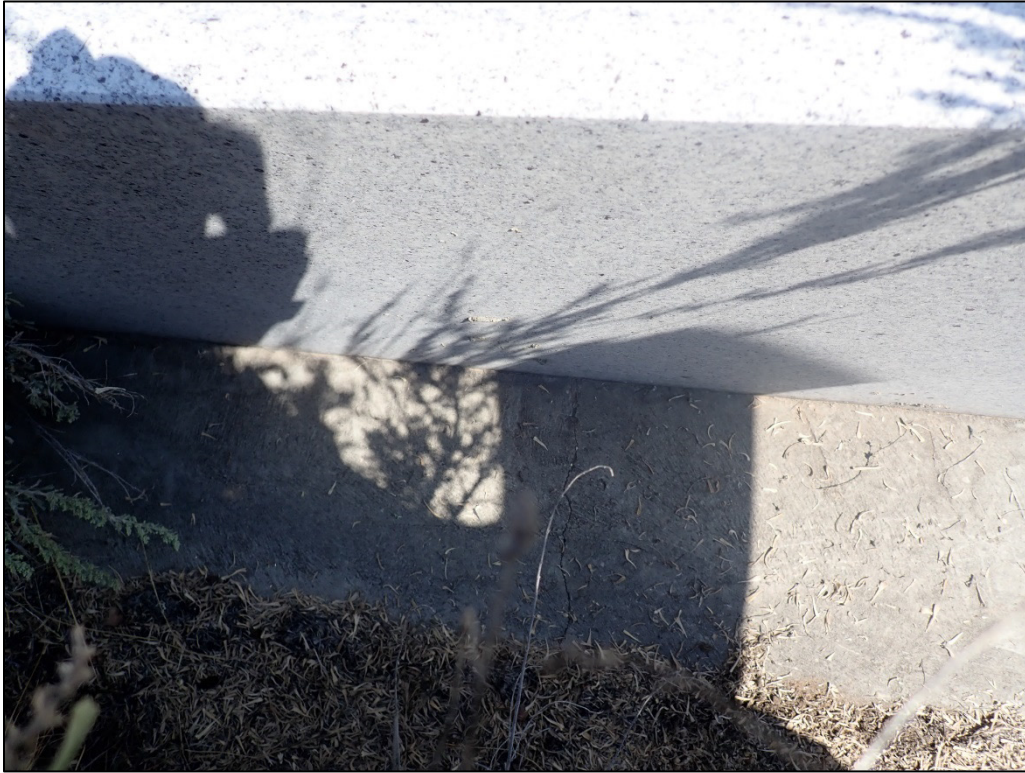
*PL-5. Granite Site Marker Cracking on Base*

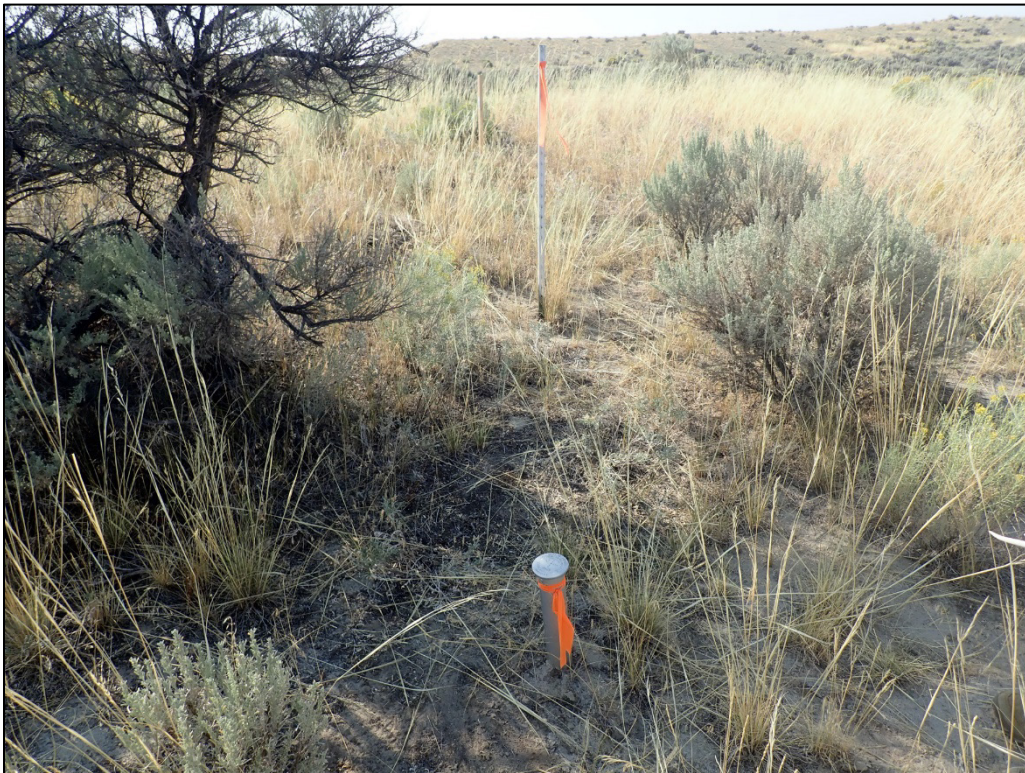
Eight boundary monuments are on the site boundary outside the fenced area (PL-6). Four of the monuments are at the property corners, and the other four define an approximate 20-foot offset along the north and south boundaries where the private land that LM acquired in fee adjoins the BLM withdrawal area on the western portion of the site. Boundary monuments BM-3 and BM-6 (capped pieces of rebar) define the two 20-foot offsets. Boundary monument BM-3 remains bent, but the monument is still in place; attempts to straighten the monument were not successful, and it is missing its cap (PL-7). No additional maintenance needs were identified.

*PL-6. Boundary Monument BM-1*

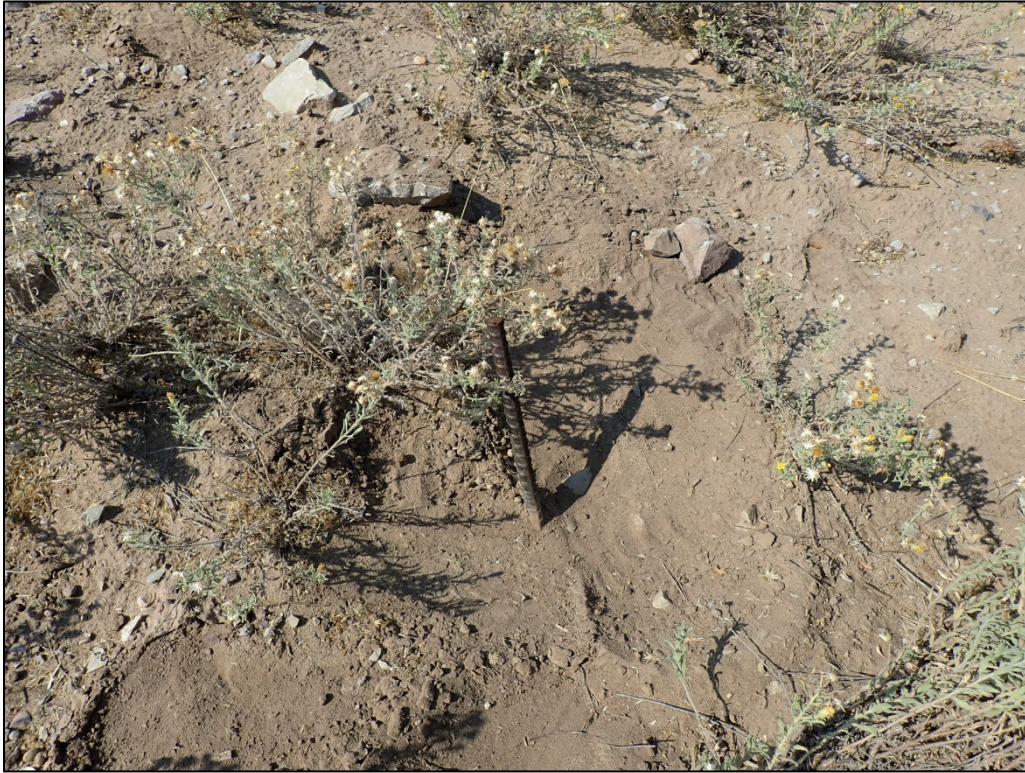
*PL-7. Boundary Monument BM-3*

Boundary monument BM-3 is damaged and will need to be repaired or replaced but continues to delineate the property. No other maintenance needs were identified.

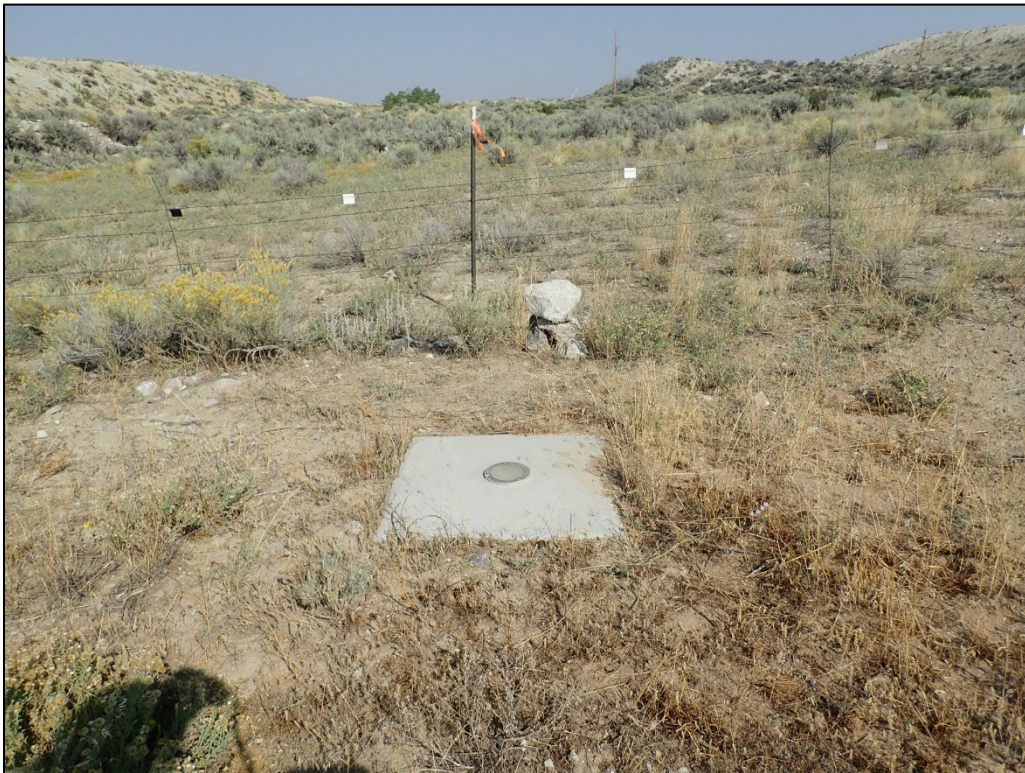
The seven aerial survey quality control (QC) monuments were inspected during the 2022 inspection (PL-8). No maintenance needs were identified.

*PL-8. Quality Control Monument QC-3*

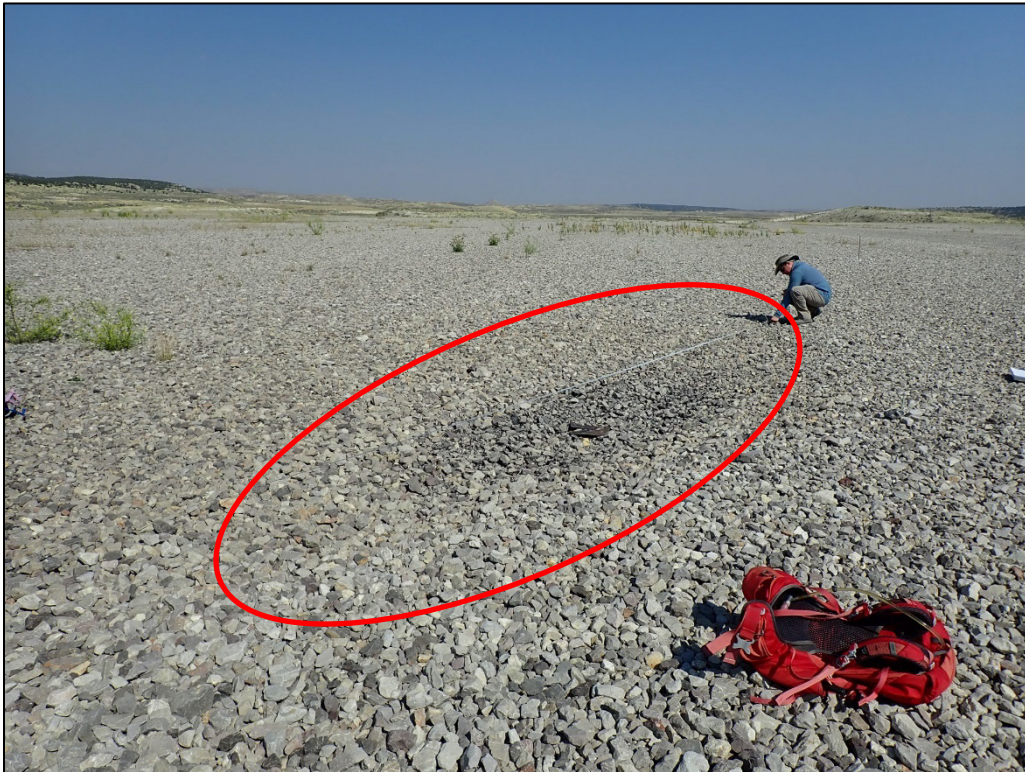
The disposal cell is on the reclaimed site of a former heap leach processing area. The top slope of the riprap-armored disposal cell occupies about 60 acres of the site. The top of the disposal cell showed no signs of significant erosion, settling, or other modifying processes that would affect the cell’s integrity. However, three small shallow depressions have been observed (just north of Diversion Channel No. 1) since the site transitioned to DOE in 2010. These depressions appear to be the result of settlement of the underlying materials since completion of the disposal cell. Depression No. 1 was discovered during the initial annual inspection in 2010 (PL-9). A second smaller and shallower depression (Depression No. 2) (PL-10) was first noted just west of the first depression during the 2016 annual inspection. A third depression (Depression No. 3 [PL-11]) was first observed during the 2018 annual inspection. During the 2022 inspection, all three depressions appeared to be approximately the same size as observed during the 2021 annual inspection.

No standing water was observed in any of the depressions during the inspection. These depressions currently do not threaten the integrity or performance of the disposal cell. No maintenance needs were identified.

*PL-9. Shallow Depression No. 1*

All three depressions will continue to be measured during annual inspections to determine if additional, more significant settlement is occurring. The comparison of 2018 baseline aerial survey data with data from the 2022 aerial survey will help LM measure and monitor the depressions.

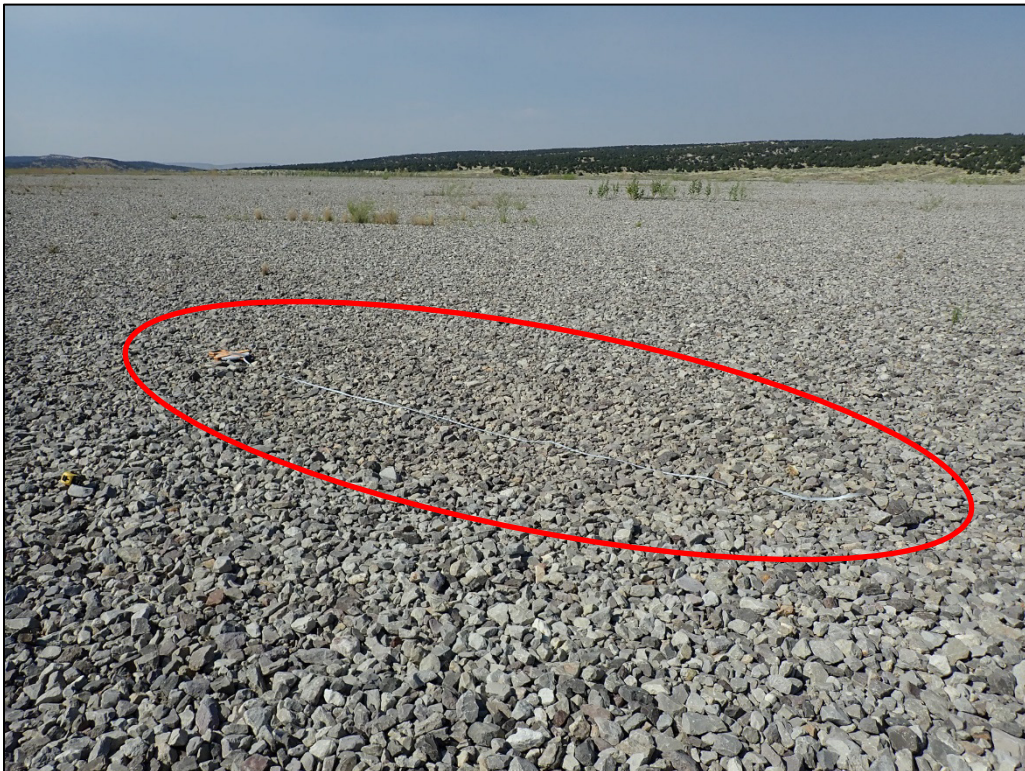
*PL-10. Shallow Depression No. 2*

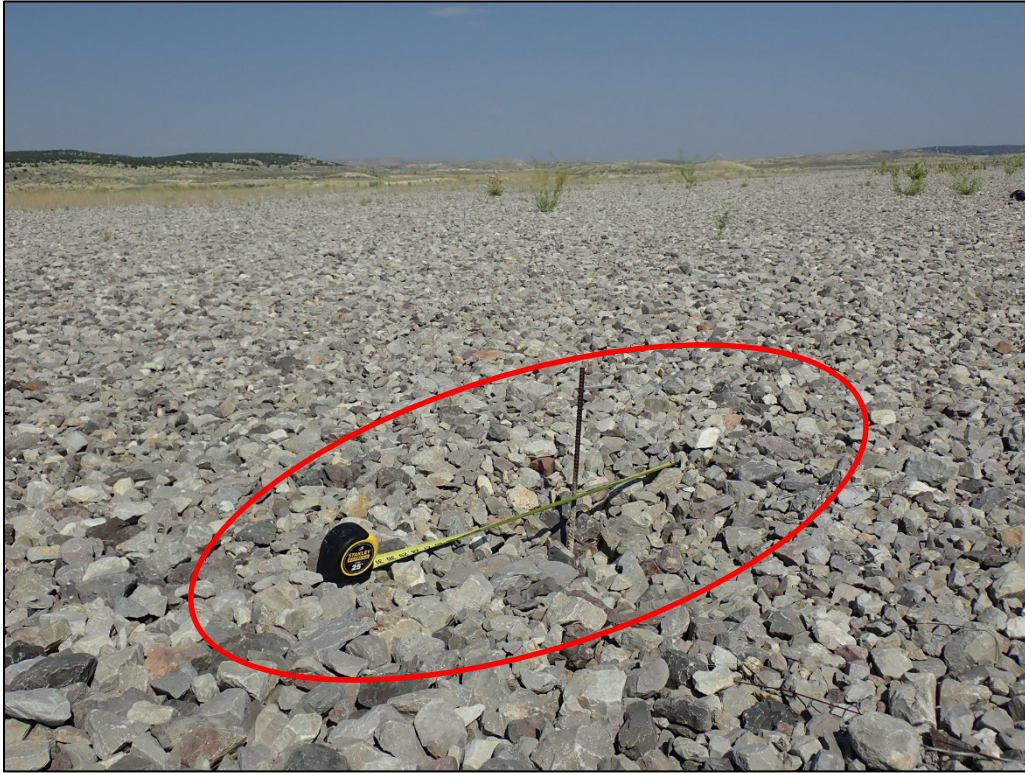
*PL-11. Shallow Depression No. 3*

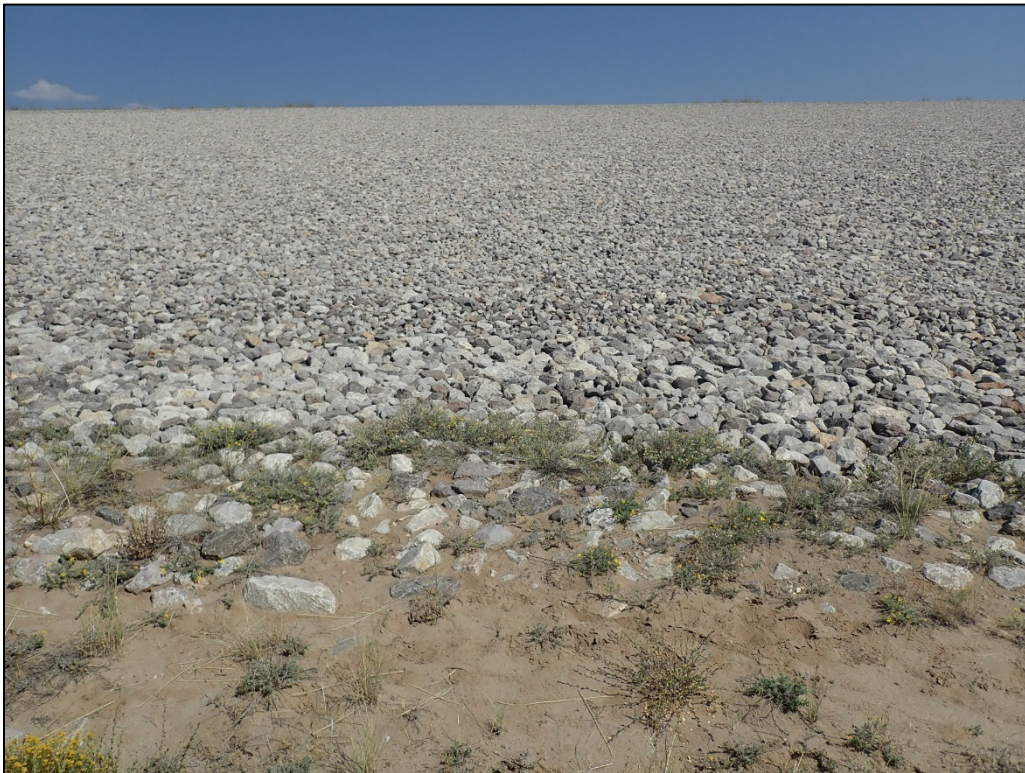
The disposal cell was designed to control surface water runoff resulting from a probable maximum flood event. The side slopes of the disposal cell were constructed with a 20% slope and are covered with a 1-foot-thick layer of riprap. Minor sediment accumulation observed in the toe drain apron below the northwest side slope appears to be windblown (PL-12), and there was no evidence of side slope instability, erosion, or settlement. This area of sediment accumulation will continue to be monitored to ensure that the toe drain and side slope are functioning properly.

*PL-12. Windblown Material Along Western Toe Slope of Disposal Cell*

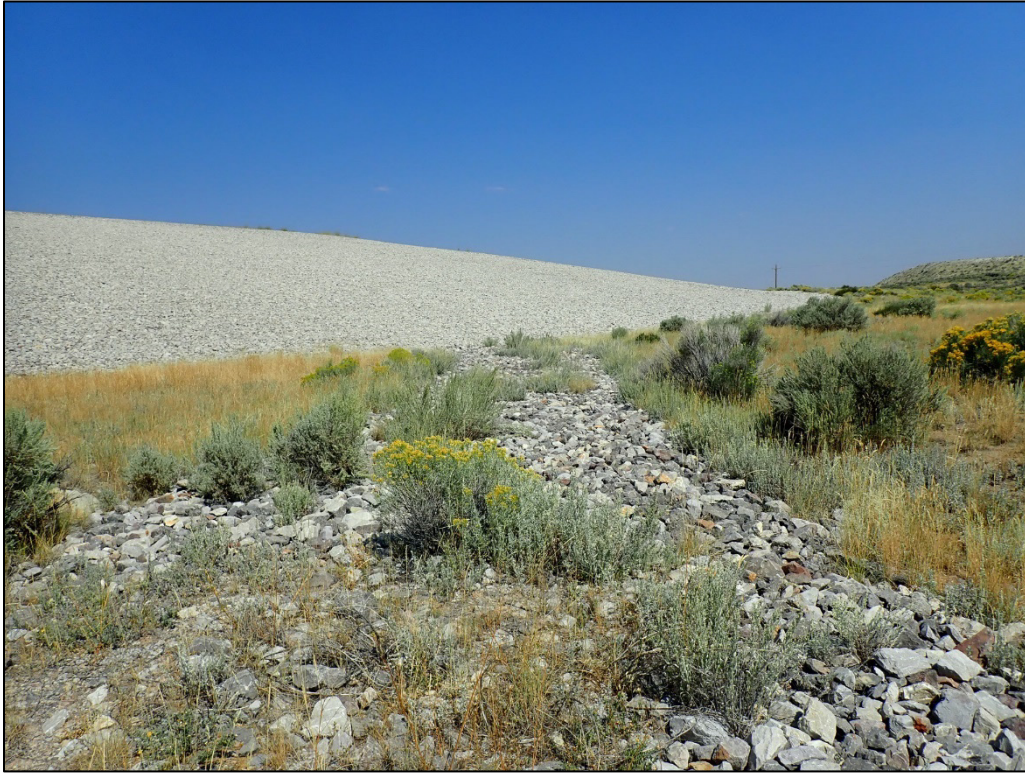
Surface water runoff from the side slopes is conveyed by an apron at the toe of the slope to six riprap-armored toe drains (PL-13) at low points in the apron. The apron and toe drains are constructed channels filled with riprap. Minor erosion has occurred adjacent to a toe drain along the north side of the disposal cell, but that has not impacted the performance of the toe drain. No maintenance needs were identified.

*PL-13. Apron Toe Drain*

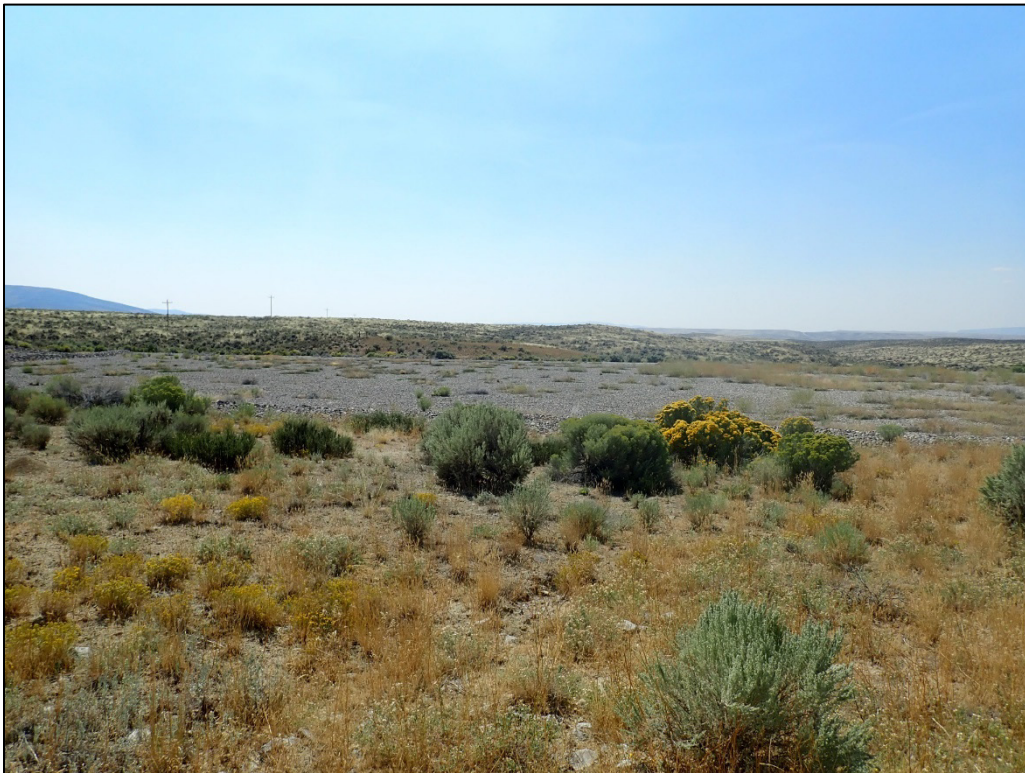
The ancillary cell (PL-14) was constructed to contain waste materials associated with the reclaimed evaporation pond area. It slopes gently toward the southwest. A rock berm wraps around its eastern and northern sides to protect it from surface water runoff. Small depressions were observed on the west end of the ancillary cell on the crest of the top slope (PL-15). Additional small depressions on the toe of the side slope (PL-16) were observed during the 2022 inspection. None of the depressions are impacting the performance of the cell, but they will continue to be monitored. Various species of deep-rooted vegetation are on the top and side slopes of the ancillary cell. Noxious weeds and deep-rooted vegetation were treated on the top slope following the inspection.

*PL-14. Ancillary Cell Top Slope*

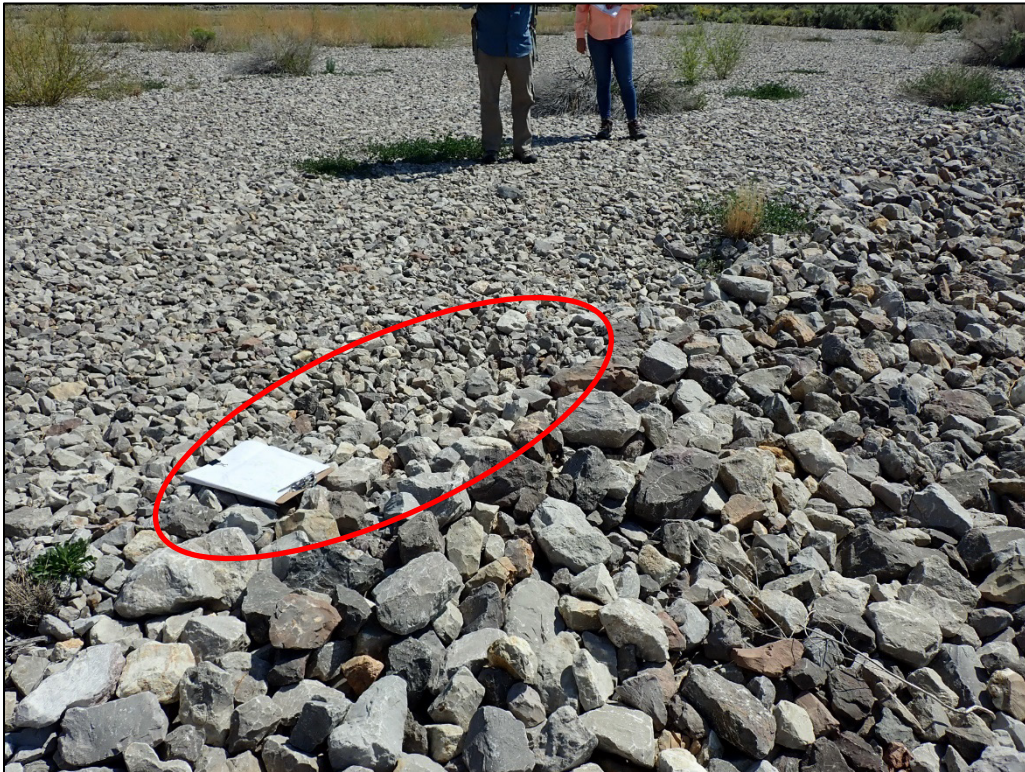
*PL-15. Small Depressions on Ancillary Cell Crest*

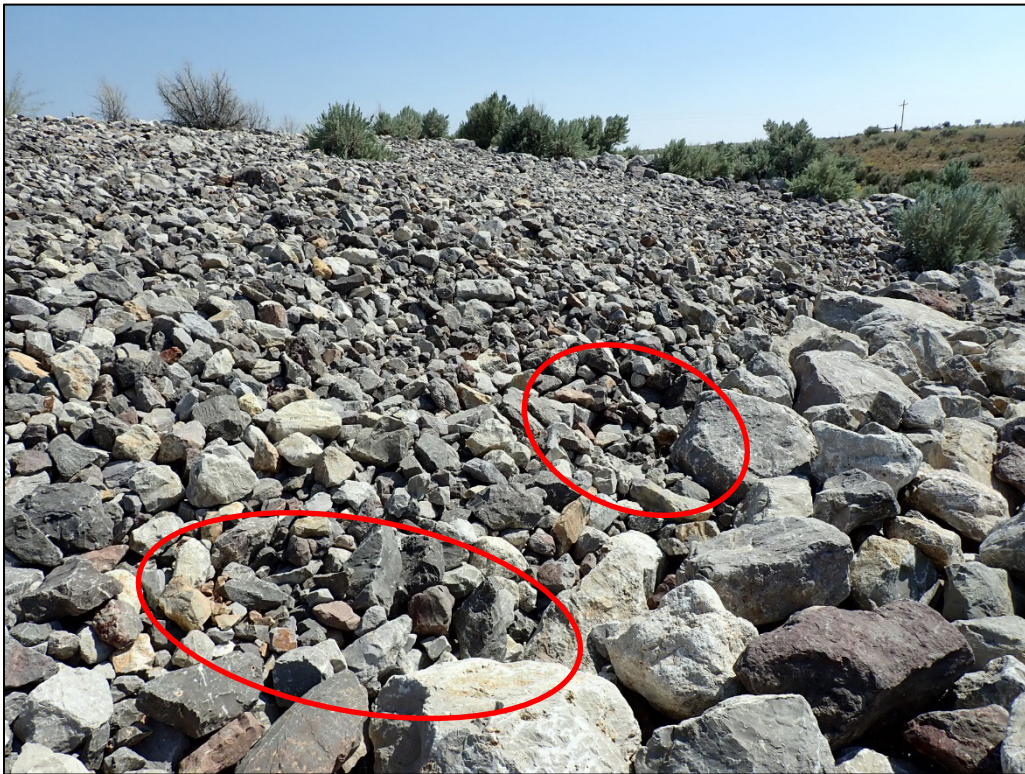
*PL-16. Large Depressions on Ancillary Cell Side Slope Toe*

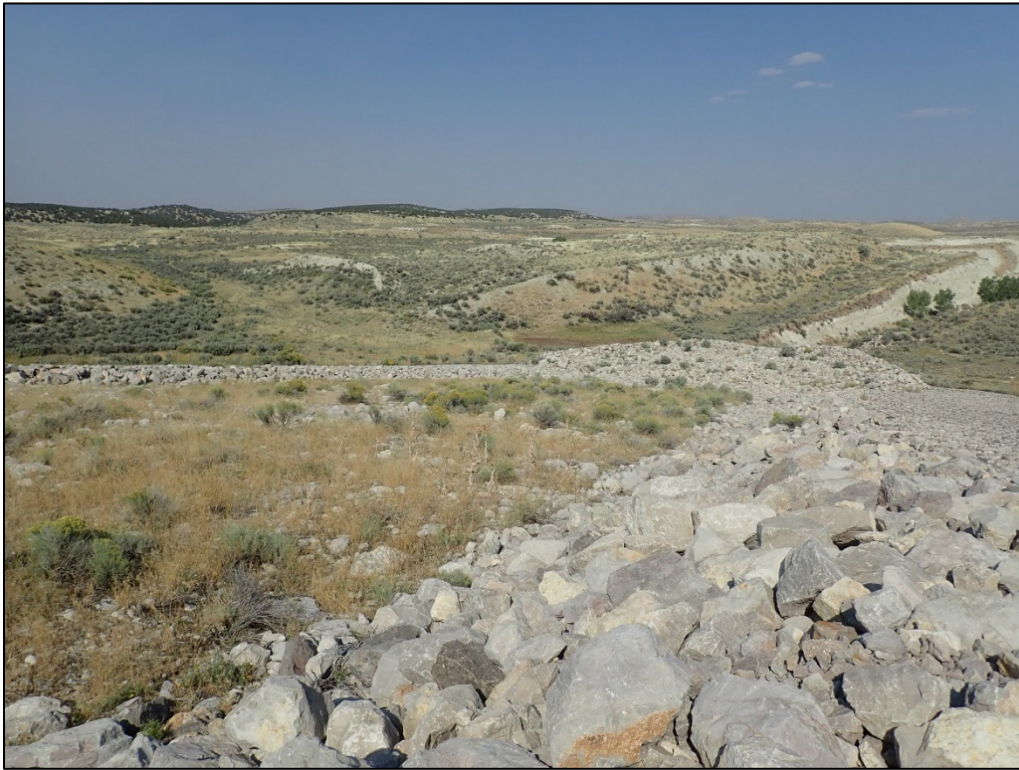
surface water runoff away from the ancillary cell. The diversion channels and outlet channel of the Launch Rock Erosion Protection Basin continue to function as designed.

*PL-17. Diversion Channel No. 1 Along Disposal Cell Eastern Side Slope and Launch Rock Erosion Protection Basin in Background*

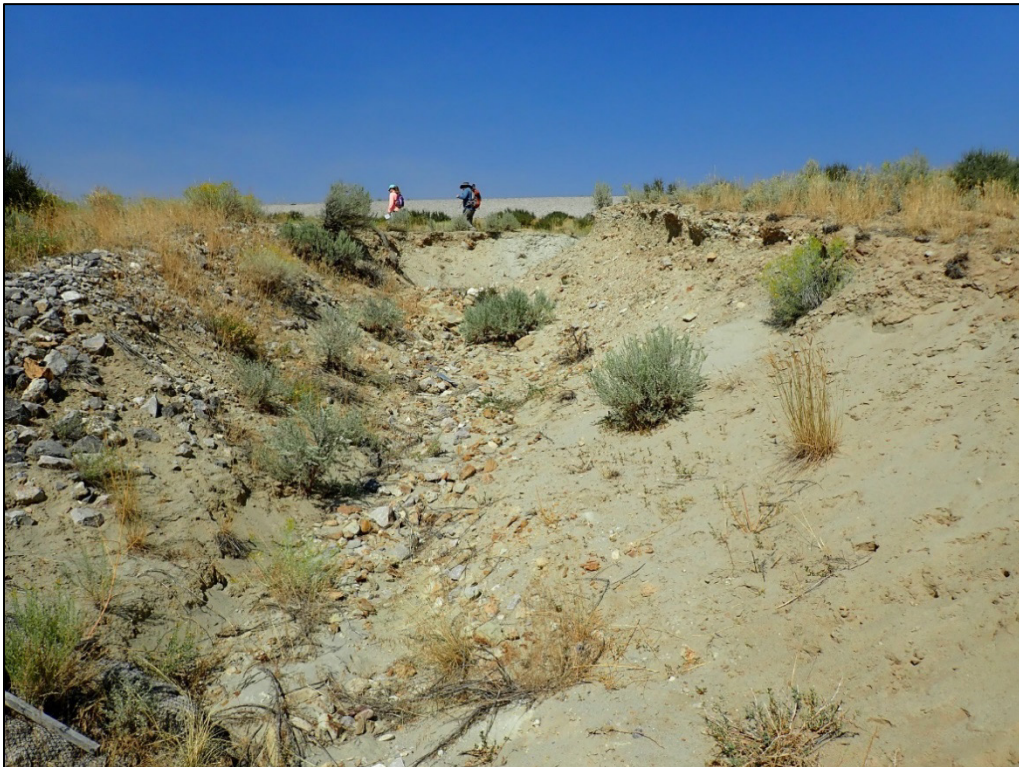
The rock berm that runs along the northern edge of the ancillary cell continues west across the slope south of the disposal cell to protect the disposal cell against erosion and headcutting. Several gullies and rills have developed on this south slope but do not threaten the integrity of the disposal cell (PL-18). The gullies will continue to be monitored and repaired as needed. No maintenance needs were identified.

*PL-18. Easternmost Erosion Between Rock Berms*
