## 3.0 L-Bar, New Mexico, Disposal Site

The L-Bar, New Mexico, Uranium Mill Tailings Radiation Control Act (UMTRCA) Title II Disposal Site was inspected on March 9, 2023. Previous inspections performed in 2021 and 2022, as required by the Long-Term Surveillance Plan (DOE 2004) (LTSP), and associated follow-up site visits, identified numerous surface degradation features on the disposal cell top slope. Two new degradation features on the top slope were identified during the March 2023 inspection. These features represent changes in cell cover characteristics, and an evaluation of the cause and need for repair is ongoing. Additionally, during an Applied Studies and Technology (AS&T) investigation in September and October of 2022, several piping features were discovered on the side slope of the disposal cell. They will continue to be monitored and do not affect the performance of the side slope at this time. Inspectors also identified several routine maintenance needs.

### **3.4 Inspection Results**

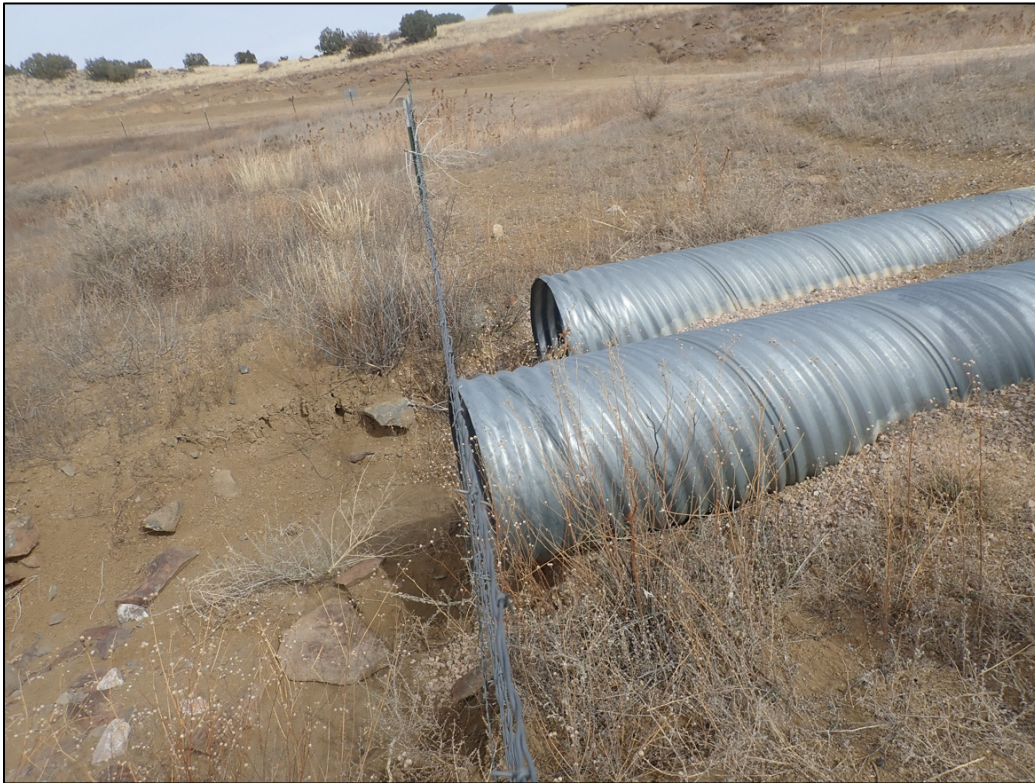
Interior roads used to access LM assets consist of two-track dirt roads with drainage culverts to convey stormwater in key locations. A gully that formed on a side slope of the G3 channel has encroached on the east site access road. Culverts were installed along the access road in 2016 to prevent washout of the road and to control erosion. Sediment is accumulating around one of the three culvert inlets and erosion is also undercutting the outlets, but they are functioning as designed, and no maintenance needs were identified (PL-1).

*PL-1. Culvert Outlets Along Access Road near Perimeter Sign P9*

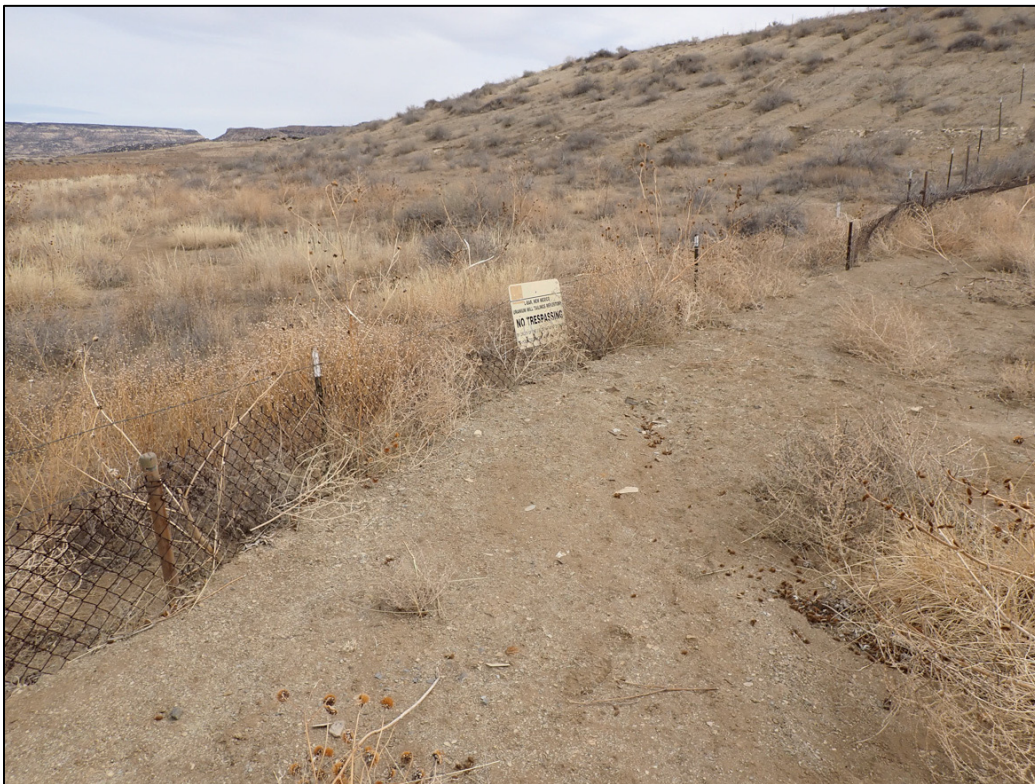
*PL-2. Partially Buried Fence from Sedimentation near Perimeter Sign P18*

Vertical extension of the fence near perimeter sign P18 due to sedimentation and the replacement of perimeter sign P18 were performed during routine site maintenance. The missing perimeter sign P31 was also replaced, and a new DOE lock was used to secure the steel entrance gate. No additional maintenance needs were identified during the inspection.

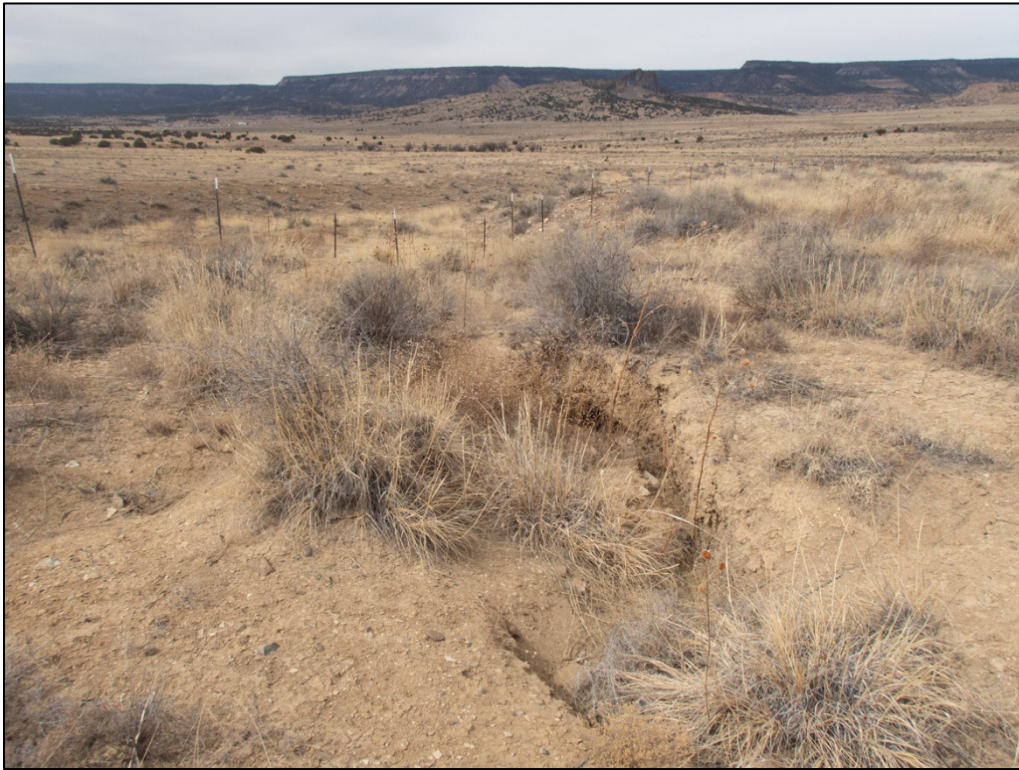
*PL-3. Erosional Feature on Southwest Fence Between Perimeter Signs P19 and P20  
(Looking from Top to Bottom)*

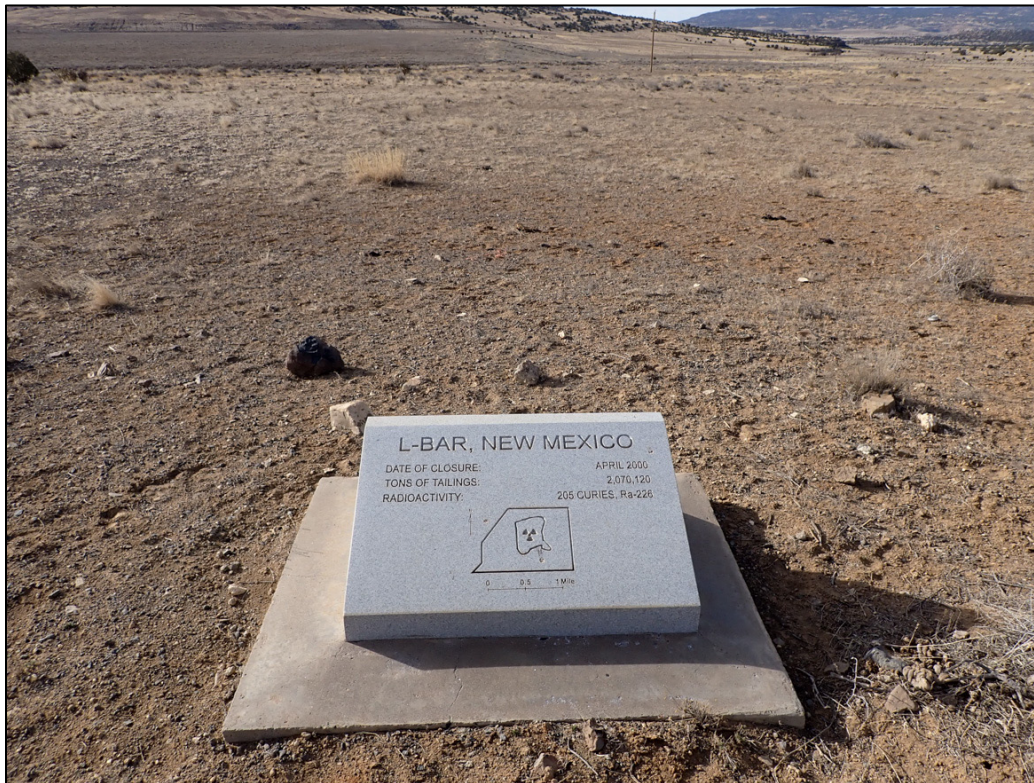
The site has one granite site marker north of the disposal cell adjacent to the site access road. Bullet damage was observed on the site marker, but it remains legible (PL-5). No maintenance needs were identified.

*PL-5. Site Marker*

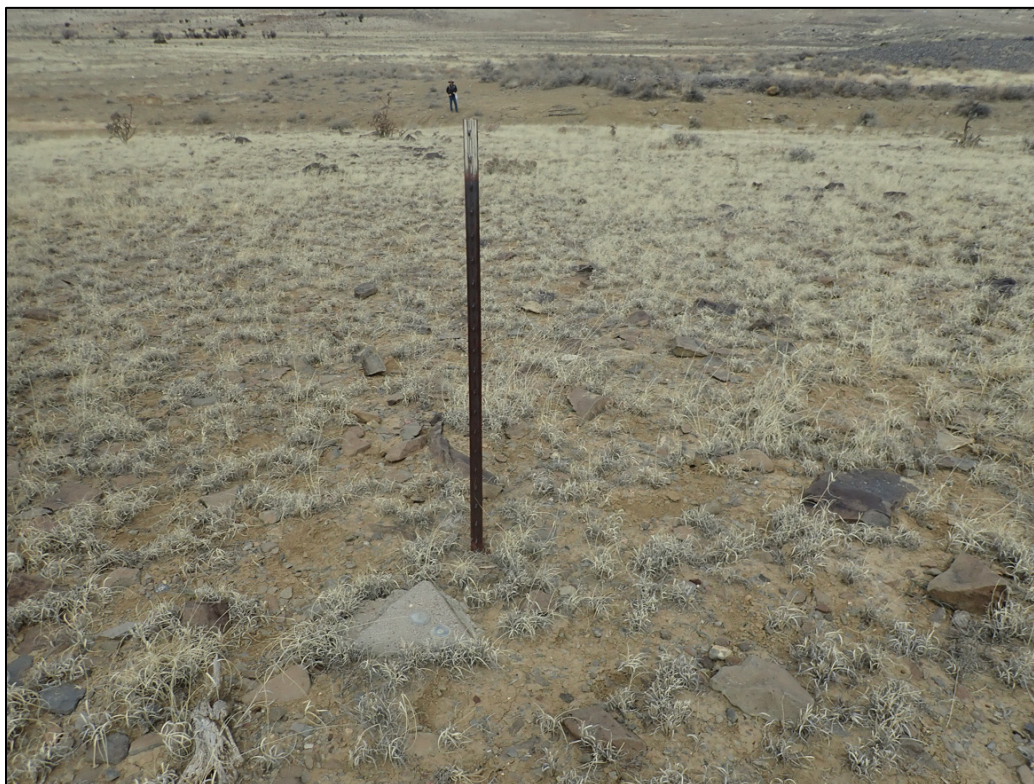
Eight boundary monuments define the site boundary (PL-6). All eight boundary monuments were observed during the 2023 inspection. No maintenance needs were identified.

*PL-6. Boundary Monument BM-3*

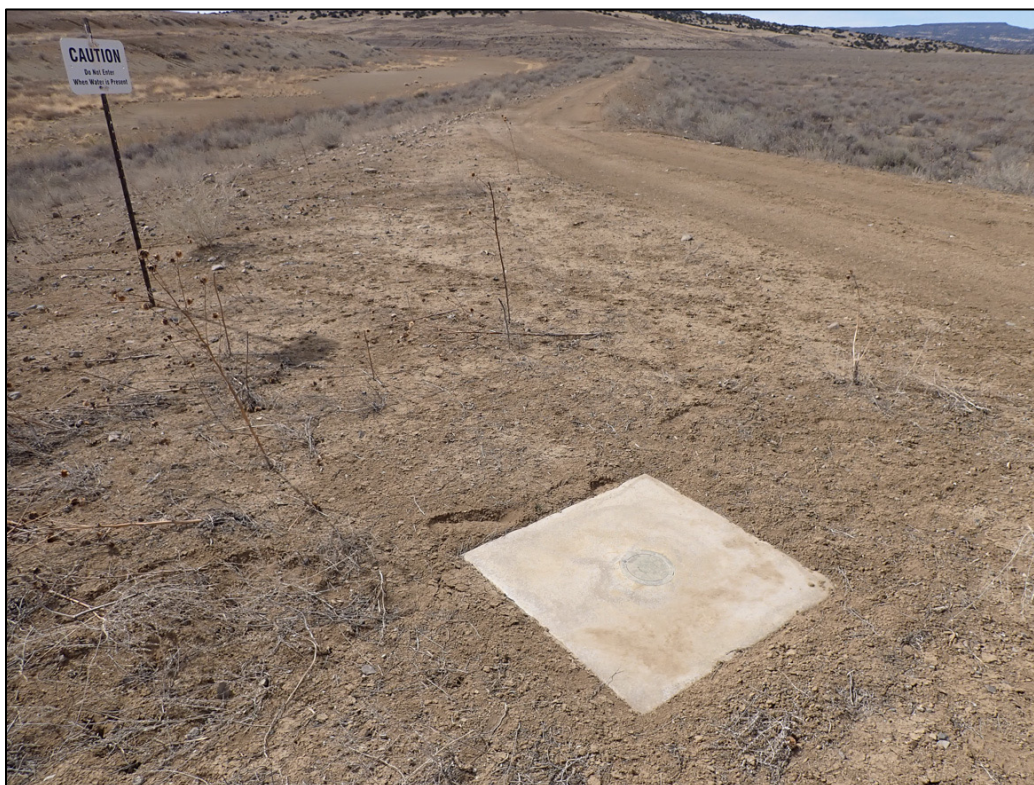
Nine aerial survey quality control monuments were inspected during the 2023 inspection (PL-7). Quality control monument QC-8 was covered in sediment. The sediment was removed during the inspection and T-posts were installed near this monument to help locate it. No additional maintenance needs were identified.

*PL-7. Quality Control Monument QC-5*

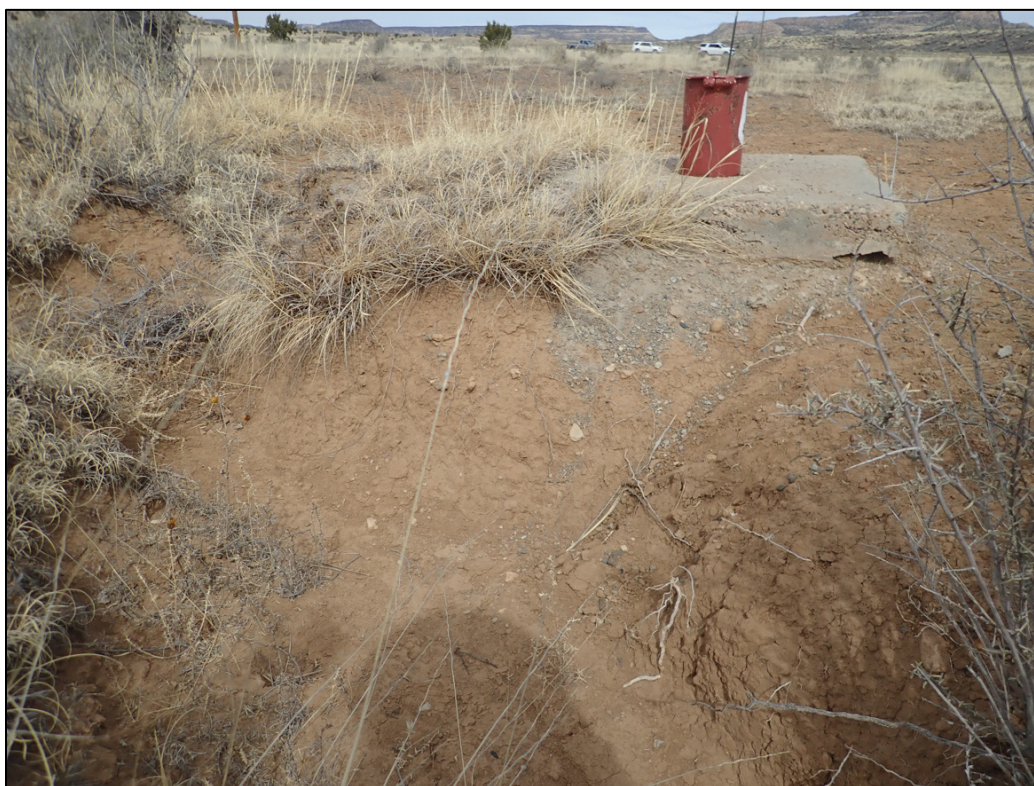
The site groundwater monitoring network consists of 10 wells. Nine of the wells are on DOE property; monitoring well 29A is outside the northeast property boundary of the site. The wellhead protectors observed during the 2023 inspection were undamaged and locked. No maintenance needs were identified. Erosion is propagating upstream near monitoring well 62 and will continue to be monitored to ensure that erosion does not impact the integrity of the well (PL-8).

*PL-8. Erosive Channeling Around Monitoring Well 62*

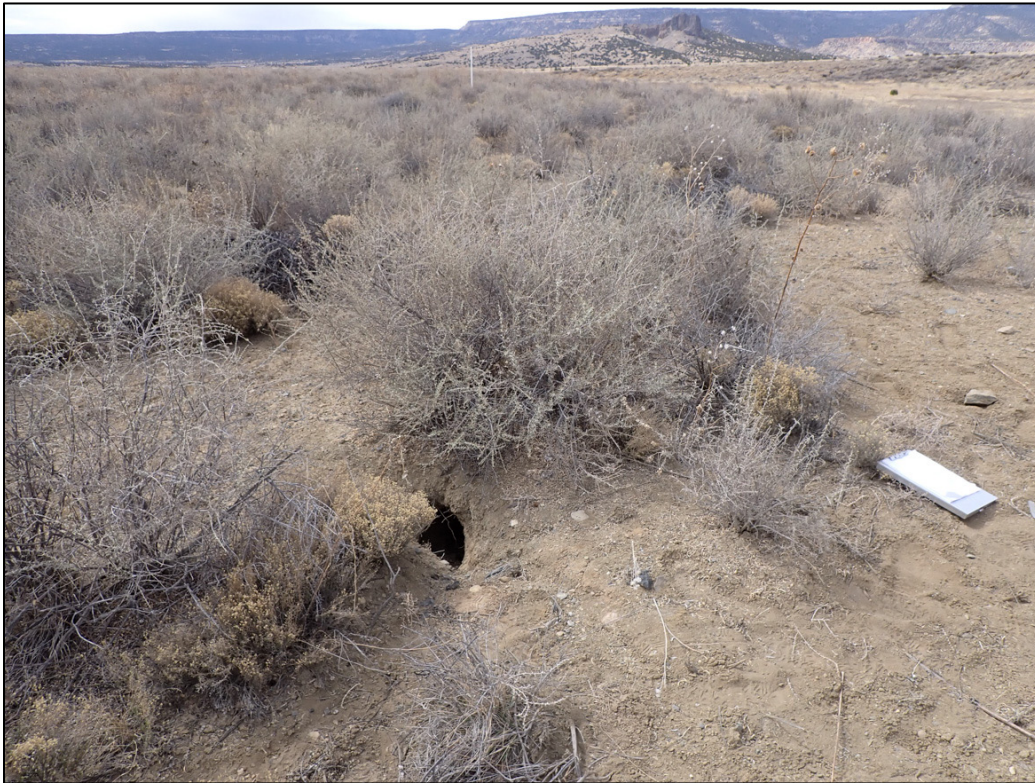
During the 2023 inspection, two more degradation features were identified (PL-9), and the most prominent degradation feature designated E-004 (PL-10) was measured and documented to track the size and erosional condition of the degradation feature. Degradation feature E-004 was previously measured in 2022 to have a surface expression of 8 ft in length and also extend vertically 8 ft below ground surface. The measurements taken during the 2023 inspection show that degradation feature E-004 has collapsed vertically and horizontal piping occurred, which nearly connects it to a nearby erosional feature (P-11). However, E-004 measured to have a surface expression of less than 2 ft in width and extend vertically around 2 ft below the ground surface.

*PL-9. Degradation Feature Roughly 120 Feet East of Erosion Monitoring Location A1*

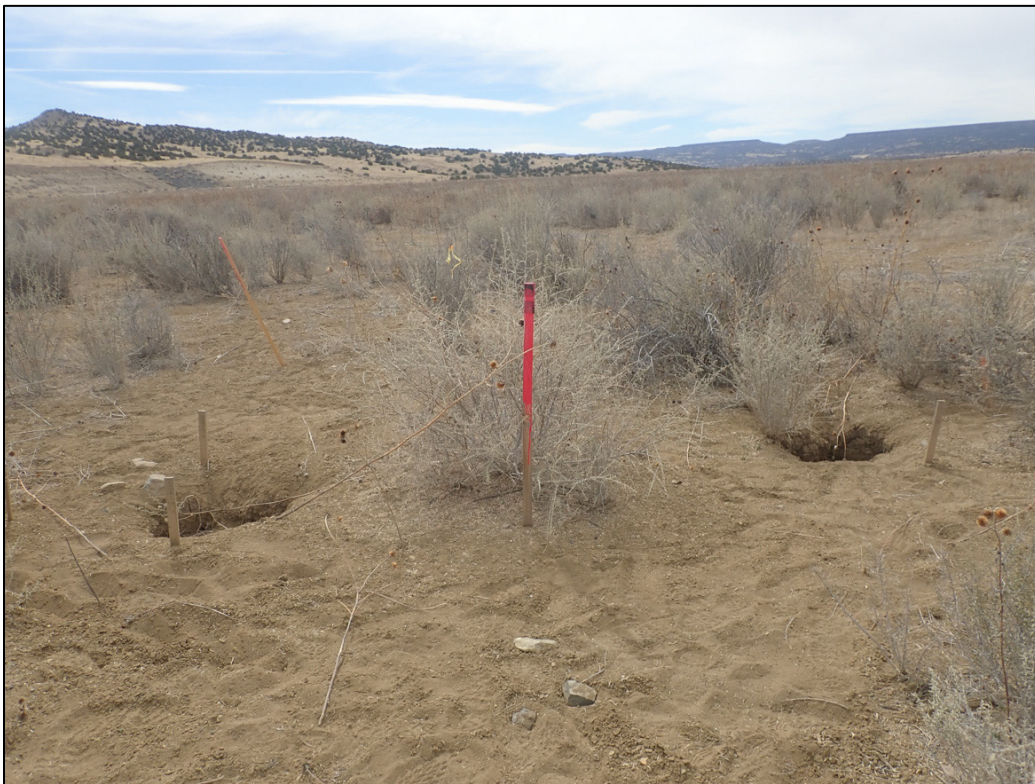
These features represent a change in the characteristics of the condition of the disposal cell cover and may require maintenance. Preliminary evaluations suggest that surface degradation features

were caused by stormwater flows penetrating the disposal cell cover via desiccation cracking (PL-12), animal burrows, and vegetation root systems.

*PL-10. Degradation Feature E-004 on Disposal Cell Top Slope*

Evaluation of the surface degradation features is ongoing, and a geophysical investigation was performed in 2023 to support further evaluation of cover degradation conditions. Multiple methods of nonintrusive geophysical techniques were implemented to analyze the subsurface tailings, radon attenuation barrier, and the common fill layer for potential void spaces. Initial findings did not indicate the potential for significant void spaces to be present. Based on the results of the recent inspection and currently available information, the disposal cell cover continues to function as designed.

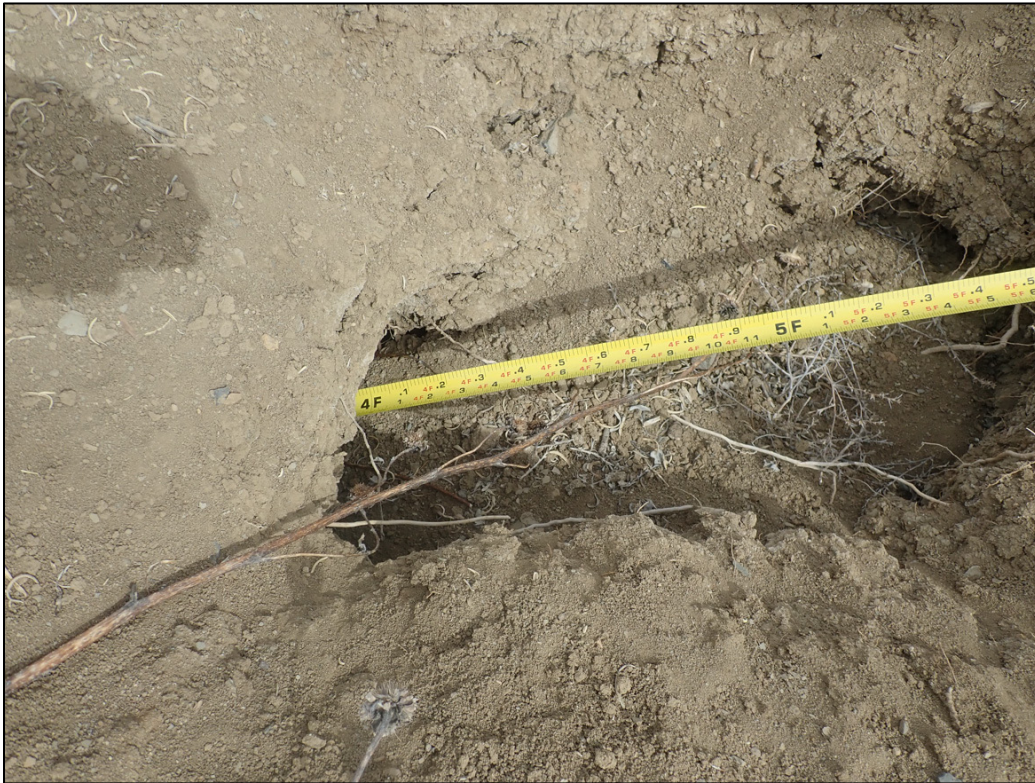
*PL-11. Degradation Feature E-004 Horizontal Piping*

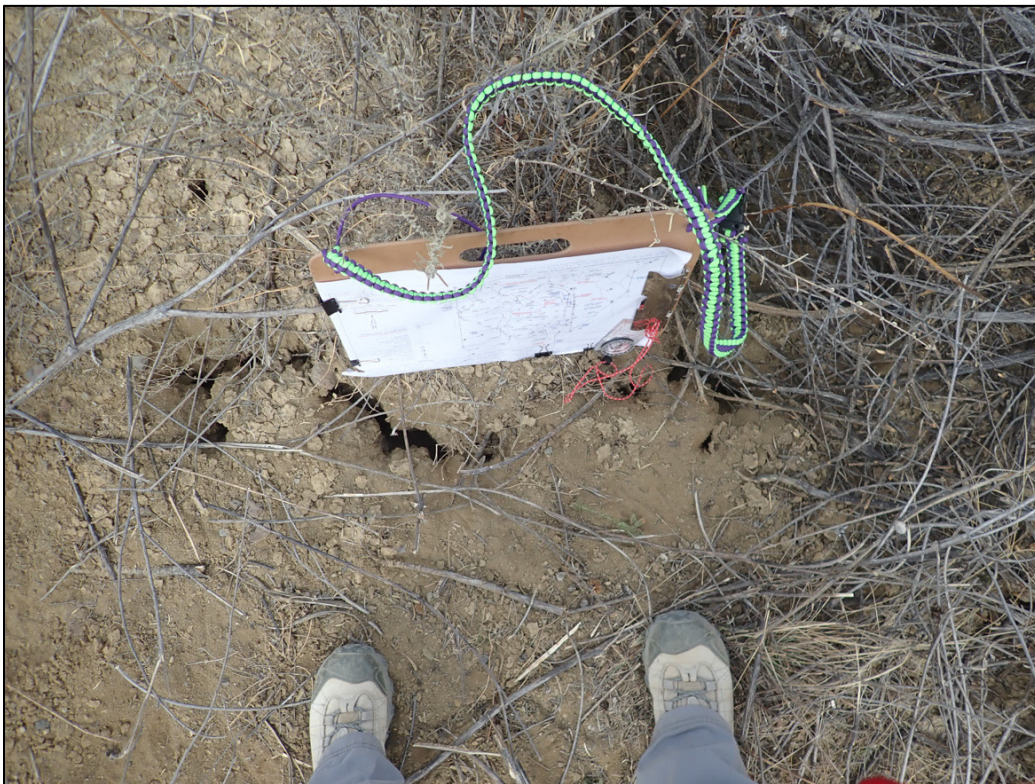
*PL-12. Deep Desiccation Cracking of Surface Soils*

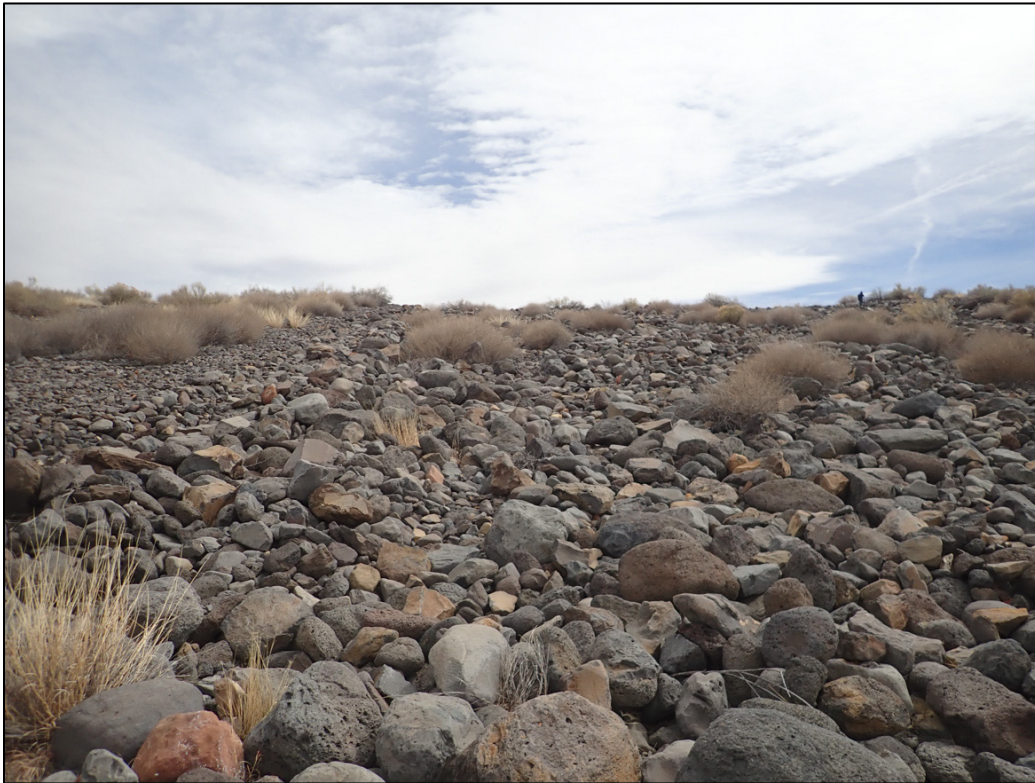
*PL-13. Overview of Stormwater Route in Spillway with Cattails Noted at Base*

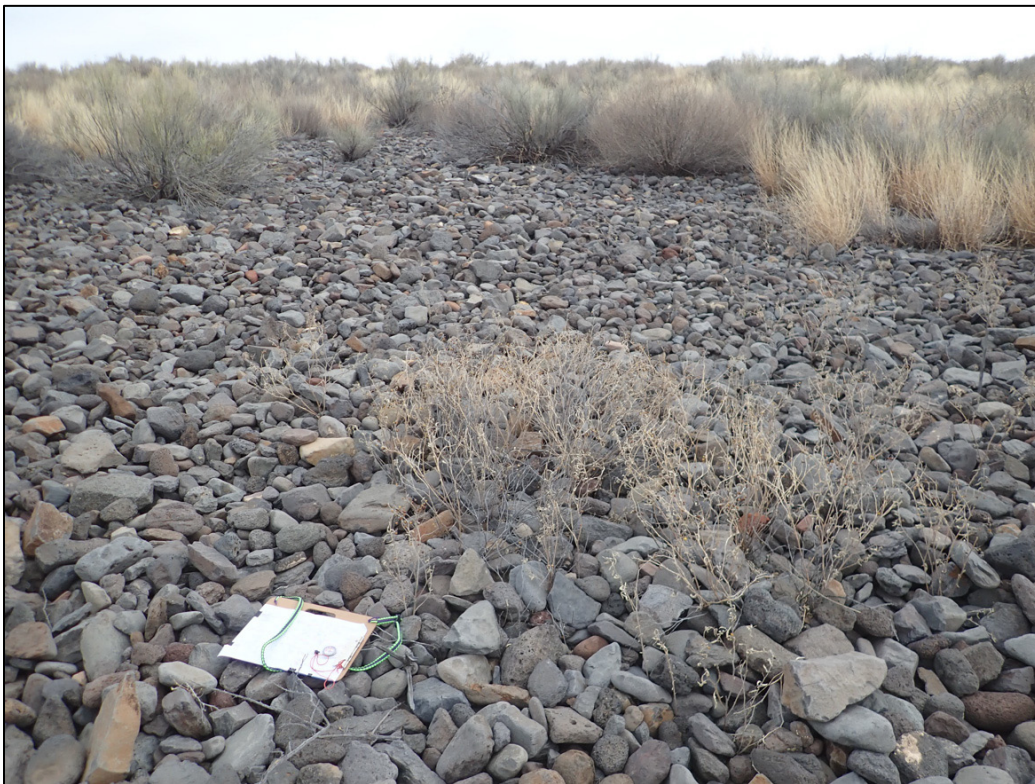
*PL-14. Additional Overview of Potential Depression Formation*

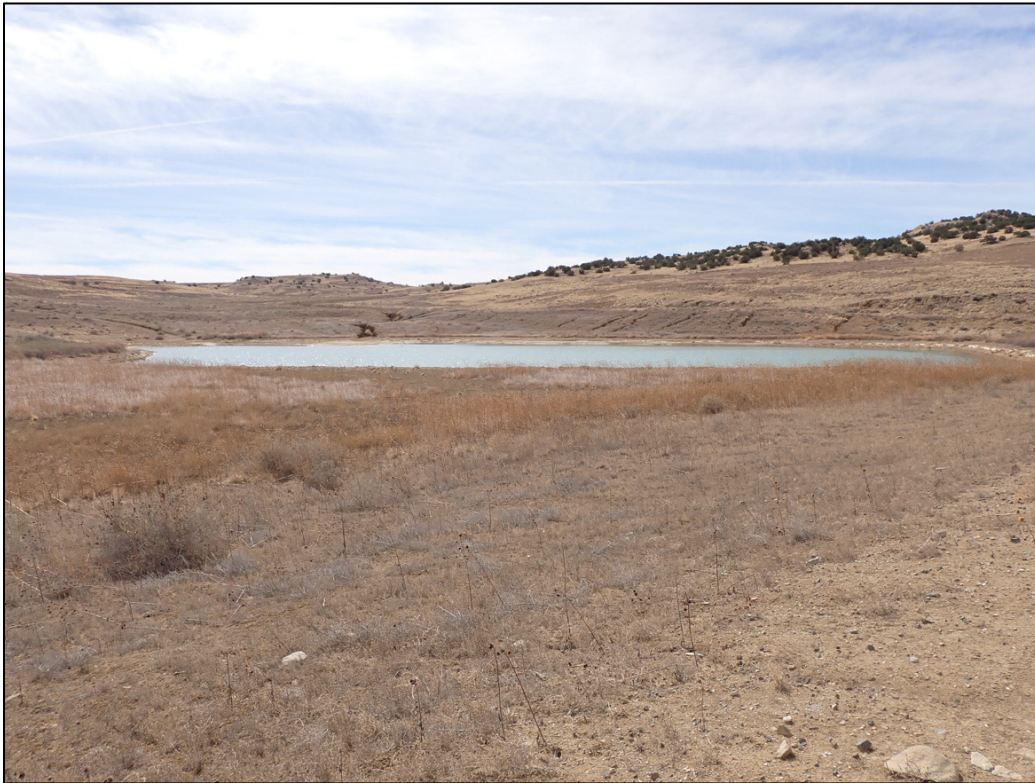
Some erosion was also observed in a watershed that encompasses the southeast portion of the site and adjacent property. Stormwater runoff from this watershed discharges into a sediment trap where the sediment load settles out. If runoff overtops the sediment trap, the flow is diverted to the east channel. Standing water was observed in the sediment trap at the time of the inspection (PL-15).

*PL-15. Water in Sediment Trap*

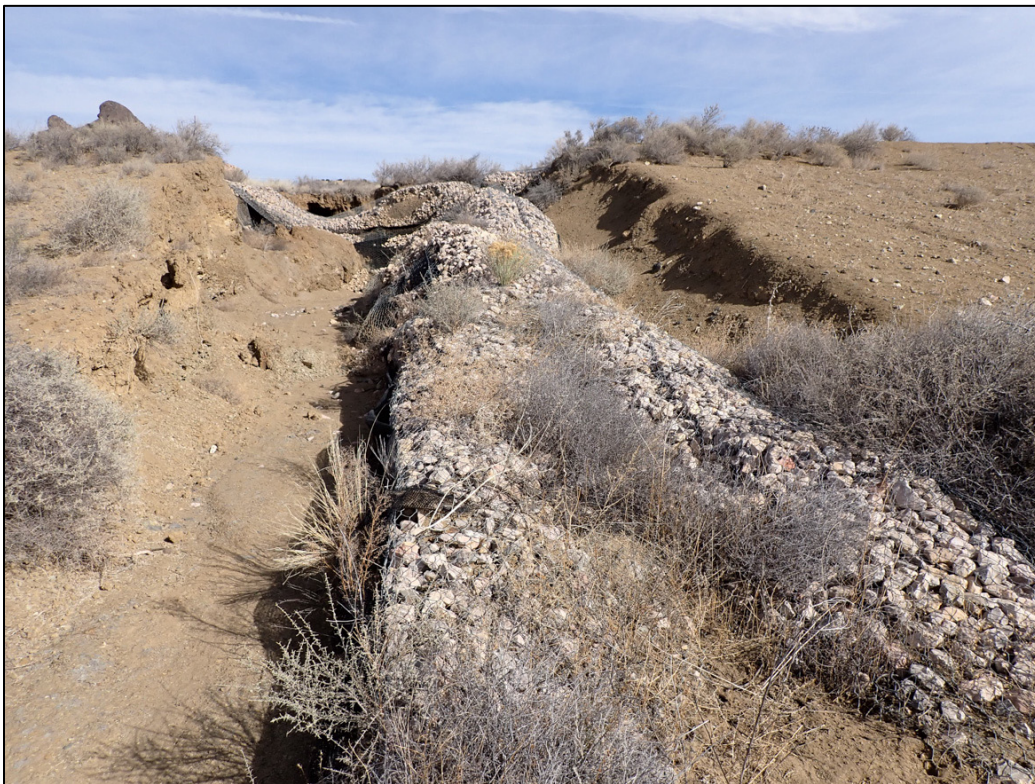
Multiple high-intensity storms since the completion of site reclamation have caused deep gullies to form in the highly erodible soils and fill materials upgradient of the sediment trap. Construction of runoff control structures to reduce the rate of erosion in the area and prevent headward migration of gullies into adjoining private property was completed in December 2009. Runoff from a storm event in September 2011 overtopped an earthen runoff control berm of Runoff Control Structure A and caused substantial damage to the berm. Subsequent runoff events have caused erosion adjacent to gabion drop structures associated with Runoff Control Structure A and nearby Runoff Control Structure D. Because of continued excessive erosion, an interagency agreement was established with USACE to repair these structures and construct additional structures in the watershed. Runoff water from the area north of the disposal cell is captured by the north channel. The water is diverted away from the site to the west. Deep gullies had formed in the alluvium and weathered shale along a portion of the north bank of the channel, and headward erosion was rapidly migrating to the north toward the site access road and property boundary. The eroded channel bank was restored to the original design configuration, and two runoff control structures were constructed in 2009 to reduce erosion and sedimentation. Runoff Control Structure F is showing signs of undermining erosion but was stable and functional at the time of the inspection. However, Runoff Control Structure G suffered severe erosion during runoff events in August and September 2011 and continues to erode (PL-16). Runoff Control Structure A is experiencing gully erosion (PL-17) and undermining at portions of the gabion block sections (PL-18), and it is likely that continued erosion will lead to failure of the structure. DOE will continue to monitor these structures and, as part of the interagency agreement, USACE will complete a design for repairs and modifications to these structures.

*PL-16. Gully Erosion at Erosion Control Structure G*

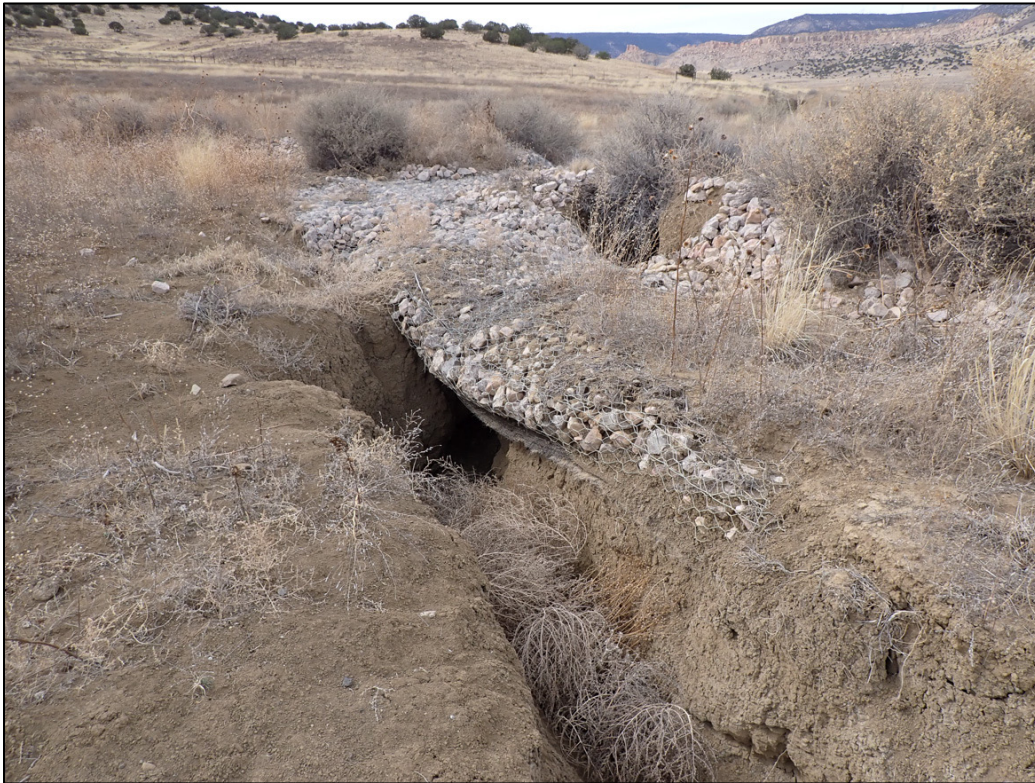
*PL-17. Erosion at Structure A*

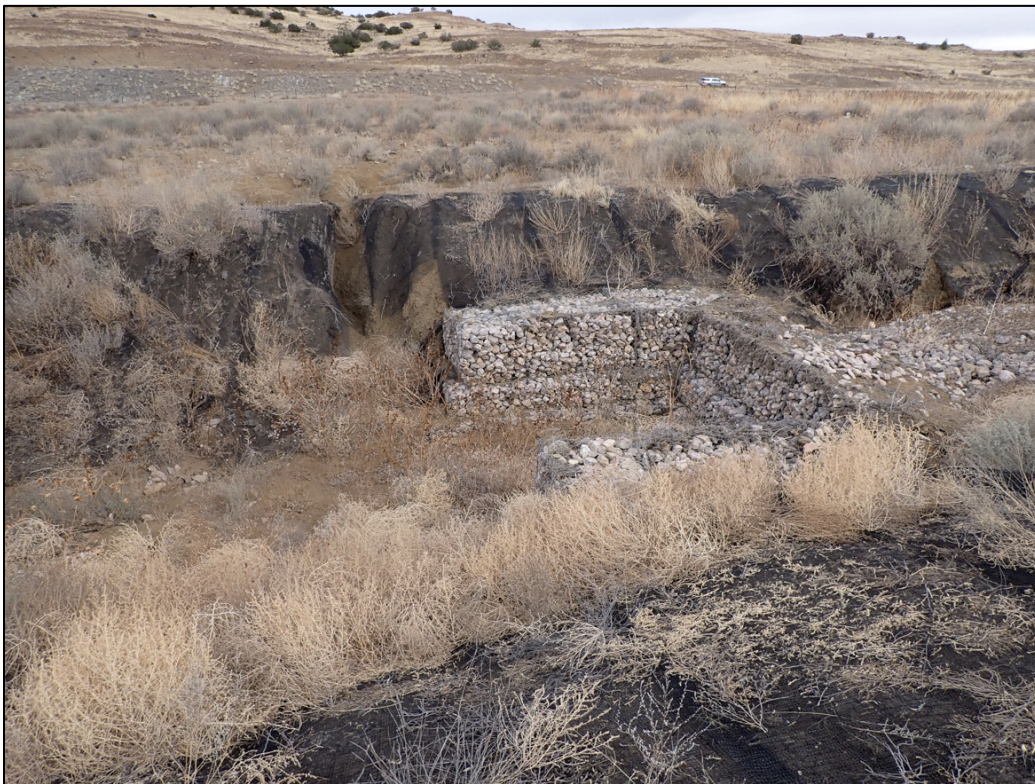
*PL-18. Erosion at Structure A Along Second Block Structure*

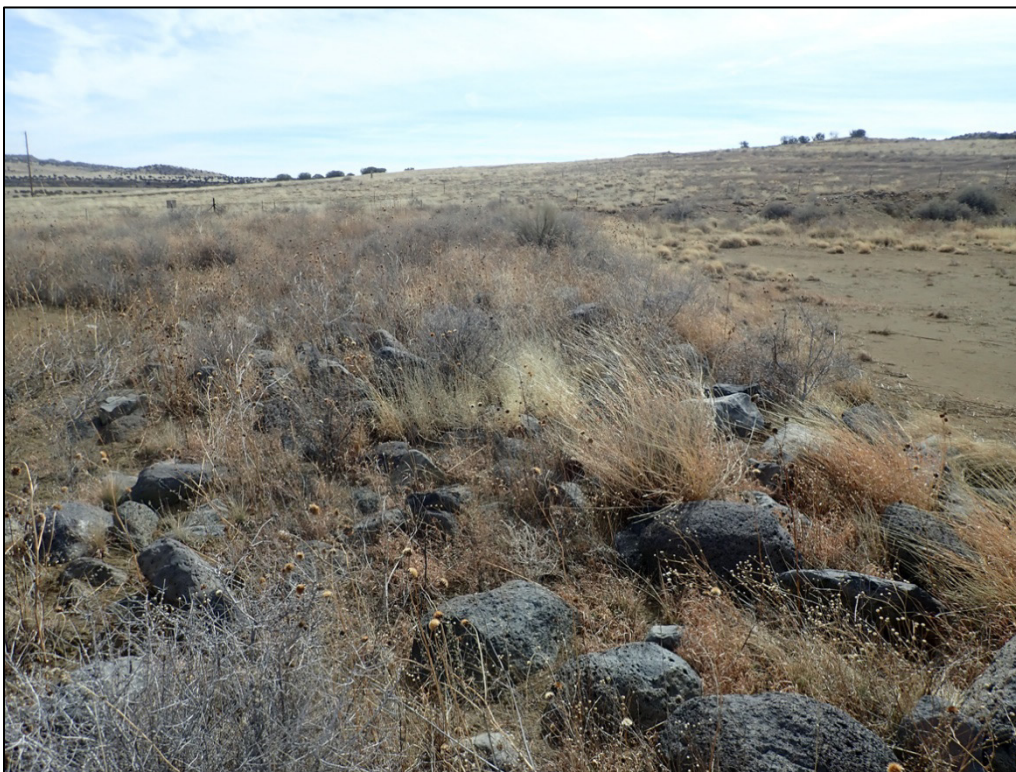
The east channel diverts stormwater runoff from the G3 channel and higher terrain immediately east of the disposal cell toward the sediment trap to the south. A northern riprap cutoff wall exists to inhibit erosion and sedimentation north of the east channel northern cutoff wall. Minimal erosion in the form of rills has occurred at this location (PL-19).

*PL-19. East Channel Cutoff Wall*

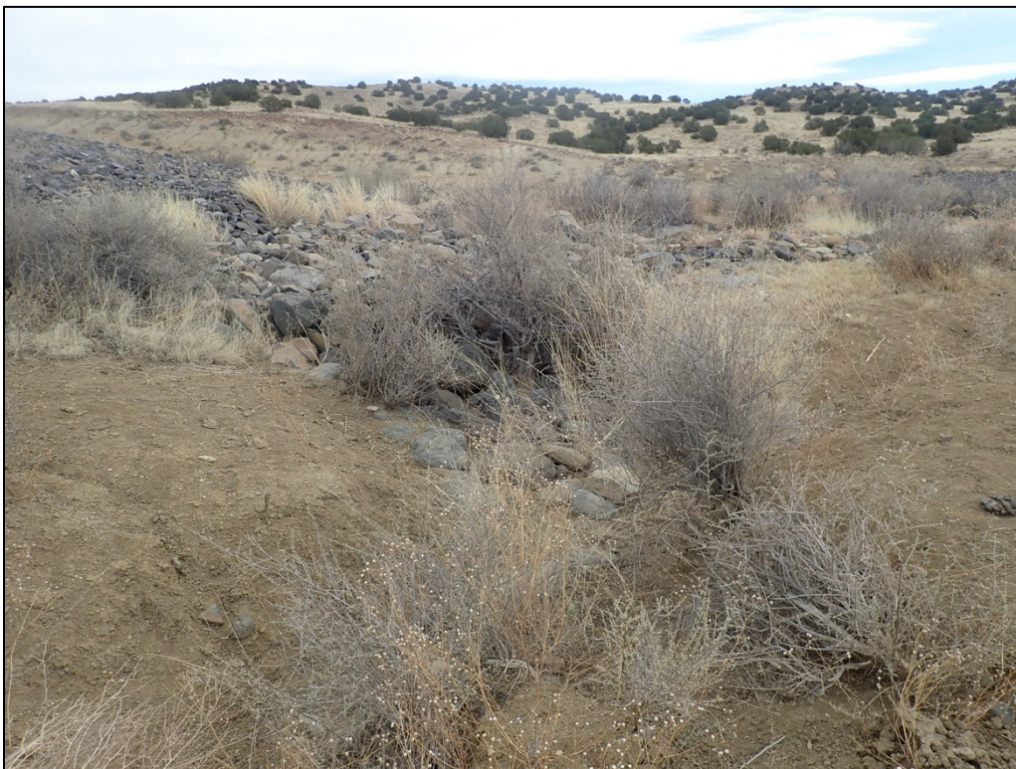
slope (south bank) to inhibit erosion along natural drainage swales. Erosion is occurring on the unprotected slope surfaces, resulting in sediment accumulation in the south channel. The erosion and sediment deposition are not impairing the function of the south channel. Erosion headcutting that has migrated to the edge of the riprap cutoff wall at the outlet of the channel was monitored during the inspection. The cutoff wall is functioning as designed and will continue to be monitored (PL-20).

*PL-20. Rilling Contacting South Channel Cutoff Wall*
