1.0 Bluewater, New Mexico, Disposal Site

1.1 Compliance Summary

The Bluewater, New Mexico, Uranium Mill Tailings Radiation Control Act (UMTRCA) Title II Disposal Site was inspected on March 7 and March 8, 2023. Minor depressions on the side slopes of the main tailings disposal cell continue to be observed. Depressions continue to be observed on the north portion of the top slope of the main tailings disposal cell. A new potential depression was identified on the southeastern top slope of the main tailings disposal cell. Inspectors identified several routine maintenance needs but found no cause for a follow-up or contingency inspection.

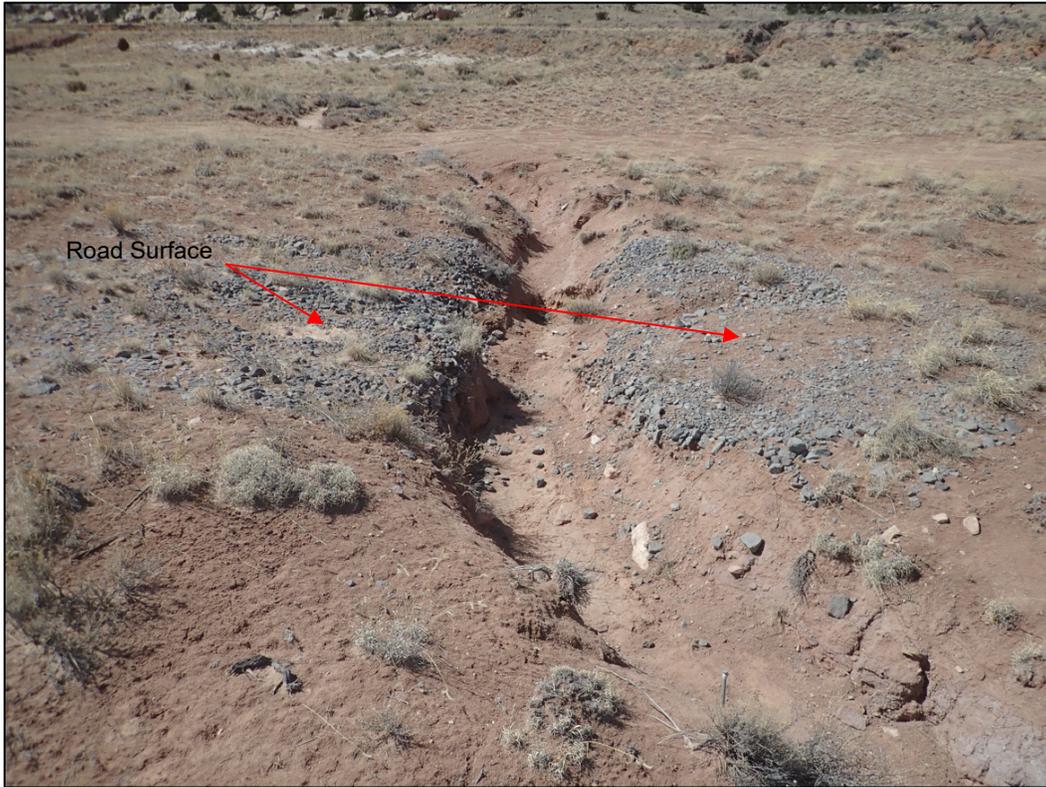
Interior roads used to access LM assets consist of a dirt track covered at places with crushed basalt. The roads are susceptible to erosion and are repaired when they become impassable. Erosion on the road northwest of the main tailings disposal cell continues to be an issue (PL-1). In 2017, riprap was added to repair a gully intersecting this section of the road. Additional erosion was noted along the road parallel to the northern perimeter of the site. Thirteen road repair areas were identified around the site perimeter road. LM is planning to repair the roads in spring 2024 through the interagency agreement with the U.S. Army Corps of Engineers (USACE). Minor areas of erosion on the site road along the west side of the site were identified during the 2023 inspection. These minor areas were top dressed with gravel to prevent further erosion during routine maintenance work in 2023. No other maintenance needs were identified.

PL-1. Erosion of Site Road Along Northwestern Corner

- Repair the loose T-post near monitoring well I(SG) and boundary monument BM-12
- Treat the noxious weeds
- Minor interior road repair was completed by LMS contractor staff in both April and August 2023

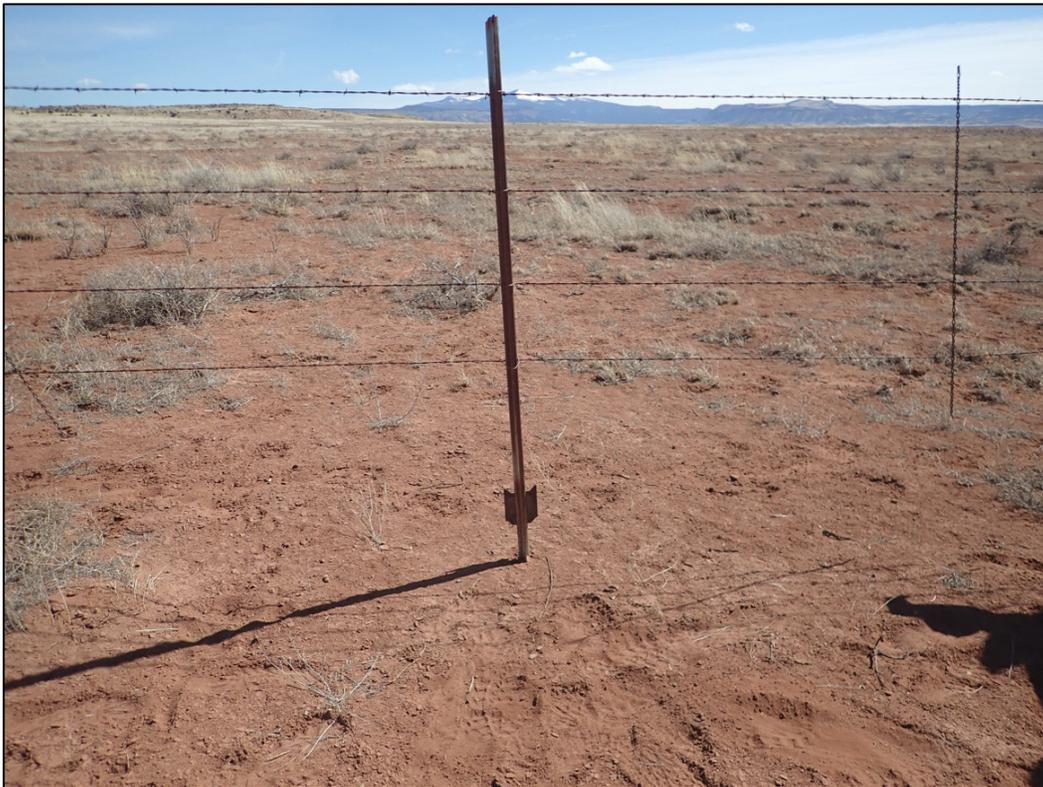
A four-strand barbed-wire fence encloses the site to facilitate land management by LM, which retains a local subcontractor to periodically check the site perimeter fence and remove trespassing cattle. Numerous sections of the fence are in remote areas of the site and cannot be observed from site access roads. Inspectors identified hanging or loose T-posts along the eastern fence near monitoring well I(SG) and boundary monument BM-12 (PL-2, PL-3), and windblown sediment was observed burying the lower strands of wire near perimeter sign P6. All were repaired post inspection during the week of April 10, 2023. A broken hinge was observed on a right-of-way gate near perimeter sign P3. Maintenance staff contacted employees from the Tri-State utility company while onsite. Tri-State said they intended to repair the gate. Inspectors observed the gullies, identified in the 2019 inspection, parallel to the perimeter fence northwest of the main tailings disposal cell. No significant changes were observed. LM will continue to monitor this area for damage to the perimeter fence.

PL-2. Wind Erosion on Eastern Fence Line (Hanging T-Post)

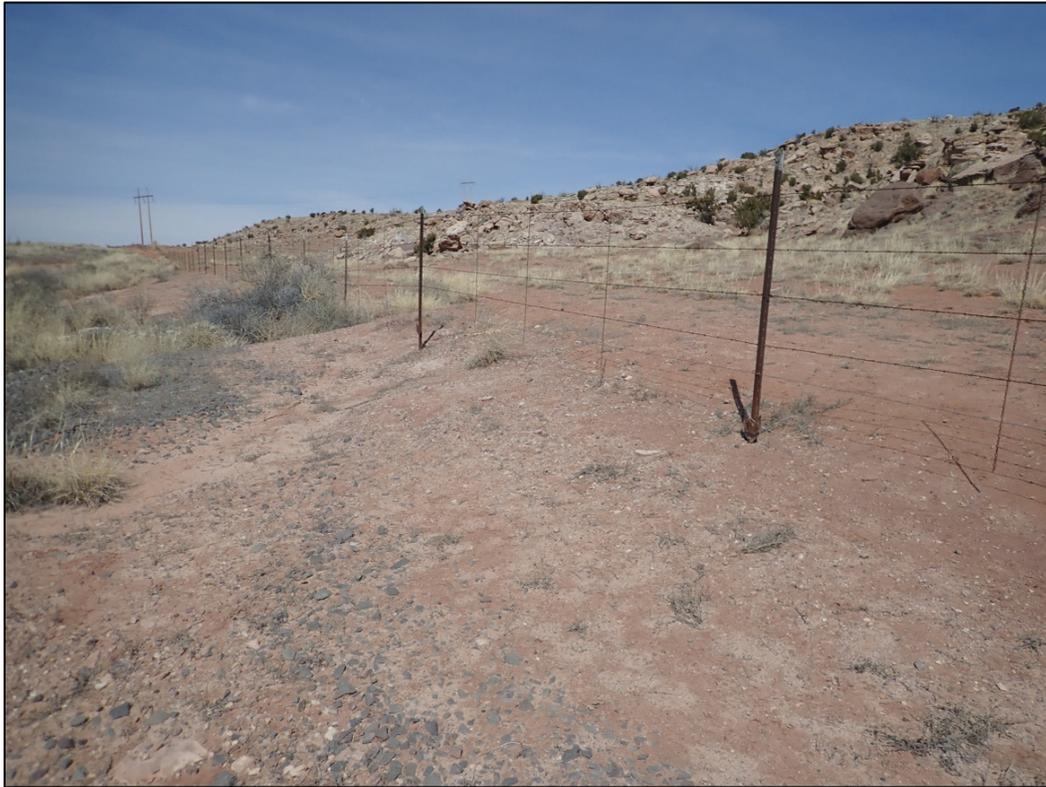
PL-3. Hanging T-Posts Between Boundary Monuments BM-12 and BM-11

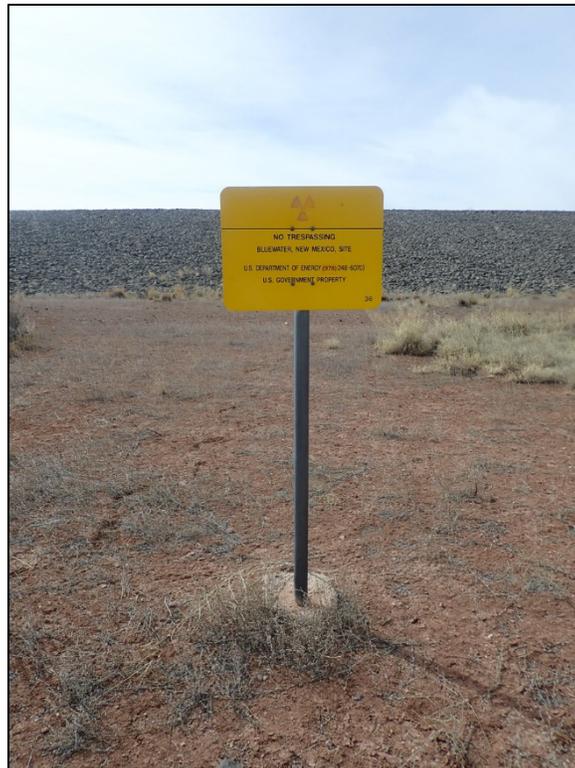
PL-4. Perimeter Sign P36

Fifty-five perimeter signs (warning and no-trespassing signs) are mounted on steel posts along the site boundary and around the main and carbonate tailings disposal cells (PL-4). Perimeter sign P10 has bullet hole damage but is legible. Perimeter sign P16 has a loose base but remains functional. No other maintenance needs were identified.

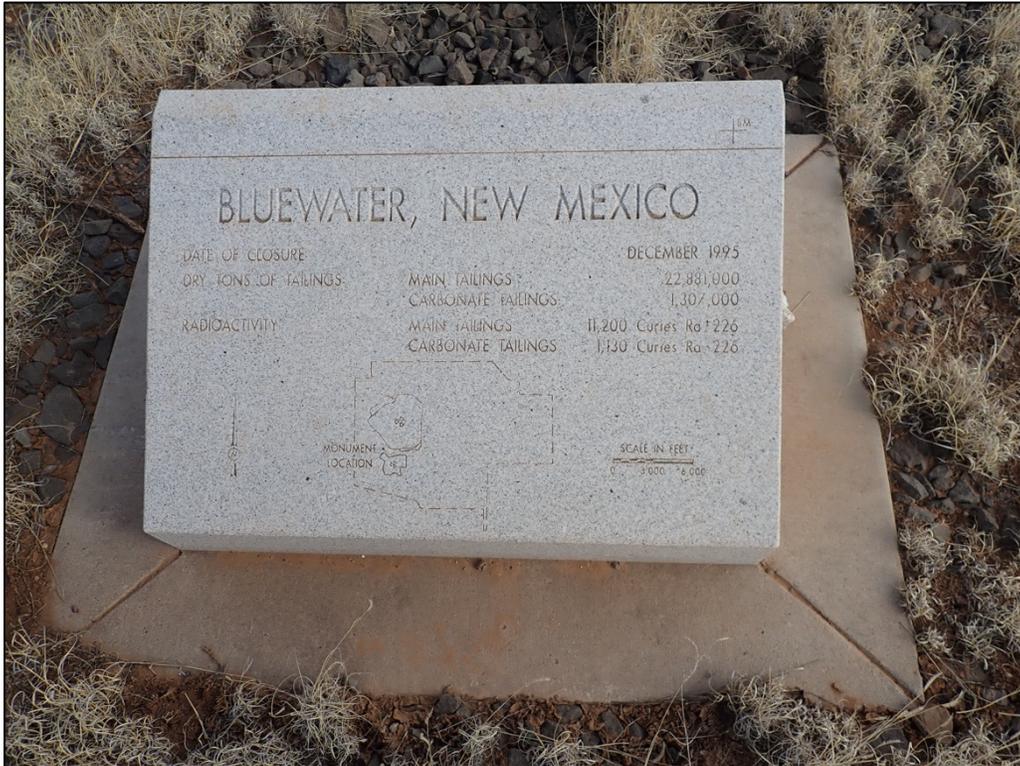
PL-5. Site Marker

The site has one granite site marker between the southwest corner of the main tailings disposal cell and the northwest corner of the carbonate tailings disposal cell (PL-5). No maintenance needs were identified.

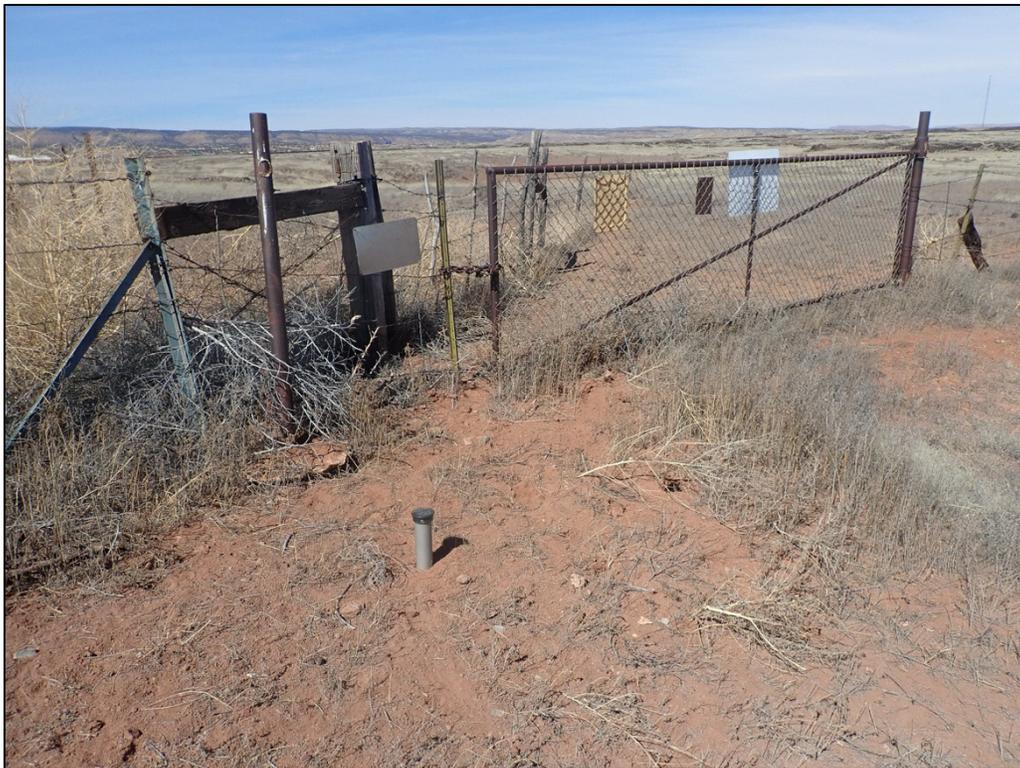
PL-6. Boundary Monument BM-2

Twenty-four boundary monuments define the site boundary (PL-6). These monuments are typically inside the perimeter fence and several feet inside the true corner or boundary line. Some monuments become covered by drifting sand, and metal T-posts have been driven at those locations to help locate them. Other boundary monuments are in remote sections of the site and cannot be observed from site access roads. All boundary monuments were inspected during the 2023 inspection except for boundary monument BM-7. Boundary monument BM-7 will be observed during the next inspection. Some erosion was observed at the base of boundary monument BM-13, but it is stable. No maintenance needs were identified.

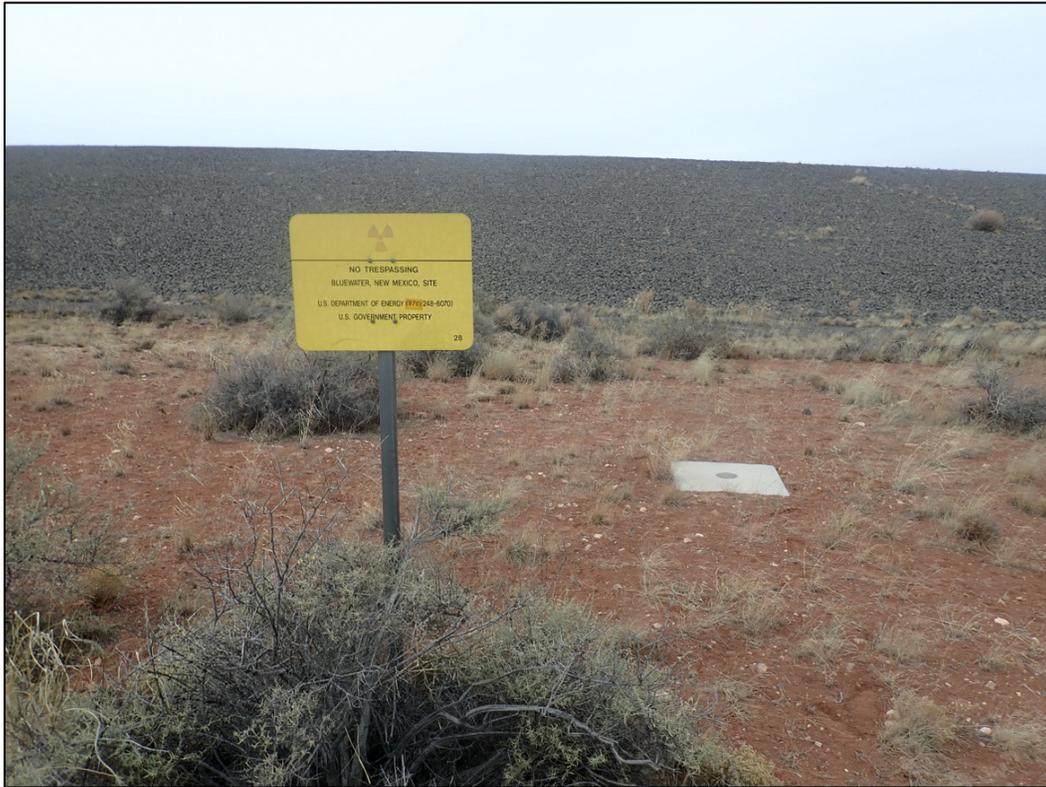
PL-7. Perimeter Sign P28 and Quality Control Monument QC-1

Thirteen aerial survey quality control monuments were installed in 2019, and an aerial survey was conducted by USACE in 2021. The aerial survey quality control monuments were inspected during the 2023 annual inspection (PL-7). No maintenance needs were identified.

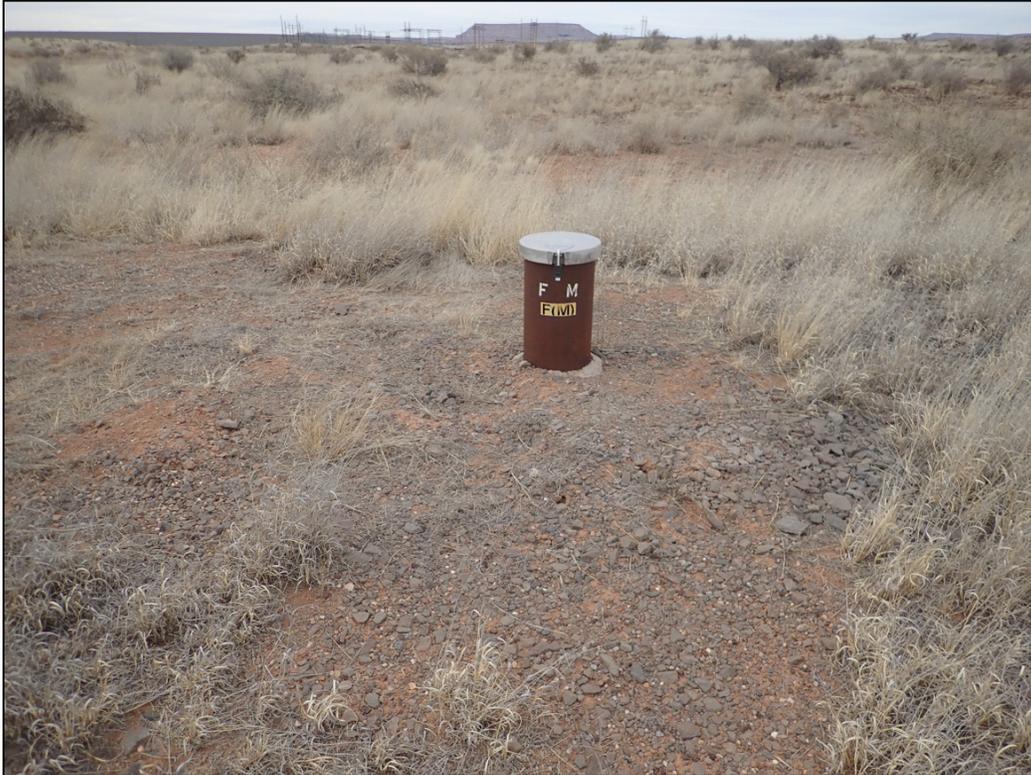
PL-9. Abandoned Animal Burrows near Monitoring Well F(M)

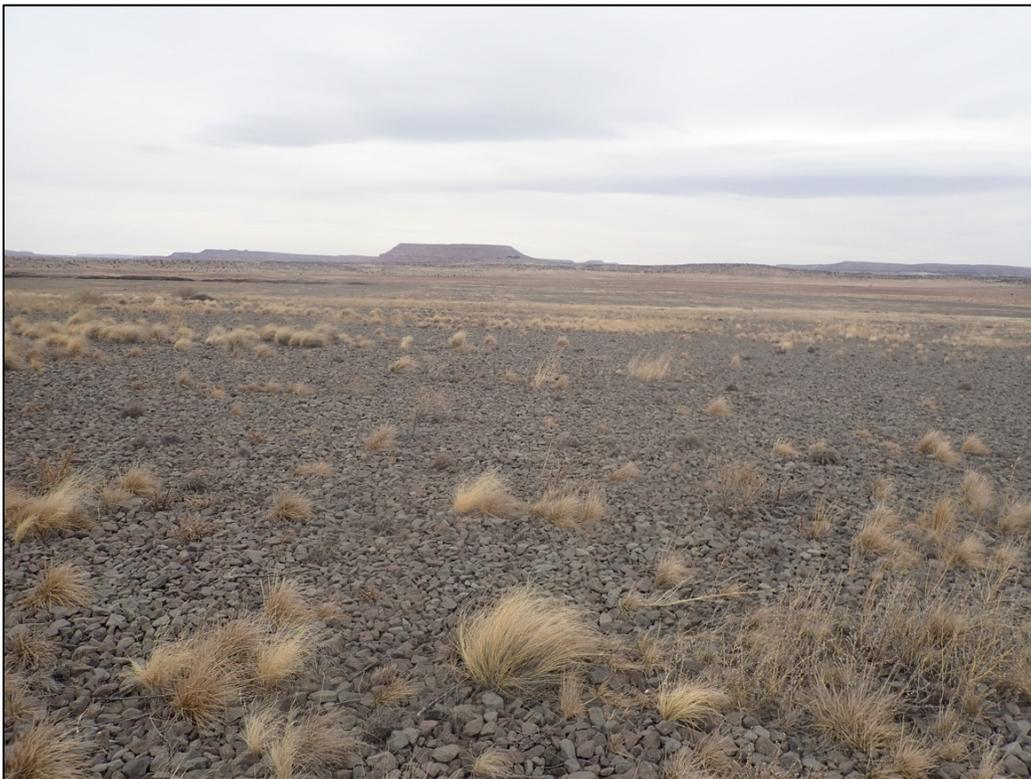
Plant encroachment (by annual weeds, perennial grasses, forbs, and scattered perennial shrubs) continues on the main tailings disposal cell top and side slopes (PL-10). Siberian elm saplings on the top slope are periodically treated with herbicide to prevent the establishment of trees that could damage the main tailings disposal cell cover materials. No live elms were observed during the inspection.

PL-10. Main Tailings Disposal Cell Top Slope Vegetation

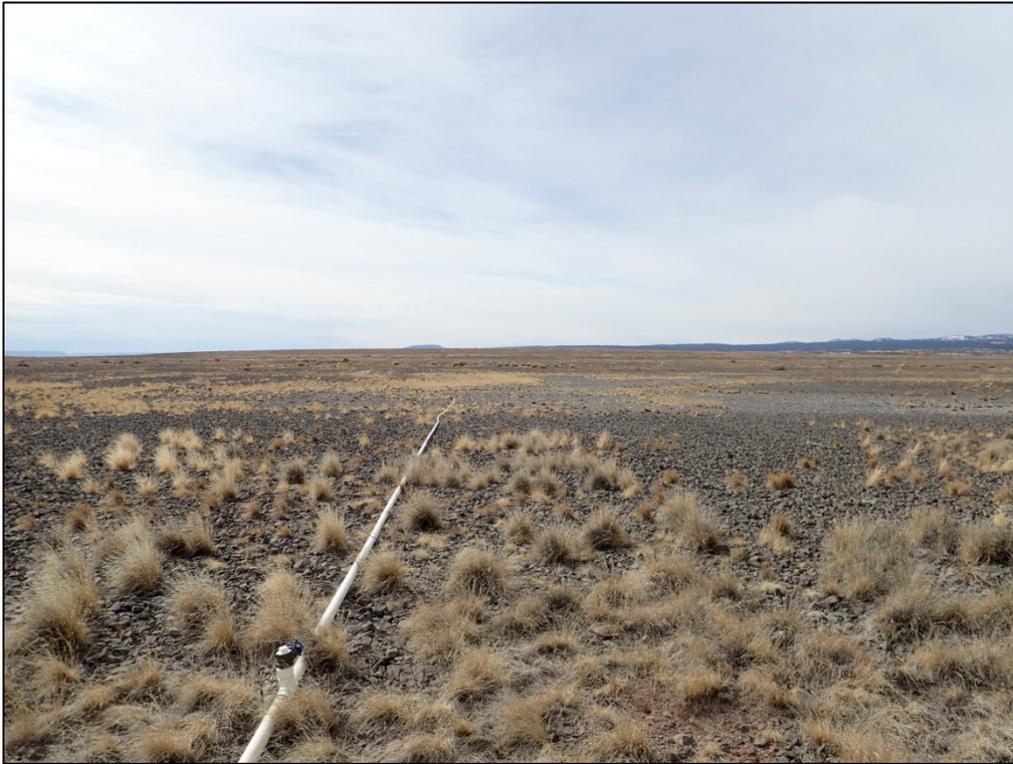
A 2-inch-diameter siphon was installed in fall 2015 to dewater as much of the ponded water as possible (PL-11). The siphon is manually started when the webcam indicates that a large pond has developed. The intent is to avoid potential erosion of the main tailings disposal cell cover materials if the pond surface reaches an elevation high enough to spill over the north side slope. Water would start to spill over at the lowest point along the north edge of the top slope, which could initiate erosion in that area. LM entered into an interagency agreement with USACE in October 2019 to design a repair to the depressions and ensure continued positive drainage from the main tailings disposal cell. In October 2023, USACE completed a geotechnical investigation on the top slope of the disposal cell to collect data on the condition of the cell cover and underlying material; results pending. NRC will be involved in reviewing designs as they are developed and will concur upon the final design before construction.

PL-11. Overview of Siphon and Vegetation on Disposal Cell Top Slope

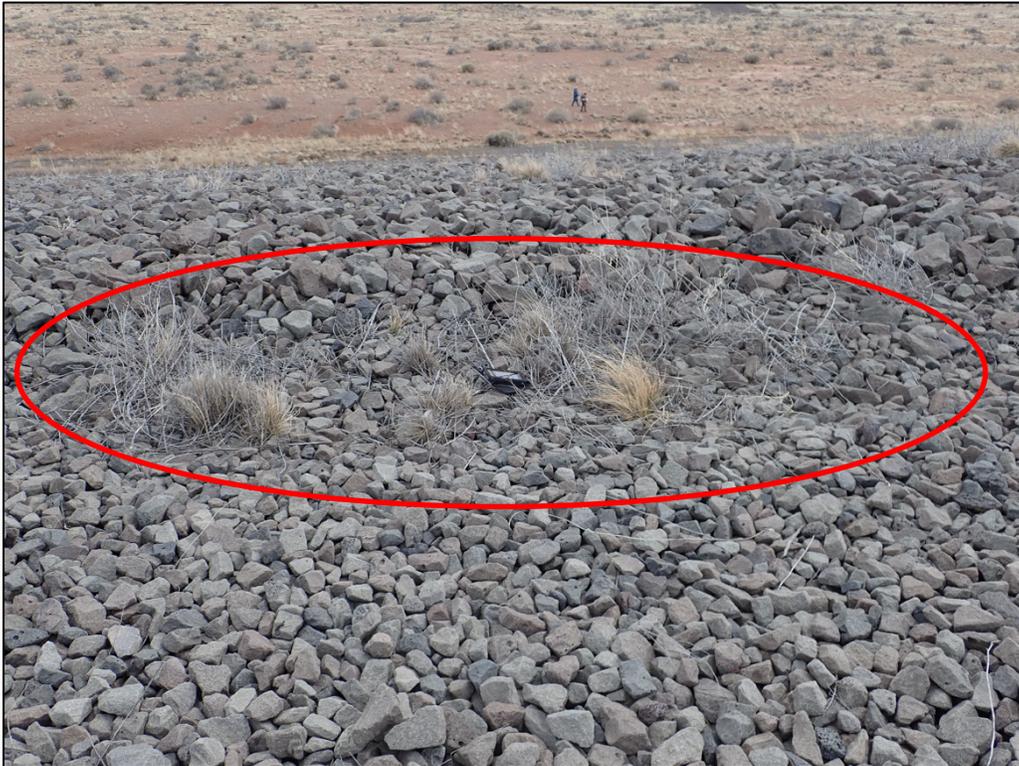
The side slopes and toe of the main tailings disposal cell were inspected for signs of erosion or sediment deposition. An area of potential depression was identified during the 2023 inspection on the southeastern portion of the top slope that is approximately 8 ft long and 3 ft wide (PL-13). A potential depression feature on the western side of the south side slope was first observed during the 2022 inspection. This was observed again in 2023 and measured approximately 15 ft long and 30 ft wide (PL-14). An area of minor depression was observed on the south side slope during the 2018 annual inspection. It was not identified during the 2021 inspection, observed again during the 2022 inspection, and not observed during the 2023 inspection. This feature is very minor and will be removed from tracking if there are no observed changes in 2024. Another area of minor depression observed in 2021 on the eastern side of the south side slope was not observed during the 2022 inspection. During 2023, inspectors believe they located this minor depression once again. Inspectors concluded there may have been a field documentation error in the location of this feature in 2021. Waypoint polygon data were collected on this feature to confirm its location. This depression was observed to be approximately 20 ft long, 10 ft wide, and 10 to 12 inches deep (PL-15, PL-16). An area of potential depression was observed on the north side slope during the 2020 annual inspection. Inspectors observed the area during the 2023 inspection, but no apparent changes were noted. The side slopes will continue to be observed for depressions. All identified depressions will continue to be monitored and will be evaluated using lidar.

PL-13. Potential Depression Area on Top Slope at Top Slope/Side Slope Boundary

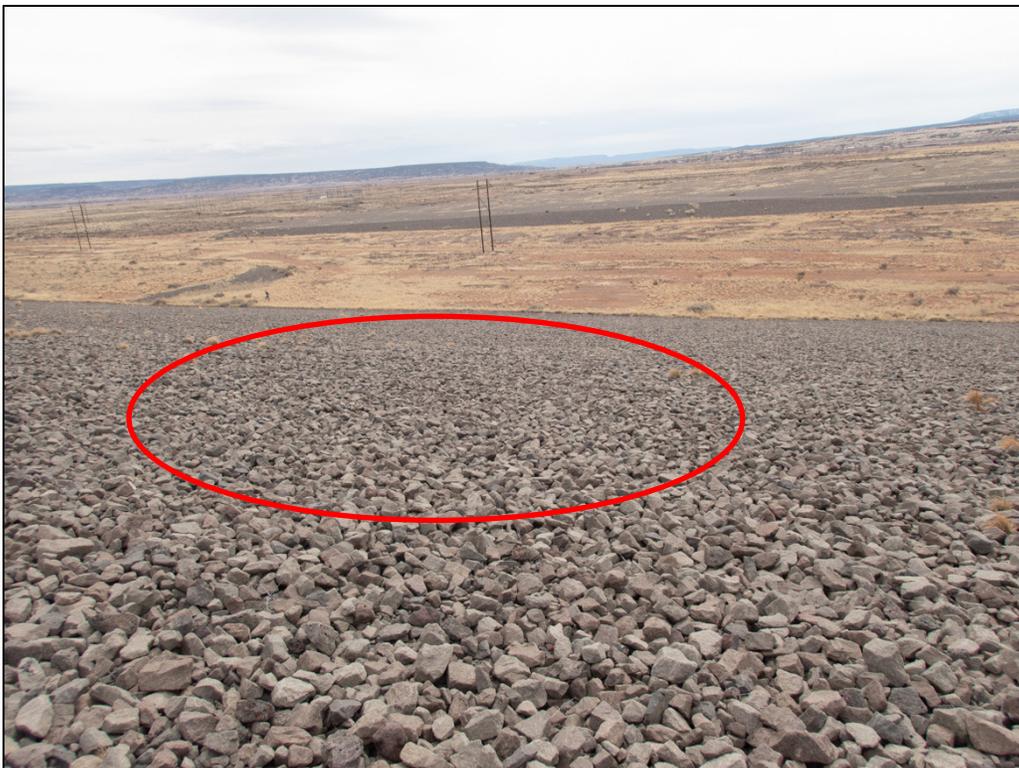
PL-14. Potential Depression Area on Main Tailings Disposal Cell Southwest Side Slope

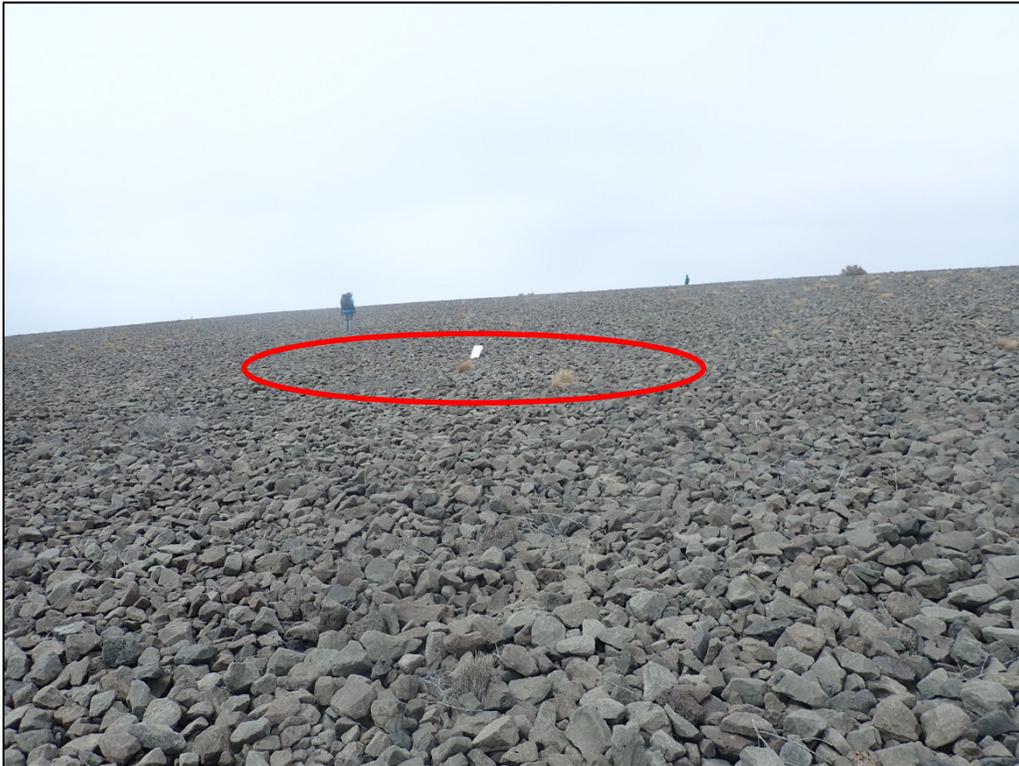
PL-15. Minor Depression on Main Tailings Disposal Cell South Side Slope

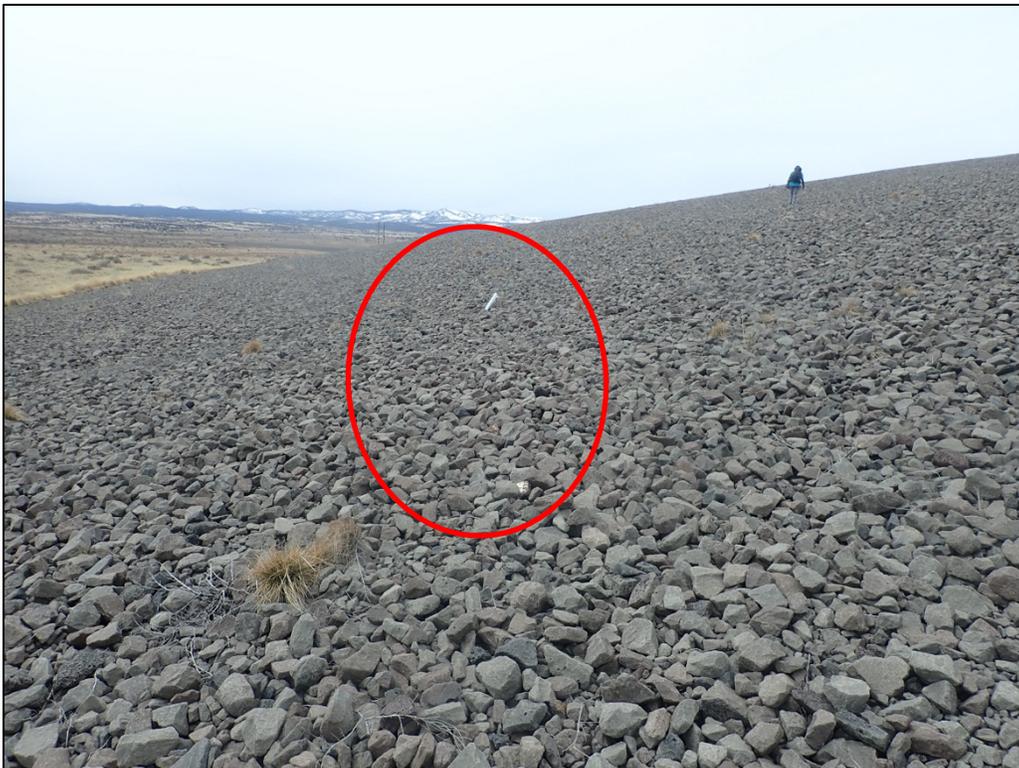
PL-16. Minor Depression on Main Tailings Disposal Cell South Side Slope

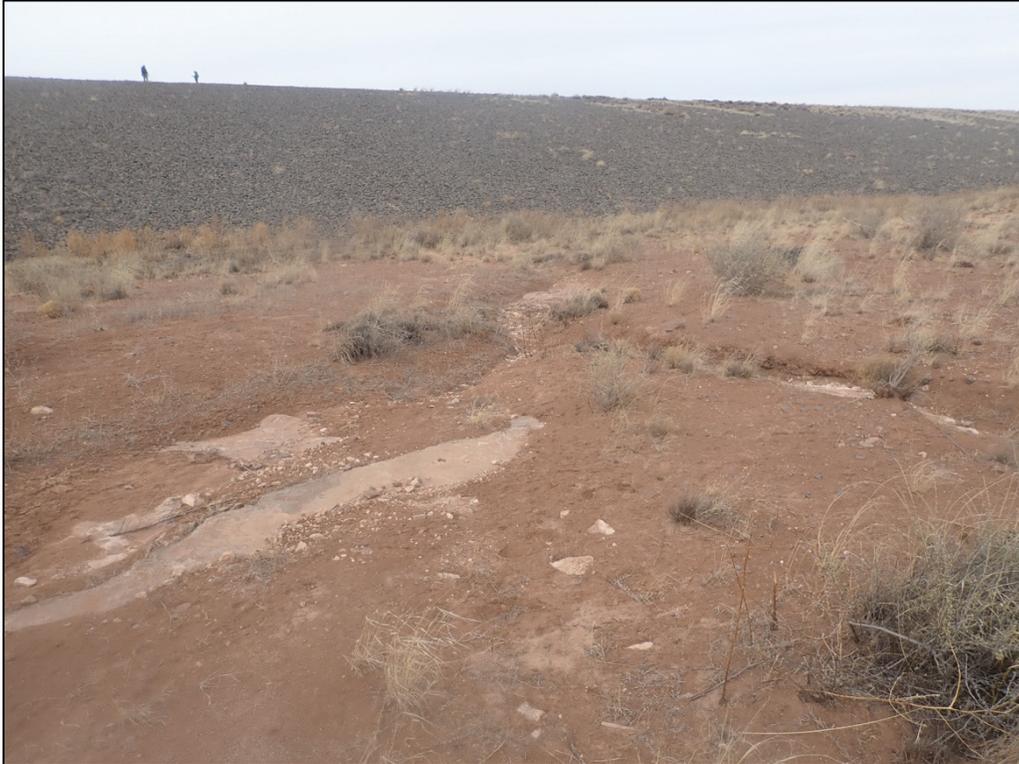
During the 2019 annual inspection, minor rills with a maximum depth of 6 inches were observed at the base of the east side slope and minor rills with a maximum depth of 8 inches were observed at the base of the south bench of the main tailings disposal. The rills did not appear to increase in depth or extent (PL-17, PL-18). During the 2020 annual inspection, a linear desiccation crack was observed along the base of the east side slope. During the 2023 inspection, inspectors observed that the linear crack had filled in with sediment; this item will be removed from the inspection drawing and not monitored in the next inspection. LM will continue to monitor the rills for potential impact to the main tailings disposal cell and south bench area. Animal burrows identified on the top of the south bench disposal area in 2022 appear to have been abandoned and filled with sediment. These burrows will not be monitored in the next inspection. New animal burrows were observed on the top slope of the acid tailings disposal area (PL-19). No sediment deposits were present along the toe. No maintenance needs for the side slopes, acid tailings, or south bench disposal areas were identified.

PL-17. Rilling Between Perimeter Signs P31 and P30

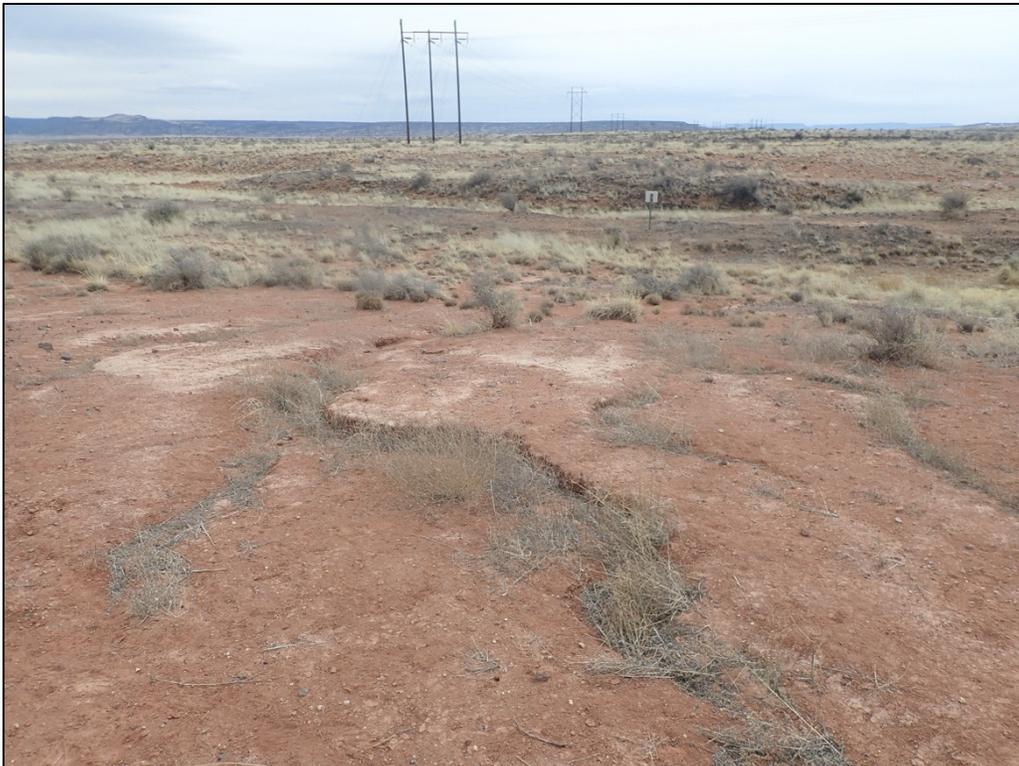
PL-18. Rilling near Perimeter Sign P24

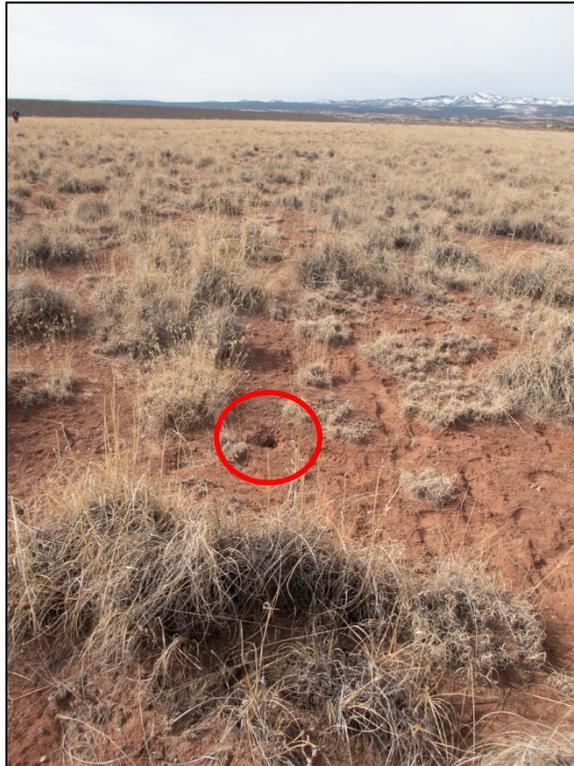
PL-19. Animal Burrow on Acid Tailings Disposal Area

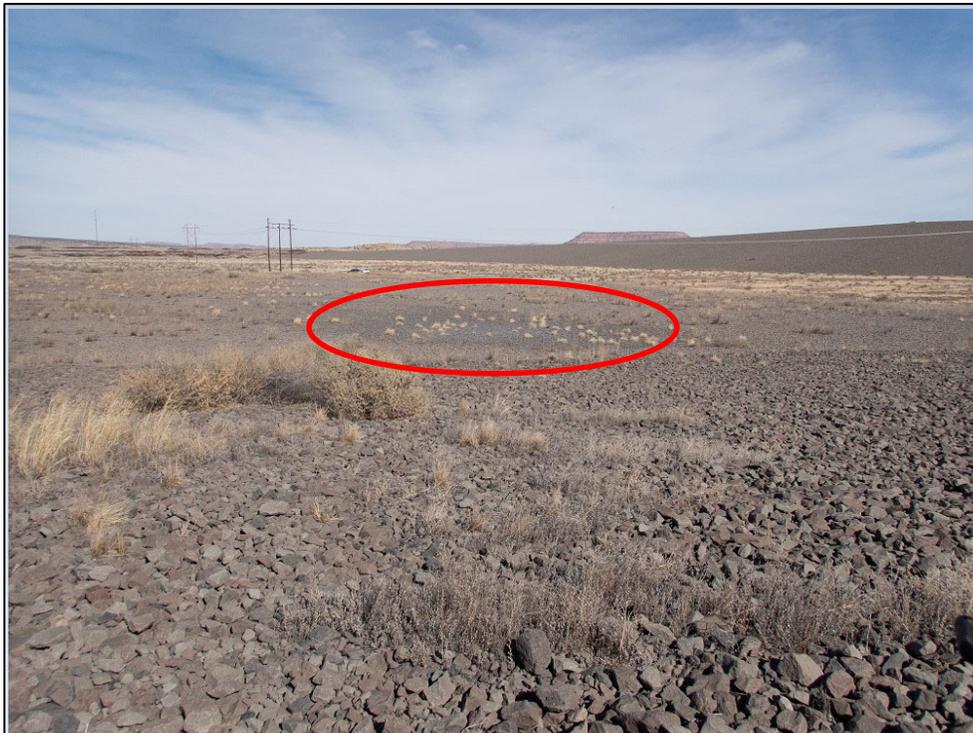
The 54-acre carbonate tailings disposal cell is south of the main tailings disposal cell. Basalt riprap covers the top and side slopes of the carbonate tailings disposal cell. The top generally slopes gently eastward. The carbonate tailings disposal cell includes extensions to the northwest and southeast. A shallow depression exists on the northwest extension, and stormwater runoff occasionally ponds at this location; the depression was dry during the 2023 inspection (PL-20). This depression does not appear to be enlarging but will continue to be visually inspected and evaluated using periodic lidar survey results. A minor depression was observed on the south-central top slope of the carbonate cell (PL-21). Annual weeds, perennial grasses, and scattered woody shrubs were on the carbonate tailings disposal cell and its extensions. Siberian elm saplings are periodically treated with herbicide. No saplings were observed during the inspection. No additional maintenance needs were identified.

PL-20. Shallow Depression on Northwest Extension of Carbonate Tailings

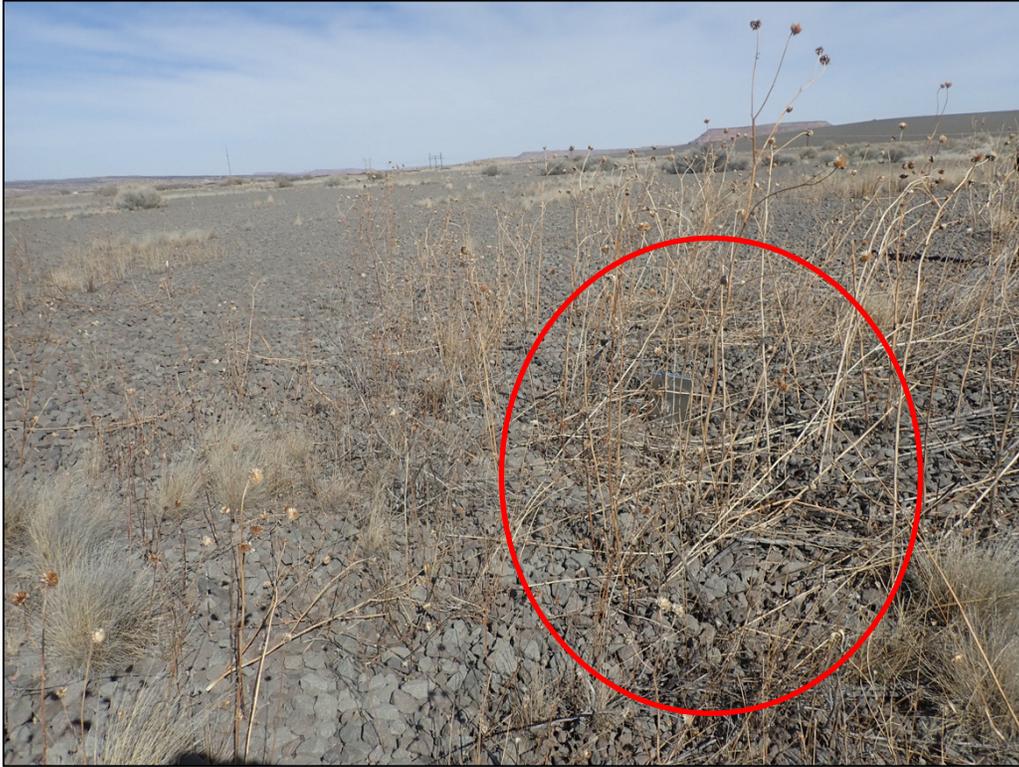
PL-21. Minor Depression with Vegetation Growth on Carbonate Tailings Disposal Cell Top Slope

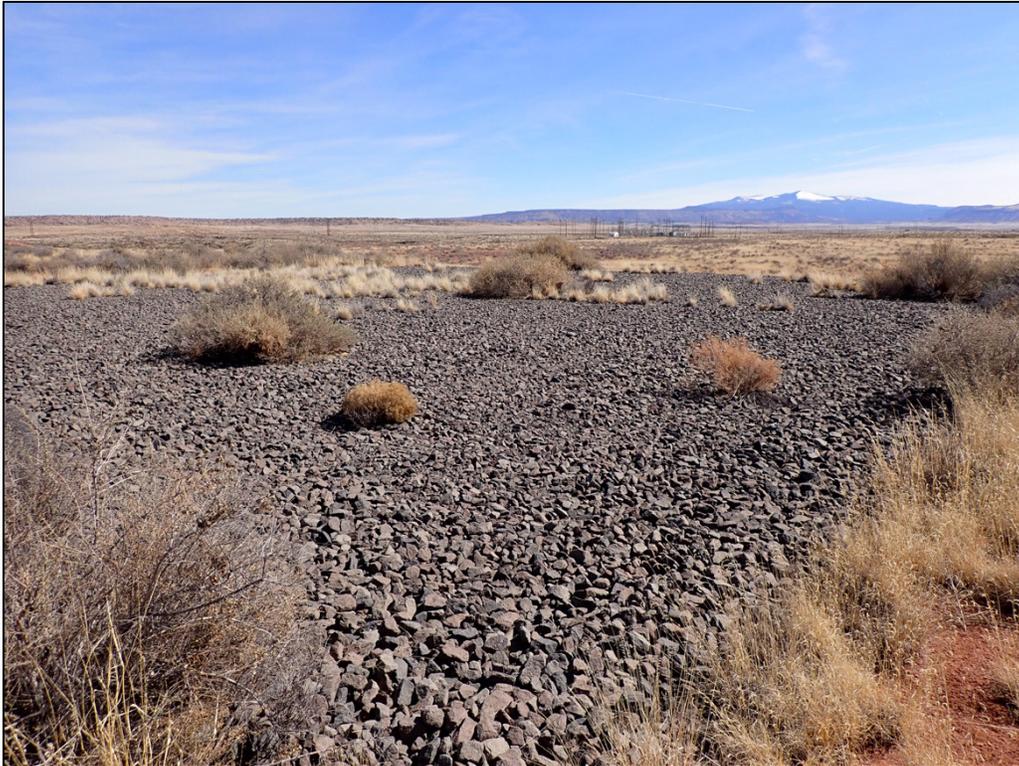
PL-22. PCB Disposal Area Cover

An 11-acre grass-covered disposal area is south of the asbestos disposal area. A small riprap-covered PCB cell (less than 1 acre) is within the disposal area (PL-22). Two grass-covered dumps, totaling approximately 2 acres, are east of the carbonate tailings disposal cell. Inspectors observed a minor erosional area along the basalt along the southern interface of the east dump; it was first identified during the 2019 annual inspection (PL-23). This feature appears to have become larger since the 2022 inspection. The erosional area was measured at approximately 11.3 ft long, 5.1 ft wide, and 4 ft deep. Wooden stakes were placed at the edges of the feature to monitor future growth. Radon gas concentration and radiation dose rate surveys were completed near the erosional area by an LMS radiological control technician. The measurements collected near the erosional area were consistent with background levels. LM will continue to observe the erosional area. No immediate maintenance needs were identified.

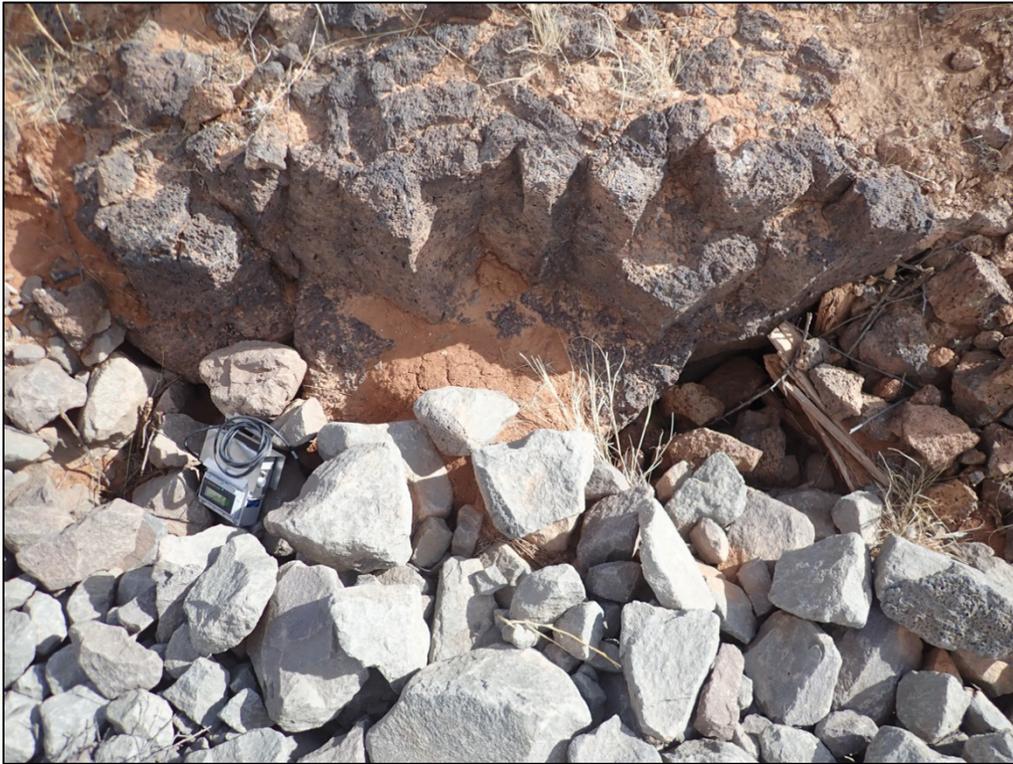
PL-23. East Dump Minor Erosion Area

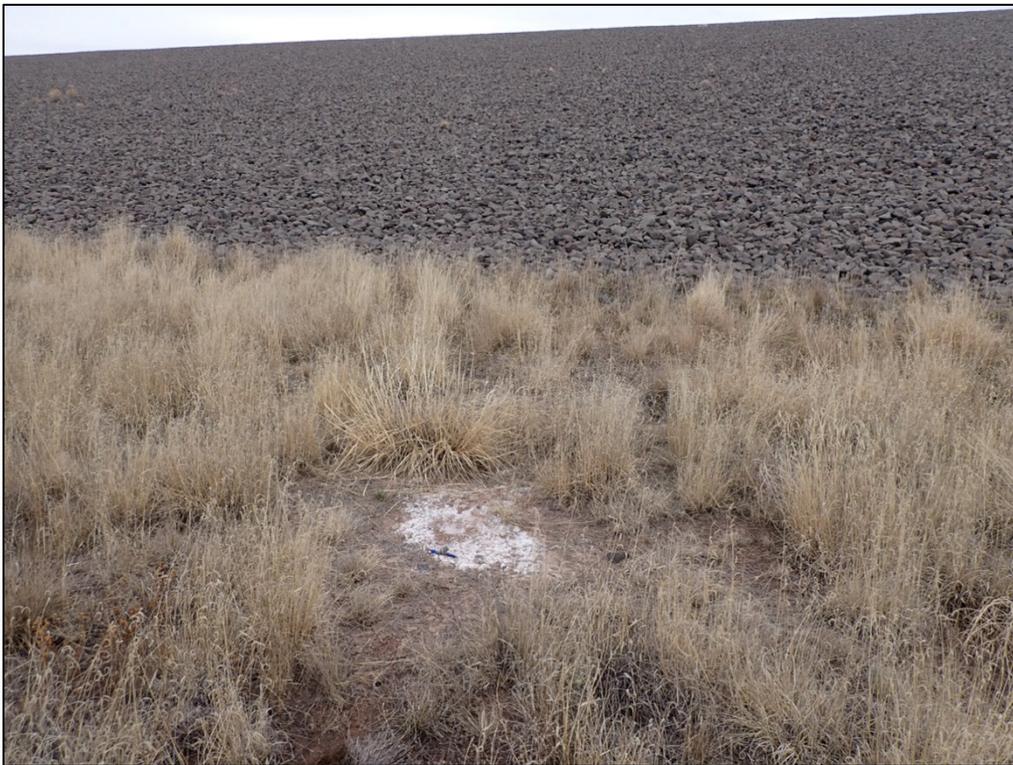
A new ephemeral pond area was observed near the southwest side slope of the main tailings disposal cell near perimeter sign P50 (PL-24). The ephemeral pond was dry when observed. This pond is not currently a concern but will be observed at least 1 additional year.

PL-24. Dry Ephemeral Pond
