2.0 Edgemont, South Dakota, Disposal Site

Figure 2-1. 2023 Annual Inspection Drawing for the Edgemont, South Dakota, Disposal Site

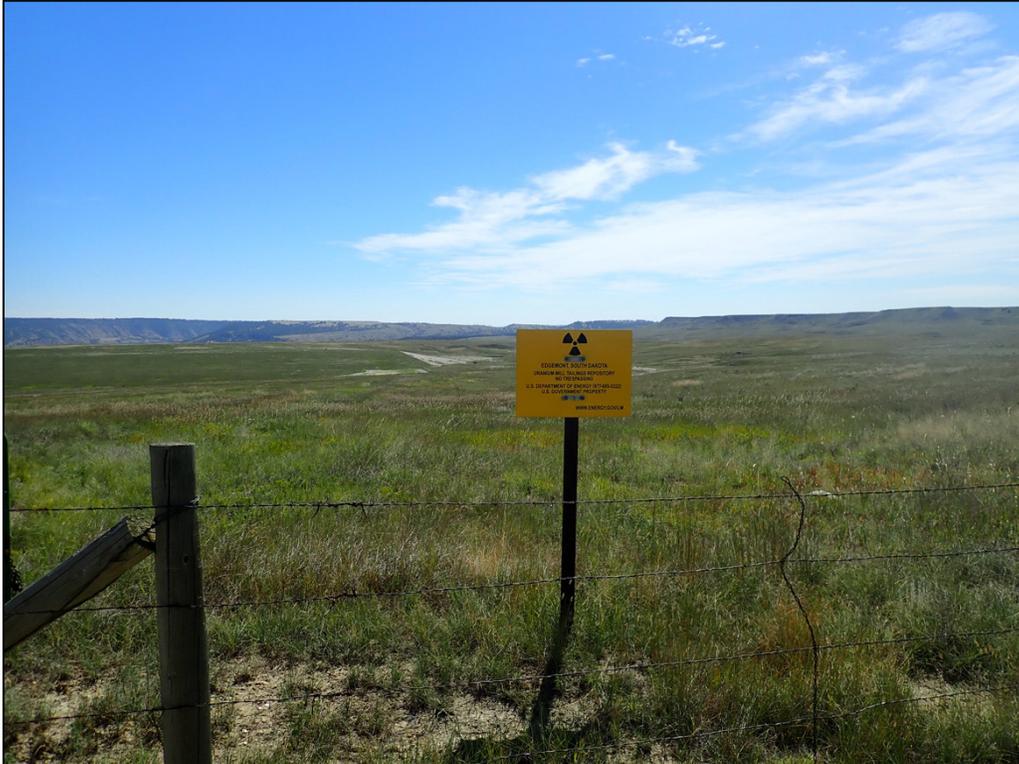
PL-1. Entrance Sign

Access to the site is from Fall River County Road 6N. The entrance sign, which is mounted on a steel post set in concrete, was in good condition (PL-1). The tubular metal entrance gate was secured by a locked chain and was intact. The perimeter fence features three additional wire gates at the following locations: (1) the northwest corner of the property, (2) approximately 700 feet north of the southeast corner (PL-2), and (3) the southeast corner of the site. All gates were closed, locked, and intact. No maintenance needs were identified.

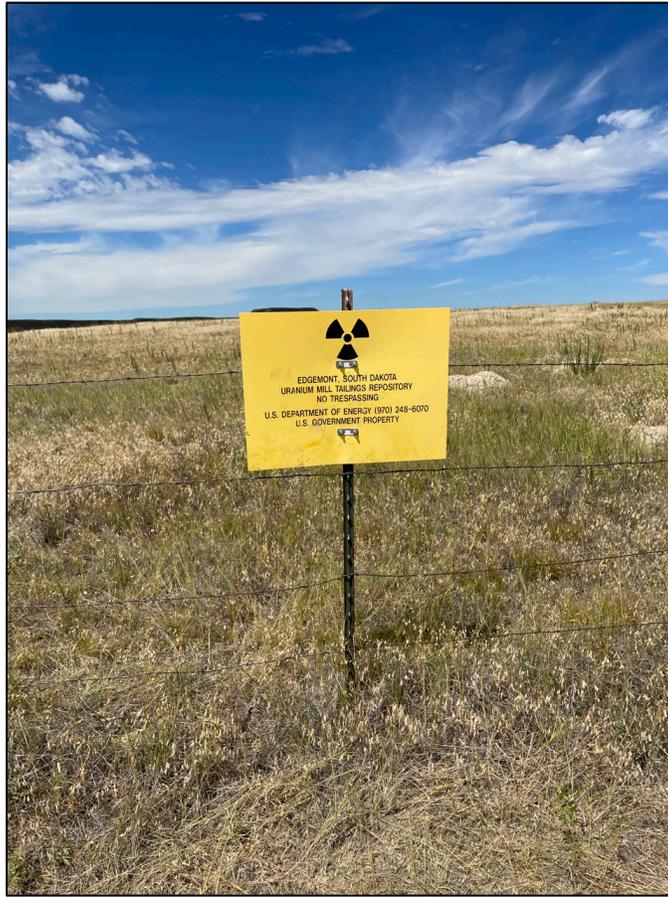
PL-3. Perimeter Sign P2

A four-strand barbed-wire fence encloses the site, truncating at the southeast corner to allow livestock access to a preexisting stock pond. There are two perimeter signs. Perimeter sign P1 attached at the northwest corner of the perimeter fence was missing and perimeter sign P2 (PL-3) is attached to the perimeter fence on the east side. By the 2024 inspection, perimeter sign P1 will be reattached to the perimeter fence.

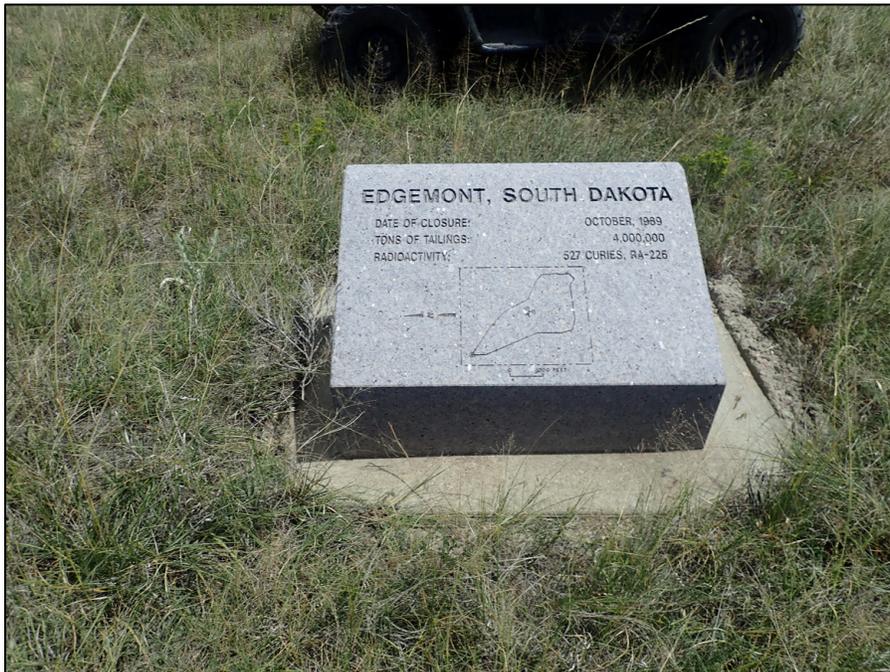
PL-4. Site Marker

The granite site marker is inside the entrance gate (PL-4). No maintenance needs were identified during the inspection.

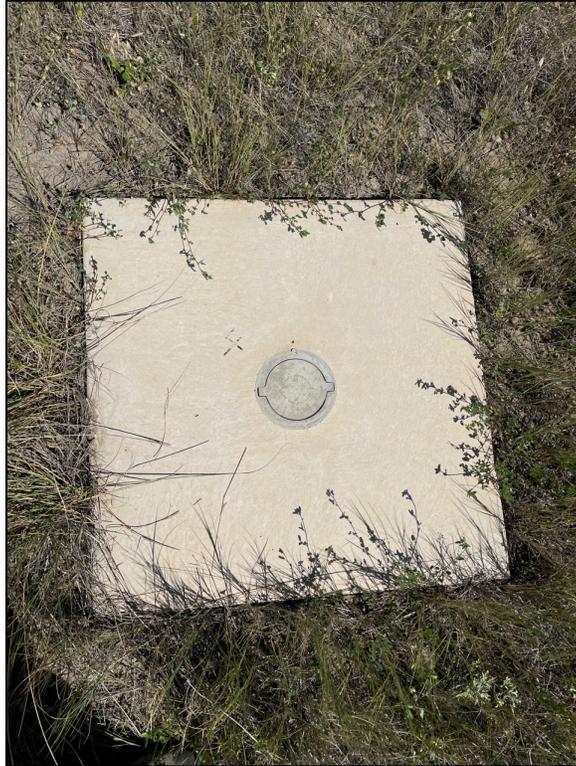
PL-5. Quality Control Monument QC-4

LM installed seven aerial survey quality control monuments in 2019 and conducted a baseline aerial survey in 2021. The quality control monuments were inspected during the 2023 annual inspection (PL-5). No maintenance needs were identified.

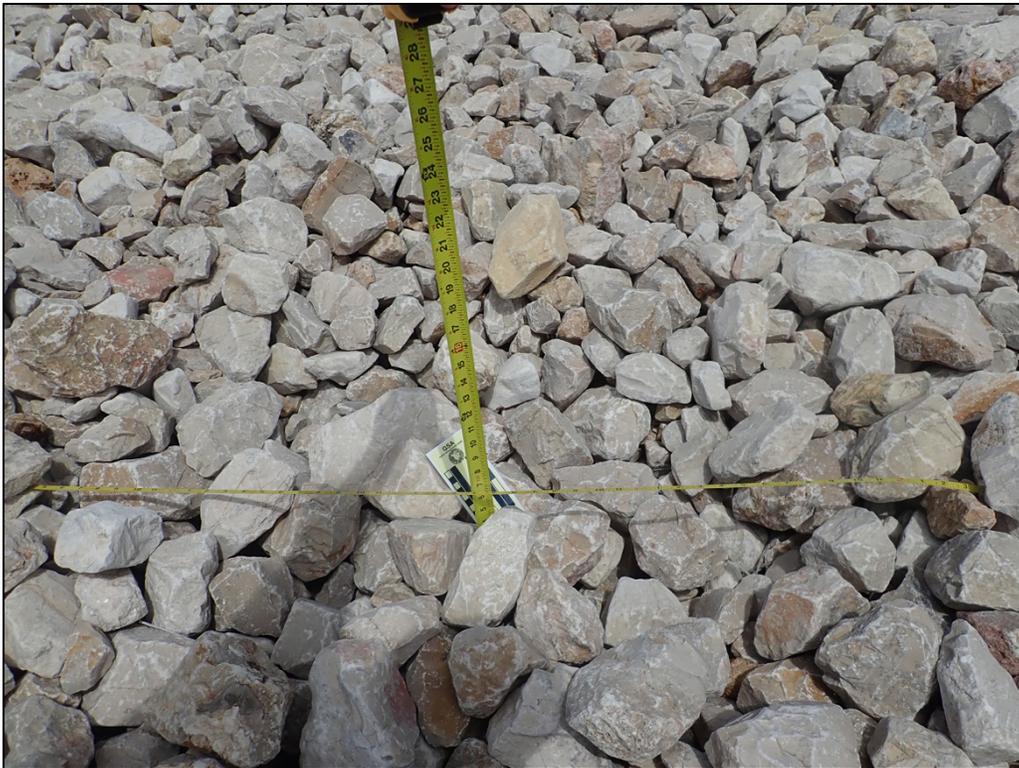
The face of the containment dam is armored with riprap. Two small depressions were observed on the containment dam during the 2021 annual inspection and measured during the 2023 inspection. Small Depression No. 1 measures approximately 25-inches long, 30-inches wide, and 17-inches deep. Small Depression No. 2 (PL-6) measures approximately 48-inches long 37-inches wide, and 9.5-inches deep. No changes to the two depressions were identified since their discovery. A new depression, Small Depression No. 3, was identified during the 2023 inspection and was measured to be about 32-inches long, 24-inches wide, and 1-foot deep (PL-7). No evidence of sediment deposition, human intervention, or other modifying processes were observed near these depressions. The three depressions do not threaten the integrity or performance of the disposal cell; however, monitoring of the depressions will continue during annual inspections and subsequent surveys. There was standing water at the toe of the containment dam consistent with the above-average water year. Grasses and annual weeds were growing in the riprap in several places. The presence of plants and standing water do not threaten the stability or function of the containment dam.

PL-6. Small Depression No. 2: Depth Measurement

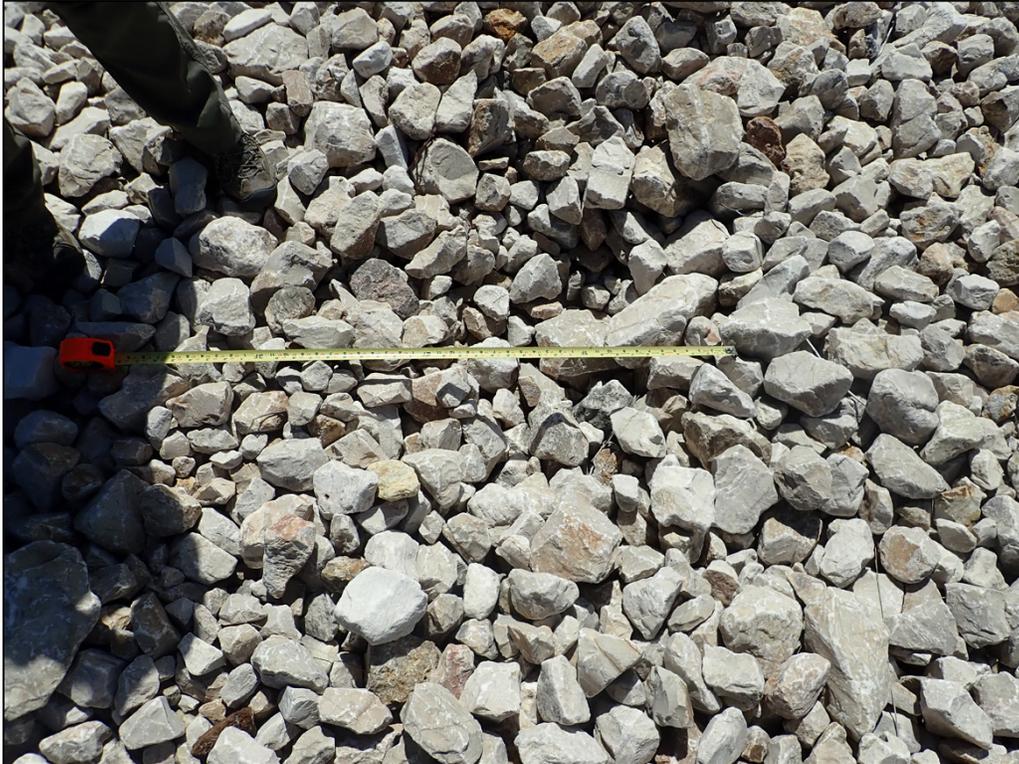
PL-7. Small Depression No. 3: New

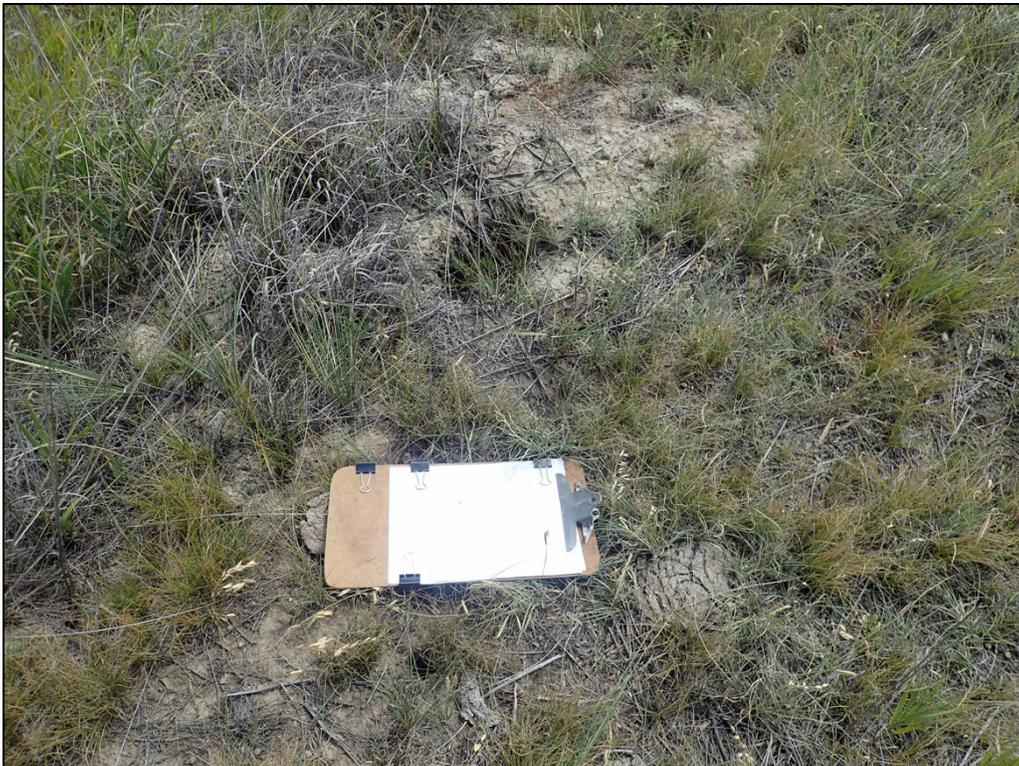
PL-8. Animal Burrow

The balance of the site consists of undisturbed areas covered with native shrubs, grasses, and forbs and formerly disturbed areas covered primarily with seeded grasses and annual weeds. Three animal burrows have been observed on the southwestern side of the drainage channel between the riprap-armored containment dam and the west diversion channel. During the 2023 inspection, the burrows were overgrown with vegetation, indicating use has been minimal or nonexistent. The animal burrows are not impacting the functionality of the disposal cell or drainage features (PL-8). Some minor erosional features are on steep slopes in an area isolated from the disposal cell; these features were stable. No maintenance needs were identified.
