## 4.0 Maybell West, Colorado, Disposal Site

### 4.1 Compliance Summary

Figure 4-1. 2023 Annual Inspection Drawing for the Maybell West, Colorado, Disposal Site

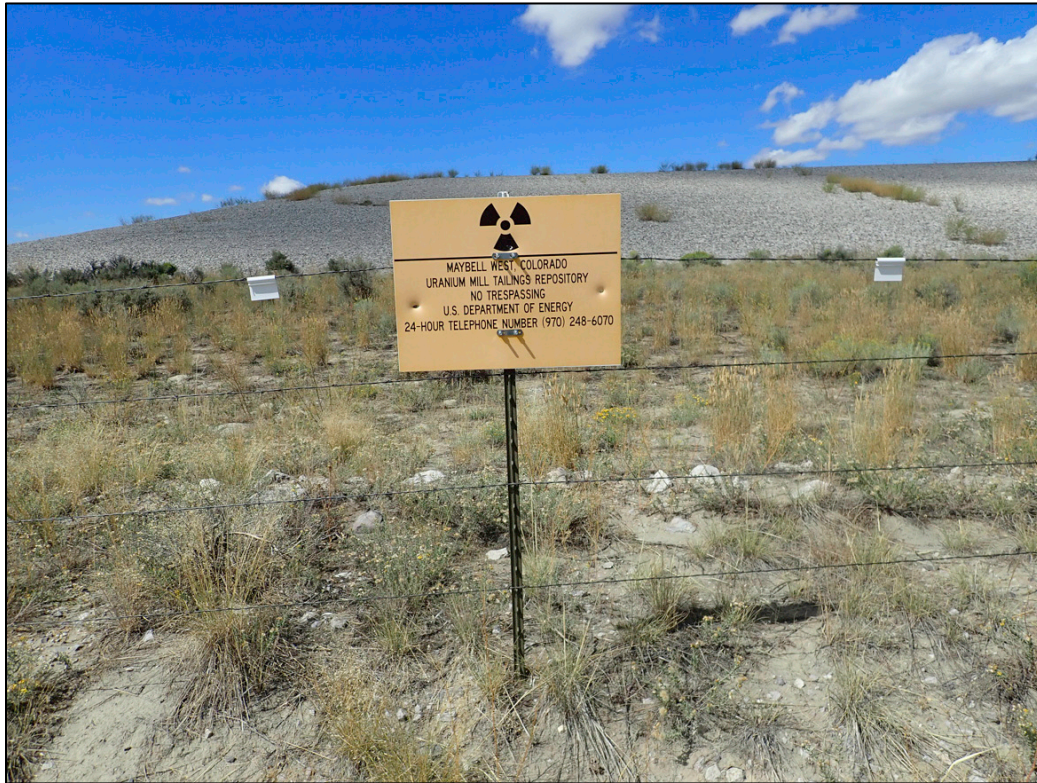
The entrance sign is mounted on a metal T-post directly south of the entrance gate. It was missing during the 2022 inspection. A generic perimeter sign was hung in its place in 2022 and was replaced with the site-specific new entrance sign in 2023. Ten warning or perimeter signs are mounted on metal T-posts around the site (PL-1). Additional warning signs were added to the entrance gate during the 2023 maintenance trip. No other maintenance needs were identified.

*PL-1. Perimeter Sign P1 with Bullet Holes*

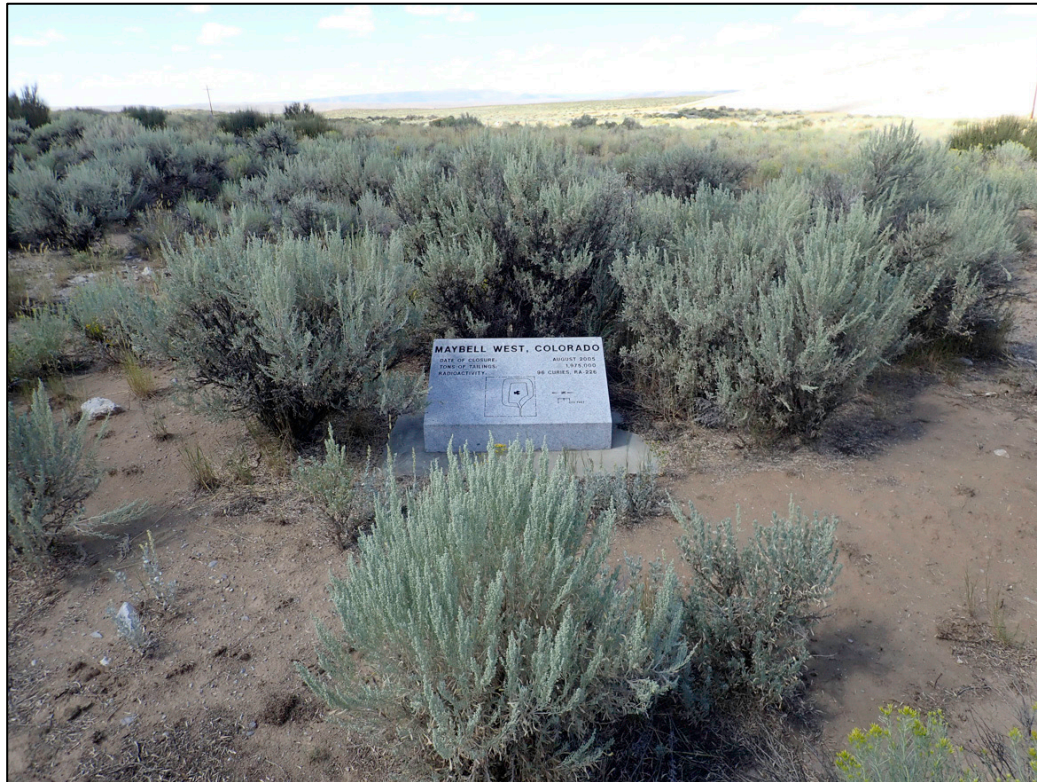
The site has one granite site marker near the entrance gate (PL-2). There is minimal cracking in the cement at the base of the site marker. It does not affect the integrity of the marker. No maintenance needs were identified.

*PL-2. Site Marker*

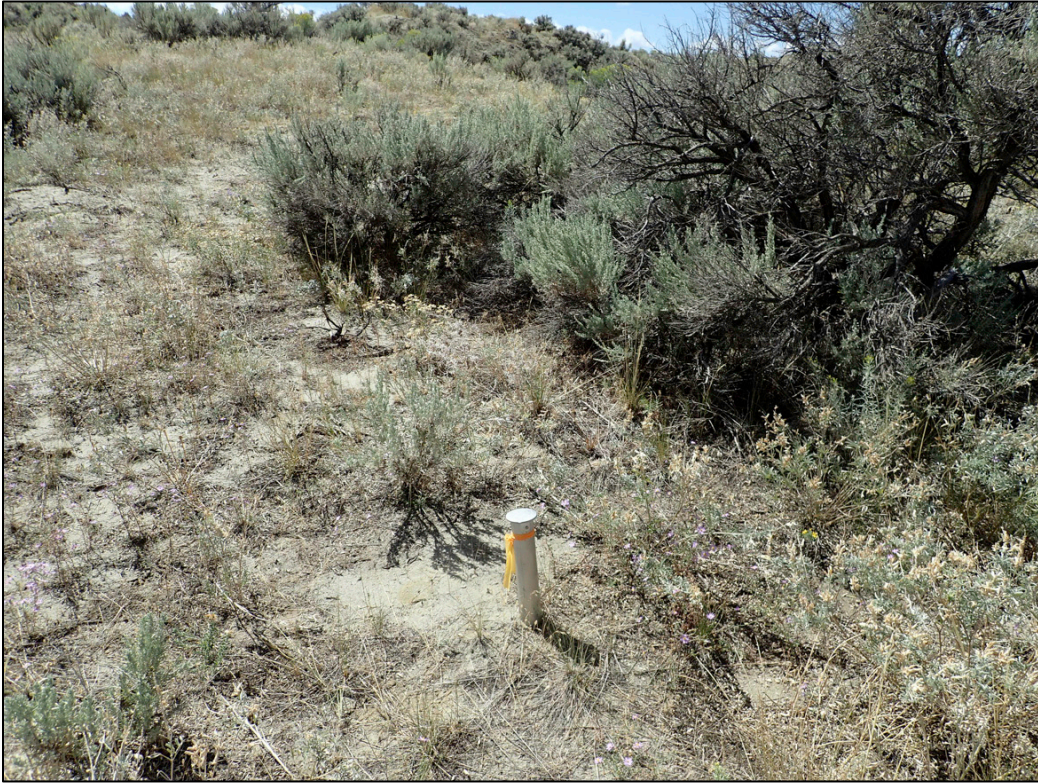
Eight boundary monuments are on the site boundary outside the fenced area (PL-3). Four of the monuments are at the property corners, and the other four define an approximate 20-foot offset along the north and south boundaries where the private land that LM acquired in fee adjoins the BLM withdrawal area on the western portion of the site. Boundary monuments BM-3 and BM-6 (capped pieces of rebar) define the two 20-foot offsets. Boundary monument BM-3 remains bent, but the boundary monument is still in place; attempts to straighten the boundary monument were not successful, and it is missing its cap. Boundary monument BM-2 is missing. It will be surveyed and reinstalled in 2024. No additional maintenance needs were identified.

*PL-3. Boundary Monument BM-1*

Boundary monument BM-3 is damaged and will need to be repaired or replaced but continues to delineate the property. Boundary monument BM-2 is missing and will need to be replaced. A survey team will perform this maintenance in 2024. No other maintenance needs were identified.

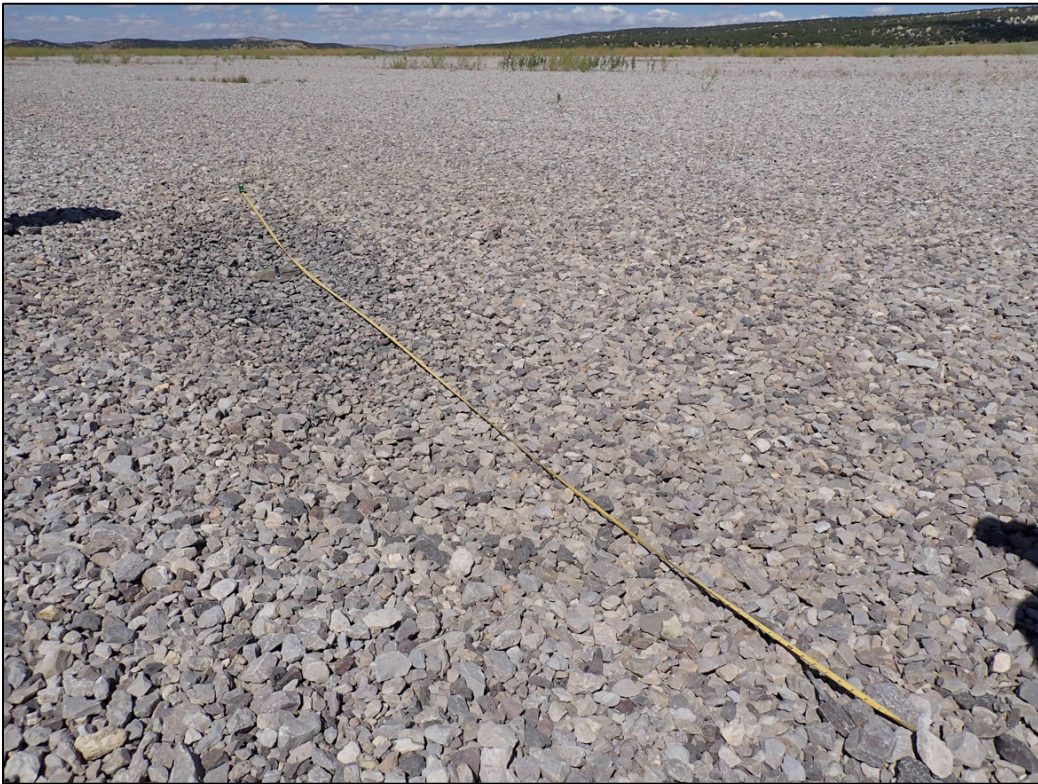
The disposal cell is on the reclaimed site of a former heap leach processing area. The top slope of the riprap-armored disposal cell occupies about 60 acres of the site. The top of the disposal cell showed no signs of significant erosion, settling, or other modifying processes that would affect disposal cell integrity. However, four small, shallow depressions have been observed (just north of Diversion Channel No. 1) since the site transitioned to DOE in 2010. These depressions appear to be the result of settlement of the underlying materials since completion of the disposal cell. Depression No. 1 was discovered during the initial annual inspection in 2010. A second smaller and shallower depression (Depression No. 2) was first noted just west of the first depression during the 2016 annual inspection (PL-4). A third depression (Depression No. 3) was first observed during the 2018 annual inspection (PL-5). A fourth depression (Depression No. 4), east of the previous three depressions, was noted during the 2023 inspection (PL-6). Depression No. 4 does not appear new, but it was not specifically noted during previous inspections. During the 2023 inspection, Depressions Nos. 1–3 appeared to be approximately the same size, as observed during the 2022 annual inspection.

An LMS engineer participated in the inspection to evaluate the depressions on the top of the cell. Depressions No. 1, 3, and 4 are shallow and widespread; these are likely settlement made more evident by accumulating surface water that is infiltrating and forcing additional consolidation as it flushes through the cover and waste profile. This is not a concern from a risk standpoint, and it is anticipated that additional features become more prominent and easier to identify with each inspection. Several minimally visible depression features were noticed while inspectors walked the western half of the cover. These features might become more noticeable over the years. Depression No. 2 is a very localized but deep depression that is concerning due to its depth to relative size. It is recommended to continue monitoring it and to perform localized light detection and ranging (lidar) testing or even standard land surveying of the area.

*PL-4. Shallow Depression No. 2*

All four depressions will continue to be measured during annual inspections to determine if additional, more significant settlement is occurring. Aerial surveys are currently scheduled to be conducted every 5 years to assist in monitoring the depressions. No standing water was observed in any of the depressions during the inspection. These depressions currently do not threaten the integrity or performance of the disposal cell. No maintenance needs were identified.

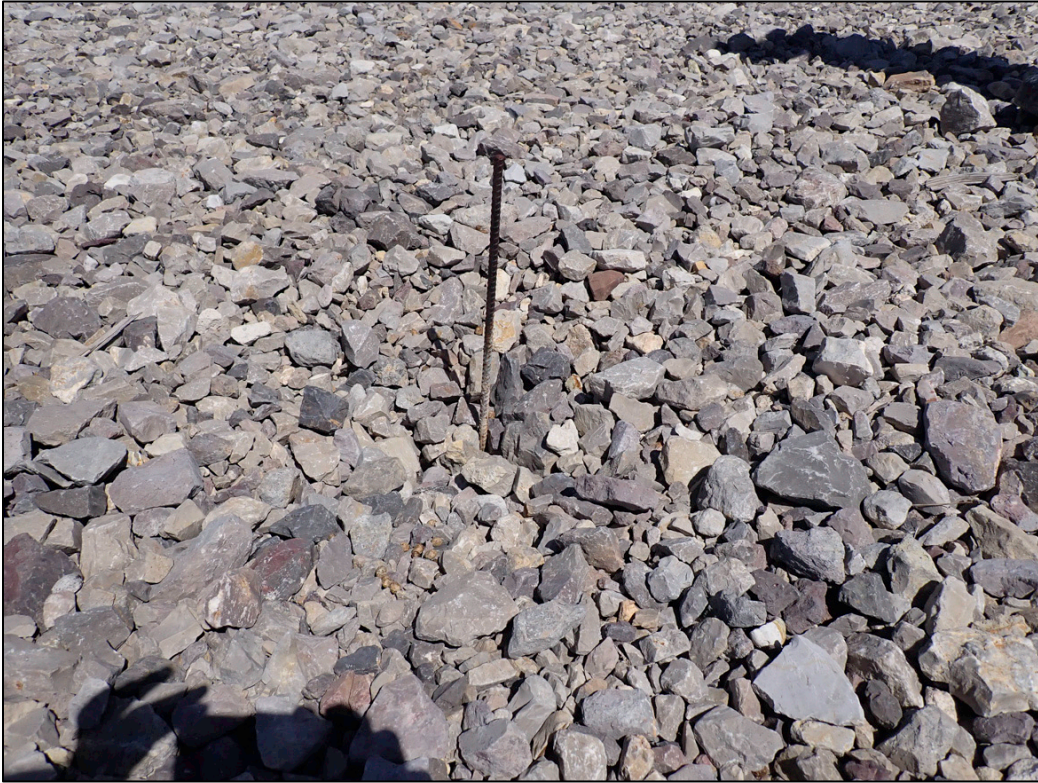
*PL-5. Shallow Depression No. 3*

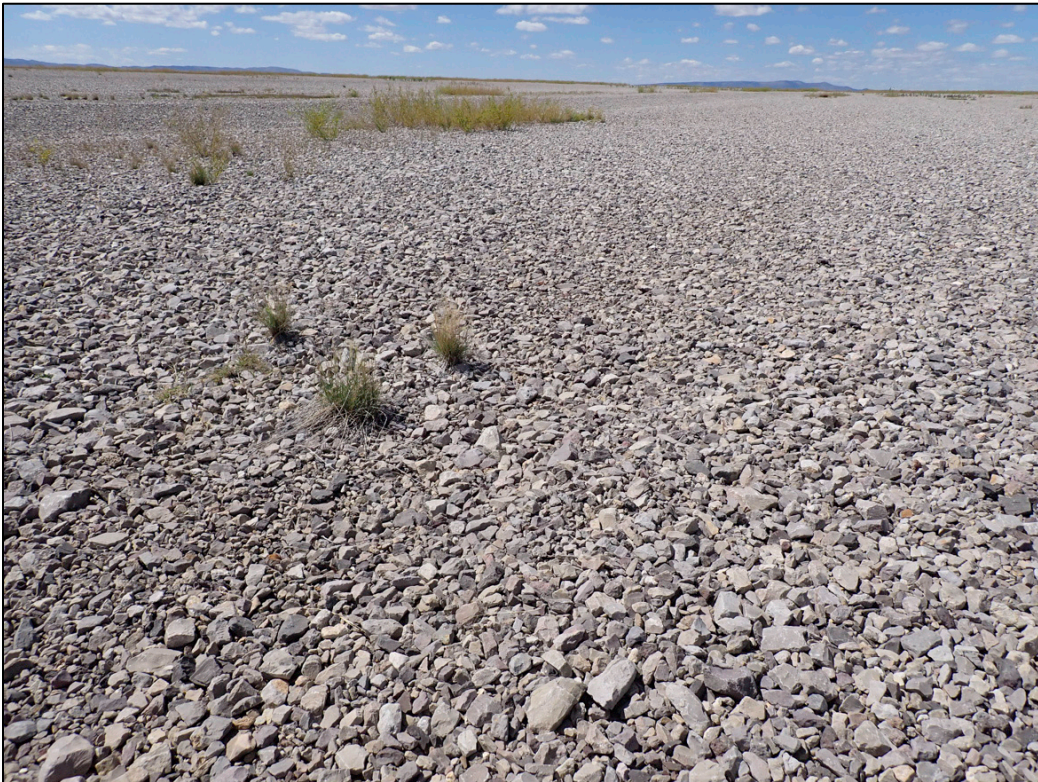
*PL-6. Shallow Depression No. 4*

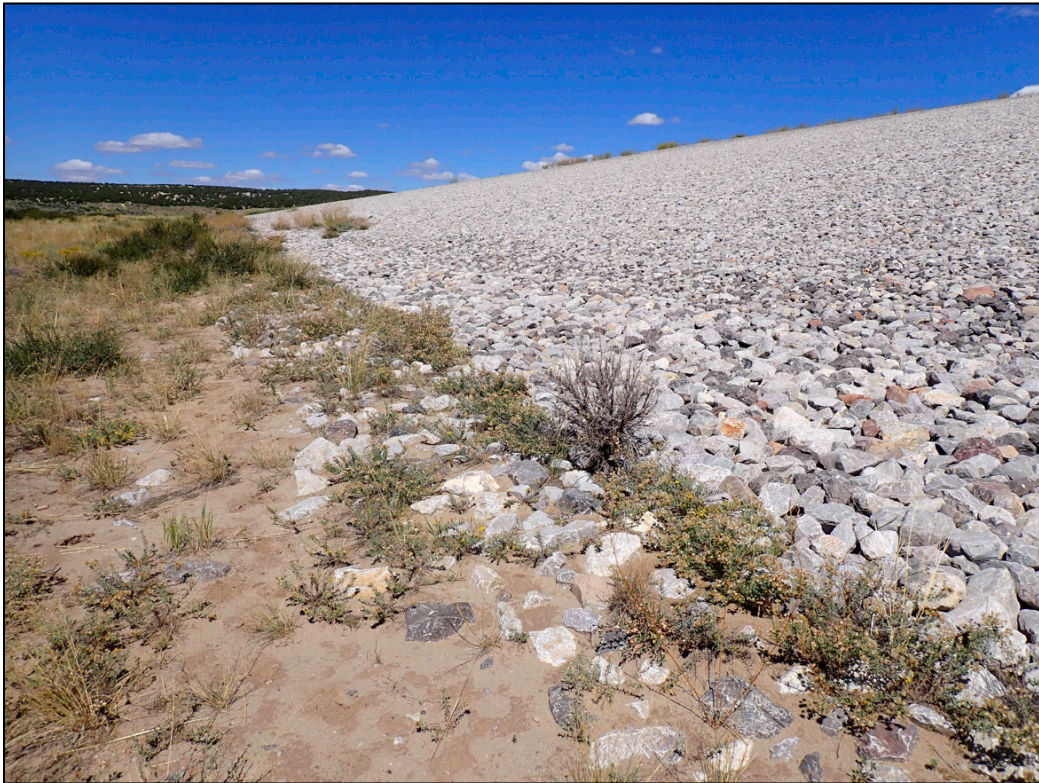
The disposal cell was designed to control surface water runoff resulting from a probable maximum flood event. The side slopes of the disposal cell were constructed with a 20% slope and are covered with a 1-foot-thick layer of riprap. Minor sediment accumulation observed at the base of the apron below the northwest side slope appears to be windblown (PL-7), and there was no evidence of side slope instability, erosion, or settlement. This area of sediment accumulation will continue to be monitored to ensure that the toe drain and side slope are functioning properly.

*PL-7. Windblown Sediment Accumulation at Toe of Side Slope*

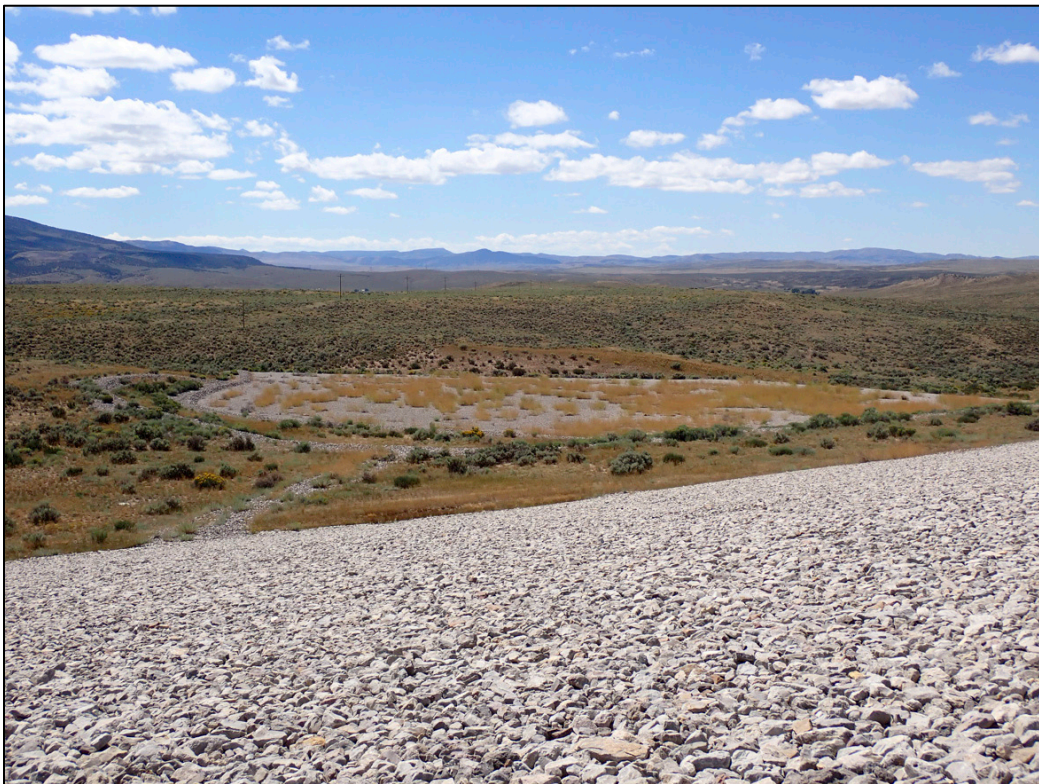
The ancillary cell (PL-8) was constructed to contain waste materials associated with the reclaimed evaporation pond area. It slopes gently toward the southwest. A rock berm wraps around its eastern and northern sides to protect it from surface water runoff. Small depressions were observed previously on the west end of the ancillary cell on the crest of the top slope (PL-9). These are very likely channelized flow from the cover eroding out areas of the top to side slope transition. Additional small depressions on the toe of the side slope (PL-10) were observed during the 2022 inspection. None of the depressions are impacting the performance of the cell, but they will continue to be monitored. Various species of deep-rooted vegetation are present on the top and side slopes of the ancillary cell. The side slopes and top of the ancillary cell were treated for brush following the inspection.

*PL-8. Ancillary Cell Overview*

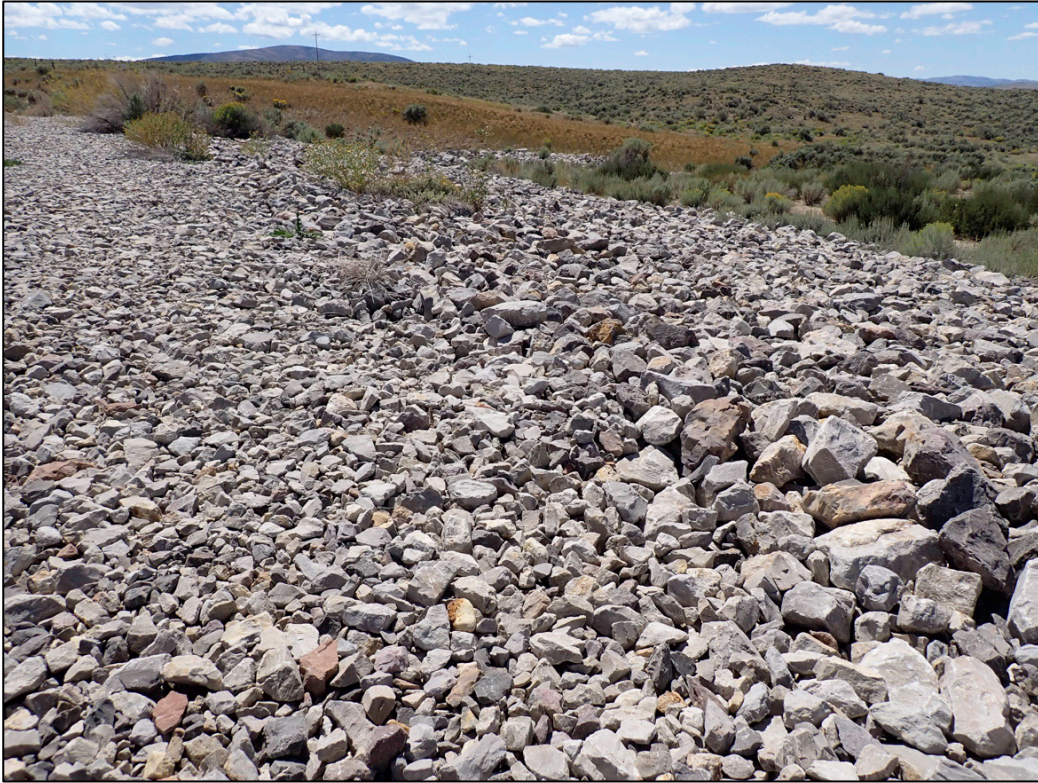
*PL-9. Depressions on Crest of Ancillary Cell*

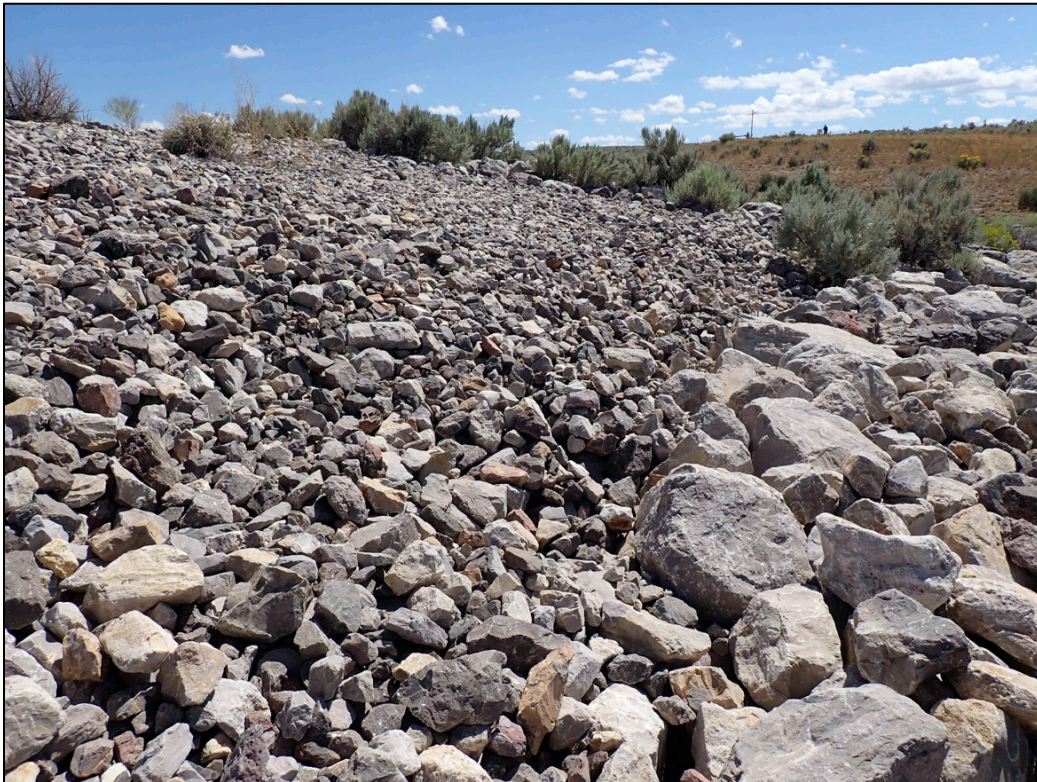
*PL-10. Depressions on Toe of Ancillary Cell*

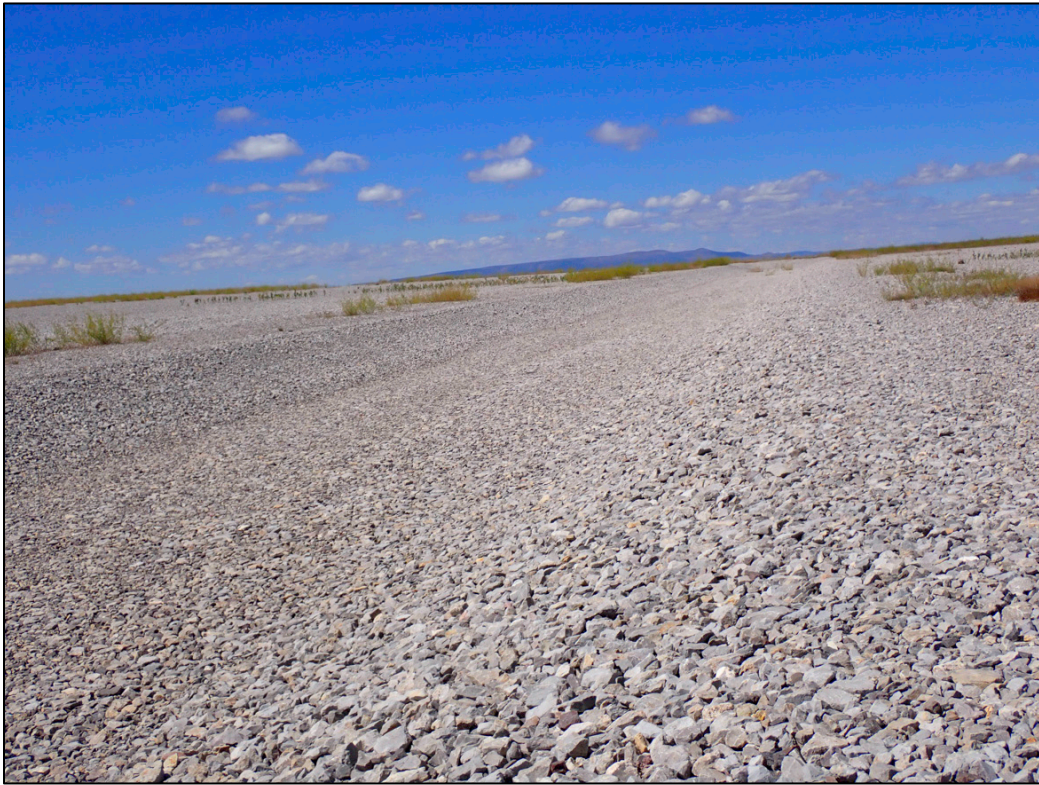
*PL-11. Diversion Channel No. 1*

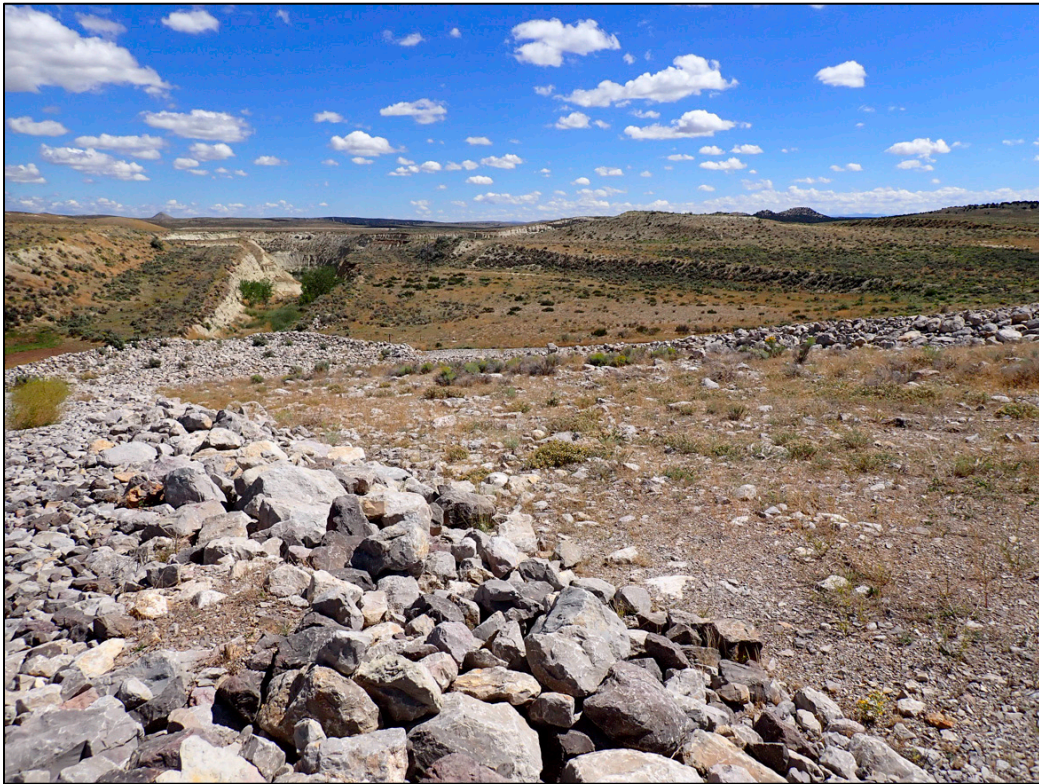
Final surface conditions at the site include a combination of rock armoring and contouring to achieve the surface water drainage control and erosion protection necessary to satisfy the design longevity requirements. The top slope of the disposal cell was designed to drain surface water runoff to the center and into riprap-armored Diversion Channel No. 1 (PL-11), which is graded toward and then down the east side slope of the disposal cell. Surface water runoff ultimately discharges into Rob Pit east of the site. An erosion protection structure, referred to as the Launch Rock Erosion Protection Basin (PL-12), was constructed at the outfall of Diversion Channel No. 1 to protect the disposal cell from headcutting that may occur from the deep channel that runs into Rob Pit. Diversion Channel No. 2 runs along the south side of the ancillary cell to convey surface water runoff away from the ancillary cell (PL-13). The diversion channels and outlet channel of the Launch Rock Erosion Protection Basin continue to function as designed.

*PL-12. Launch Rock Erosion Protection Basin*

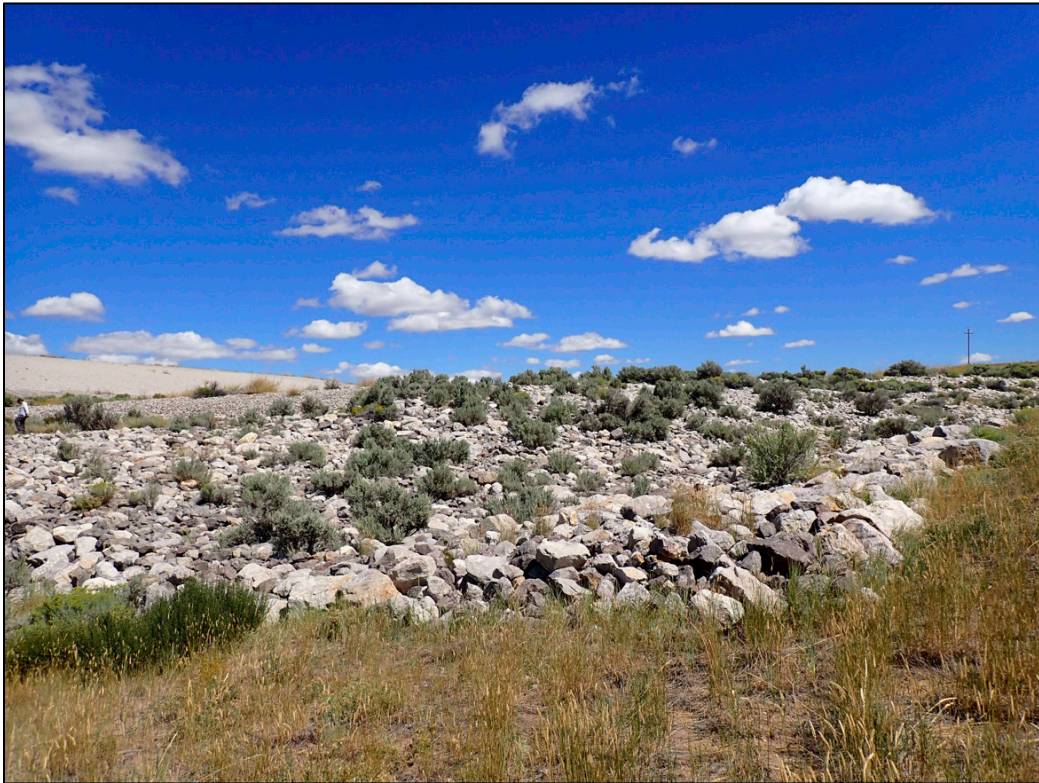
*PL-13. Diversion Channel No. 2*

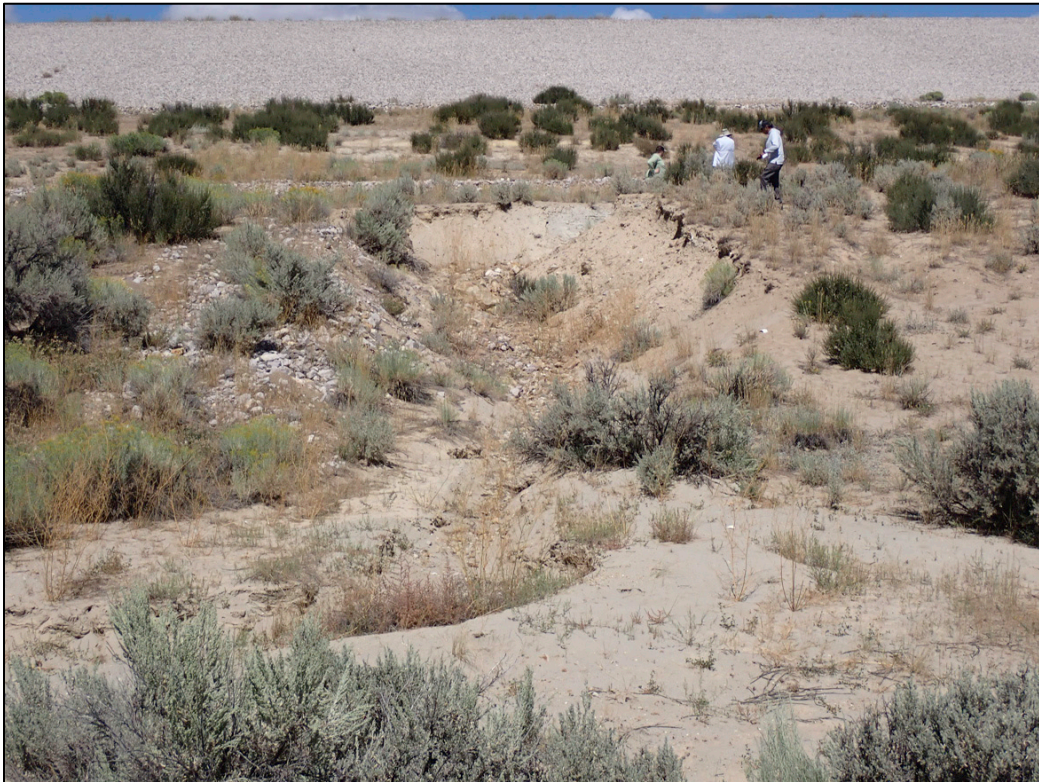
The rock berm that runs along the northern edge of the ancillary cell continues west across the slope south of the disposal cell to protect the disposal cell against erosion and headcutting. Several gullies (PL-14) and rills (PL-15) have developed on this south slope but do not threaten the integrity of the disposal cell. The gullies will continue to be monitored and repaired as needed. No maintenance needs were identified.

*PL-14. Largest Gully Below Rock Berm*

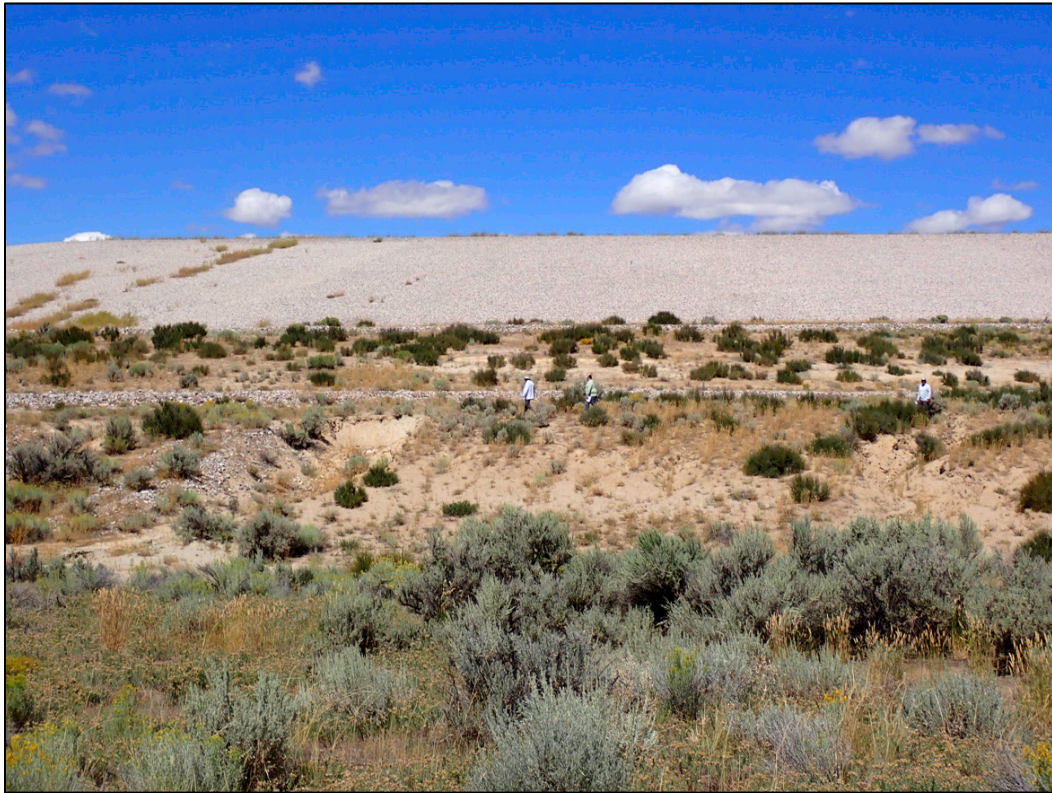
*PL-15. Erosion Below Rock Berm*
