## 6.0 Shirley Basin South, Wyoming, Disposal Site

### 6.1 Compliance Summary

The Shirley Basin South, Wyoming, Uranium Mill Tailings Radiation Control Act (UMTRCA) Title II Disposal Site was inspected on July 27, 2023. No major changes were observed on the disposal cell or in associated drainage features. Inspectors identified maintenance needs and found no cause for a follow-up inspection.

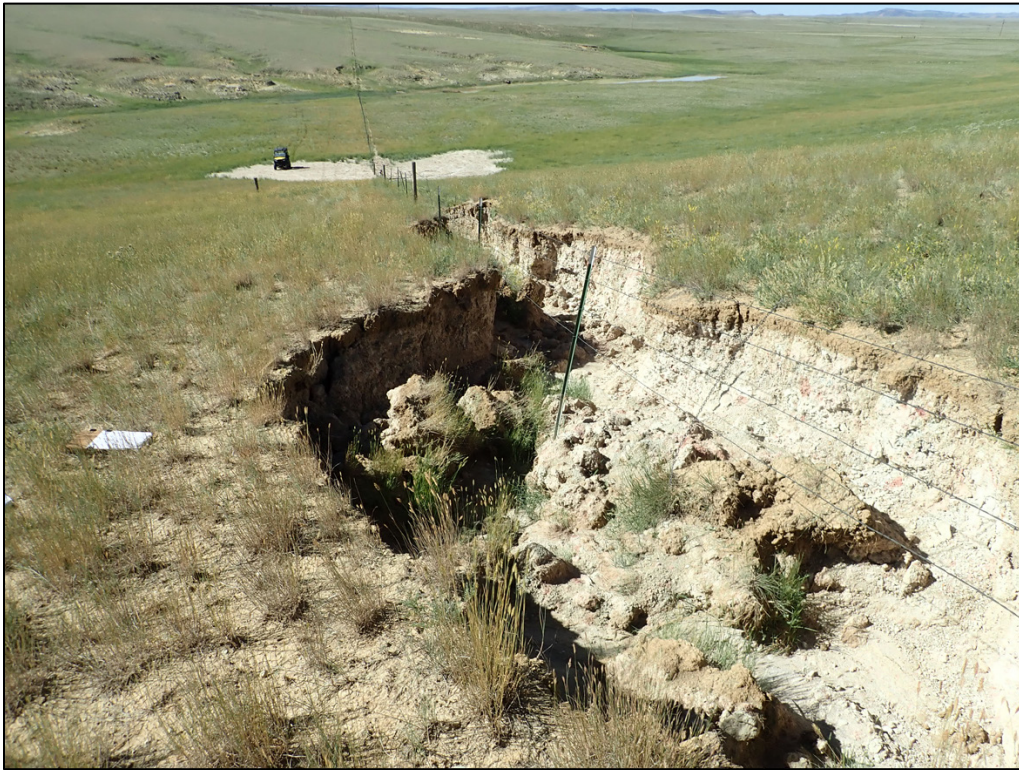
A four-strand barbed-wire fence encloses the site. A grazing license LM granted to a local rancher allows him to graze livestock onsite in exchange for minor maintenance of the perimeter fence. An animal burrow is present under the fence near boundary monument BM-18, and a post is bent on the north side near boundary monument BM-24. These items are minor and will be addressed by the grazing licensee. A large erosional feature (arroyo) has formed underneath the fence on the southern portion of the west boundary (PL-1). The arroyo formed inline with the fence, damaging several sections. Sediment from the erosional event was deposited below the slope break. This section of the fence line was subsequently realigned approximately 30 feet inward (away from the arroyo) in October 2023. Another erosional feature is developing north of the arroyo but is not yet impacting the fence.

*PL-1. Arroyo Under Fence on Lower Reclaimed Slopes*

In accordance with the LTSP (DOE 2004), routine site maintenance will be performed by LM as needed. Realignment of the eroded disposal site fence was conducted in October of 2023. Unlocked gates will be secured during the 2024 inspection.

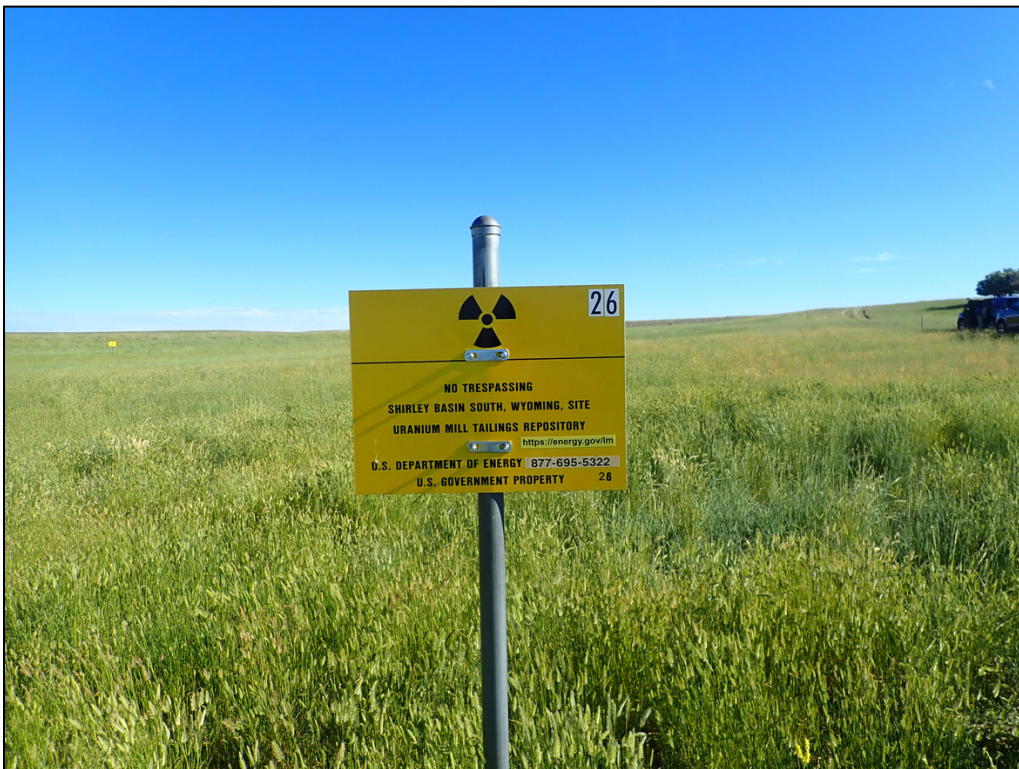
Nine perimeter signs (warning and no-trespassing signs) are posted along the site perimeter at potential points of access (PL-2), and another 25 signs are positioned around the disposal cell. Perimeter signs P1, P2, and P33 have bullet holes but remain legible. Several perimeter signs have exposed concrete at the base but remain stable. No maintenance needs were identified.

*PL-2. Perimeter Sign P26*

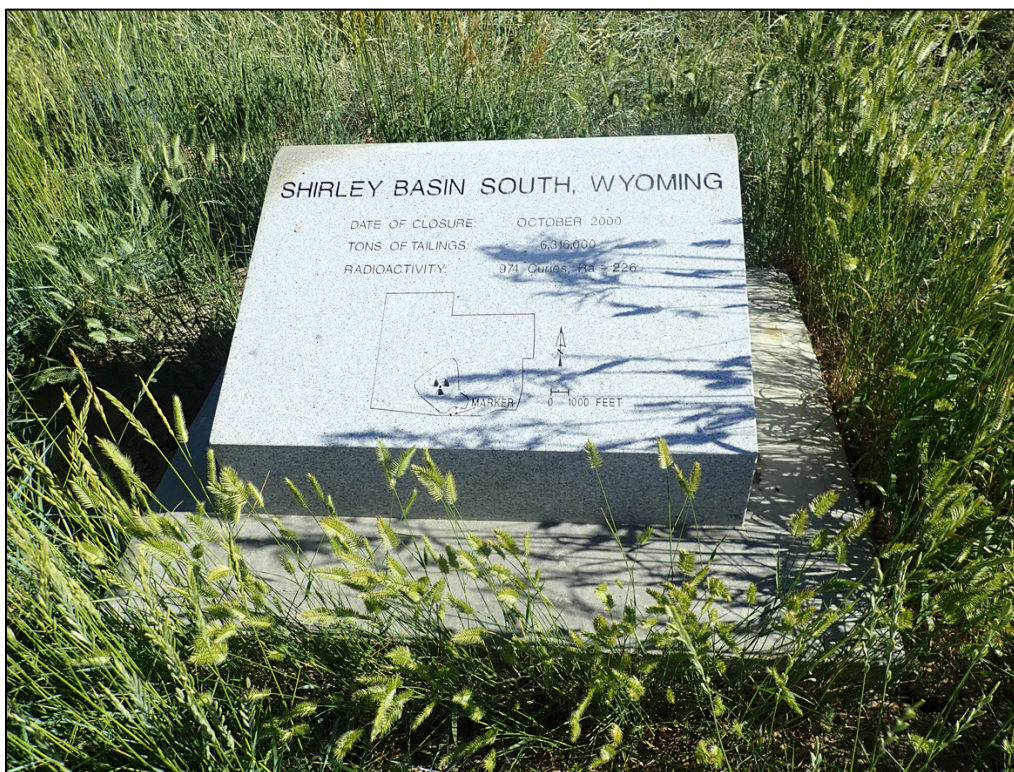
The site has one granite site marker (PL-3) near the entrance gate. No maintenance needs were identified.

*PL-3. Site Marker at Entrance Gate*

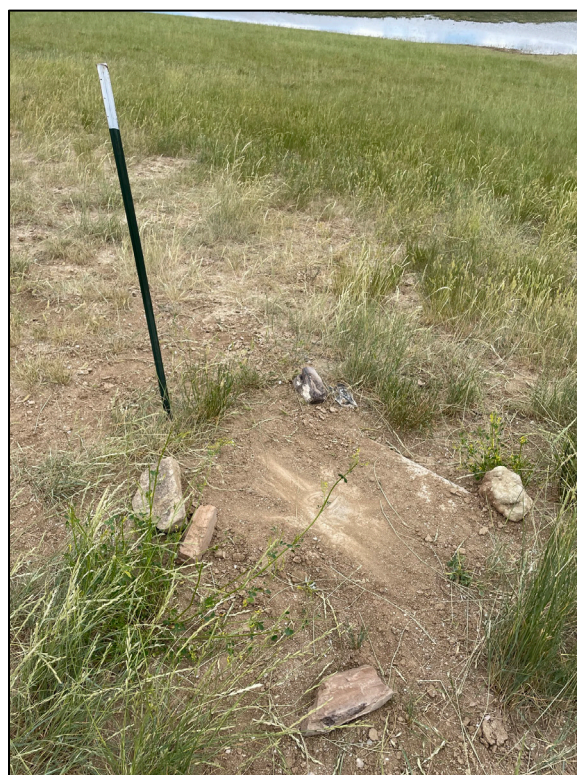
In July 2019, eight permanent aerial survey quality control monuments were installed at the site for an aerial survey of the disposal cell. The quality control monument locations are shown in Figure 6-1. Quality control monument QC-7 was covered by sediment, which was removed during the inspection (PL-4). T-posts were placed near all quality control monuments prior to the 2023 inspection to improve visibility. Concrete is spalling around quality control monument QC-8, but it is still functioning as intended. No maintenance needs were identified.

*PL-4. Quality Control Monument QC-7*

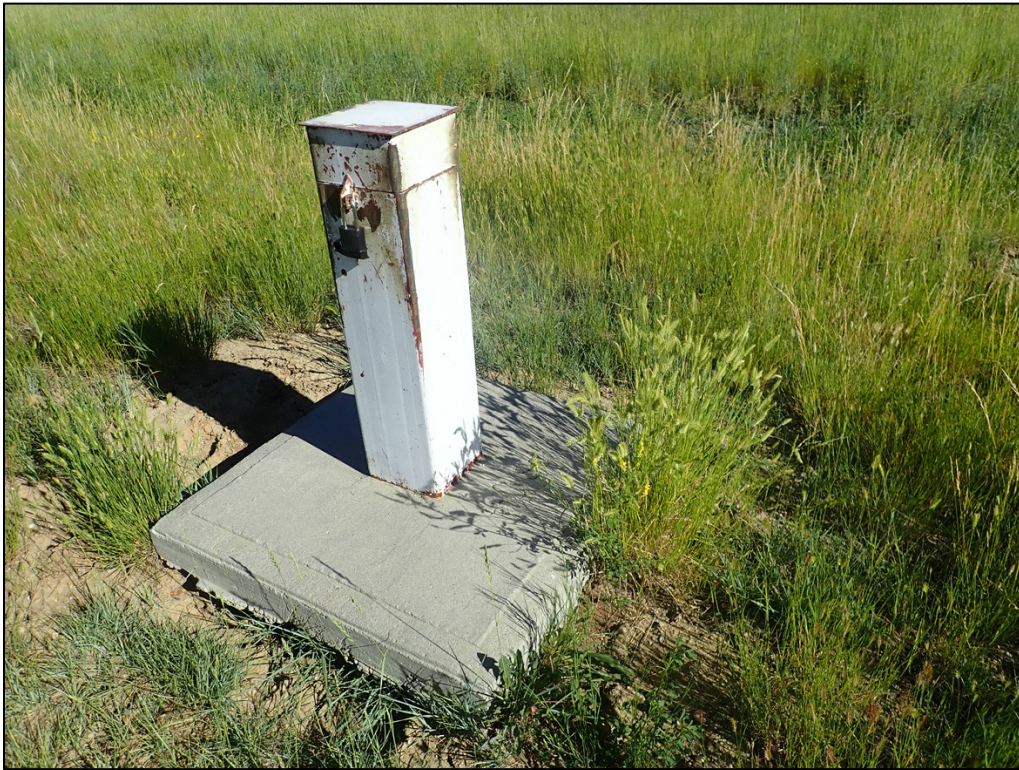
The site groundwater monitoring network consisted of eight monitoring wells when the site was transferred to LM. Six additional wells (100-SC, 101-SC, and 102-SC in the Upper Sand Aquifer and 110-DC, 112-DC, and 113-DC in the Main Sand Aquifer) were installed in 2008 to provide a better understanding of the characteristics and behavior of the affected aquifers at the site. The groundwater monitoring network now consists of 14 monitoring wells. The wellhead protectors were undamaged and locked. Monitoring well 40-SC has two small animal burrows under the concrete slab but remains stable (PL-5). No maintenance needs were identified.

*PL-5. Burrowing Near Monitoring Well 40-SC*

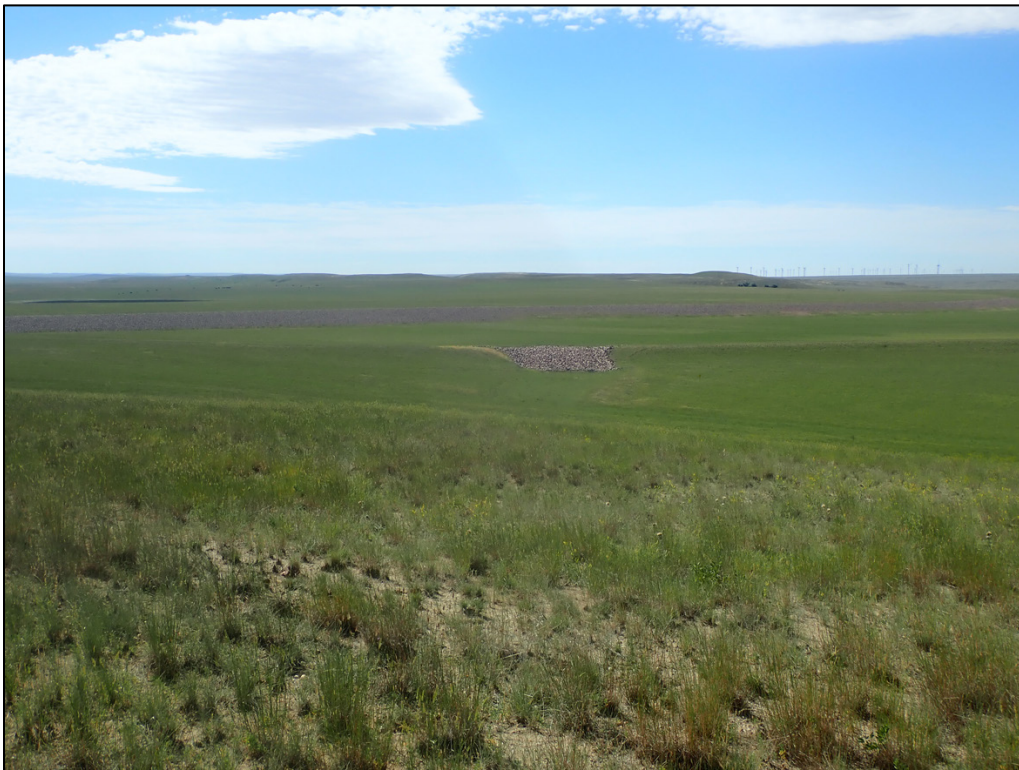
The disposal cell, completed in 2000, occupies 142 acres. It has a soil cover and was revegetated primarily with rangeland and native grasses. The vegetation on the disposal cell and throughout the site is managed through the grazing license. The disposal cell surface is constructed at two elevations (the upper, eastern surface and the lower, western surface) that are separated by a riprap-armored slope (PL-6).

*PL-6. Overview North Side of Disposal Cell and North Swale Discharge Point*

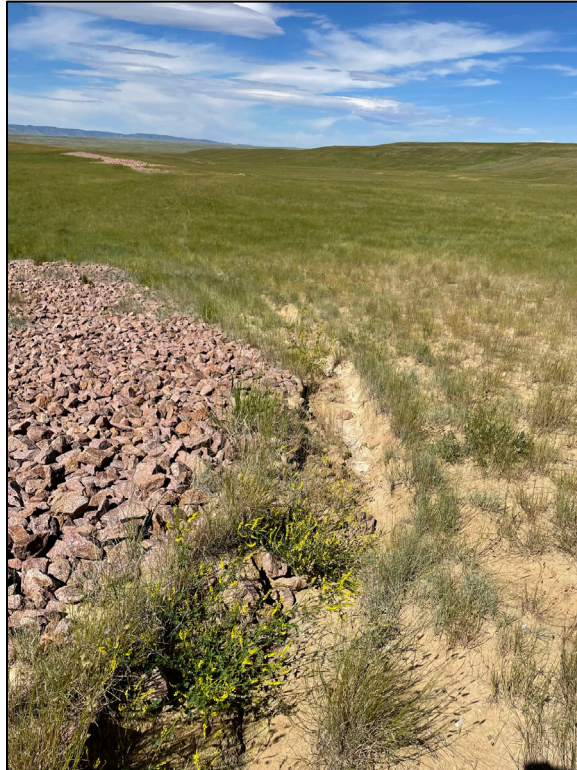
Cattle have worn trails around the riprap-armored slopes, which has caused erosion on the north (PL-7) and south (PL-8) ends of the eastern riprap-armored slope. These trails may need to be repaired in the future to prevent degradation of the as-built feature. No settlement, or other

*PL-7. Erosion Caused by Animal Trail North of Upper Riprap Slope*

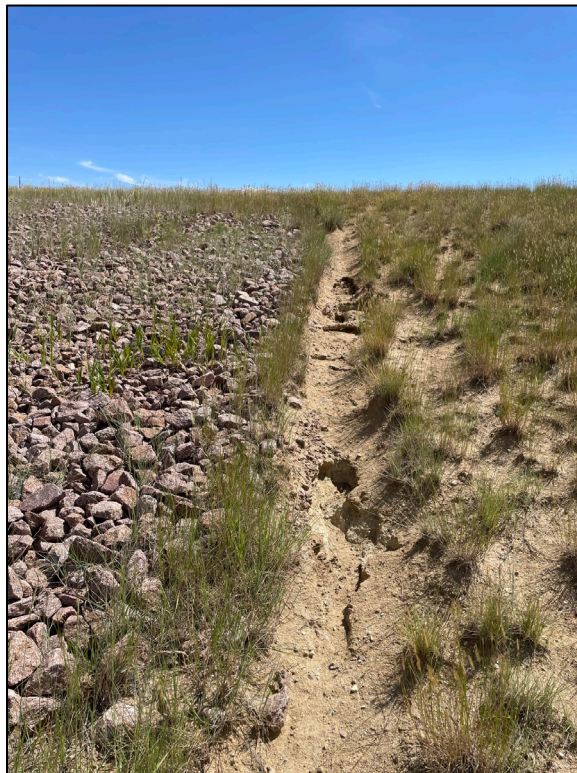
*PL-8. Erosion Caused by Animal Trail South of Upper Riprap Slope*

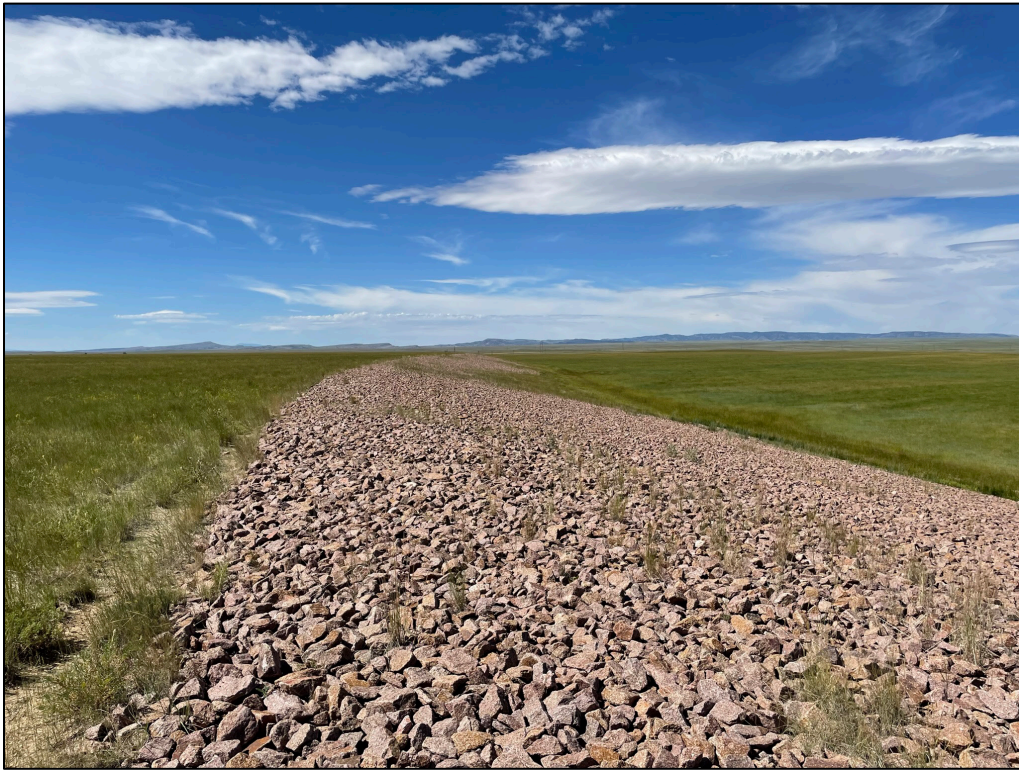
Gradual vegetation encroachment has been observed in the riprap on the slope that separates the two elevations (PL-9). The establishment of perennial vegetation enhances slope stability. Riparian vegetation is establishing at the toe of the slope in areas that accumulate snowmelt runoff and summer precipitation.

*PL-9. Vegetation Encroachment on Upper Riprap Slope*

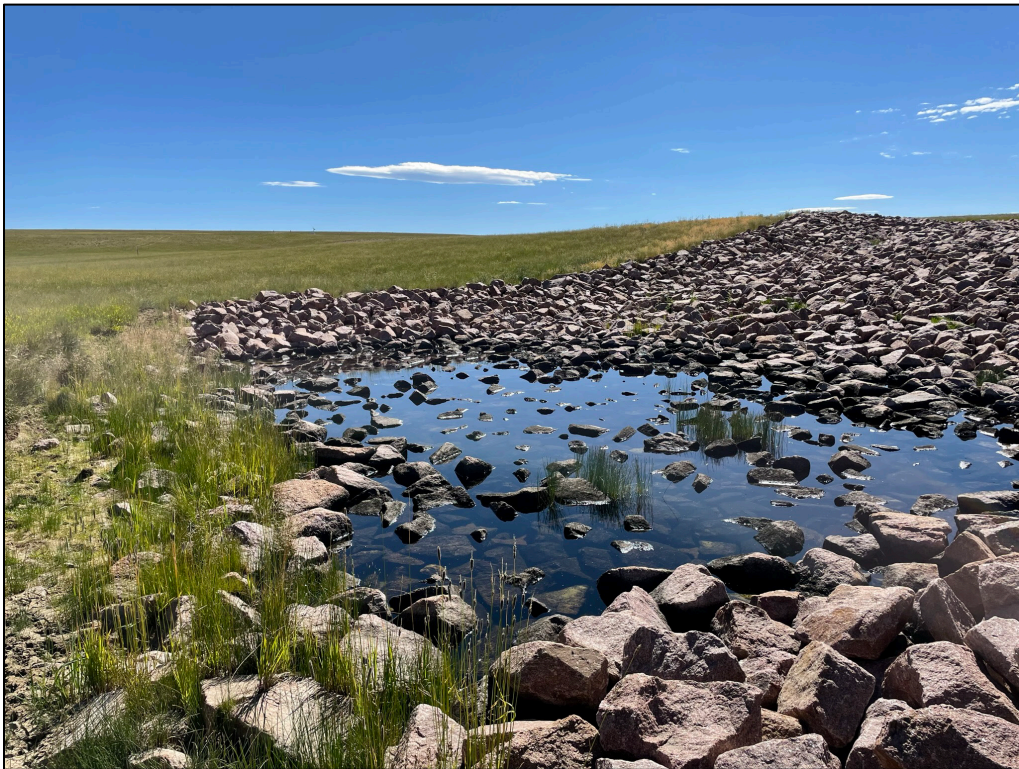
*PL-10. North Swale Discharge Point*

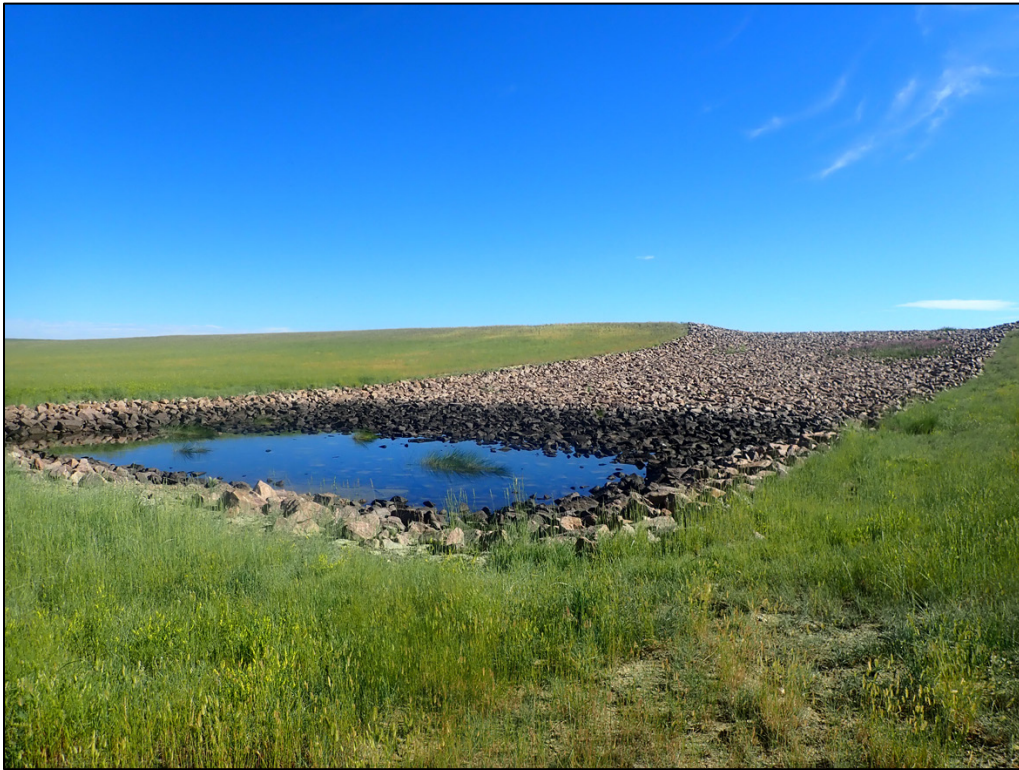
*PL-11. South Swale Discharge Point*

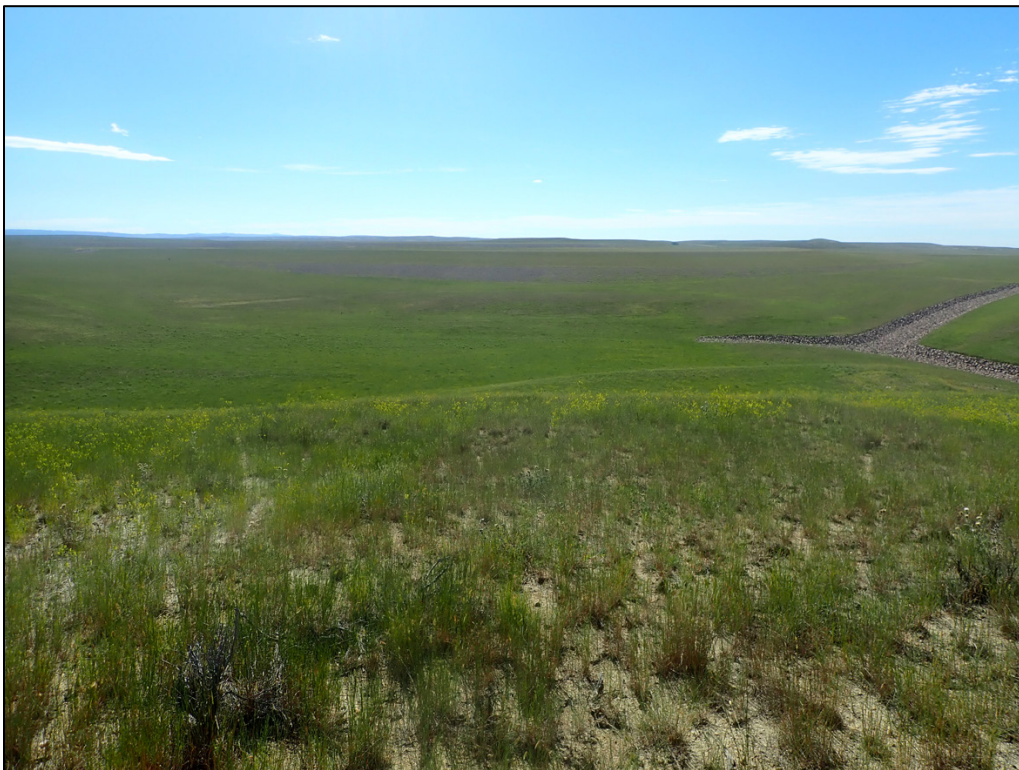
The surface water diversion system consists of a combination of diversion channels, drainage basins, and contoured surfaces (PL-12). Two primary diversion channels, the north, and the southwest diversion channels, keep runoff away from the disposal cell. Rock armor was placed on the steeper slopes and flow concentration points where design flow velocities could erode surfaces and impact the disposal cell. A probable maximum flood (PMF) channel was constructed north of the disposal cell along the side of the reclaimed mine overburden soil pile. Part of the PMF channel drains to the west and discharges to a small, closed basin. Water was present during the inspection in this closed basin. The portion of the PMF channel that flows eastward and discharges into the East Drainage Basin (PL-13) captures stormwater from a larger drainage area. Water was present in the part of the PMF channel that drains to the east about 0.25 mile west of where it intersects the main road. These drainage basins are large enough to accommodate PMF water volumes.

*PL-12. Overview of Diversion Channels and Contoured Surfaces West of Disposal Cell*

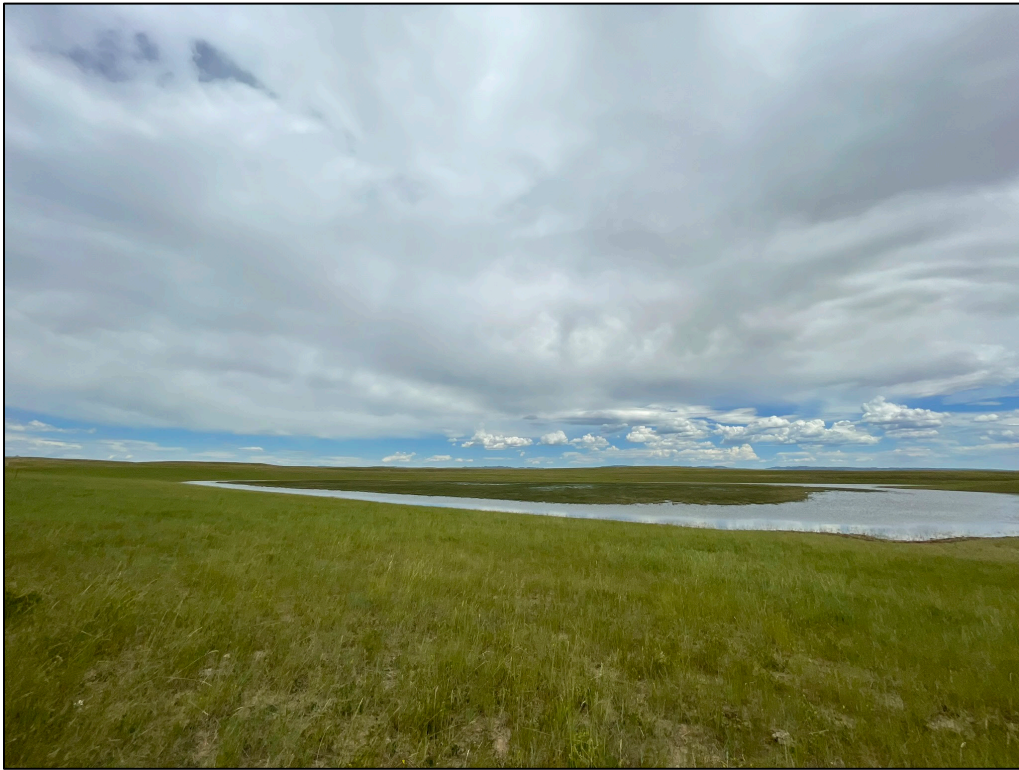
*PL-13. East Drainage Basin*

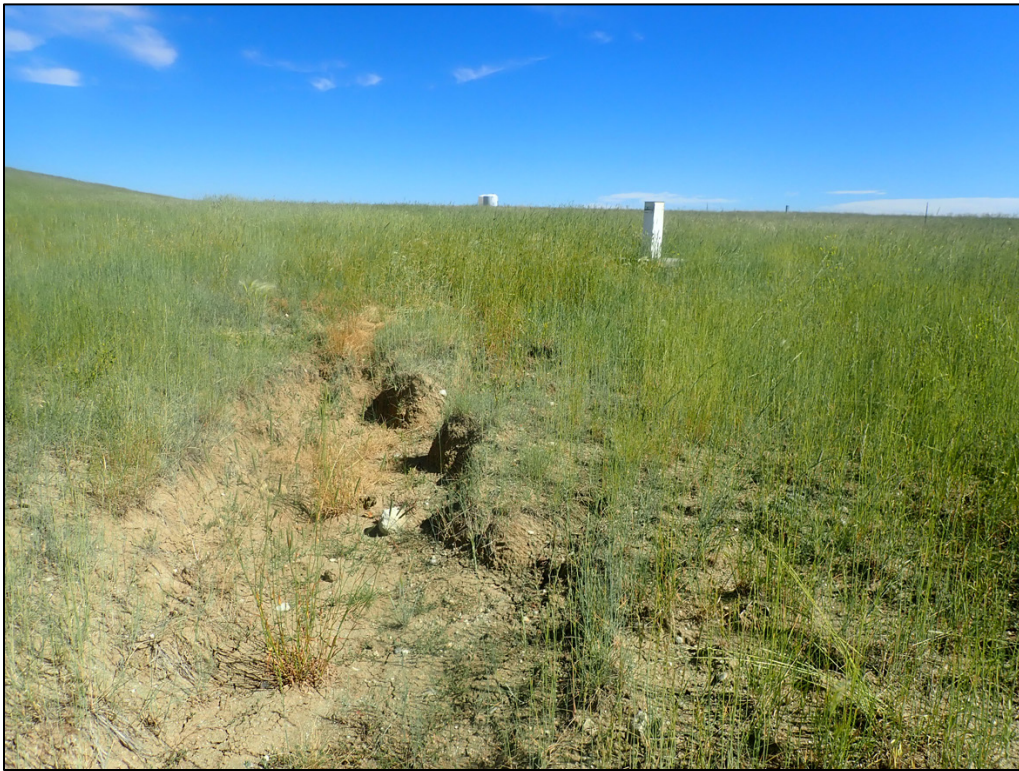
Discharge plumbing from the water storage tank has caused minor erosion near monitoring well 54-SC (PL-14) and the PMF channel. This discharge is not impacting site features currently, but headcutting erosion could occur toward the well and well pad, causing the well pad to become destabilized. Inspectors will continue to monitor this area. No maintenance needs were identified.

*PL-14. Erosion Caused from Overflowing Water Storage Tank*

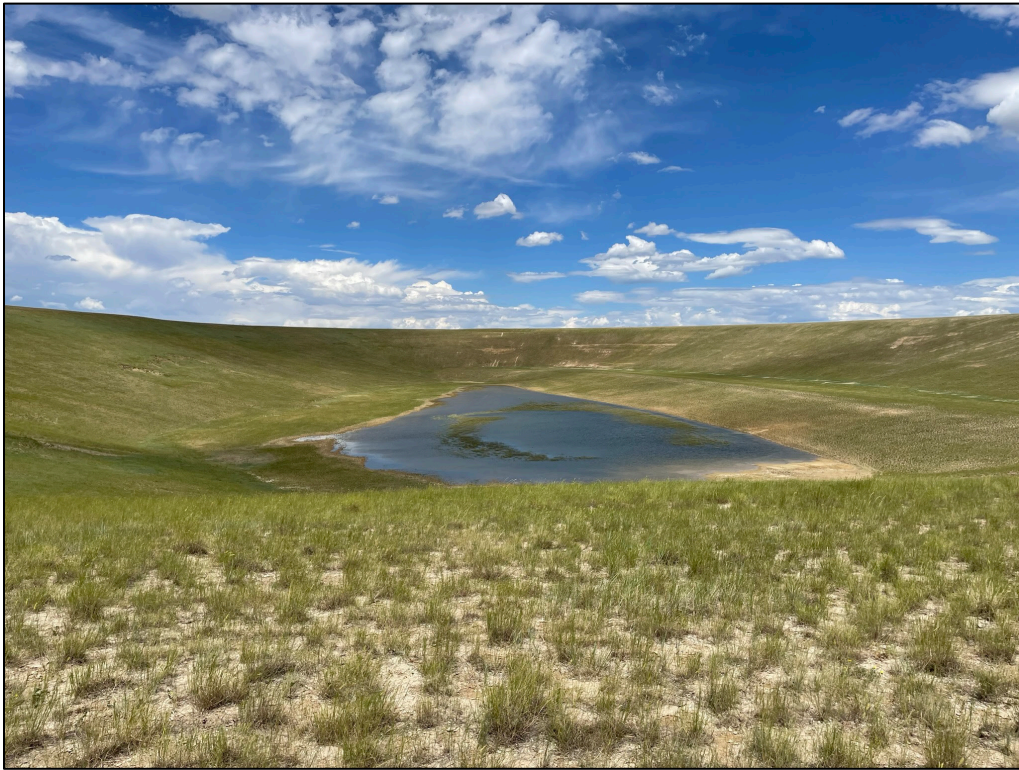
*PL-15. Pit 4 Overview and Wetland Area*

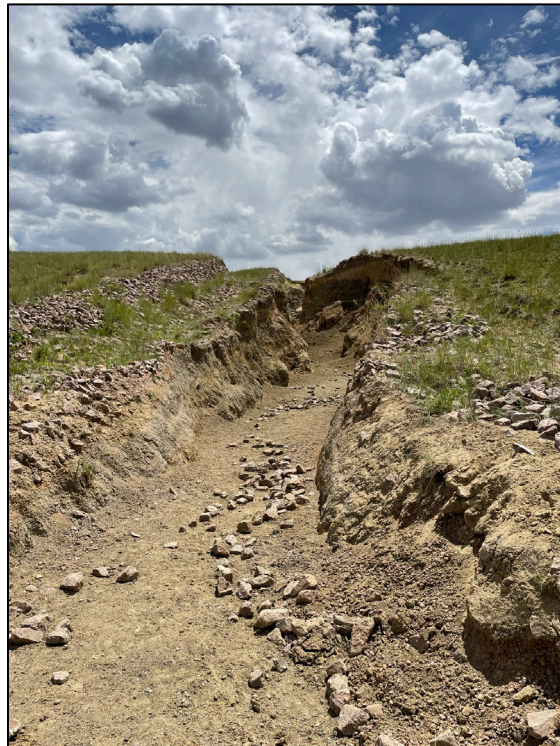
*PL-16. Pit 4 Lower Riprap Armored Drainage Channel Erosion*
