## 5.0 Sherwood, Washington, Disposal Site

### 5.1 Compliance Summary

The Sherwood, Washington, Uranium Mill Tailings Radiation Control Act (UMTRCA) Title II Disposal Site was inspected on June 8, 2023. No changes were observed to the disposal cell, containment dam, or associated drainage features. Inspectors identified several routine maintenance needs but found no cause for a follow-up or contingency inspection.

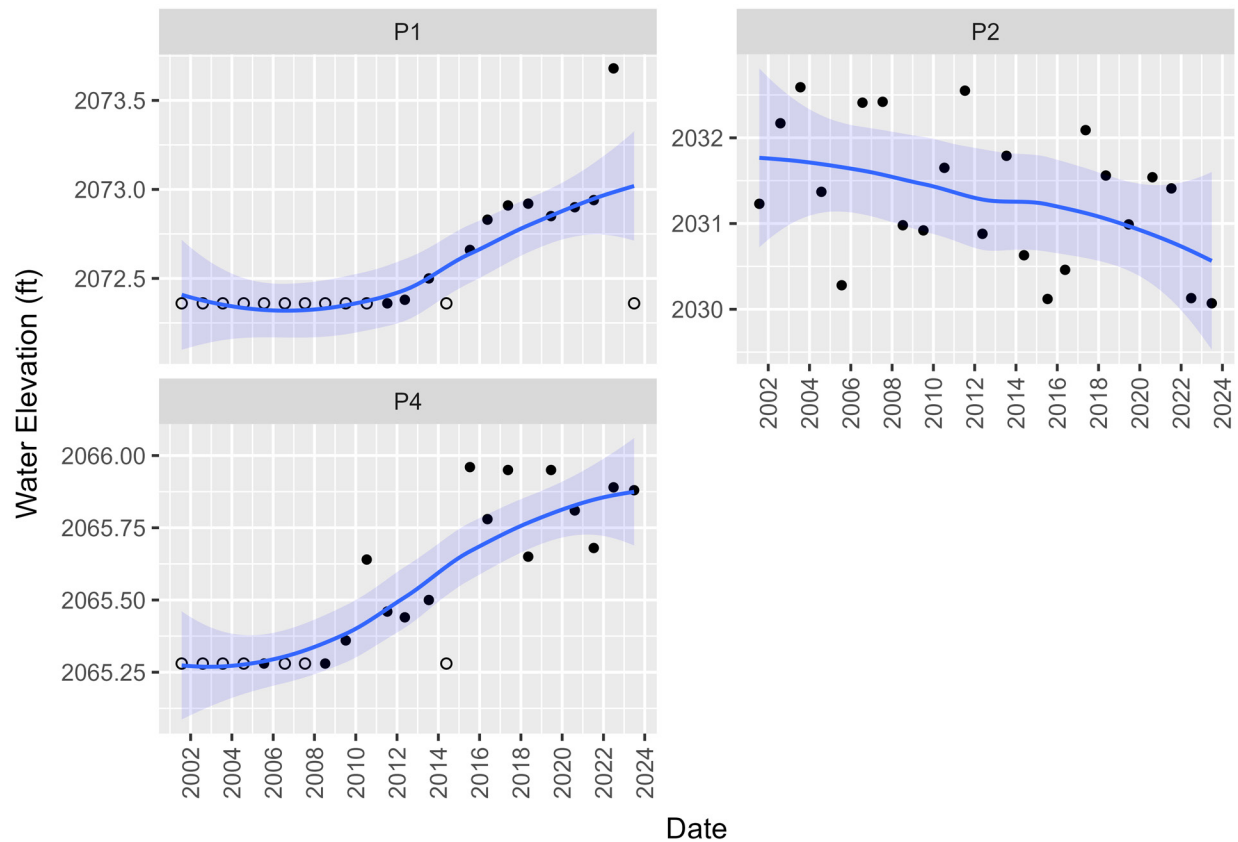
*Figure 5-3. Groundwater Elevations in Piezometers P1, P2, and P4: Unique Scales  
 Sherwood, Washington, Disposal Site*

**Notes:** To provide greater resolution, y-axis scales are unique for each well. Therefore, any between-well comparisons of groundwater elevations should be made with caution. Results for piezometer P3 are not shown because the well has been dry since 2016 and in most preceding sampling events (Figure 5-2). The vertical datum is North American Vertical Datum of 1988. Mann-Kendall trend analysis indicates statistically significant increasing trends in groundwater elevations in piezometers P1 and P4 (the shallowest piezometers). However, consistent with observations in 2001–2010 and in 2014, piezometer P1 was again dry during the June 2023 sampling event. A statistically significant decreasing trend in water levels was found for piezometer P2.

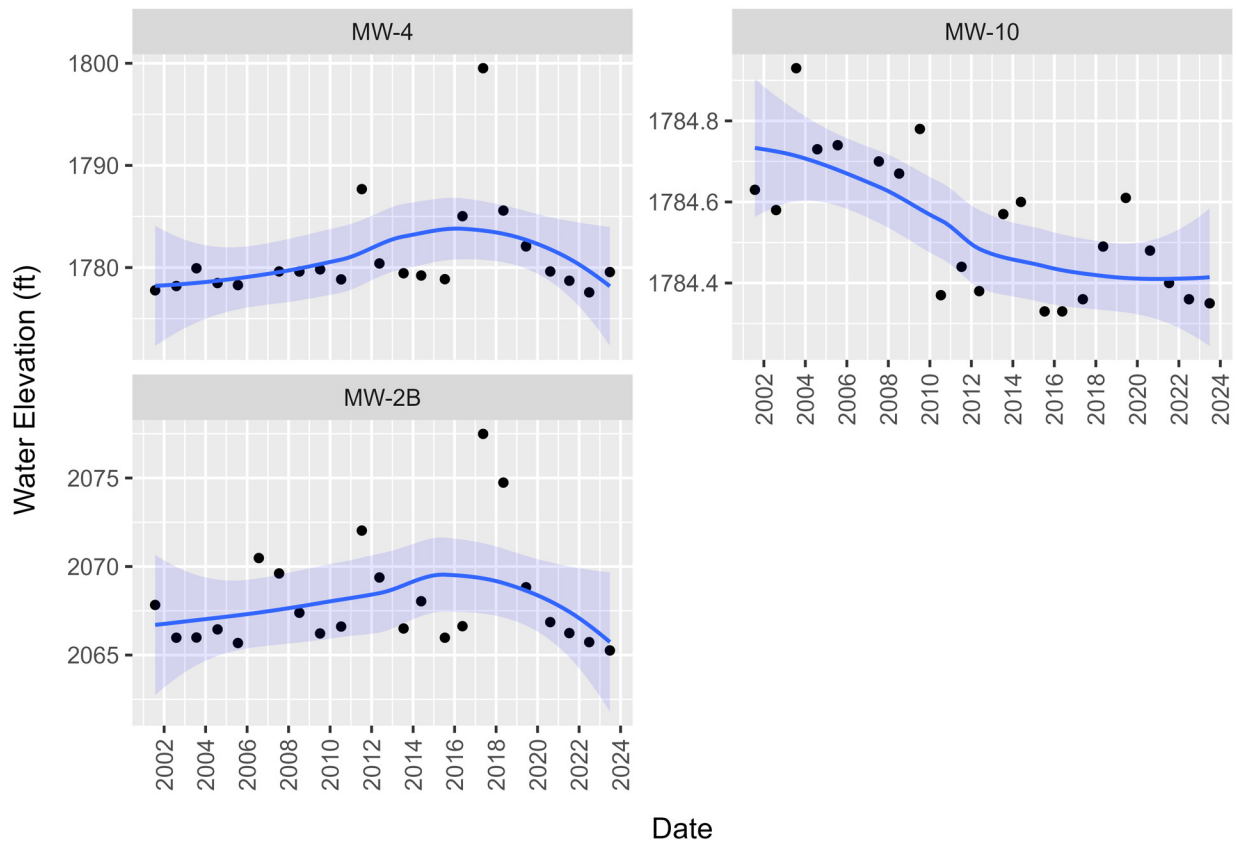
*Figure 5-9. Groundwater Elevations in Monitoring Wells MW-4, MW-10, and MW-2B: Unique Scales Sherwood, Washington, Disposal Site*

**Notes:** To provide greater resolution, y-axis scales are unique for each well. Therefore, any between-well comparisons of groundwater elevations should be made with caution. The vertical datum is NAVD 88. Mann-Kendall trend analysis identified a statistically significant decreasing trend in groundwater elevations for monitoring well MW-10; no trend was found for monitoring wells MW-4 or MW-2B.

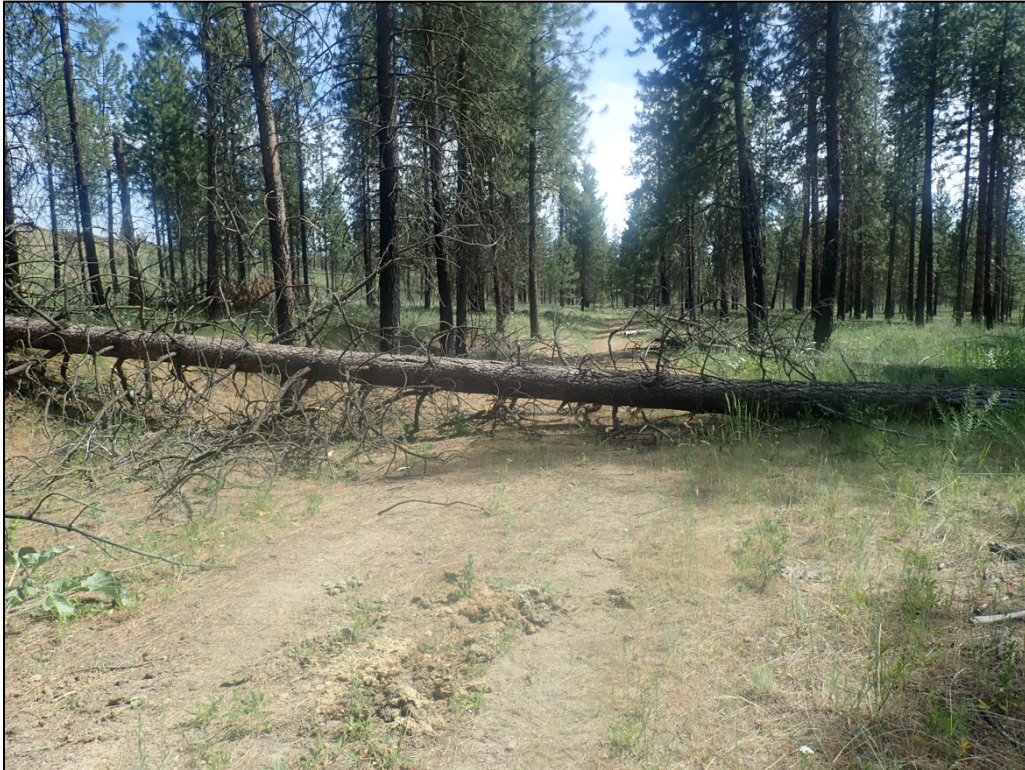
Access to the site is from Elijah Road, a gravel-surfaced, BIA-maintained road over which LM has permanent right of access. The entrance gates are present but no longer used. They are permanently open and allow unrestricted access to the site. A fallen tree is blocking the road on the access road south of the disposal cell (PL-1). The tree will be removed during the maintenance trip in 2024.

*PL-1. Fallen Tree Along Road*

- Removal of the bollard at monitoring well MW-4
- Removal of the fallen tree along the access road
- Trimming of vegetation along the dike road
- Numbering of piezometers

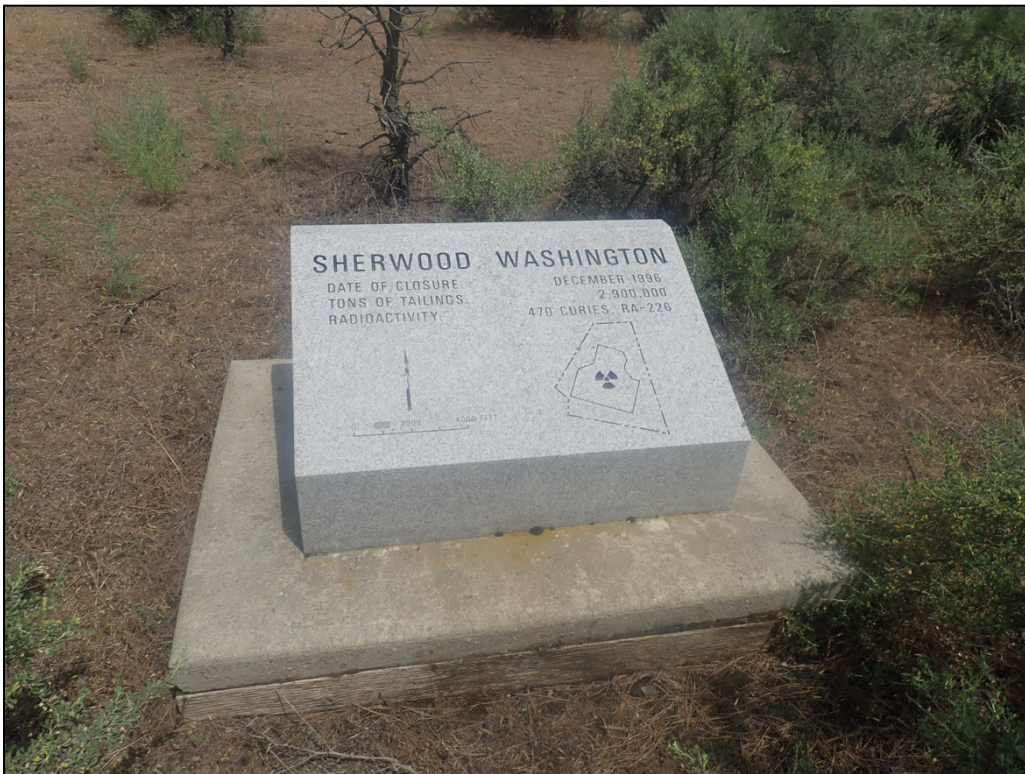
There is one granite site marker on the southwest side of the site where the access road lies closest to the site boundary (PL-2). No maintenance needs were identified.

*PL-2. Site Marker*

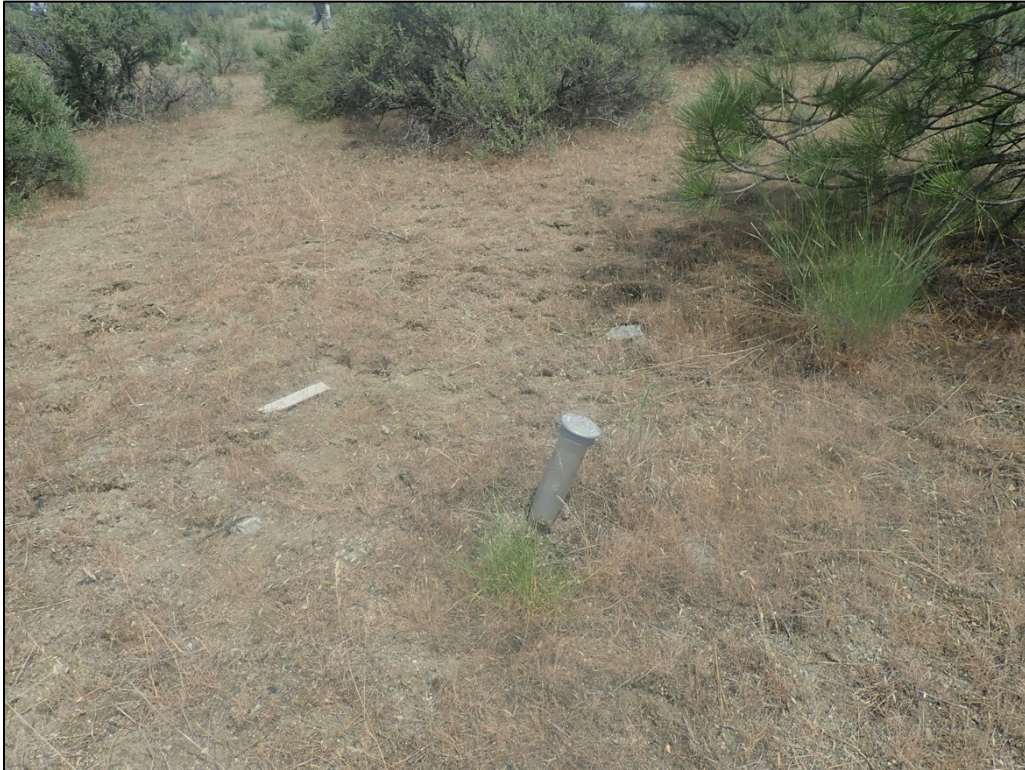
Six boundary monuments set in concrete define the site boundary. Because surrounding vegetation has made it difficult to locate some of the monuments, metal T-posts were installed at each boundary monument location. All boundary monuments were located during the inspection. Boundary monument BM-3A is bent but still visible and intact (PL-3). No maintenance needs were identified.

*PL-3. Bent Boundary Monument BM-3A*

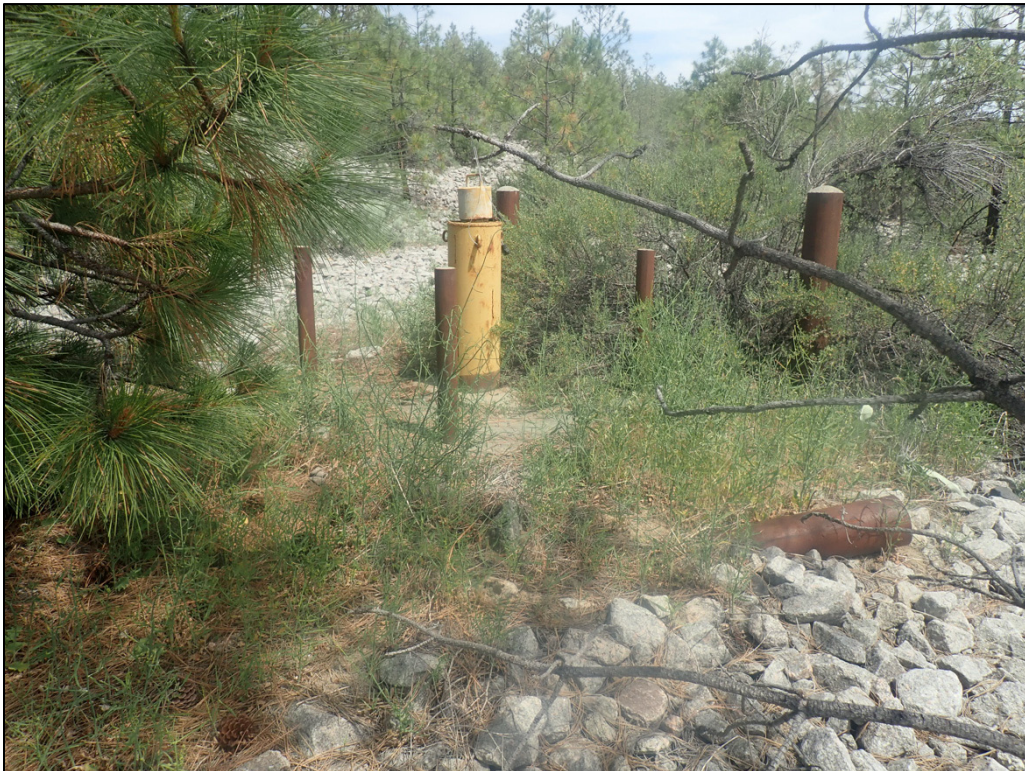
The site groundwater monitoring network consists of monitoring wells MW-2B, MW-4, and MW-10. Each monitoring well is protected by eight surrounding bollards. At monitoring well MW-4, one of the outermost bollards has been knocked over (PL-4). The LMS groundwater sampling team verified that the integrity of the well has not been affected. The fallen bollard will be removed in 2024. As part of the dam safety inspection program, four piezometers were installed in November 2000 along the crest of the containment dam at a depth equivalent to the base of the dam. All piezometers were undamaged and locked. None of the piezometer wellheads or concrete pads have any designation of their number. To avoid potential errors, it is suggested that the piezometers have their number punch stamped on the wellhead by the environmental monitoring organization during the 2024 sampling event. No further maintenance needs were identified.

*PL-4. Monitoring Well MW-4 with Damaged Bollard*

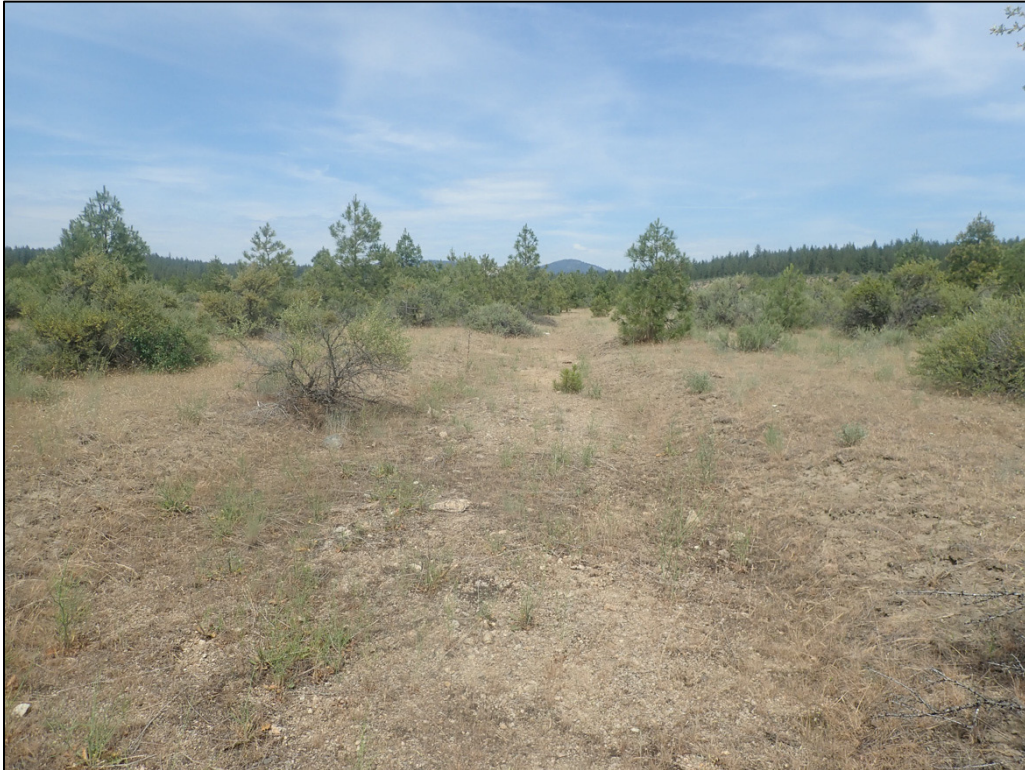
A small, shallow runoff channel near the southeast corner of the disposal cell discharges water into a riprap-armored swale east of the containment dam (PL-5). The channel is stable and is not above the tailings impoundment. In previous inspections, rilling was found below the riprap-armored swale. These features will continue to be monitored to ensure that they do not affect the integrity of the disposal cell.

*PL-5. Runoff Channel on Southeast Area of Disposal Cell*

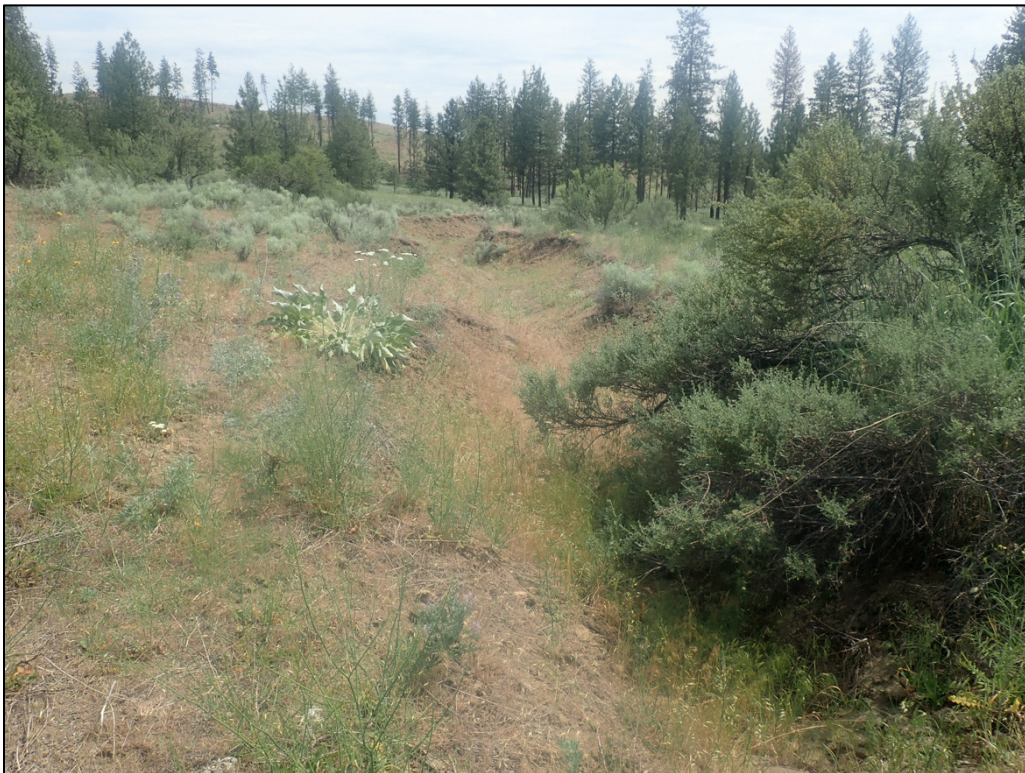
Two prominent gullies are present: one is outside the site boundary between perimeter sign P1 and P2 (PL-6) and the other is along the access road near the dike road on the southeast corner of the disposal cell. The erosion areas are stable and are not impacting site features but will continue to be monitored. No maintenance needs were identified.

*PL-6. Gully near Swale*

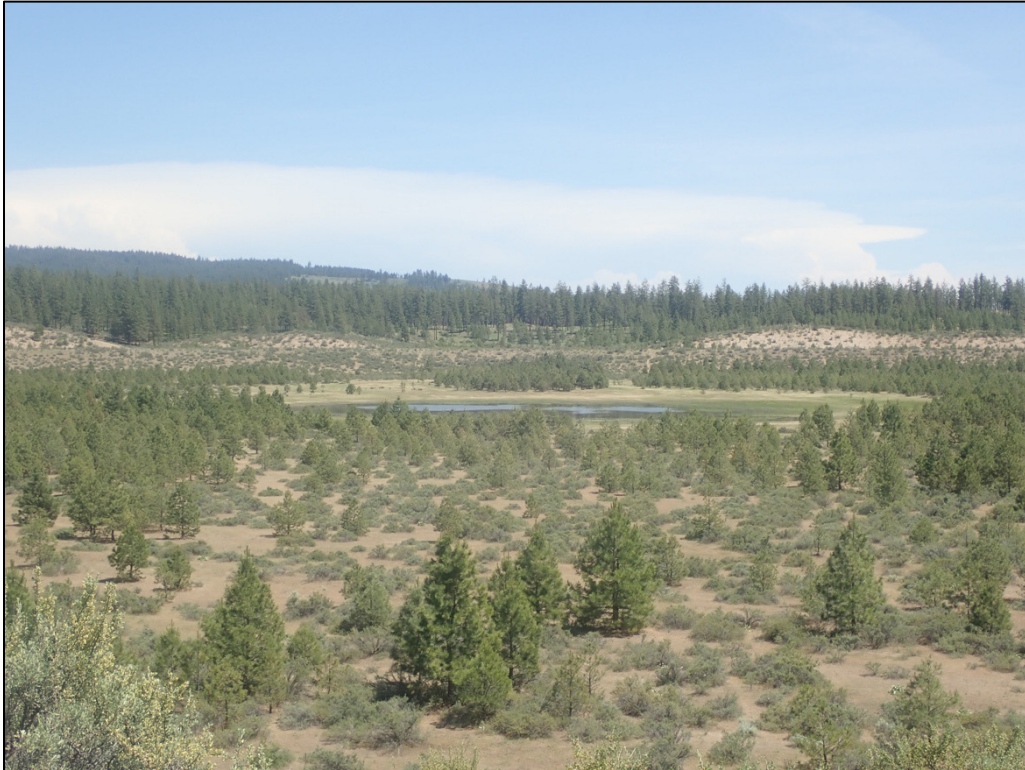
As described in detail in the LTSP (DOE 2001), the disposal cell cover was designed to stabilize, and settlement was expected to occur. The largest area of settlement is at the center of the cell (PL-7) where plant species adapted to wetland environments are present. Four distinct ponds were mapped during past inspections, but these are merging into one distinct pond. An evaluation of topographic surveys conducted in 2016 and 2017 indicated that up to 4.4 ft of settlement has occurred near the pond since construction of the disposal cell. The cover design allowed for up to 10 ft of settlement (DOE 2018b). The disposal cell surface will continue to be monitored for unusual settlement features to ensure that the disposal cell is performing as designed. In October 2021, aerial light detection and ranging (lidar) surveys were conducted to collect high-resolution topographic data of the disposal cell and surrounding area. The data collected include natural color imagery and lidar elevation data to be used as a baseline. A follow-up aerial survey is scheduled for 2028. The data collected in the 2021 aerial survey confirm that settlement is less than the 10 ft allowance. No maintenance needs were identified.

*PL-7. Pond on Disposal Cell*

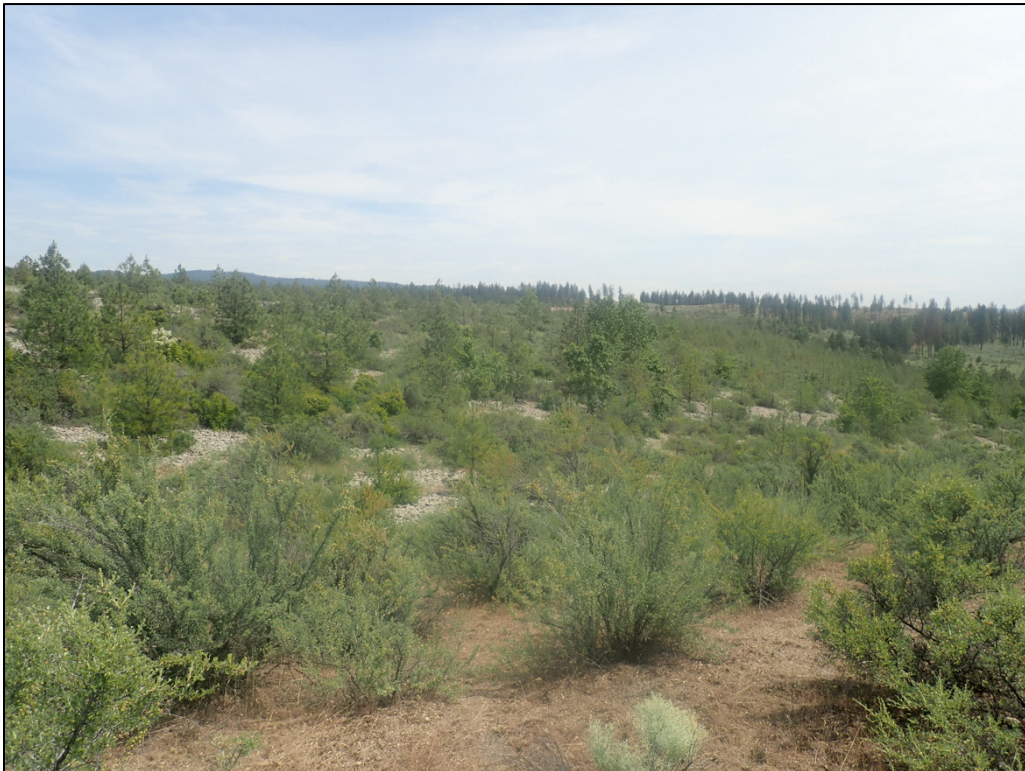
establish and, therefore, stabilize the surface and mitigate erosion. The dam face was heavily vegetated in 2023 (PL-8). No maintenance needs were identified.

*PL-8. Containment Dam Face*

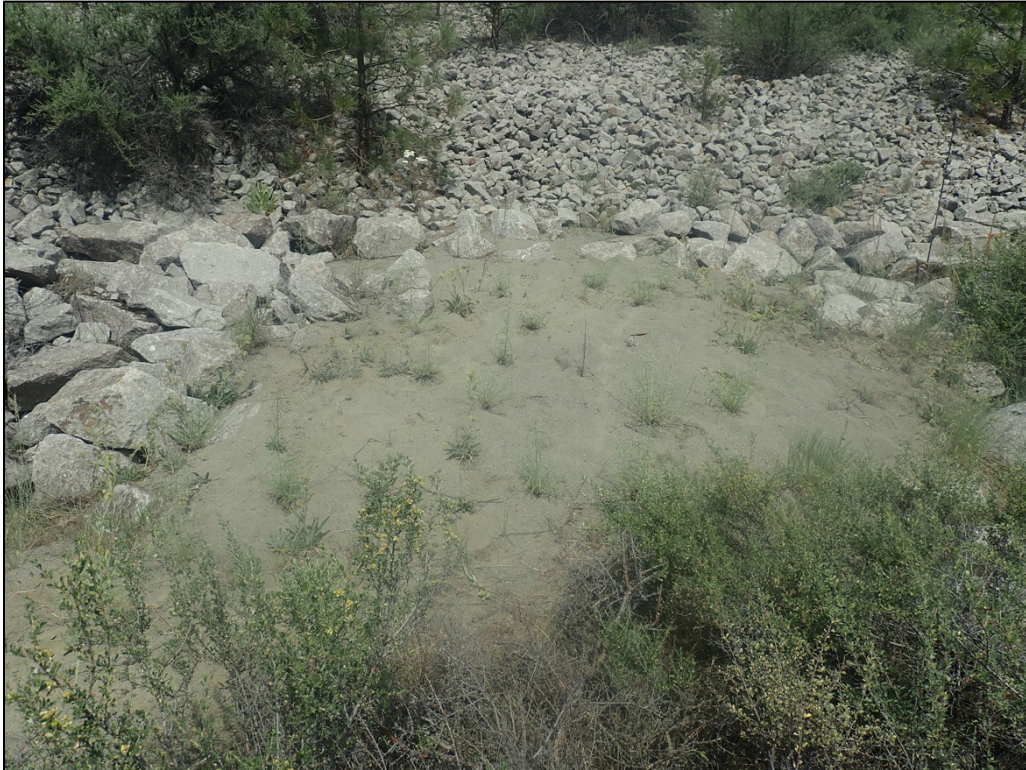
During past inspections, areas of sand deposition have been described that indicate that materials have washed out from underneath the dam rock cover (DOE 2018a). The largest sand deposit (PL-9), measuring approximately 16 × 14 ft, was evaluated by a soil erosion specialist during the 2022 inspection. This area will be visually monitored and measured during future inspections and by periodic lidar surveys. Several smaller deposits on the dam, especially on the western half, were also evaluated, as were several areas along the toe of the dam. DOE will continue to monitor or implement repair options in consultation with NRC as necessary. Deposition is occurring in several areas along the toe of the containment dam. Continued deposition over time could lead to accumulation in amounts rendering the water-draining ability of the containment dam toe inefficient. This is not an issue currently, but inspectors will continue to monitor the areas.

*PL-9. Sand Deposit on Containment Dam*

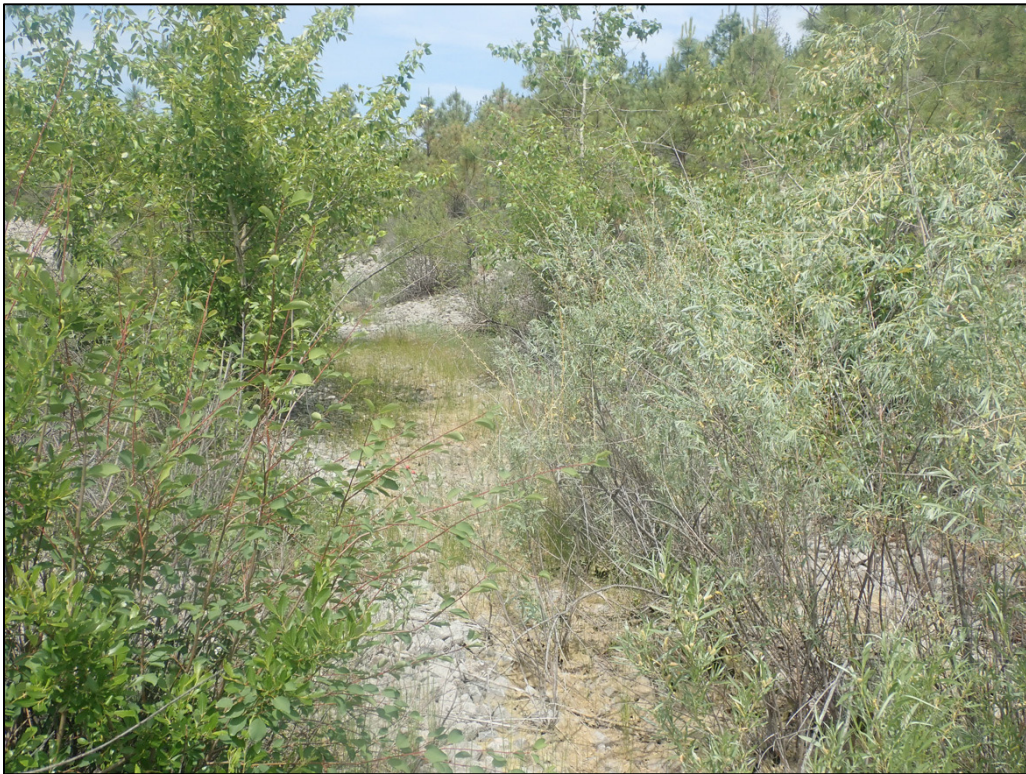
A riprap-armored diversion channel surrounds the disposal cell, diverting runoff away from the cell. The diversion channel was designed to allow for sedimentation and for vegetation to establish over time. Trees, shrubs, grasses, and wetland plants have established in most areas of the diversion channel (PL-10). Sediment deposition is found in many places in the diversion channel, and trails in these areas indicate that wildlife frequently access the cell for forage and water. No evidence of erosion was observed downgradient of the diversion channel outlets. No maintenance needs were identified.

*PL-10. Armored Diversion Channel*
