Inspection Status Report of Site A/Plot M

Report for 2023

2023 Inspection Status Report of Site A/Plot M

September 2023

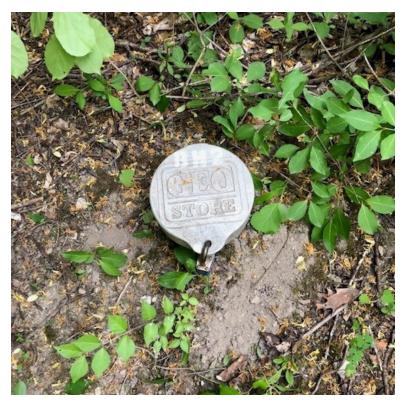
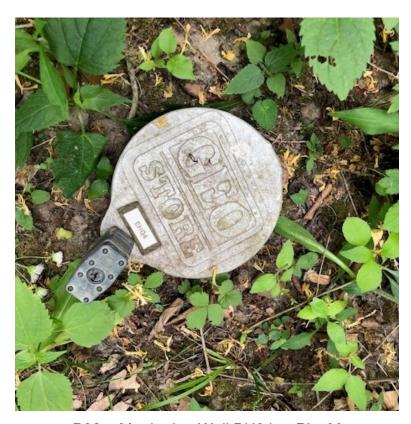
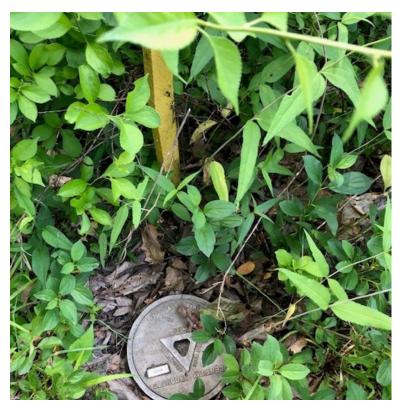
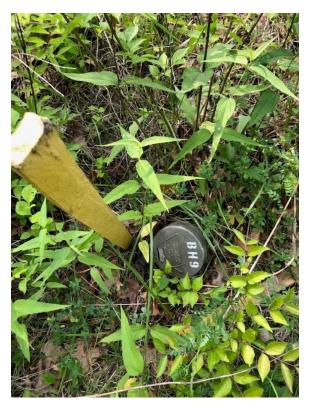
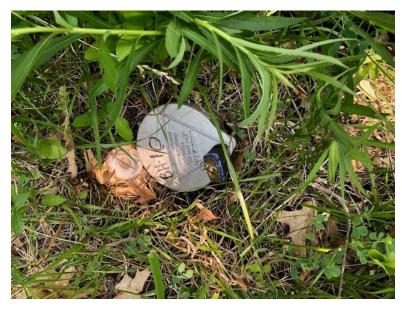
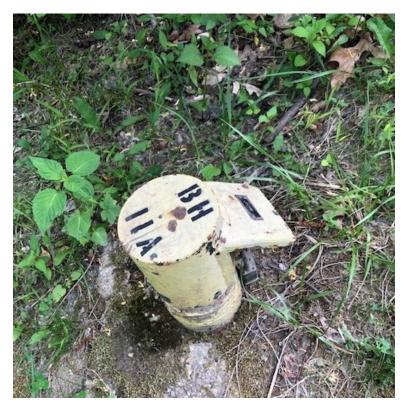
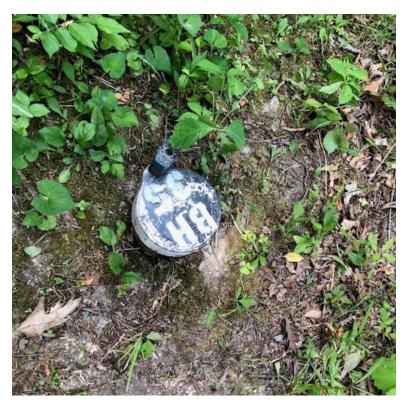
this report. Photographs P01 through P09 show the various monitoring wells at Plot M. Argonne personnel are keeping the Plot M monitoring wells secure and in good condition.

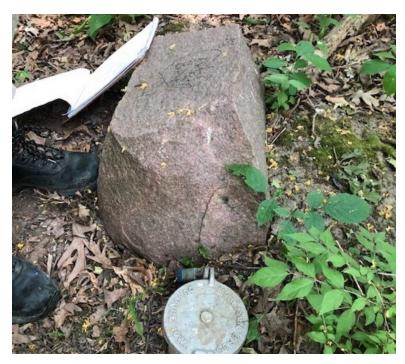
P07- Monitoring Well BH26 (Before) at Plot M

All groundwater wells at Plot M were locked and intact and found to be in good condition. During the inspection, Argonne noted that the identification found on the well cap to BH26 was absent. Immediate action by Argonne involved re-painting and affixing a new label to the BH26 well cap. This was cited as an improvement opportunity, and further discussed in Section 5.0 of

2. **Improvement Opportunity #2:** Repaint and/or affix a new label to Plot M well cap BH26.

Corrective Action: Argonne personnel repainted the label and affixed a new label to properly identify the Plot M monitoring well BH26, at the time of the inspection.

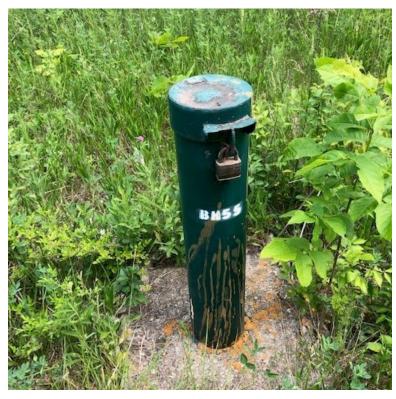
P10 – Monitoring Well BH55 at Site A

The locations of the two groundwater wells at Site A are shown in Figure 4.4. Both wells, BH55 and BH56, were found to be locked and intact and in good condition, with the well numbers visible on the outer casing. Photographs P10 and P11 show the two monitoring wells, BH55 and BH56, respectively, at Site A. Argonne personnel are keeping the two monitoring wells secure and in good condition at Site A.

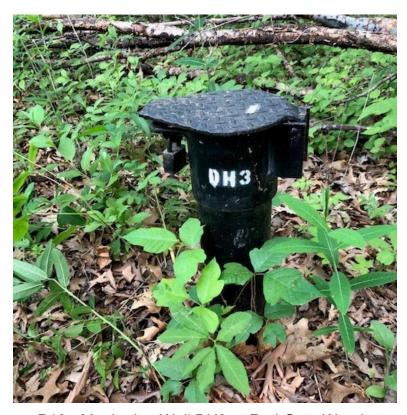
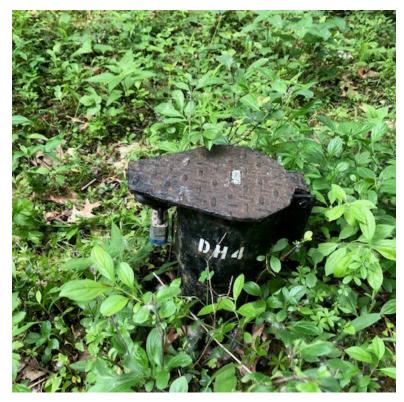
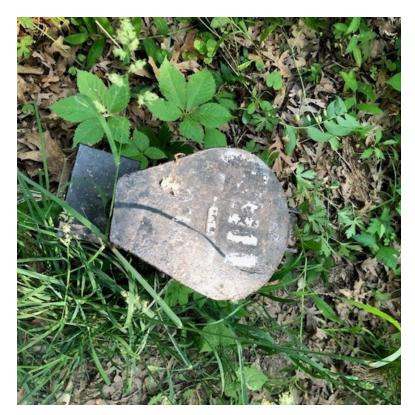
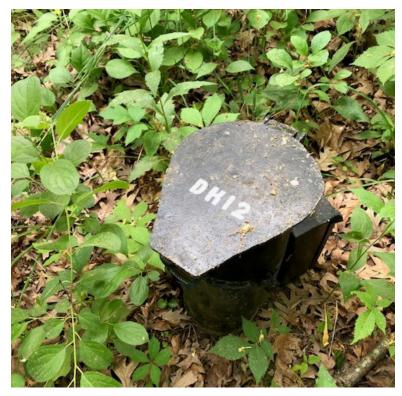
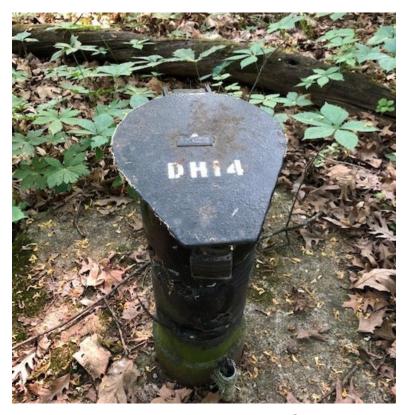
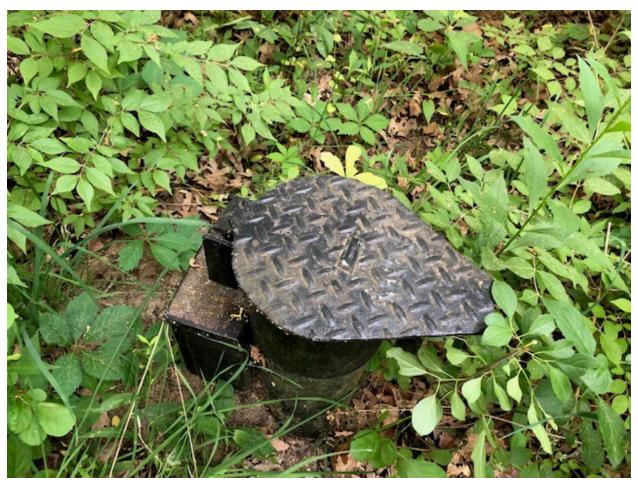
Six dolomite wells, shown in Photographs P12-P17, were all locked and intact and in good condition with all well numbers on the outer casing. Argonne personnel are keeping the Red Gate Woods monitoring wells secure and in good condition.

Six wells cased into the dolomite bedrock are located downgradient of Plot M. One of the dolomite wells is located near Plot M, and five are located north of Plot M in the Red Gate Woods area, as shown in Figure 4.5. The two dolomite wells, DH03 and DH04, are located close to and downgradient of Plot M. All six of these wells are shown in photographs P12 through P17.

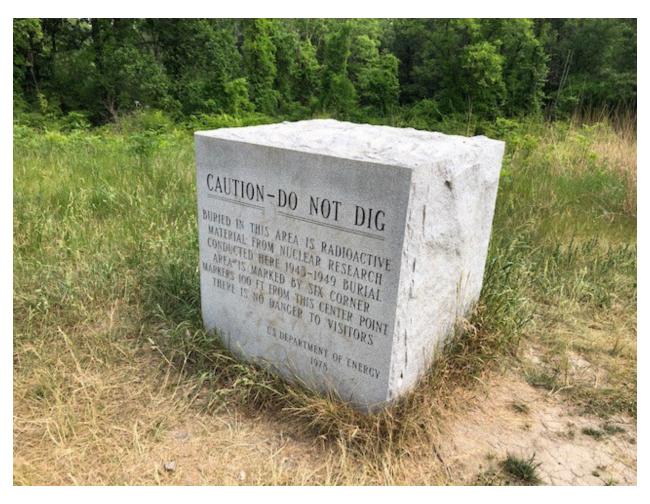
P18 - Plot M Monument, Front View

The Plot M monument was replaced in May 2021. Several letters had been chiseled off the old monument by vandals as reported several years ago. Photographs P18 and P19 show the new monument at Plot M; it remains in good condition. During the inspection, graffiti, which appeared to be made using charcoal, was observed on the rear face of the Plot M monument. Noted as an improvement opportunity, and further discussed in Section 5.0 of this report, Argonne will remove the graffiti. All six corner markers of Plot M were located during the inspection and found to be in good condition. Photograph P20 shows one of the Plot M corner markers, with the Plot M monument in the distant background. Erosion controls have been reasonably effective with the addition of four additional landscape timbers installed in 2020 along the north trail. Argonne conducts quarterly maintenance reviews of the cap and north trail. Photograph P21 shows the terraced steps along the eastern slope of Plot M. Photograph P22 shows erosion control measures recently carried out by Argonne in the Spring of 2023.

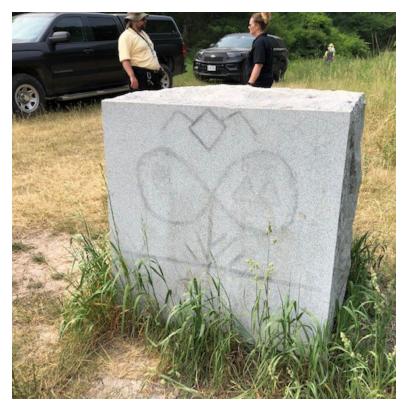
P19 – Plot M Monument, Rear View, with IEMA Representatives in Background

1. **Improvement Opportunity #1:** At the time of the inspection, the rear of the Plot M monument was observed to have been tagged with graffiti, which appeared to be made using charcoal.

Corrective Action: Argonne personnel will remove the graffiti from the rear of the Plot M monument prior to November 1, 2023.

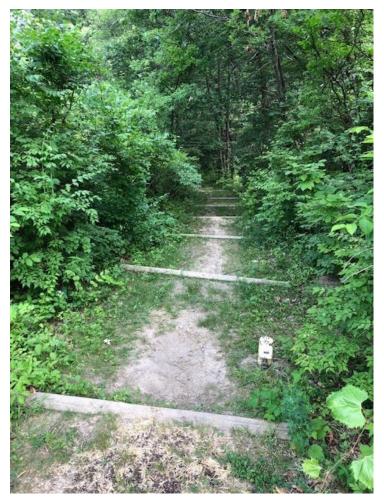
P21 – Terraced Steps Along Eastern Slope of Plot M

During the May 2018 Annual Inspection, increased erosion was noted along the path from the northeast corner of Plot M heading down towards the creek. Twelve timber steps were installed by Argonne during the Summer 2018 to reduce erosion along the northeast trail. In 2020, four additional timber steps were installed on the steep, top portion of the northeast trail. During the Spring of 2023, additional erosion control measures at this location, such as the addition of clay and topsoil, grass seeding, followed with the placement of biodegradable turf netting, were carried out by Argonne personnel. At the time of the inspection, it was observed that the installation of the additional timber steps and erosion control measures has been effective in reducing erosion along this trail.

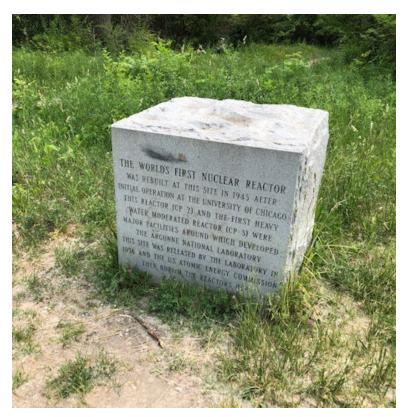
P23 - Site A Monument, Front View

The Site A monument was replaced in May 2021. Visible cracks were present in the old monument. Photographs P23 and P24 show front and rear views, respectively, of the new monument at Site A, which remains in good condition. At the time of the inspection, a small amount of graffiti, which appeared to be made using charcoal, was observed on the front and near the top surface of the Site A monument. Argonne identified this as an improvement opportunity and is further discussed in Section 5.0 of this report.

3. **Improvement Opportunity #3:** During the inspection, the front, near the top surface, of the Site A monument was observed to have been tagged with graffiti, which appeared to be made using charcoal.

Corrective Action: Argonne personnel will remove the graffiti from the front of the Site A monument prior to November 1, 2023.
