# **2024 Annual Inspection Report for the DOE Monticello, Utah, Mill Tailings Site and Monticello Vicinity Properties**

**December 2024**

Legacy  
Management

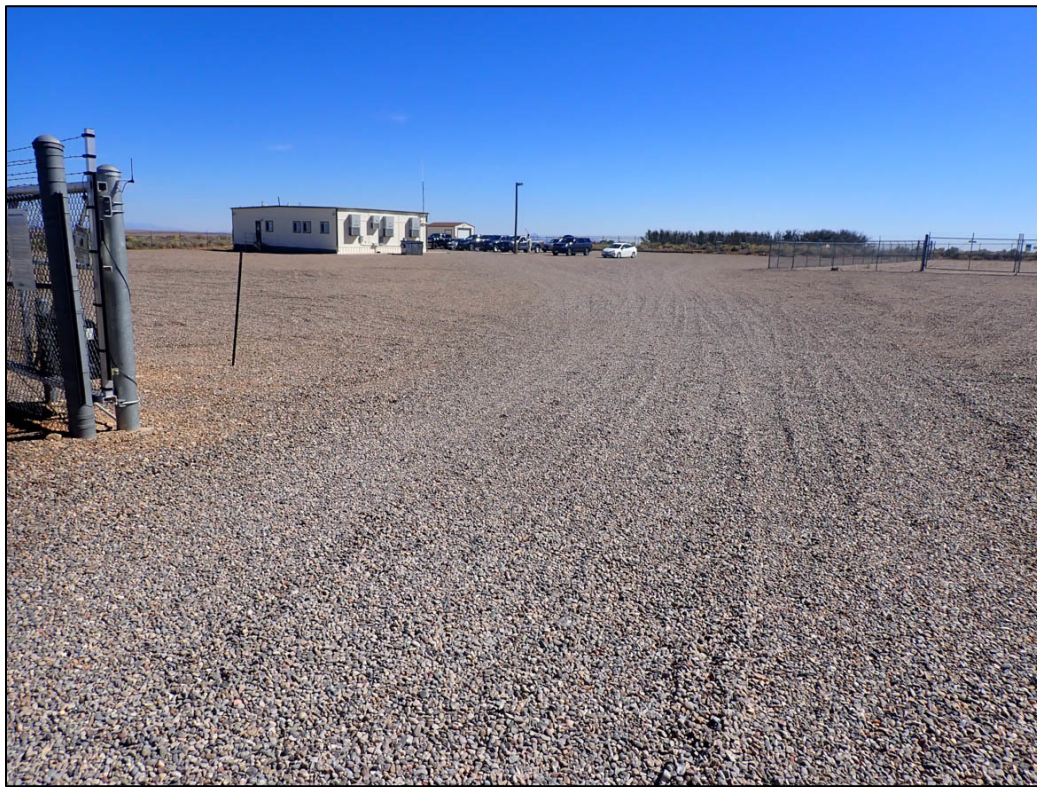
The Monticello field office buildings and associated structures were in excellent condition and well maintained (PL-1). Video surveillance cameras are inside and outside of the main office building. Site access signs displaying contact information were visible and in good condition (PL-2). The site's paved access road was in very good condition.

*PL-1. Field Office and Associated Structures*

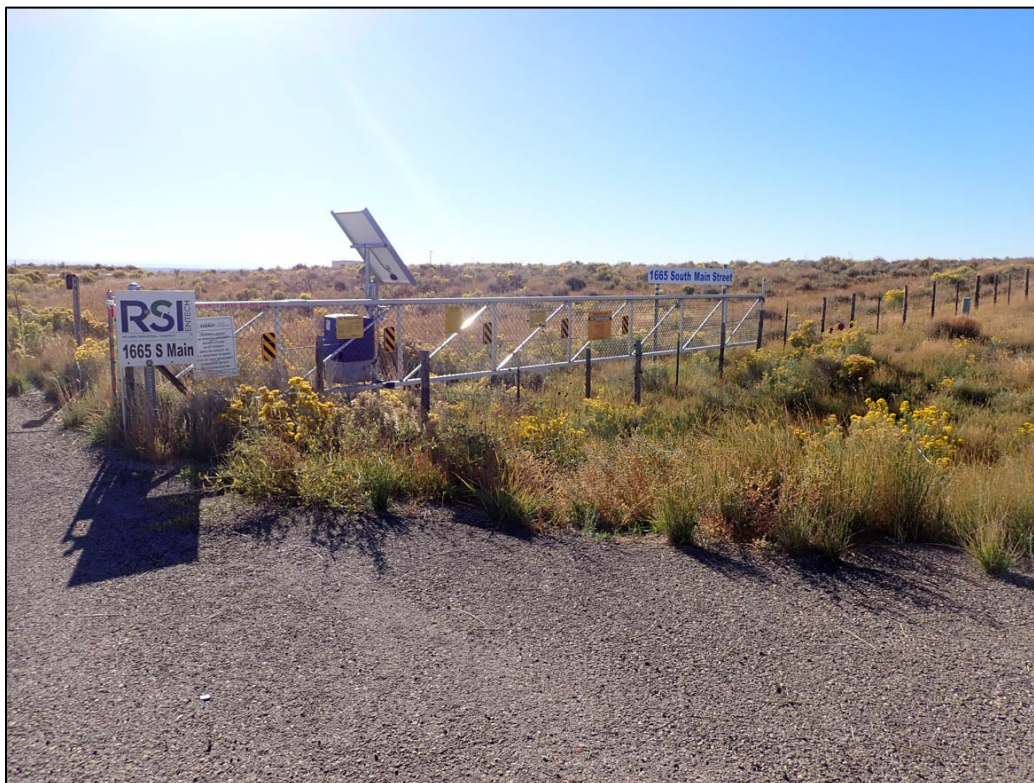
*PL-2. Main Entrance Site Gate with RSI EnTech, LLC, Postings*

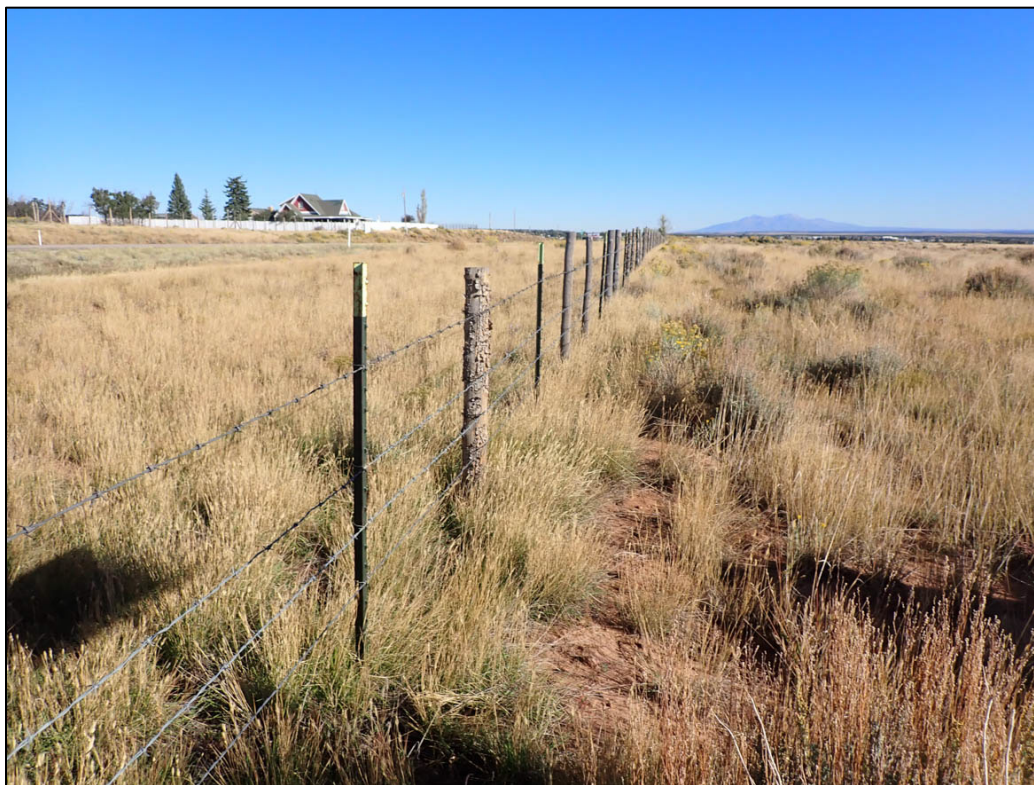
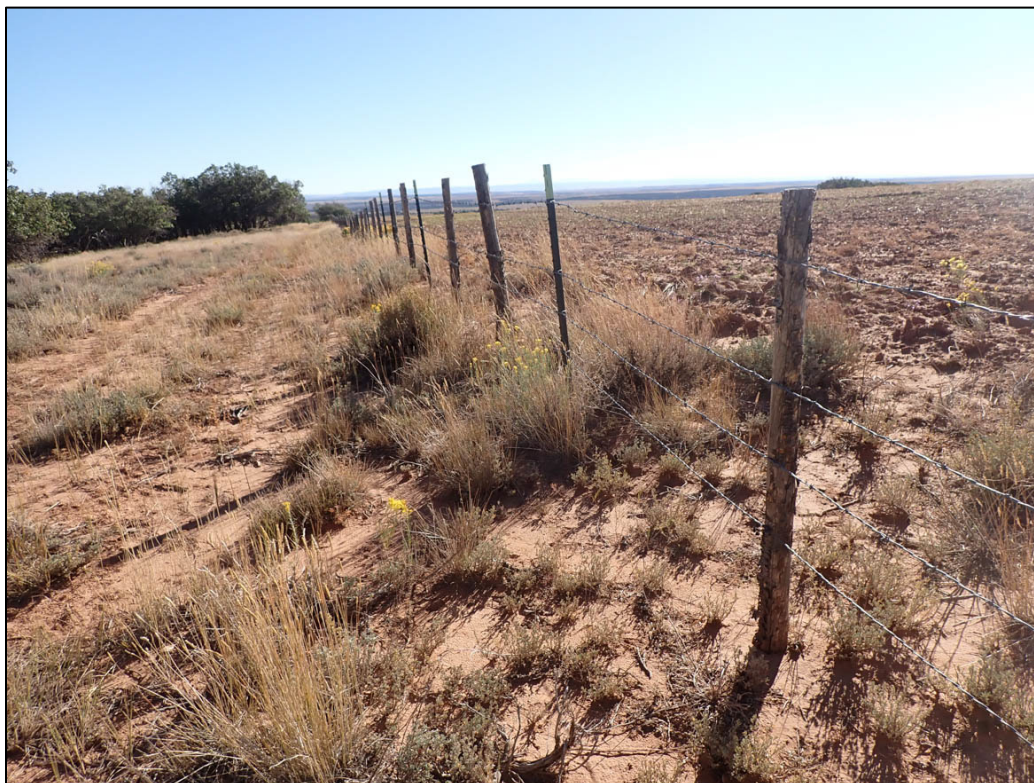
The north, south, east, and west perimeter fences were in good condition (PL-3, PL-4). There was no evidence of vandalism. Areas of excessive vegetation was identified along the southern fence line. The vegetation does not hinder the function of the fence but will need to be treated with herbicide in 2025. There was no debris buildup.

*PL-3. West Fence Line Looking North*

*PL-4. South Boundary of Wildlife-Friendly Fence, Looking East*

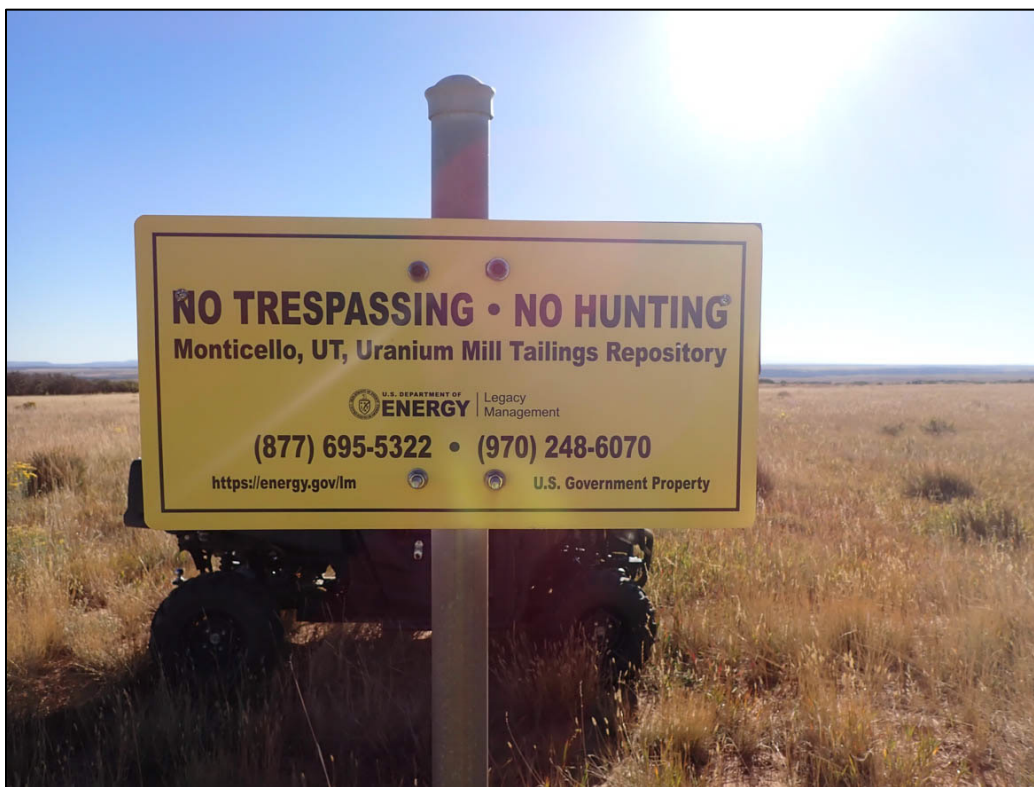
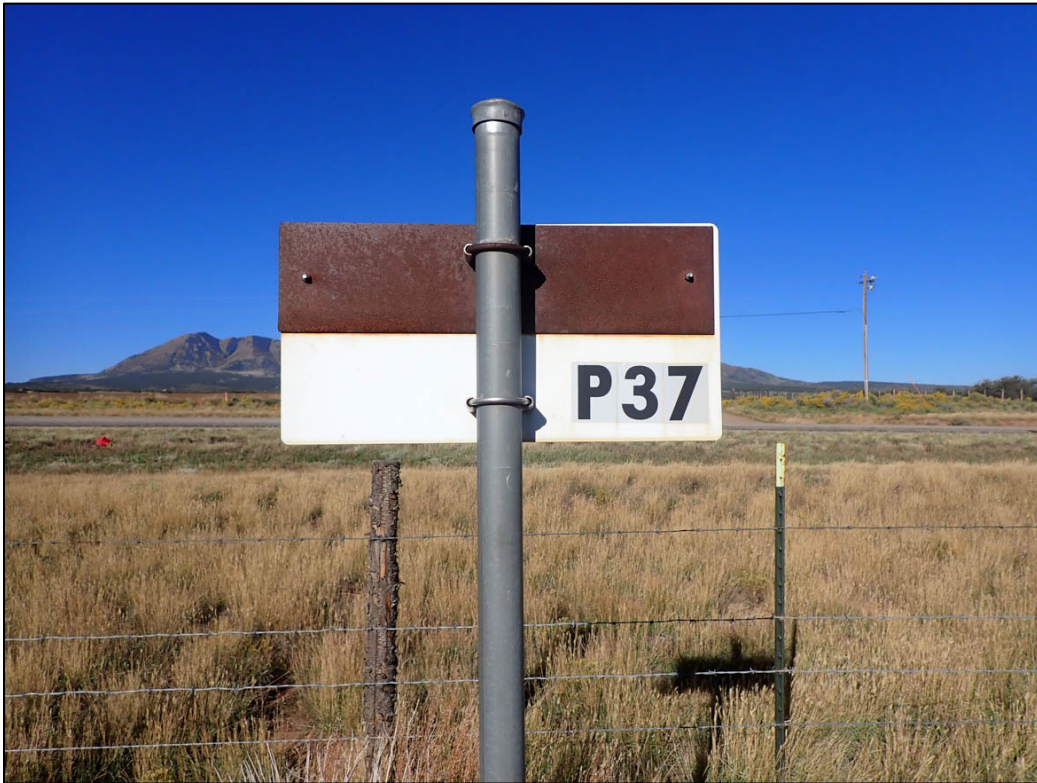
All perimeter signs were in good condition (PL-5, PL-6). Black-numbered decals to identify sign numbers were in good condition.

*PL-5. Perimeter Sign P37, Front Label*

*PL-6. Perimeter Sign P37, Back Label*

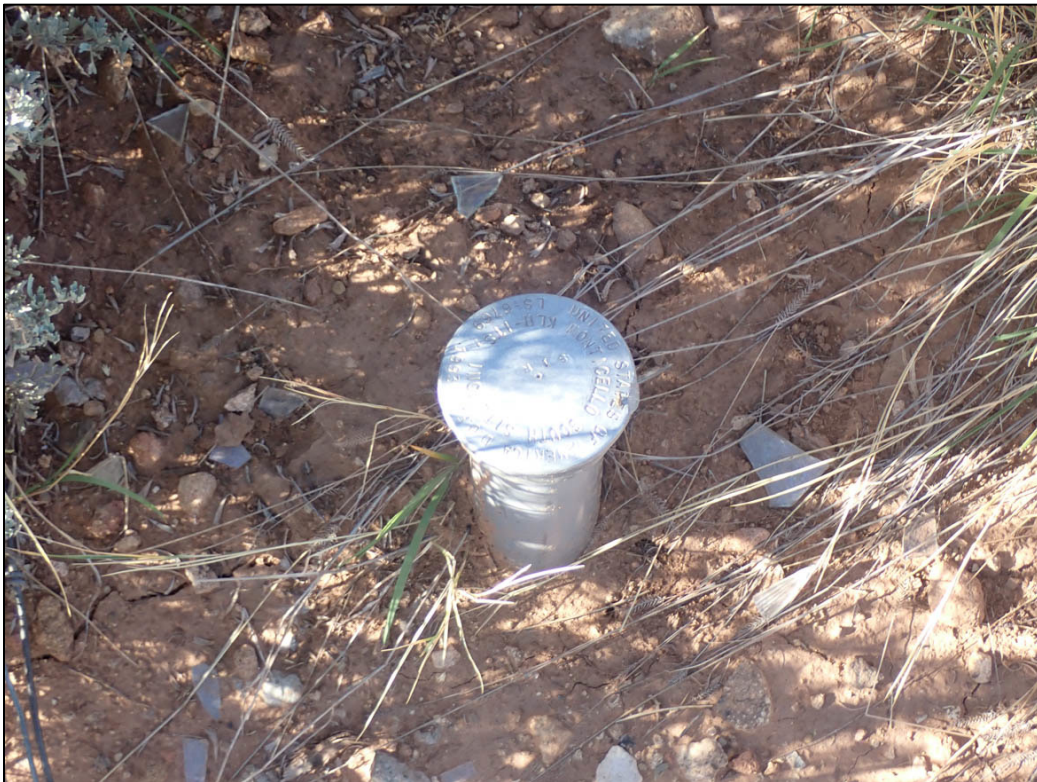
All six boundary markers were located during the inspection, and all were in good condition (PL-7).

*PL-7. Boundary Survey Marker S1R*

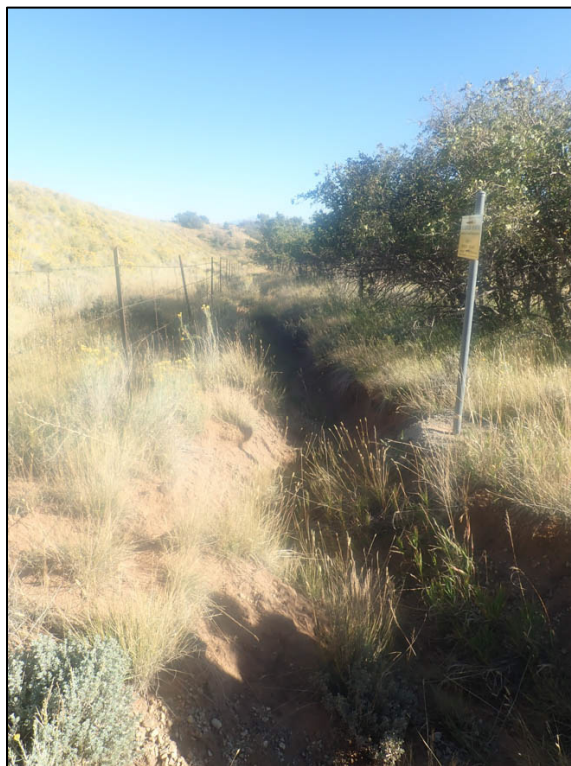
*PL-8. Looking North Toward Perimeter Sign P1 (No Change in Erosion Channel)*

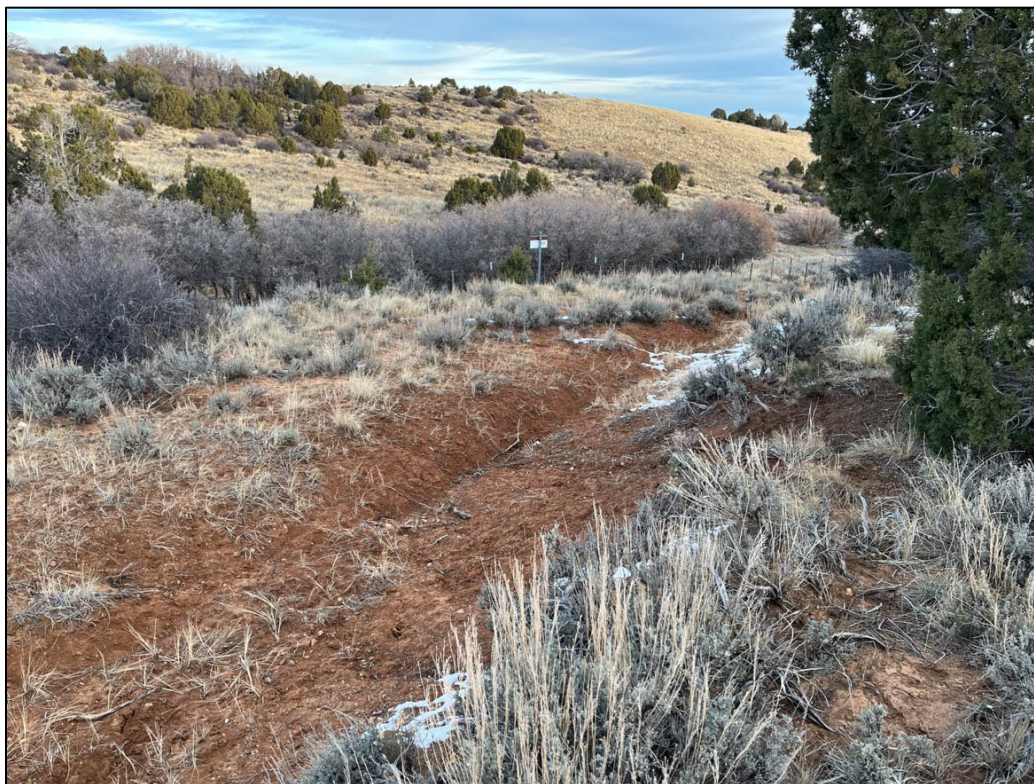
Erosion channels and drainages around the site perimeter were generally well vegetated and had not changed significantly since the 2023 annual inspection. Erosion controls and revegetated areas related to the GRO system were in good condition, and no major erosional areas were noted. The deep gully on the west edge of the disposal site described in previous inspection

*PL-9. Erosion Gully Near Perimeter Sign P7, Looking Northeast*

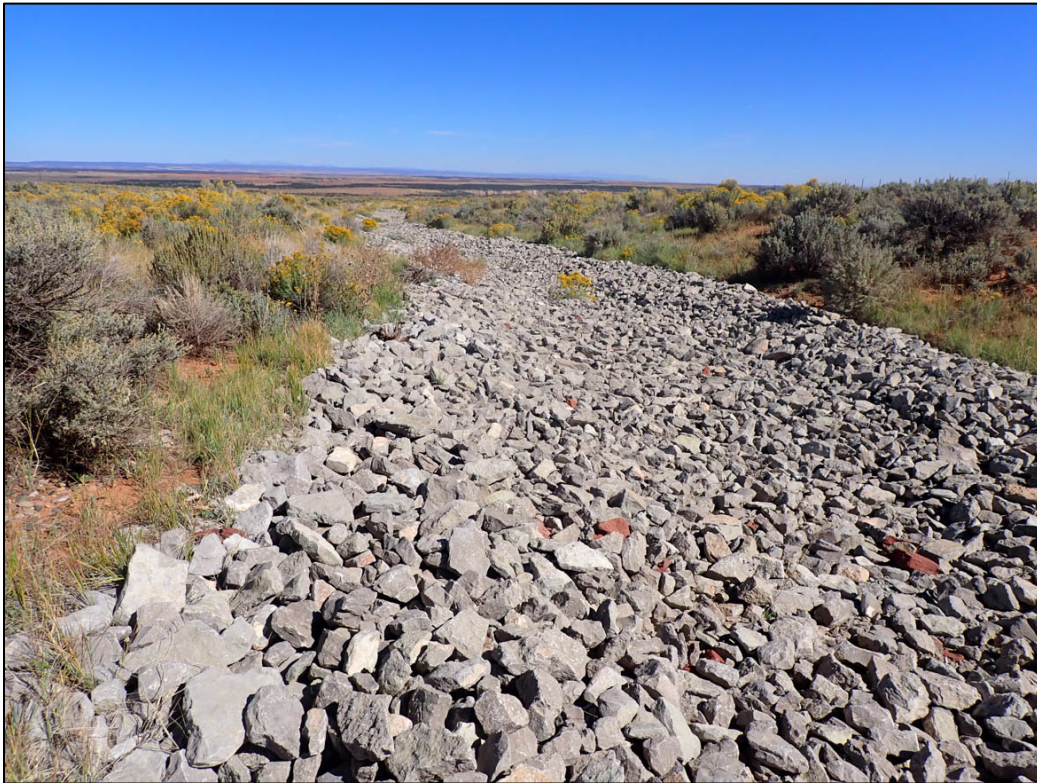
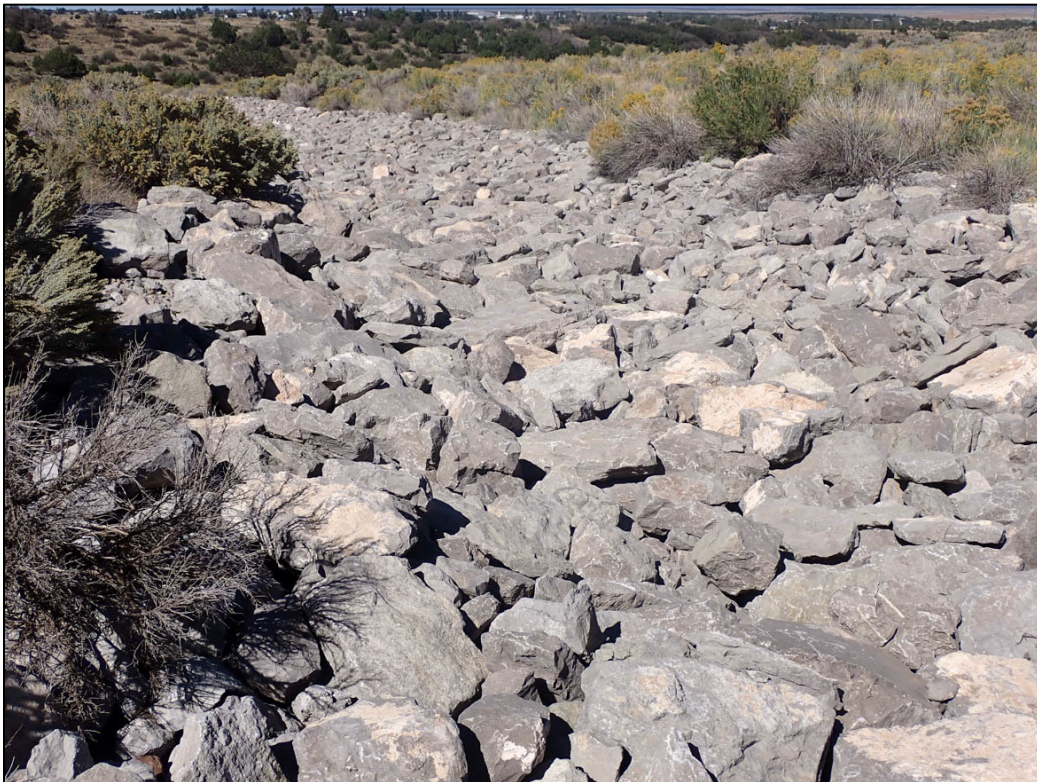
The South and West Drainage Channels were in good condition (PL-10, PL-11). Small erosion rills, repaired in October 2020, on the West Drainage Channel were in good condition. Small amounts of young shrubs were found inside the West and South drainage channels. The shrubs inside the drainage are small enough to be treated with herbicide in fall 2025. Burrows from small rodents that are found in places along the margin of the channels do not threaten the channels' integrity.

*PL-10. South Drainage Channel, Looking East*

*PL-11. West Drainage Channel, Looking North*

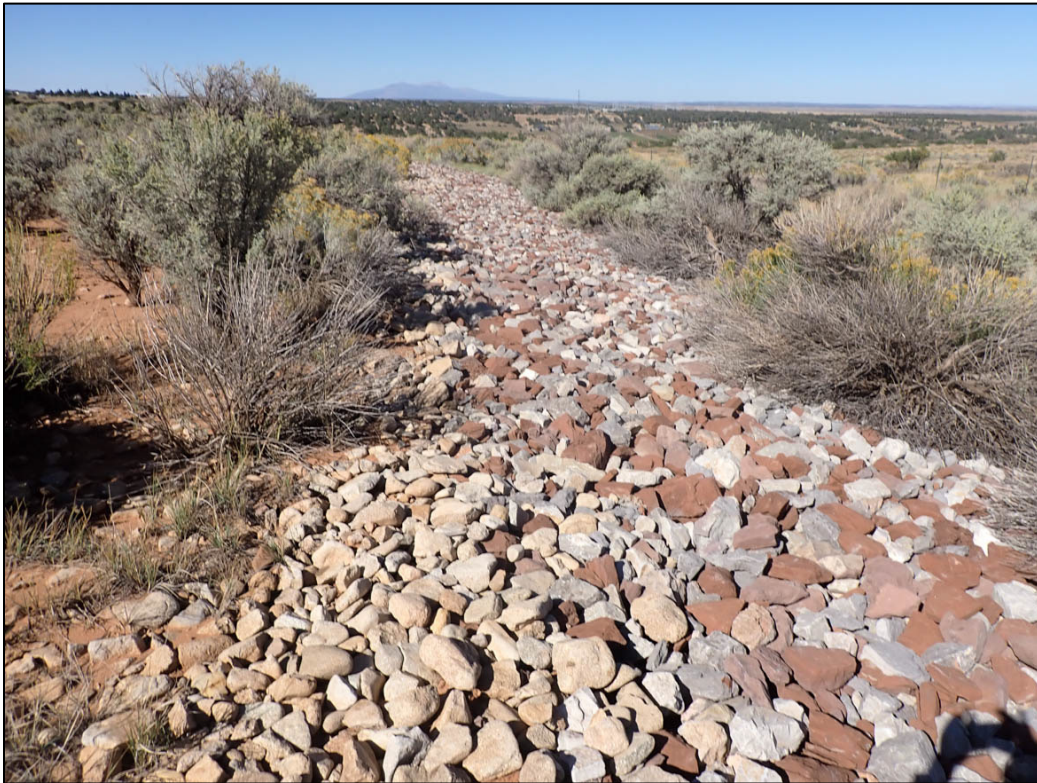
The East Toe Trench and North Toe Trench were in good condition. No erosion of these trenches was evident. Beginning in 2013, inspectors observed increased siltation from the repository side slope into both toe trenches during heavy rainfall events. The siltation does not impair the functioning of the trenches (PL-12).

*PL-12. East Toe Trench, Looking North*

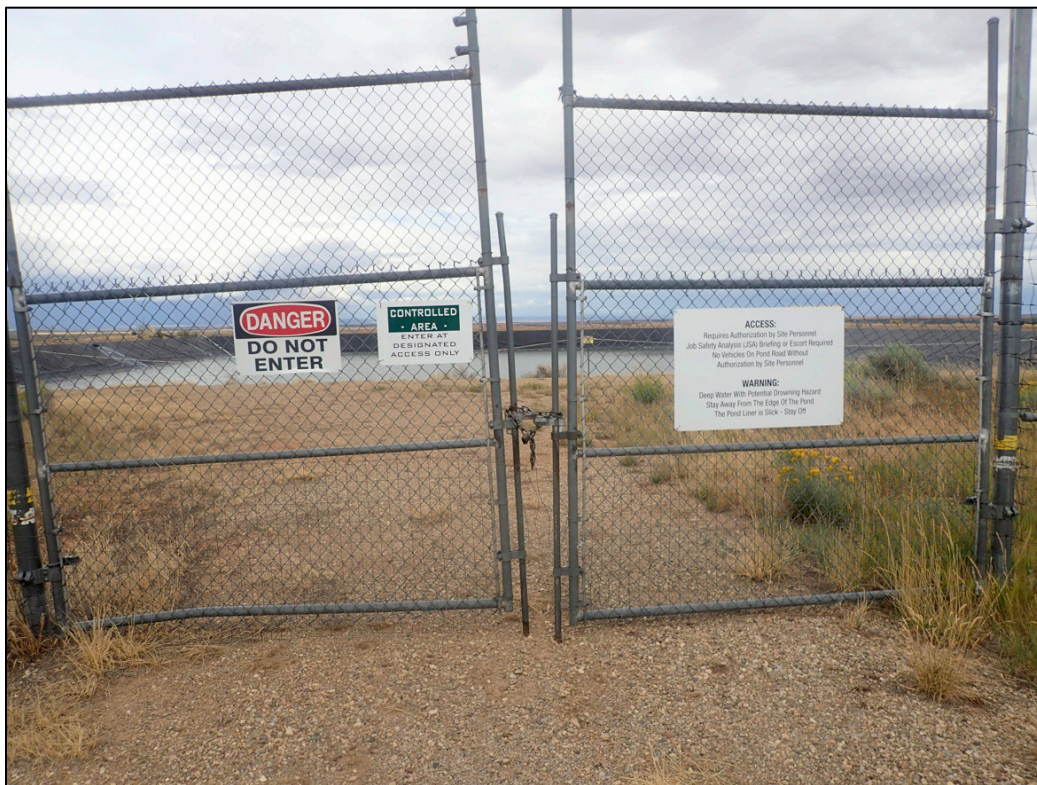
All gates were in good working condition. Warning signs on the perimeter fence were easily visible and legible. There was no evidence of vandalism or trespassing, and all gates were locked at the time of the inspection (PL-13).

*PL-13. Pond 4 Entrance Gate with Postings*

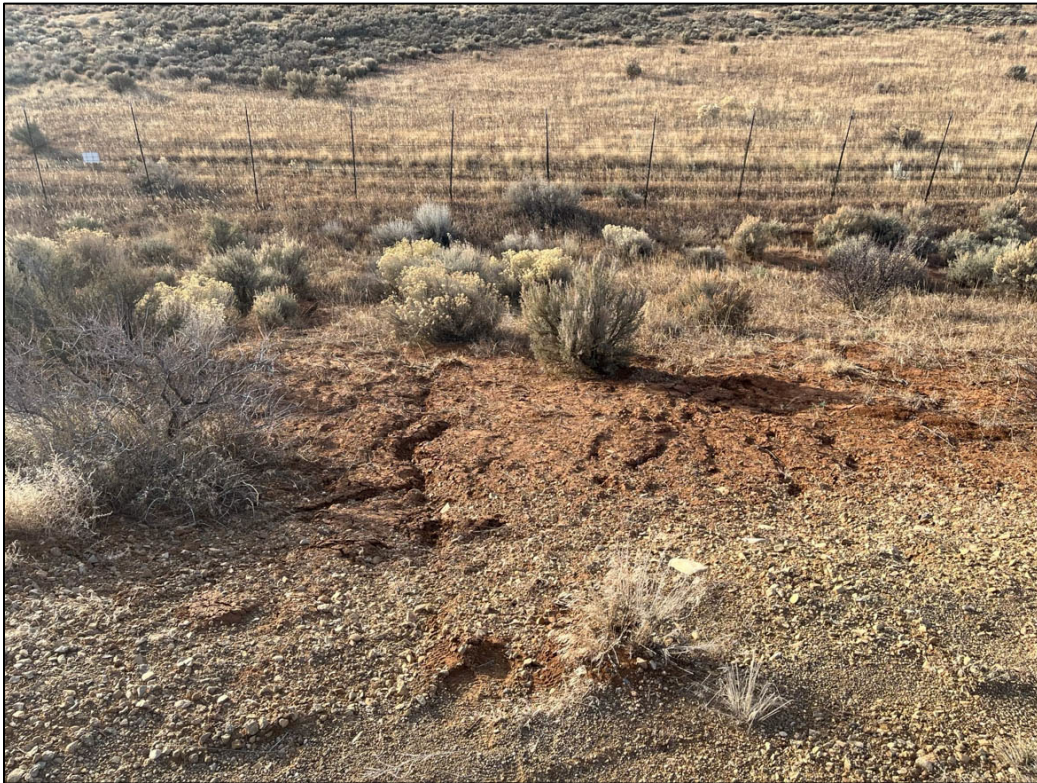
The water in Pond 4 was approximately 6.95 feet deep at the time of the inspection, due mostly to the operation of the GRO system. Only the exposed liner was inspected. The exposed liner on the east side of the pond had two holes located approximately 8 feet above the waterline along the welded seams (PL-18 and PL-19). The function of the liner is not impaired, and repairs are scheduled tentatively for spring 2025. New erosion was present on the east slope of the Pond 4 berm. The erosion does not affect the integrity of the berm but will continue to be monitored.

*PL-14. Erosion on the South Slope of Pond 4 Berm, Looking South*

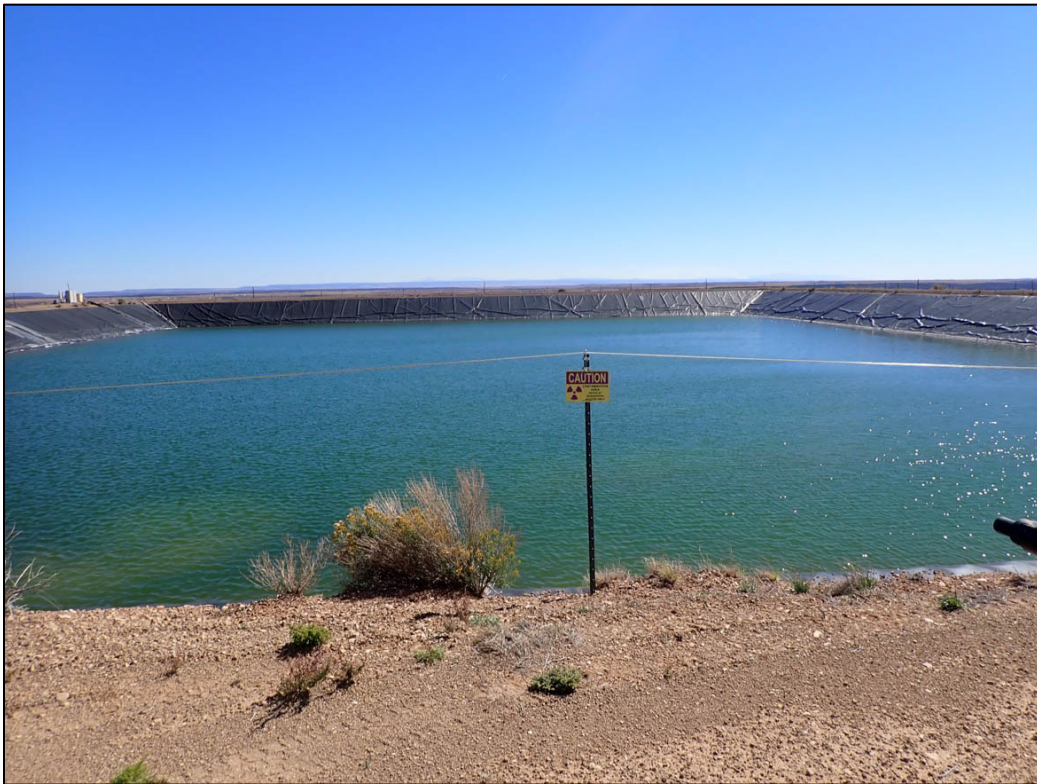
The pond's new wire radiological rope barrier was intact and in good condition. The vegetation along the pond's access road was mowed and the road is in good condition. Animal burrows made by voles and other small rodents were visible on and below the pond's berm on all sides. However, no large burrows that might threaten the berm's integrity were found. Vegetation on the slopes of the berm was well established and healthy. New erosion was present on the south slope of the Pond 4 berm (PL-14). The erosion does not affect the integrity of the berm but will continue to be monitored. Pond 4 is shown in PL-15. The fence around Pond 4 was in good condition.

*PL-15. Pond 4, Looking East*

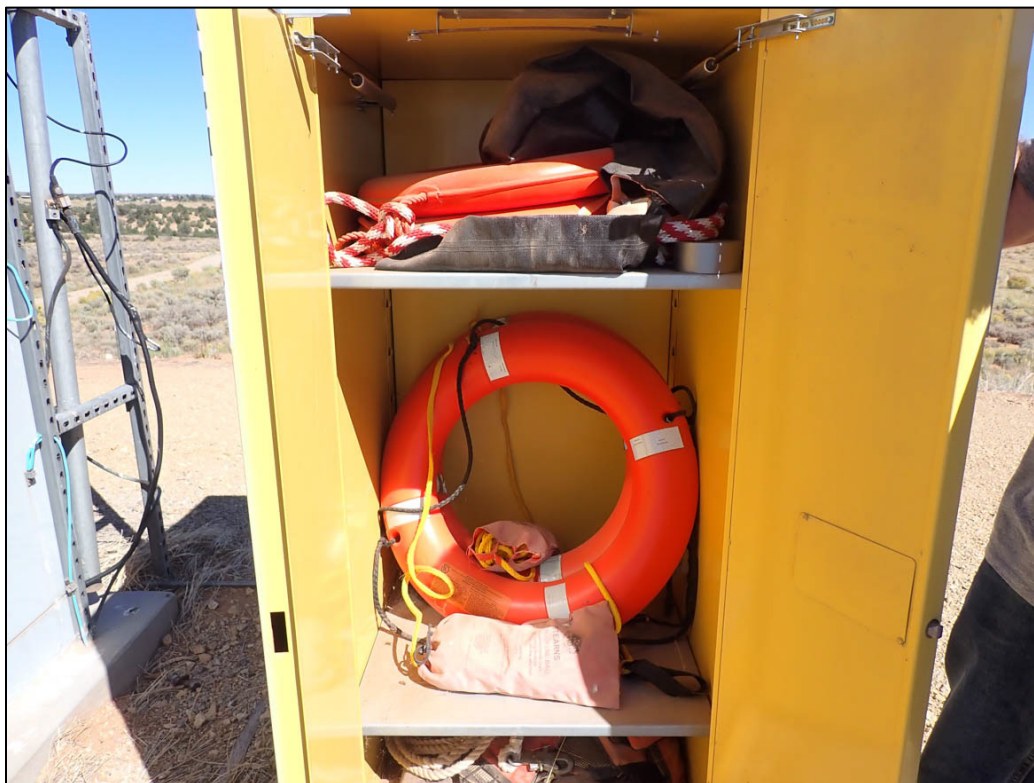
Lifesaving rings and a rescue and work skiff were present and easily accessible near the pond. Cabinets containing water rescue equipment were also highly visible, adequately labeled, and in good condition (PL-16).

*PL-16. Pond 4 Safety Equipment and Cabinet Interior*

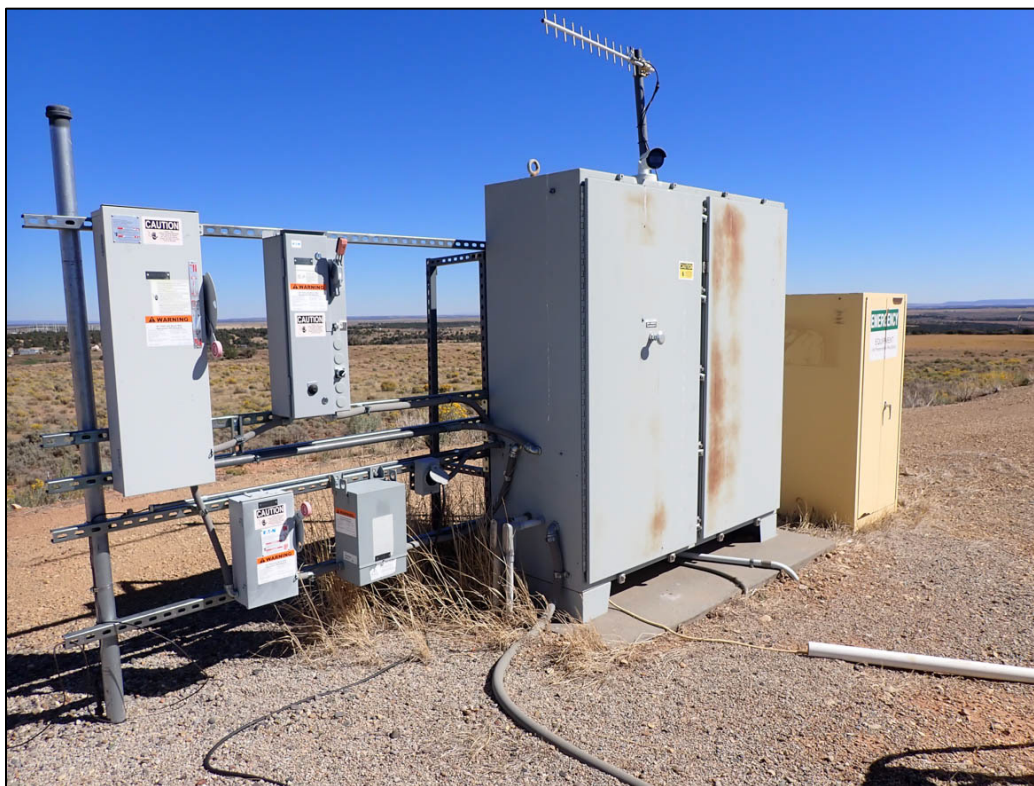
The weatherproof LCRS and LDS control cabinet was in good condition (PL-17). Operation of the Pond 4 LCRS and LDS is described in Section 2.1.6.

*PL-17. Pond 4 LCRS and LDS Control Cabinet*

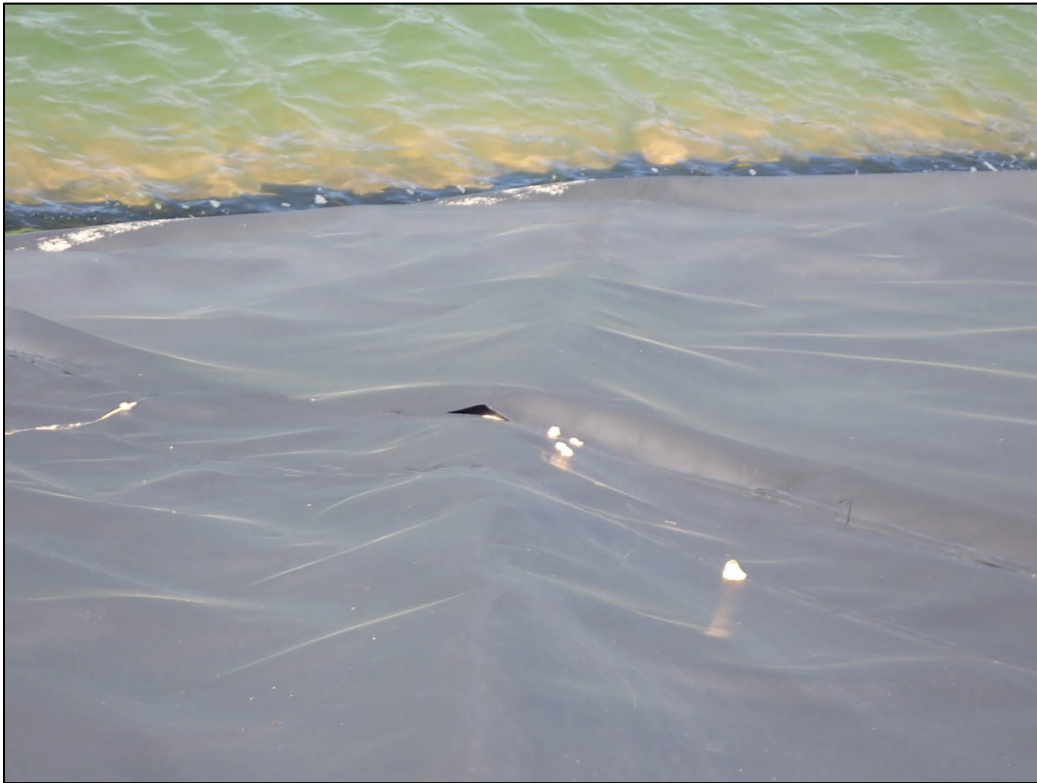
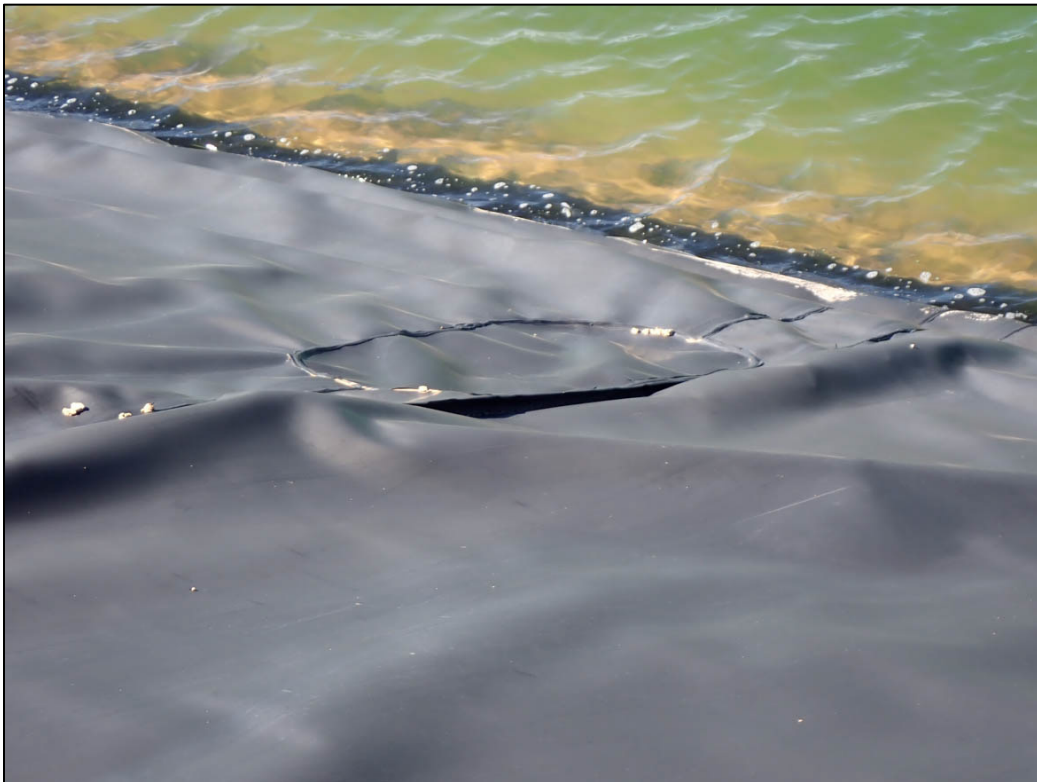
*PL-18. Pond 4 Liner Seam Hole on East Side*

*PL-19. Pond 4 Liner Hole on East Side*

<i><u>There was evidence of rodent biointrusion on the north and west sides, but liner function is not impaired. Continued monitoring is recommended. Two holes were discovered on the east side of the exposed pond liner. The function of the liner is not impaired, and repairs are scheduled tentatively for spring 2025. New erosion was present on the east slope of the Pond 4 berm. The erosion does not affect the integrity of the berm but will continue to be monitored.</u></i>			
<b>C. Repository Cover Inspection</b>			
<b>1. Top Perimeter Road and Road to Pond 4</b>	X Satisfactory	<input type="checkbox"/> Unsatisfactory	
<b>2. Interior Wildlife Fence and Wildlife Gates</b>			
Physical condition is:	X Satisfactory	<input type="checkbox"/> Unsatisfactory	
<b>3. Cover Vegetation</b>	See attached <i>Repository Cover Vegetation Index</i> form; note areas of concern on map		
<b>4. Riprap Armoring</b>			
X Slumping/sliding not evident	<input type="checkbox"/> Slumping/sliding evident (locate on map)

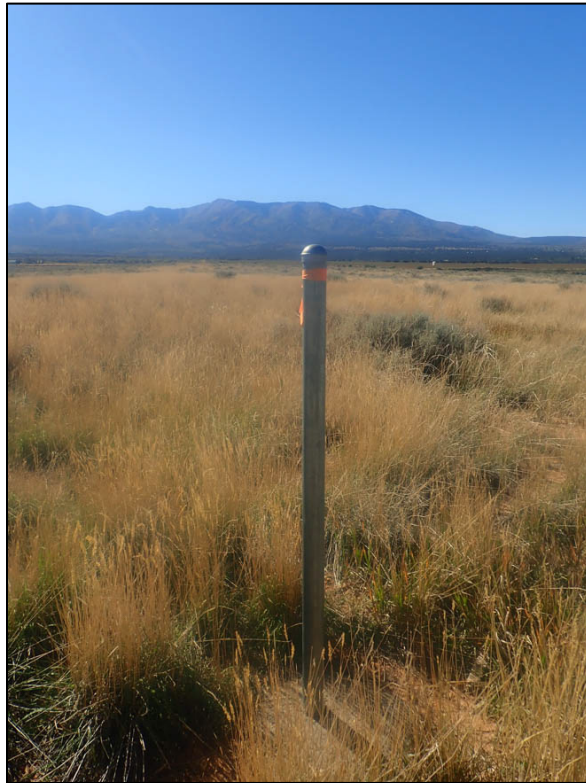
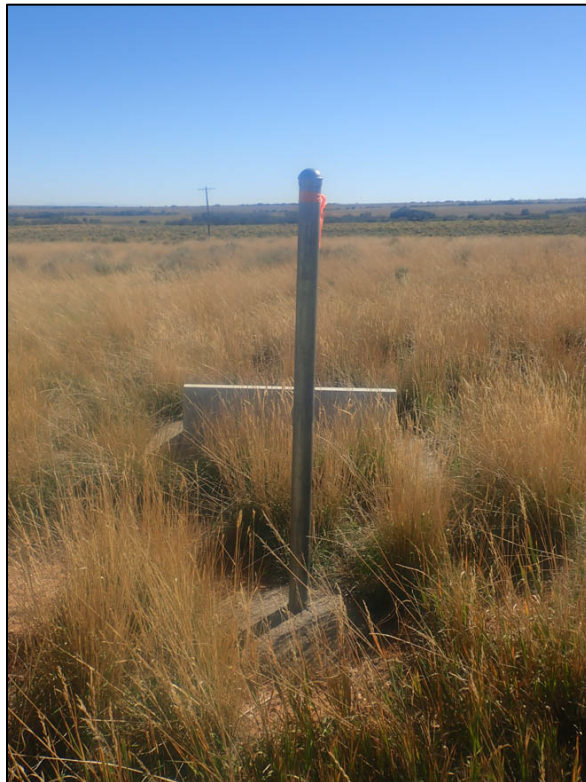
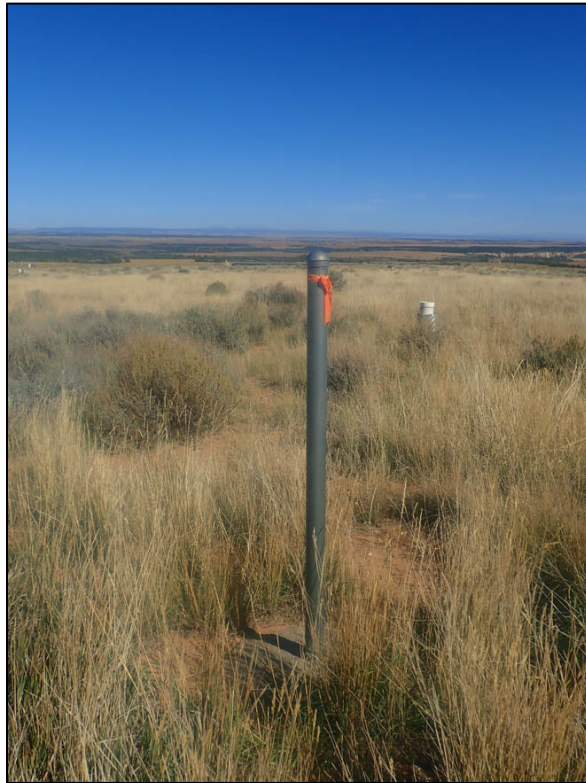
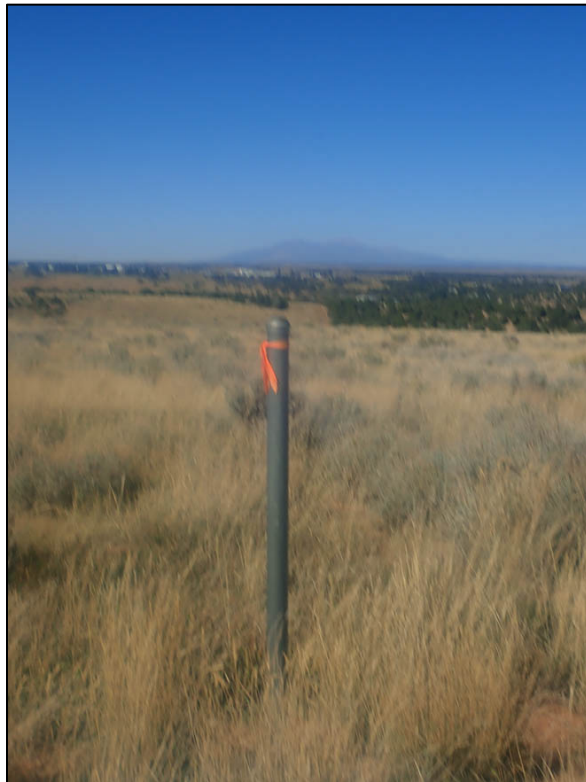
Desirable plants remained well-established on the cover, and no significant barren or eroded areas were identified (PL-22, PL-23, PL-24, PL-25). No damage to vegetation or soils from rainstorms was apparent, and no species of phreatophyte shrubs were growing on the cover. As in recent years, there were many healthy young sagebrush (*Artemisia tridentata*) plants. Standing dead sagebrush was manually removed from the cell top in September 2024 for wildfire mitigation. The small quantity of field bindweed (*Convolvulus arvensis*), which the State of Utah lists as a Class C noxious weed, was still present on the cover, but control was not necessary.

*PL-22. Top of Disposal Cell Cover, Looking West from Site Monument 2*

*PL-23. Top of Disposal Cell Cover, Looking South from Site Monument 2*

*PL-24. Top of Disposal Cell Cover, Looking East from Site Monument 2*

*PL-25. Top of Disposal Cell Cover, Looking North from the Site Monument 2*

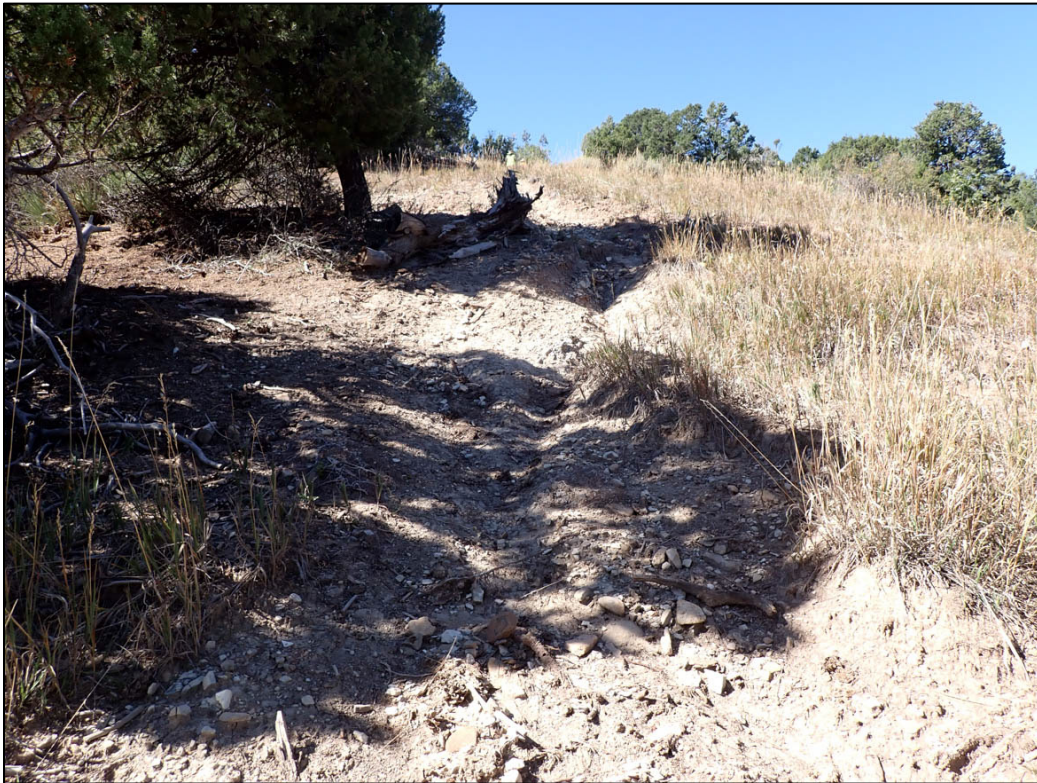
*PL-30. Property MP-01077 Erosion Gully Toward Groundwater Transfer Building, Looking Southwest*

Old and new gully erosions on property MP-01077 will continue to be monitored due to their location uphill from the Groundwater Transfer Building. The function of these areas is not impaired, but continued monitoring is recommended.

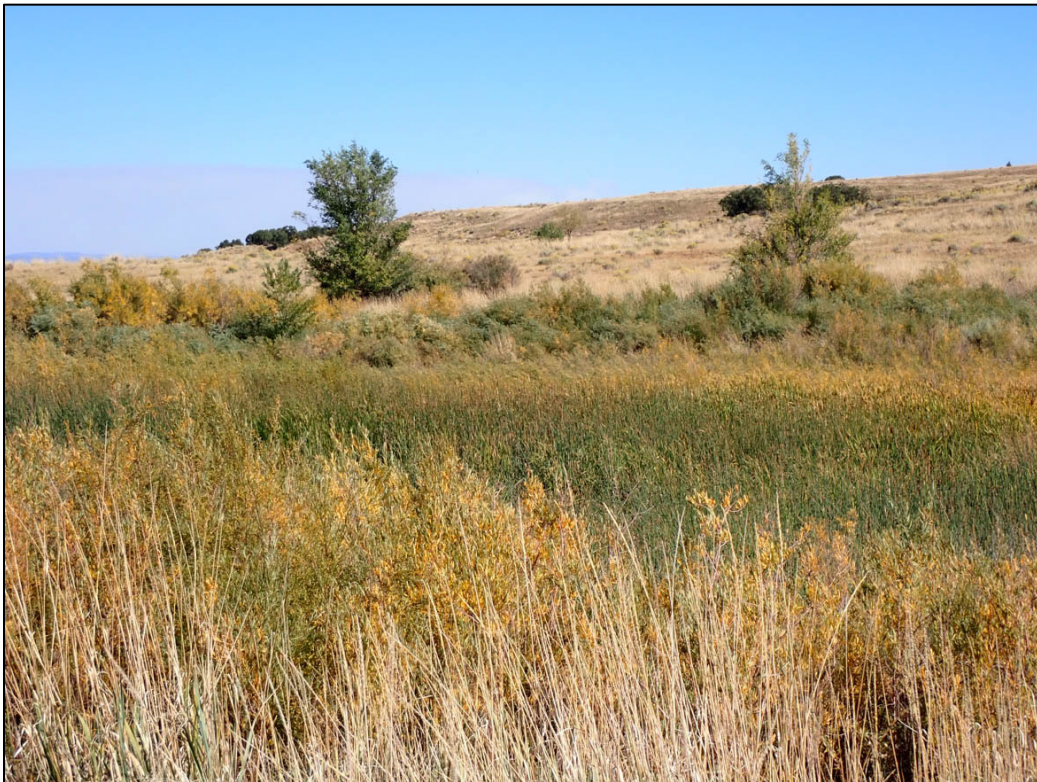
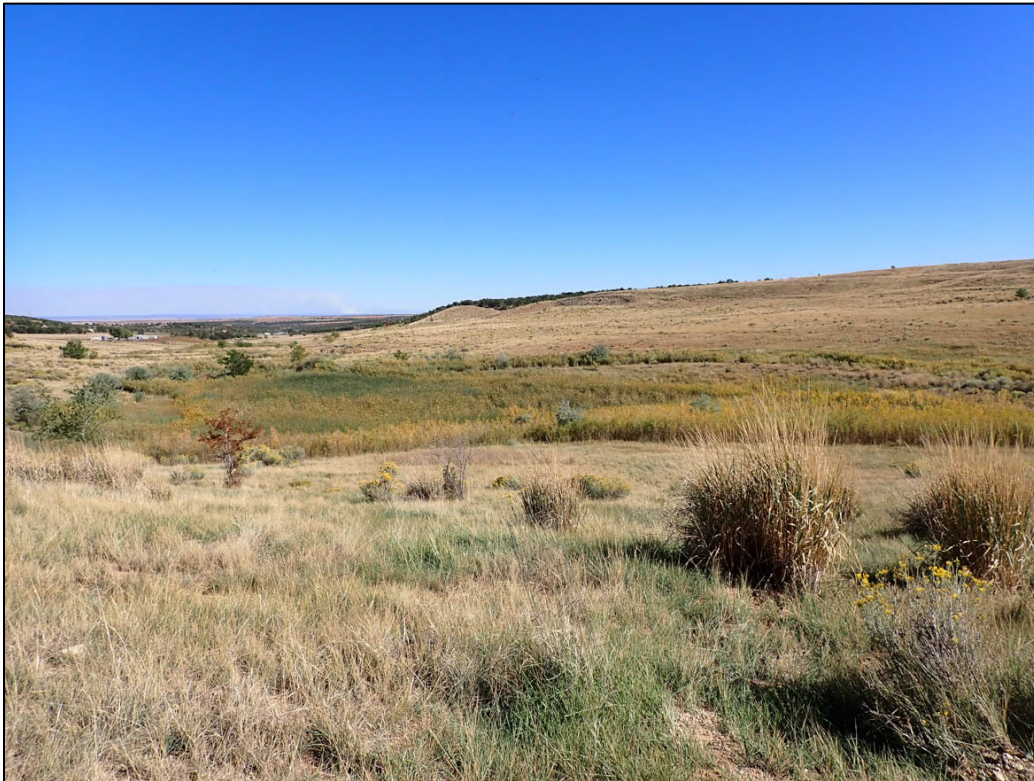
Wetlands 1, 2, and 3 are ecologically healthy and undamaged (PL-31, PL-32). There was no evidence of damage from human activity or natural causes. Upgradient erosion from heavy rain events will continue to be monitored due to its proximity to Wetlands 1 and 2.

*PL-31. Wetland 1 on Former Mill Site, Looking South*

*PL-32. Wetland 2 on Former Mill Site, Looking South*

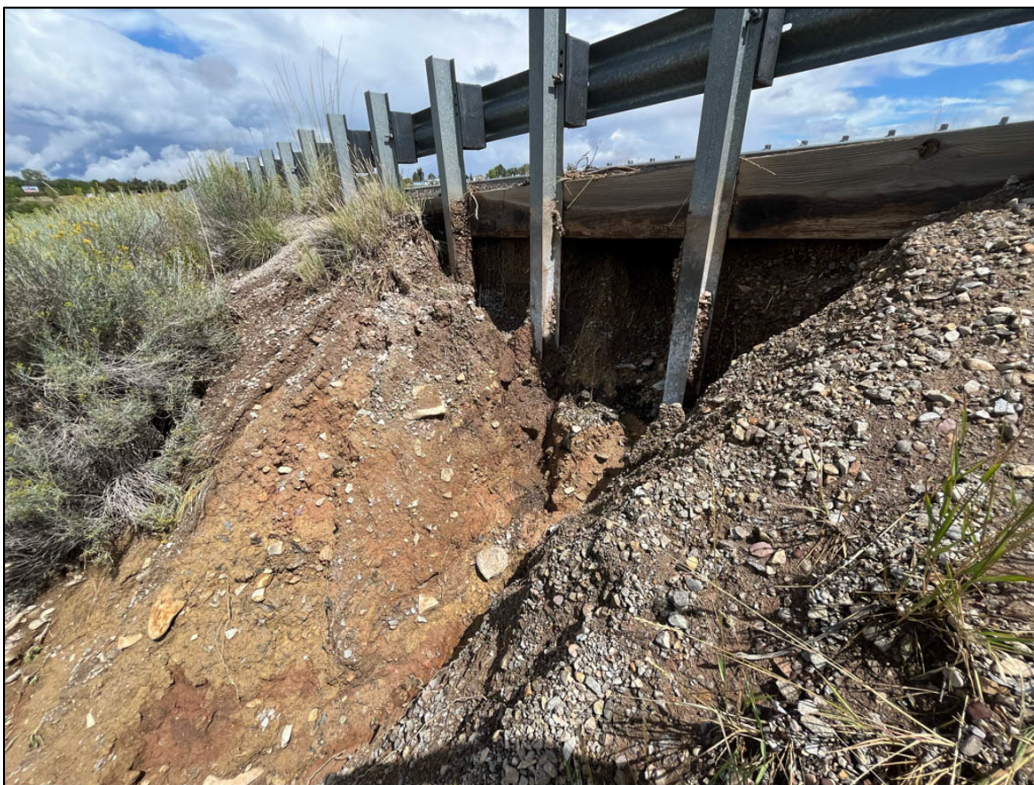
*PL-33. Erosion on West Side of Highway 191 Embankment, Looking North*

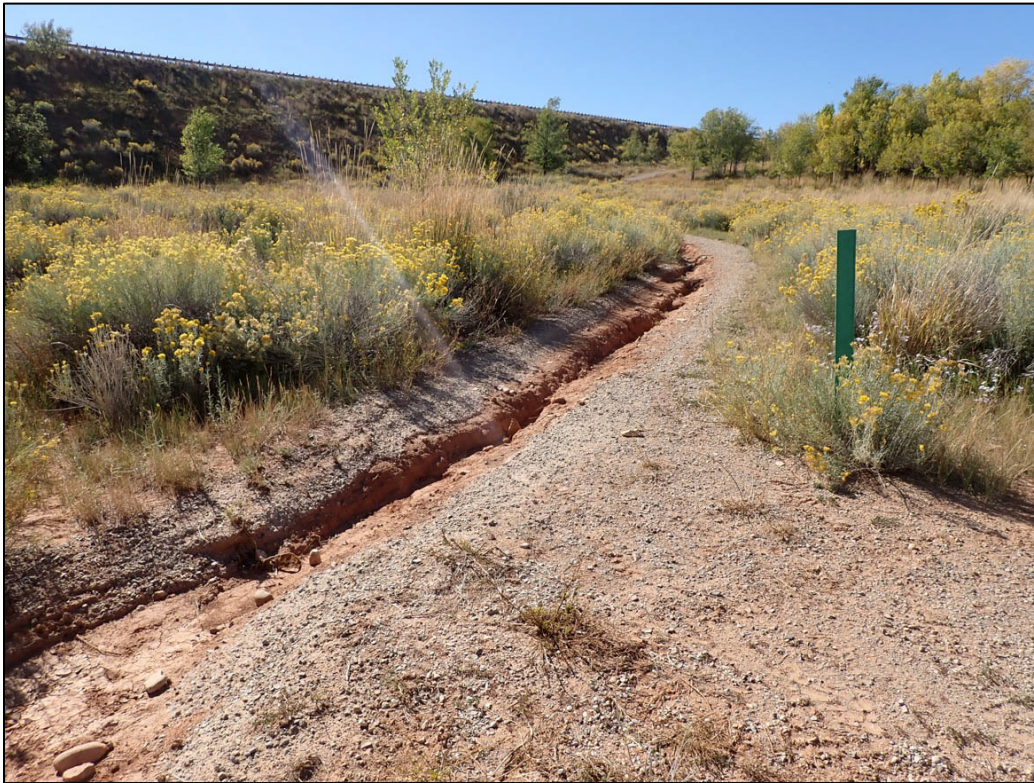
*PL-34. Property MP-00181 Erosion Along Walking Path, Looking Northwest*
