# **2024 Annual Inspection Report for the DOE Monticello, Utah, Mill Tailings Site and Monticello Vicinity Properties**

**December 2024**

Legacy  
Management

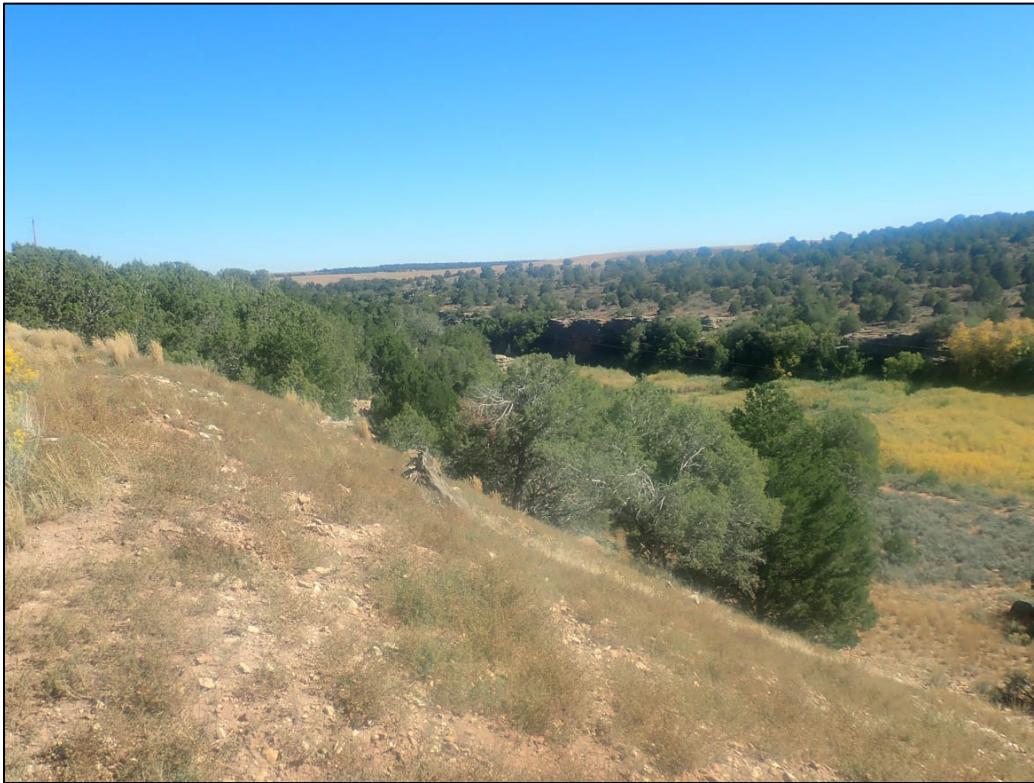
Properties in the Montezuma Creek Restrictive Easement Area are inspected on a regular basis by onsite and water sampling personnel; during these visits, no evidence of significant erosion or soil removal from the restricted areas of these properties was noted. During the 2024 annual inspection, portions of Montezuma Canyon were inspected from observation points above the area, and no evidence of land-use changes or disturbance to the easement area was found. Observations in the easement area (PL-36) are recorded in Appendix A, Section V.

*PL-36. Montezuma Canyon, View Downstream, Looking Southeast*
