3.0 L-Bar, New Mexico, Disposal Site

3.1 Compliance Summary

The L-Bar, New Mexico, Uranium Mill Tailings Radiation Control Act (UMTRCA) Title II Disposal Site was inspected on March 20–21, 2024. Previous inspections performed in 2021, 2022, and 2023, as required by the Long-Term Surveillance Plan (DOE 2004) (LTSP), and associated follow-up site visits identified numerous surface degradation features on the disposal cell top slope. No new degradation features on the top slope were identified during the March 2024 inspection. During an Applied Studies and Technology (AS&T) investigation in September and October 2022, several piping features were discovered on the side slope of the disposal cell. These features continue to be monitored and currently do not affect the performance of the side slope. Inspectors also identified several routine maintenance needs during the March 2024 inspection.

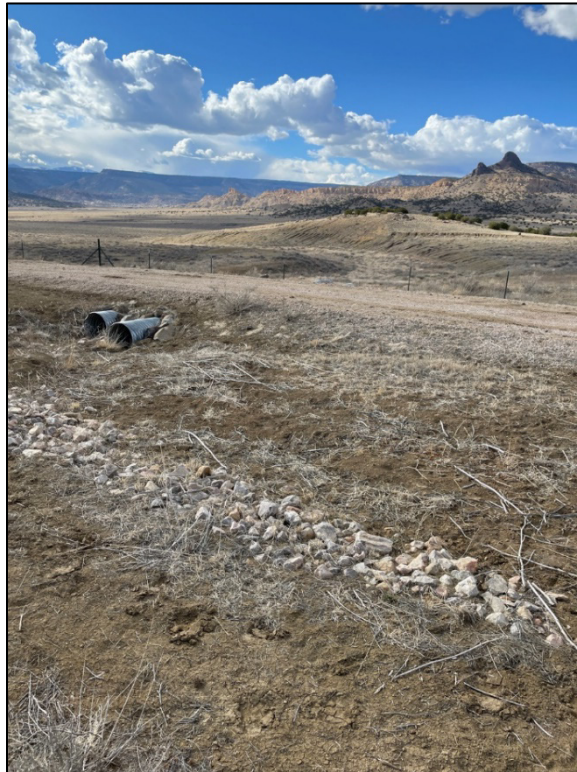
PL-1. Culverts

Interior roads used to access LM assets consist of two-track dirt roads with drainage culverts to convey stormwater in key locations. A gully that formed through headcutting on a side slope of the G3 channel has encroached on the east site access road. Culverts were installed along the access road in 2016 to prevent washout of the road and to control erosion. Sediment is accumulating around one of the three culvert inlets, and erosion is also undercutting the outlets. Two of the three culverts are functioning as designed (PL-1). The U.S. Army Corps of Engineers (USACE) conducted culvert cleanout in October 2024.

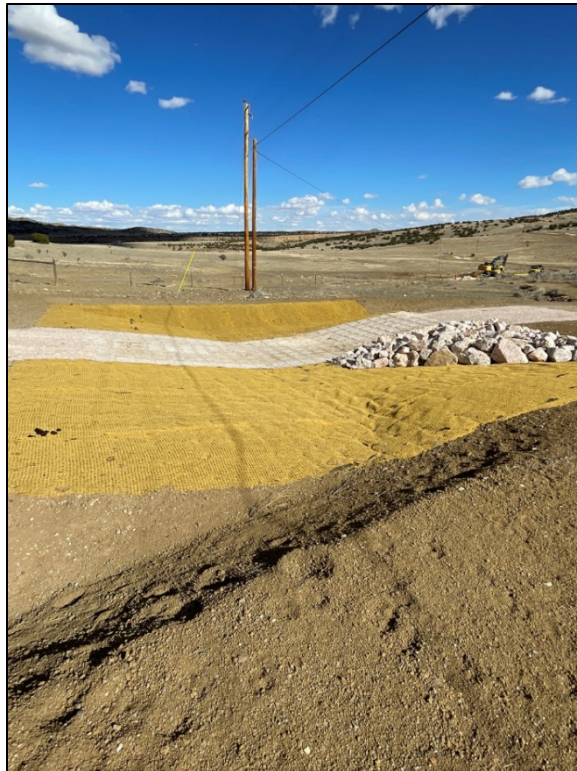
PL-2. Road Repair near Entry Gate

Access roads are susceptible to erosion and are repaired when they become impassable. In fall 2023, through an interagency agreement with USACE, LM began to repair access roads and construct low-water crossings in areas impacted by erosion. Road construction is in accordance with the engineering specifications and design plans in the *Department of Energy Legacy Management Bluewater and L-Bar Road Repairs Cibola County, New Mexico* document (USACE 2022). The USACE contractor was observed on site constructing one of the low-water crossings during the March 2024 inspections (PL-2). No additional maintenance needs were identified.

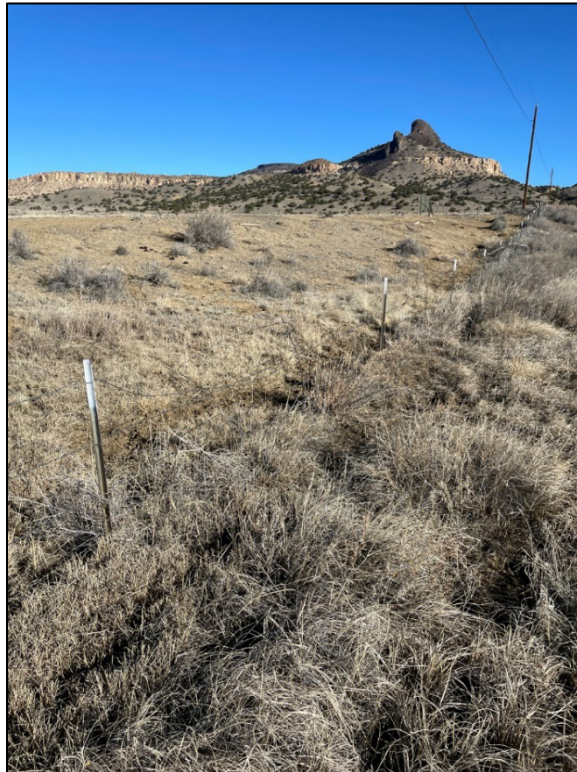
PL-3. Broken Fence

A barbed-wire fence encloses the disposal cell and associated drainage structures and is intended to prohibit trespassing and livestock intrusion on the disposal cell to prevent gullies from developing from the livestock trails. The fence is about 3300 ft inside the property boundary, and the area between the fence and the boundary is grazed in accordance with an LM grazing license with the Cebolleta Land Grant stakeholders, who collectively own and manage the surrounding property. Cattle were observed within the fence-enclosed area and inspectors discovered a portion of fence line with the top strands of barbed wire broken, which allowed cattle to cross over between perimeter signs P24 and P25 (PL-3). Additionally, sediment is accumulating along the fence line near perimeter sign P28, and the fence was extended vertically due to the sedimentation. The damaged fence line was repaired during the 2024 annual maintenance trip. Erosion is undercutting the perimeter fence in several locations where the fence was extended vertically to prohibit livestock from entering the site. Erosion features were monitored along the northern fence line (PL-4 and PL-5). Two tubular steel gates were installed to allow personnel to cross the fence line safely. One gate was installed in 2021 on the west side near perimeter sign P23, and the other gate was installed in 2022 on the south side near perimeter sign P19.

- Extended the fence vertically between perimeter signs P28 and P29 due to sedimentation
- Extended areas of the fence vertically between perimeter signs P24 and P25 to keep livestock out
- Repaired the fence near perimeter sign P28
- Replaced the cracked concrete well pad for monitoring well 63 with new concrete
- Replaced perimeter sign P32
- Performed minor road repairs
- Performed culvert maintenance

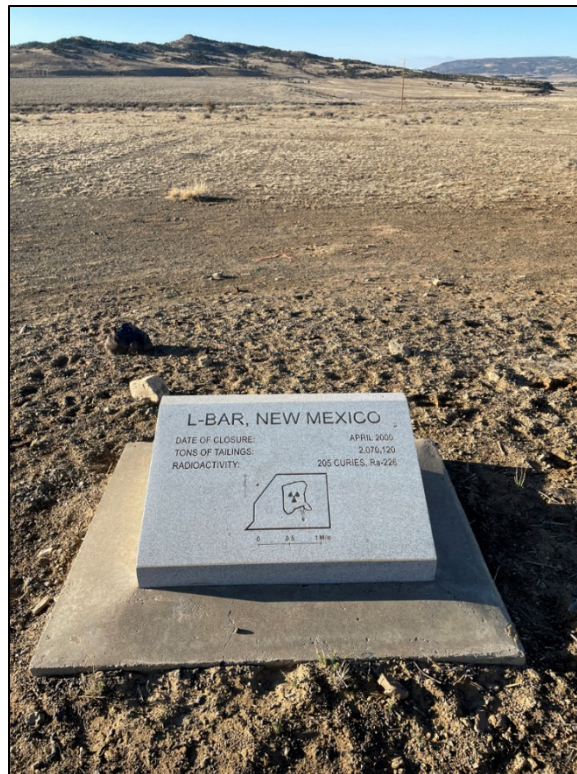
PL-6. Site Marker

The site has one granite site marker north of the disposal cell adjacent to the site access road. Bullet damage was observed on the site marker, but it remains legible (PL-6). No maintenance needs were identified.

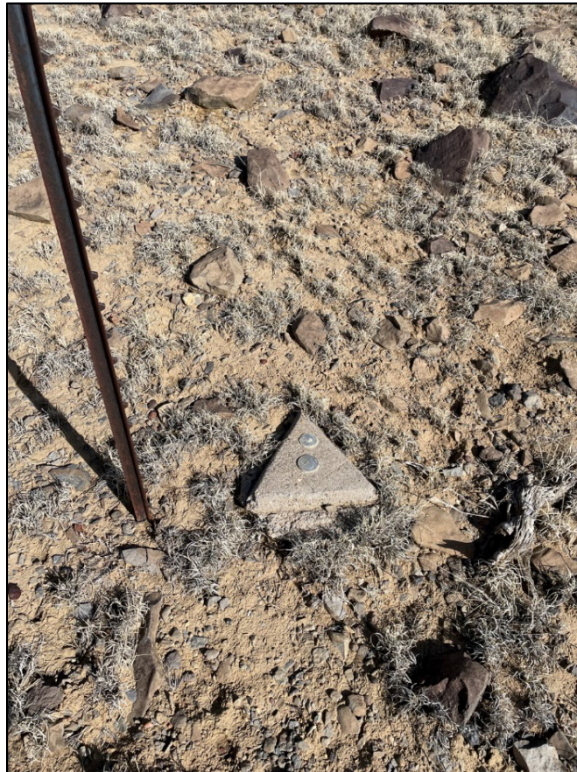
PL-7. Boundary Marker BM-3

Eight boundary monuments define the site boundary (PL-7). All eight boundary monuments were observed during the 2024 inspection. No maintenance needs were identified.

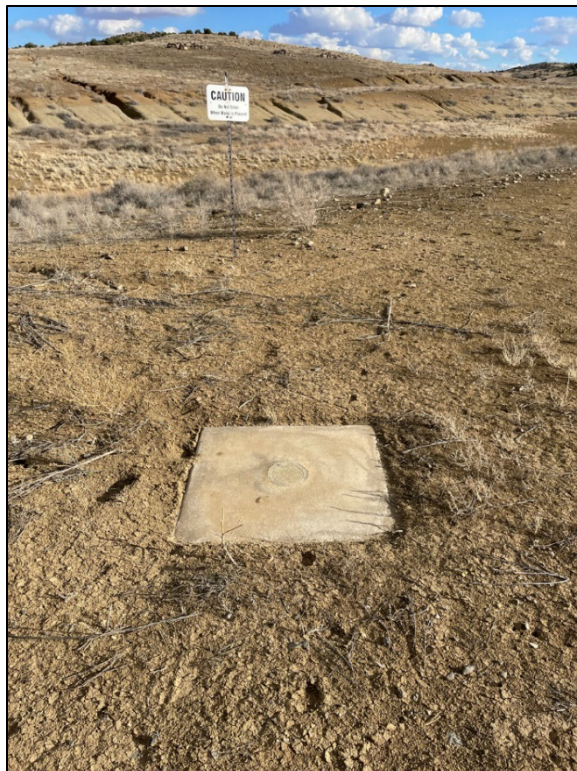
PL-8. Quality Control Monument QC-5

Nine aerial survey quality control monuments were inspected during the 2024 inspection (PL-8). Quality control monuments QC-7 and QC-8 were covered in sediment. T-posts were installed near these monuments to help locate them. The sediment was removed from quality control

monument QC-7; however, quality control monument QC-8 was not located under the sediment and may need to be located and uncovered with a metal detector in the future. No additional maintenance needs were identified.

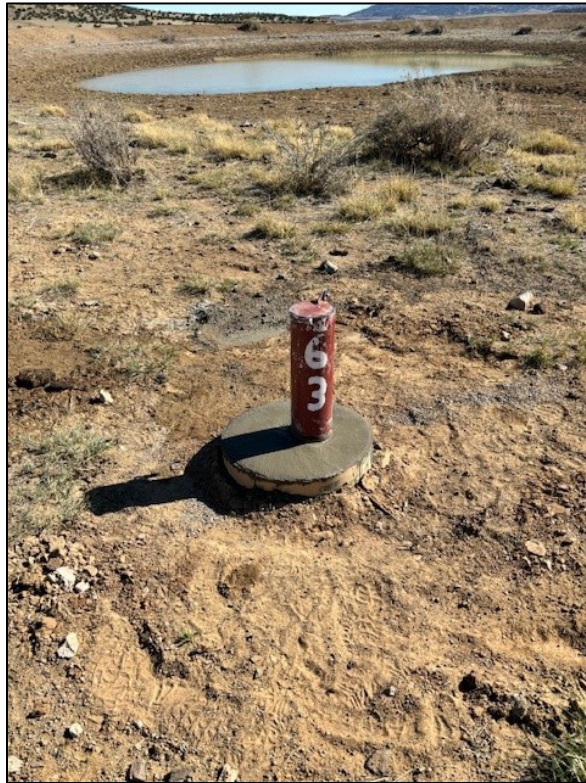
PL-9. New Concrete Pad at Monitoring Well 63

The site groundwater monitoring network consists of 10 wells (Figure 3-1; Figure 3-2). Nine of the wells are on DOE property; background monitoring well 29A is outside the northeast property boundary of the site. The wellhead protectors observed during the 2024 inspection were undamaged and locked. The concrete pad for well 63 was observed to be severely cracked. It was repaired during the 2024 spring maintenance trip (PL-9). Erosion is propagating upstream near monitoring well 62 and will continue to be monitored to ensure that erosion does not impact the integrity of the well. No additional maintenance needs were identified.

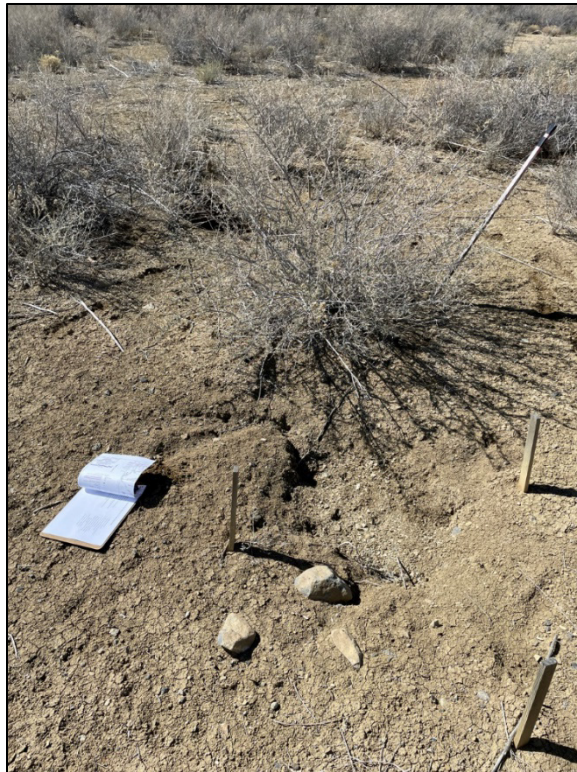
PL-10. Degradation Feature E-004 East Extent

During the 2024 inspection, no additional degradation features were identified, and the most prominent degradation feature (E-004) designated (PL-10) was observed to have collapsed on itself or filled with sediment. This feature, along with most of the previously documented features, was observed to look more similar to a minor depression now (PL-11) rather than as degraded piping features during the 2023 inspection.

These features represent a change in the characteristics of the condition of the disposal cell cover and may require annual monitoring. Preliminary evaluations suggest that surface degradation features were caused by stormwater flows penetrating the disposal cell cover via desiccation cracking, animal burrows, and vegetation root systems.

To evaluate the surface degradation features, a geophysical investigation was performed in 2023 to support further evaluation of cover degradation conditions. Multiple methods of nonintrusive geophysical techniques were implemented to analyze the subsurface tailings, radon attenuation barrier, and the common fill layer for potential void spaces. Initial findings did not indicate the potential for significant void spaces to be present. Based on the results of the recent inspection and currently available information, the disposal cell cover continues to function as designed.

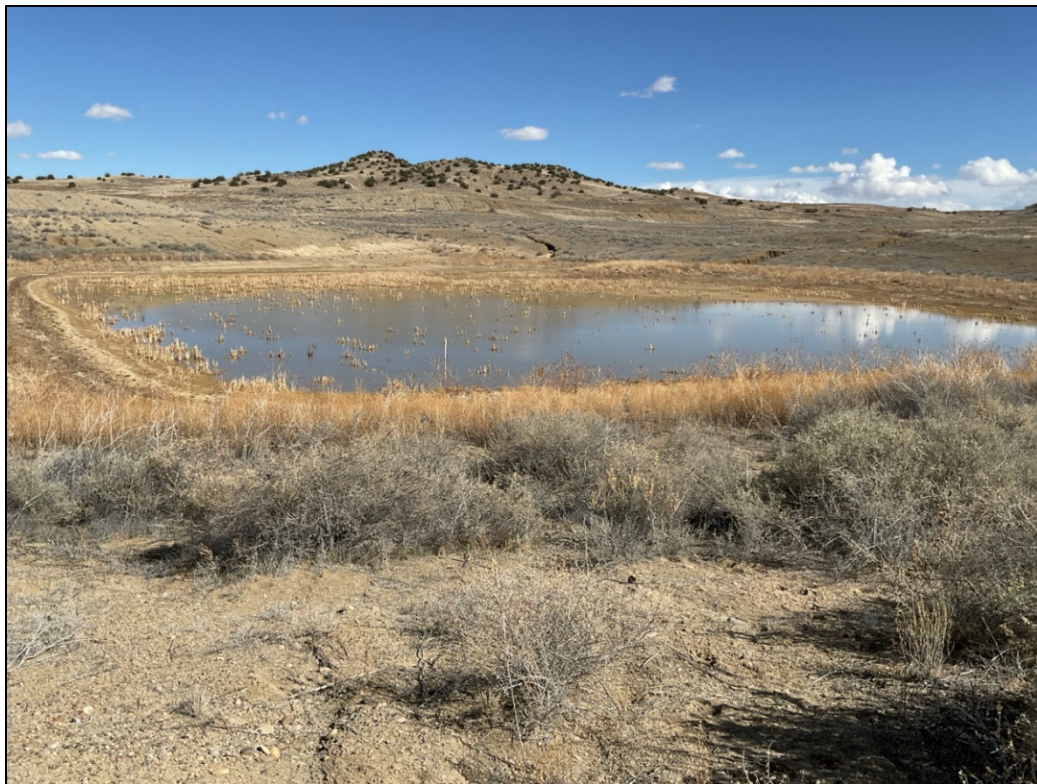
PL-12. Sediment Trap

Some erosion was also observed in a watershed that encompasses the southeast portion of the site and adjacent property. Stormwater runoff from this watershed discharges into a sediment trap where the sediment load settles out. If runoff overtops the sediment trap, the flow is diverted to the east channel. Standing water was observed in the sediment trap at the time of the inspection (PL-12).

Since the completion of site reclamation, multiple high-intensity storms have caused deep gullies to form in the highly erodible soils and fill materials upgradient of the sediment trap. Construction of runoff control structures to reduce the rate of erosion in the area and prevent headward migration of gullies into adjoining private property was completed in December 2009. Runoff from a storm event in September 2011 overtopped an earthen runoff control berm of Runoff Control Structure A and caused substantial damage to the berm. Subsequent runoff events have caused erosion adjacent to gabion drop structures associated with Runoff Control Structure A near Runoff Control Structure D. Because of continued excessive erosion, an interagency agreement was established with USACE to repair these structures and construct additional structures in the watershed. Runoff water from the area north of the disposal cell is captured by the north channel. The water is diverted away from the site to the west. Deep gullies had formed in the alluvium and weathered shale along a portion of the north bank of the channel, and headward erosion was rapidly migrating to the north toward the site access road and property boundary. The eroded channel bank was restored to the original design configuration, and two runoff control structures were constructed in 2009 to reduce erosion and sedimentation. Runoff Control Structure F is showing signs of undermining erosion but was stable and functional at the time of the inspection (PL-13). However, Runoff Control Structure G suffered severe erosion during runoff events in August and September 2011 and continues to erode (PL-14). Runoff Control Structure A is experiencing gully erosion (PL-15) and undermining at portions of the gabion block sections (PL-16), and it is likely that continued erosion will lead to failure of the structure. DOE will continue to monitor these structures and, as part of the interagency agreement, USACE will complete a design for repairs and modifications to these structures.

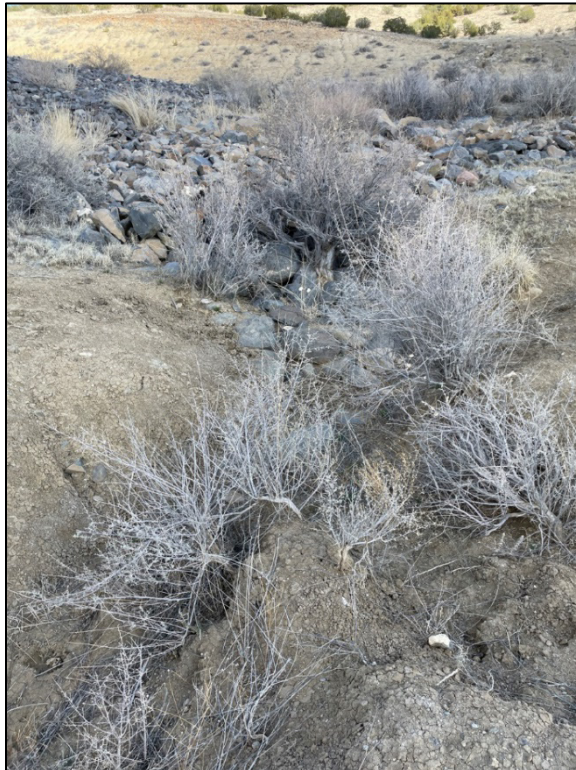
PL-17. Cutoff Wall Riprap

The south channel diverts stormwater runoff from higher terrain immediately south of the disposal cell toward the channel outlet to the west. Two riprap structures are on the north-facing slope (south bank) to inhibit erosion along natural drainage swales. Erosion is occurring on the unprotected slope surfaces, resulting in sediment accumulation in the south channel. The erosion and sediment deposition are not impairing the function of the south channel. Erosion headcutting that has migrated to the edge of the riprap cutoff wall at the outlet of the channel was monitored during the inspection. The cutoff wall is functioning as designed and will continue to be monitored (PL-17).

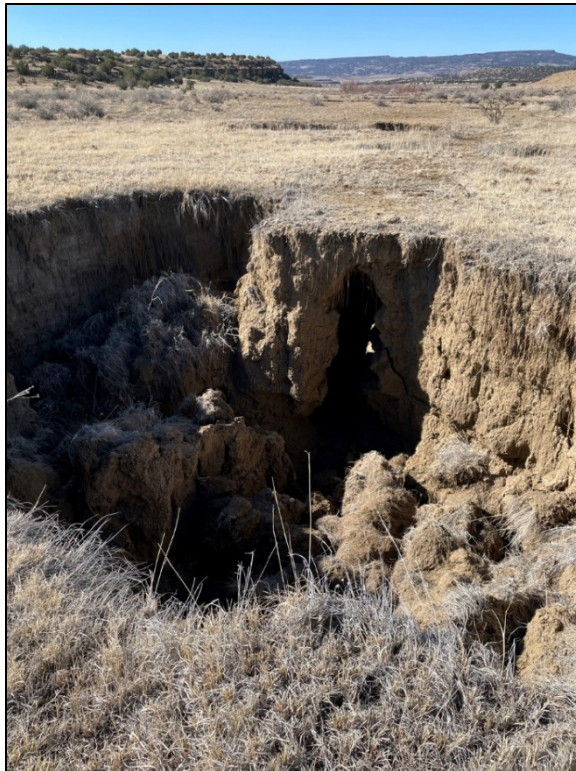
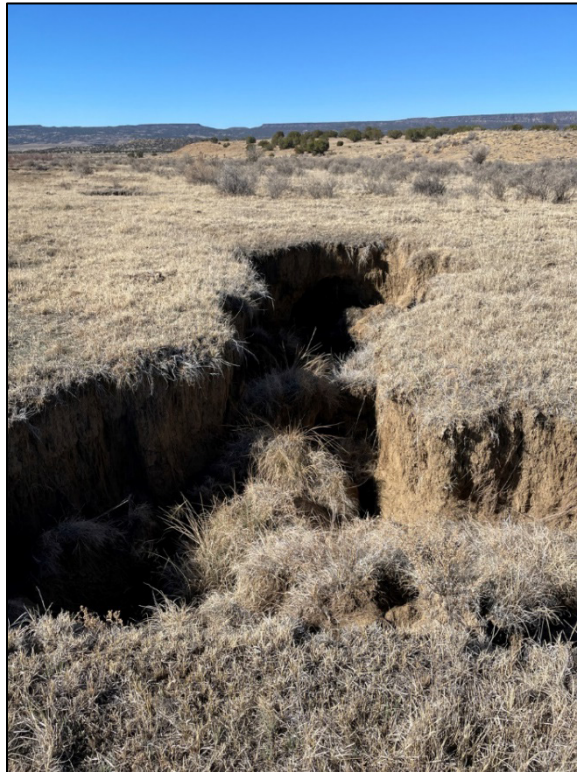
The access road to monitoring well 100 in the southwest corner of the site is damaged by subsurface erosion (soil piping) near the head of an arroyo. The affected area has been mapped, metal fence posts have been installed next to soil collapse features, and the information has been identified on the inspection and sampling maps to prevent injury or vehicle damage. Consequently, monitoring well 100 is accessed by foot or all-terrain vehicle during sampling events. The arroyo system that limits access to monitoring well 100 presents a potential major risk to the disposal cell. This arroyo is over 100 ft wide in places and 10 to 20 ft deep (PL-18). It is headcutting in a northeast trajectory toward the western side slope of the disposal cell (PL-19). LM has begun to track the yearly erosion rate via satellite imagery. At this time, no maintenance actions are needed.

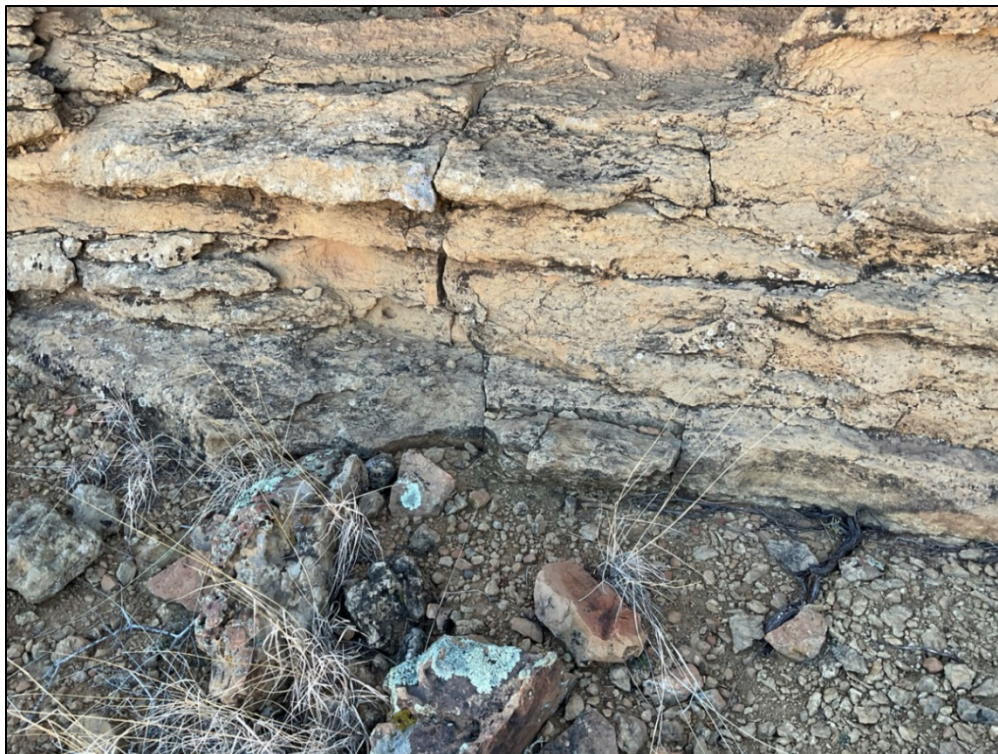
PL-20. Tres Hermanos Sandstone Outcrop—Dry

A Tres Hermanos Sandstone unit of the Mancos Shale crops out in the southwest corner of the site. This unit is reported to be hydraulically connected to contaminated groundwater under the disposal cell, and the outcrop is considered a potential evapotranspiration area. The outcrop was dry at the time of the inspection, and there is no evidence that seepage has occurred (PL-20). This location will continue to be monitored for seepage and recommended for sampling if seep water is present.
