2.0 Edgemont, South Dakota, Disposal Site

2.1 Compliance Summary

The Edgemont, South Dakota, Uranium Mill Tailings Radiation Control Act (UMTRCA) Title II Disposal Site was inspected on July 24, 2024. No changes were observed in the disposal cell cover or in associated drainage features. The grazing licensee and the Office of Legacy Management (LM) will remove the unmaintained interior fence. Inspectors identified no other maintenance needs or cause for a follow-up inspection. Groundwater monitoring is not required at the site.

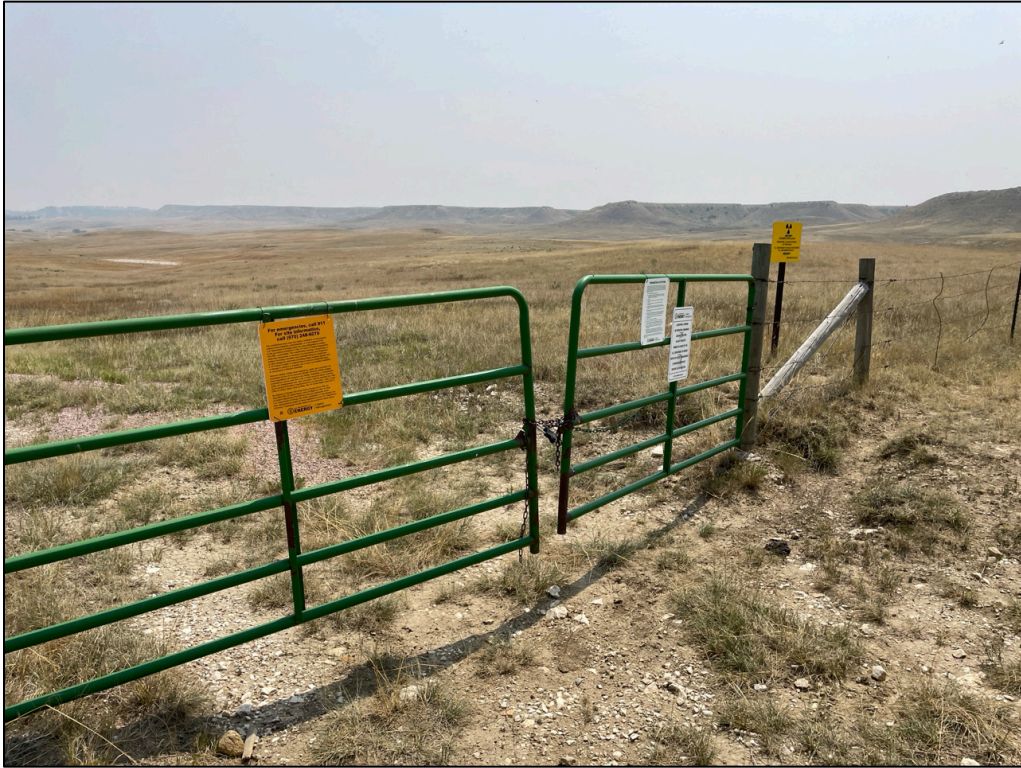
Access to the site is from Fall River County Road 6N. The entrance sign, which is mounted on a steel post set in concrete, was in good condition. The tubular metal entrance gate was secured by a locked chain and was intact (PL-1). The perimeter fence features three additional wire gates at the following locations: (1) the northwest corner of the property, (2) approximately 700 feet north of the southeast corner, and (3) the southeast corner of the site. All gates were closed, locked, and intact. No maintenance needs were identified.

PL-1. Entrance Gate and Sign

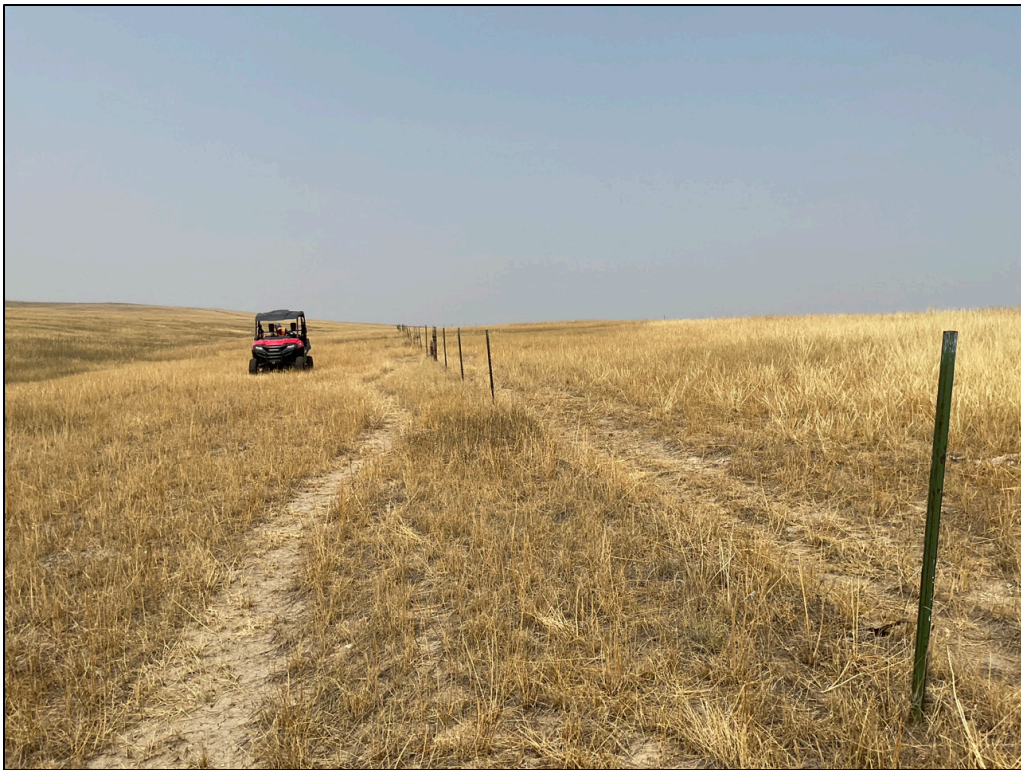
The licensee proposed removing the unmaintained interior fence that had been installed to prevent grazing while vegetation was establishing after the disposal cell was closed. The LM site manager concurred with this proposal, as this fence is no longer required. During the 2024 inspection, the inspection team removed approximately 445 feet of interior fence on the southeast side of the disposal cell (PL-2). The fence will continue to be removed by the grazing licensee and inspectors during future inspections. No other maintenance needs were identified.

PL-2. Location of Removed Interior Fence

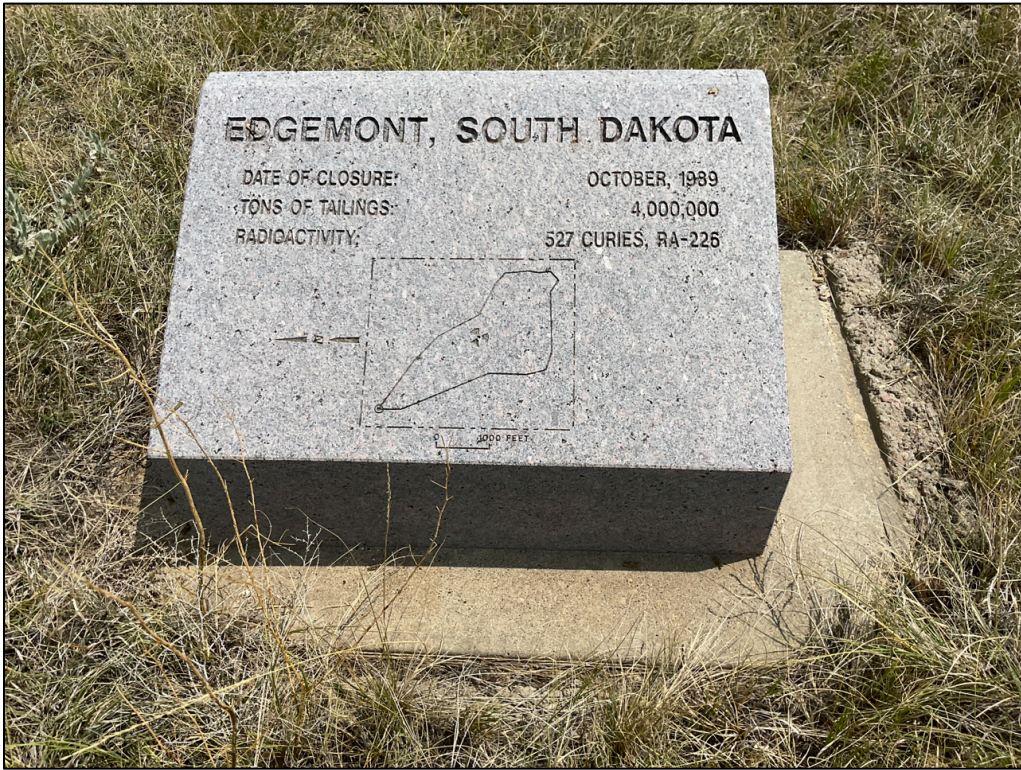
The granite site marker is inside the entrance gate (PL-3). No maintenance needs were identified.

PL-3. Site Marker

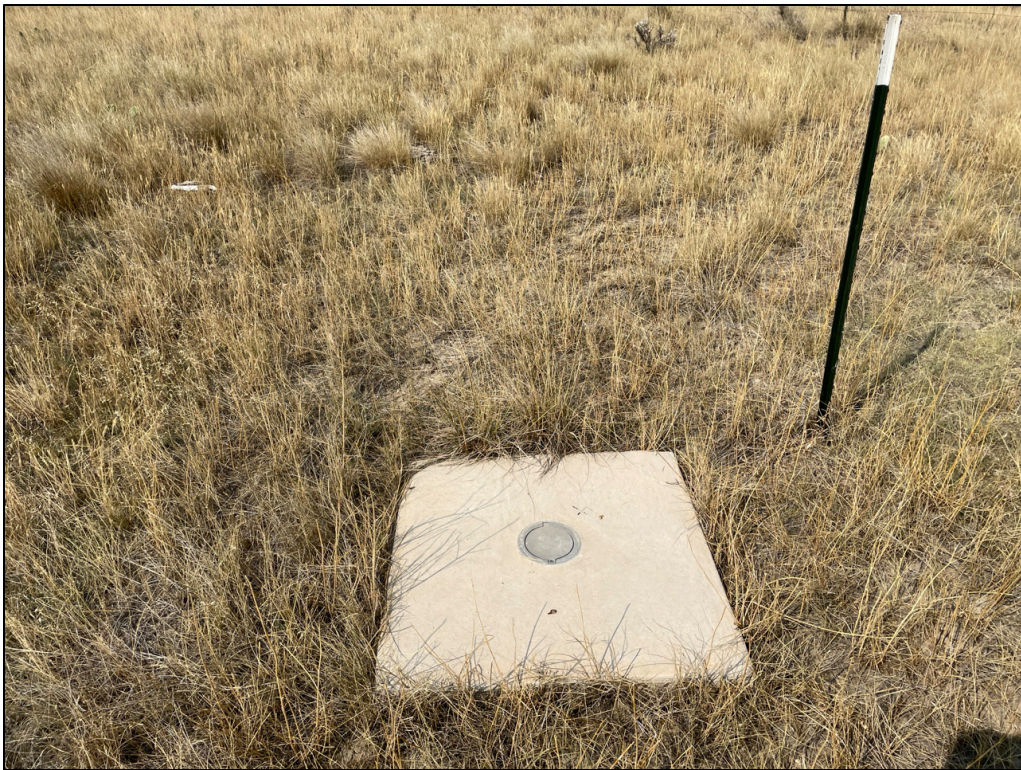
LM installed seven aerial survey quality control monuments in 2019 and conducted a baseline aerial survey in 2021. The quality control monuments were inspected during the 2024 annual inspection (PL-4). No maintenance needs were identified.

PL-4. Quality Control Monument QC-4

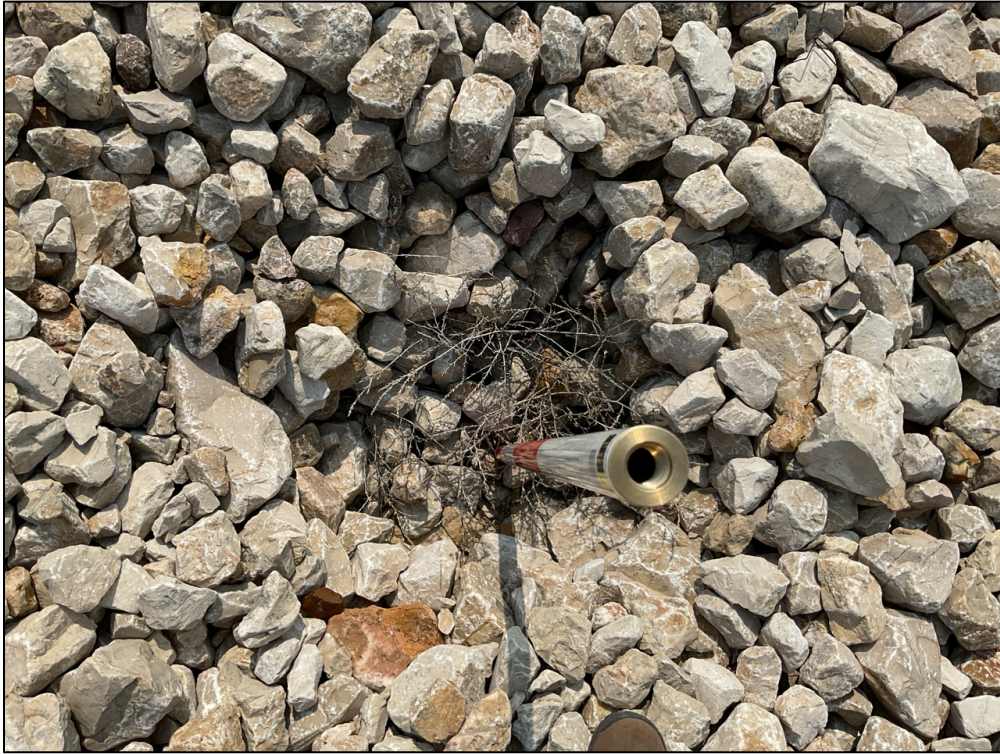
The face of the containment dam is armored with riprap. In 2021 and then in 2023, a total of three depressions were identified on the containment dam. During the 2024 inspection, only small depression No. 1 was inspected (PL-5). No evidence of sediment deposition, human intervention, or other modifying processes have been observed near the depressions. The depressions do not threaten the integrity or performance of the disposal cell; however, monitoring will continue during annual inspections and subsequent surveys. No standing water was present at the toe of the containment dam during the 2024 inspection. Vegetation has established in the riprap. The vegetation helps to stabilize these areas and does not impair the function of the containment dam. No maintenance needs were identified.

PL-5. Small Depression No. 1

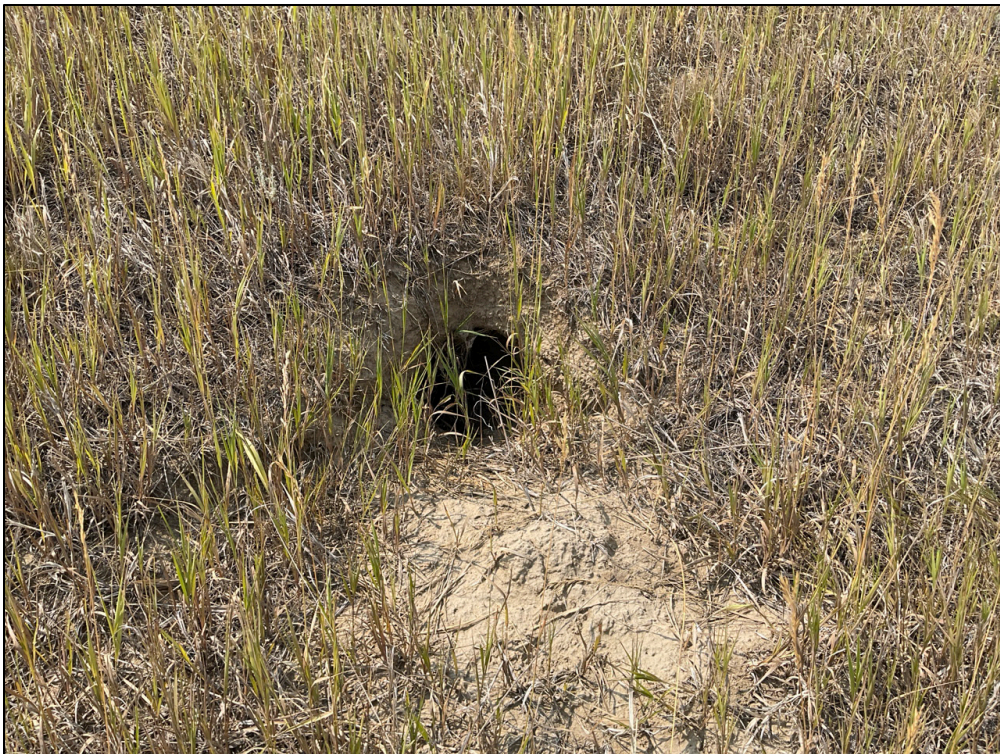
The balance of the site consists of undisturbed areas covered with native shrubs, grasses, and forbs and formerly disturbed areas covered primarily with seeded grasses and annual weeds. Animal burrows have been observed on the southwestern side of the drainage channel between the riprap-armored containment dam and the west diversion channel. In 2024, two new animal burrows were observed (PL-6). The animal burrows are not impacting the functionality of the disposal cell or drainage features. No maintenance needs were identified.

PL-6. Animal Burrow
