6.0 Shirley Basin South, Wyoming, Disposal Site

The Shirley Basin South, Wyoming, Uranium Mill Tailings Radiation Control Act (UMTRCA) Title II Disposal Site was inspected on July 25, 2024. No significant changes were observed on the disposal cell or in associated drainage features. Inspectors identified routine maintenance needs but found no cause for a follow-up inspection.

Figure 6-1. 2024 Annual Inspection Drawing for the Shirley Basin South, Wyoming, Disposal Site

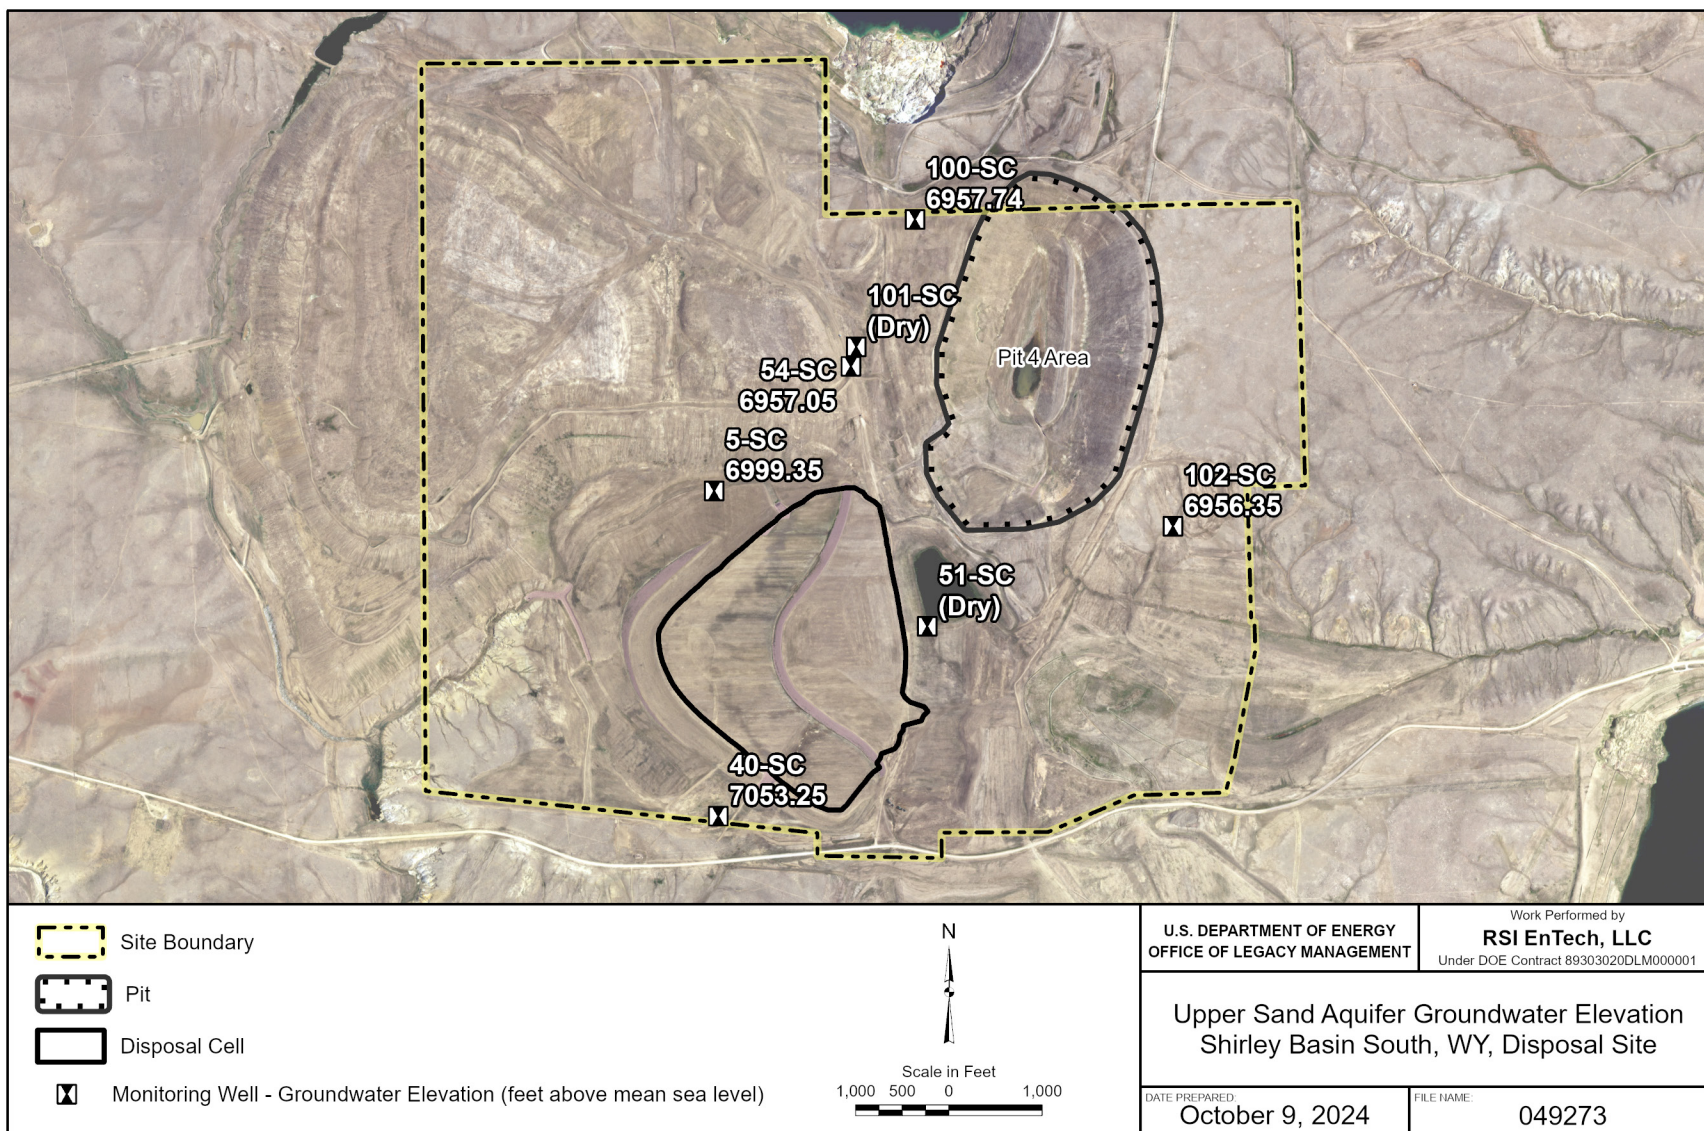
Figure 6-3. June 2024 Groundwater Elevations in the Upper Sand Aquifer at the Shirley Basin South, Wyoming, Disposal Site

The apparent groundwater flow direction within the Upper Sand Aquifer at the site is in the direction of structural dip and toward the eastern site boundary (Figure 6-3). Water levels are increasing in wells 100-SC and 102-SC but have been relatively constant in the remaining Upper Sand Aquifer wells (Figure 6-4). Well 51-SC was dry and has not recorded a water level since November 2010. Well 101-SC has been dry since its installation in 2008.

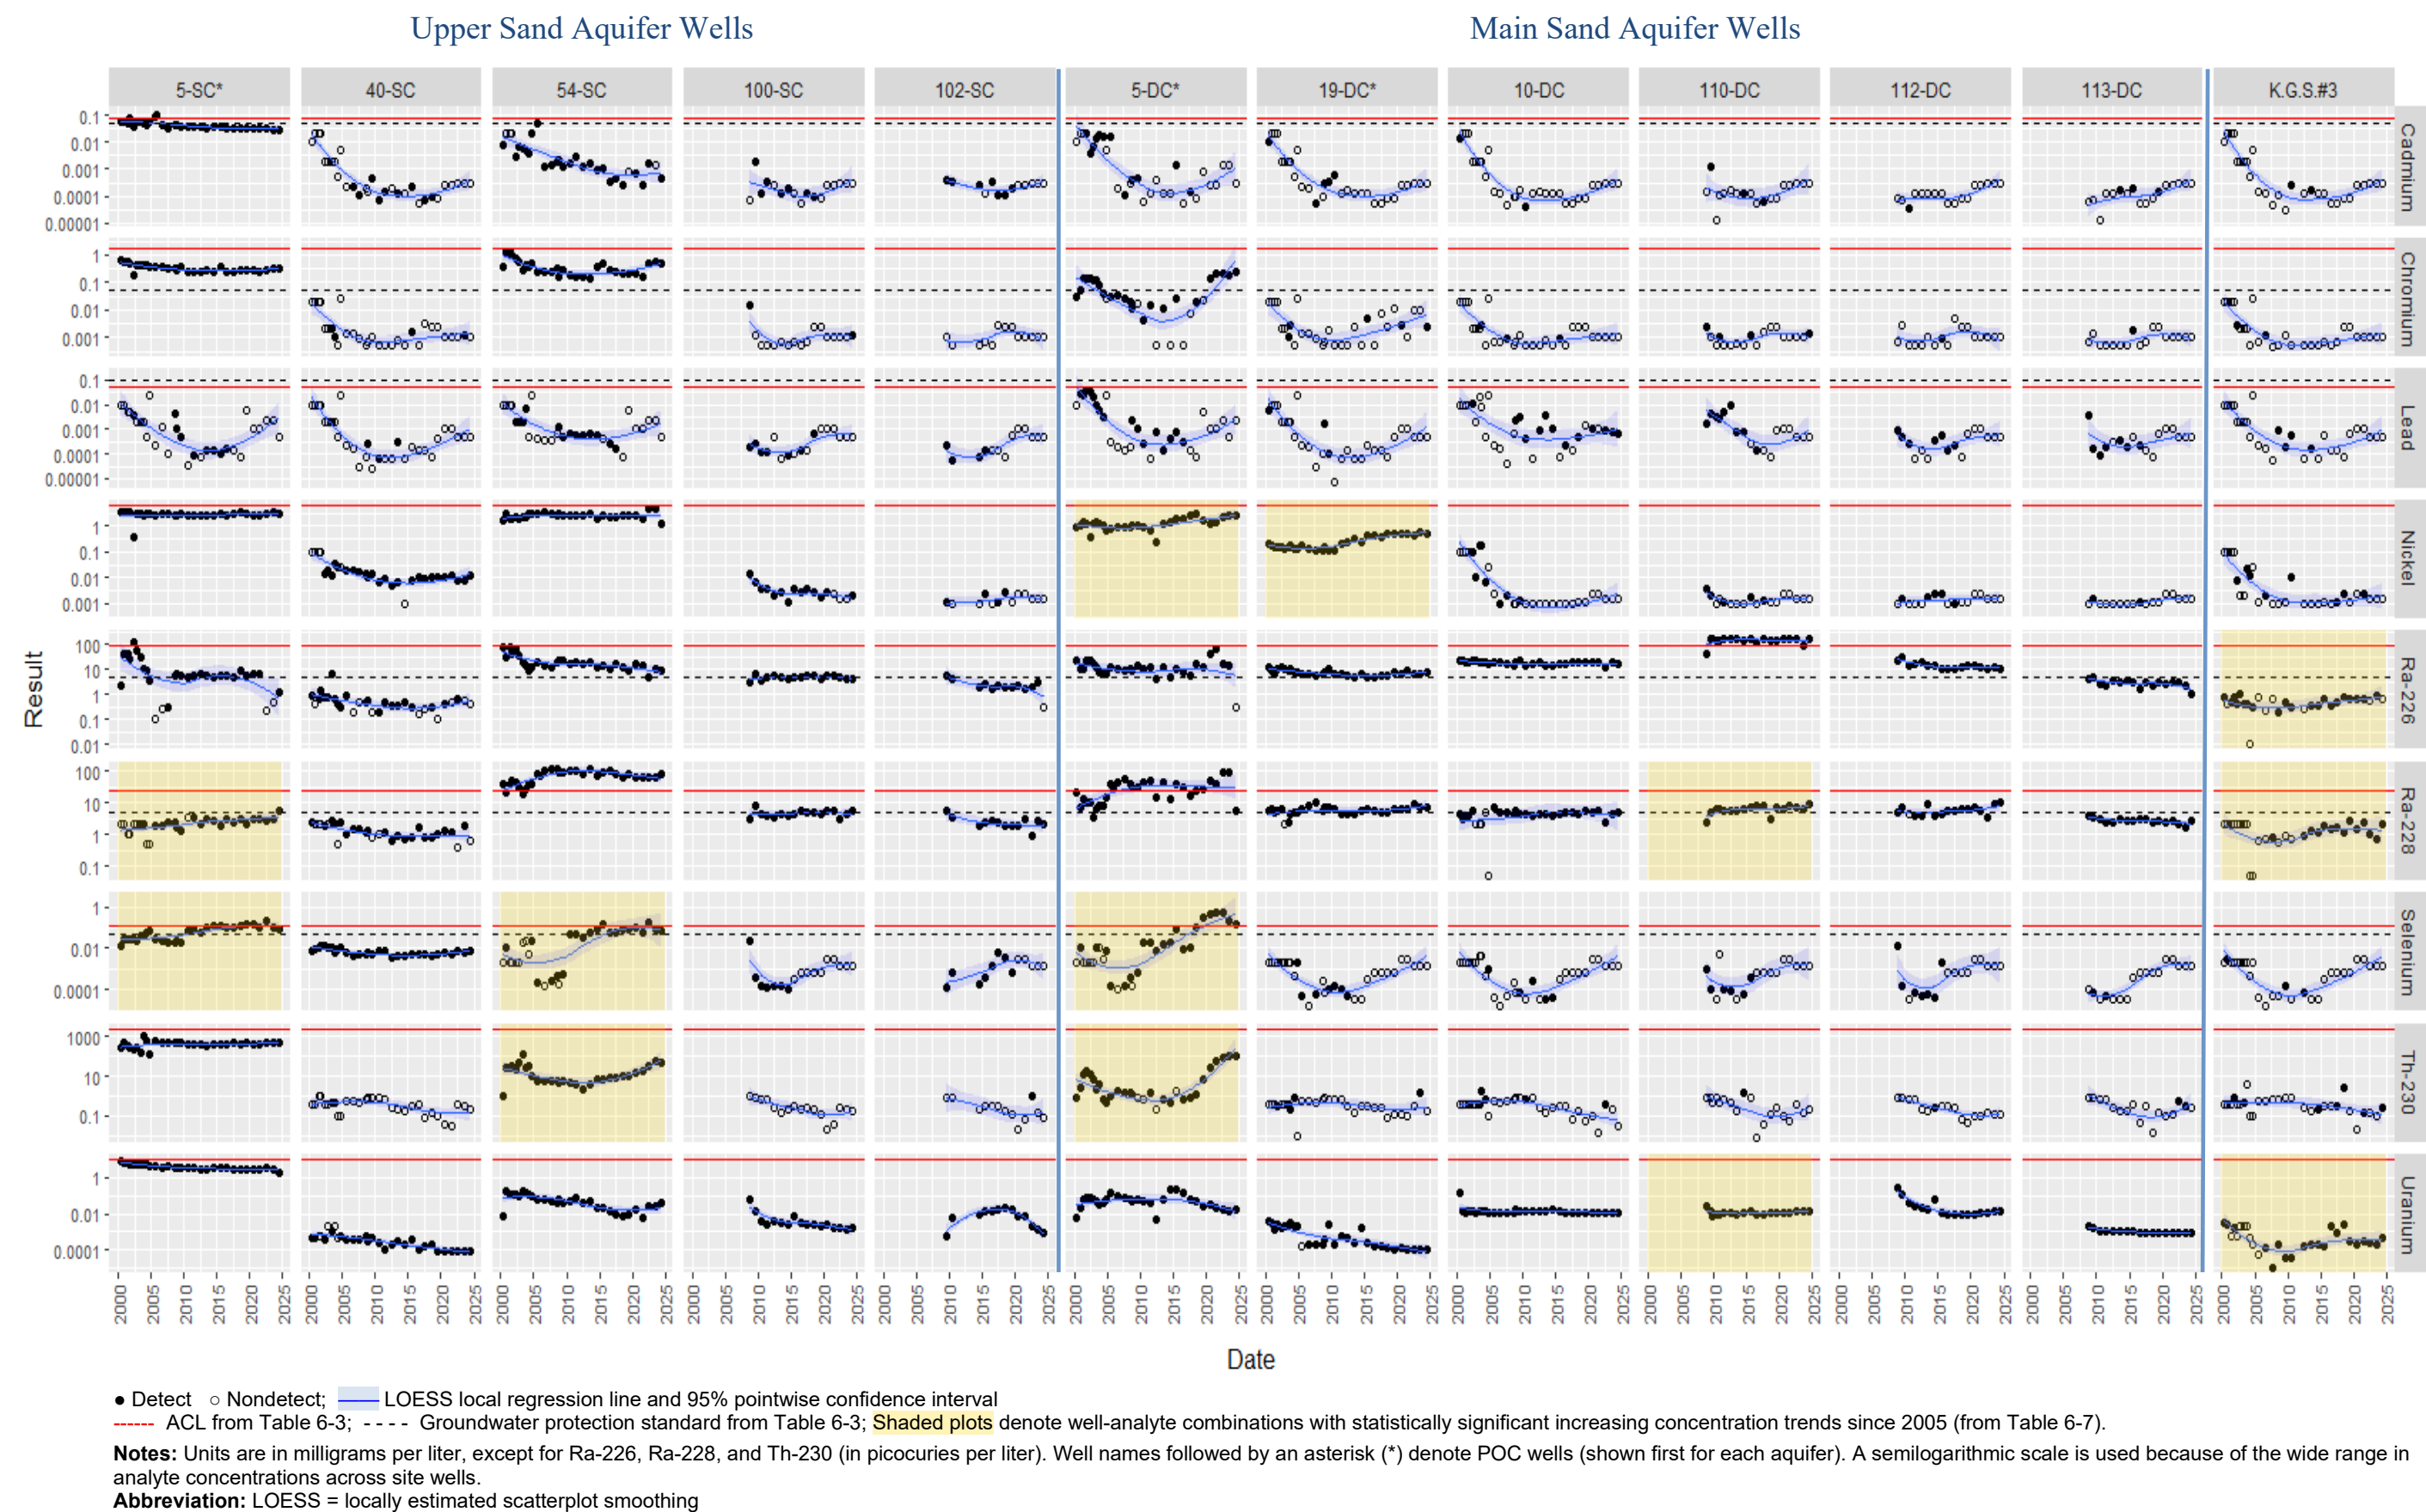
Figure 6-7. Time-Concentration Plots of Analytes with ACLs in Monitoring Wells, Shirley Basin South, Wyoming, Disposal Site: 2000–2024

Radium-226 concentrations in well 110-DC, installed in 2008 near the north site boundary, consistently exceeded the ACL between 2009 and 2022, and again in 2024 (Figure 6-7). LM evaluated the cause of these exceedances and determined that the elevated concentrations do not represent a contaminant plume migrating offsite; rather, they are attributed to natural conditions within the ore-bearing sand unit as aquifer recovery continues (DOE 2011a). In 2024, the ^{226}Ra concentration in this well was 161 picocuries per liter (pCi/L), consistent with most historical measurements. Although below the ACL, ^{226}Ra concentrations in most remaining wells (exceptions being 40-SC, 102-SC, 113-DC, and K.G.S. #3) typically exceed the 5 pCi/L groundwater protection standard for combined ^{226}Ra and ^{228}Ra .

Selenium concentrations have exceeded the ACL and the groundwater protection standard in wells 5-SC, 54-SC, and 5-DC (Figure 6-7). Mann-Kendall trend analysis continues to indicate statistically significant increasing selenium trends in these wells (Table 6-7). LM previously noted that selenium is a relatively poor early indicator constituent for tailings seepage, as selenium concentrations measured in tailings water were relatively low and attenuated easily (DOE 2011b).

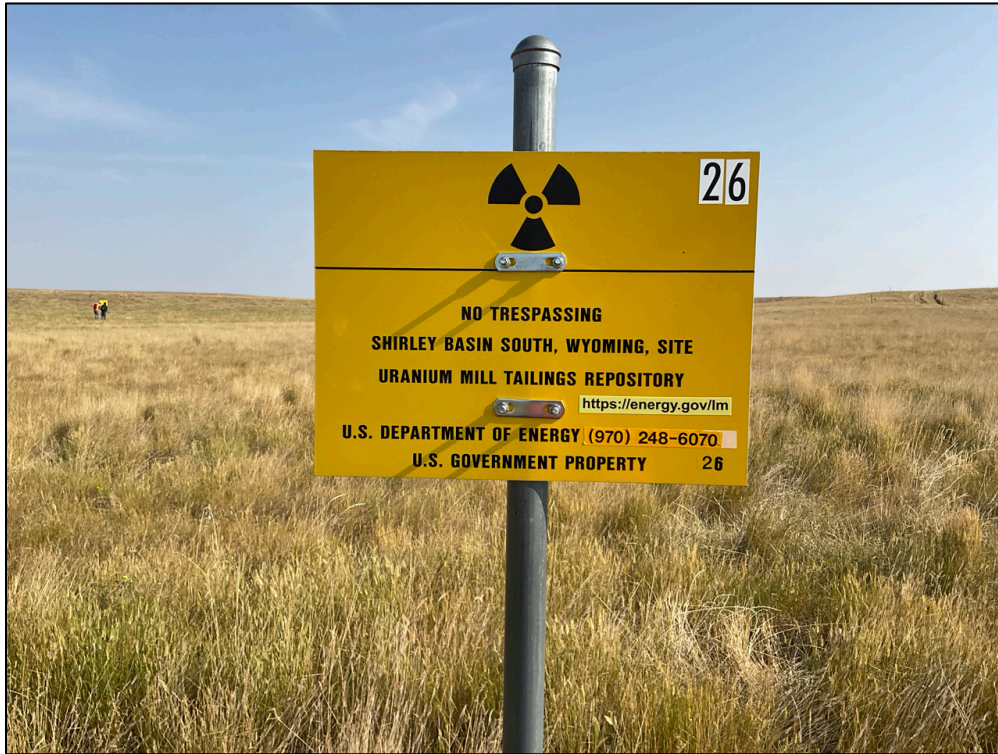
The entrance sign identified as perimeter sign P26 (PL-1) is on the main site access road near the site marker. Nine perimeter signs (warning and no-trespassing signs) are posted along the site perimeter at potential points of access, and another 25 signs are positioned around the disposal

PL-1. Entrance Sign

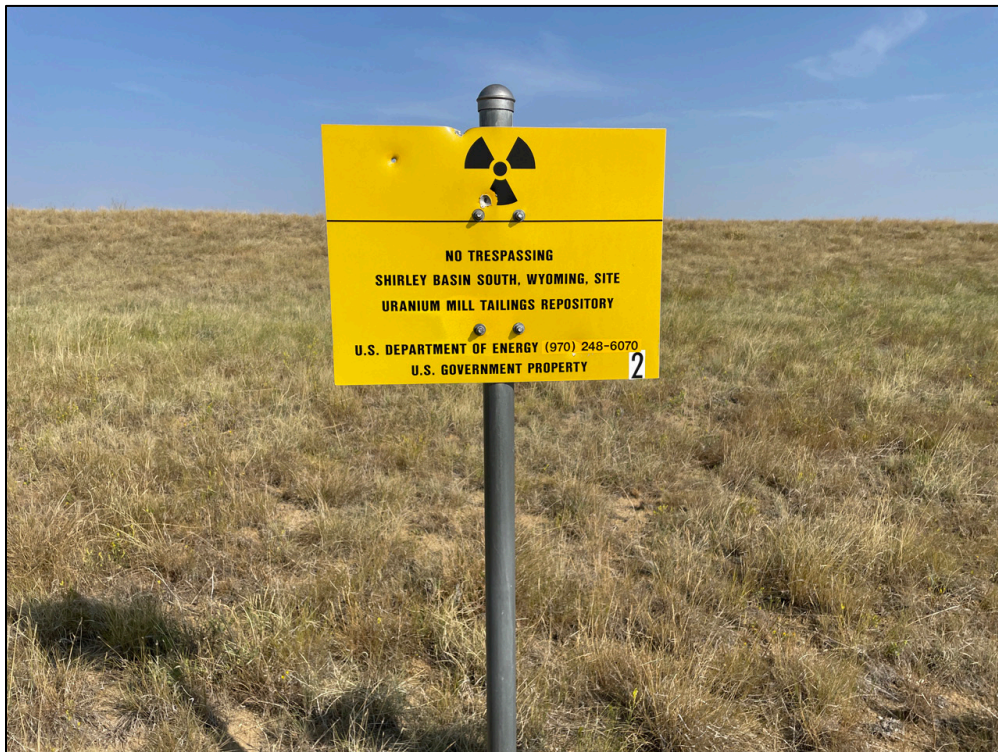
cell. Perimeter signs P1, P2 (PL-2), and P33 have bullet holes but remain legible. No maintenance needs were identified.

PL-2. Perimeter Sign P2 Showing Bullet Holes

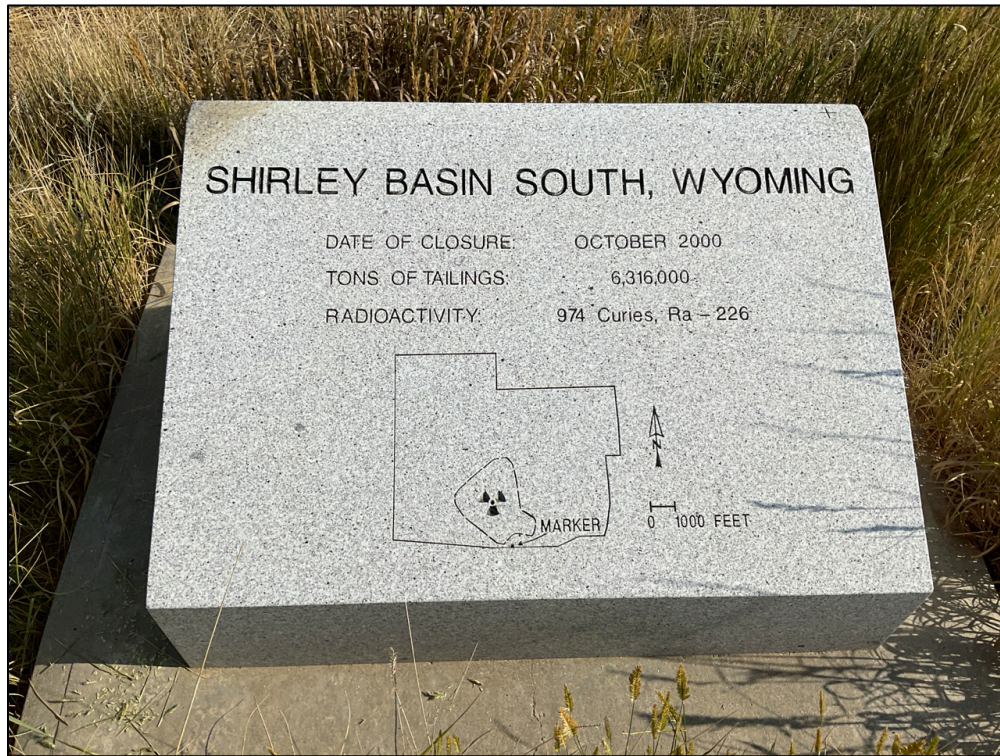
The site has one granite site marker (PL-3) near the entrance gate. No maintenance needs were identified.

PL-3. Site Marker

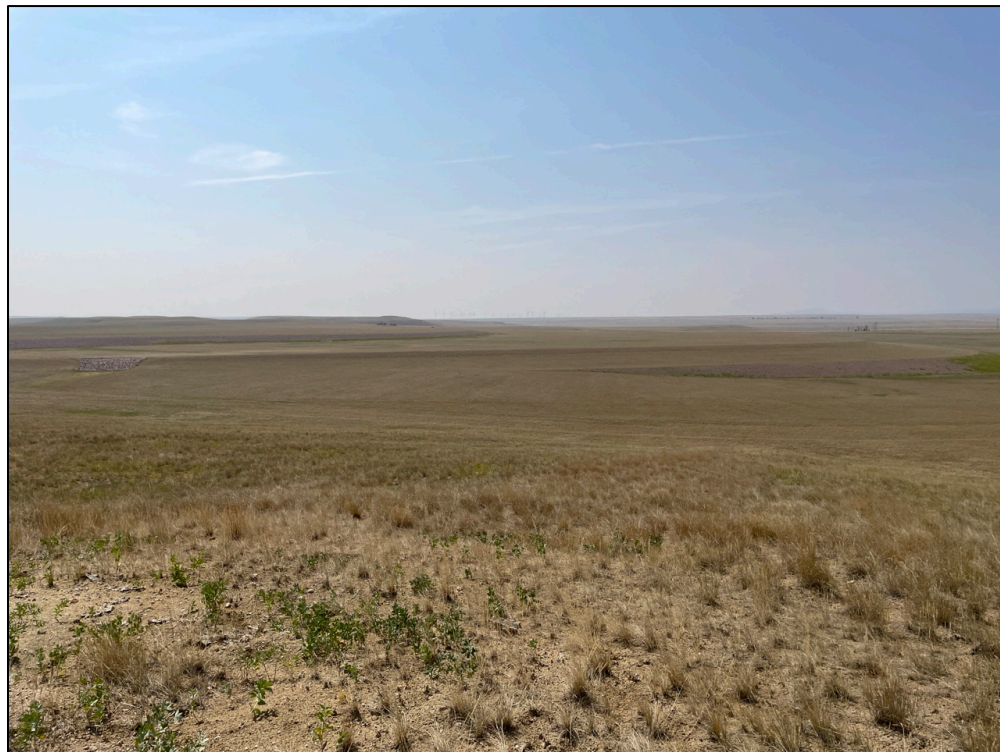
PL-4. Disposal Cell Overview

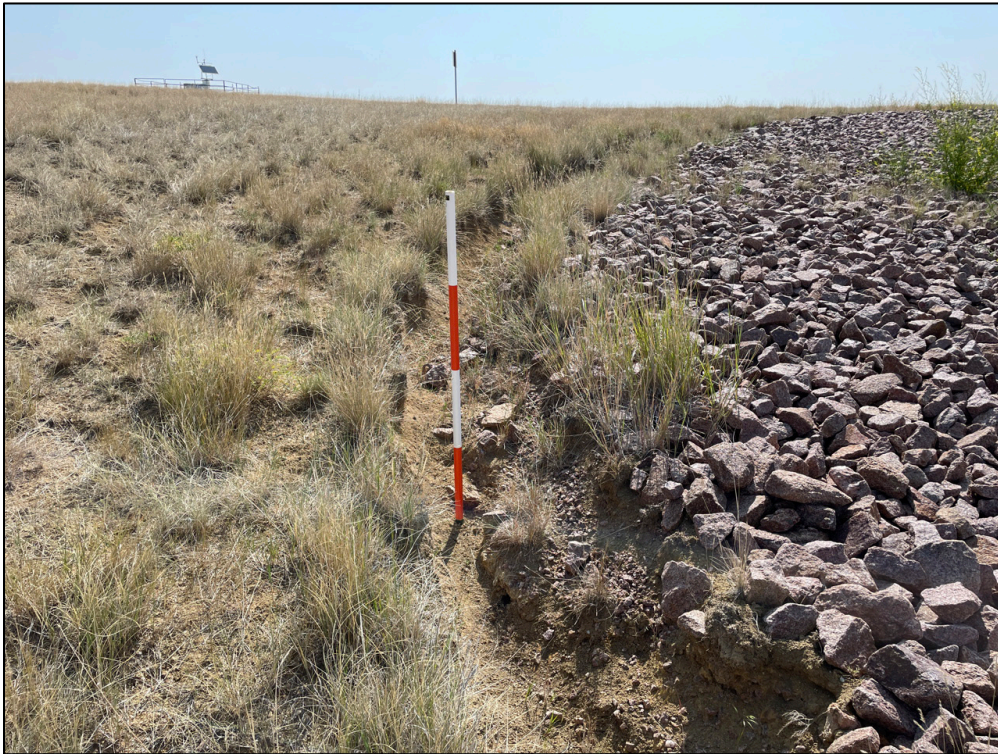
Cattle have worn trails around the riprap-armored slopes, which has caused erosion on the north (PL-5) and south (PL-6) ends of the eastern riprap-armored slope. Grazing of the paddock containing the disposal cell was paused in 2022 to consider options for addressing the erosion. These trails are to be protected from cattle by the rancher to prevent degradation of the as-built riprap features before resuming grazing of the disposal cell paddock.

PL-5. Erosion Caused by Animal Trail North of Upper Riprap Slope

In accordance with the LTSP (DOE 2004), routine site maintenance will be performed by LM as needed. Unlocked interior gates will be locked, minor fence repairs will be conducted, and cattle trail erosion will be protected by the rancher. Repair of the western fence will be subcontracted by LM. No other maintenance needs were identified.

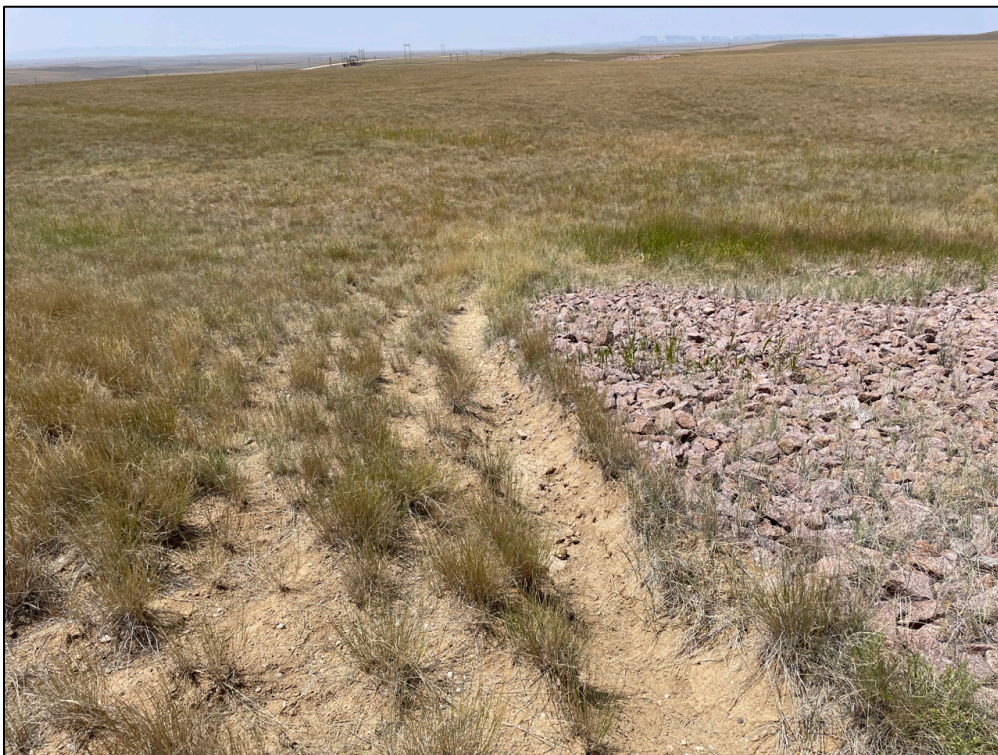
PL-6. Erosion Caused by Animal Trail South of Upper Riprap Slope

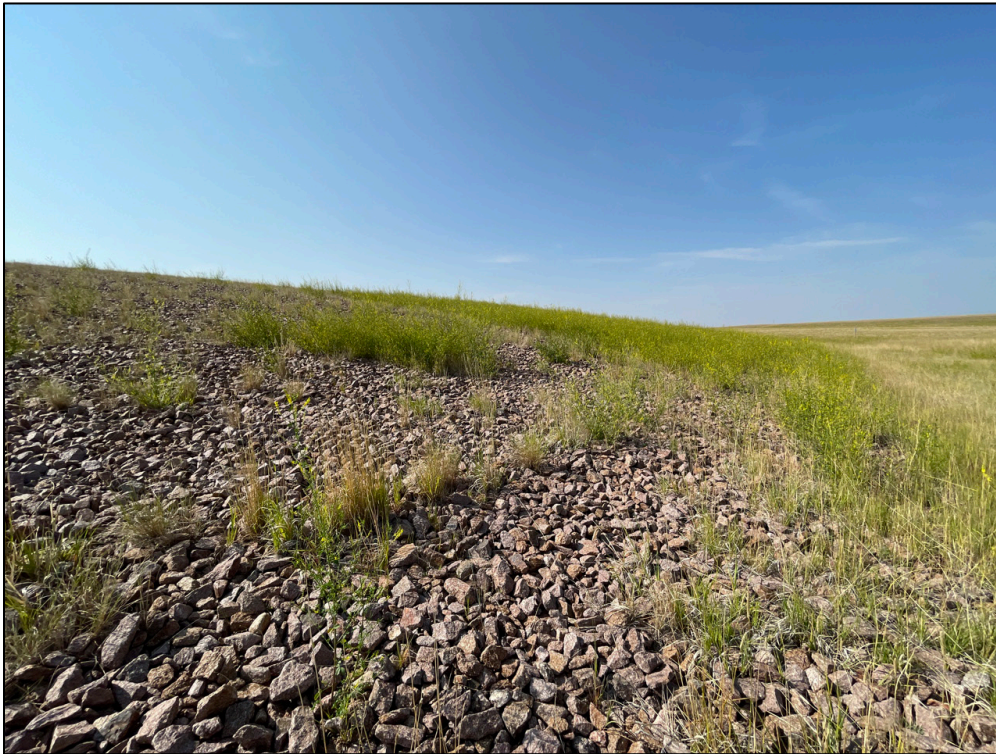
Gradual vegetation encroachment has been observed in the riprap on the slope that separates the two elevations and on the lower riprap slope (PL-7). The establishment of perennial vegetation enhances slope stability. Riparian vegetation has established at the toe of the slopes in areas that accumulate snowmelt runoff and summer precipitation.

PL-7. Vegetation Encroachment on Lower Riprap Slope

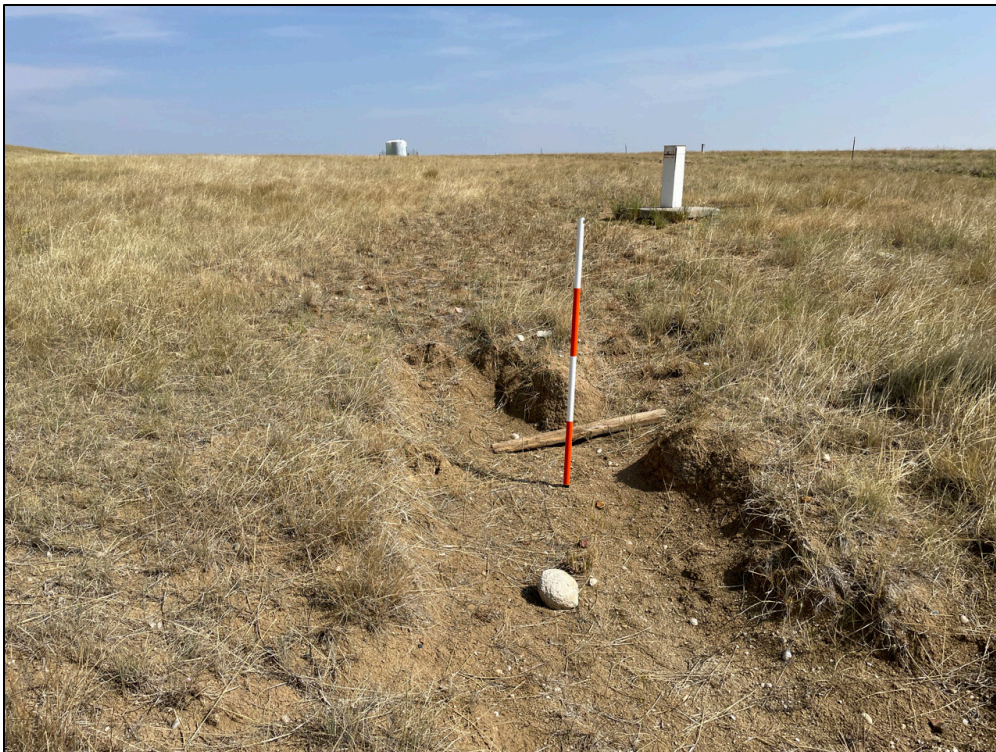
Discharge plumbing from the water storage tank has caused minor erosion near monitoring well 54-SC (PL-8) and the PMF channel. This discharge is not impacting site features currently, but headcutting erosion could occur toward the well and well pad, causing the well pad to become destabilized. Inspectors will continue to monitor this area. No maintenance needs were identified.

PL-8. Erosion Caused from Overflowing Water Storage Tank

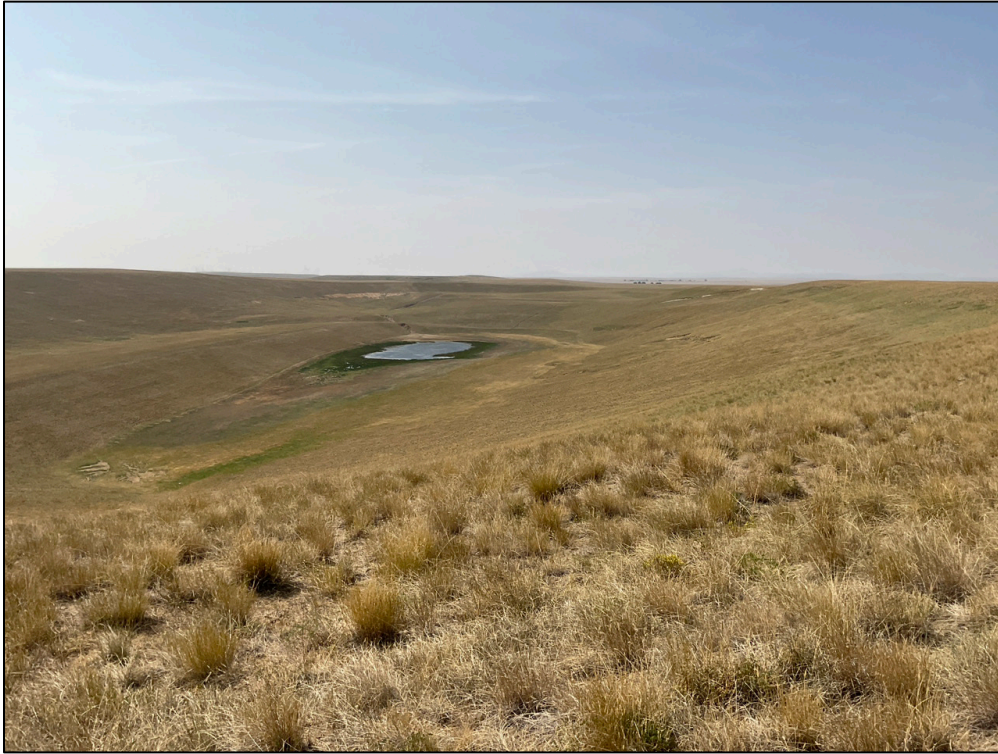
projected surface of the uppermost aquifer, revegetating the surfaces, and protecting against potential erosion areas with riprap. Vegetation is well established, and a wetland area has formed at the bottom of the pit (PL-9). Some minor slumps and displacement features are present on the west and southeast side slopes of the pit, but they do not represent a significant slope stability concern. A riprap-armored drainage channel near the bottom of the pit, first reported to have eroded in 2016, has continued to erode (PL-10). Repair of the riprap armor is not necessary because potential erosion in that portion of the pit is not expected to impact the disposal cell.

PL-9. Pit 4 Overview and Wetland Area

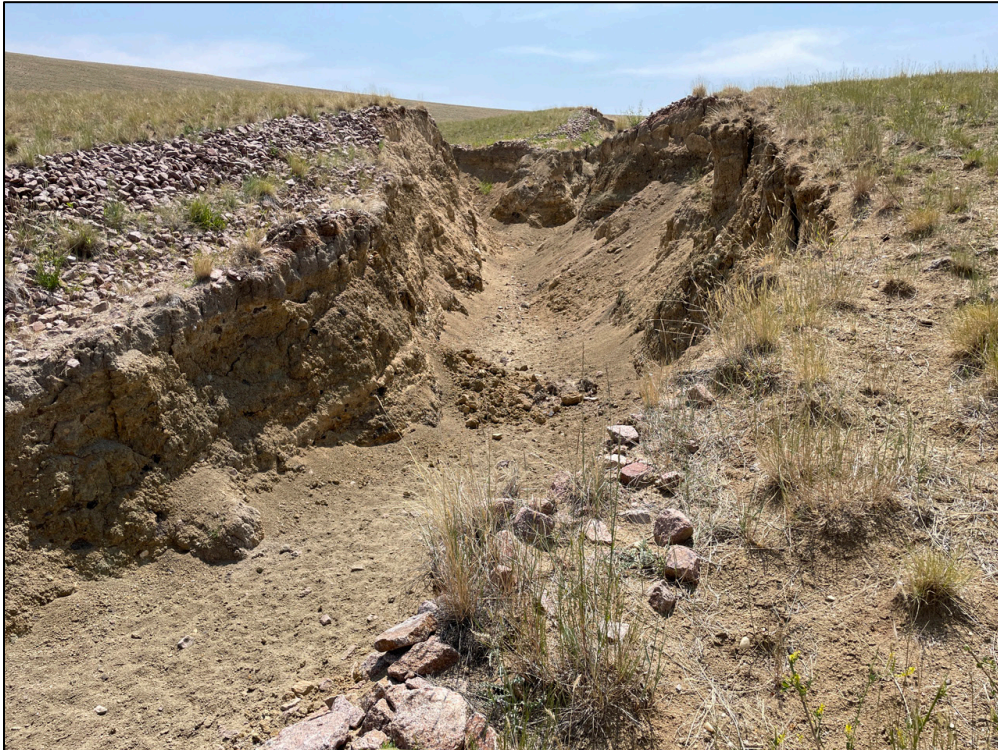
PL-10. Pit 4 Lower Riprap-Armored Drainage Channel Erosion

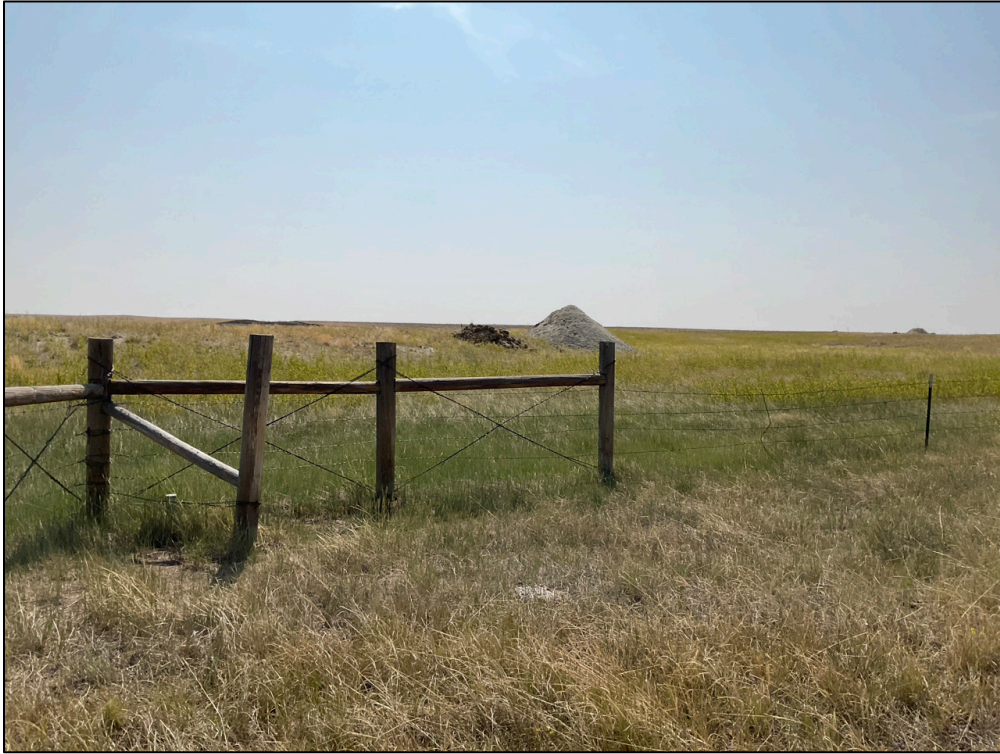
The area 0.25 mile beyond the site boundary was visually observed for erosion, changes in land use, or other phenomena that might affect the long-term integrity of the site. Land use changes since the 2023 inspection include: new drilling activity north of the site on Ur-Energy property (PL-11) and associated road improvements including a culvert installation near the northeast corner (PL-12). No other changes were identified.

PL-11. Drilling Activity North of Site Boundary

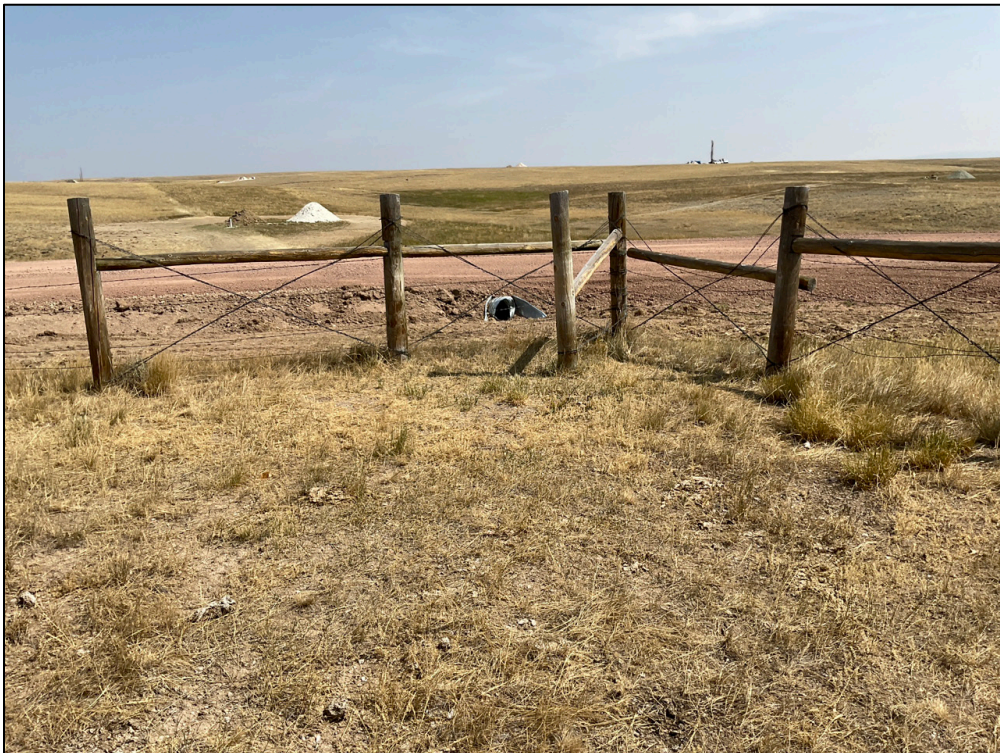
PL-12. Road Improvements Adjacent to Northeast Site Boundary
