## 5.0 Sherwood, Washington, Disposal Site

### 5.1 Compliance Summary

The Sherwood, Washington, Uranium Mill Tailings Radiation Control Act (UMTRCA) Title II Disposal Site was inspected on May 16, 2024. No changes were observed to the disposal cell, containment dam, or associated drainage features. Inspectors identified several routine maintenance needs but found no cause for a follow-up or contingency inspection.

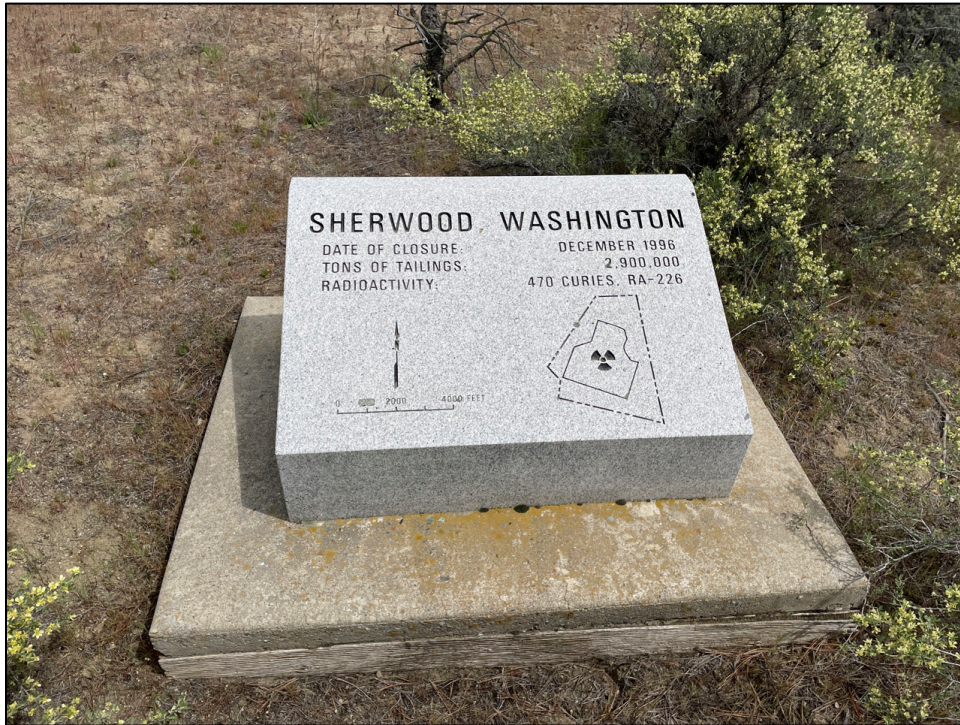
There is one granite site marker on the southwest side of the site where the access road lies closest to the site boundary (PL-1). No maintenance needs were identified.

*PL-1. Site Marker*

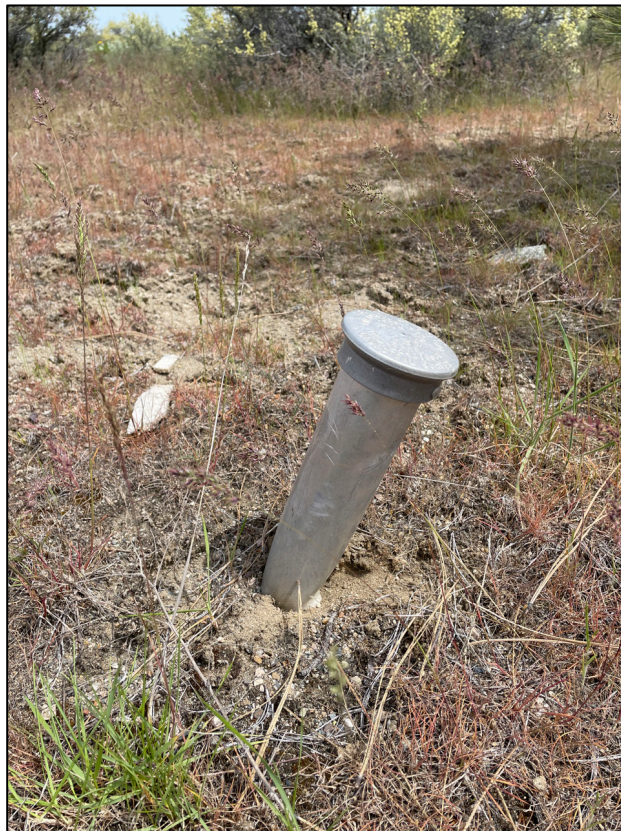
Six boundary monuments set in concrete define the site boundary. Because surrounding vegetation has made it difficult to locate some of the monuments, metal T-posts were installed at each boundary monument location. All boundary monuments were located during the inspection. Boundary monument BM-3A is bent but still visible and intact (PL-2). No maintenance needs were identified.

*PL-2. Bent Boundary Monument BM-3A*

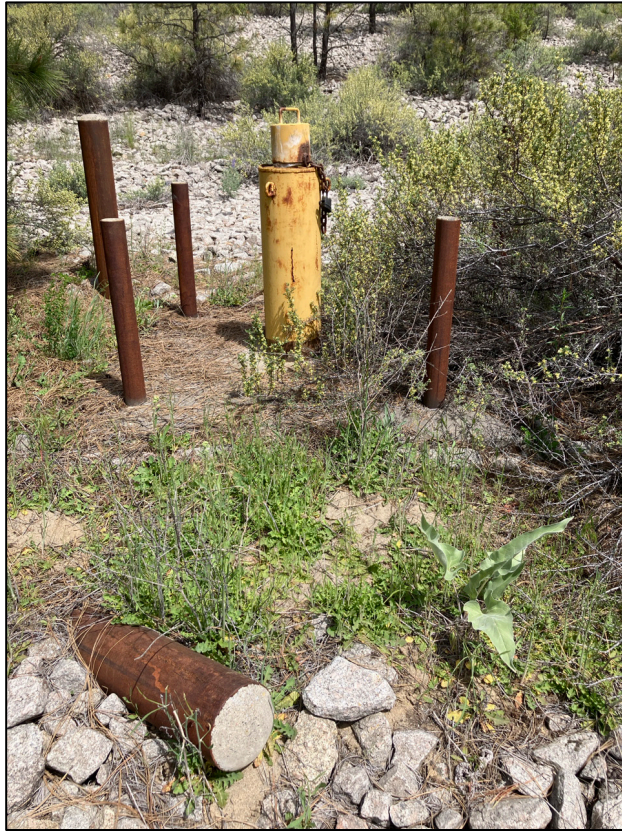
The site groundwater monitoring network consists of monitoring wells MW-2B, MW-4, and MW-10. Each monitoring well is protected by eight surrounding bollards. At monitoring well MW-4, one of the outermost bollards has been knocked over (PL-3). The LMS groundwater sampling team verified that the integrity of the well has not been affected. The fallen bollard was removed after the inspection. As part of the dam safety inspection program, four piezometers were installed in November 2000 along the crest of the containment dam at a depth equivalent to the base of the dam. All piezometers were undamaged and locked. None of the piezometer wellheads or concrete pads have any designation of their number. To avoid potential errors, it is suggested that the piezometers have their number punch stamped on the wellhead by the Environmental Monitoring, Operations and Sciences department in the future. No additional maintenance needs were identified.

*PL-3. Damaged Bollard at MW-4 (removed)*

- Removal of the damaged bollard at monitoring well MW-4
- Removal of the fallen tree along the southern access road
- Trimming of vegetation along the dike road

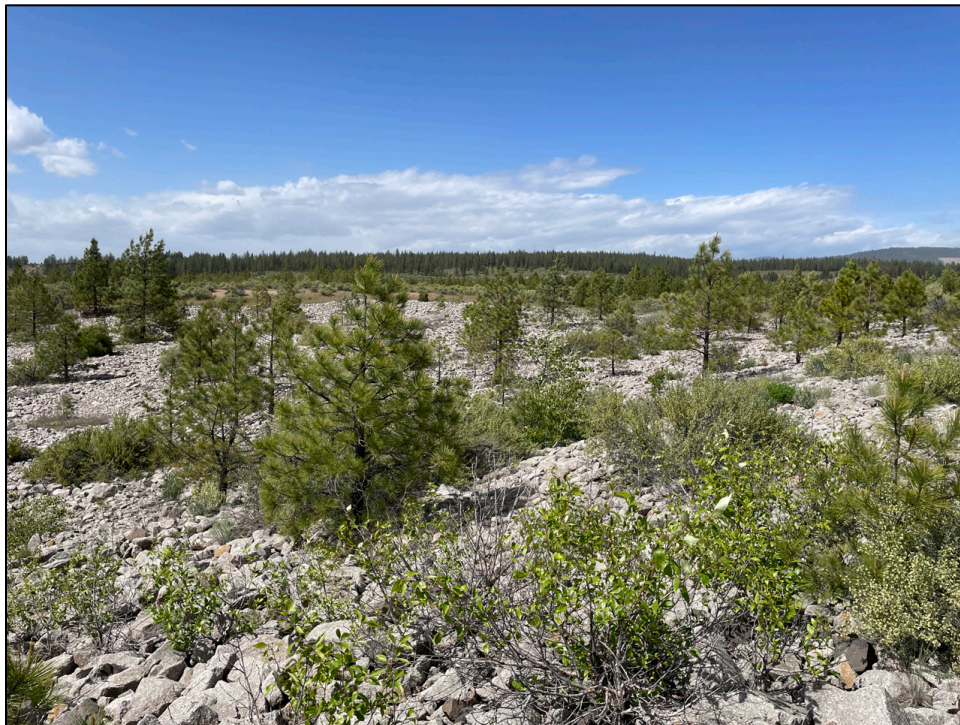
A small, shallow runoff channel near the southeast corner of the disposal cell discharges water into a riprap-armored swale east of the containment dam (PL-4). The channel is stable and is not above the tailings impoundment. In previous inspections, rilling was found below the

riprap-armored swale. These features will continue to be monitored to ensure that they do not affect the integrity of the disposal cell.

*PL-4. Swale*

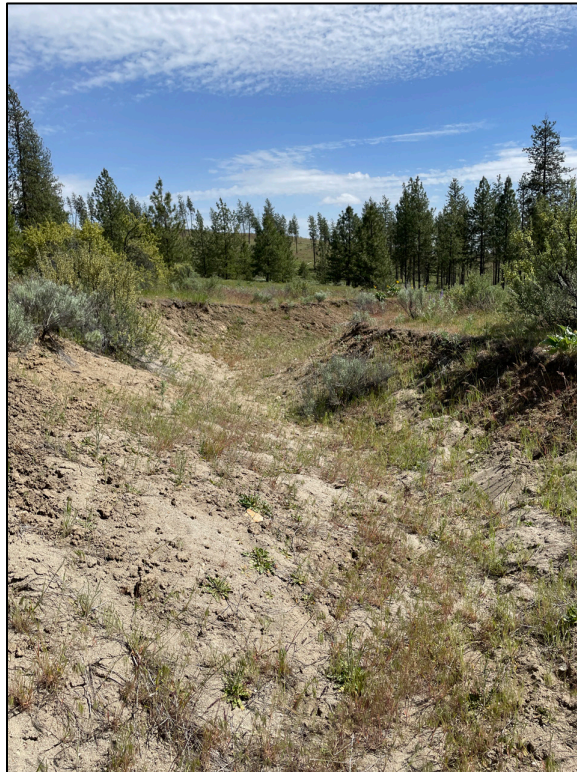
Two prominent gullies are present: one is outside the site boundary between perimeter sign P1 and P2 (PL-5) and the other is along the access road near the dike road on the southeast corner of the disposal cell. The erosion areas are stable and are not impacting site features but will continue to be monitored. No maintenance needs were identified.

*PL-5. Gully near Perimeter Sign P1*

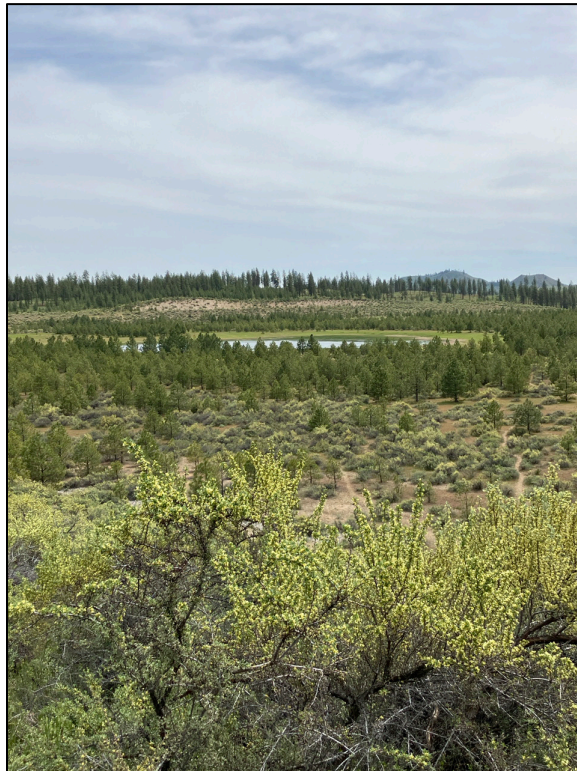
As described in detail in the LTSP (DOE 2001), the disposal cell cover was designed to stabilize, and settlement was expected to occur. The largest area of settlement is at the center of the disposal cell (PL-6) where plant species adapted to wetland environments are present. Four distinct ponds, or wetland areas, were mapped during past inspections, but they are merging into one distinct pond. A settlement analysis of the ponding area completed in 2023 indicated that a maximum of 5.54 ft of settlement has occurred near the pond since construction of the disposal cell (DOE 2023). The cover design allowed for up to 10 ft of settlement (DOE 2018b). The disposal cell surface will continue to be monitored for unusual settlement features to ensure that the disposal cell is performing as designed. In October 2021, aerial light detection and ranging (lidar) surveys were conducted to collect high-resolution topographic data of the disposal cell and surrounding area. The data collected include natural color imagery and lidar elevation data to be used as a baseline. A follow-up aerial survey is scheduled for 2028. The data collected in the 2021 aerial survey confirm that settlement is less than the 10 ft allowance. No maintenance needs were identified.

*PL-6. Pond on the Disposal Cell*

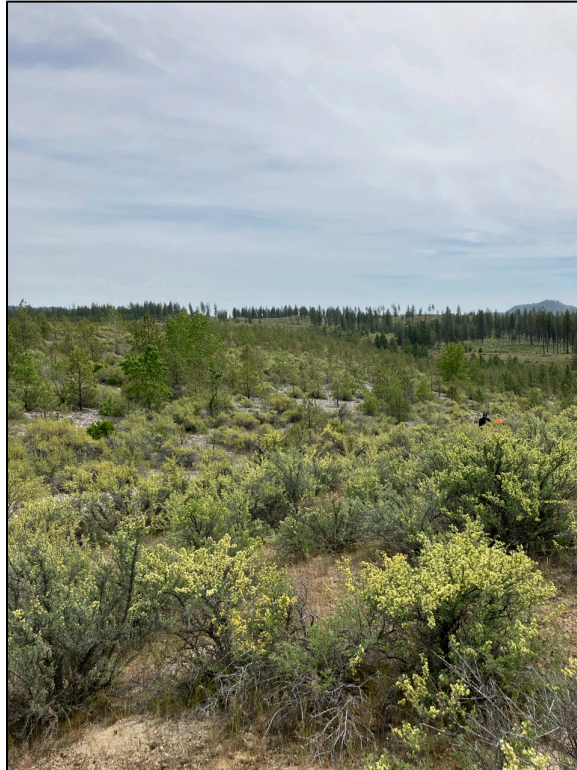
The containment dam face has a rock cover consisting primarily of highly durable quartz monzonite. The face was designed to allow for a vegetated cover, including mature trees, to establish and stabilize the surface and mitigate erosion. The dam face was heavily vegetated in 2024 (PL-7). No maintenance needs were identified.

*PL-7. Dam Face*

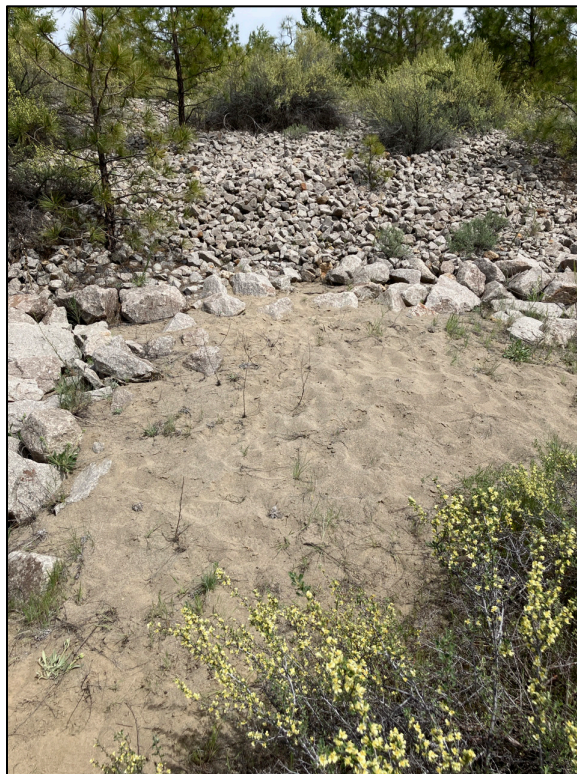
During past inspections, areas of sand deposition have been described that indicate that materials have washed out from underneath the dam rock cover (DOE 2018a). The largest sand deposit (PL-8), measuring approximately  $16 \times 14$  ft, was evaluated by a soil erosion specialist during the 2022 inspection. This area will be visually monitored and measured during future inspections and by periodic lidar surveys. Several smaller deposits on the dam, especially on the western half, were also evaluated, as were several areas along the toe of the dam. DOE will continue to monitor or implement repair options in consultation with NRC as necessary. Deposition is occurring in several areas along the toe of the containment dam. Continued deposition over time could lead to accumulation in amounts rendering the water-draining ability of the containment

dam toe inefficient. This is not an issue currently, but inspectors will continue to monitor the areas.

*PL-8. Sand Washout Area*

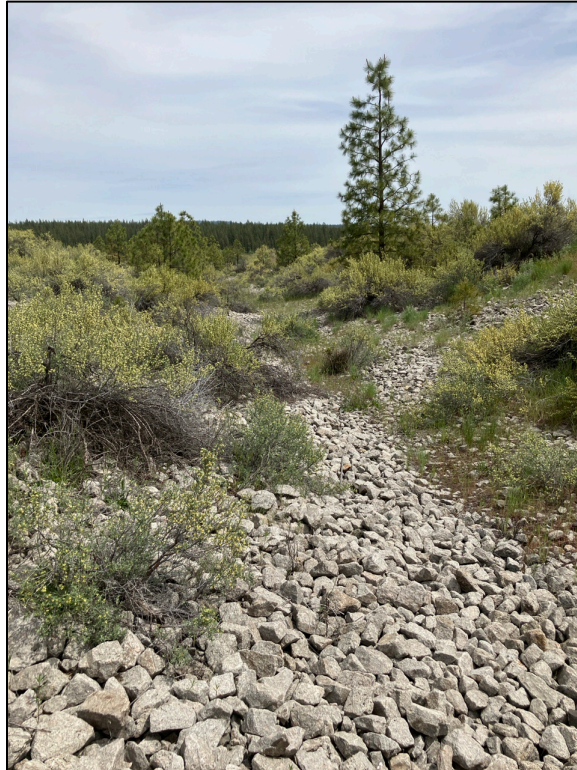
A riprap-armored diversion channel surrounds the disposal cell, diverting runoff away from the cell. The diversion channel was designed to allow for sedimentation and for vegetation to establish over time. Trees, shrubs, grasses, and wetland plants have established in most areas of the diversion channel (PL-9). Sediment deposition is found in many places in the diversion channel, and trails in these areas indicate that wildlife frequently access the disposal cell for forage and water. No evidence of erosion was observed downgradient of the diversion channel outlets. No maintenance needs were identified.

*PL-9. North Diversion Channel*
