17.0 Slick Rock, Colorado, Disposal Site

17.1 Compliance Summary

Figure 17-1. 2008 Annual Compliance Drawing for the Slick Rock Disposal Site

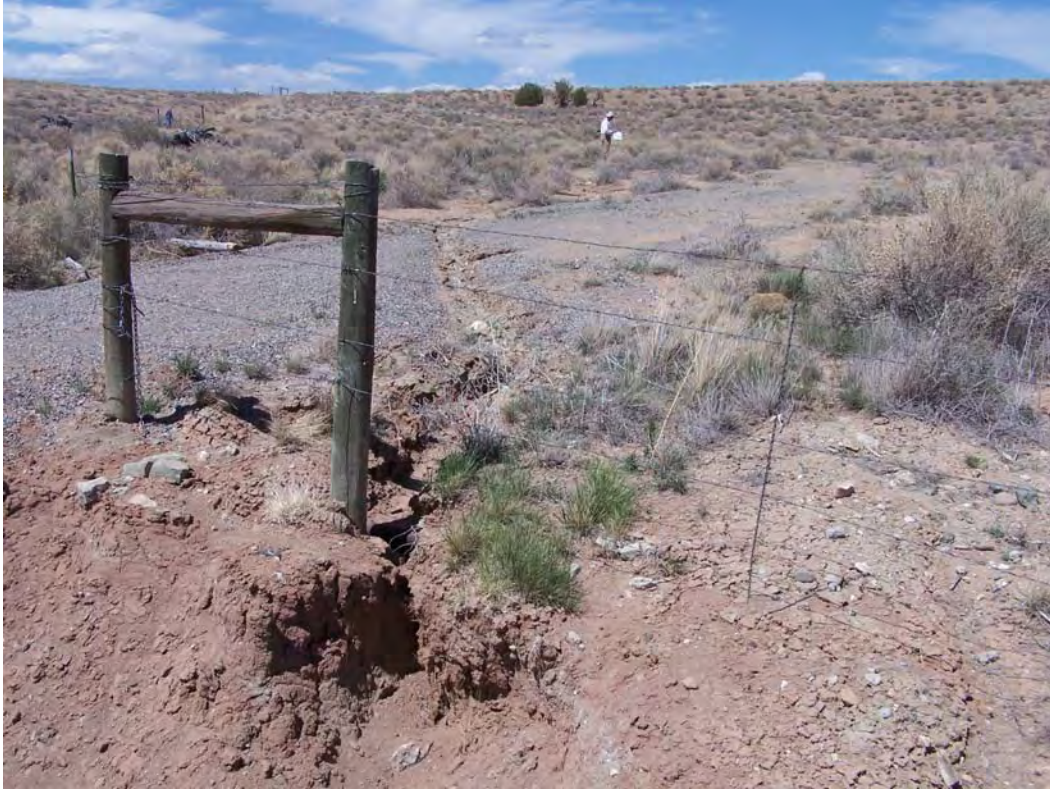
17A **Access Road, Gate, Fence, and Signs**—Access to the site is off County Road T11, an improved gravel-and-dirt road maintained by San Miguel County. The road was in good condition at the time of the inspection, although minor erosion had occurred across the road just inside the entrance gate (PL–1). Since 2006, inspectors have noted that the 8-inch-diameter culvert, installed beneath the access road in 2004 to allow runoff to flow along the borrow ditch, was being continually eroded by stormwater runoff. In May 2008, inspectors noted that additional erosion was evident at both ends of the culvert (PL–2). Additionally, tumbleweeds (noted in the 2007 inspection) were still accumulating in the inlet to the culvert. As it was apparent that the culvert’s small diameter could not adequately handle storm runoff, the culvert was replaced with a 15-inch-diameter culvert in July 2008 (PL–3), and tumbleweeds present in the inlet were removed. The minor erosion across the access road was also repaired.

SRK 5/2008. PL-1. Gully across access road just inside entrance gate; repaired in July 2008.

In 2008, for erosion control purposes, DOE replaced the 8-inch-diameter culvert at the entrance gate near the country road with a 15-inch-diameter culvert. Minor erosion across the access road just inside the entrance gate was also repaired. Two large gullies containing deep headcuts that had formed southwest of the retention pond were repaired. As part of an ongoing weed maintenance program, several areas where noxious weeds were noted were re-treated with herbicide.

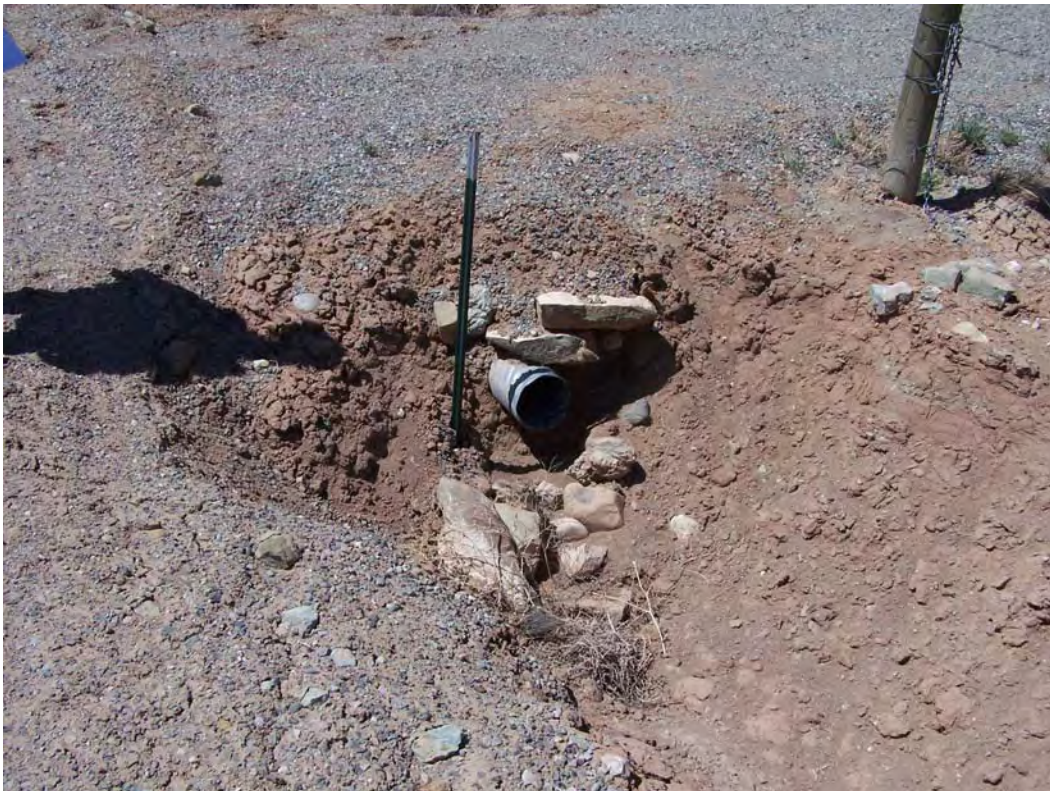
SRK 5/2008. PL-2. View of outlet with eroded 8-inch-diameter culvert (May 2008).

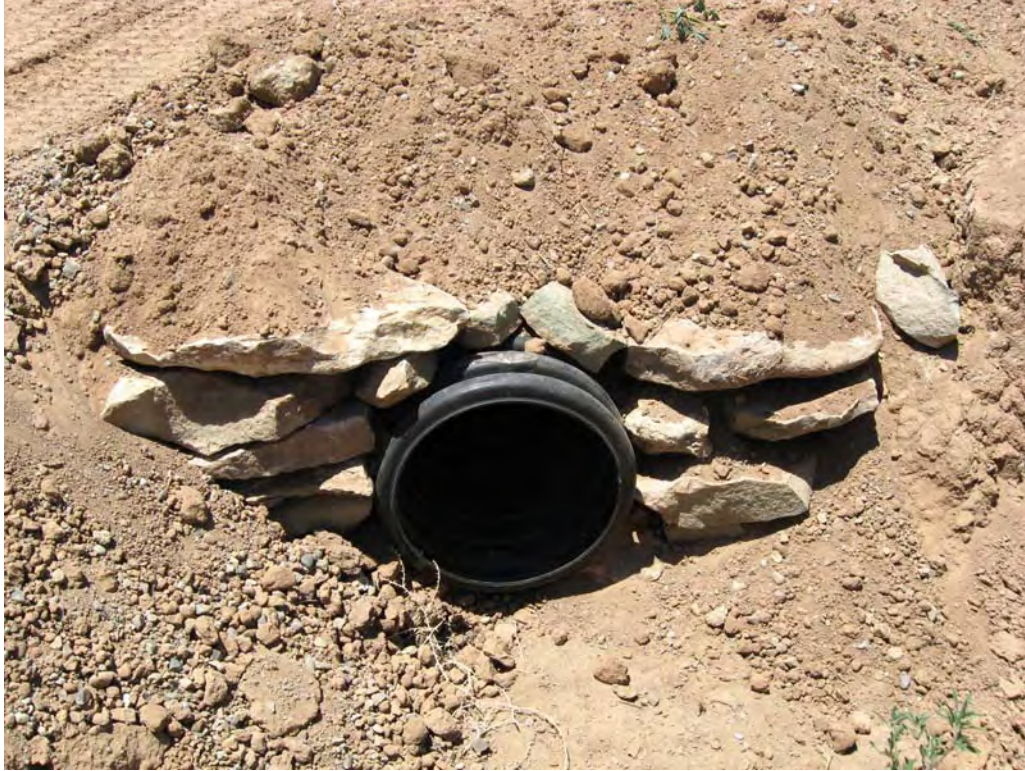
SRK 7/2008. PL-3. Outlet of newly installed 15-inch-diameter replacement culvert (July 2008).

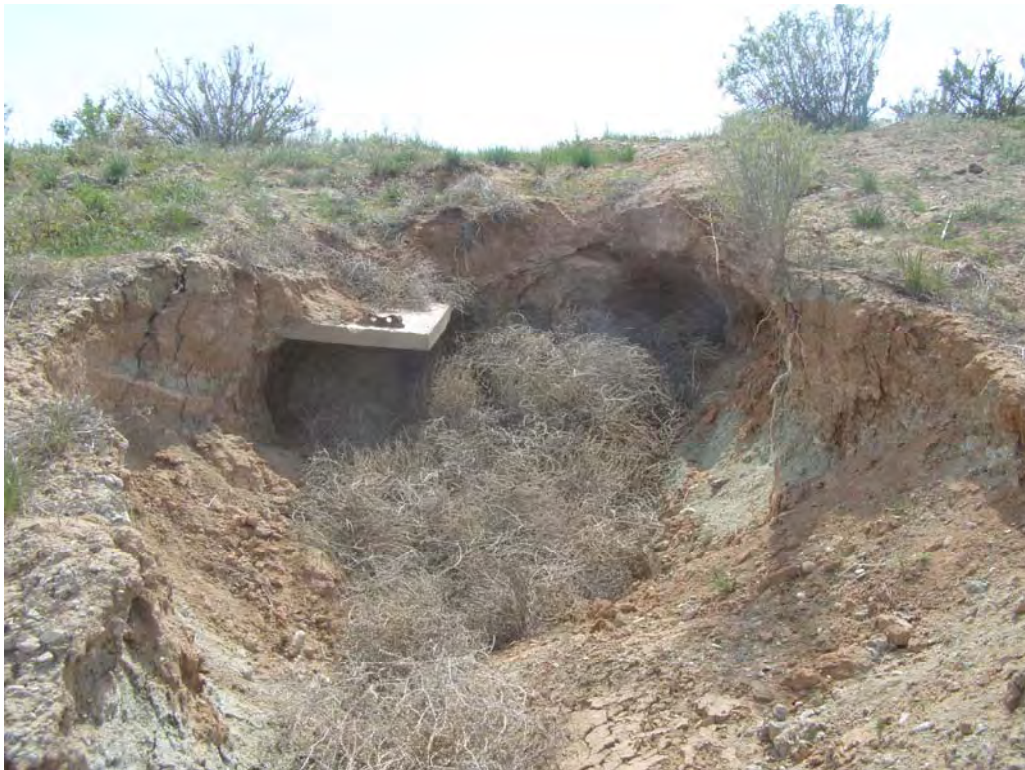
17B Areas of erosion between the apron and the retention pond were repaired in 2004. Although the area downslope of the apron is stabilizing, some erosion is still occurring. Several large storm runoff events during the last 2 years had increased the size of gullies southwest and northwest of the retention pond. The largest gully, located southwest of the retention pond below the culvert outlet on the county road, was 10 feet wide by 35 feet in length, with a 7-foot-deep vertical headcut, at the time of the inspection (PL-4). A second gully, located a short distance to the southeast and characterized by a 3-foot vertical headcut, had not increased in size since 2007 but was still in need of repair. Both of these headcuts were repaired in July 2008 (PL-5). Gullies previously noted on the northwest side of the retention pond are still as deep as 30 inches, but they do not present a hazard to the disposal cell or to any site feature. As such, action is still not warranted at this time. All of the aforementioned erosion areas will continue to be monitored as part of future inspections.

SRK 5/2008. PL-4. Primary gully below county road with 7-foot-deep vertical headcut, repaired in July 2008.

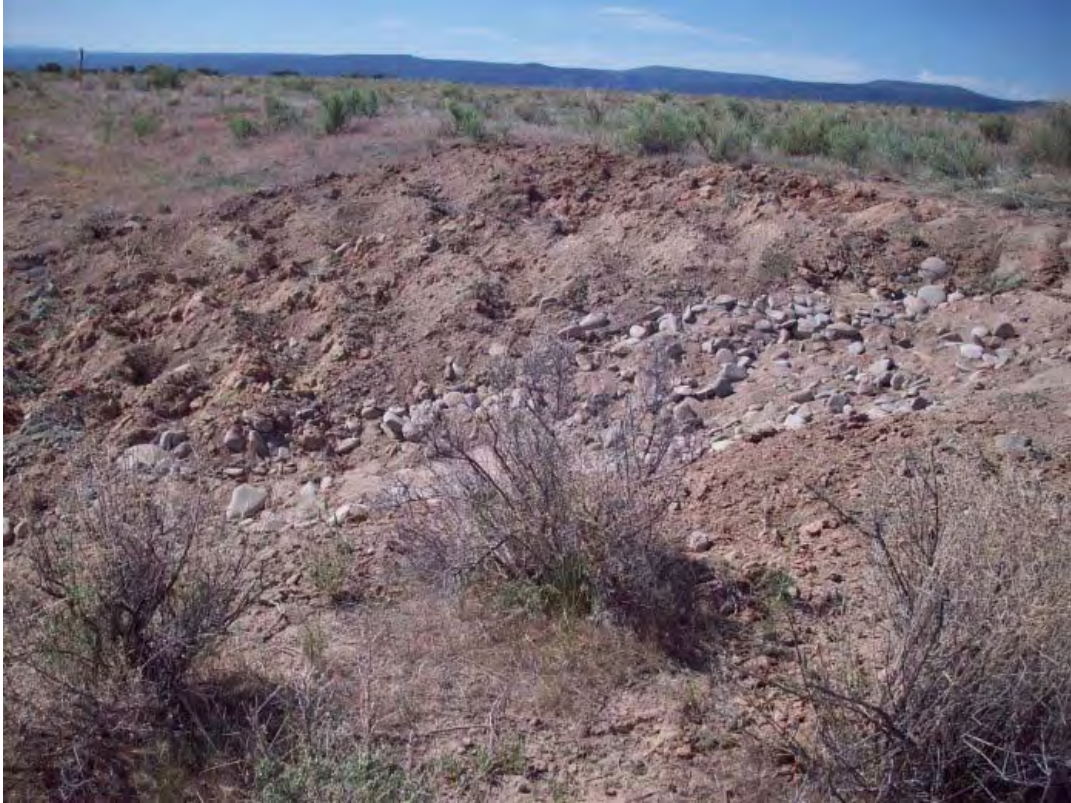
SRK 7/2008. PL-5. July 2008 erosion repair of primary gully.

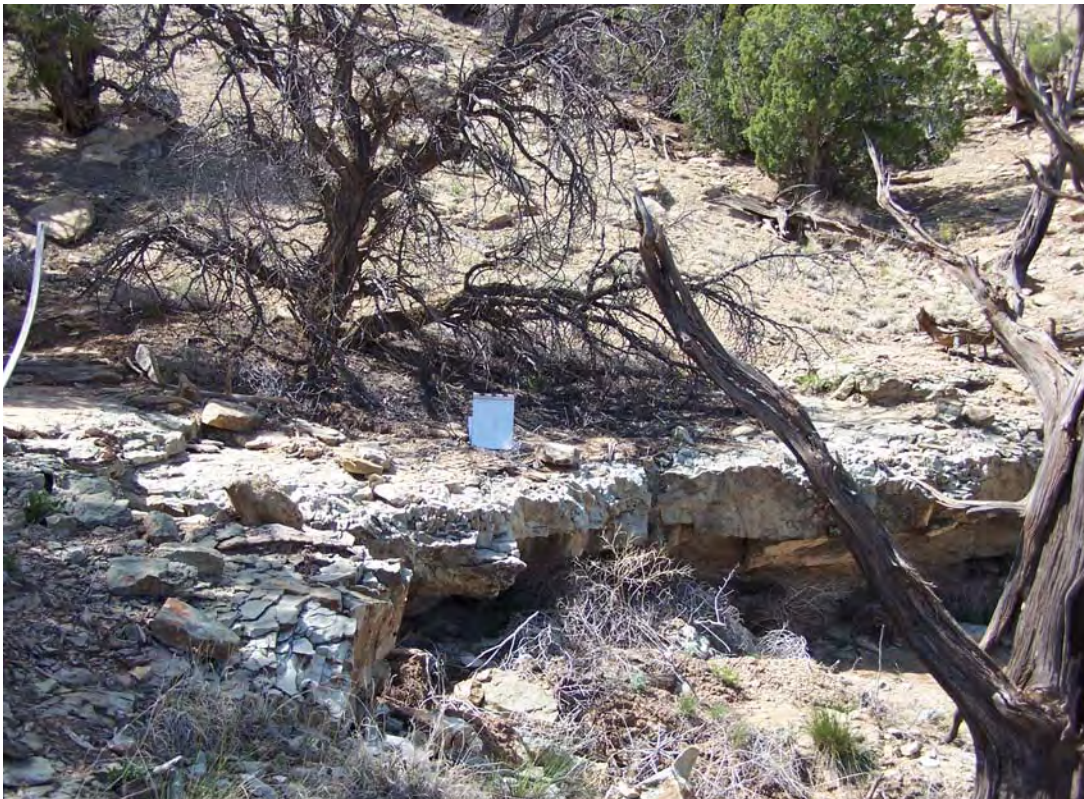
The Kd-1 (Dakota) sandstone unit, which crops out near the northeast corner of the property, was identified in the LTSP as a potential pathway of lateral migration of transient drainage from the disposal cell. In 2007, inspectors noted that minor erosion of the surface had taken place along the outcrop; however, there was no evidence of moist soil, mineralization, or phreatophyte vegetation that would indicate that transient drainage is occurring along this interface. The latter was still the case at the time of the 2008 inspection (PL-6).

SRK 5/2008. PL-6. Kd-1 (Dakota) sandstone outcrop.
