2.0 Burrell, Pennsylvania, Disposal Site

2.1 Compliance Summary

The Burrell, Pennsylvania, Uranium Mill Tailings Radiation Control Act (UMTRCA) Title I Disposal Site was inspected on October 22, 2014. No evidence of erosion or slope instability was observed on the disposal cell. There was some minor fence damage along the south fence line due to fallen trees, and some cracked or broken concrete monitoring well pads; these features will be repaired. An additional locking feature will be added to the entrance gate to prevent or deter unauthorized access. Routine vegetation management, consisting of herbicide treatments and mowing of noxious and invasive plants, continued in 2014. Inspectors identified no other maintenance needs or cause for a follow-up inspection.

Figure 2-1. 2014 Annual Inspection Drawing for the Burrell Disposal Site

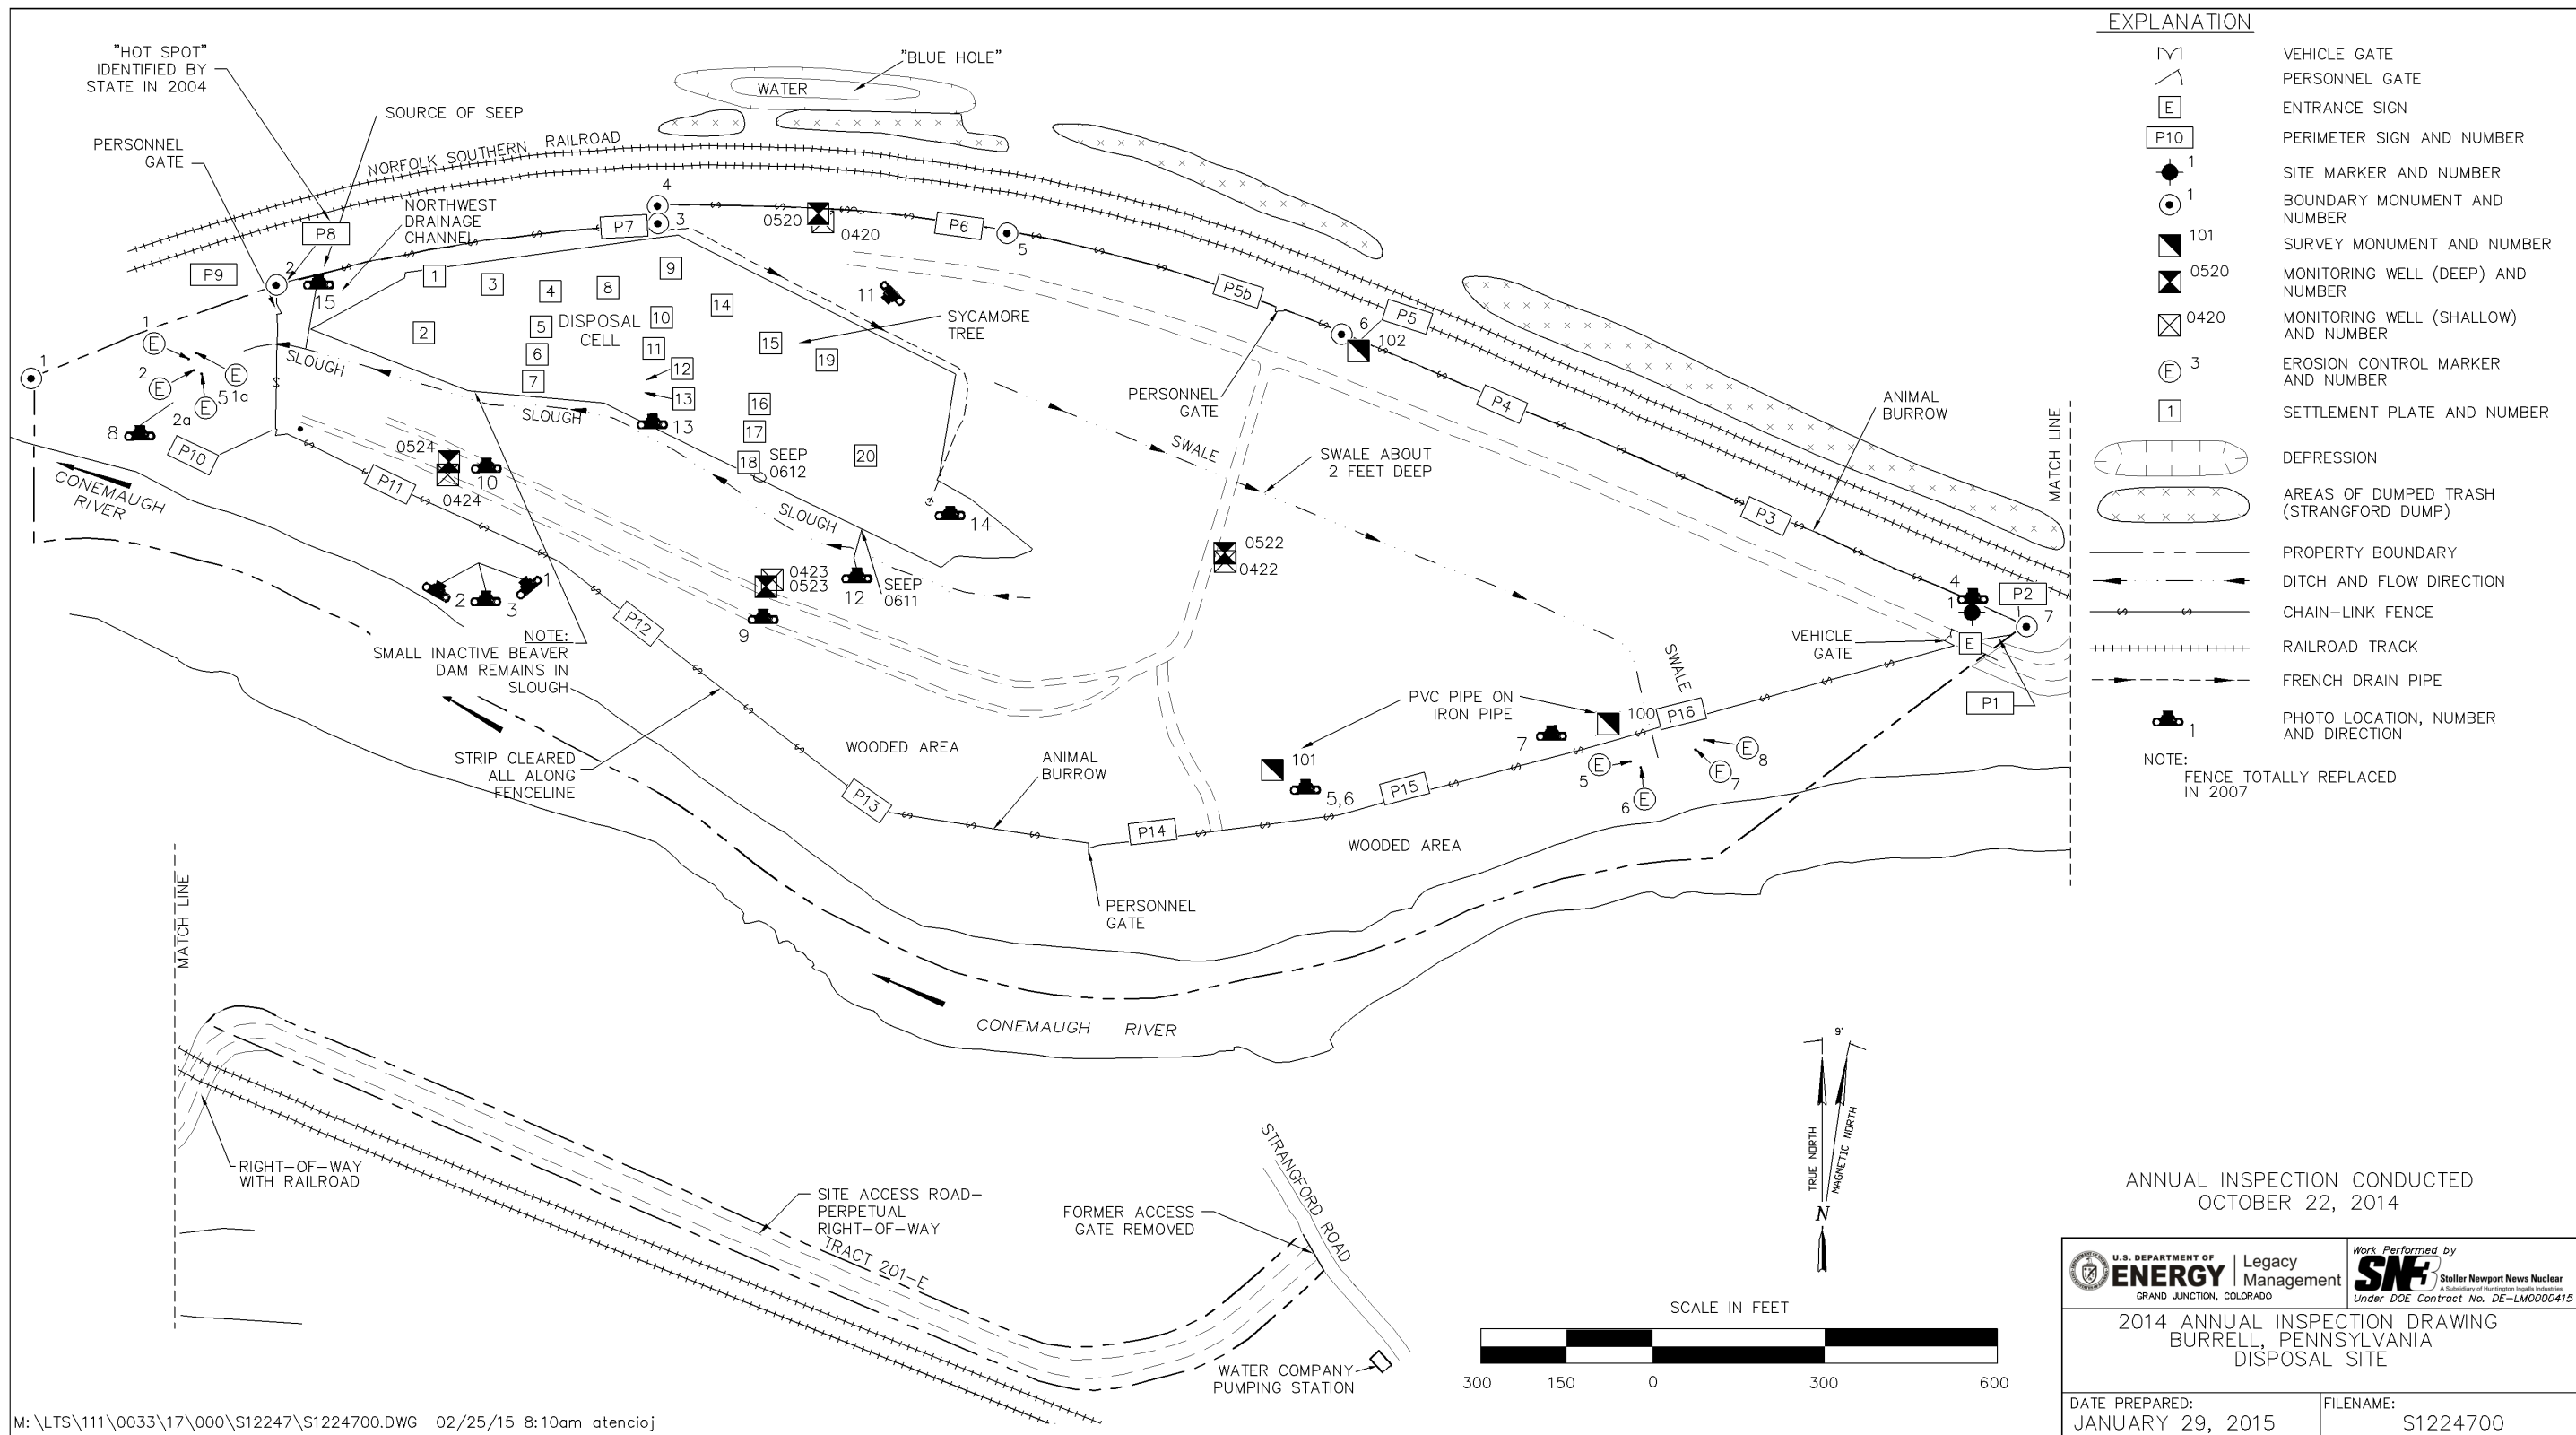
Figure 2-1 shows the locations of site surveillance features. Inspection results and recommended maintenance activities associated with site surveillance features are included in the following subsections. Photographs to support specific observations are identified in the text and in Figure 2-1 by photograph location (PL) numbers.

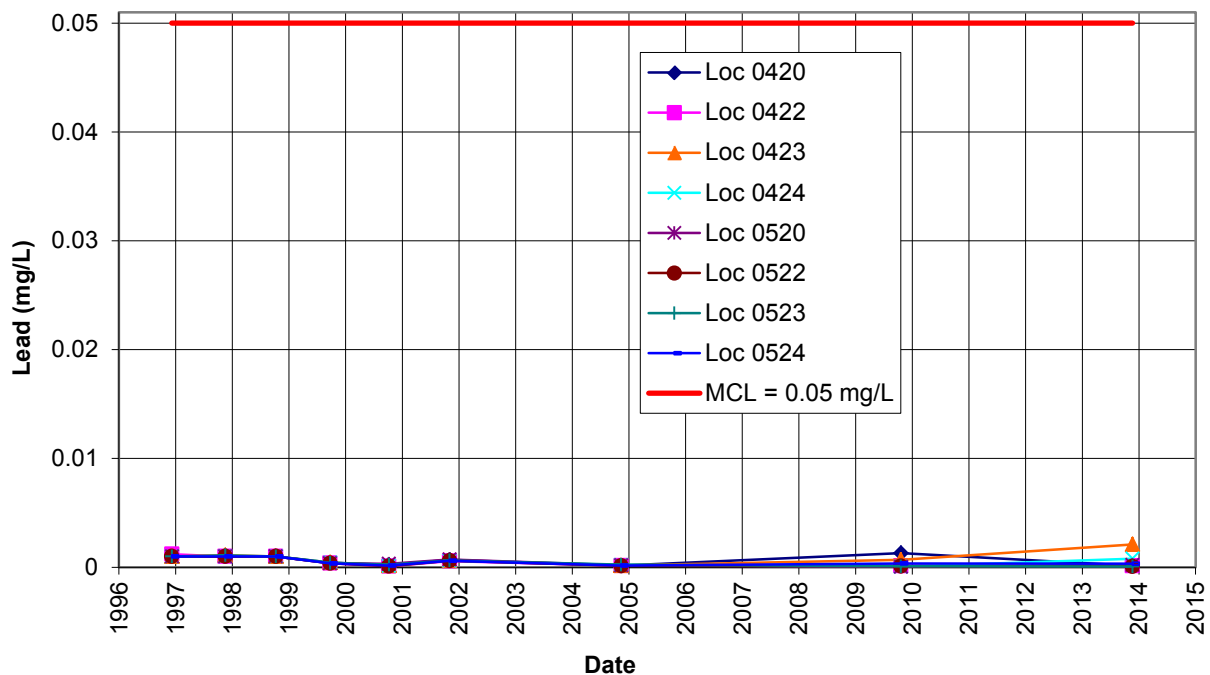
Figure 2-2. Lead Concentrations in Groundwater

Concentrations of lead in groundwater in both the shallow alluvial wells and the deeper bedrock wells remain well below the MCL of 0.05 milligram per liter (mg/L). 2013 results from all locations were more than an order of magnitude below the MCL (Figure 2-2).

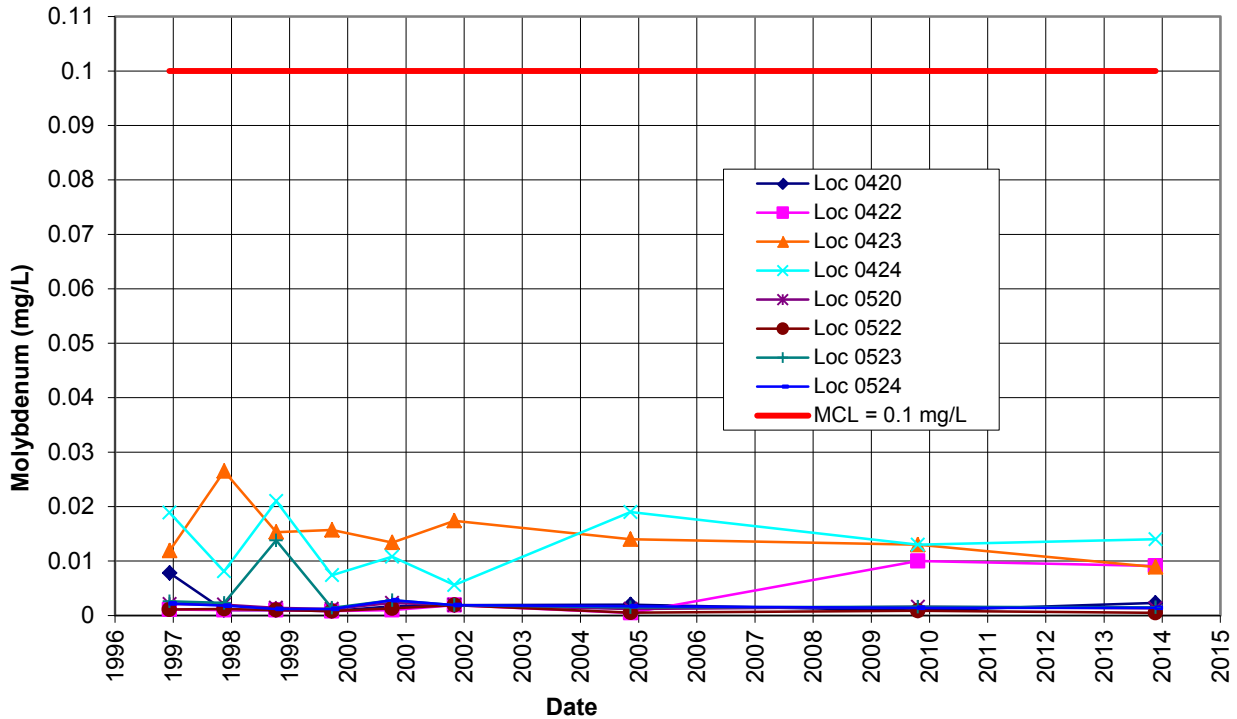
Figure 2-3. Molybdenum Concentrations in Groundwater

Concentrations of molybdenum in groundwater in both the shallow alluvial wells and the deeper bedrock wells remain well below the MCL of 0.1 mg/L. 2013 results from all locations, except down gradient wells 0422, 0423, and 0424, were more than an order of magnitude below the MCL and near or below the laboratory detection limit. Concentrations in wells 0422, 0423, and 0424 were about an order of magnitude below the MCL (Figure 2-3).

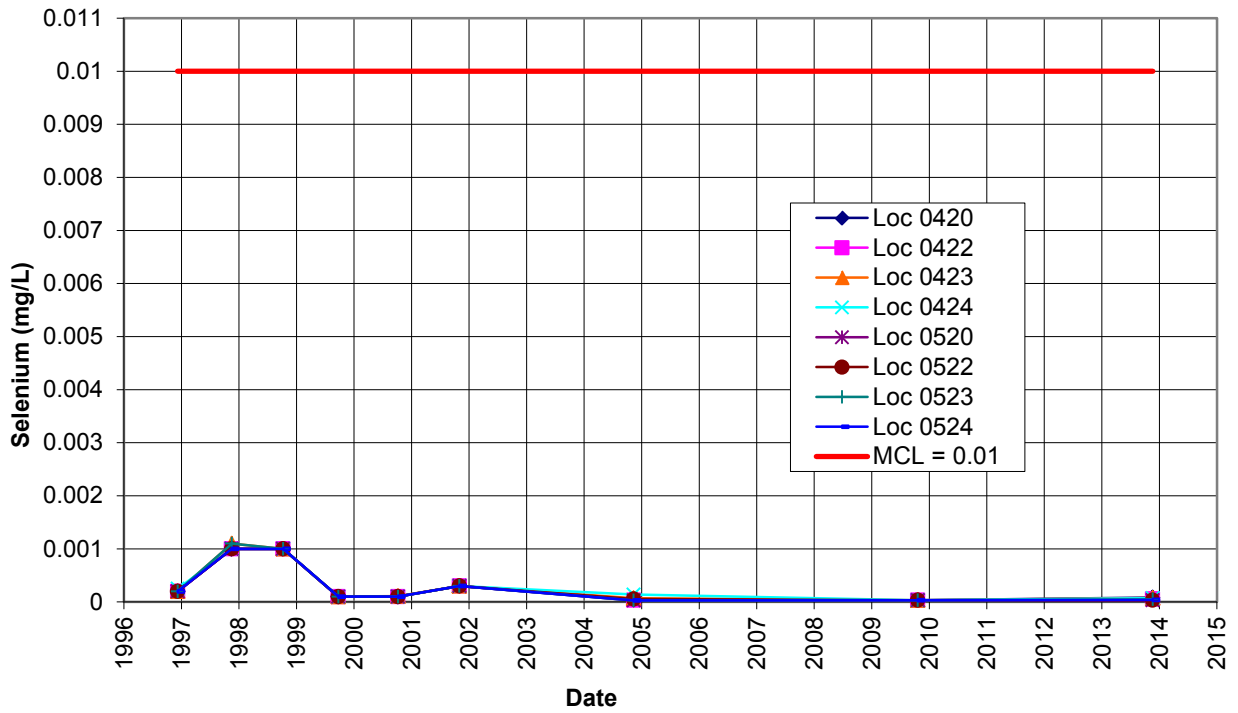
Figure 2-4. Selenium Concentrations in Groundwater

Concentrations of selenium in groundwater in both the shallow alluvial wells and the deeper bedrock wells remain well below the MCL of 0.01 mg/L. 2013 results from all locations were more than two orders of magnitude below the MCL and approached the laboratory detection limit (Figure 2-4).

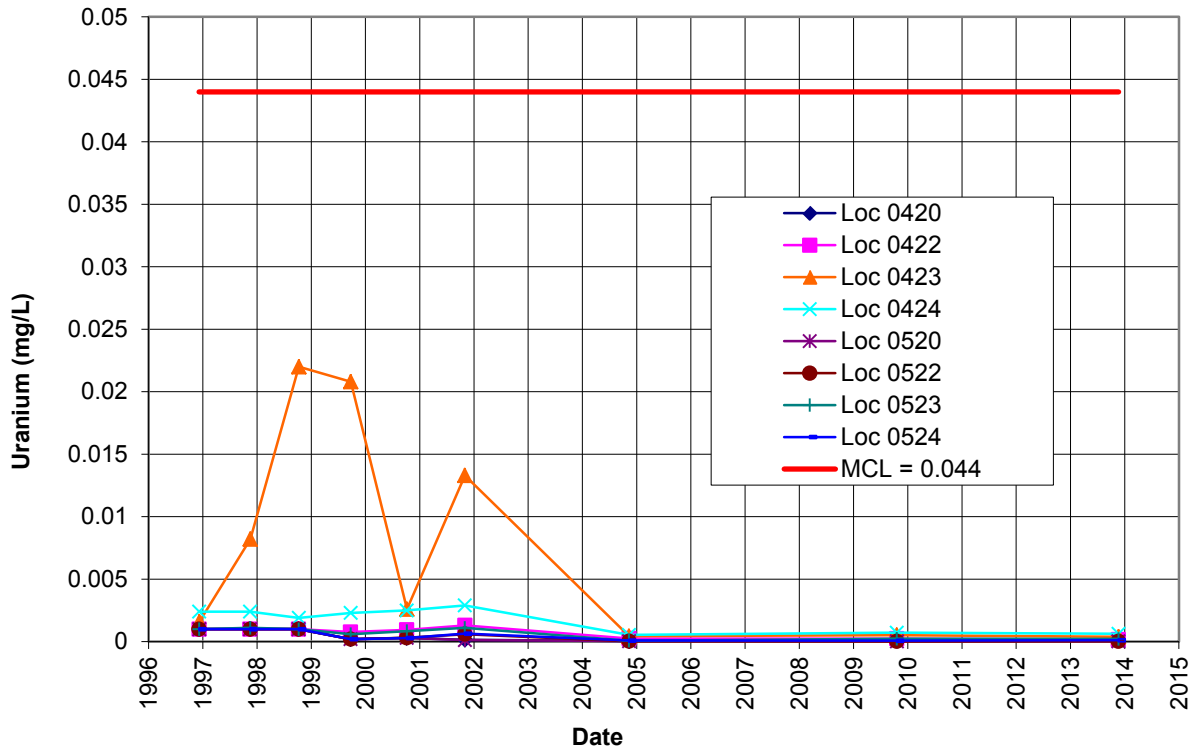
Figure 2-5. Uranium Concentrations in Groundwater

Concentrations of uranium in groundwater in both the shallow alluvial wells and the deeper bedrock wells remain well below the MCL of 0.044 mg/L. 2013 results from all locations were an order of magnitude or more below the MCL and approach the laboratory detection limit (Figure 2-5).

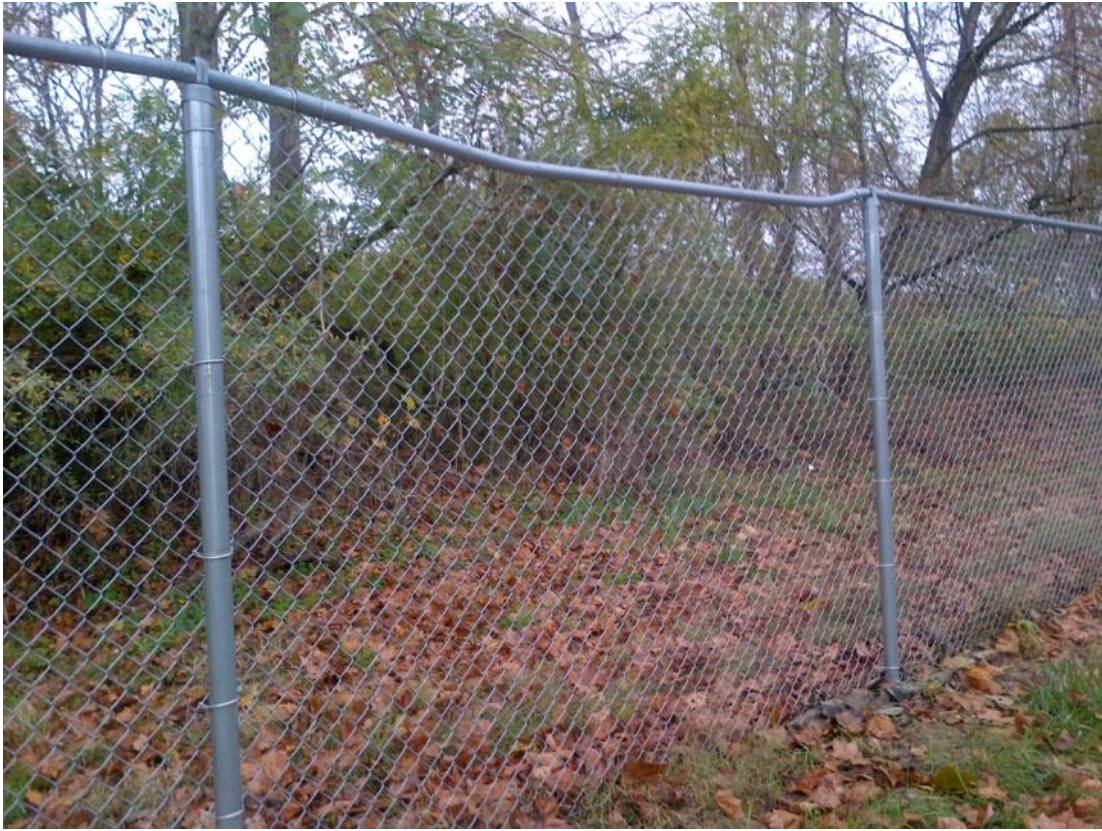
The chainlink perimeter fence that encircles the site was replaced in 2007. At the time of the 2014 inspection the fence had minor damage at several locations along the south fence line due to fallen trees (PL-1, PL-2, and PL-3). Overall, however, the fence is functional and in good condition, and the personnel gates were locked and in good condition.

BUR 10/2014. PL-1. Slight damage to top rail of perimeter fence.

Routine vegetation management was conducted in 2014 (mowing and herbicide treatments). The inspection identified the need for minor fence repairs and well pad repairs, and the addition of a locking feature on the entrance gate.

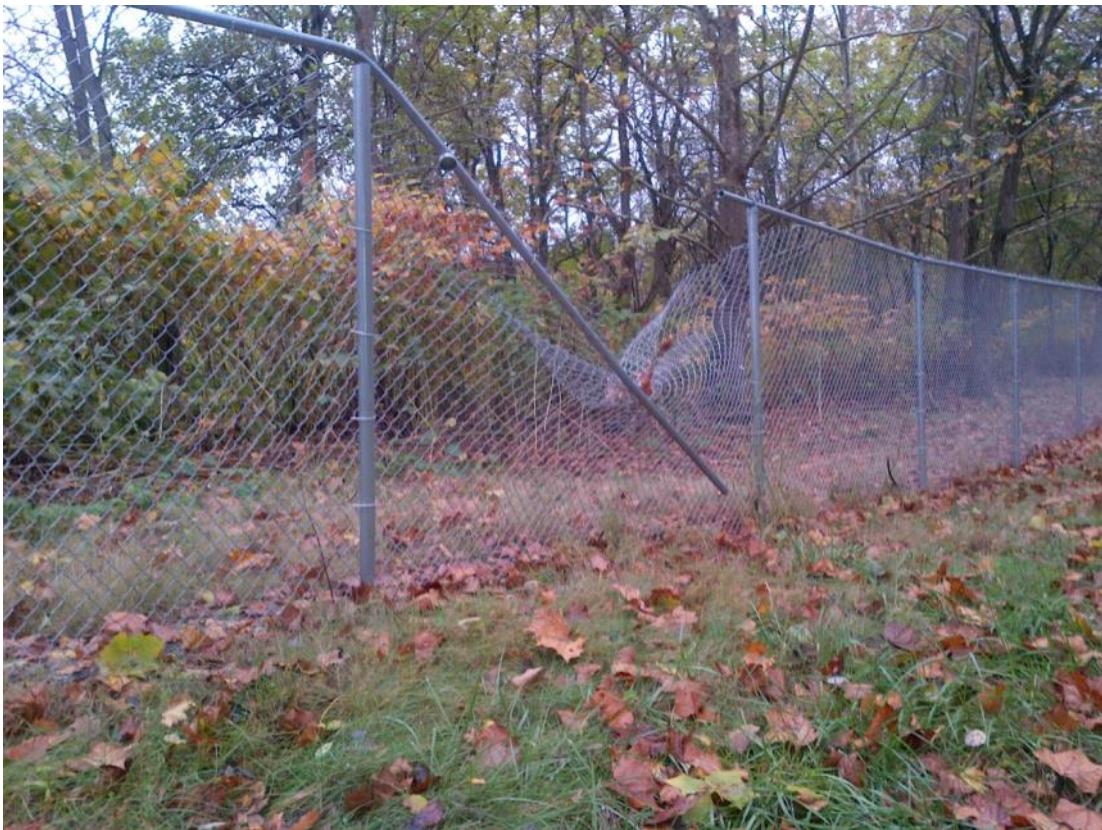
BUR 10/2014. PL-2. Damage to perimeter fence.

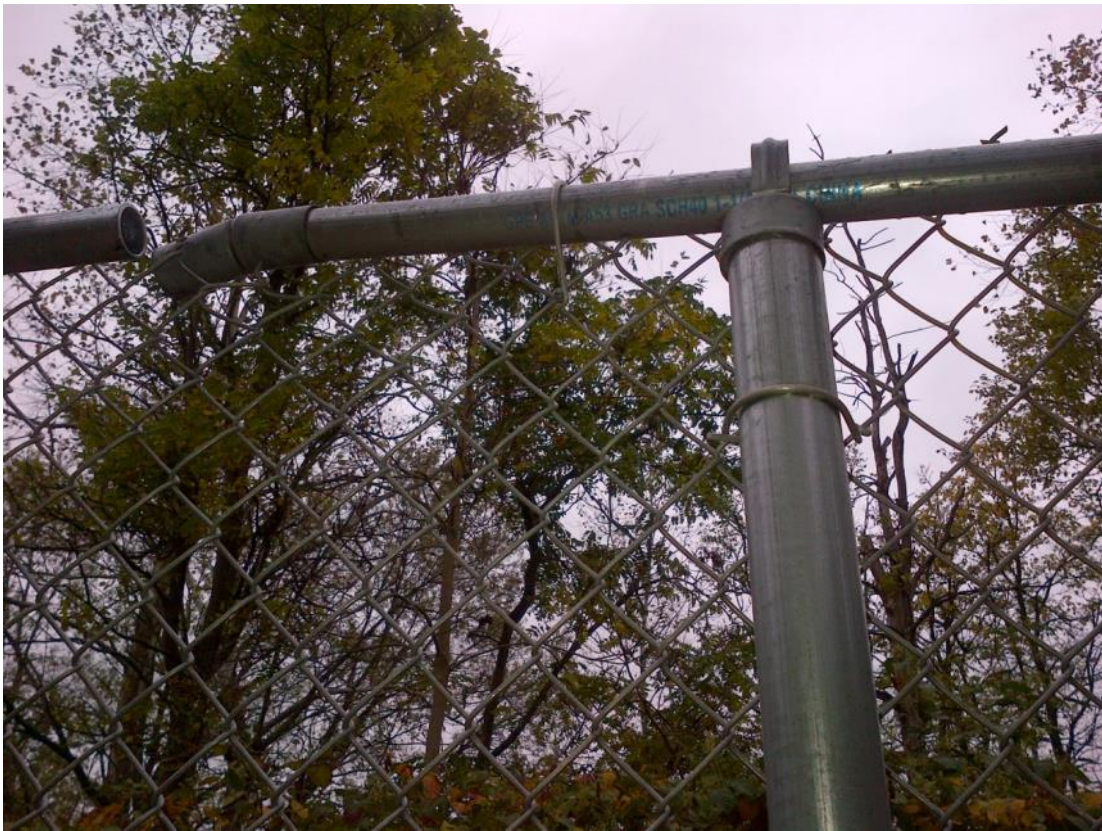
BUR 10/2014. PL-3. Damage to top rail of perimeter fence.

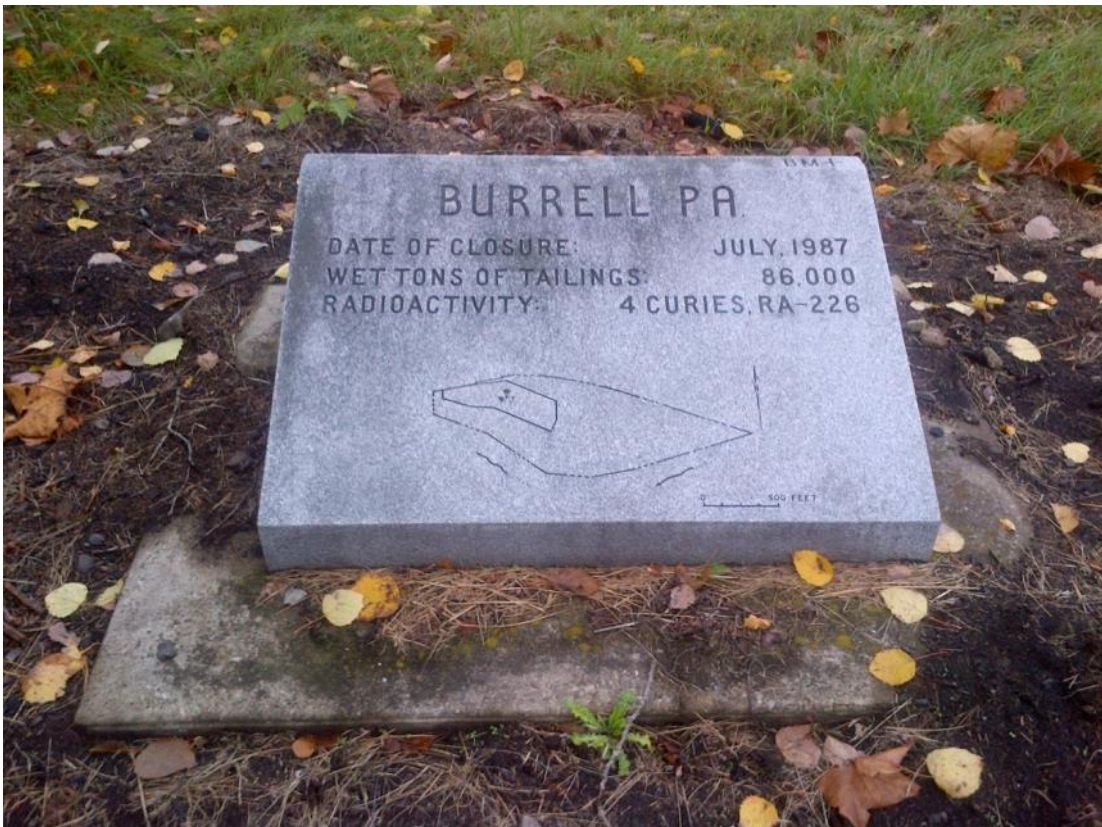
One granite site marker is present at the site. It is located just inside the main entrance gate and was in excellent condition (PL-4).

BUR 10/2014. PL-4. Burrell site marker.

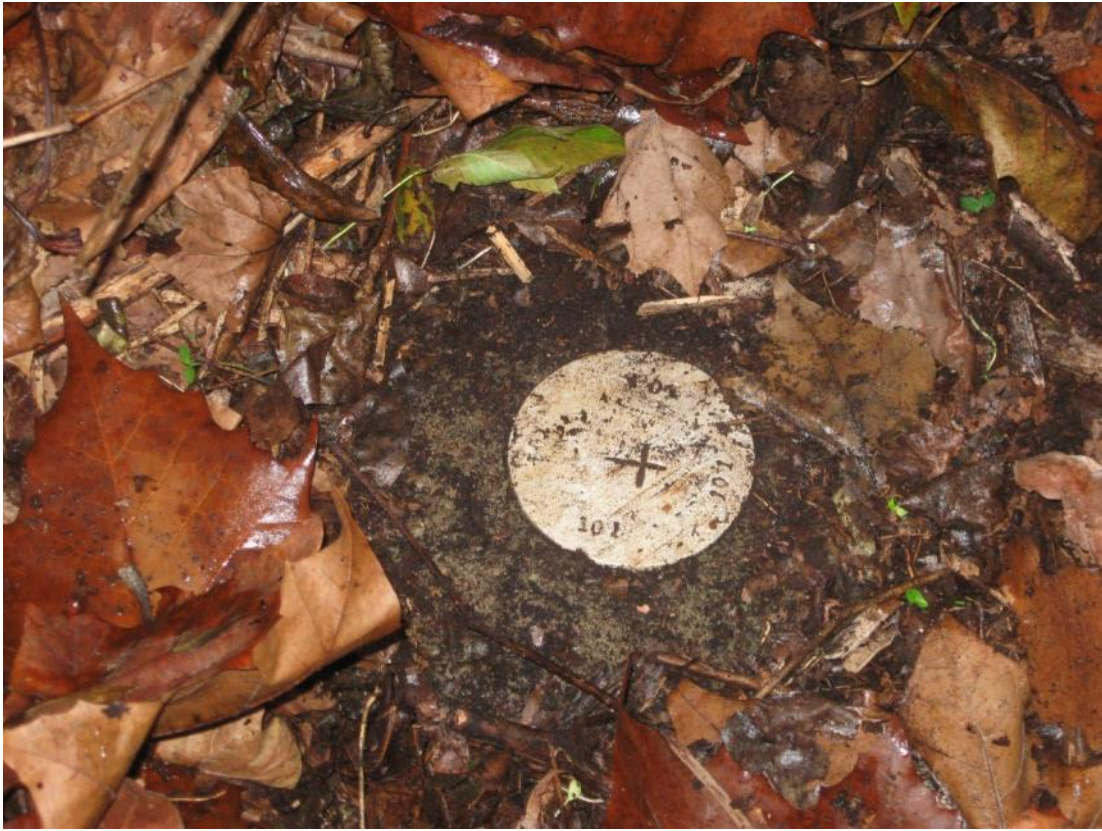
There are three survey monuments at the site. White PVC pipe has been installed near survey monuments SM-100 and SM-101 to aid in their location (PL-5 and PL-6). Although the PVC pipe for SM-100 was located, the actual monument was not because it was apparently covered with soil (PL-7). A metal detector will be used during the 2015 inspection to locate the monument.

BUR 10/2014. PL-5. Survey monument SM-101.

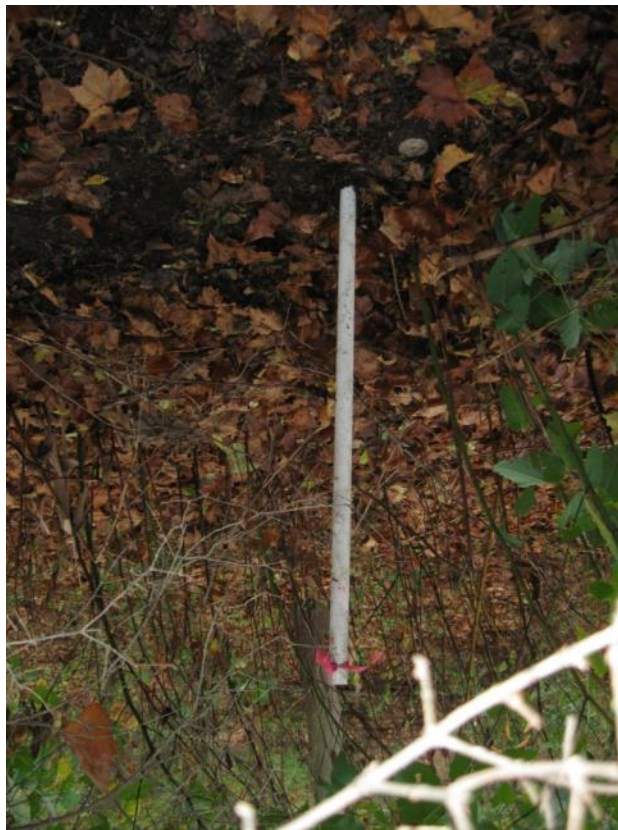
BUR 10/2014. PL-6. PVC marker for survey monument SM-101.

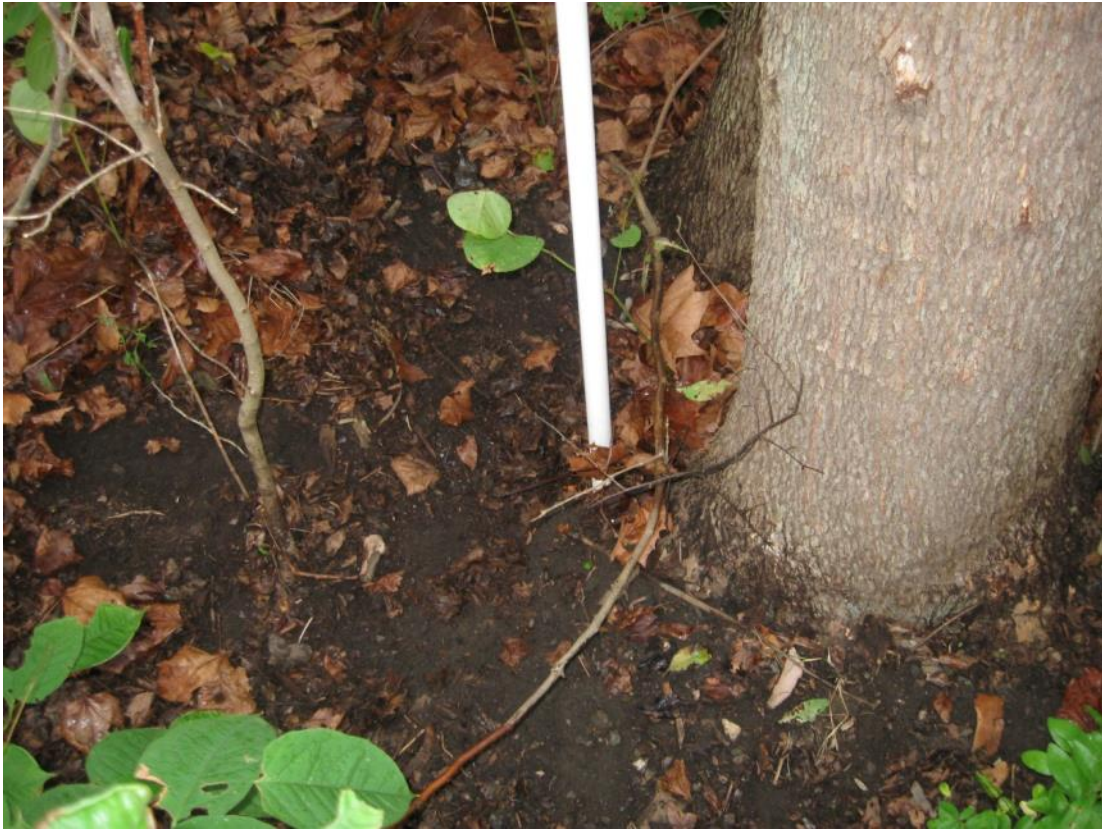
BUR 10/2014. PL-7. PVC marker for survey monument SM-100.

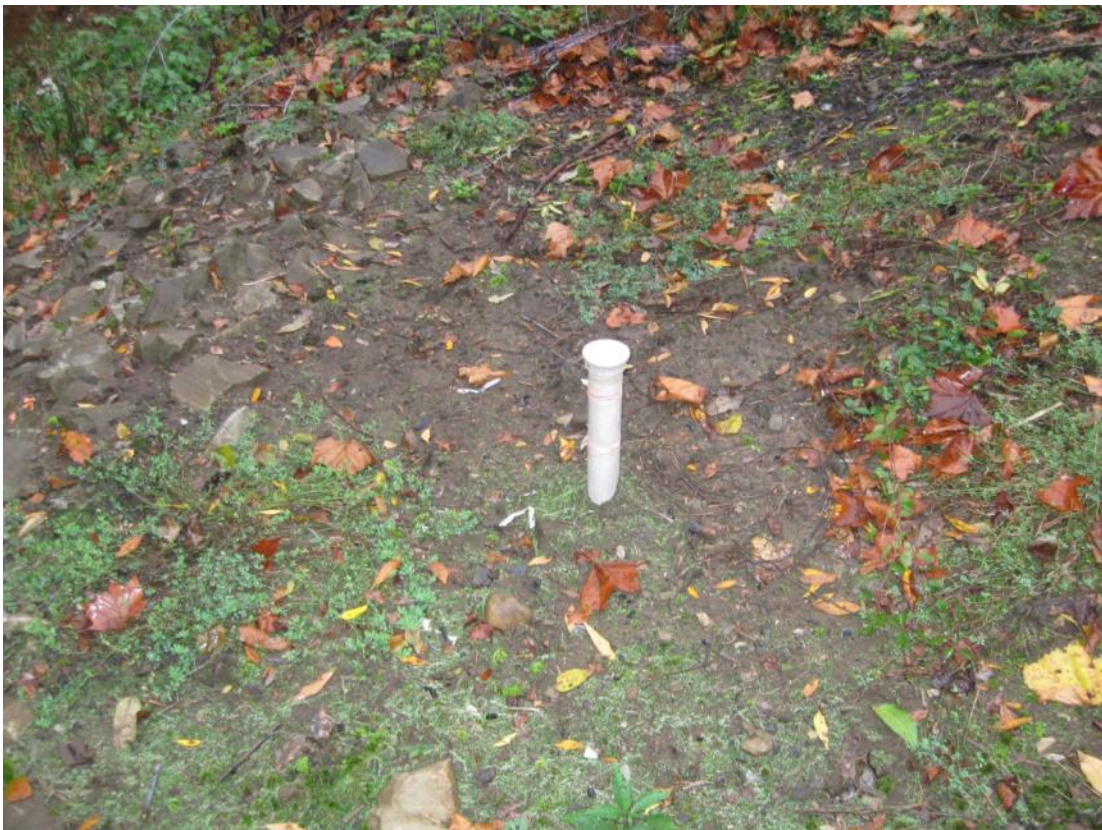
There are eight erosion control markers at the site. All of the markers were located and were in good condition (PL-8).

BUR 10/2014. PL-8. Erosion control marker 2A.

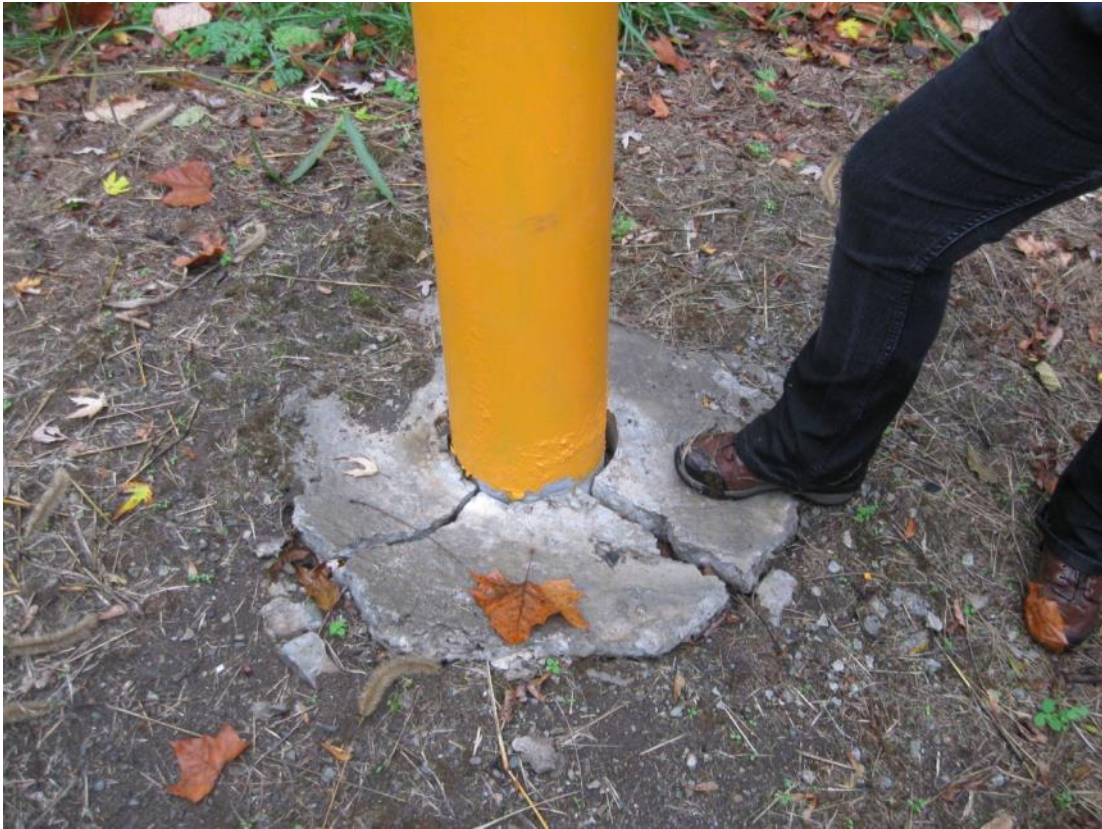
All wells encountered during the inspection were properly locked. The concrete pad around the surface casing of monitoring well 0523 is broken (PL-9). A few of the monitoring wells do not have a concrete pad (PL-10). The well pads will be repaired or installed as appropriate prior to the next sampling event in 2018.

BUR 10/2014. PL-9. Broken concrete around base of monitoring well 0523.

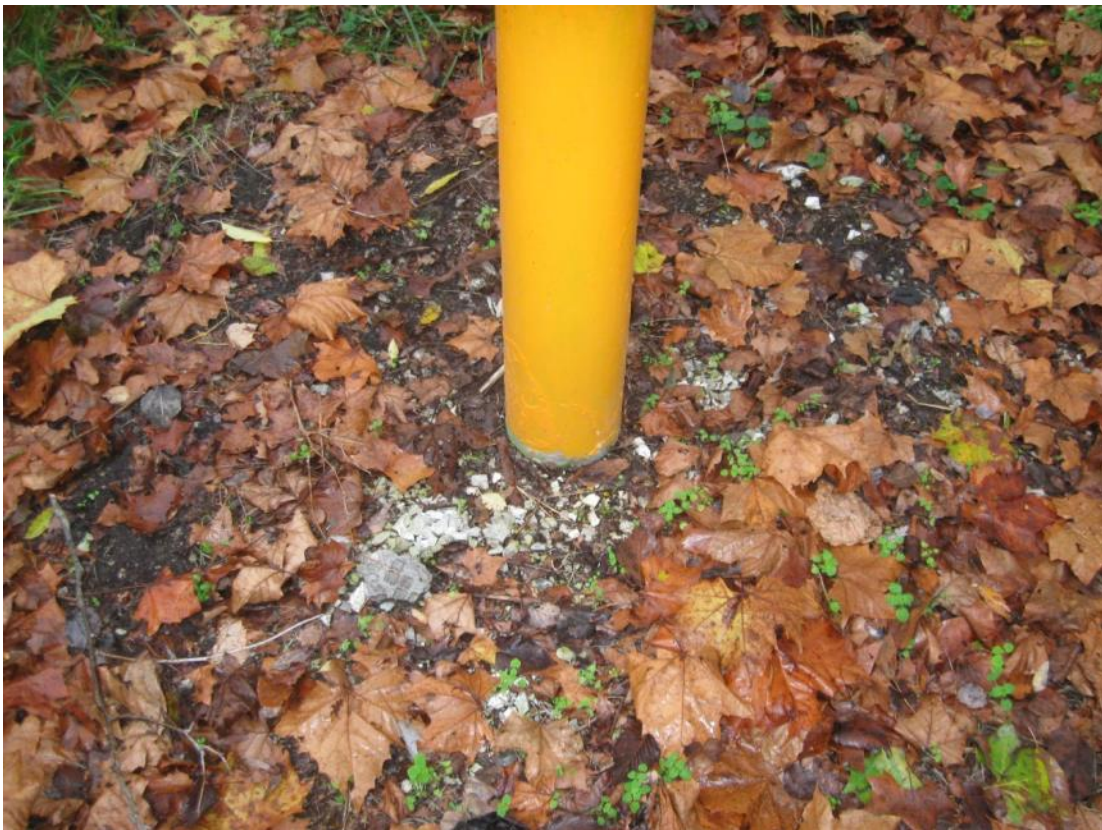
BUR 10/2014. PL-10. Base of monitoring well 0524.

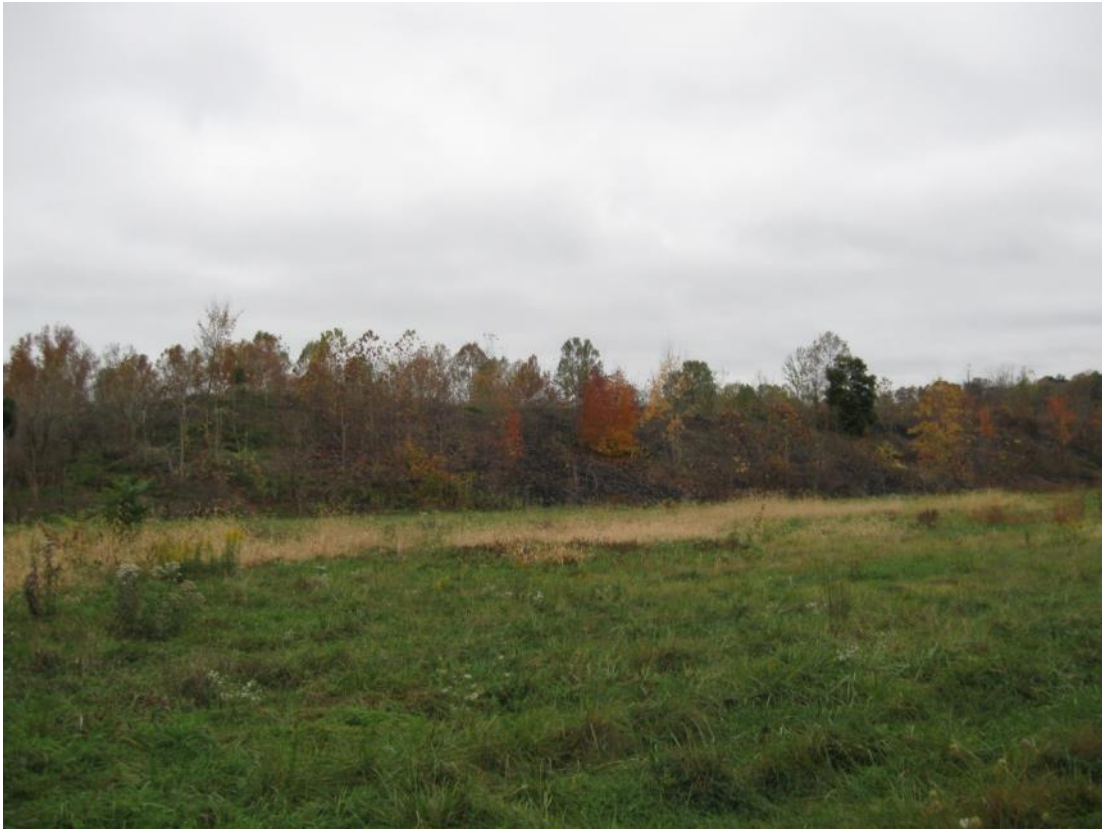
The 5-acre disposal cell was completed in 1987. No indications of cell instability (e.g., slumping, bulging, or differential settlement) were observed (PL-11). Rock quality remains good, with no evidence of riprap degradation. Seep 0611 (located on the south side slope of the disposal cell) was flowing during the inspection (PL-12).

BUR 10/2014. PL-11. Northeast slope of disposal cell.

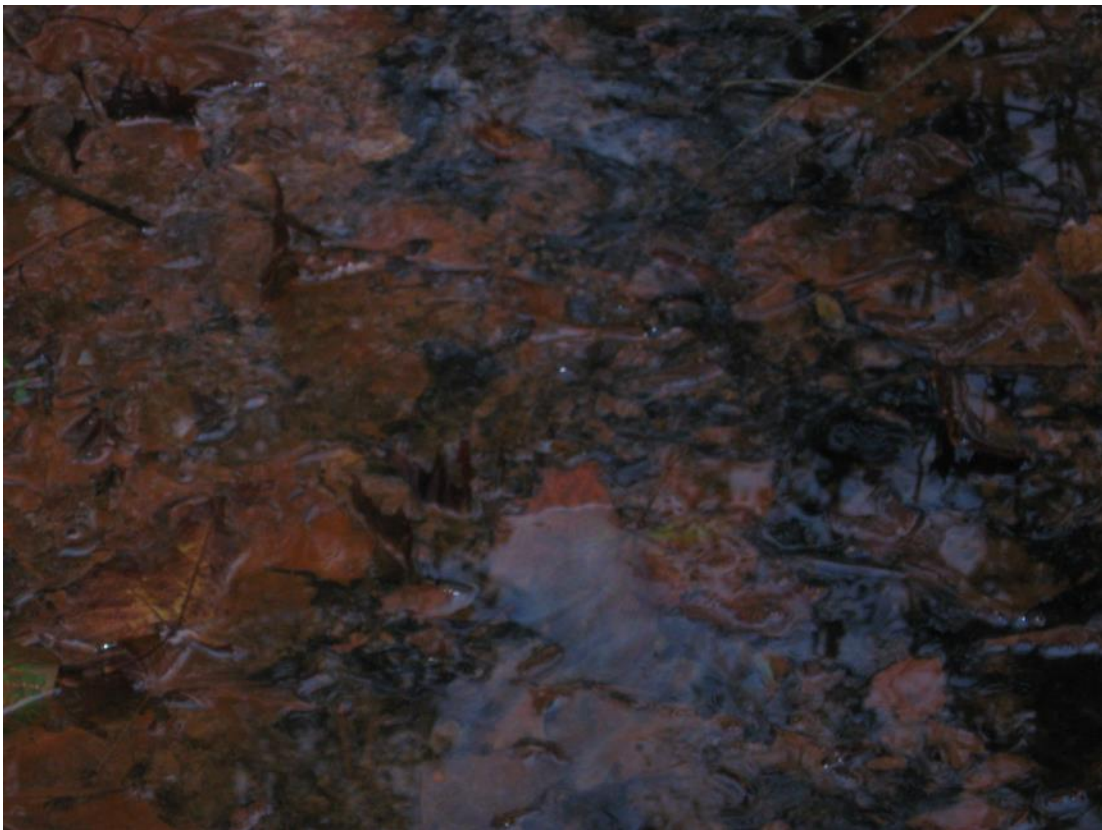
BUR 10/2014. PL-12. Seep 0611 (flowing).

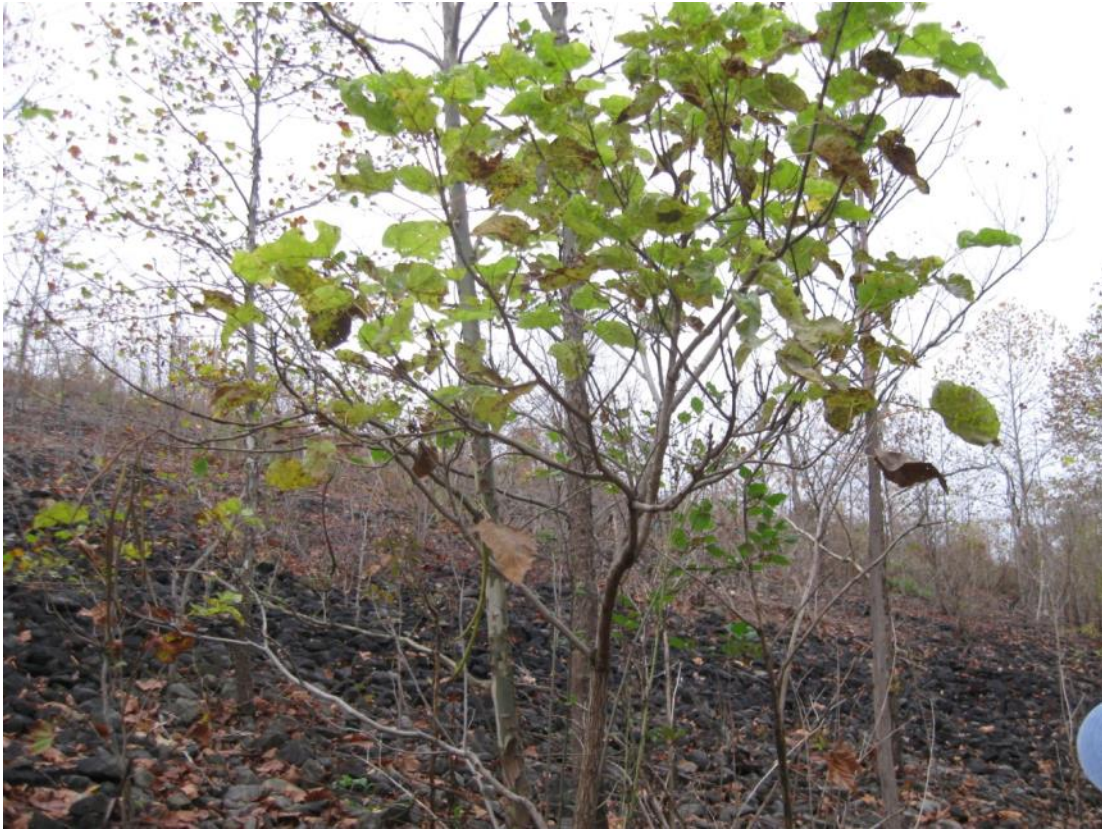
Trees and large shrubs grow on the top and slopes of the cell cap, including sycamore, maple, elm, cherry, aspen, willow, and catalpa trees (PL-13). Some of the trees are beginning to get rather large, including a sycamore that is noted on the inspection map.

BUR 10/2014. PL-13. Catalpa tree on south slope of disposal cell.

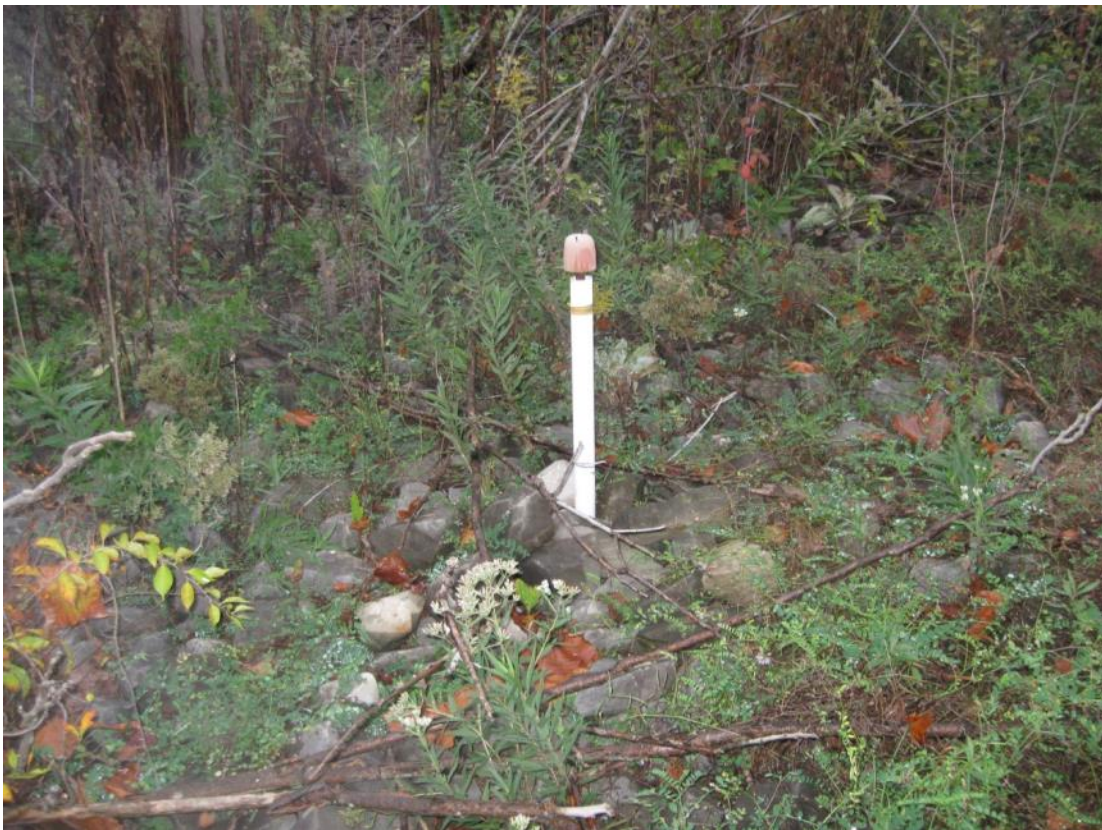
A French drain was installed north of the disposal cell in 1998 to prevent ponding of water next to the cell. The outlet for the French drain, located in the southeast corner of the disposal cell, was in good condition (PL-14). Prior to installation of the drain, it was thought that seeps present along the south slope of the disposal cell were being recharged by the ponded rainwater and snowmelt. Water has not been observed flowing from the outlet of the French drain and, up until 2010, no water was observed flowing from the seeps on the south slope of the cell since the French drain was installed. In spring 2010, a seep was observed on the south side of the disposal cell (Seep 0611).

BUR 10/2014. PL-14. Outlet of French drain.

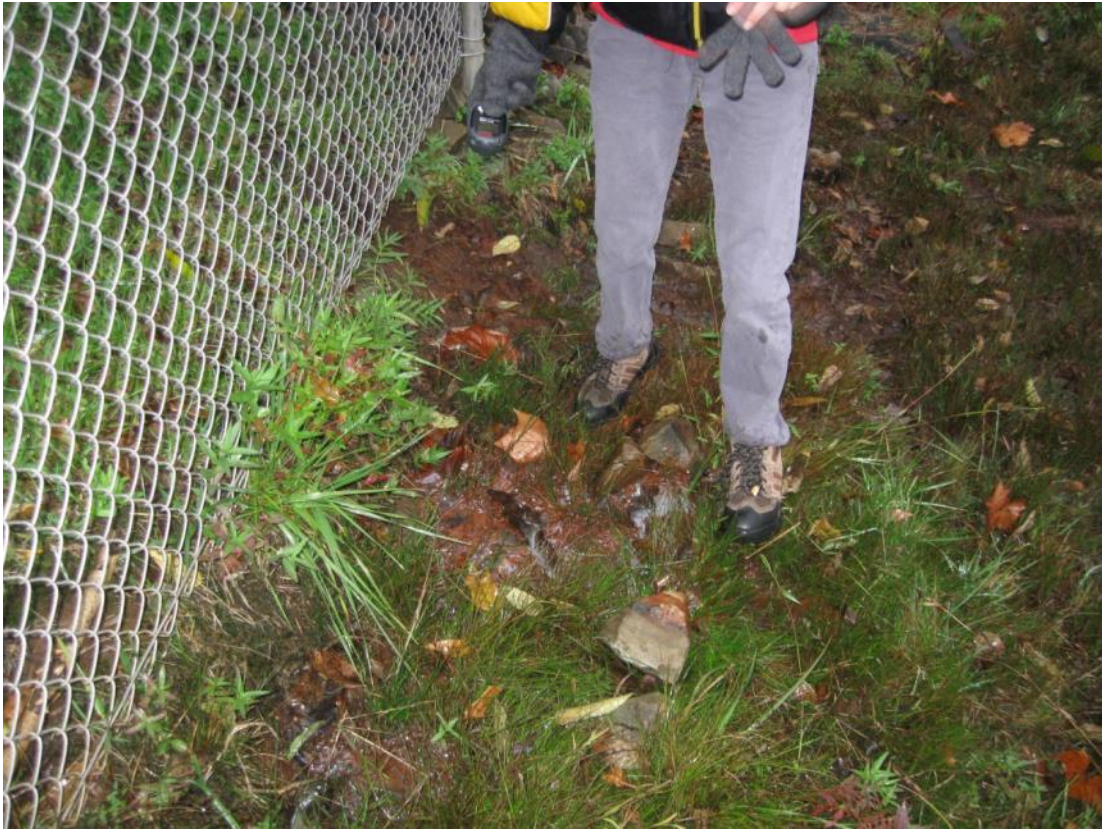
An active seep is located near the north security fence, about 60 feet east of perimeter sign P8. The seep was flowing during this year's inspection, and the flow appeared to be about the same as last year (PL-15). This area will continue to be monitored to determine if the seep poses a threat to the integrity of the disposal cell. The water for the seep along the fence line appears to be coming from bluffs north of the railroad tracks.

BUR 10/2014. PL-15. Active seep northwest of disposal cell.
