## 2.0 Burrell, Pennsylvania, Disposal Site

### 2.1 Compliance Summary

Figure 2-1. 2013 Annual Inspection Drawing for the Burrell Disposal Site

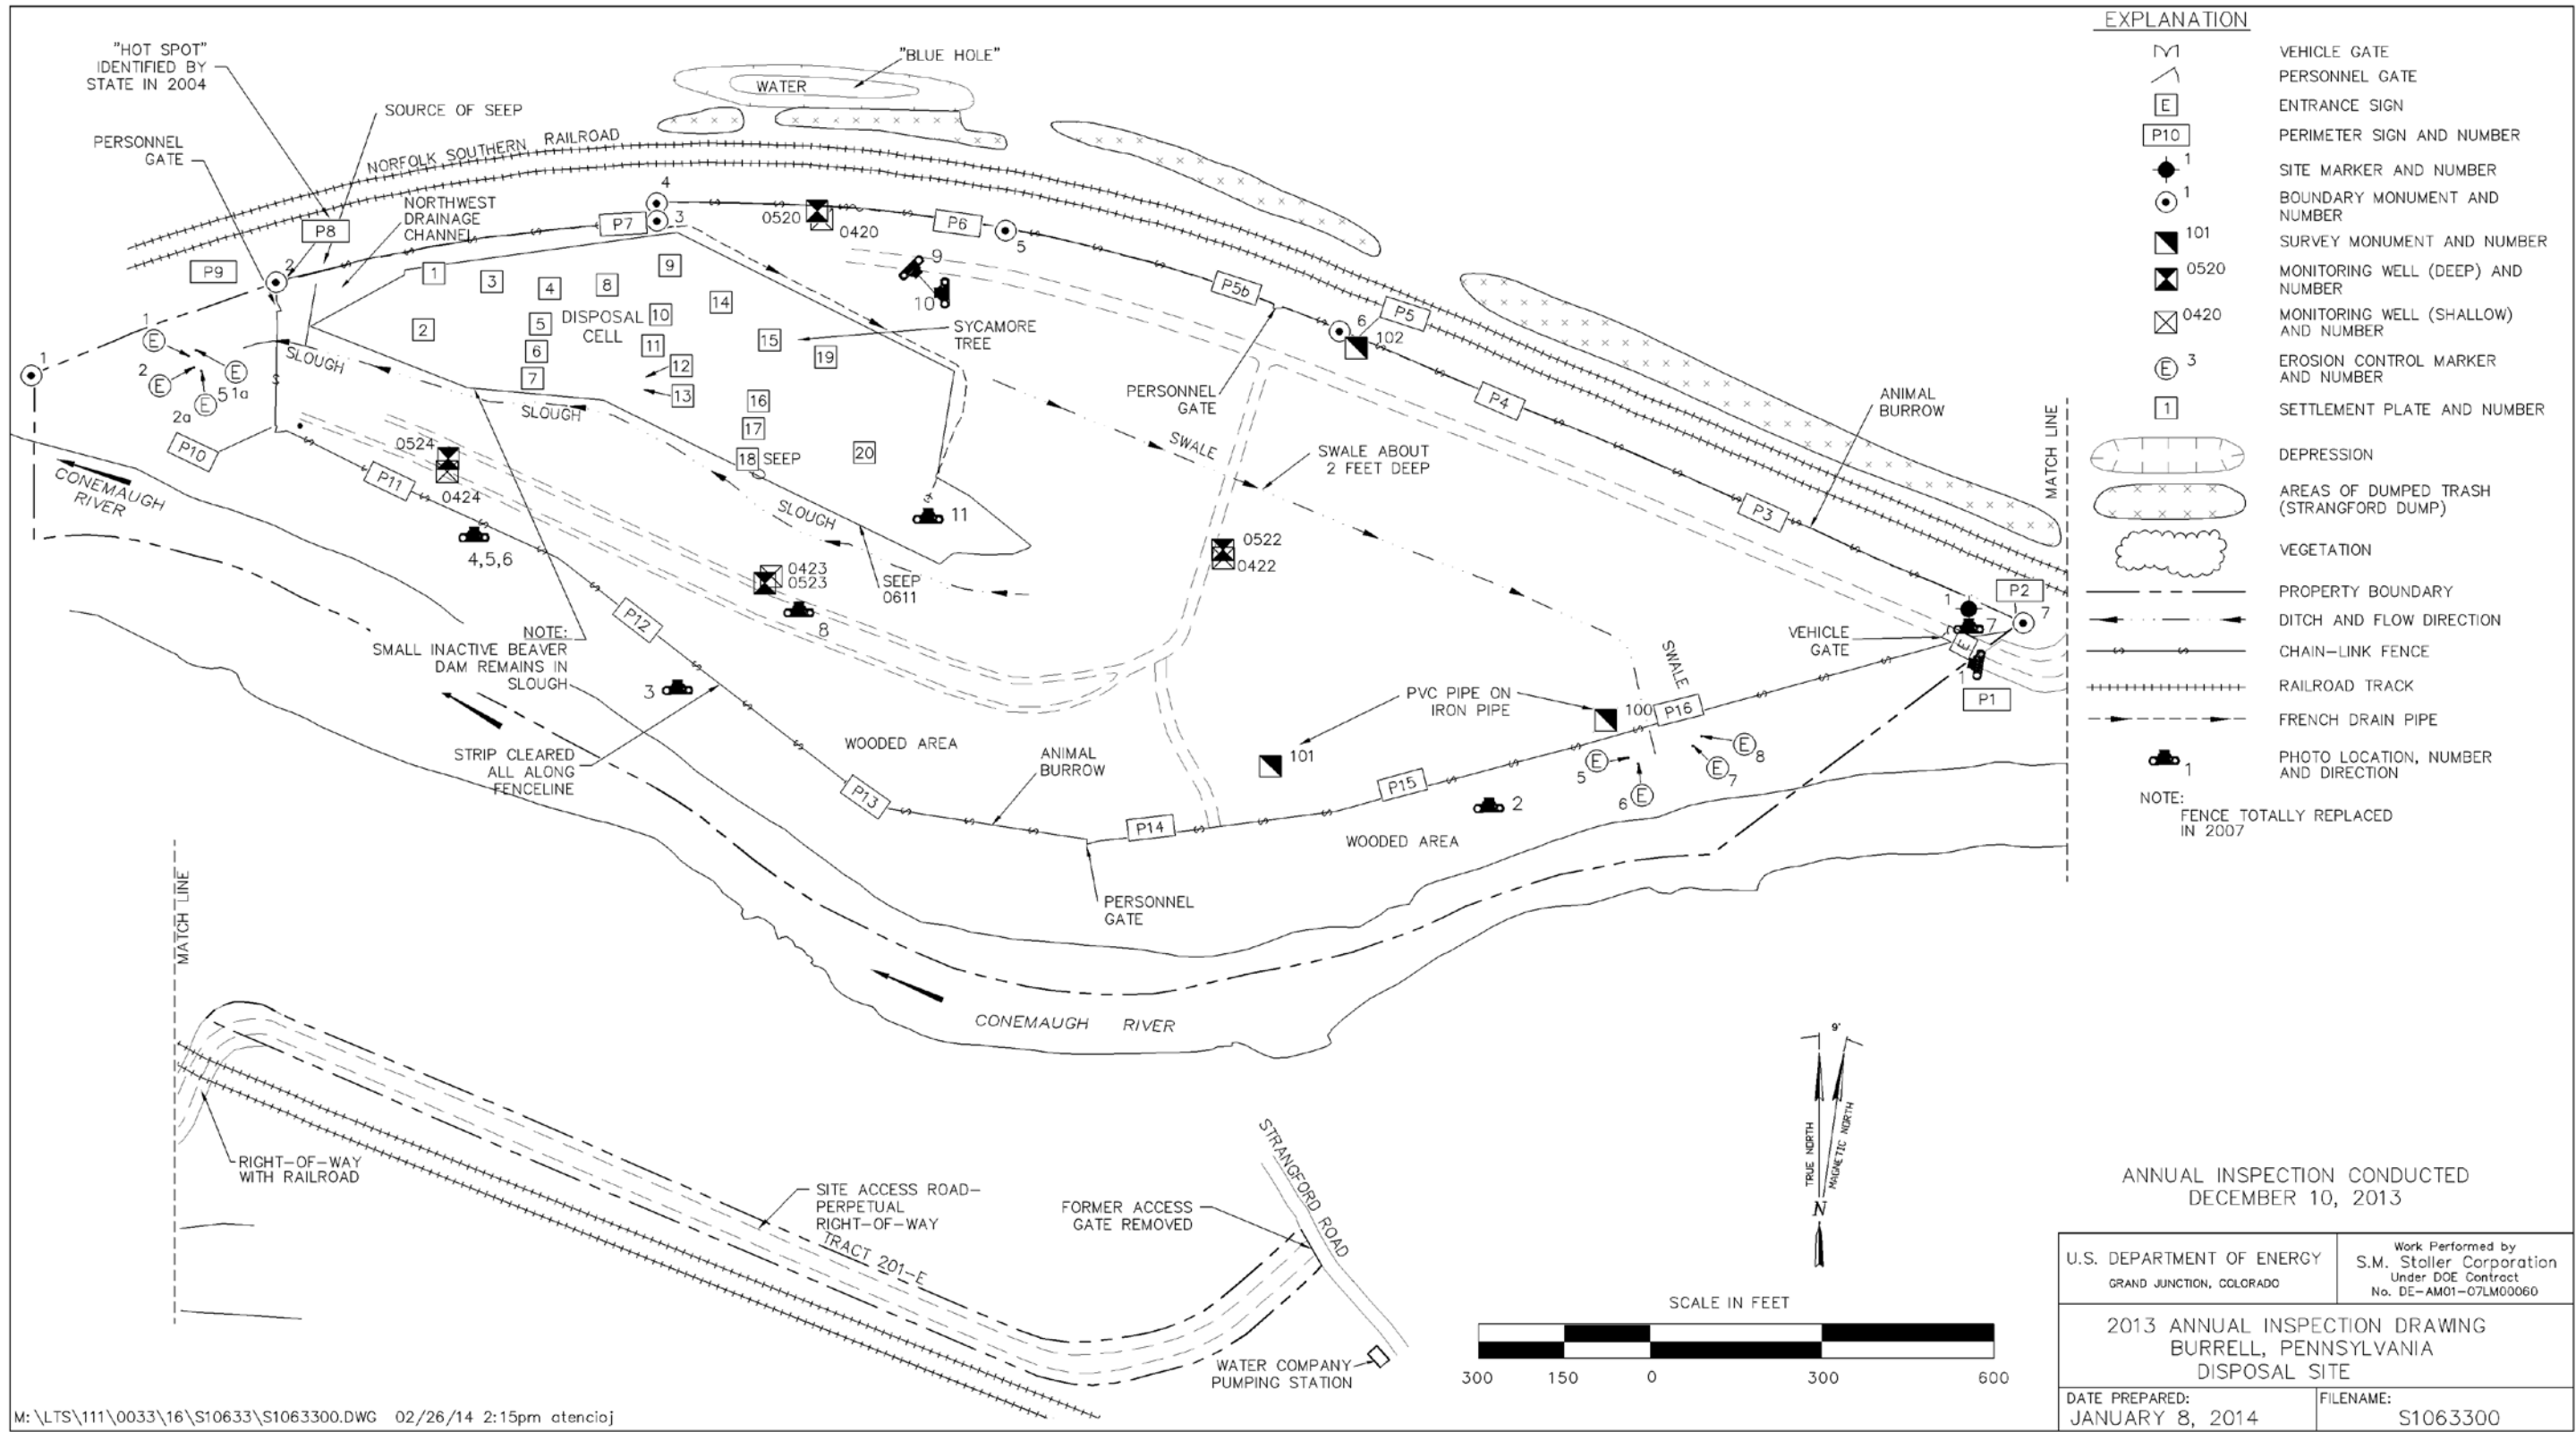
Figure 2-1 shows the locations of site surveillance features. Inspection results and recommended maintenance activities associated with site surveillance features are included in the following subsections. Photographs to support specific observations are identified in the text and in Figure 2-1 by photograph location (PL) numbers.

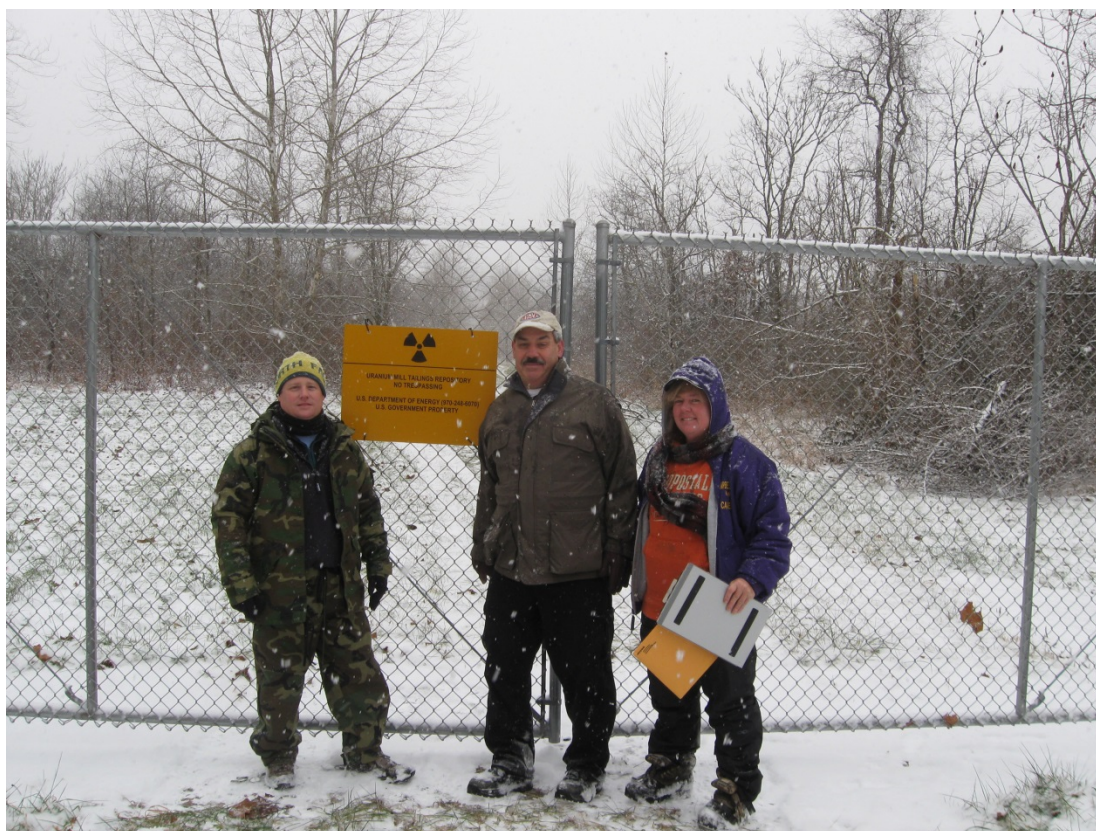
Entrance gates were in good condition, and all gates were properly locked. The main gate lock was rusted and difficult to open, and inspectors replaced it with a new LM lock during the inspection. The entrance sign at the front gate was missing, and inspectors attached a new sign during the inspection (PL-1).

*BUR 12/2013. PL-1. Inspectors in front of entrance gate.*

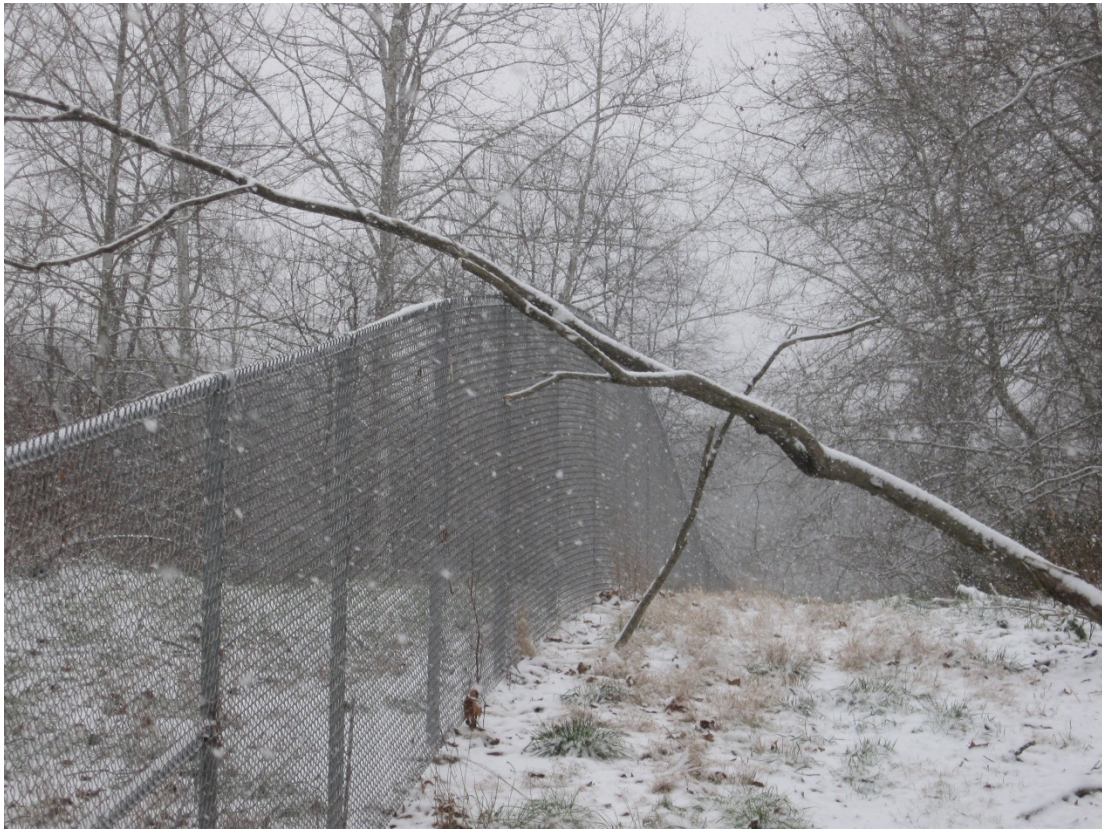
The chain link perimeter fence that encircles the site was replaced in 2007. The fence had minor damage at several locations along the south fence line due to fallen trees (PL-2 thru PL-6).

*BUR 12/2013. PL-2. Tree down on south fence.*

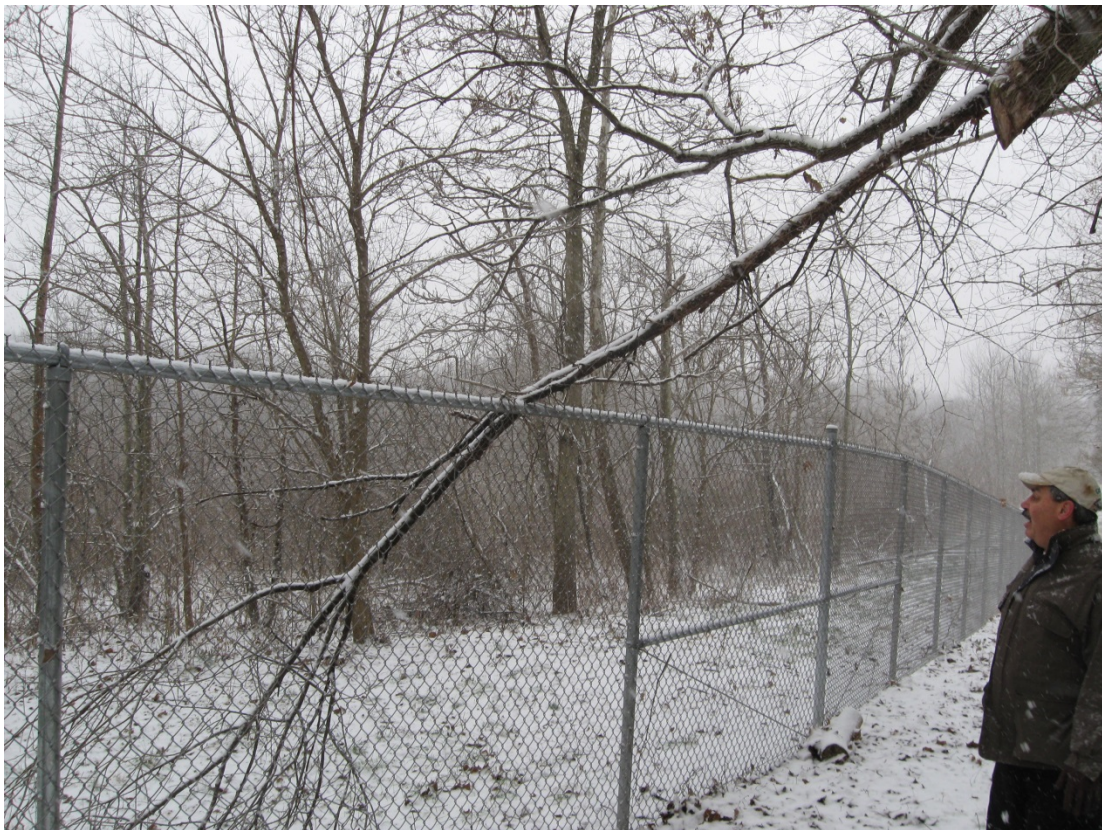
*BUR 12/2013. PL-3. Tree across southern fence.*

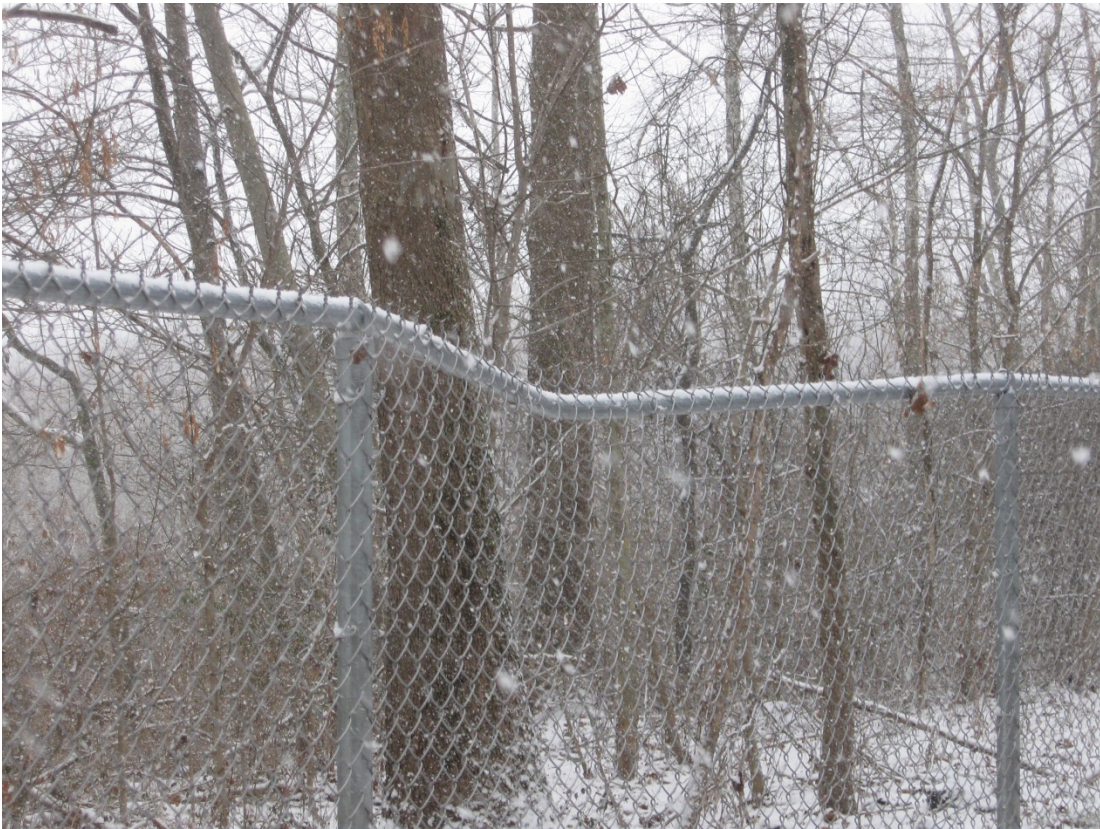
*BUR 12/2013. PL-4. Damaged fence east of perimeter sign P12.*

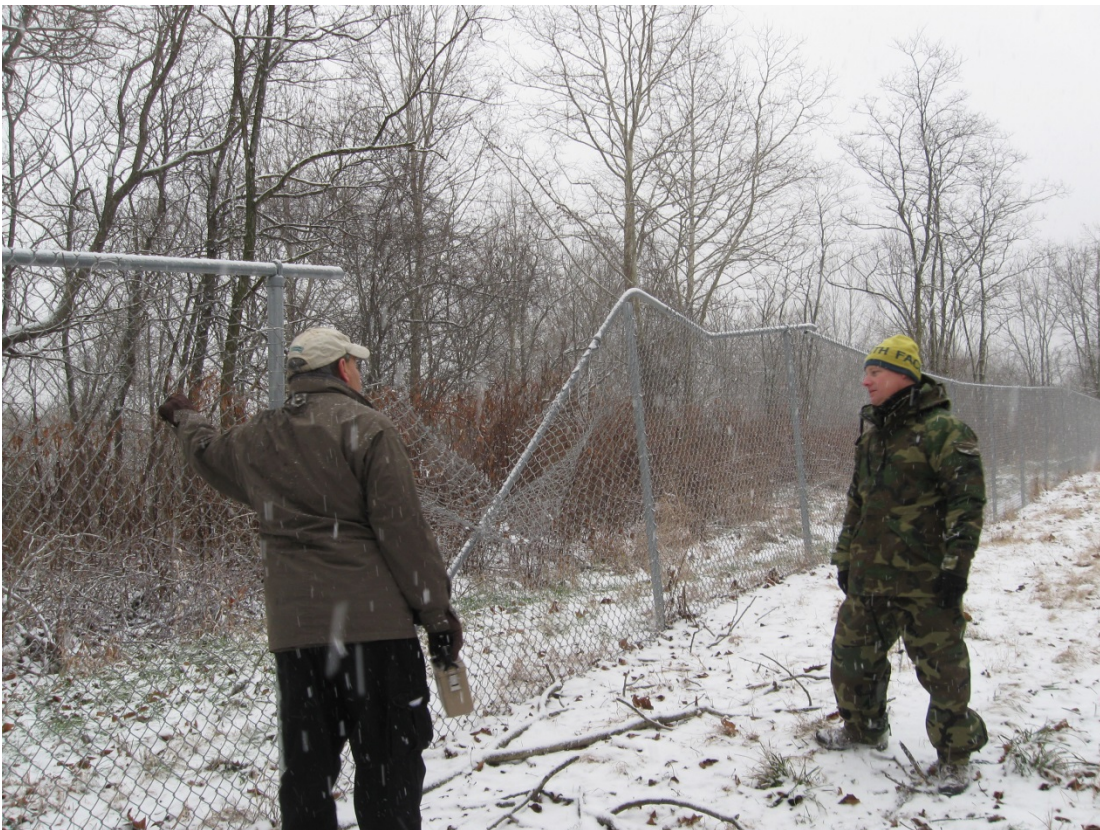
*BUR 12/2013. PL-5. Damaged fence east of perimeter sign P11.*

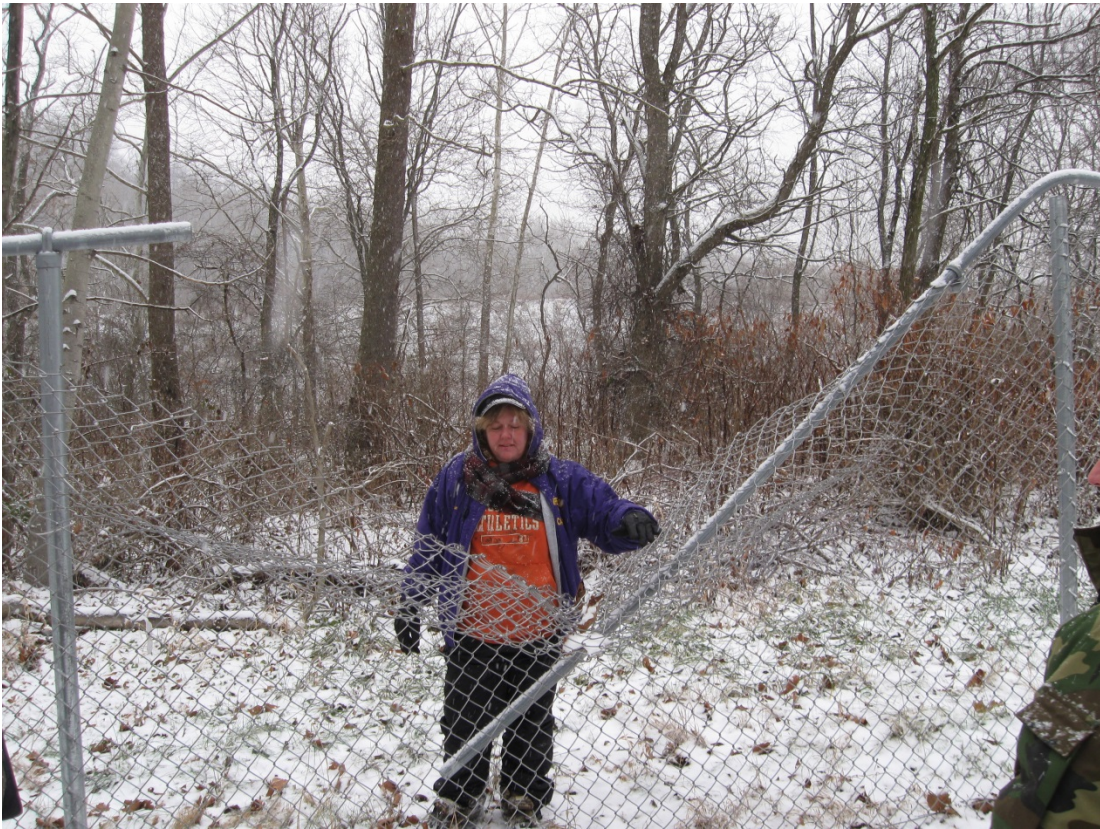
*BUR 12/2013. PL-6. Damaged fence east of perimeter sign P11.*

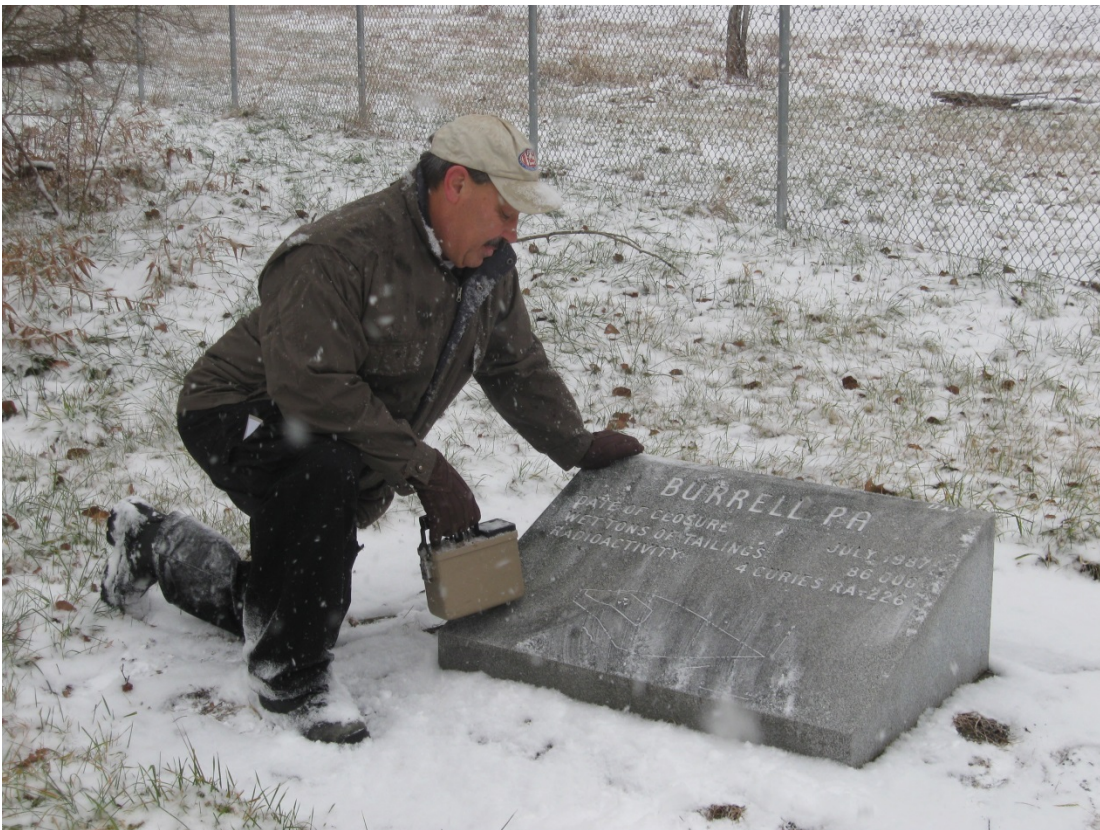
The Burrell site has one site marker. It is located just inside the main entrance gate and was in excellent condition (PL-7).

*BUR 12/2013. PL-7. Inspector at site marker.*

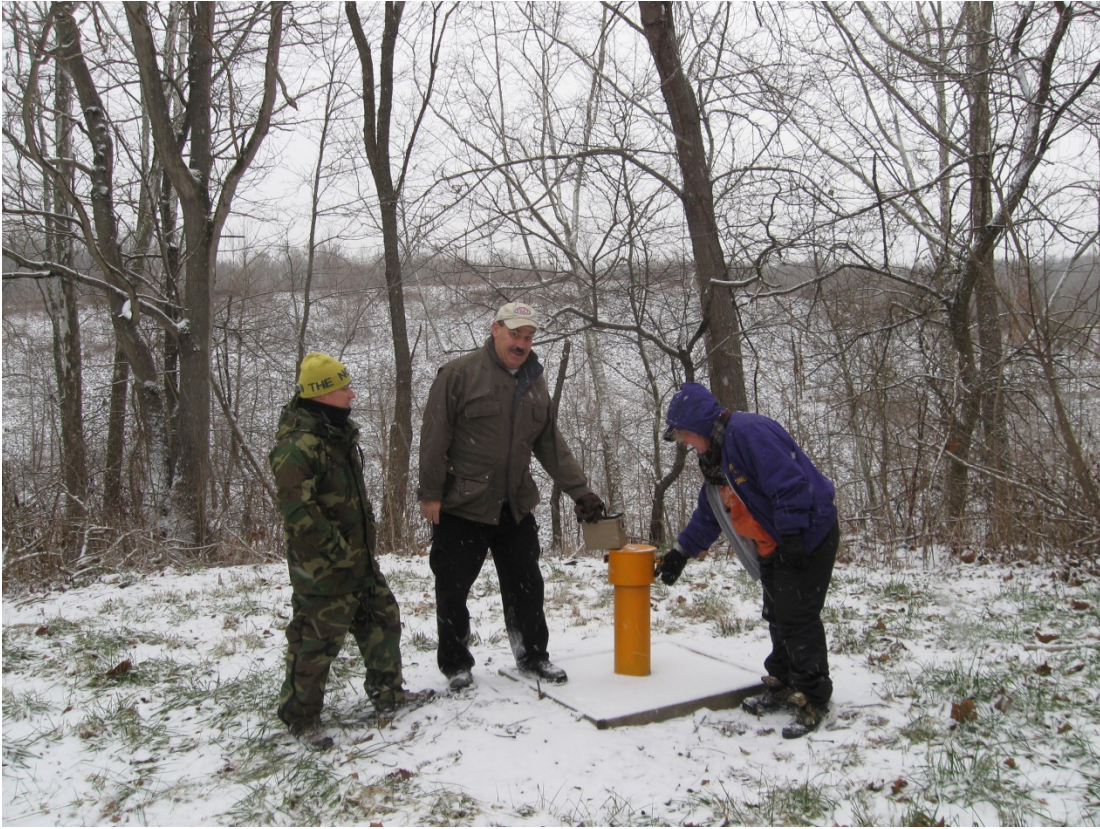
All wells found during the inspection were properly locked (PL-8). The interior of the monitoring wells were not inspected this year. The interiors were last inspected by the water sampling crew in November 2013 and found to be in good shape.

*BUR 12/2013. PL-8. Inspectors at monitoring well 0423.*

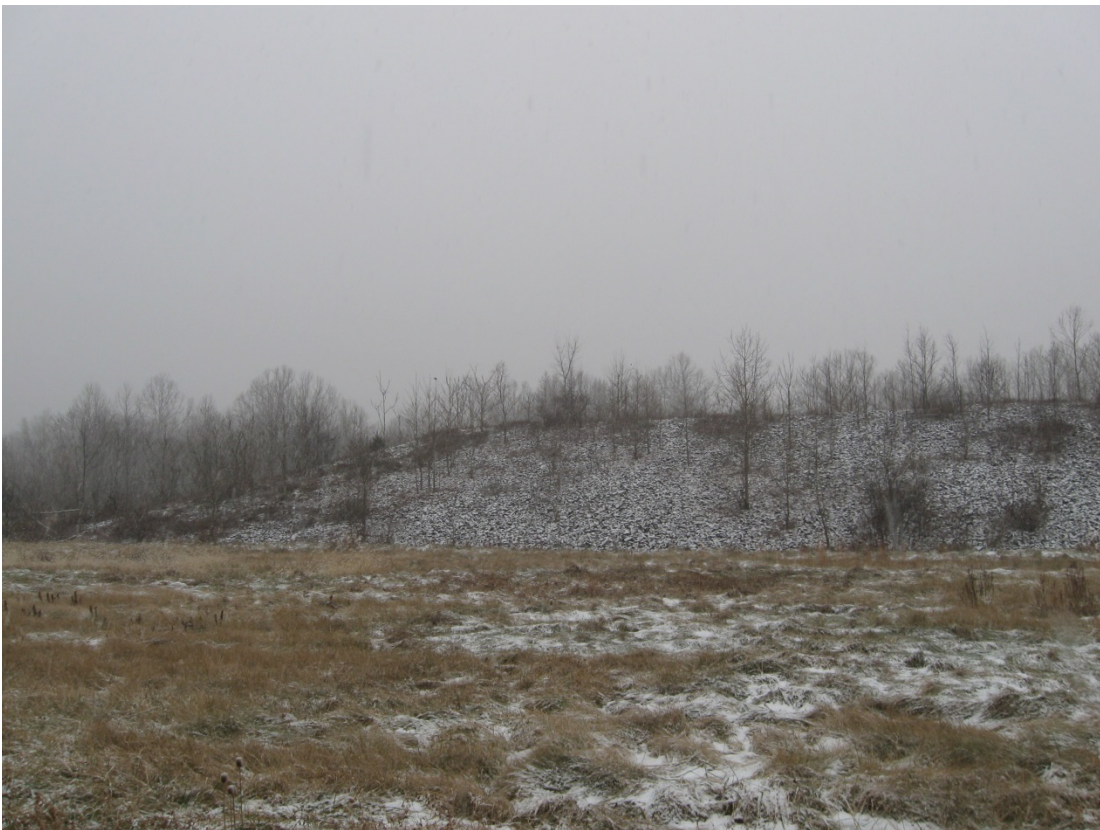
No indications of cell instability were noted by the inspectors (e.g., slumping, bulging, or differential settlement) (PL-9 and PL-10). Rock quality remains good; degradation of the riprap was not evident. No active seeps were found along the south slope of the disposal cell during the inspection.

*BUR 12/2013. PL-9. Northeast face of disposal cell.*

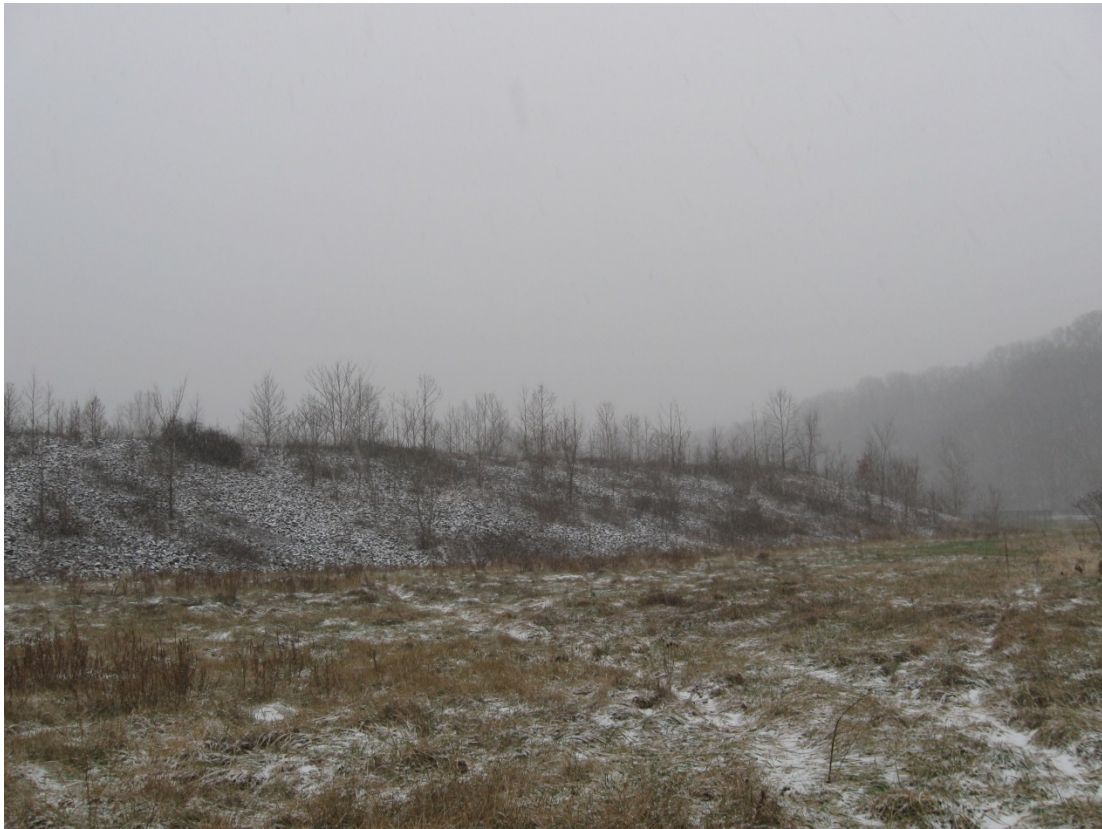
*BUR 12/2013. PL-10. Northeast face of disposal cell.*
