2.0 Annual Inspection of the Burrell, Pennsylvania, UMTRCA Title I Disposal Site

The Burrell, Pennsylvania, Uranium Mill Tailings Radiation Control Act (UMTRCA) Title I Disposal Site, inspected on October 17, 2012, was in excellent condition. The disposal cell and all associated drainage diversion structures were in good condition and functioning as designed. No maintenance needs or cause for a follow-up or contingency inspection was identified.

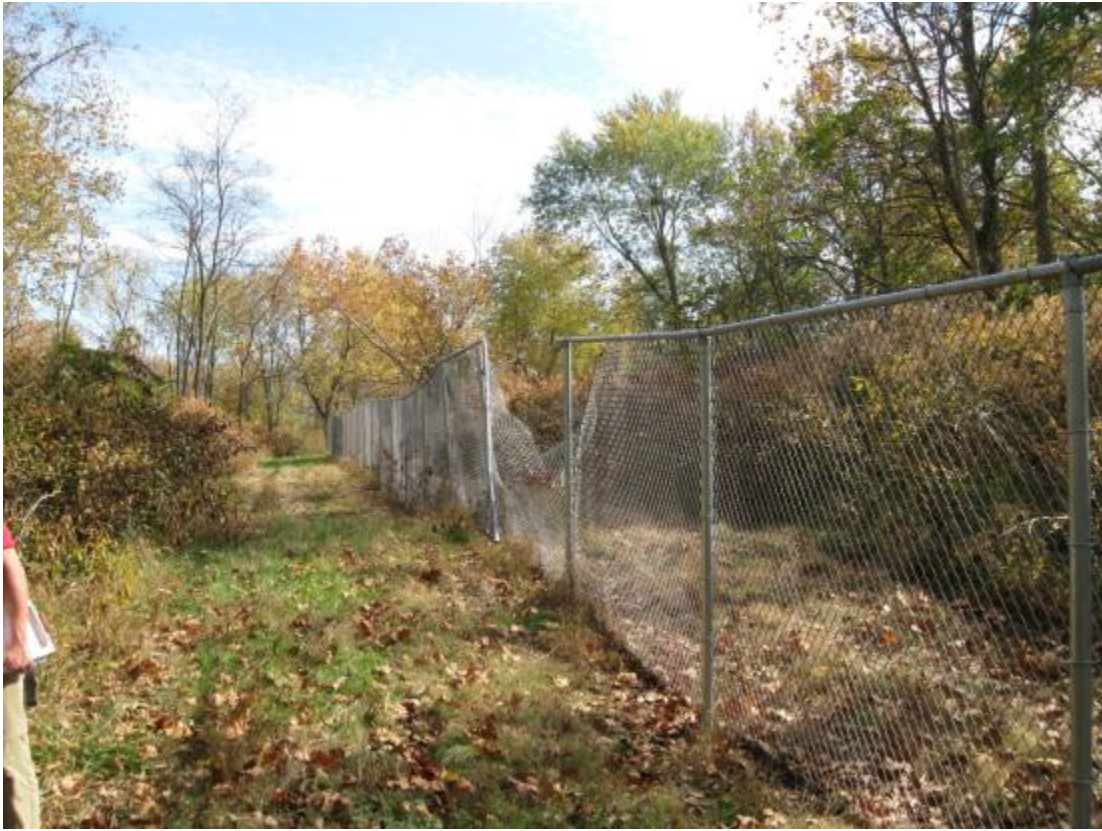
The chain-link security fence, replaced in 2007, remains in excellent condition, with the exception of a bent rail on the south fence (PL–1). The fence rail was damaged when a tree fell across it in 2011. The tree was safely removed from the fence shortly after being discovered. The top rail of the fence needs to be replaced. A vegetation-free corridor remains established along the fence line (PL–2). Several of the 17 perimeter signs mounted on the security fence have been damaged by bullet holes, but they remain serviceable (PL–3).

BUR 10/2012. PL-1. Fence damage.

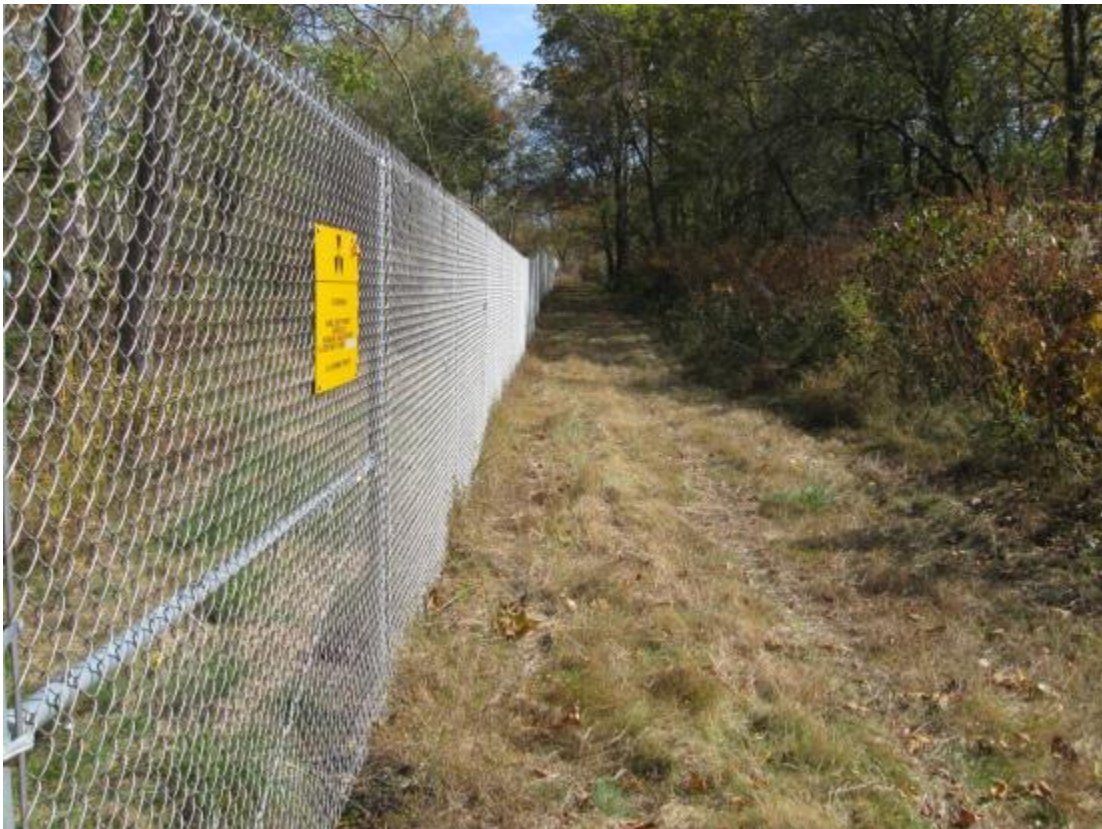
BUR 10/2012. PL-2. Southwest fence line.

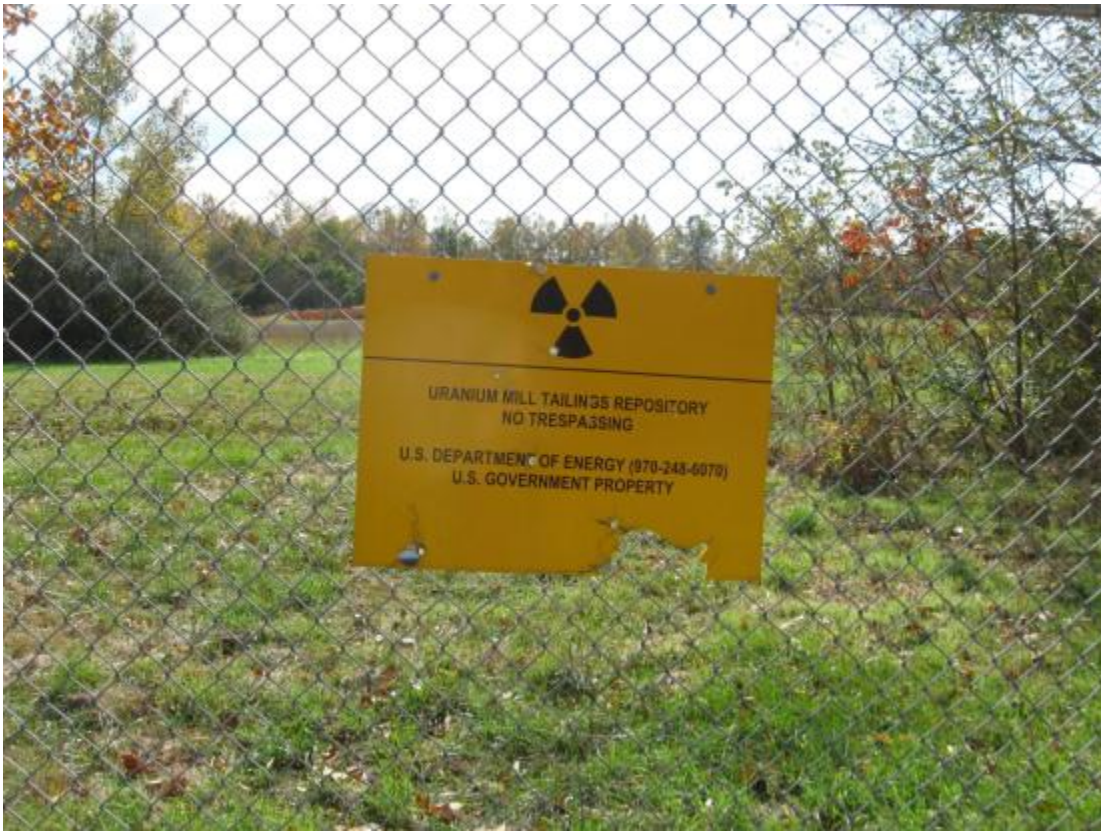
BUR 10/2012. PL-3. Bullet holes in perimeter fence sign P4.

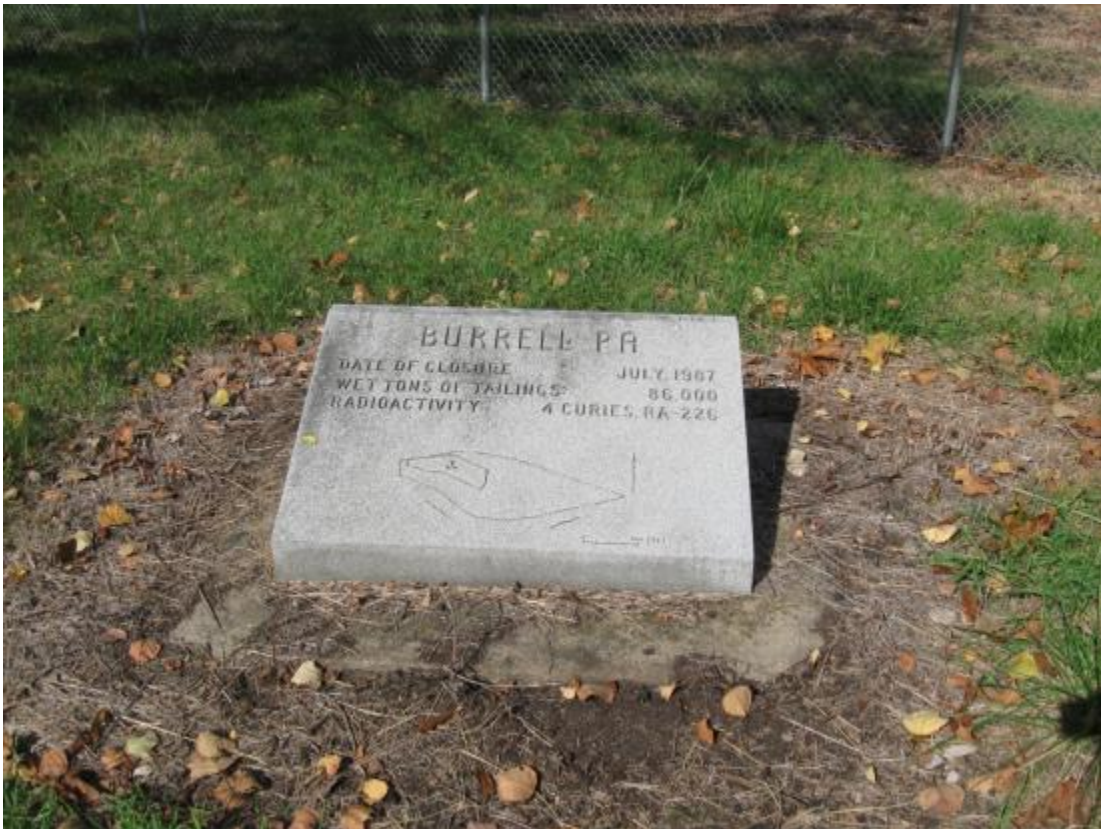
Site marker SMK–1 was in excellent condition (PL–4).

BUR 10/2012. PL-4. Site marker SMK-1.

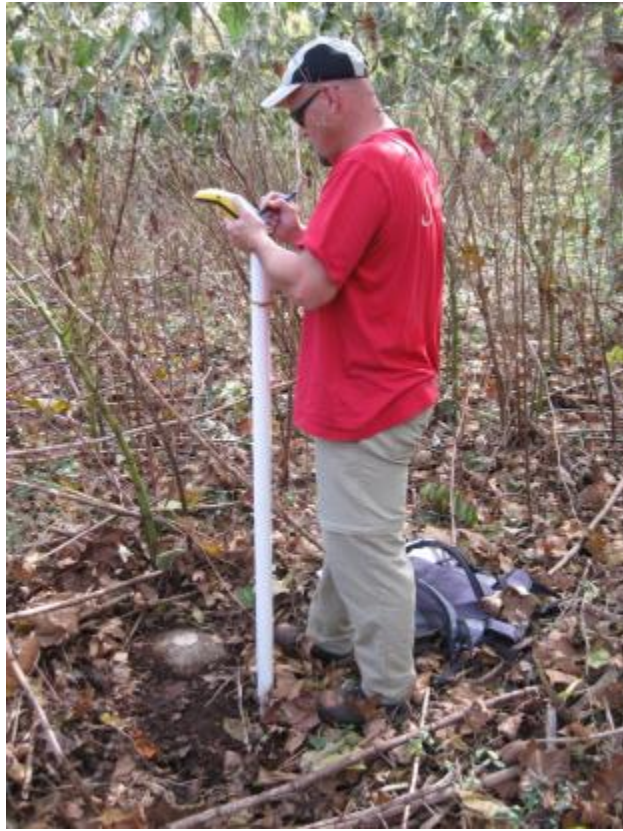
The site has 10 monuments (three survey monuments and seven boundary monuments). All three survey monuments (SM–100, SM–101, and SM–102) are located at points on the property that originally afforded a sweeping view of the site during construction. Several years ago, inspectors installed tall pieces of white PVC pipe near SM–100 and SM–101 to make them easier to locate (PL–5).

Survey monuments SM-101 and SM-102 were in good condition. Although the PVC pipe near SM-100 was located, the actual boundary monument plate was not located. Additional efforts will be made during next year's inspection to find the monument plate.

BUR 10/2012. PL-5. Survey monument SM-101.

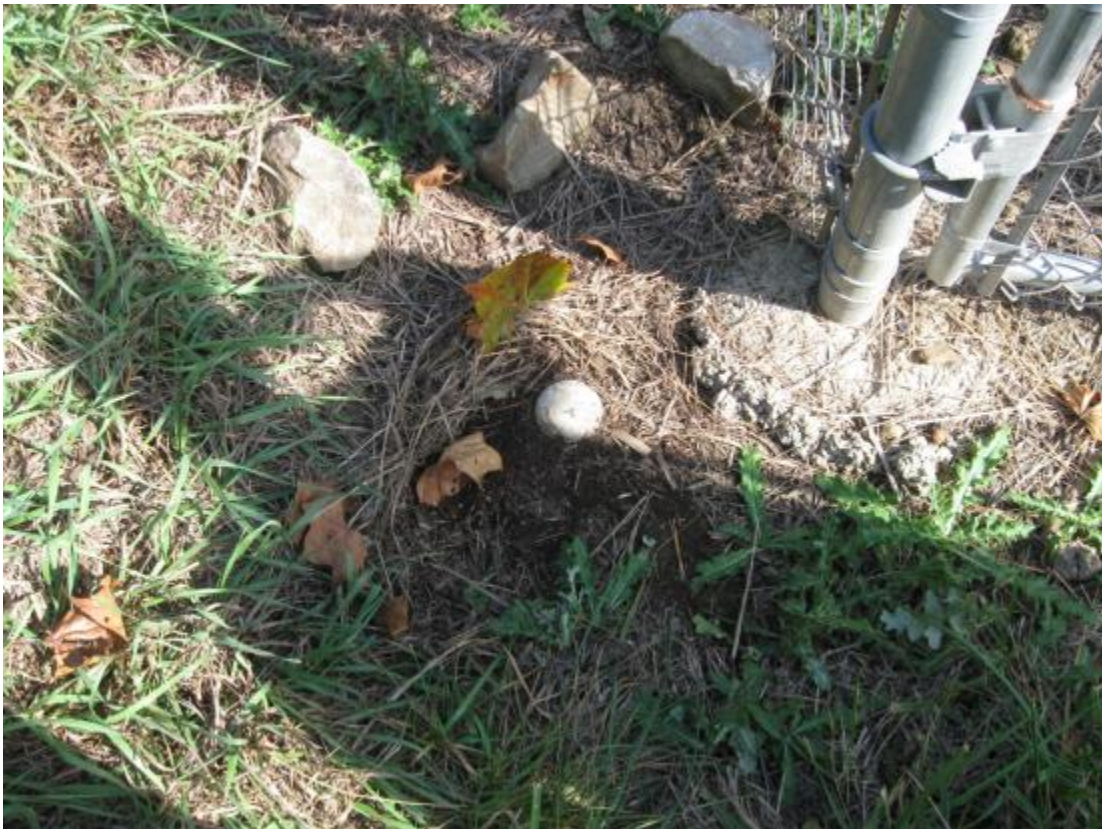
Seven boundary monuments are located along the north perimeter fence. Five of the seven boundary monuments (BM-2, BM-3, BM-4, BM-5, and BM-7) were located during the inspection and observed to be in good condition (PL-6). Vegetation near boundary monument BM-1 was too dense to allow access. It is recommended that the site maintenance contractor be asked to clear a path through the vegetation for the inspection next year. Boundary monument BM-6 could not be located. Extra effort will be made during next year's inspection to find boundary monument BM-6.

BUR 10/2012. PL-6. Boundary monument BM-2.

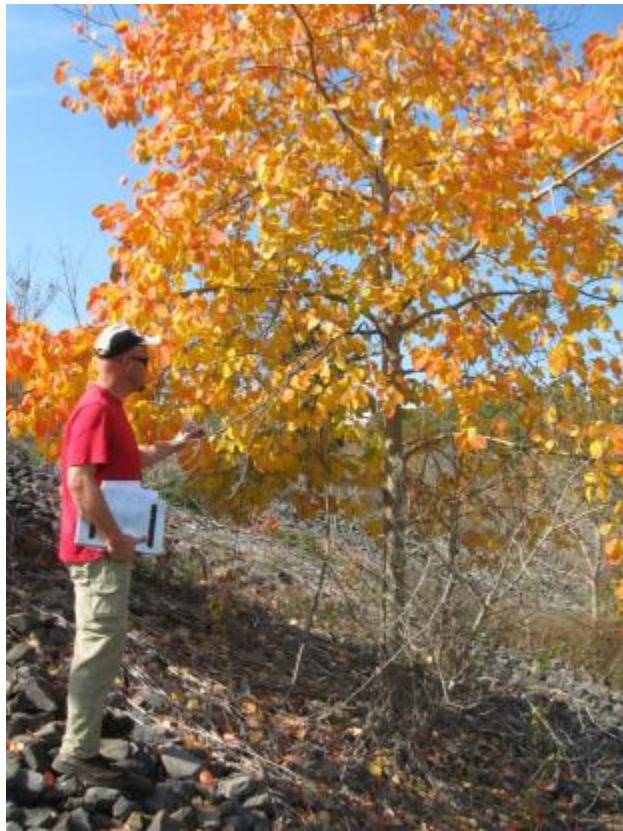
Active control of vegetation on the cell cap has not been required since 2000 (PL-7). Past studies at the site concluded that deep-rooted plant growth on the cell puts the public and the environment at no greater risk of exposure to contaminants within the disposal cell. Vegetation growth on the cell might actually enhance cover performance through evapotranspiration. These studies further concluded that plant growth would not impede the proper functioning of the radon

BUR 10/2012. PL-7. Examining tree at base of disposal cell.

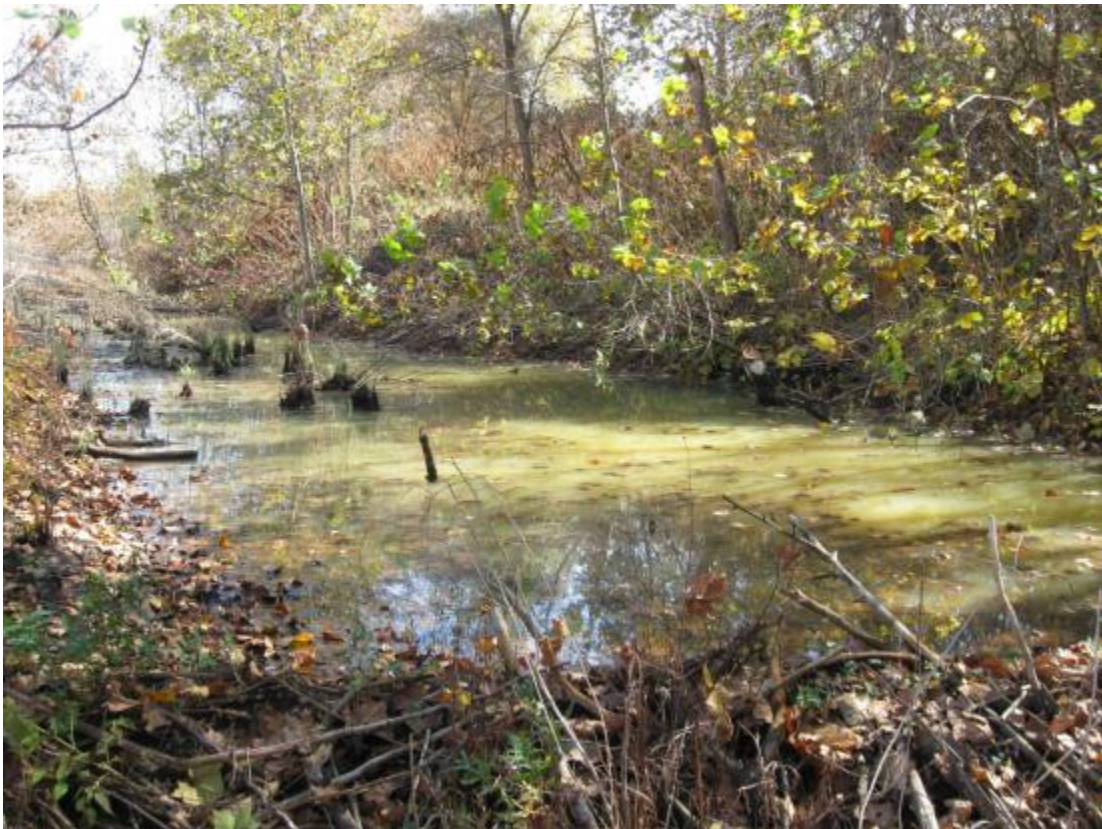
A small, inactive beaver dam remains within the slough at the base of the south slope of the disposal cell, and water continues to collect behind it. The water level behind the dam is not high enough to saturate the tailings or impact the integrity of the disposal cell (PL-8). Therefore, DOE has elected not to remove the dam. Instead, DOE will continue to monitor the dam and its possible impacts on the disposal site.

BUR 10/2012. PL-8. Small inactive beaver dam.

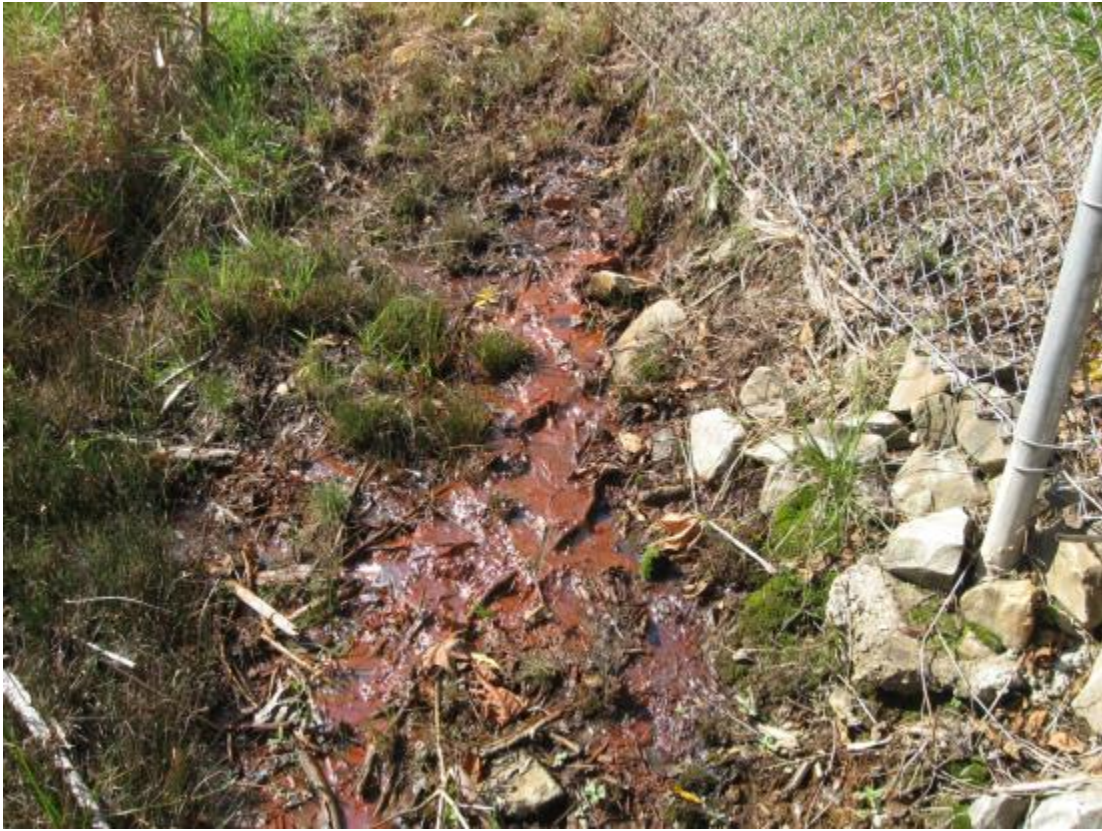
A known seep along the north security fence, about 60 feet east of perimeter sign P8 and west of the disposal cell, was flowing at the time of the 2012 inspection (PL-9). It appeared to be about the same as observed in 2011. This area will continue to be monitored for seeps to determine if they threaten the disposal cell's integrity. Conceivably, the seeps also could destabilize the nearby railroad embankment. The water for this seep may be coming from other seeps on the bluffs, above and just north of the railroad tracks.

BUR 10/2012. PL-9. Active seep; north fence.
