## 2.0 Burrell, Pennsylvania, Disposal Site

### 2.1 Compliance Summary

The Burrell, Pennsylvania, Uranium Mill Tailings Radiation Control Act (UMTRCA) Title I Disposal Site, inspected on October 4, 2011, was in excellent condition. The disposal cell and all associated drainage diversion structures were in good condition and functioning as designed. No cause for a follow-up or contingency inspection was identified.

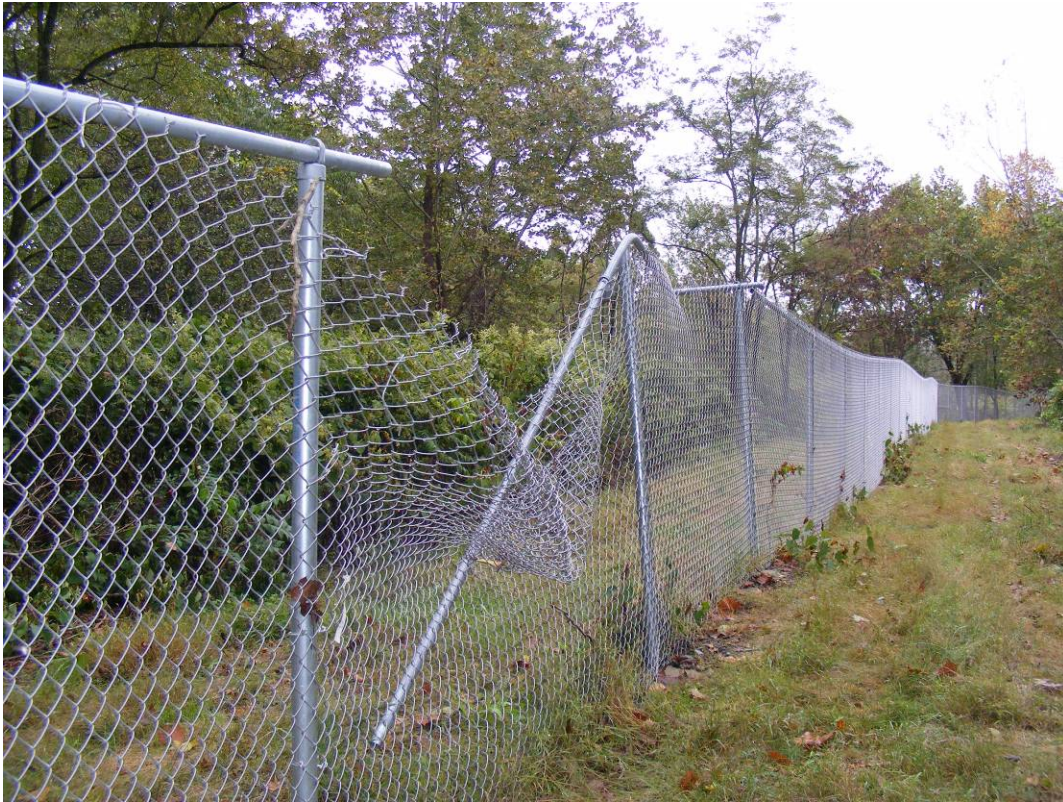
The chain-link security fence, replaced in 2007, remains in excellent condition, with the exception of a bent rail on the south fence (PL–1). The fence rail was damaged when a tree recently fell across it. The tree was safely removed from the fence shortly after being discovered. The top rail of the fence needs to be replaced. A vegetation-free corridor remains established along the fence line (PL–2). The entrance gate and four personnel gates were in good condition. Several of the 17 perimeter signs mounted on the security fence have been damaged by bullet holes, but they remain serviceable (PL–3).

*BUR 10/2011. PL-1. Damage to perimeter fence.*

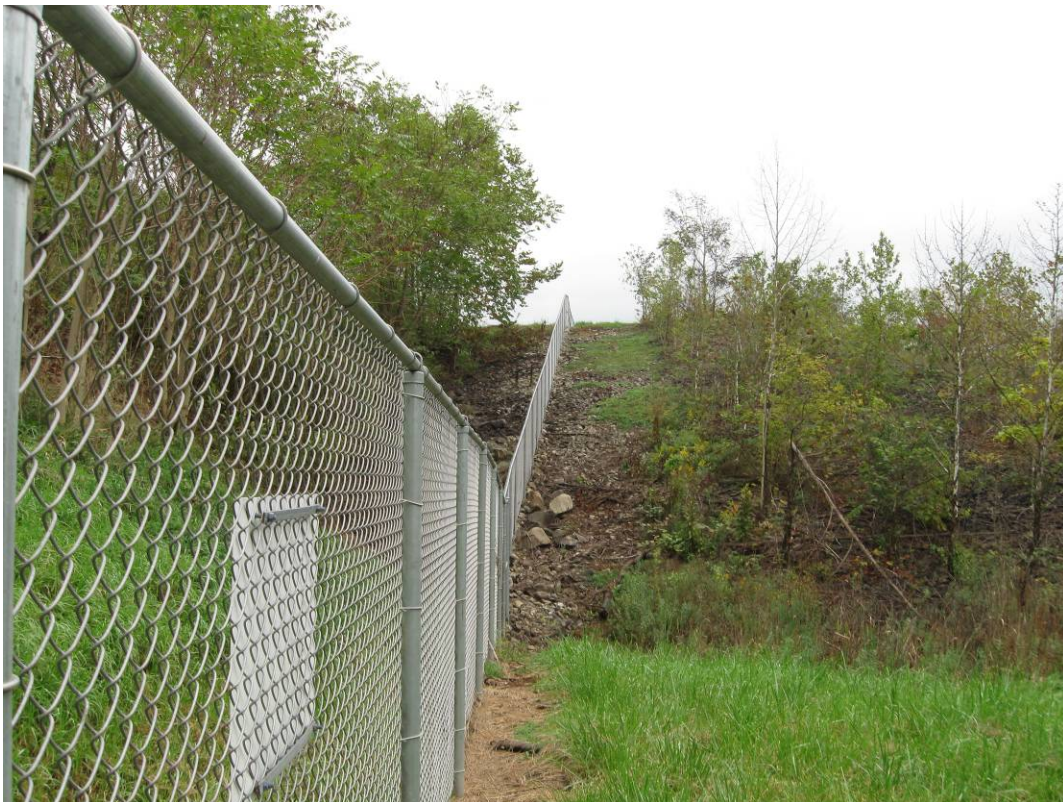
*BUR 10/2011. PL-2. Vegetation cleared from perimeter fence.*

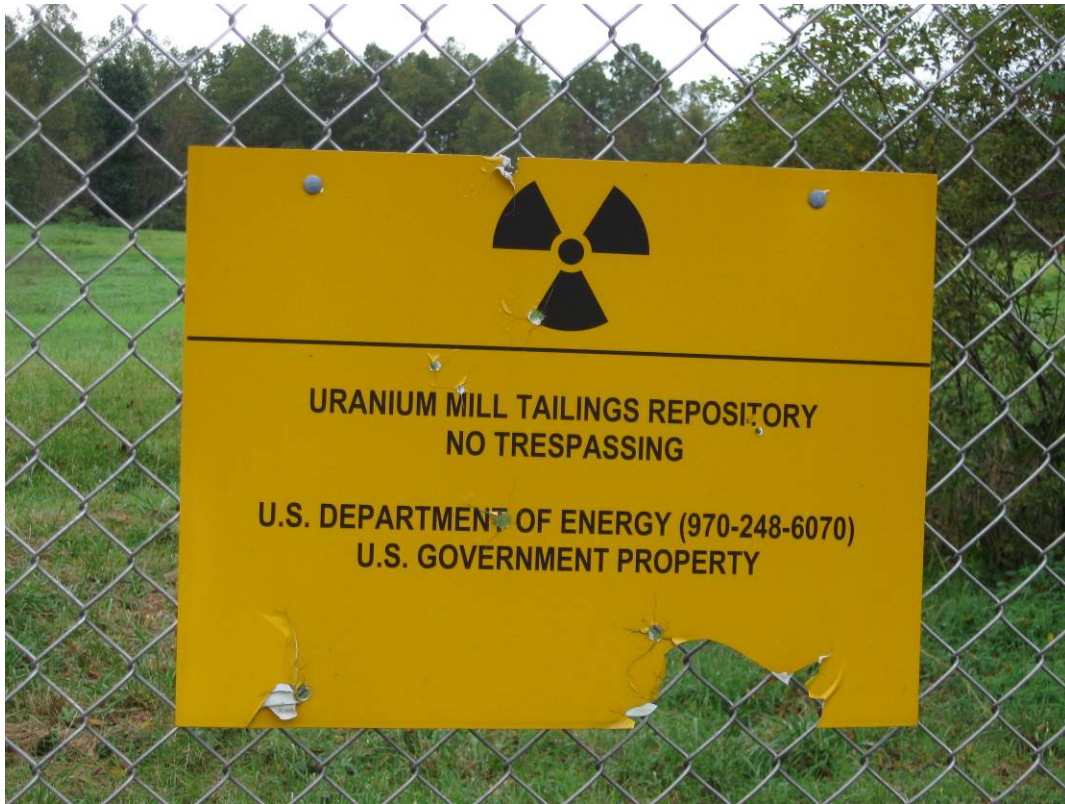
With the exception of bullet holes in several of the site perimeter signs, inspectors found no evidence that these institutional controls were ineffective or violated.

*BUR 10/2011. PL-3. Bullet holes in perimeter fence sign P3.*

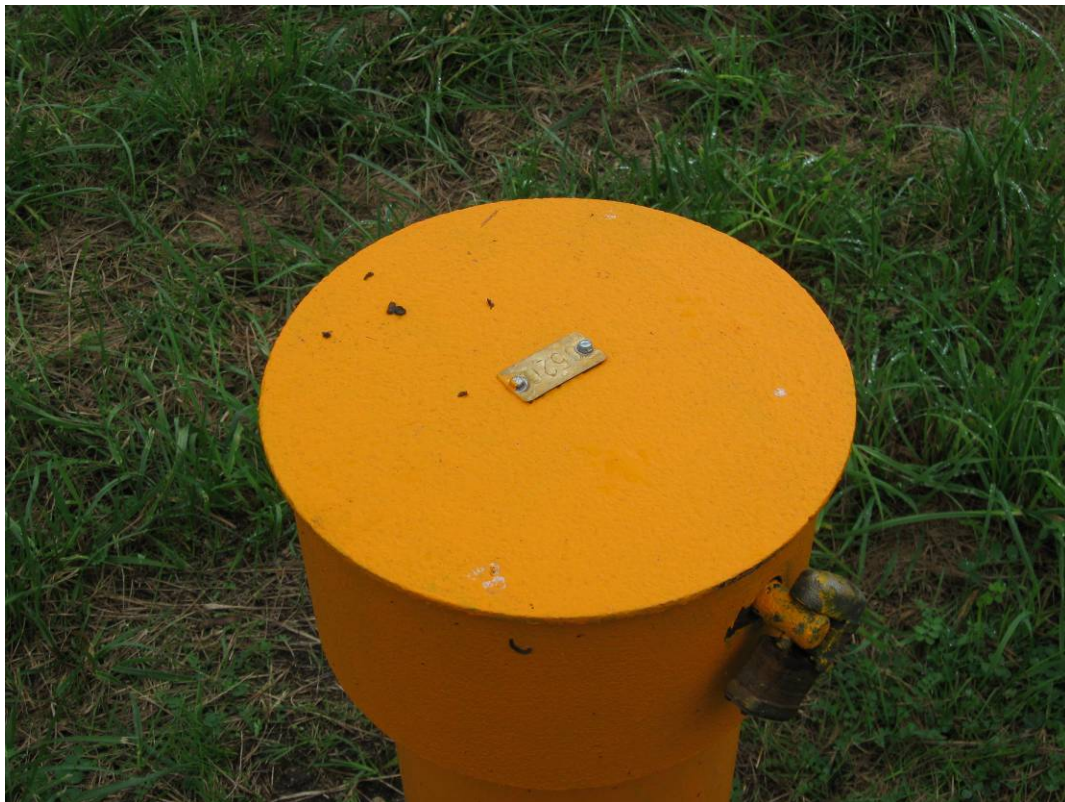
**Monitoring Wells**—The site has four pairs of monitoring wells. Each pair consists of a shallow (alluvial) completion and a deeper (bedrock) completion. Monitoring wells were not inspected in 2010. The water sampling crew last inspected them in 2009. The monitoring wells will be inspected again when they are sampled in 2014. All wells encountered during the 2010 site inspection were locked and secured. All of the outer protective casings had been recently painted and identified with brass identification tags (PL–4).

*BUR 10/2011. PL-4. Brass ID tag, top of monitoring well 0520.*

In 2011, noxious and invasive weed control continued, and the routes to the monitoring wells were mowed. Minor maintenance was conducted at the monitoring wells. Protective casings were painted and brass identification tags installed. Two broken or missing boundary monuments and one erosion control marker were replaced.

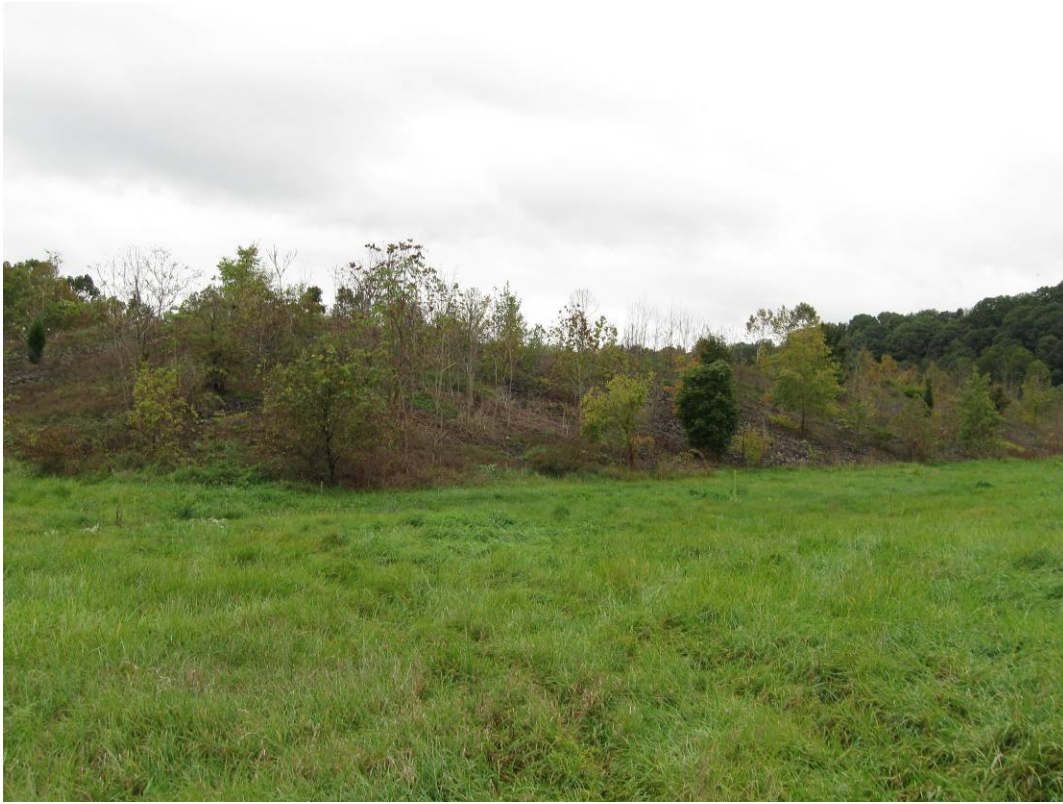
**Disposal Cell**—The riprap-covered disposal cell was in excellent condition (PL–5). There were no indications of cell instability, such as slumping, bulging, or differential settlement. Rock quality was excellent; degradation of the limestone riprap was not evident.

*BUR 10/2011. PL-5. Northeast corner of disposal cell.*
