2.0 Burrell, Pennsylvania, Disposal Site

2.1 Compliance Summary

The site, east of Blairsville, Pennsylvania, was inspected on October 19, 2010. The results of the inspection are described below. Figure 2–1 shows features and photograph locations (PLs) mentioned in this report. Numbers in the left margin of this report refer to items summarized in the “Executive Summary” table.

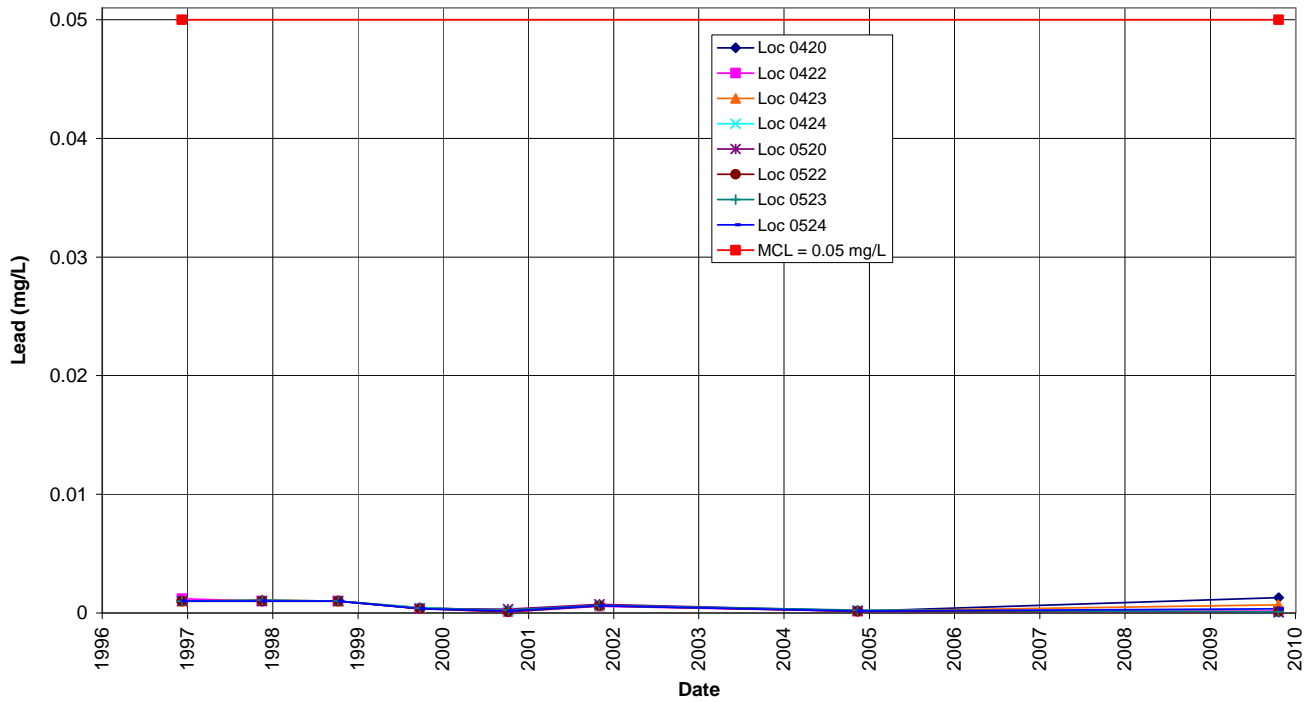
Figure 2–2. Time-Concentration Plot of Lead in Groundwater at the Burrell Disposal Site

Concentrations of lead in groundwater in both the shallow alluvial wells (400-series wells) and the deeper bedrock wells (500-series wells) remained well below the MCL. The 2009 results from all locations were more than an order of magnitude below the MCL (Figure 2–2).

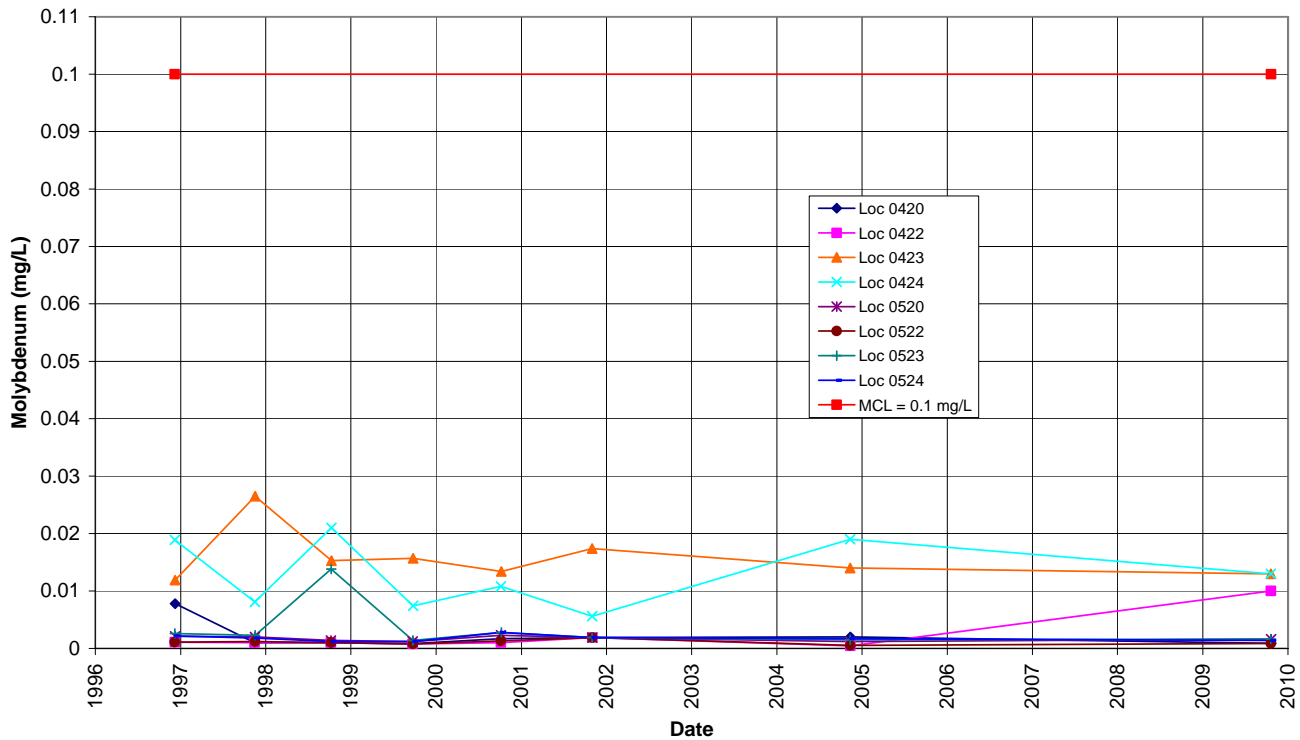
Figure 2–3. Time-Concentration Plot of Molybdenum in Groundwater at the Burrell Disposal Site

Concentrations of molybdenum in groundwater in both the shallow alluvial wells (400-series wells) and the deeper bedrock wells (500-series wells) remained well below the MCL. The 2009 results from all locations (except downgradient wells MW–0422, MW–0423 and MW–0424) were more than an order of magnitude below and at or near the laboratory detection limit. Concentrations in wells MW–0422, MW–0423 and MW–0424 were well below the MCL (Figure 2–3).

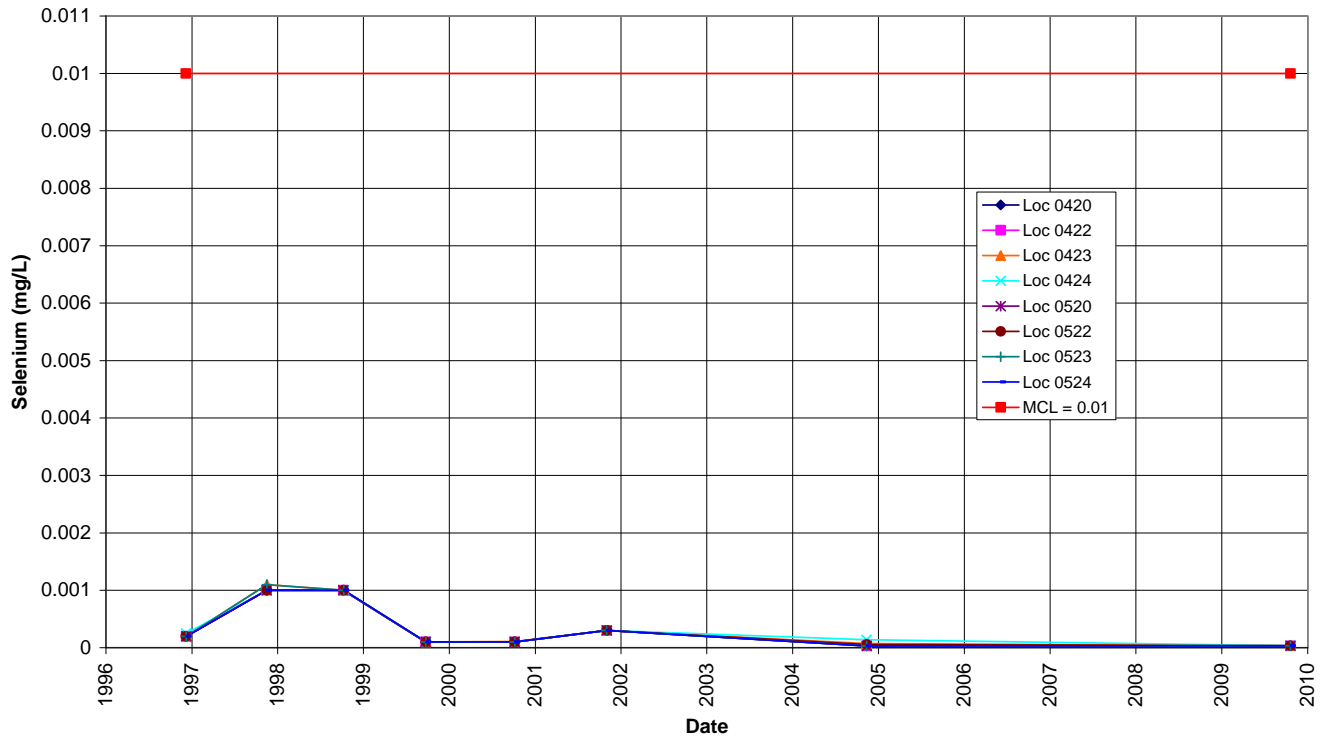
Figure 2-4. Time-Concentration Plot of Selenium in Groundwater at the Burrell Disposal Site

Concentrations of selenium in groundwater in both the shallow alluvial wells (400-series wells) and the deeper bedrock wells (500-series wells) remained well below the MCL. The 2009 results from all locations were more than two orders of magnitude below the MCL and approached the laboratory detection limit (Figure 2–4).

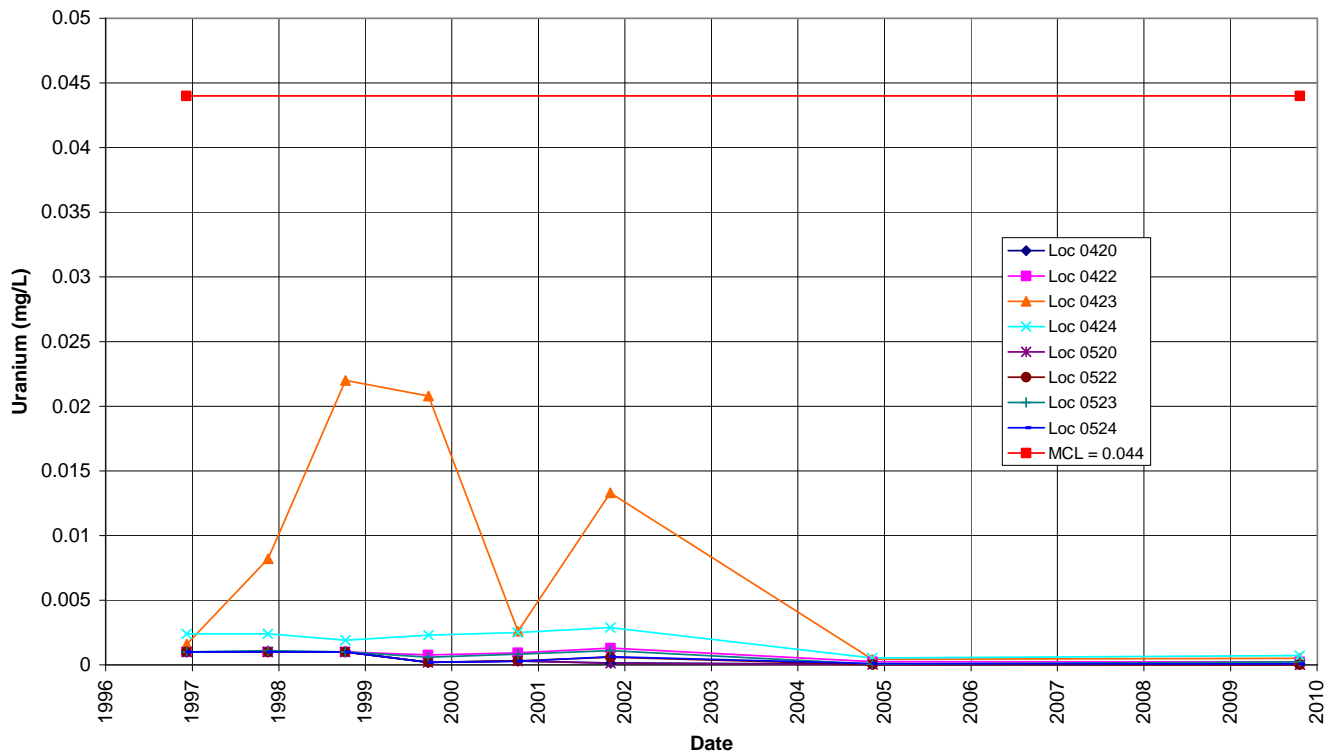
Figure 2-5. Time-Concentration Plot of Uranium in Groundwater at the Burrell Disposal Site

Concentrations of uranium in groundwater in both the shallow alluvial wells (400-series wells) and the deeper bedrock wells (500-series wells) remain well below the MCL. The 2009 results from all locations were two orders of magnitude or more below the MCL and approached the laboratory detection limit (Figure 2–5).

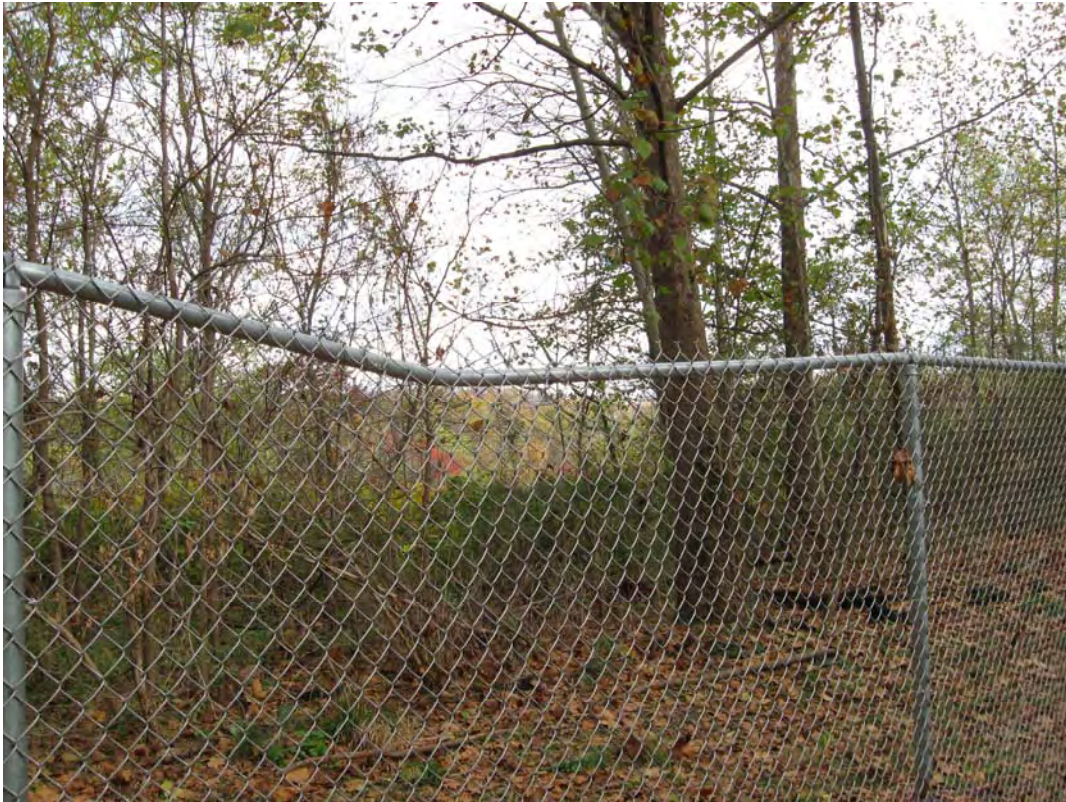
The chain-link security fence, replaced in 2007, remains in excellent condition, with the exception of a bent rail on the south fence (PL–1). The top rail was bent when a tree fell across it in the spring of 2010. The tree was safely removed from the fence shortly after being discovered. The top rail, although bent, remains serviceable. A vegetation-free corridor remains established along the fence line (PL–2). The entrance gate and four personnel gates were in good condition. Of the 17 perimeter signs mounted on the security fence, four have been damaged by bullet holes, but they remain serviceable.

BUR 10/2010. PL-1. Bent rail on top of south perimeter fence.

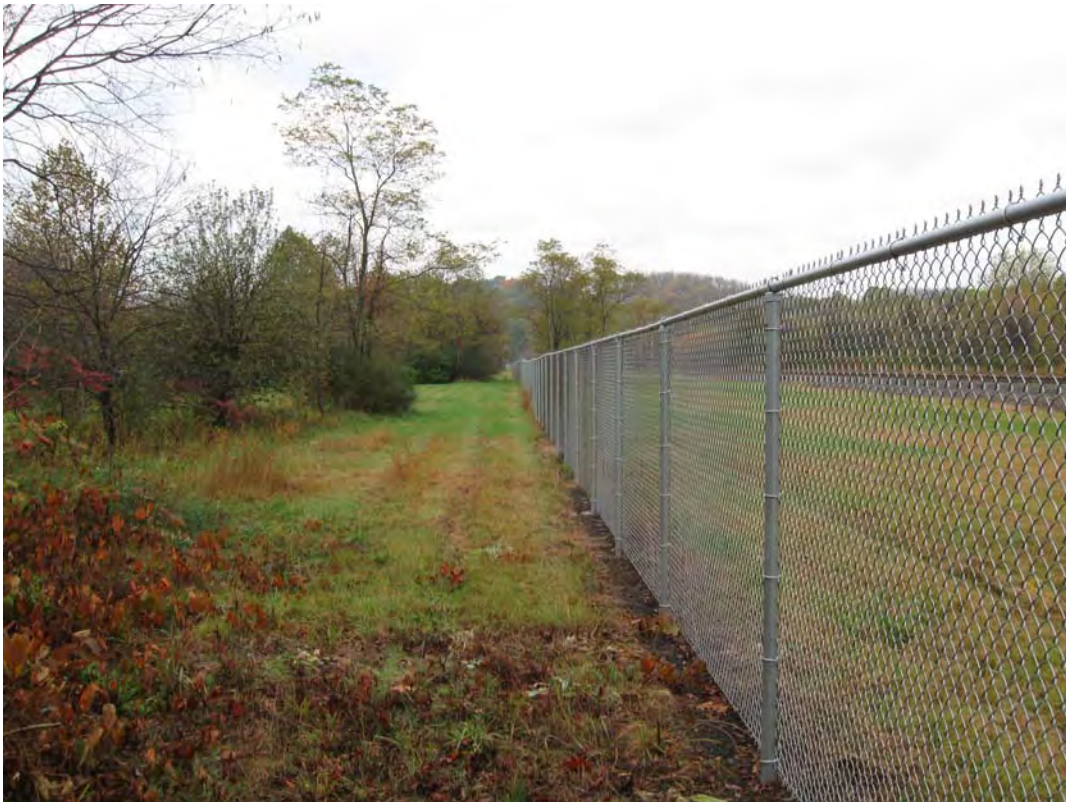
BUR 10/2010. PL-2. View down the inside of the north perimeter fence.

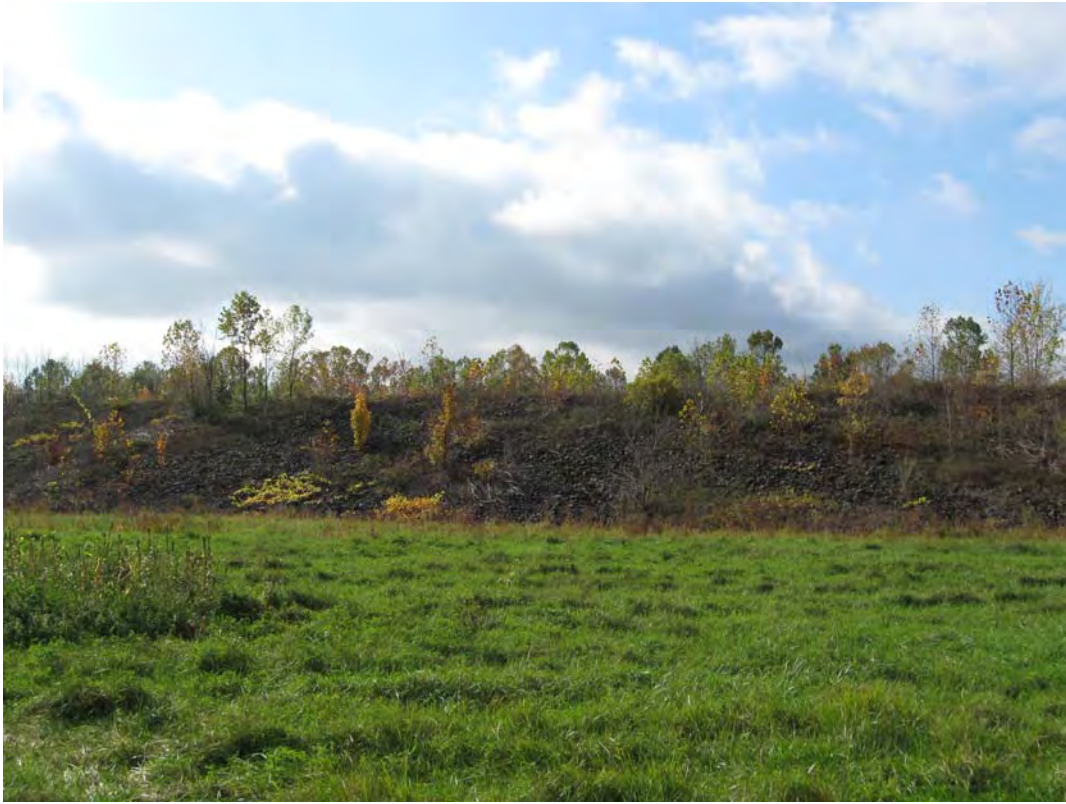
Disposal Cell—The riprap-covered disposal cell was in excellent condition (PL–3). There were no indications of cell instability, such as slumping, bulging, or differential settlement. Rock quality was excellent; degradation of the limestone riprap was not evident.

BUR 10/2010. PL-3. North side of the disposal cell.

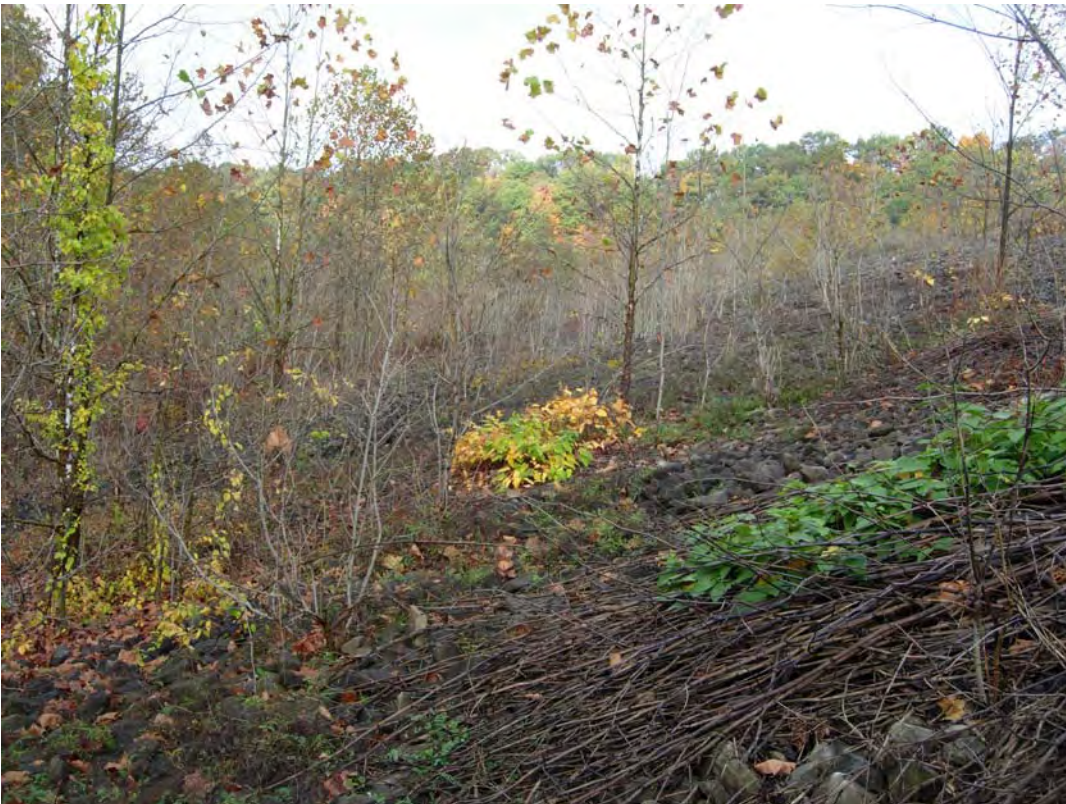
Although vegetation is allowed to grow on the disposal cell, the cell is sprayed for noxious weeds. The Japanese knotweed infestation on the cell cap is still declining, but continued efforts are needed to reduce stands on the south slope (PL–4). Deep-rooted woody species continue to proliferate on the cell cap (i.e., sycamore, tree of heaven, elm, tulip poplar, black locust, catalpa, and maple). As the trees mature, there is some concern that uprooting could damage the disposal cell cover, which would require repair. Vegetative growth on the disposal cell will continue to be monitored.

BUR 10/2010. PL-4. Japanese knotweed control on south side of the disposal cell.

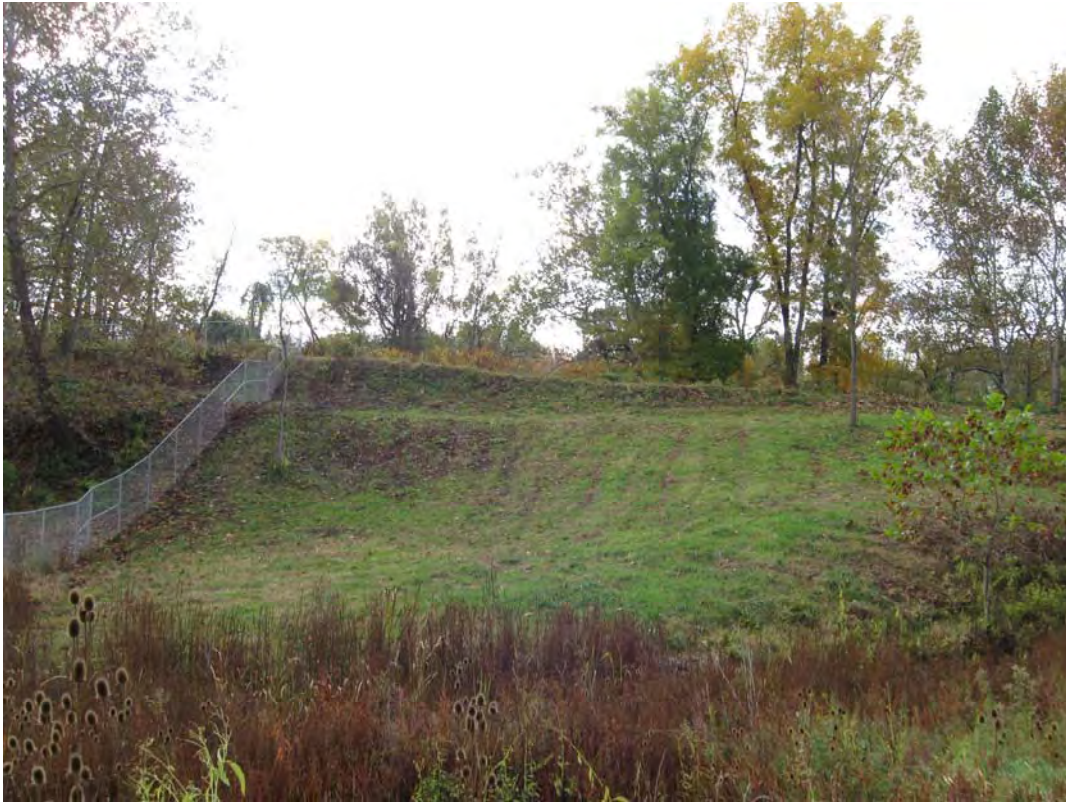
2A Implementation of a new vegetation management plan in 2008 has been successful in controlling noxious and invasive plants across the site. A combination of spot herbicide application and more-frequent mowing continues to be effective and will continue. The plan includes utilizing a woodland right-of-way mix to reduce the resprouting of Japanese knotweed and other noxious weeds in areas cleared by spot herbicide application. A large patch of Japanese knotweed was cleared southwest of the disposal cell and reseeded. Revegetation of the area using the woodland mix was mostly successful along the slope but some additional grass is needed (PL–5). A test-

BUR 10/2010. PL-5. Looking south toward seeded slope.

plot of the woodland right-of-way mix along the south fence is considered to be a success. Use of the woodland mix will be expanded across the site as deemed appropriate.
