2.0 Burrell, Pennsylvania, Disposal Site

2.1 Compliance Summary

Figure 2-1. 2009 Annual Compliance Drawing for the Burrell Disposal Site

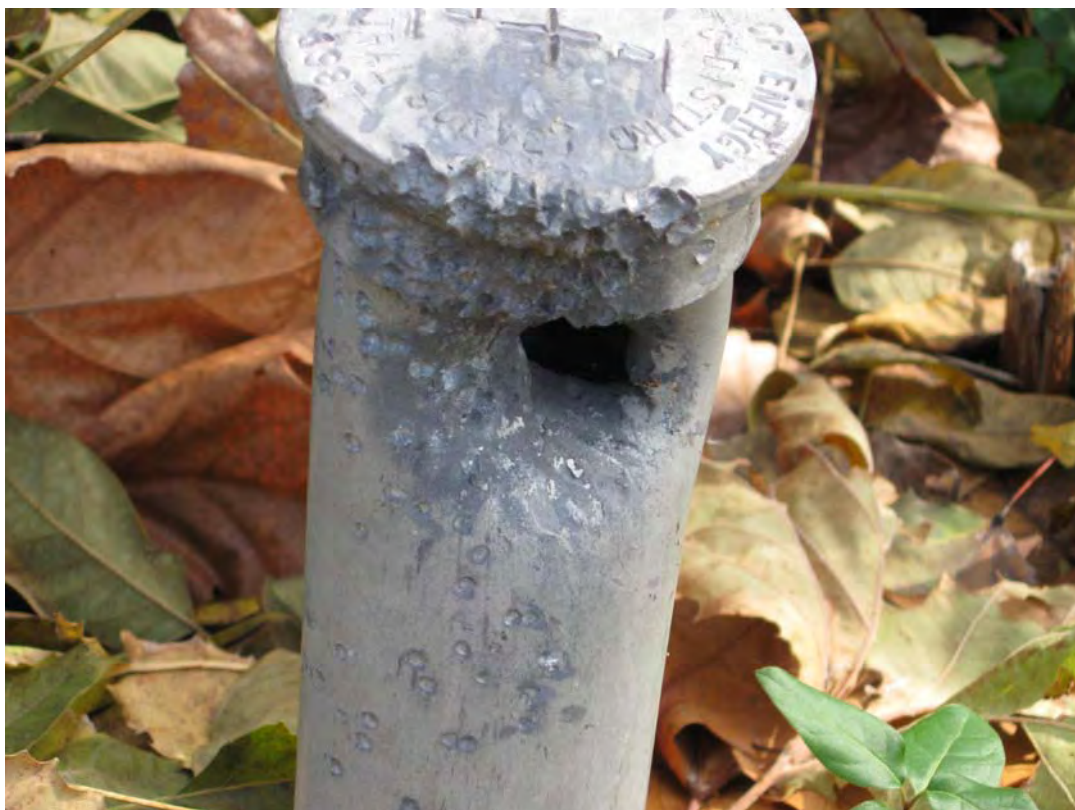
Site Markers and Monuments—The site has nine markers (a site marker and eight erosion control markers). Site marker SMK–1 was in excellent condition. All eight erosion control markers were located during the inspection, and seven were in good condition. Erosion control marker E–7 was damaged this past year and will be repaired or replaced (PL–2). Vegetation control efforts this past year have made the erosion control markers easier to find.

BUR 10/2009. PL-2. Erosion control marker E-7 damage, possibly by grass-cutting equipment.

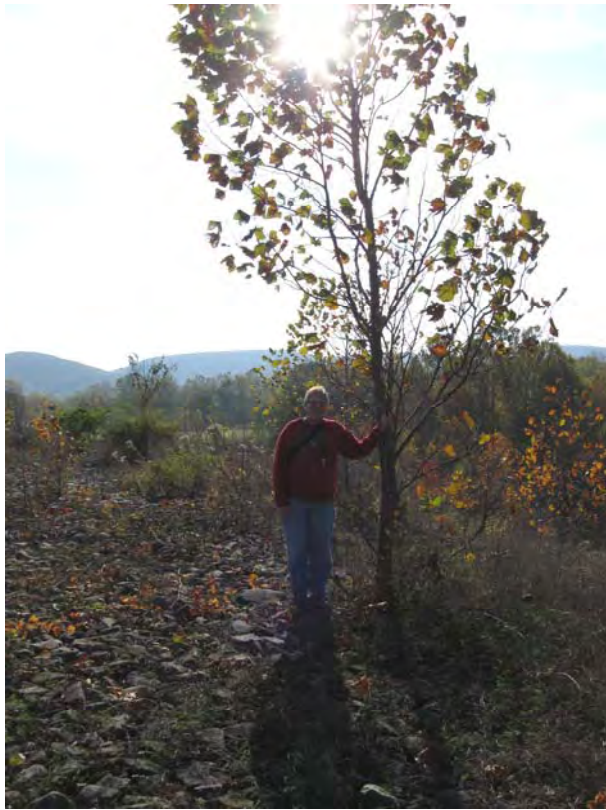
Although vegetation is allowed to grow on the disposal cell, the cell is sprayed for noxious weeds. The Japanese knotweed infestation on the cell cap is still declining, but continued efforts are needed to reduce stands on the south slope. Deep-rooted woody species continue to proliferate on the cell cap (i.e., sycamore, tree of heaven, elm, tulip poplar, black locust, catalpa, and maple). As the trees mature, there is some concern that uprooting could damage the disposal cell cover, which would require repair (PL-3). Vegetative growth on the disposal cell will continue to be monitored.

BUR 10/2009. PL-3. Sycamore tree on top of the disposal cell.

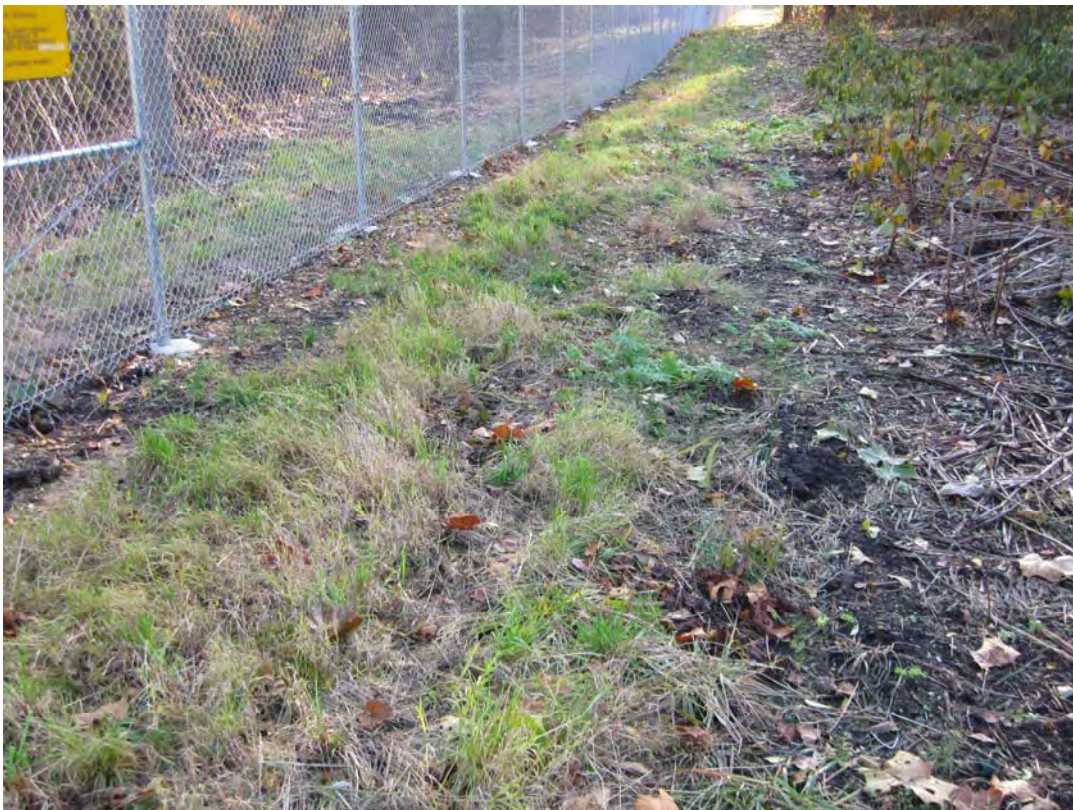
- 2A In 2008, a new vegetation management plan was implemented to control noxious and invasive plants across the site. The plan's implementation has greatly reduced the presence of noxious and invasive plants. The combination of spot herbicide application and more-frequent mowing is proving to be effective and will continue. The plan includes utilizing a woodland right-of-way mix to reduce the re-sprouting of Japanese knotweed and other noxious weeds in areas cleared by spot herbicide application; this mix is being tested along the south perimeter fence (PL-4). If successful, utilizing this seed mix could reduce the need for future herbicide applications.

BUR 10/2009. PL-4. Vegetation test area along the outside of the south perimeter fence.

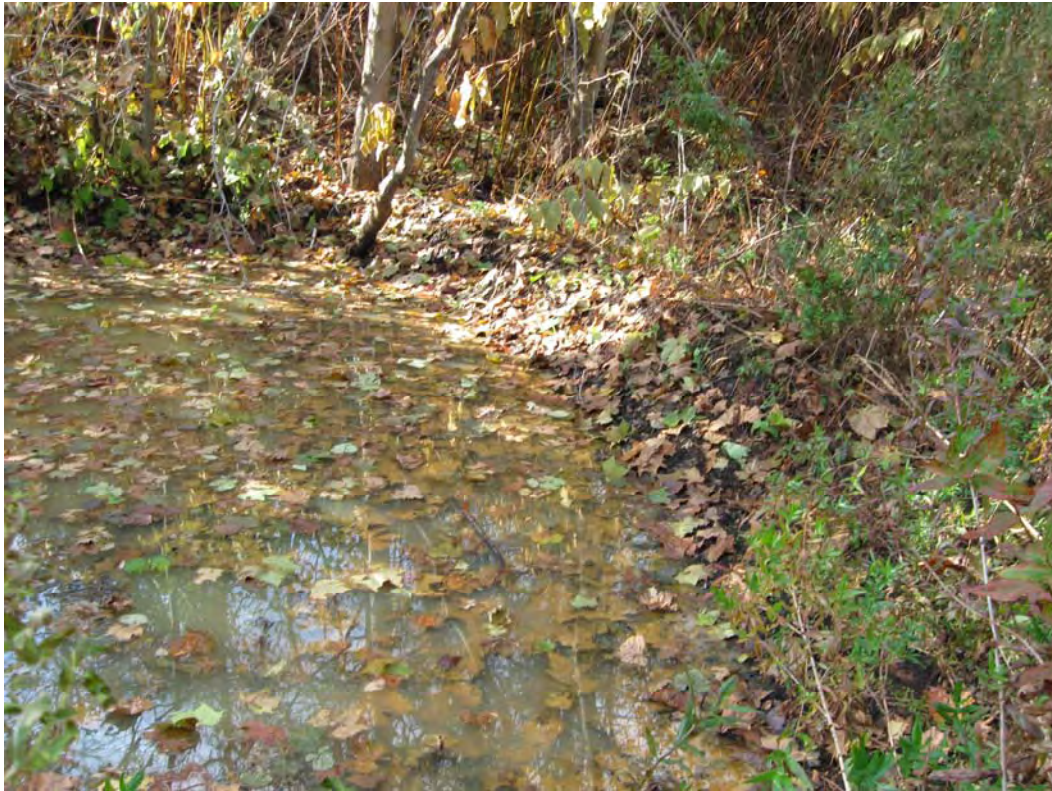
- 2B A small, inactive beaver dam (PL-5) remains within the slough at the base of the south slope of the disposal cell, and water continues to collect behind it. The water level behind the dam is not high enough to saturate the tailings or impact the integrity of the disposal cell and appears unchanged from prior inspection. Therefore, DOE has elected not to remove the dam. Instead, DOE will continue to monitor the dam and its possible impacts on the disposal site.

BUR 10/2009. PL-5. Inactive beaver dam; unchanged from prior inspection.

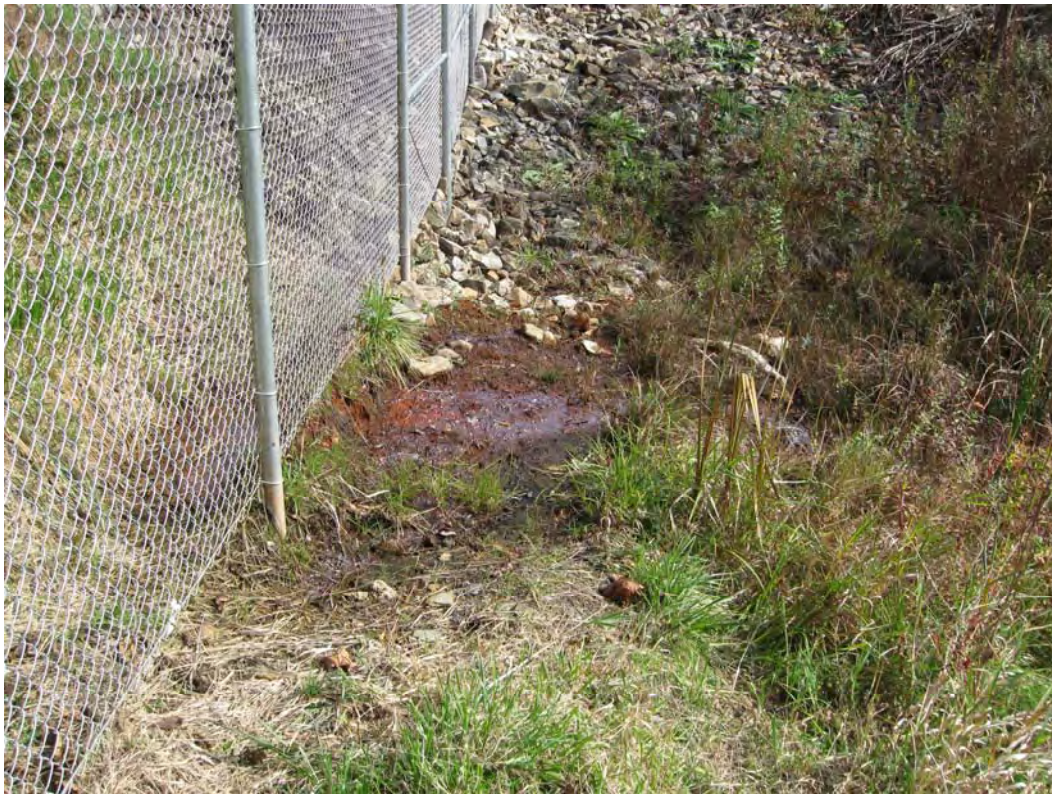
Site Perimeter—A known seep along the north security fence, about 60 feet east of perimeter sign P8 and west of the disposal cell, was flowing at the time of the 2009 inspection (PL-6). This

area will continue to be monitored for seeps to determine if they threaten the disposal cell's integrity. Conceivably, the seeps also could destabilize the nearby railroad embankment. The water for this seep may be coming from other seeps on the bluffs, above and just north of the railroad tracks.

BUR 10/2009. PL-6. Active seep under the north perimeter fence.
