## 2.0 Burrell, Pennsylvania, Disposal Site

### 2.1 Compliance Summary

Figure 2-1. 2008 Annual Compliance Drawing for the Burrell Disposal Site

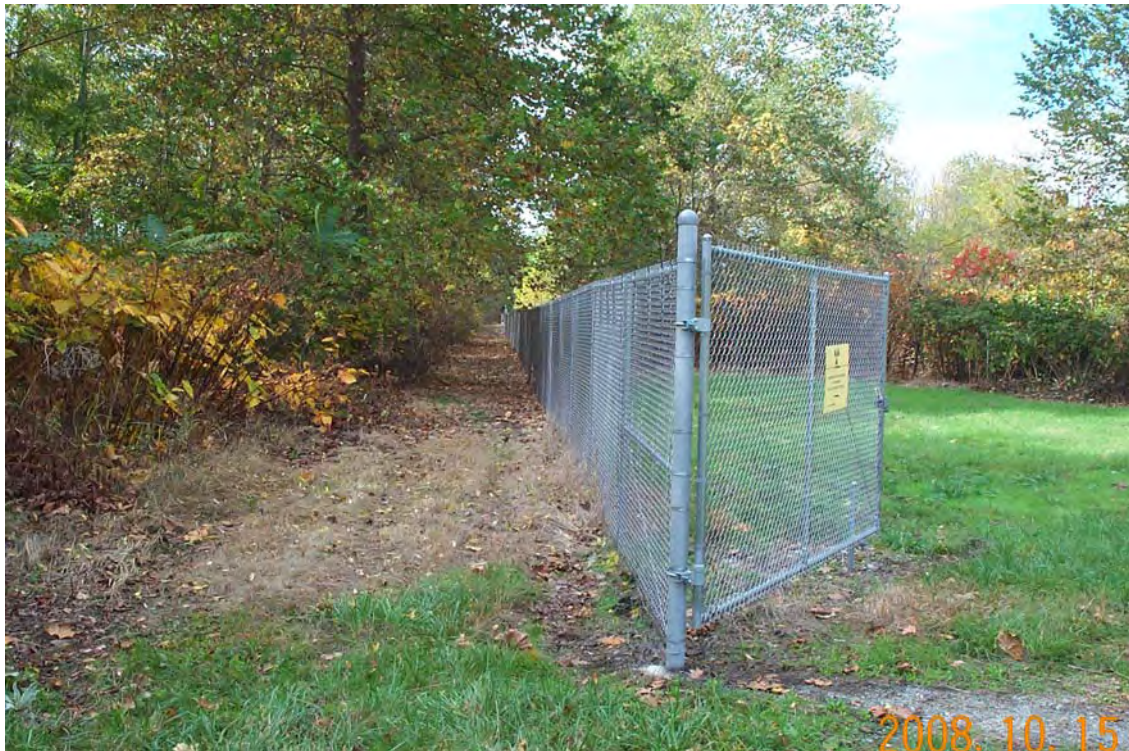
The chain-link security fence, replaced in 2007, was in excellent condition. A vegetation-free corridor has been established along the fence line (PL–1). The entrance gate and four personnel gates were in good condition.

*BUR 10/2008. PL-1. Vegetation-free corridor along south perimeter fence.*

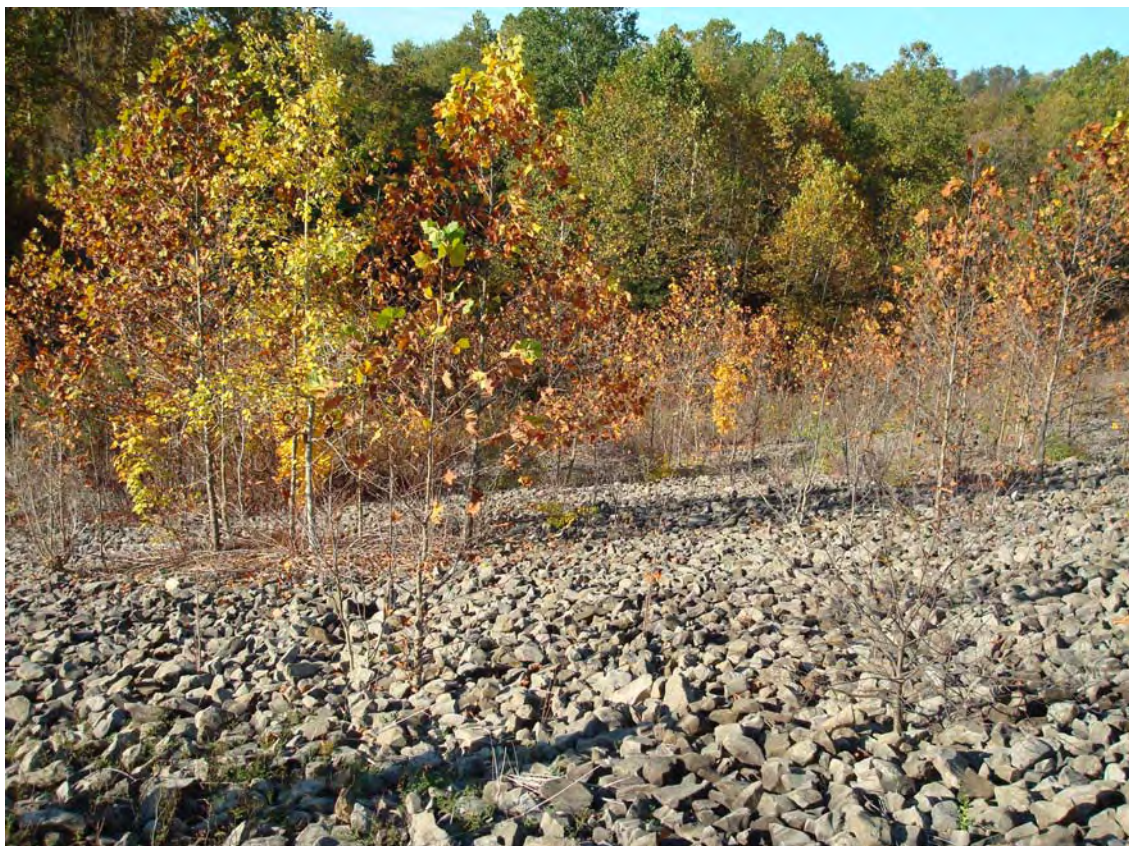
2B Trees and shrubs continue to establish in the riprap on the disposal cell (PL-2 and PL-3). Studies at the Burrell Site concluded that plant growth on the cell poses no added public or environmental risk of exposure to contaminants within the disposal cell. It was concluded that vegetation growth at this site might actually enhance cover performance through evapotranspiration processes. These studies further concluded that plant growth would not be detrimental to the proper functioning of the radon barrier. NRC concurred in the revised LTSP, which no longer requires active control of vegetation on the cell cover. NRC has suggested that DOE reevaluate the effects of vegetation on cover performance in 10 or 20 years to confirm performance parameters and predictions. As the trees mature, there is some concern that uprooting could occur and cause damage to the disposal cell cover, which would require repair. Vegetative growth on the disposal cell will continue to be monitored.

*BUR 10/2008. PL-2. Vegetation growth on the disposal cell.*

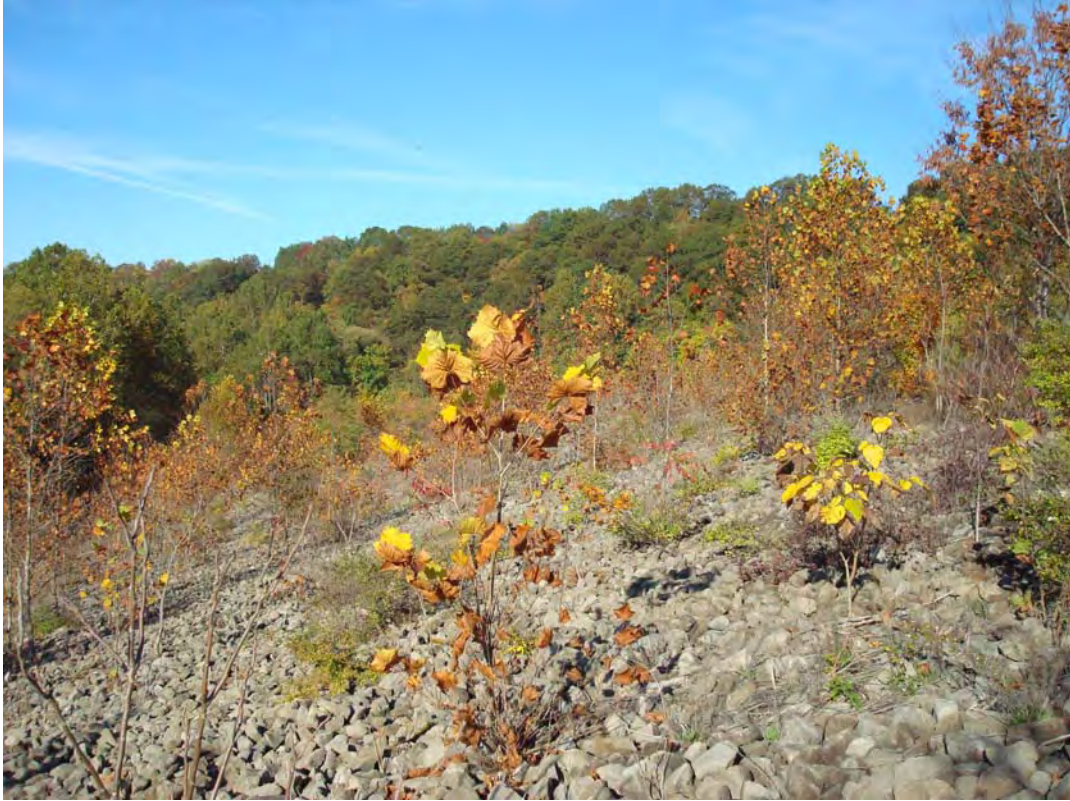
*BUR 10/2008. PL-3. Vegetation growth on the disposal cell.*

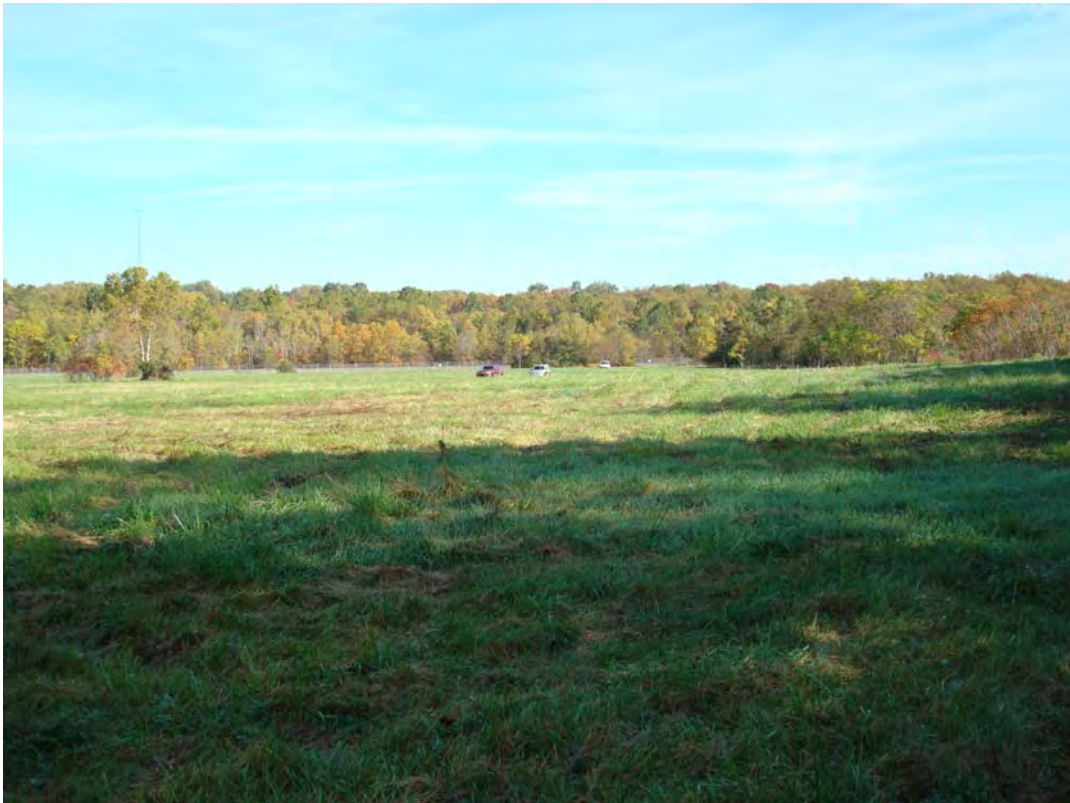
**Area Between the Disposal Cell and Site Boundary**—The area surrounding the disposal cell and inside the security fence was cleared during reclamation and is covered by thick grass and reestablishing hardwood trees. Periodic mowing has maintained access to monitor wells; the area east of the cell remains grassland (PL-4).

*BUR 10/2008. PL-4. Grass meadow east of the cell.*

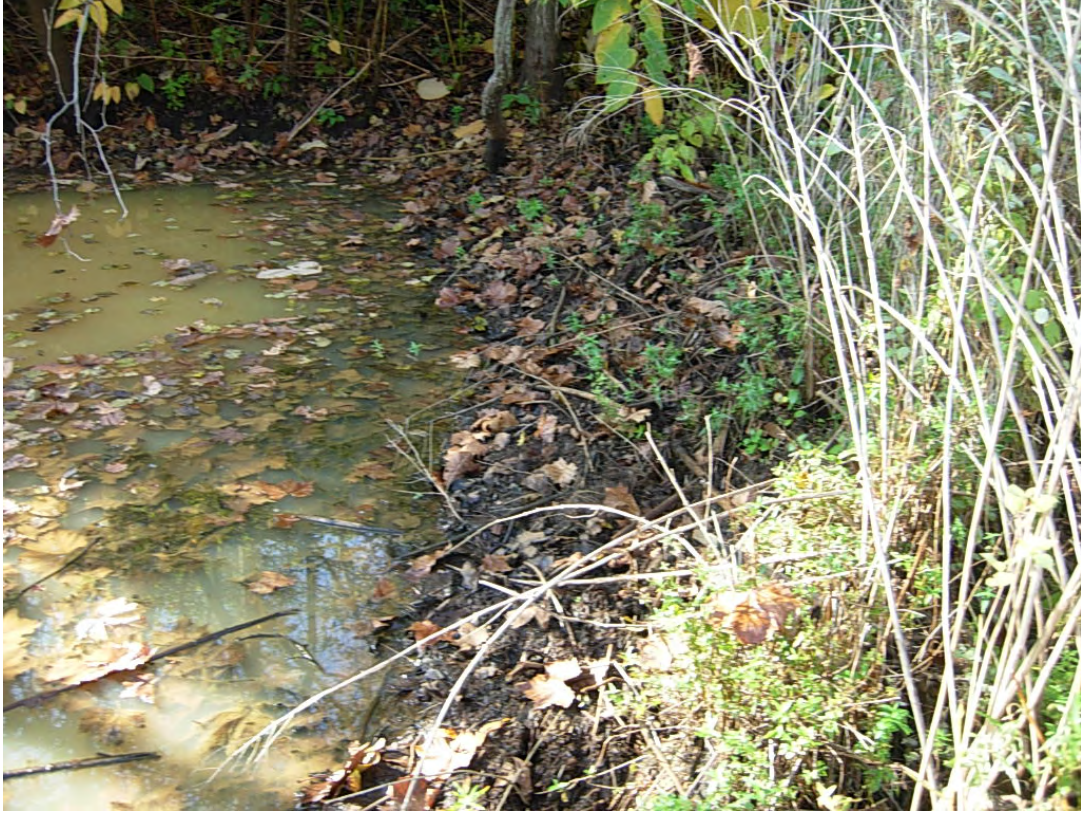
2C An inactive beaver dam (PL-5) remains within the slough at the base of the south slope of the disposal cell; several feet of water continue to collect behind the dam. In November 2005, DOE coordinated with State wildlife officials to remove the beavers, in accordance with State regulations, and then breached a dam downstream of the site that caused the water to backup against the base of the cell. The water levels behind the inactive dam are not high enough to saturate the tailings or impact the integrity of the disposal cell. Therefore, DOE has elected not to mobilize equipment to remove the dam. Instead, DOE will continue to monitor the dam and possible impacts to the disposal site.

*BUR 10/2008. PL-5. Inactive beaver dam in drainage slough directly south of the disposal cell.*
