## 2.0 Burrell, Pennsylvania, Disposal Site

### 2.1 Compliance Summary

The Burrell, Pennsylvania, Disposal Site, inspected on September 19, 2007, was in excellent condition. The disposal cell, its cover, and associated drainage features are performing as designed. The security perimeter fence was replaced in 2007. Control of undesirable vegetation and noxious weeds continued at the site. Groundwater monitoring is required every 5 years and was not performed in 2007. The 2004 monitoring indicated there is no contamination being released and that the disposal cell is performing as designed. No cause for a follow-up or contingency inspection was identified.

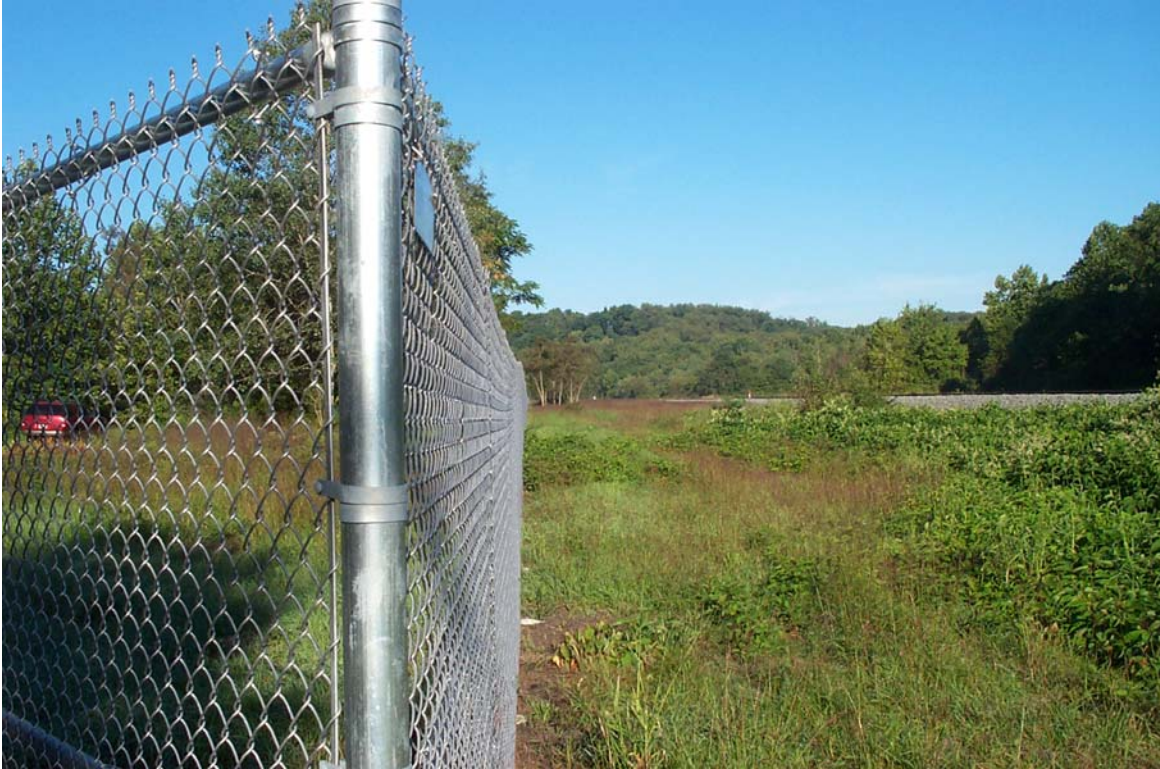
- 2A A new security fence was installed in the summer of 2007 (PL-1). The chain link fence includes a top rail, but no angle brackets or barbed wire were installed. Of the 17 perimeter signs mounted on the security fence, 13 were in good condition, three are missing and need to be replaced (P1, P2, and P16), and one has 3 bullet holes in it (P15) but it is still serviceable. The site entrance sign was missing. A temporary sign was installed during the inspection. A permanent sign will be installed in 2008.

*BUR 9/2007. PL-1. View down the outside of the site perimeter fence, from boundary monument BM-7.*

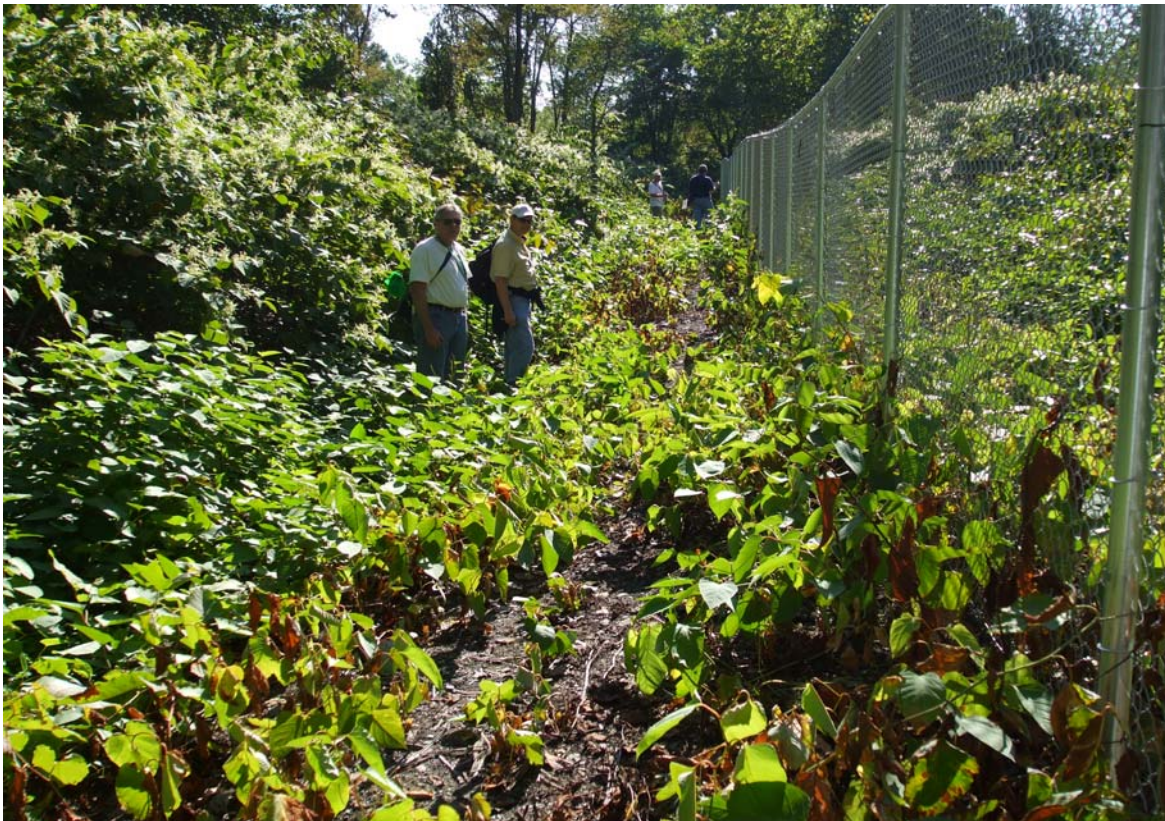
All gates to the site are new and in excellent condition. Three new personnel gates have been added to the site in addition to the existing personnel and entrance gates. Locations of the new gates are shown on Figure 2-1. Vegetation (i.e., primarily Japanese knapweed) is rapidly encroaching upon areas of the new fence; a vegetation free maintenance corridor is maintained along the fence line (PL-2).

Japanese knapweed is established along the south and west sides of the site perimeter and encroaching upon the new security fence (PL-2). Erosion control markers can be particularly hard to find in the dense vegetation. Also, spotted knapweed patches remain along access paths to groundwater monitor wells within wooded areas. DOE uses mowing and herbicide applications to control this listed weed.

*BUR 9/2007. PL-2. Vegetation encroaching on new fence.*

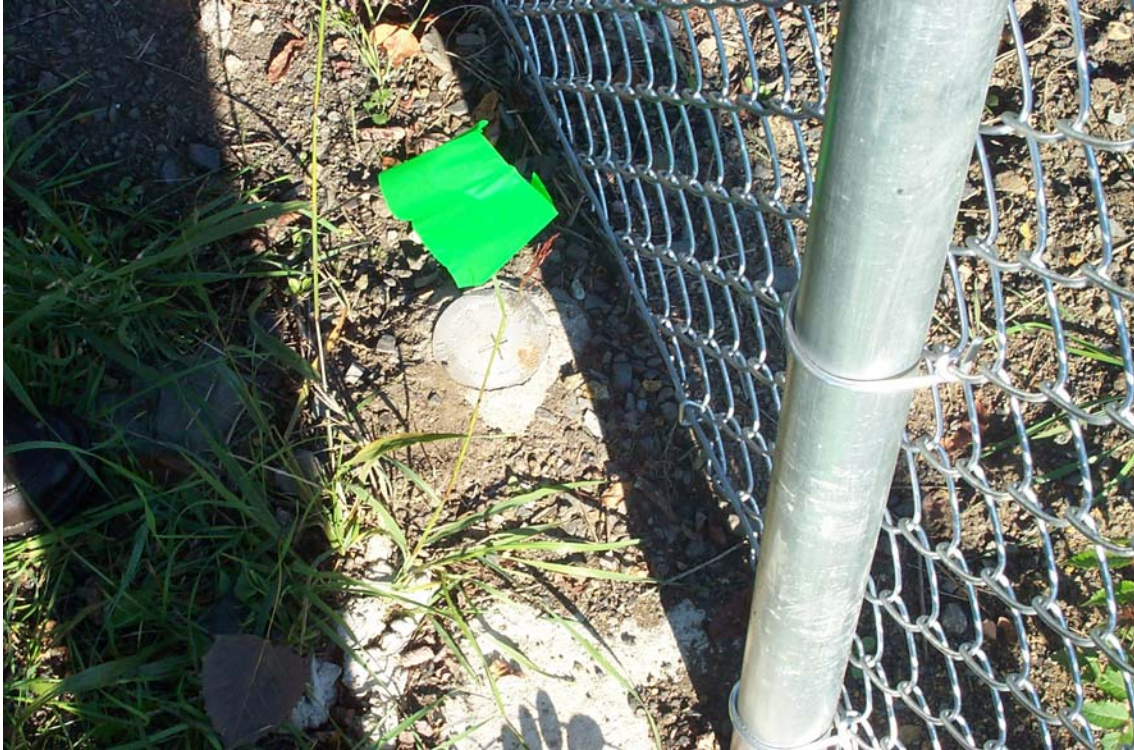
The site has seven boundary monuments and three survey monuments. Four boundary monuments were in good condition, BM-4 is missing entirely, and the cap to BM-5 is broken (PL-3). Both boundary monuments were most likely damaged as a result of the fence replacement and will be replaced in 2008. Boundary monument BM-1 is covered with soil in an area overgrown by vegetation and was not inspected.

*BUR 9/2007. PL-3. Boundary monument BM-5, damaged.*

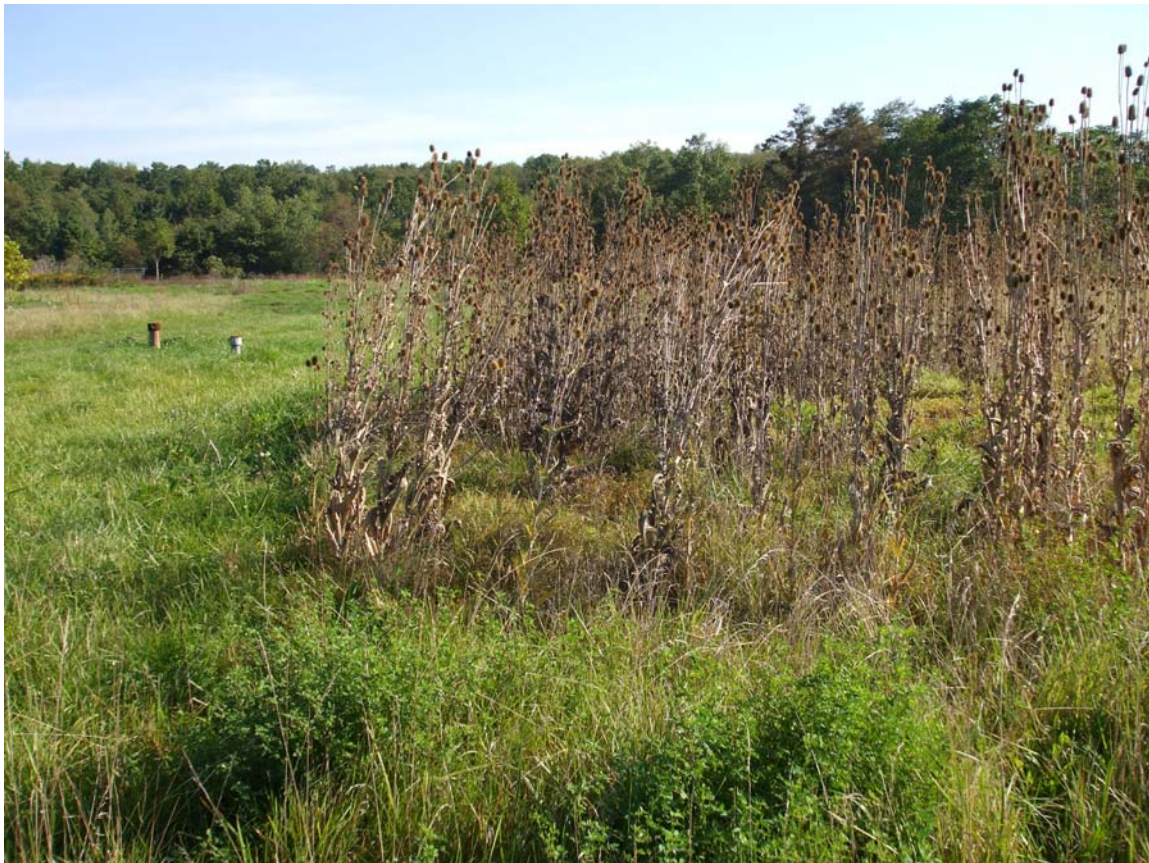
**Area Between the Disposal Cell and Site Boundary**—The area surrounding the disposal cell and inside the security fence was cleared during reclamation and is covered by thick grass and re-establishing hardwood trees (PL-4). Periodic mowing has maintained access to monitoring wells; the center and northern portions of the site remain as grassland.

*BUR 9/2007. PL-4. Vegetation at center of site.*

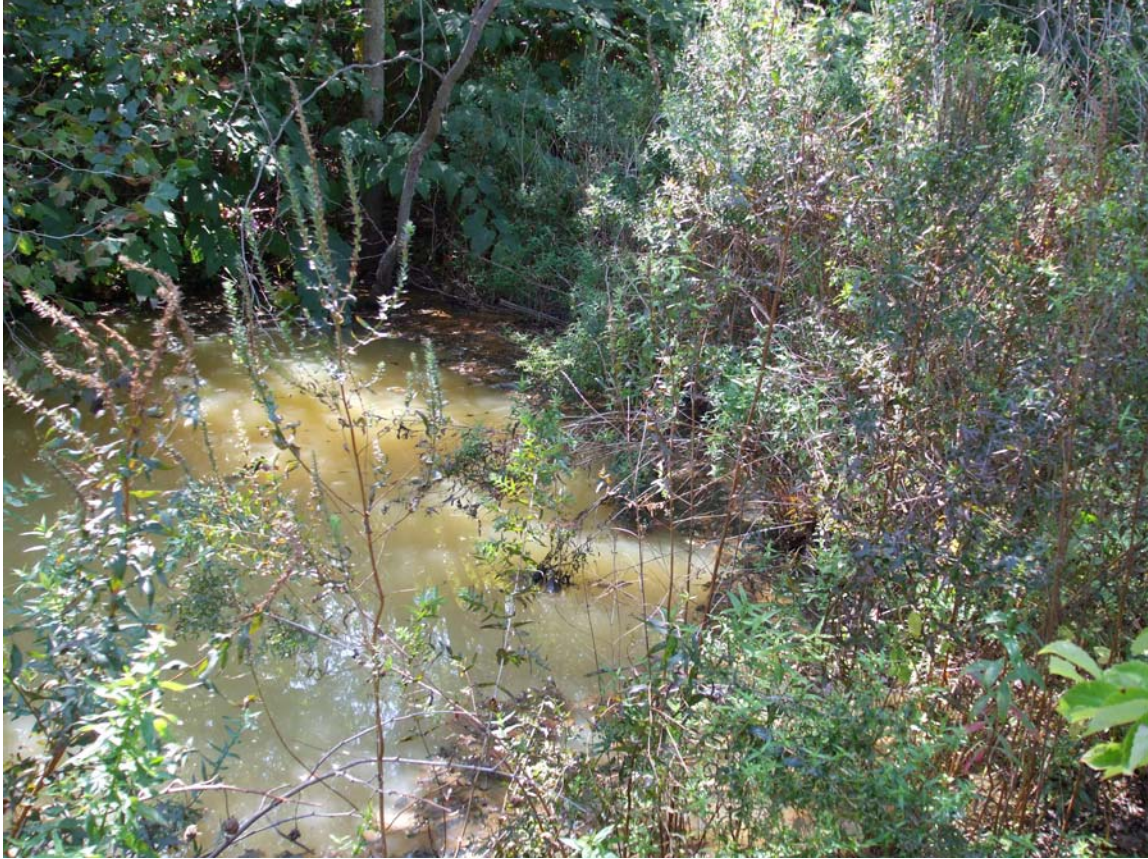
2C A beaver dam is present on the slough at the top of the toe of the riprap slope south of the disposal cell and several feet of water has collected behind the dam. This dam appears to be inactive and water levels behind the dam are not high enough to saturate the tailings or impact the integrity of the disposal cell (PL-5). Therefore, DOE has elected not to mobilize equipment to remove the dam. Instead DOE will continue to monitor the dam and possible impacts to the disposal site.

*BUR 9/2007. PL-5. Water behind beaver dam at toe of riprap blanket below south side slope.*
