## 2.0 Burrell, Pennsylvania, Disposal Site

### 2.1 Compliance Summary

Figure 2-1. 2006 Annual Compliance Drawing for the Burrell, Pennsylvania, Disposal Site

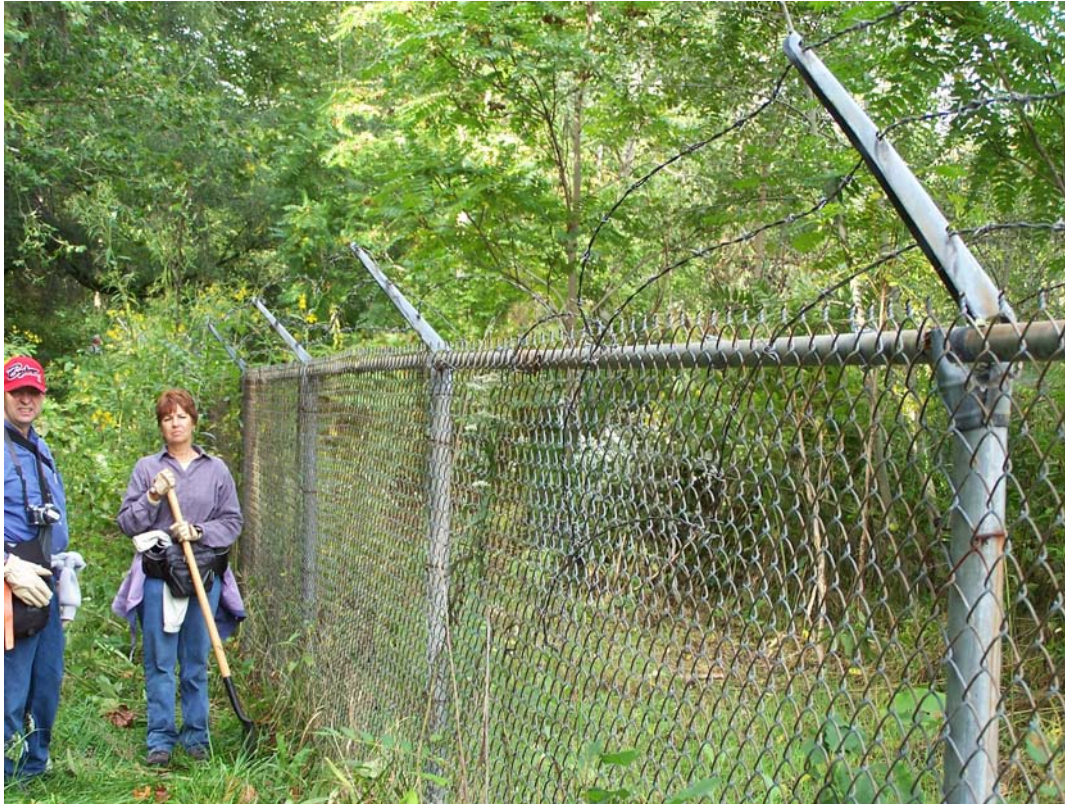
- 2B Overall, the security fence was in good condition at the time of the inspection. Several strands of barbed wire were found broken along the south fence line and need repair (PL–1). DOE replaced the fabric on the south panel of the security fence after a maintenance contractor found it damaged.

*BUR 9/2006. PL-1. Broken strands of barbed wire on south fence line.*

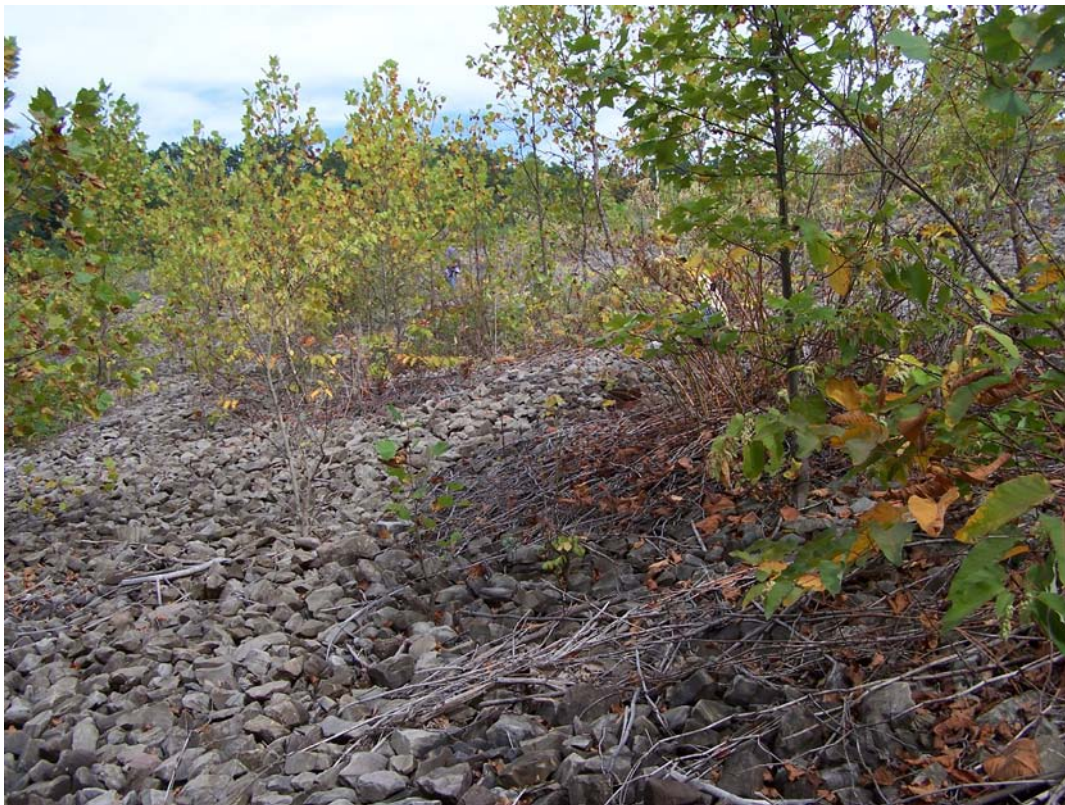
Trees and shrubs continue to establish in the riprap (PL-2), as vegetation eradication is no longer a requirement of the LTSP. A study that evaluated risks posed by encroachment of plants on the disposal cell demonstrated that the plants will not degrade the long-term performance of the cell and may improve performance by reducing moisture in the cover through evapotranspiration. The study concluded that plant growth on the cell poses no added public or environmental risk of exposure to contaminants within the disposal cell because the cell contains only 4 curies of radium-226 and the hazardous constituents are not leachable, even if infiltration occurs. These studies further concluded that plant growth would not be detrimental to the proper functioning of the radon barrier. Because vegetation grows so vigorously at this site, effective vegetation control on the cell cover would require an aggressive program entailing, at a minimum, an annual application of herbicides. The potential environmental and health risks associated with such a program are greater than risks resulting from allowing vegetation to establish naturally. The LTSP was revised (April 2000) to allow vegetation to grow on the disposal cell without further intervention; stating that such growth will not increase risk to public health, safety, or the environment. In their concurrence of the of the revised LTSP, the U.S. Nuclear Regulatory Commission suggested that DOE reevaluate the effects of vegetation on cover performance in 10 or 20 years to confirm performance parameters and predictions.

*BUR 9/2006. PL-2. Vegetation growth on the disposal cell south side slope.*

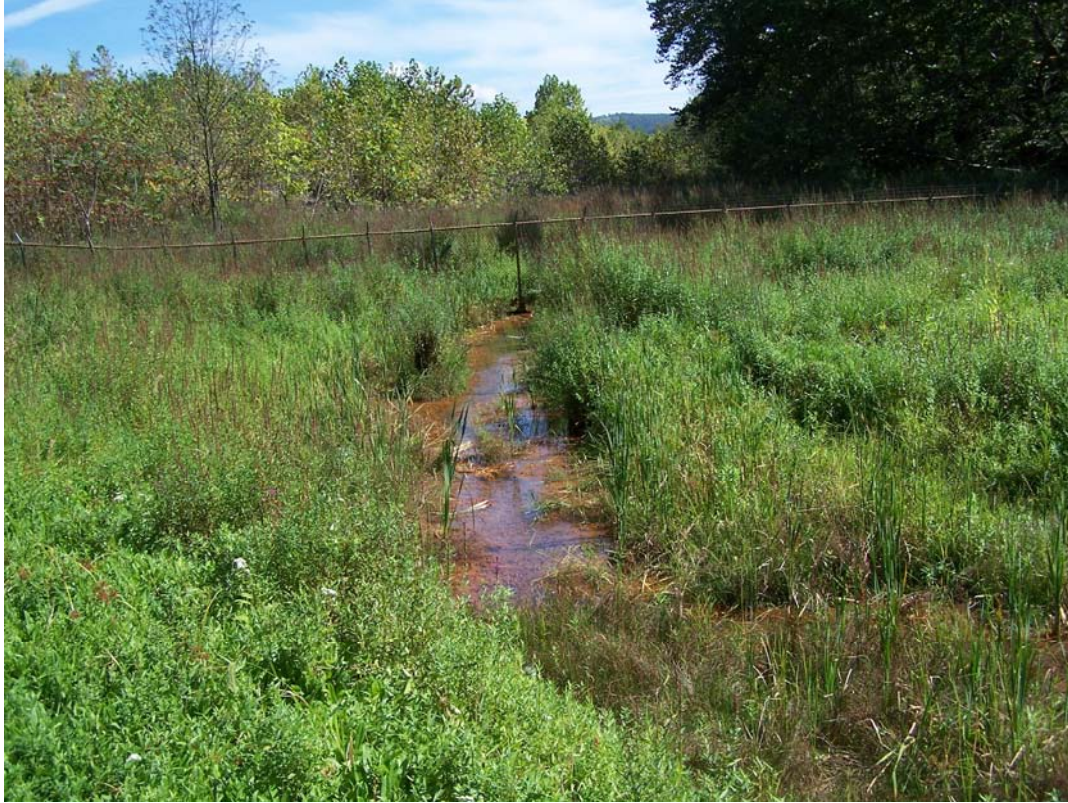
In 2005, inspectors found that the slough along the south side of the disposal cell, fed by ground water, had backed up as a result of a beaver dam on the slough west of the site boundary. The dam caused water to back up half way up the security fence. In November 2005, DOE coordinated with State wildlife officials to remove the beavers in accordance with State regulations, and then breached the dam. Water levels in the slough have returned to normal

(PL-3). A smaller beaver dam remains that has caused some ponding of water, but is not currently considered problem enough to warrant removal; the water had not risen to the elevation of the contaminated materials within the cell.

Since the removal of the beaver dam, water in the slough has returned to normal flows and relieved ponding that was covering the bottom of the security fence on the west end of the property (PL-3).

*BUR 9/2006. PL-3. Slough and west fence line.*
