## 3.0 Canonsburg, Pennsylvania, Disposal Site

### 3.1 Compliance Summary

The Canonsburg, Pennsylvania, Uranium Mill Tailings Radiation Control Act (UMTRCA) Title I Disposal Site was inspected on October 27, 2015. The site was in excellent condition. No evidence of erosion or slope instability was observed on the disposal cell. A trespass campsite was discovered hidden among the trees in the southwest corner of the property, outside the perimeter fence. The Canonsburg Police Department was notified; however, law enforcement could not locate the occupant of the camp. The Canonsburg Police Department will continue to patrol the area in order to find the camper, and to decrease the potential for future trespass.

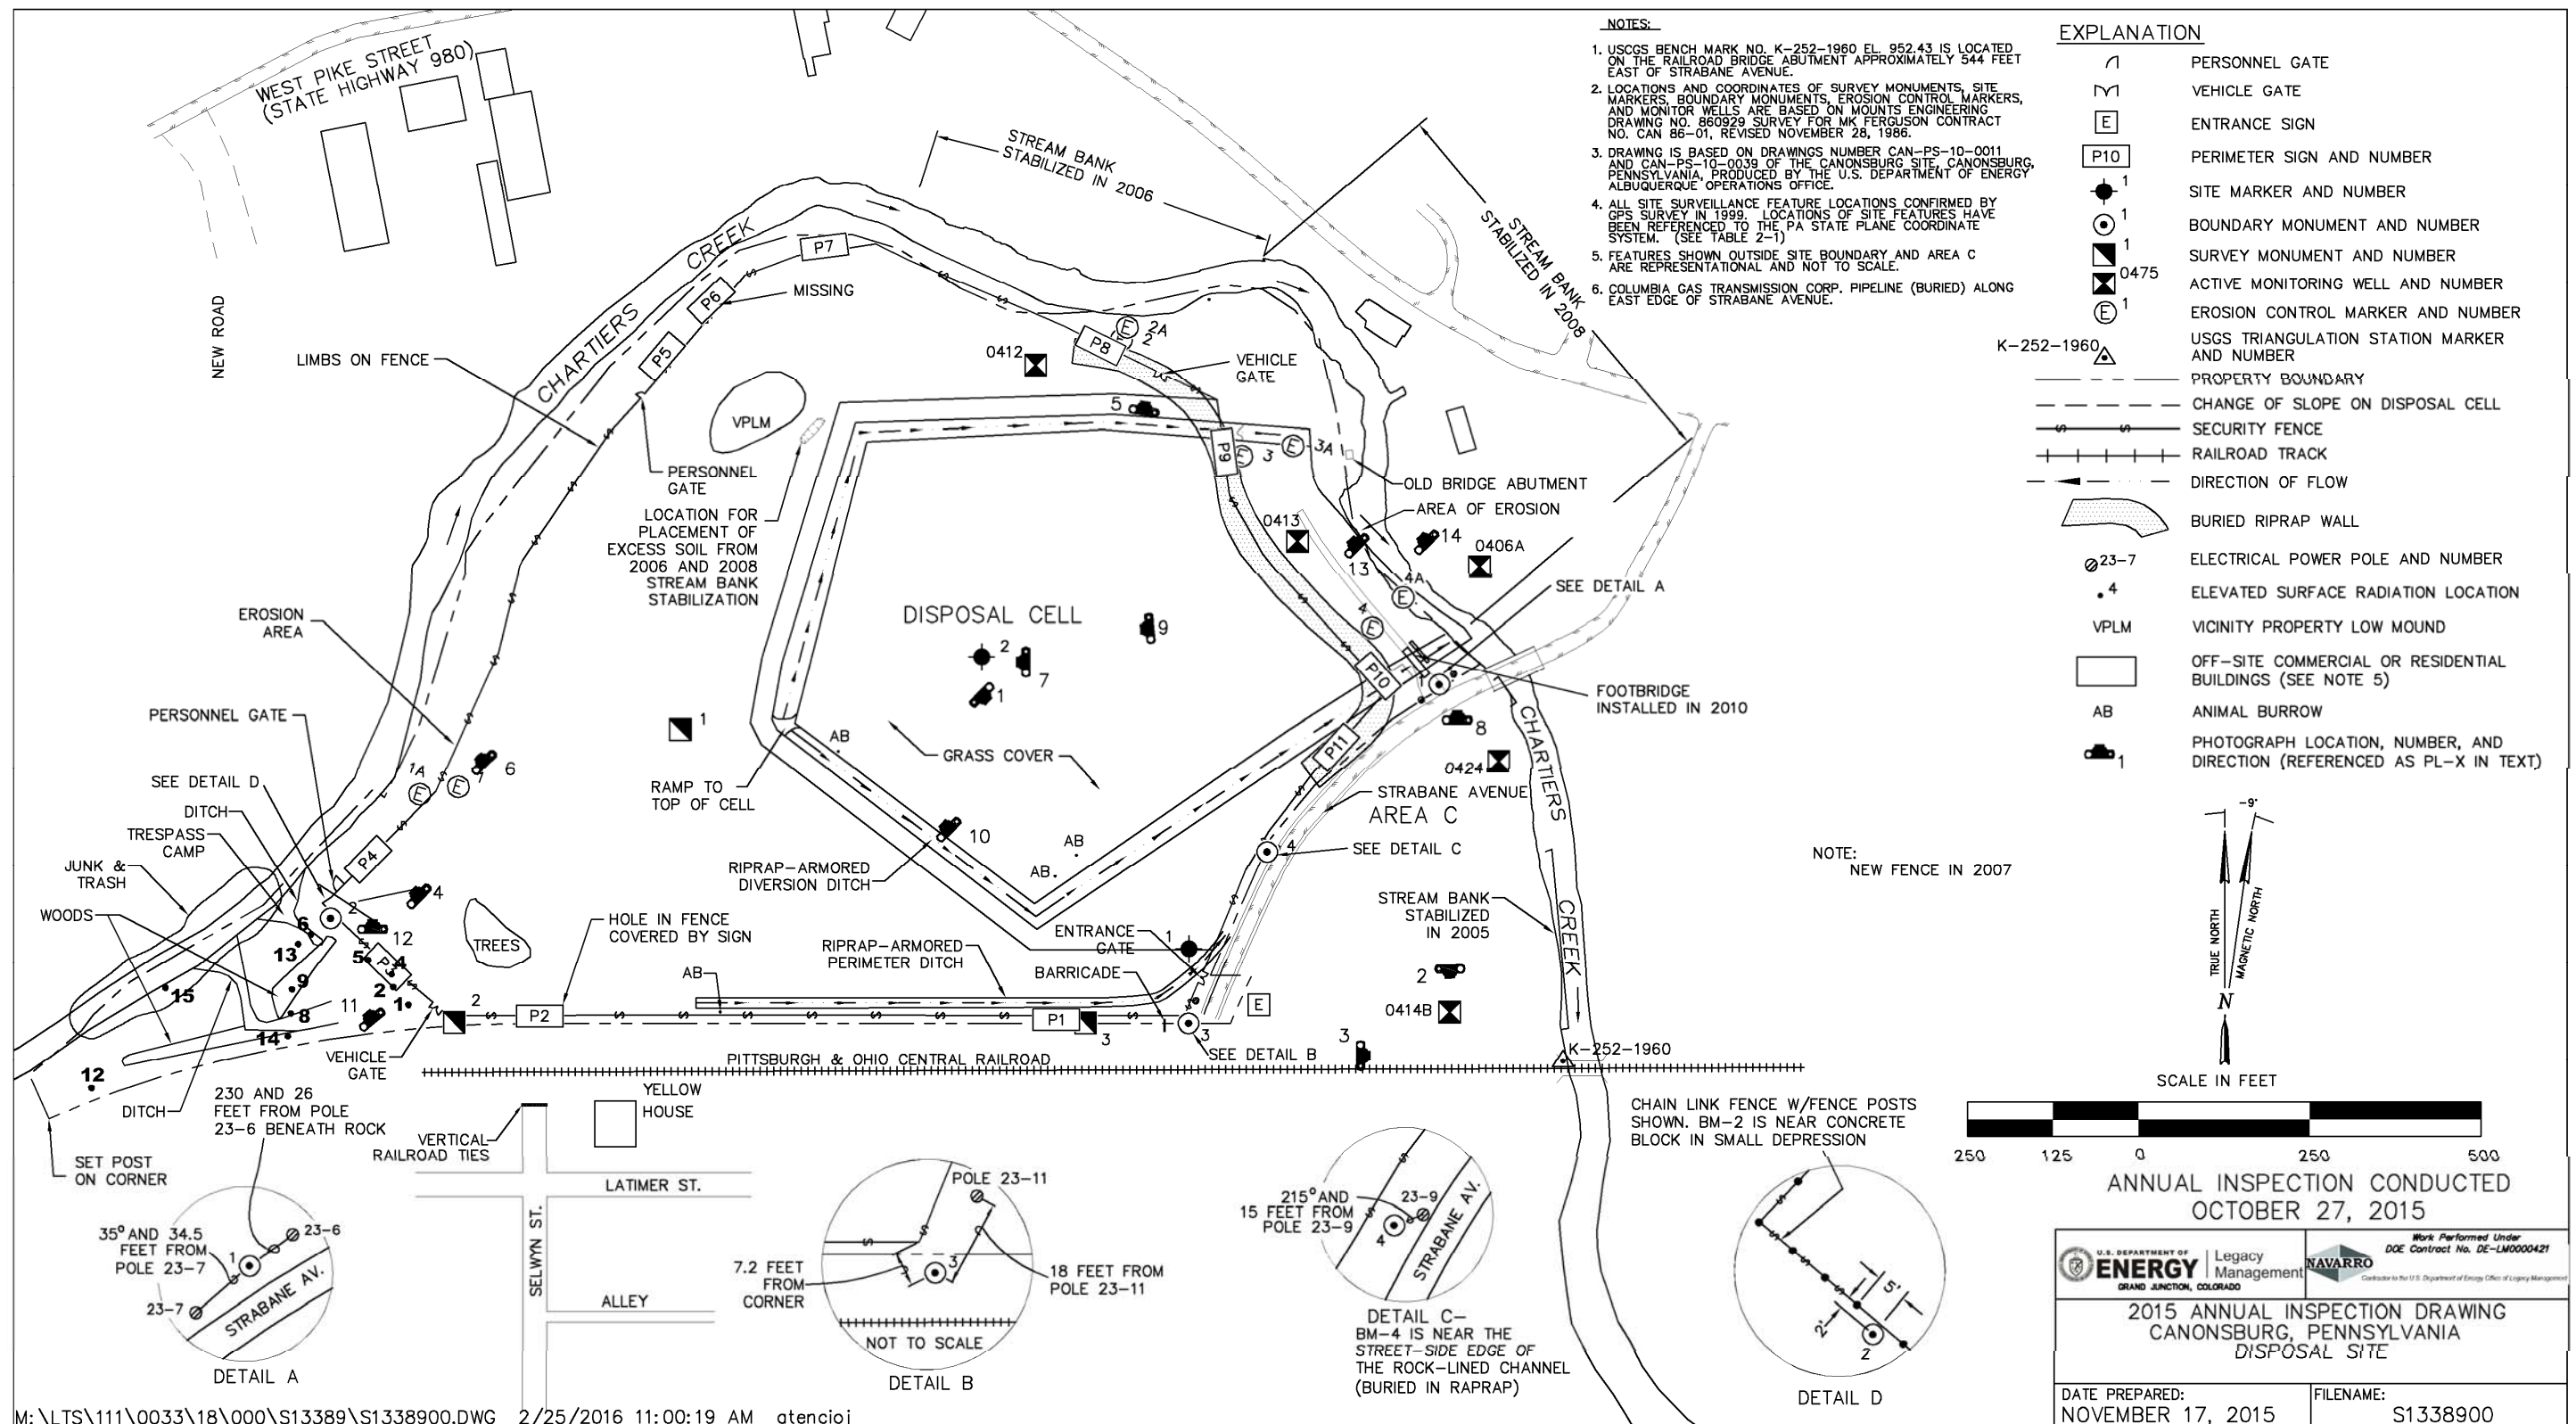
Figure 3-1. 2015 Annual Inspection Drawing for the Canonsburg Disposal Site

The locations of site surveillance features are shown in Figure 3-1. Inspection results and recommended maintenance activities associated with site surveillance features are included in the following subsections. Photographs to support specific observations are identified in the text and in Figure 3-1 by photograph location (PL) numbers.

An area of erosion under the west perimeter fence remains (see Figure 3-1). The area appears to be stable and has not grown in size in several years (PL-6). For added security, the gap that is present between the bottom of the fence and the ground surface will be better secured with a few stakes and some wires or additional fence fabric.

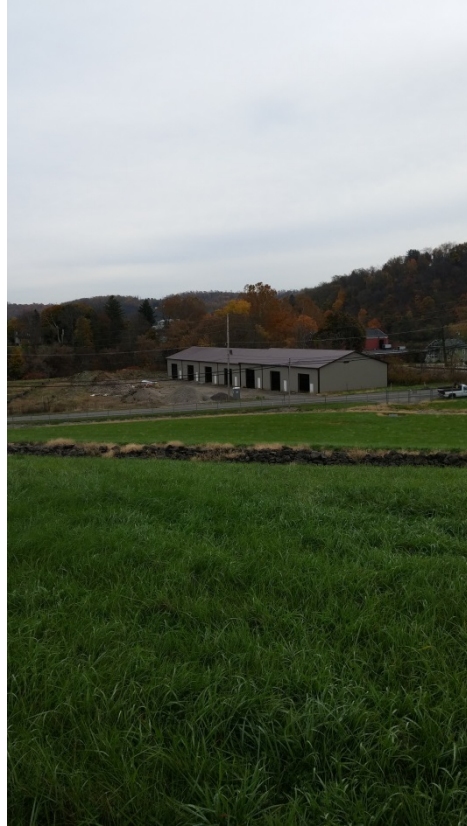
The owner of the property is constructing storage units (PL-1). Access to monitoring wells MW-0424 and MW-0414B is being maintained. The area around monitoring well MW-0414B is becoming overgrown with weeds (PL-2). Drainage from the storage unit foundation is directed behind monitoring well MW-0414B via a pipe (PL-3). Inspectors plan to keep an eye on this area to assess how/if drainage from the pipe might impact the area near the monitoring well.

The landowner of Area C and Tract 117 has elevated the ground surface. The landowner is in the process of building above ground storage units (PL-1). The Property Deed shows that the ground

surface was raised approximately 6 feet using clean fill material prior to construction of the storage building. Excavation ICs call for no structure excavation deeper than 4 feet or utilities excavation deeper than 6 feet. These excavation ICs do not appear to be violated.

*CAN 10/2015. PL-1. Looking southeast from the top of the disposal cell toward Area C.*

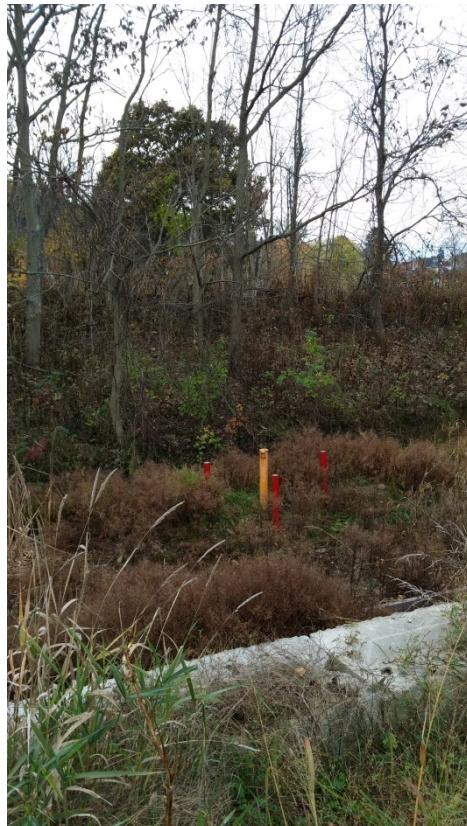
DOE has a two groundwater monitoring wells in Area C and Tract 117 (MW-0424 and MW-0414B, respectively) that are part of the groundwater-monitoring network. DOE ensured ongoing access to these wells through the sale agreements. The private property owner has done a good job maintaining access to the wells, and has graded the land surface so that surface water will not collect and pool around the well pads. Inspectors noted that drainage from the storage unit foundation is directed behind monitoring well MW-0414B via a pipe (PL-3). Inspectors will continue to monitor this area to assess how/if the drainage pipe might impact the monitoring well area.

*CAN 10/2015. PL-2. Monitoring well MW-0414B.*

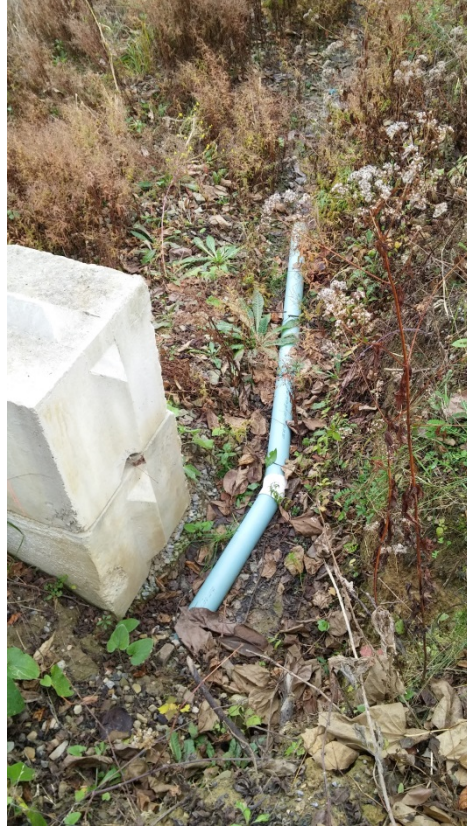
*CAN 10/2015. PL-3. Drainage pipe from storage building, next to monitoring well MW-0414B.*

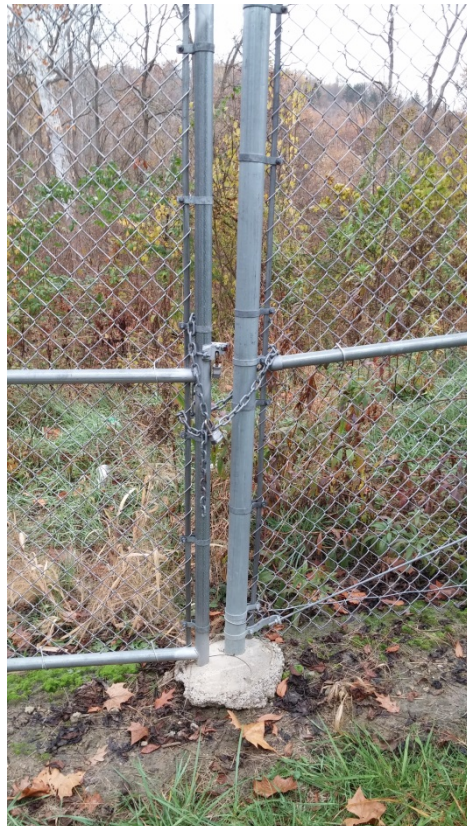
Access to the Canonsburg site is directly off of Strabane Avenue. The main entrance gate for the site was locked and in good condition. The personnel gate in the southwest corner of the site has a broken hasp that will be repaired. The gate is currently secured with a chain (PL-4). The hasp on the gate along with the lock will be repaired. The other personnel and vehicle gates were in good condition.

*CAN 10/2015. PL-4. Chain lock on southwest personnel gate, near boundary monument BM-2.*

A broken hasp on the southwest personnel gate near boundary monument BM-2 and the associated lock will be replaced. As a measure of added security, the gap currently present beneath the bottom of perimeter fence (north of perimeter sign P4) will be addressed. Steel pins protruding from the concrete footer near BM-1 will be removed to prevent tire accidents and perimeter sign P6 will be replaced.

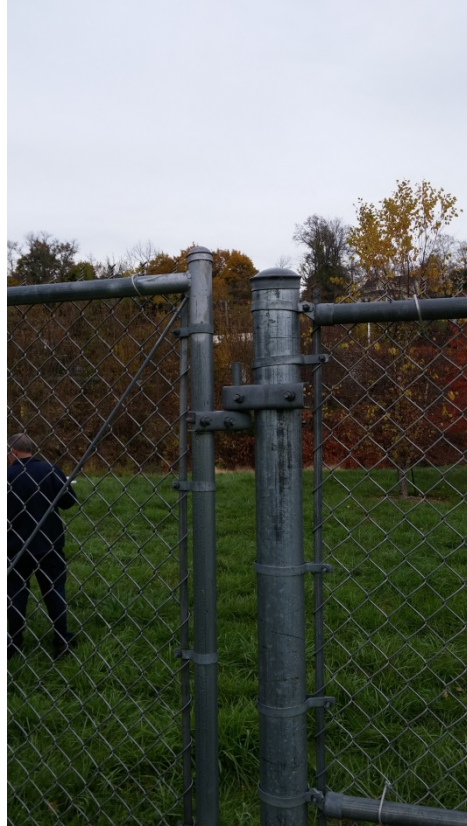
- 3A The security fence was replaced in 2007 and is in excellent condition. The north vehicle gate hinge was repaired in 2015 and is in good condition (PL-5). A vegetation-free buffer zone is being maintained around the entire site security fence.

*CAN 10/2015. PL-5. Repaired hinge on northeast vehicle gate.*

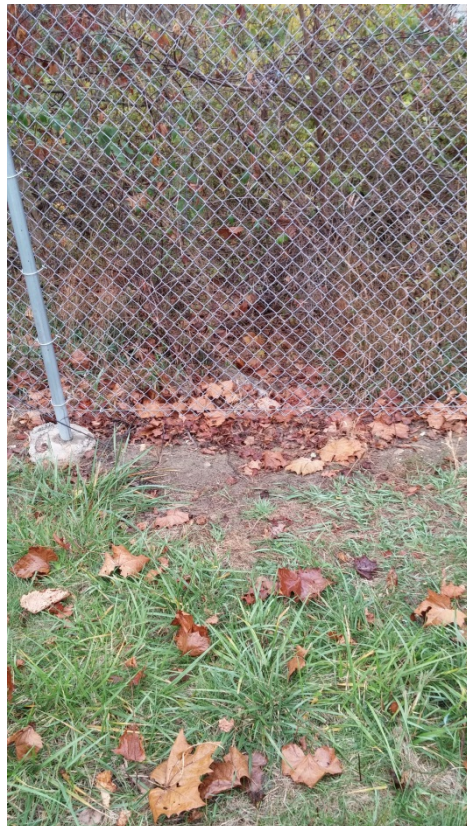
*CAN 10/2015. PL-6. Gap beneath fence fabric and ground in area of erosion.*

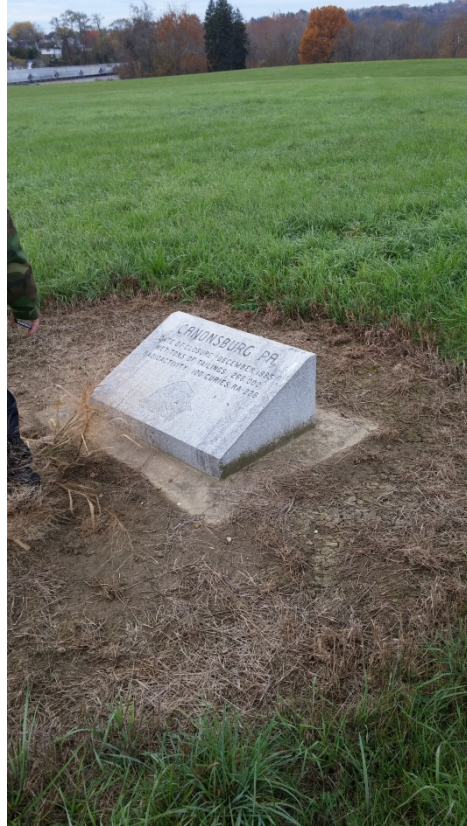
The site has two markers. Both site markers were in good condition (PL-7).

*CAN 10/2015. PL-7. Site marker SMK-1 on top of the disposal cell.*

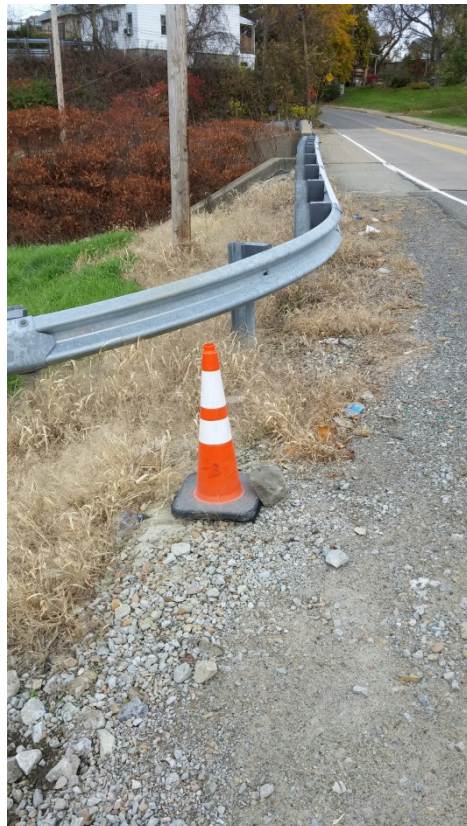
The guardrail along Strabane Avenue near boundary monument BM-1 was repositioned a little during the last stream bank stabilization effort. A concrete footer remains that has a few metal pins protruding. The pins present a tire hazard and will be cut off flush with the ground surface. During the inspection, a safety cone was placed over the pins as a temporary measure until the pins can be cut off (PL-8).

*CAN 10/2015. PL-8. Cone over concrete with pins.*

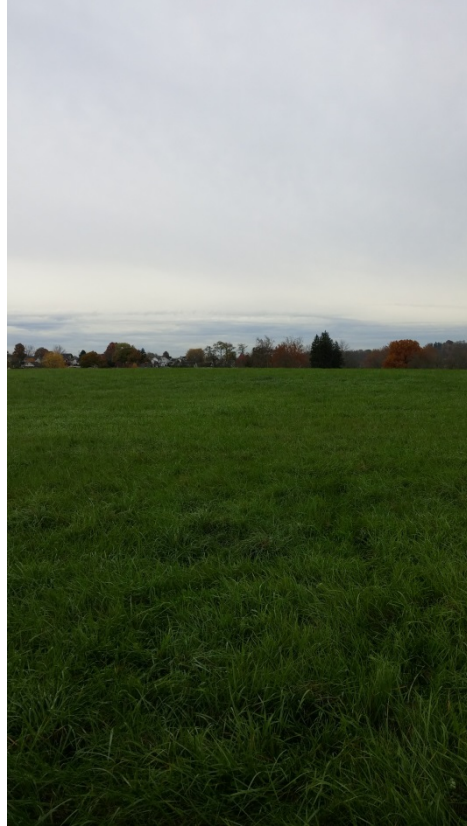
The grass-covered disposal cell was in excellent condition. No evidence of erosion or slope instability was observed during the inspection (PL-9).

*CAN 10/2015. PL-9. Looking west from disposal cell.*

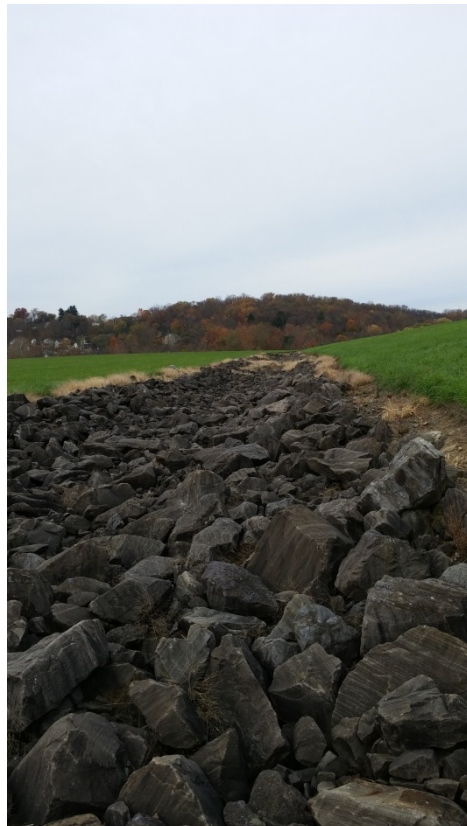
The presence of woody vegetation in the channels and ditches was not observed (PL-10). Physical removal and spot herbicide applications have been effective at reducing woody vegetation. Periodic walkdowns and spot herbicide applications will continue.

*CAN 10/2015. PL-10. Armored diversion ditch on the southeast side of the disposal cell.*

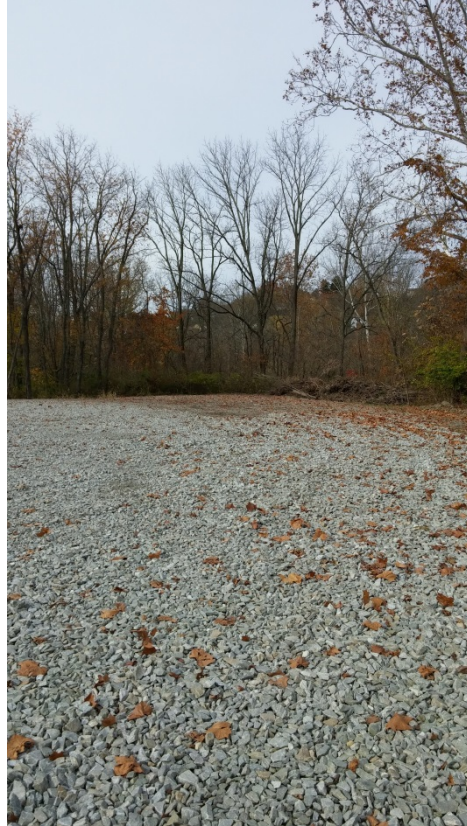
A plastics company has cleared some of DOE’s property south of the railroad track and spread gravel to create a turnaround for their trucks. The size of the turnaround appeared to be slightly

larger during the 2015 inspection (PL-11). Also, some junk and trash is present in the wooded portion of the land parcel.

*CAN 10/2015. PL-11. Truck turnaround near railroad tracks.*

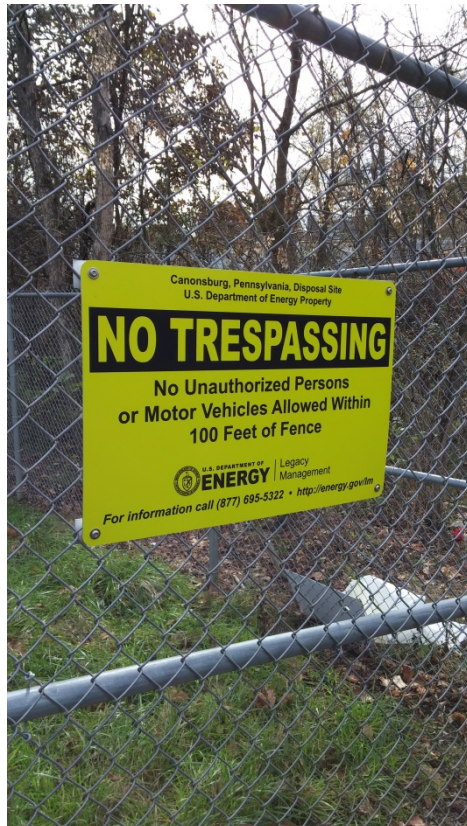
3B Trespass was observed during the inspection. A campsite was discovered in the southwest corner of the site, outside of the locked perimeter fence, hidden among the trees. The Canonsburg Police Department responded, but the occupant of the campsite could not be located. The Canonsburg Police Department will follow up and try to locate the camper. In addition, increased patrols in the future will help prevent further trespass events. Inspectors installed additional signage along the perimeter fence in the southwest corner of the site as an additional deterrent to future trespass (PL-12).

*CAN 10/2015. PL-12. New trespassing sign installed on the perimeter fence in the southwest corner of the site.*

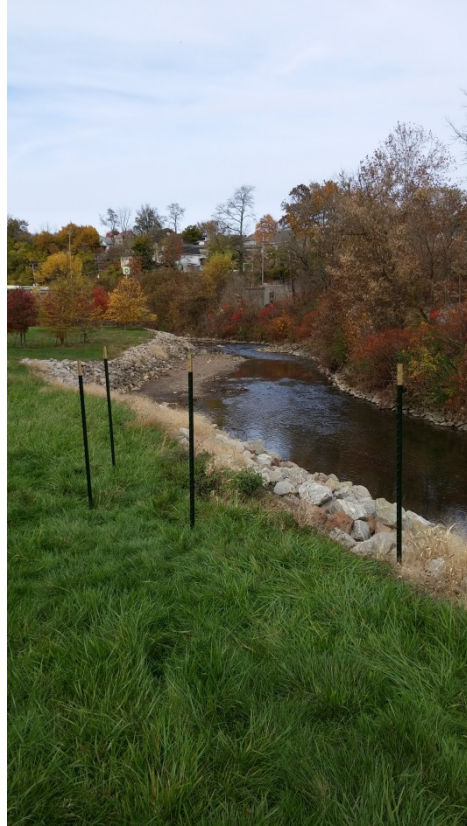
Heavy mowing equipment operating near the edge of the stream bank could be undermining the integrity of the bank. Inspectors installed four t-posts around the erosion area to make it more visible to the mowing crews (PL-13). Mowing crews will be instructed to keep heavy equipment back from the edge of the stream bank to avoid undermining the integrity of the bank. Vegetation growth on the riprap-armored southern bank is being controlled so that visual inspections of how well the riprap is holding up can be obtained. The stream bank west of the perimeter fence appears to remain in a stable condition. Bedrock outcrops and mature trees indicate that the bank is stable. The stream bank north of the perimeter fence is also in good condition. The planted vegetation within the floodplain appears to be well established. A small area of erosion (noted during last year's inspection) along the stream bank north of the disposal cell, believed to be caused by surface water runoff to the creek, was observed to be about the same size this year (PL-14).

*CAN 10/2015. PL-13. T-posts installed around erosion area.*

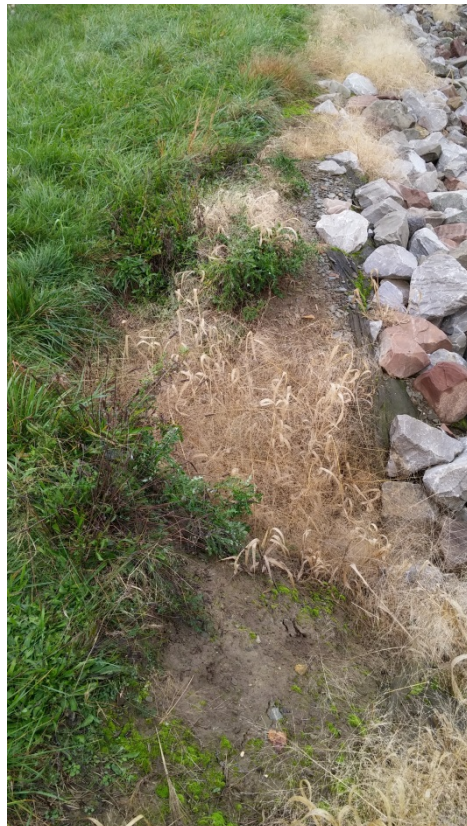
*CAN 10/2015. PL-14. Small area of erosion along the bank of Chartiers Creek, above armored riprap.*
