## 3.0 Canonsburg, Pennsylvania, Disposal Site

Figure 3-1. 2014 Annual Inspection Drawing for the Canonsburg Disposal Site

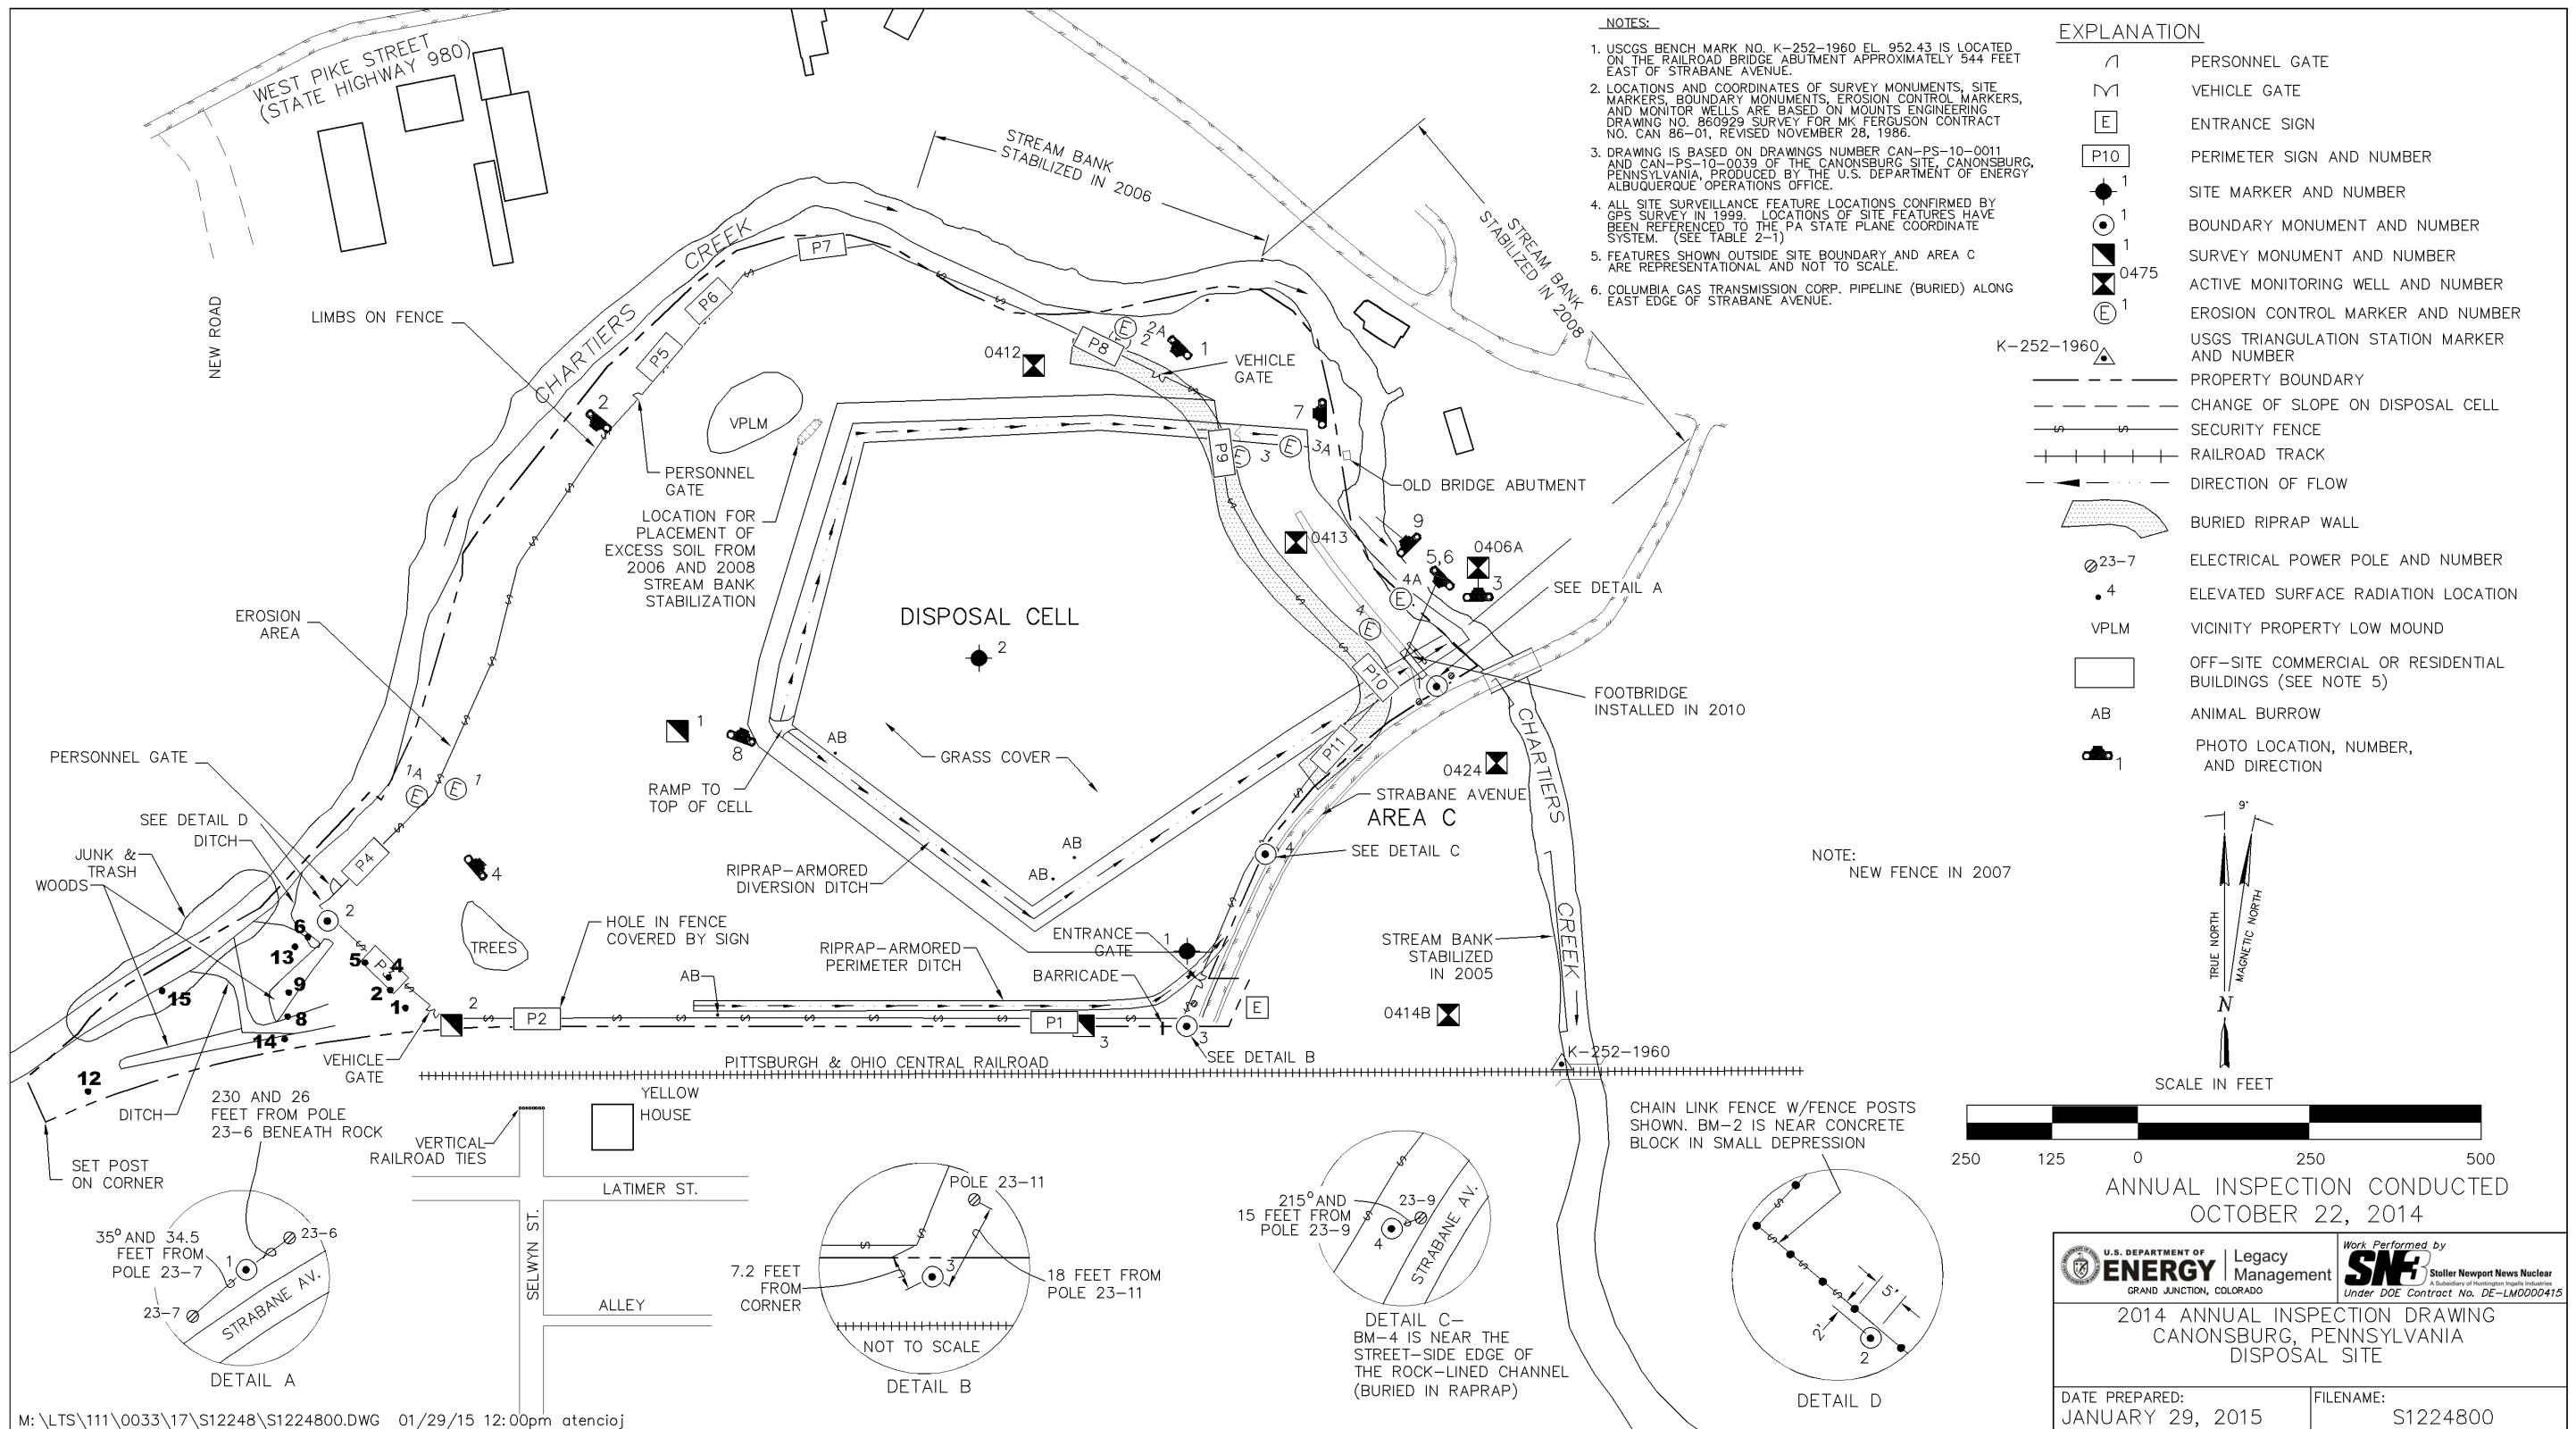
The area between the perimeter fence and the site boundary was in good condition. A vegetation-free buffer zone is being maintained around the entire site security fence. An area of erosion remains under the fence along the western edge of the site where the old fence line was located (shown on Figure 3-1). The area was stable and does not need to be filled in at this time.

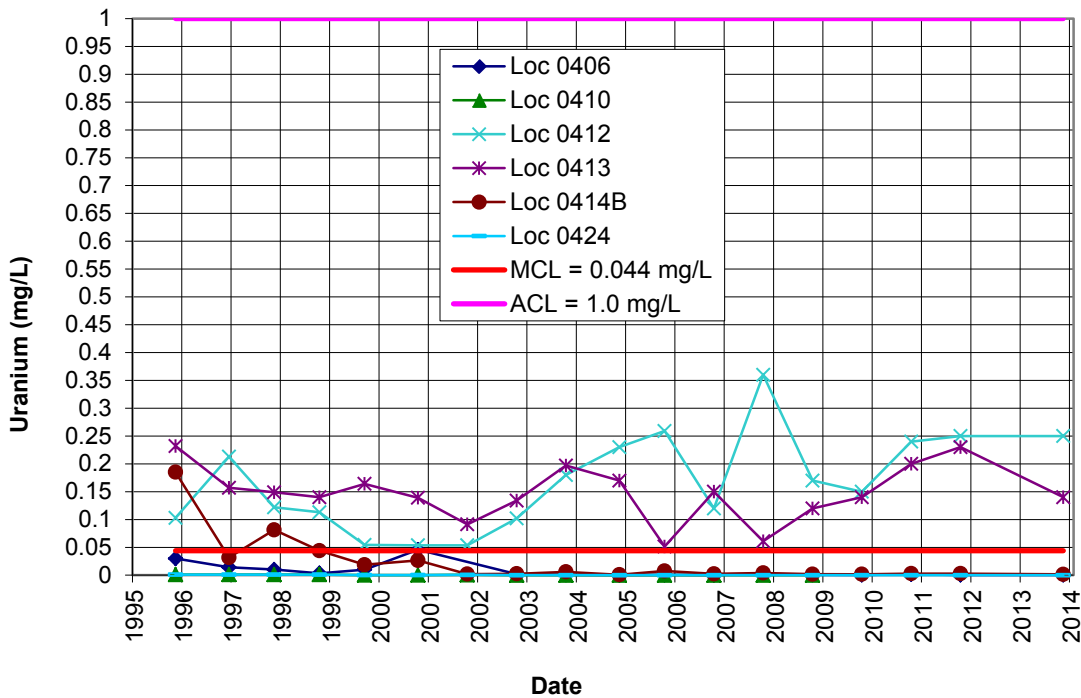
Figure 3-2. Time-Concentration Plot of Uranium in Groundwater at the Canonsburg Disposal Site

Uranium concentrations in 2013 were considerably below the established ACL of 1.0 mg/L (Figure 3-2). With the exception of monitoring wells 0412 and 0413, uranium concentrations in 2013 were also below the MCL. No trends are evident.

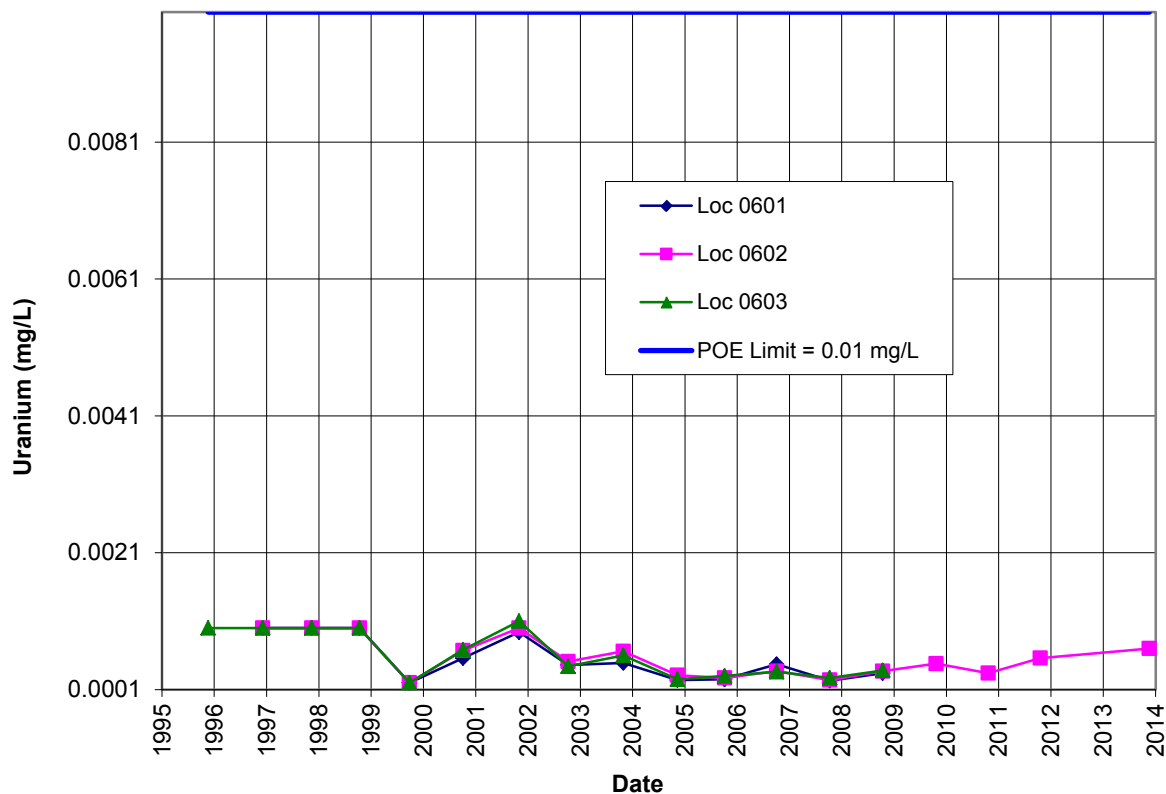
Figure 3-3. Time-Concentration Plot of Uranium in Surface Water at the Canonsburg Disposal Site

The 2013 uranium concentration of surface water at location 0602 remained significantly below the established concentration limit of 0.01 mg/L (Figure 3-3). No trend is evident.

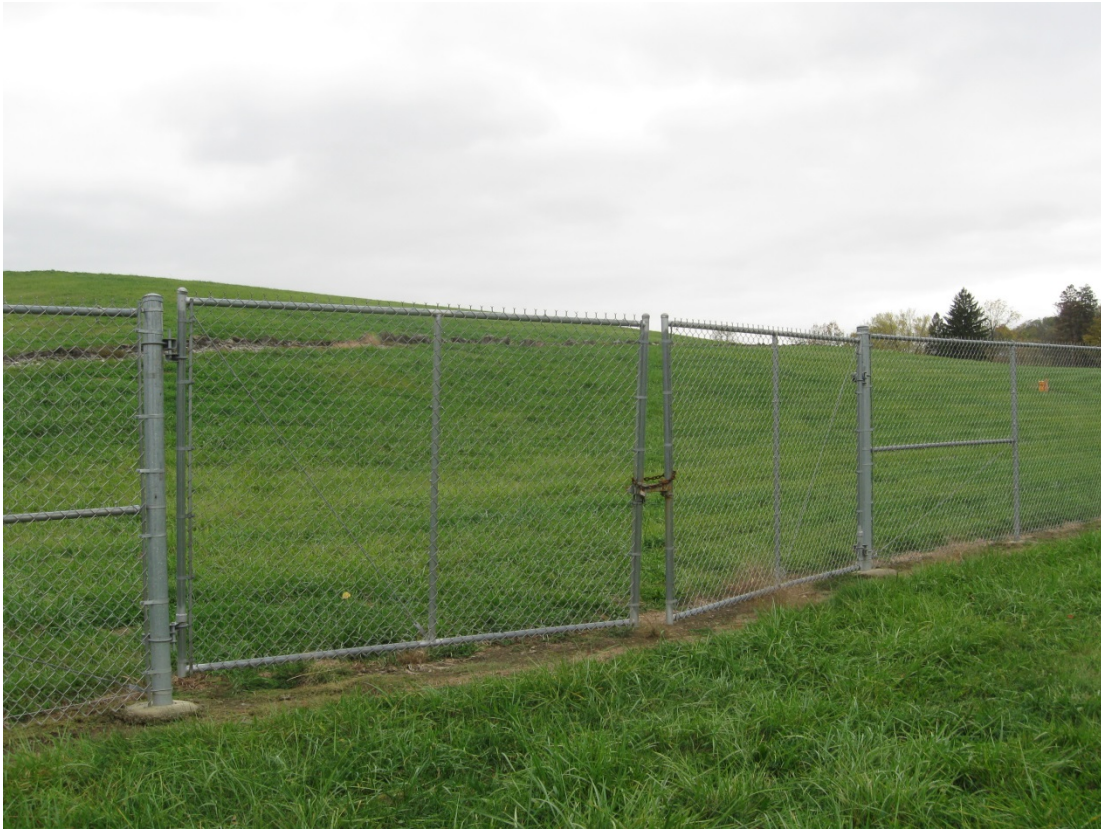
The security fence was replaced in 2007 and remains in excellent condition. The hinge on the northeast vehicle gate requires minor adjustment, but the gate remains operable (PL-1). The personnel gate in the southwest corner of the site has a broken hasp that needs to be repaired and a lock that needs to be replaced. Some small tree limbs have fallen across the top of the west perimeter fence but did not damage the fence (PL-2). The site maintenance contractor will remove the limbs from the fence.

*CAN 10/2014. PL-1. Northeast vehicle gate.*

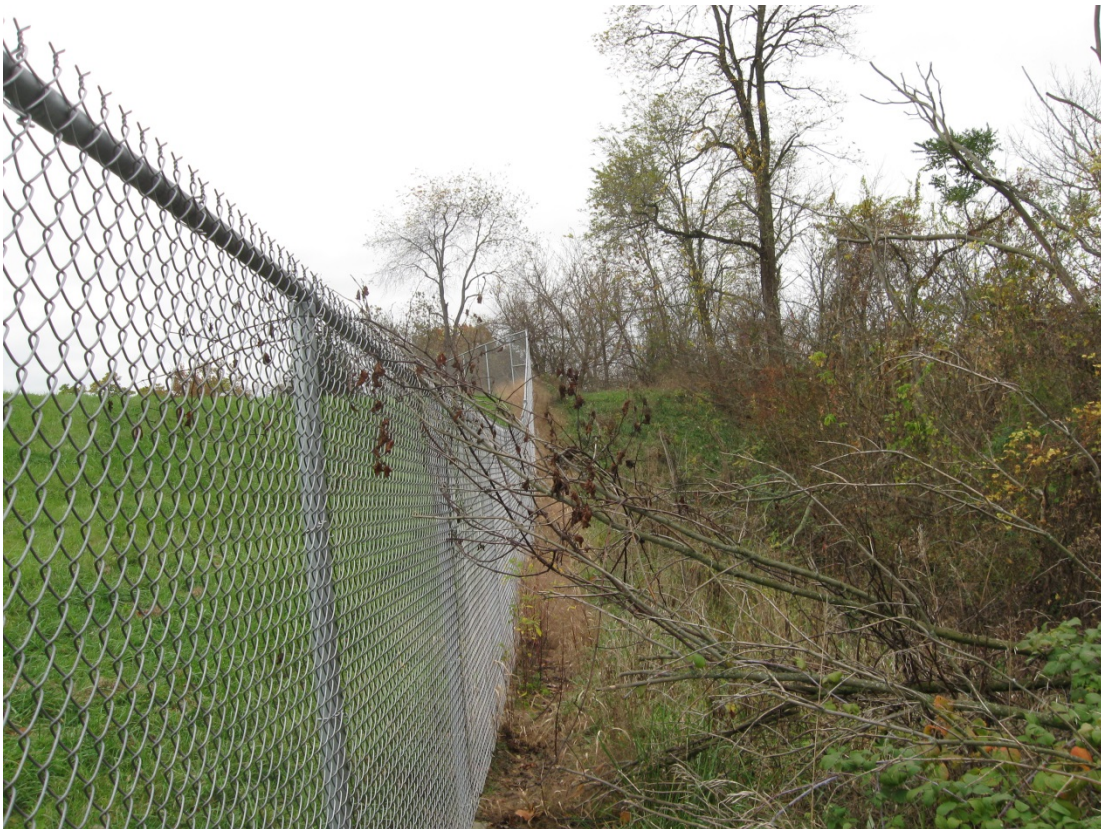
*CAN 10/2014. PL-2. Small tree limbs on perimeter fence.*

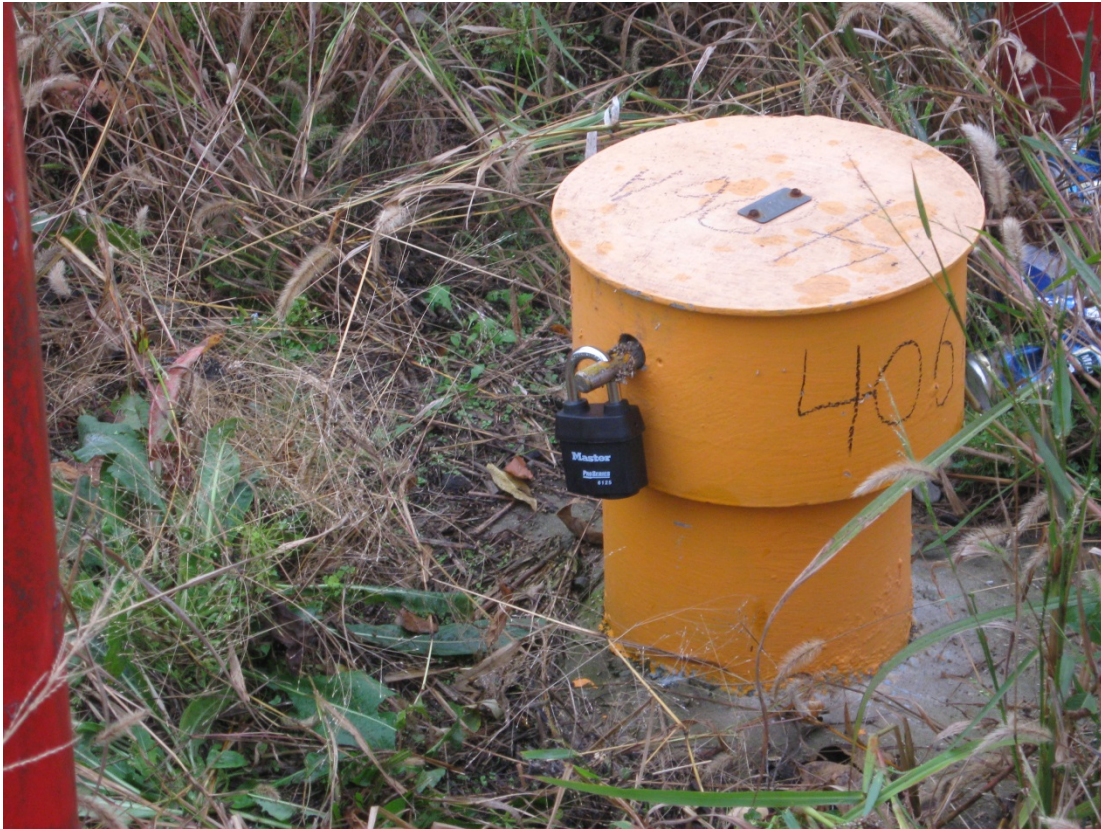
The site has five groundwater monitoring wells. The wells were locked and in good condition (PL-3).

*CAN 10/2014. PL-3. Monitoring well 406A.*

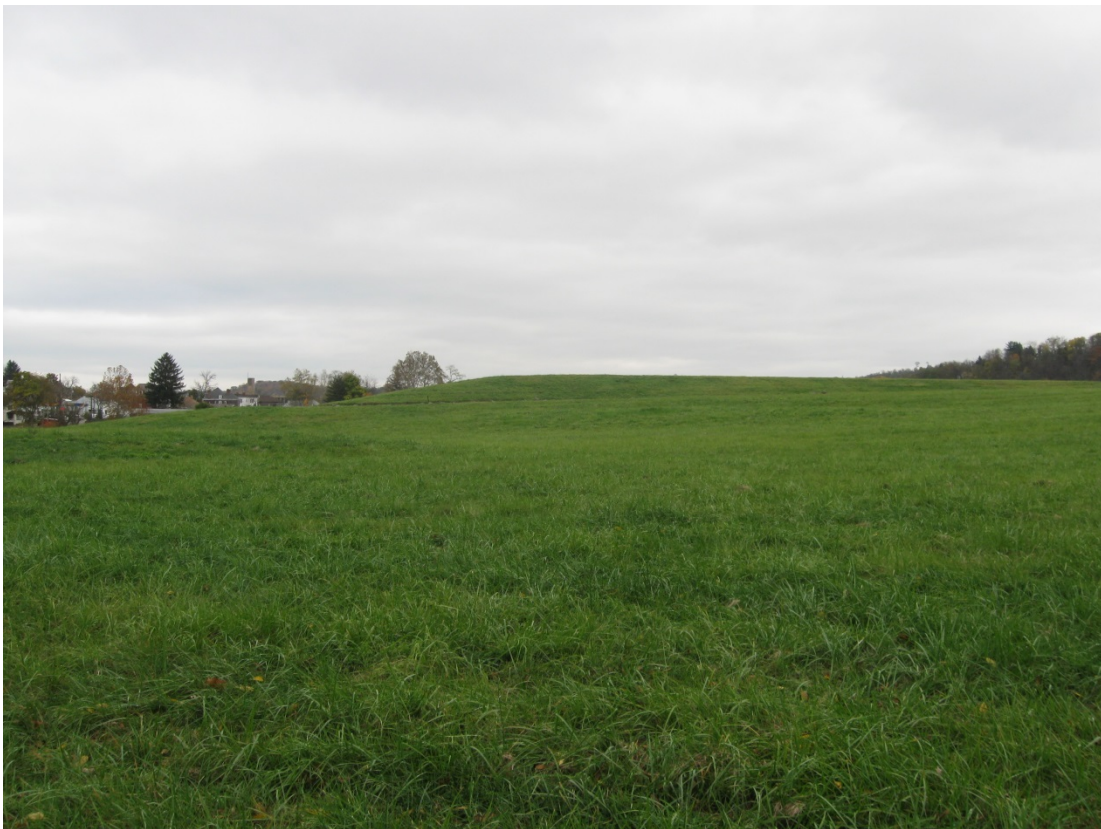
The grass-covered disposal cell was in excellent condition. No evidence of erosion or slope instability was observed during the inspection (PL-4).

*CAN 10/2014. PL-4. Grass-covered disposal cell.*

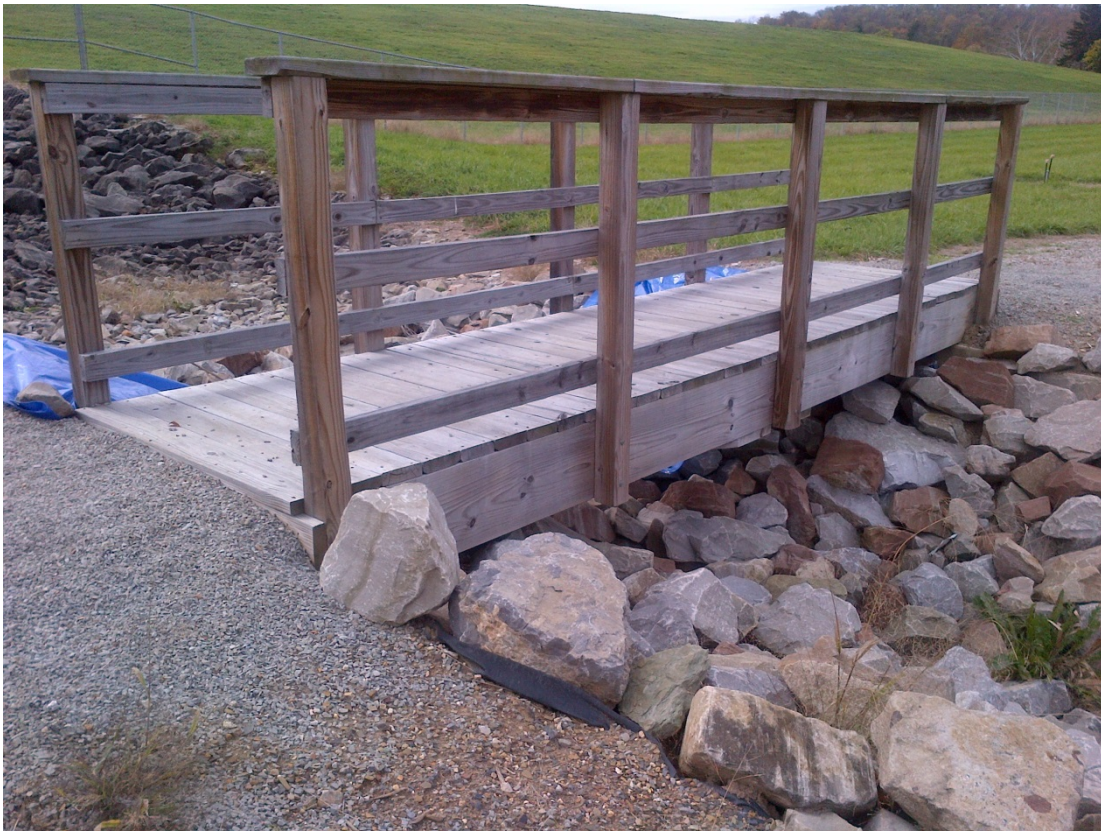
A small pedestrian footbridge was installed northeast of the disposal cell in 2010 to allow safe crossing of the riprap-armored diversion ditch. The footbridge was in excellent condition. Inspectors painted the footbridge during this year’s inspection (PL-5 and PL-6).

*CAN 10/2014. PL-5. Side of bridge before being painted.*

The pedestrian bridge was repainted. Several other minor maintenance items will be addressed prior to the next inspection.

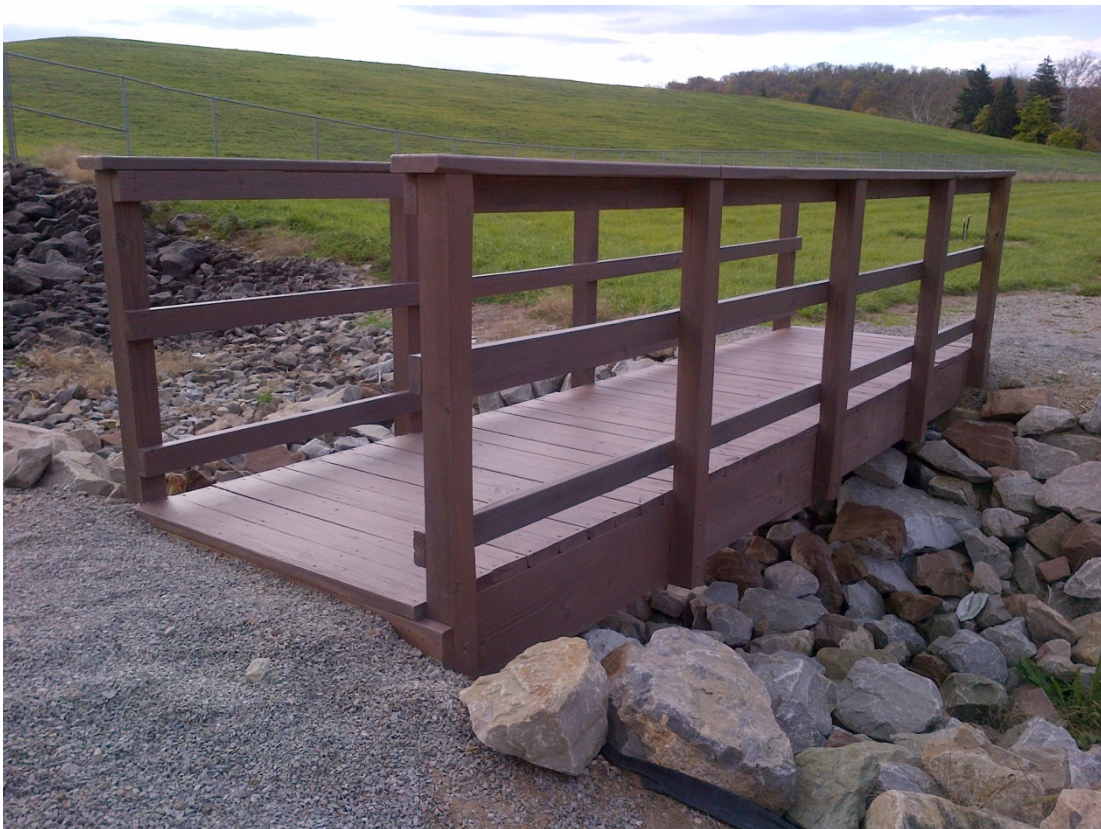
*CAN 10/2014. PL-6. Side of bridge after two coats of paint.*

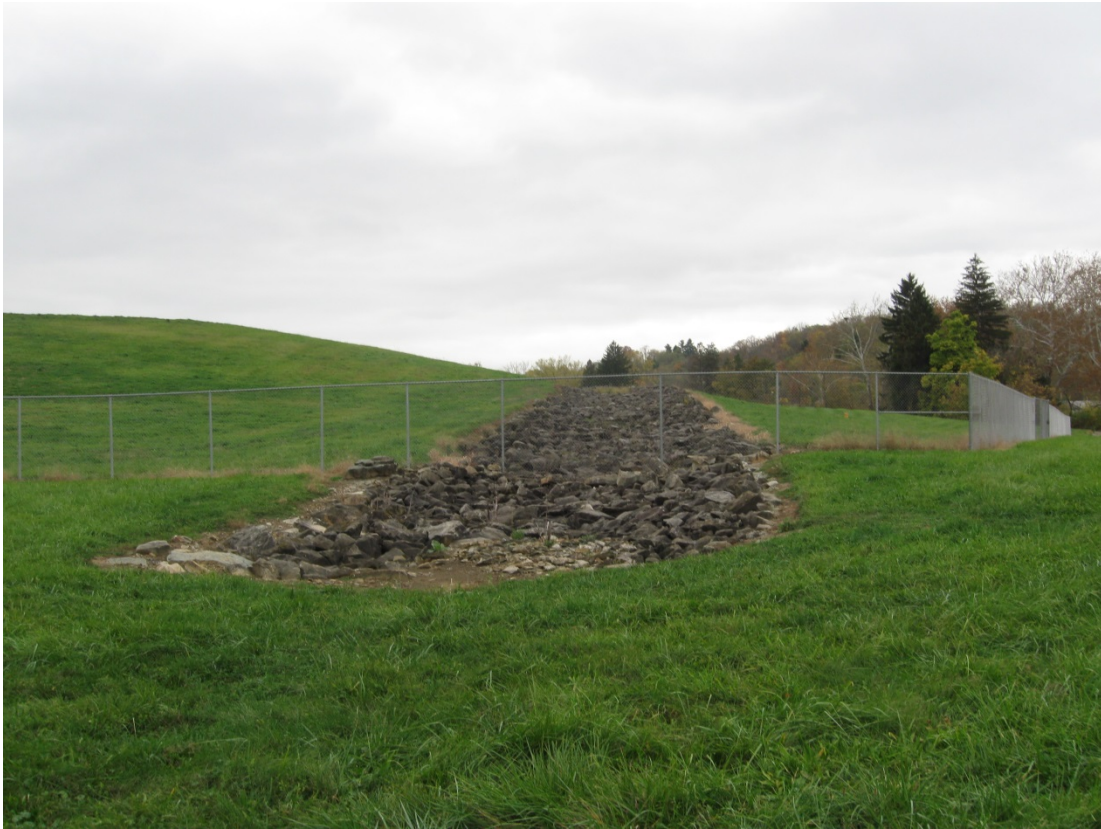
No woody vegetation in the channels and ditches was observed (PL-7 and PL-8). Physical removal and spot herbicide applications have been effective at reducing woody vegetation.

*CAN 10/2014. PL-7. Riprap-armored diversion ditch.*

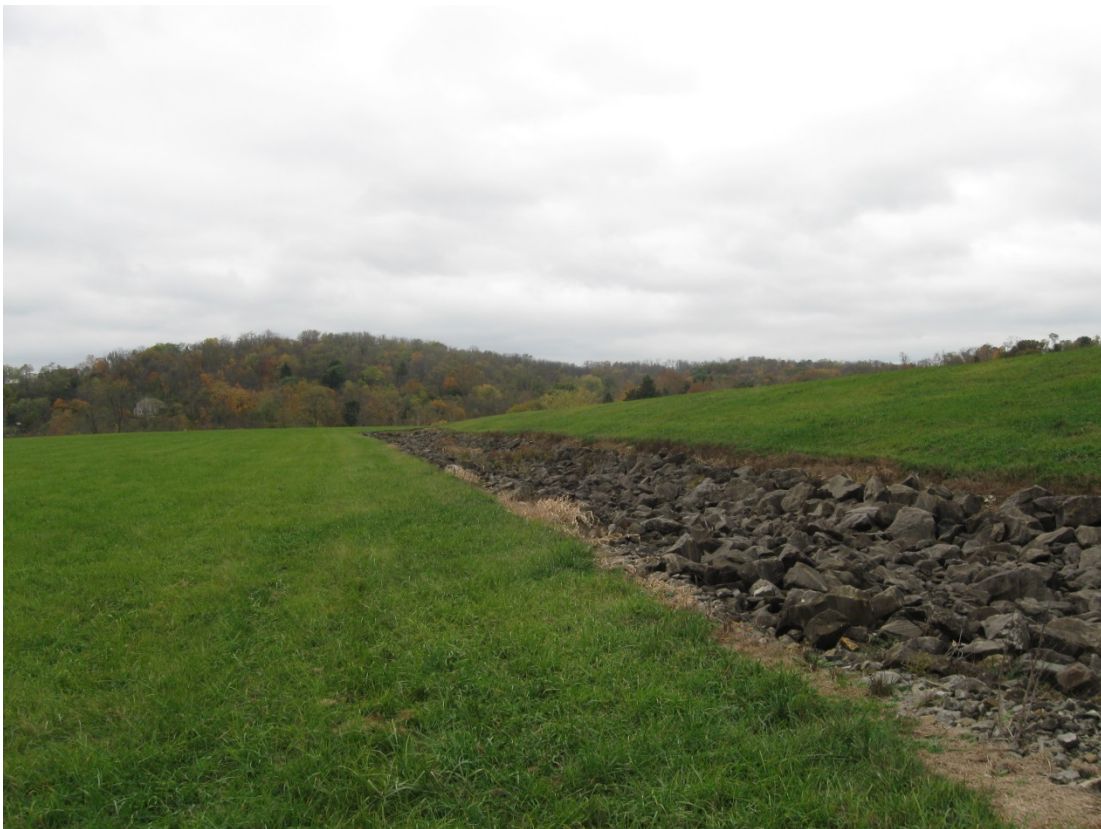
*CAN 10/2014. PL-8. Riprap-armored diversion ditch.*

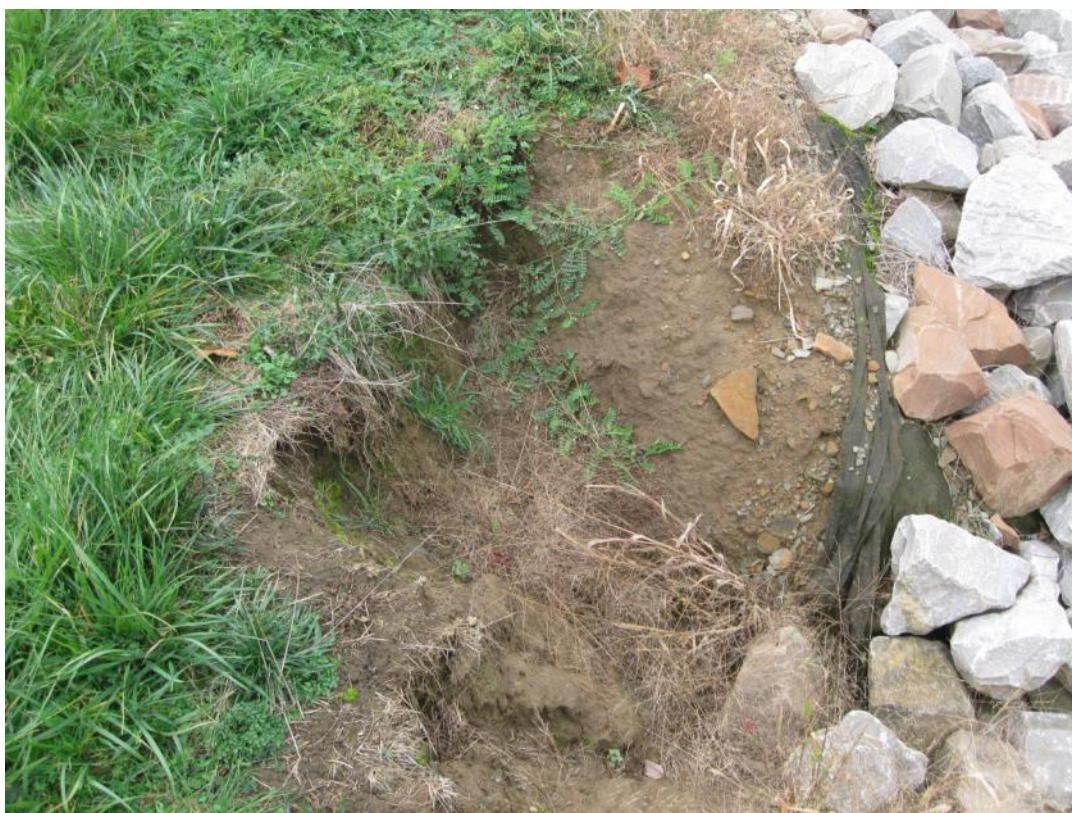
**Chartiers Creek Bank**—Chartiers Creek is meandering waterway that flows around the east, north, and west sides of the site. The creek tends to cut into the bank and has required several stream bank stabilization projects along the east and north sides of the site between 2001 and 2009. The stabilized areas were in good condition. A small area of erosion was noted during this year's inspection and is believed to be caused by surface water runoff to the creek (PL-9). This small area will be modified to decrease the impact of the surface water runoff. The stream bank west of the perimeter fence, which has not required repairs, appears to remain in stable condition.

*CAN 10/2014. PL-9. Small area of erosion along stream bank.*
