3.0 Canonsburg, Pennsylvania, Disposal Site

3.1 Compliance Summary

Figure 3-1. 2013 Annual Inspection Drawing for the Canonsburg Disposal Site

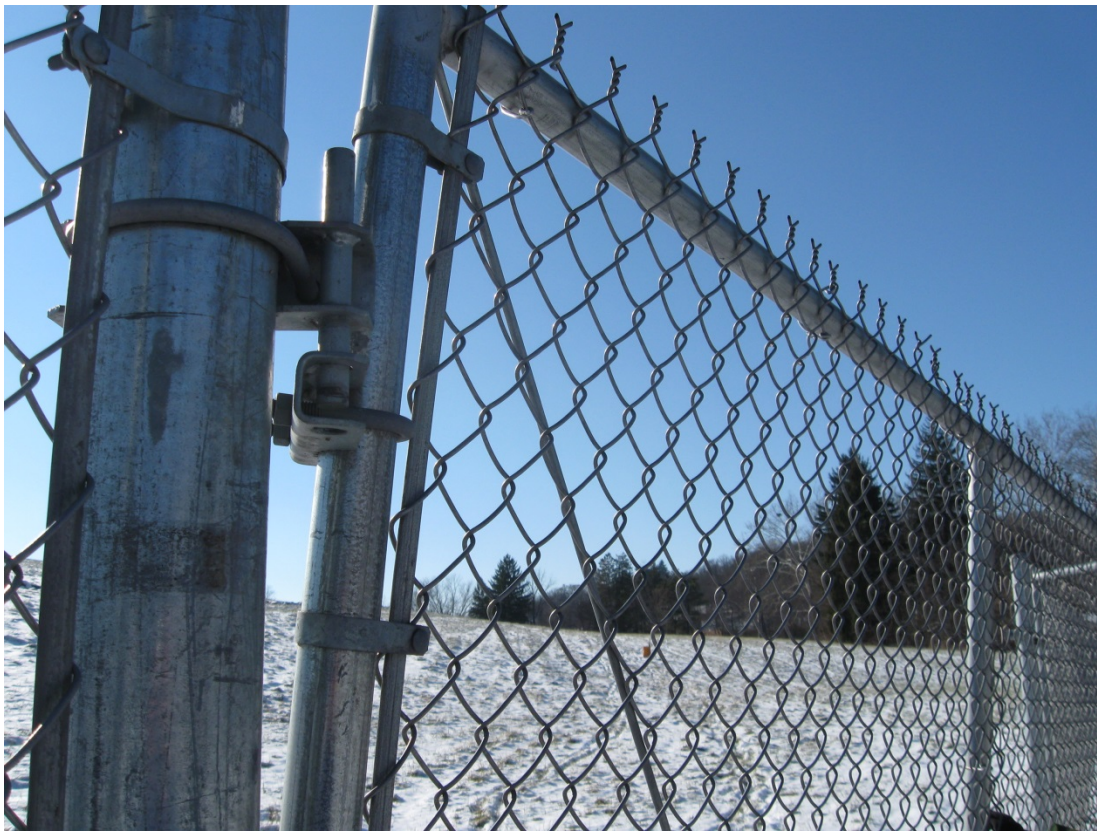
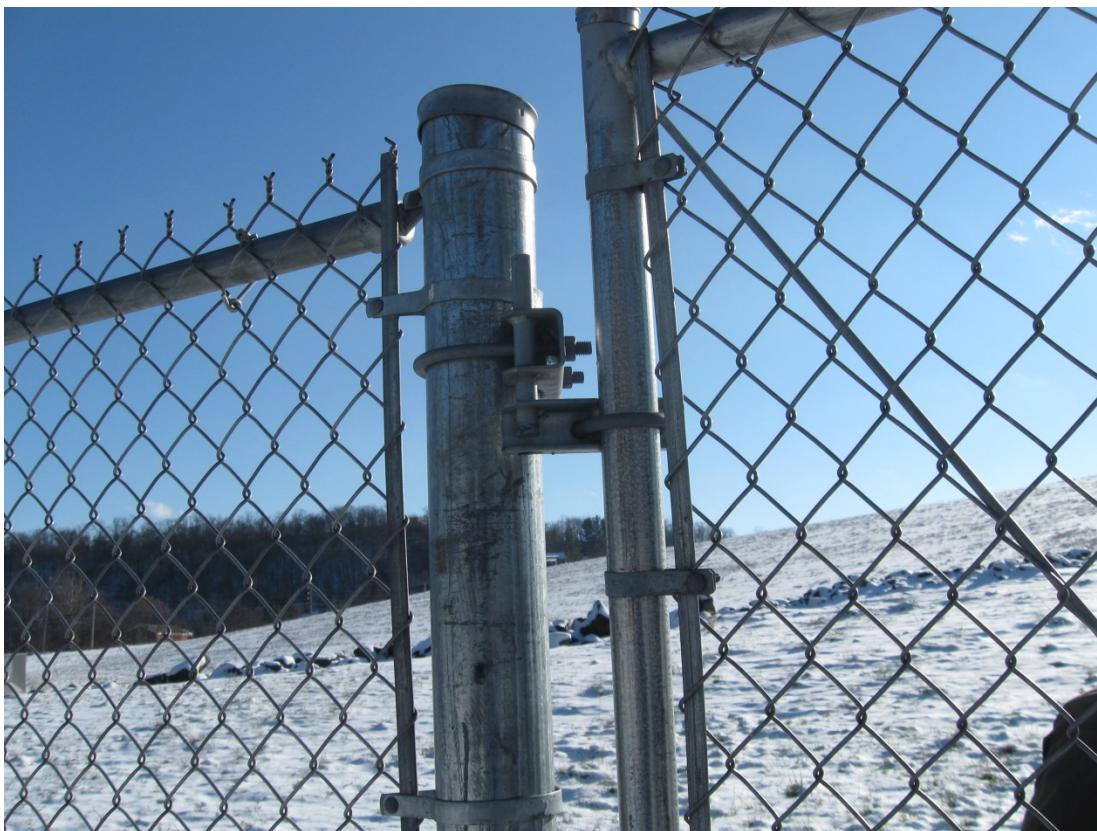
The security fence was replaced in 2007 and remains in excellent condition, with the exception of the north vehicle gate. The hinge on the north vehicle gate requires minor adjustment (PL-1 and PL-2). A vegetation-free buffer zone is being maintained around the entire site security fence.

CAN 10/2013. PL-1. Damage to vehicle gate near perimeter sign P8.

CAN 10/2013. PL-2. Damage to vehicle gate near perimeter sign P8.

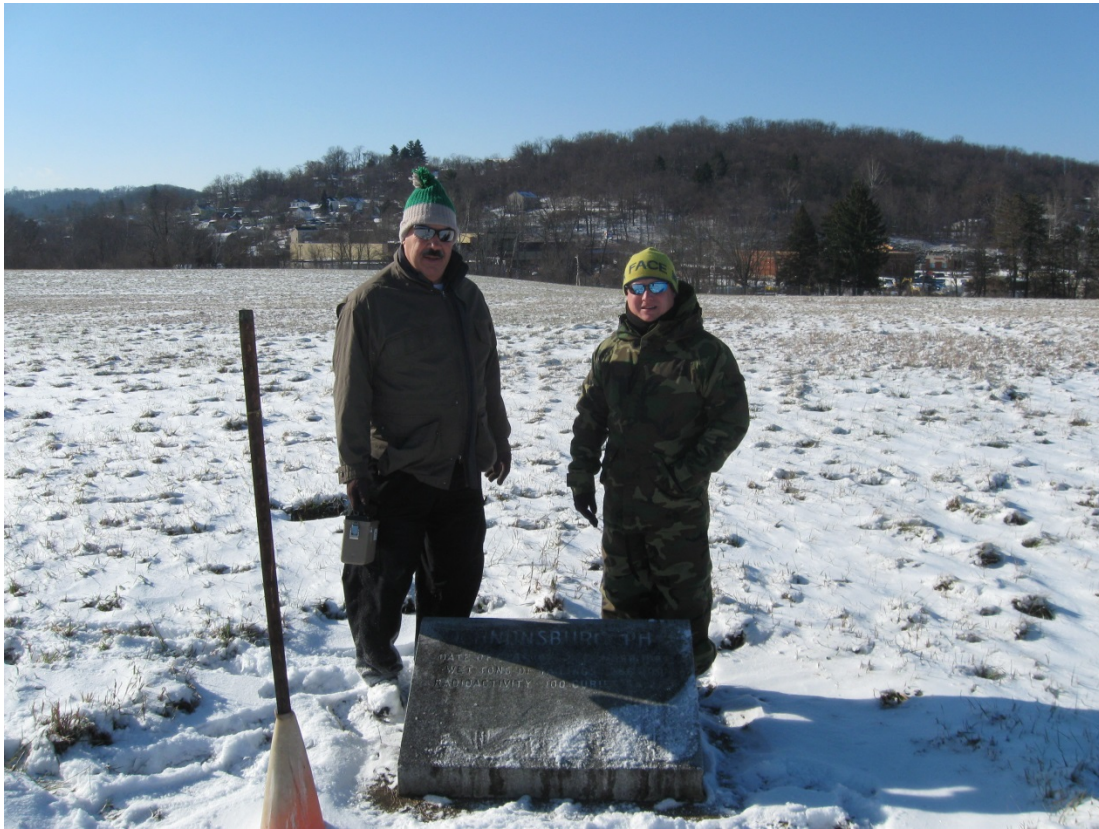
The site has two site markers. Both site markers were in good condition (PL-3).

CAN 10/2013. PL-3. Inspectors at site marker on cell cap.

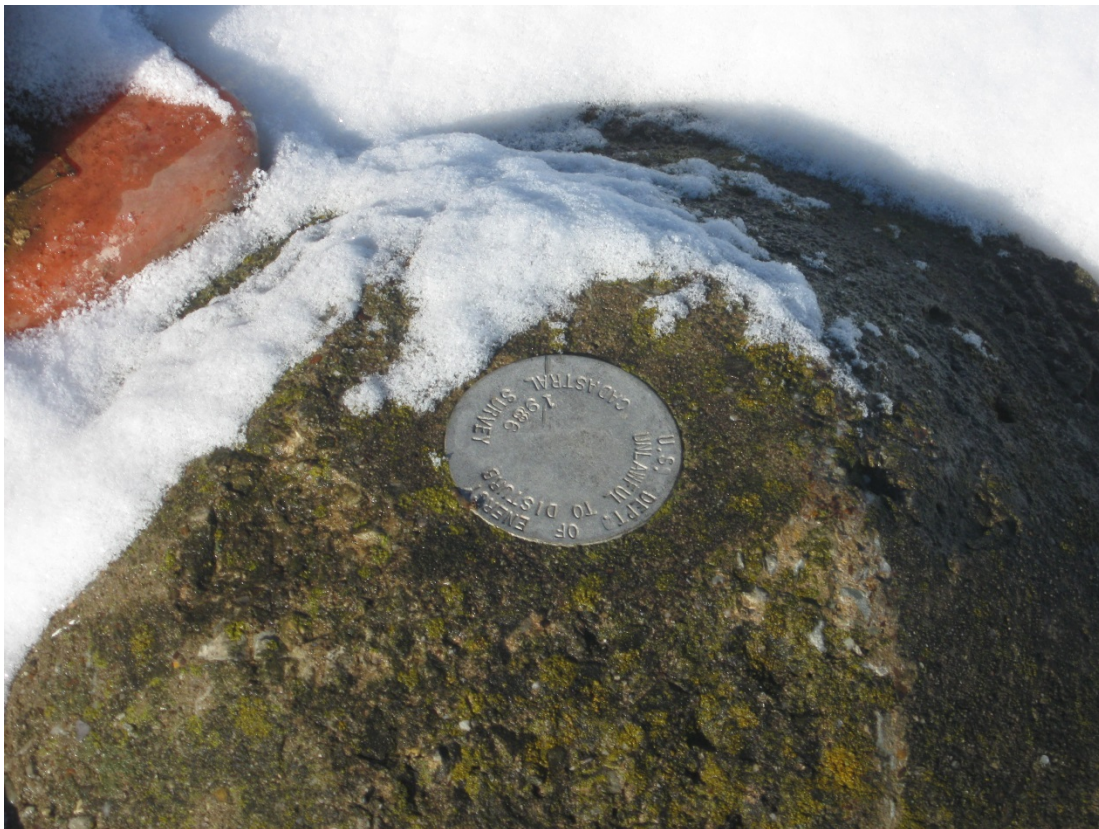
The site has three survey monuments and four boundary monuments. Survey monument SM-1 was in good condition (PL-4). Snow cover limited verification of other survey and boundary monuments during this inspection. They were verified during the 2012 inspection and also during a recent Facilities Information Management System site visit.

CAN 10/2013. PL-4. Survey monument SM-1.

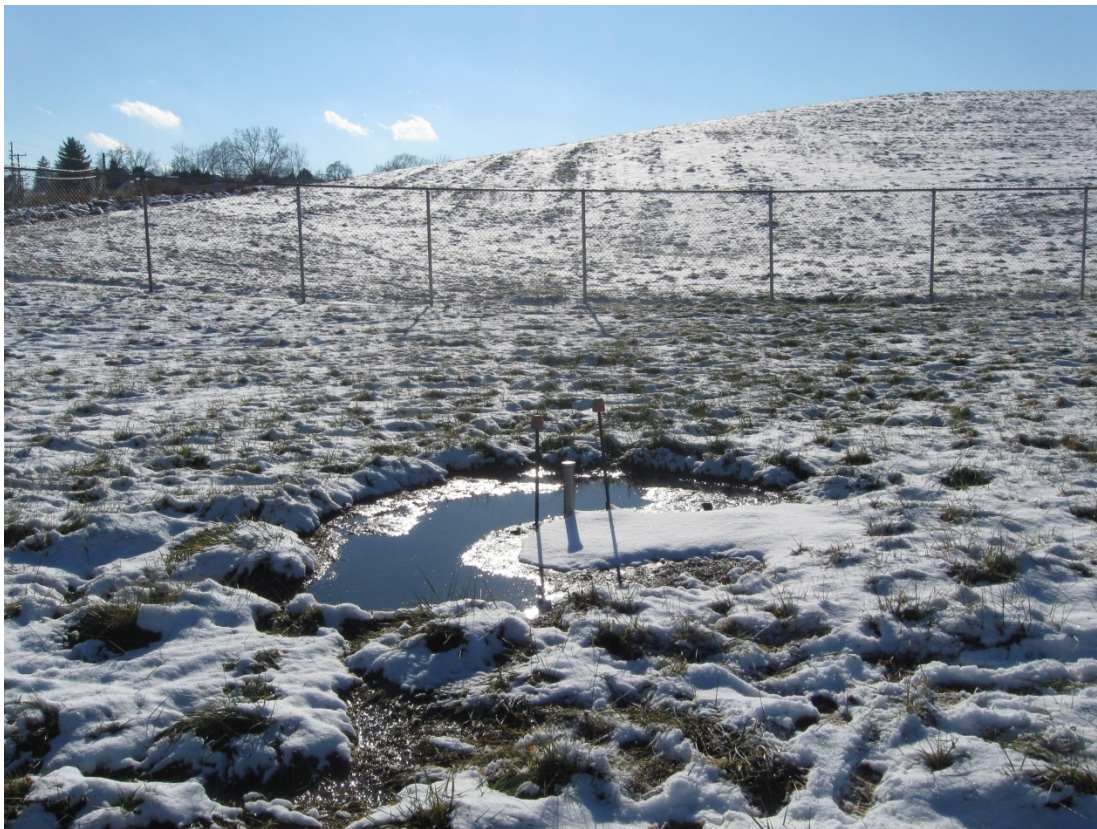
The site has four pairs of erosion control markers; all were in good condition (PL-5 and PL-6).

CAN 10/2013. PL-5. Erosion control marker 4B.

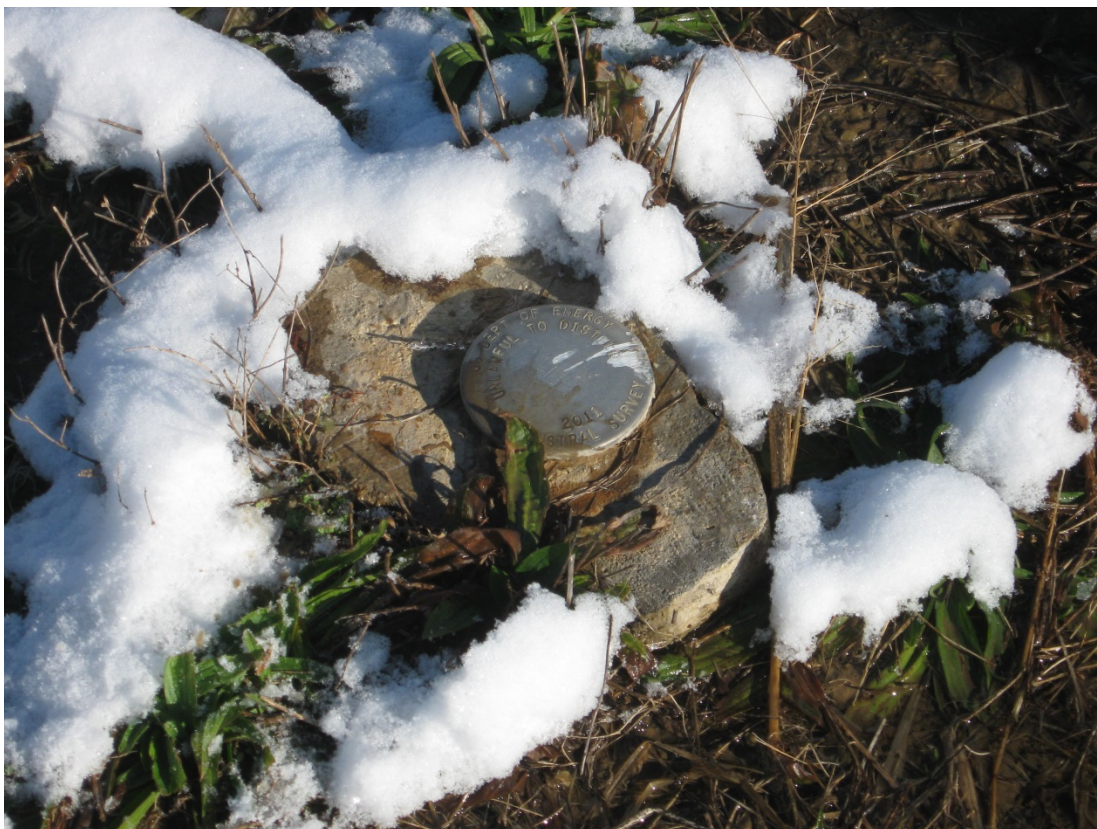
CAN 10/2013. PL-6. Erosion control marker 4A.

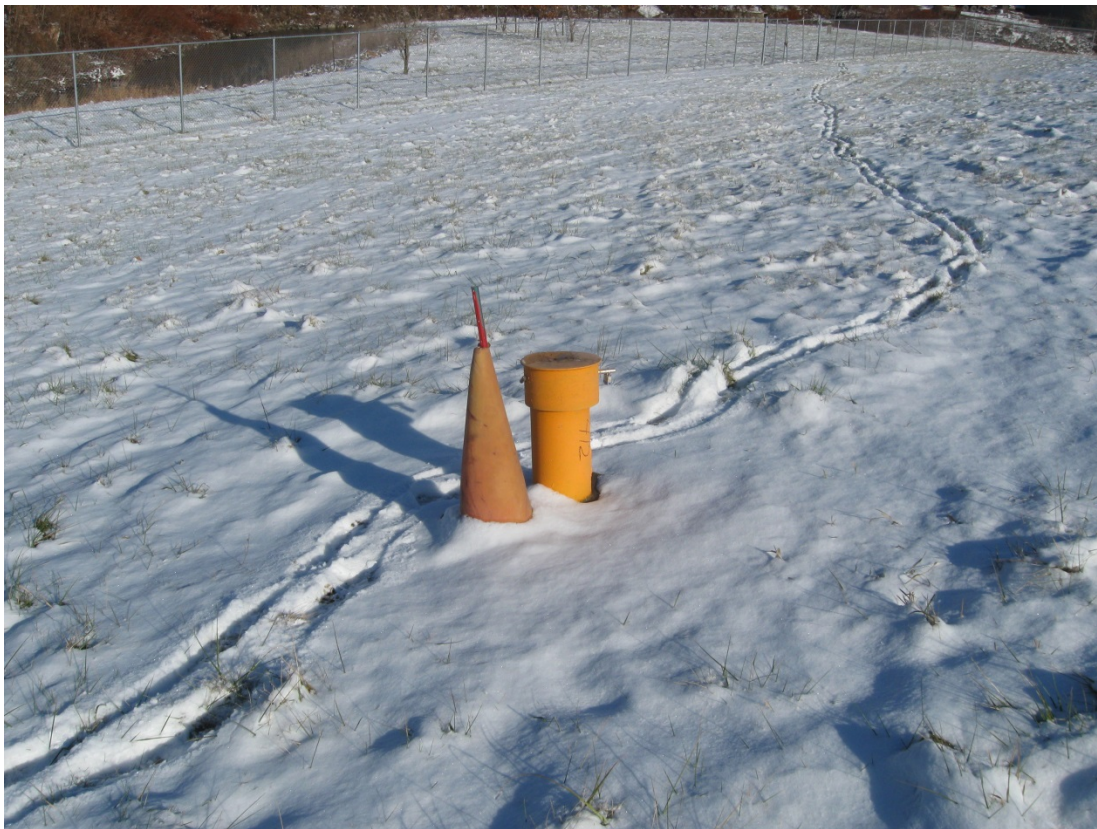
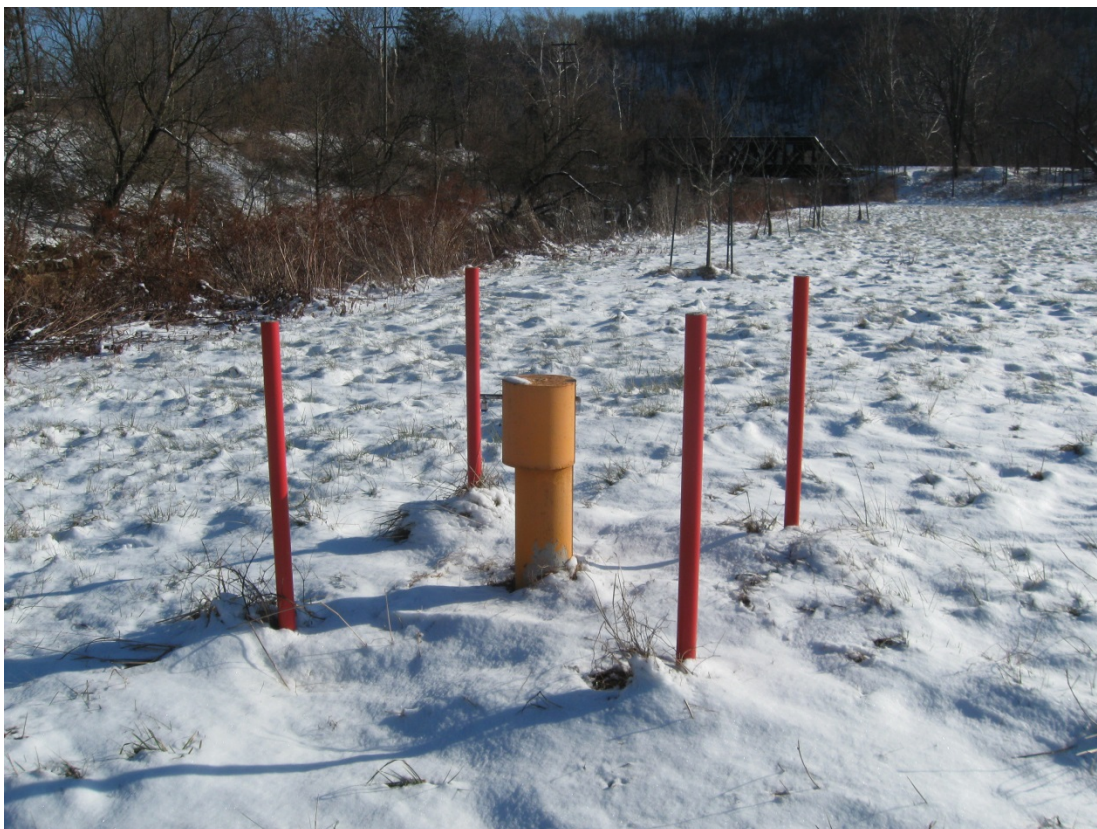
All monitoring wells were observed to be properly locked during the inspection (PL-7 and PL-8).

CAN 10/2013. PL-7. Monitoring well 0412.

CAN 10/2013. PL-8. Monitoring well 0412.

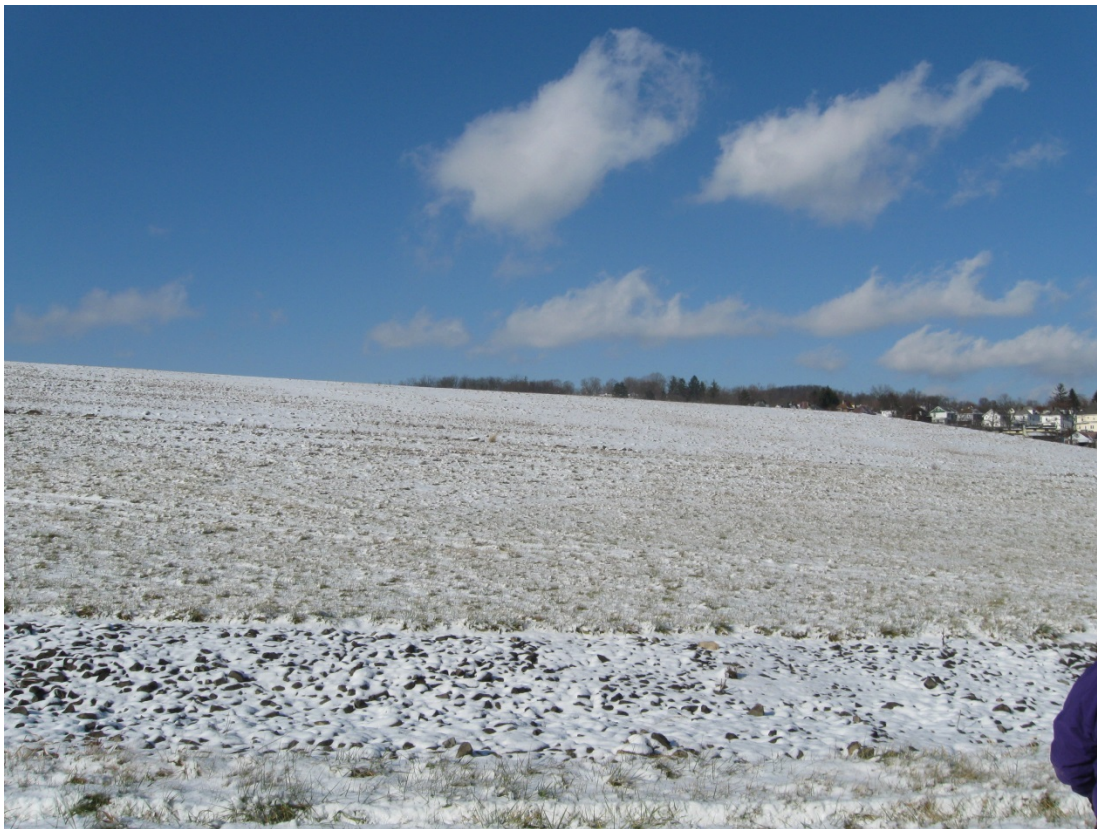
The grass-covered disposal cell was in excellent condition (PL-9). No evidence of erosion or slope instability was observed during the inspection.

CAN 10/2013. PL-9. Southeast side of disposal cell.

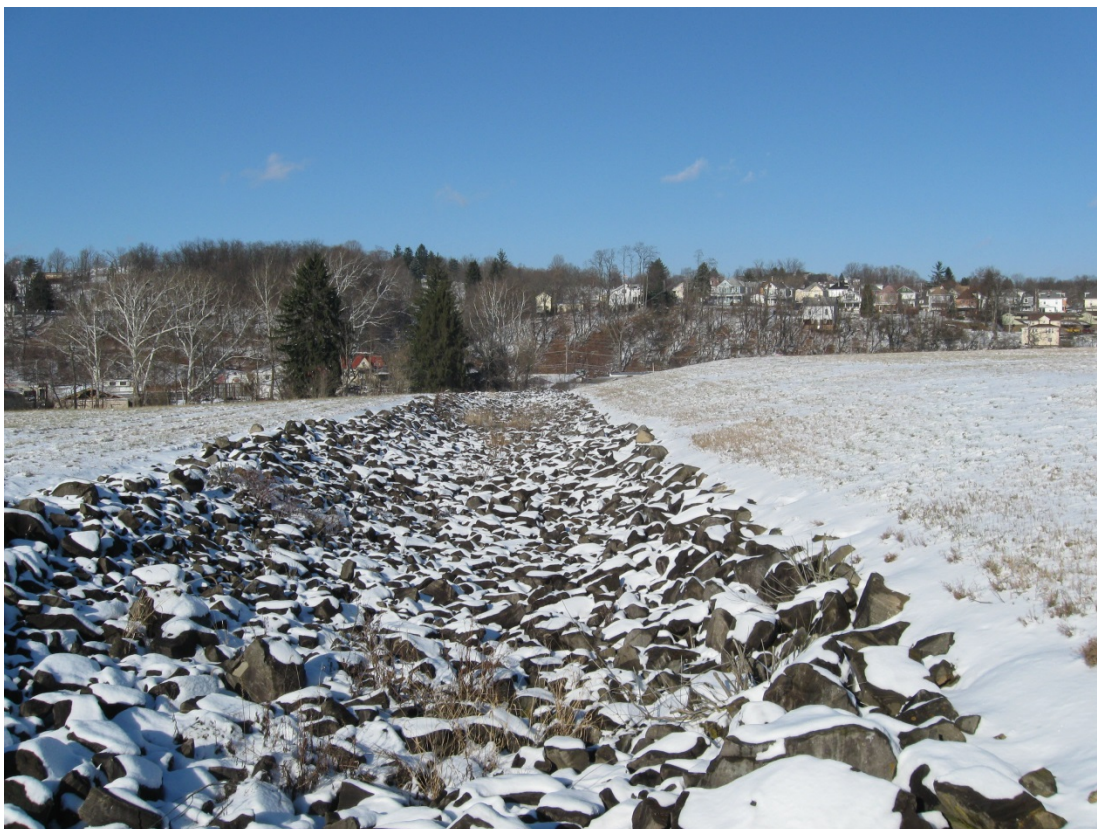
No woody vegetation in the channels and ditches was observed (PL-10 and PL-11). Physical removal and spot herbicide applications have been effective at reducing woody vegetation.

CAN 10/2013. PL-10. Riprap-armored diversion ditch on southwest side of disposal cell.

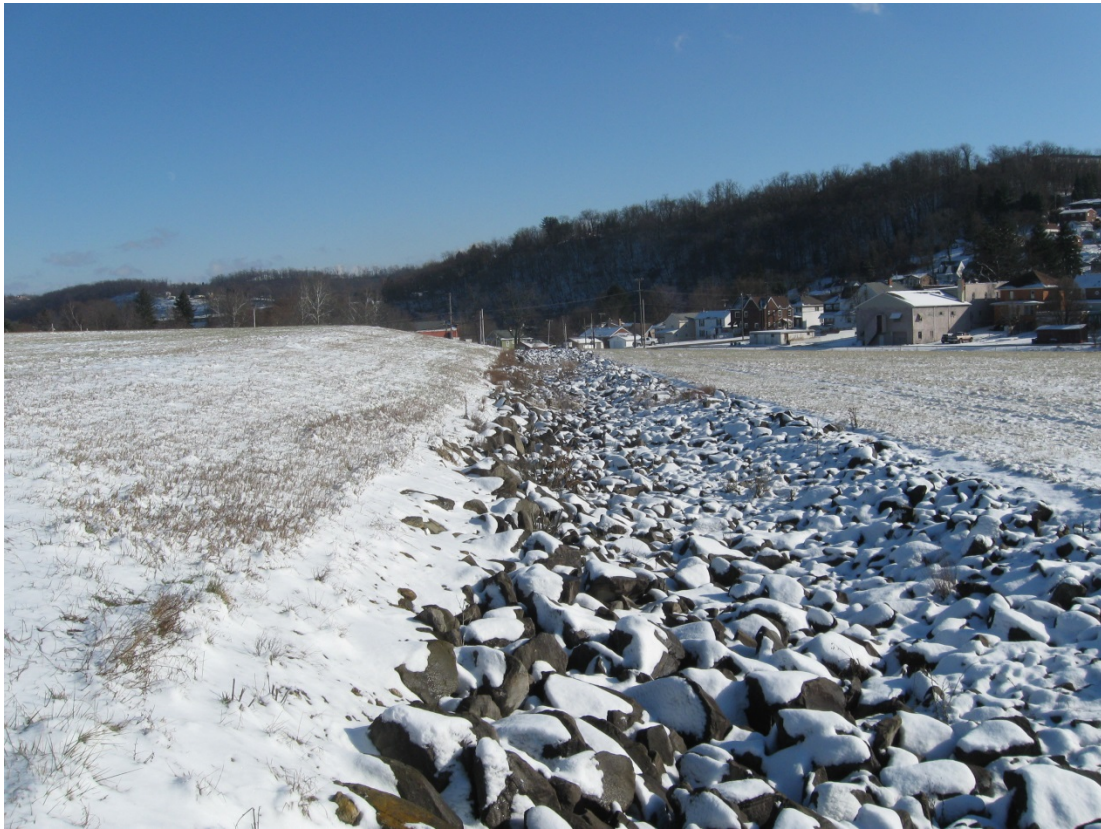
CAN 10/2013. PL-11. Riprap-armored diversion ditch on northwest side of disposal cell.
