3.0 Annual Inspection of the Canonsburg, Pennsylvania, UMTRCA Title I Disposal Site

3.1 Compliance Summary

The Canonsburg, Pennsylvania, Uranium Mill Tailings Radiation Control Act (UMTRCA) Title I Disposal Site was inspected on October 17, 2012. The disposal cell and all associated surface water diversion and drainage structures were in excellent condition and functioning as designed. No additional maintenance needs or cause for a follow-up or contingency inspection was identified.

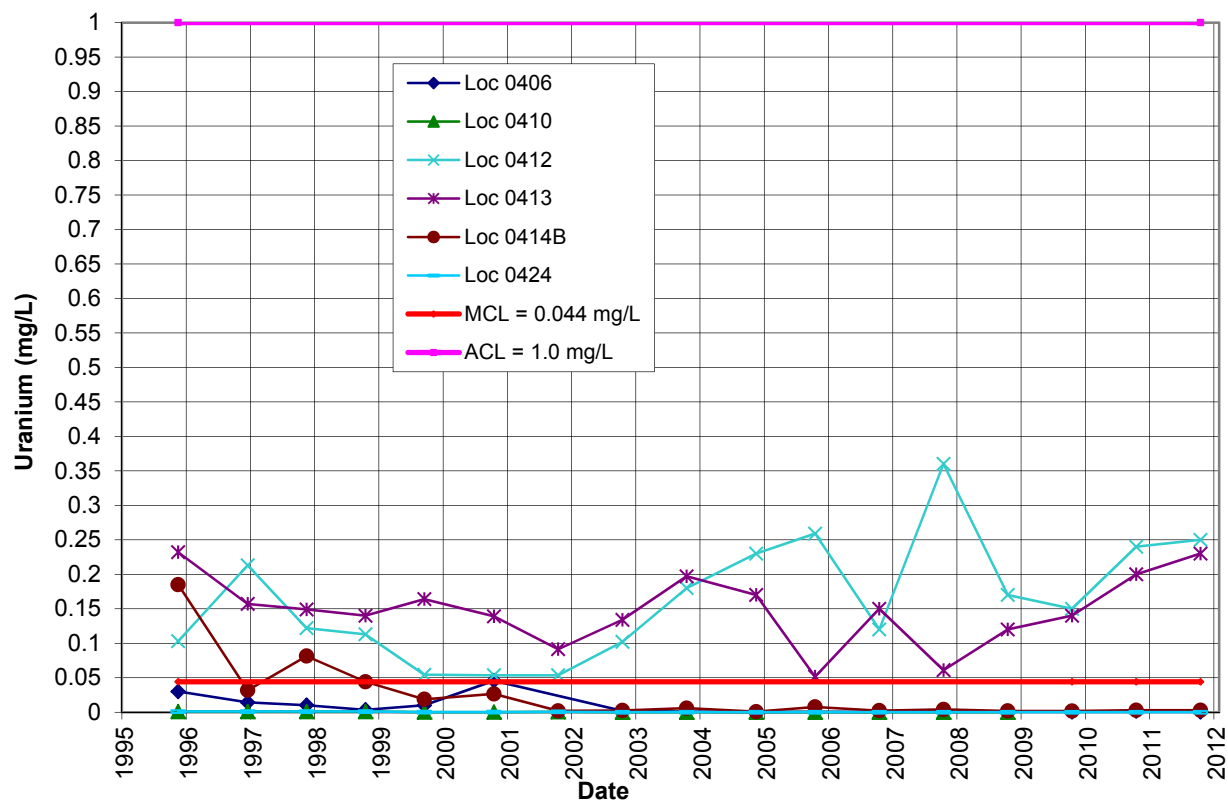
Figure 3–2. Time-Concentration Plot of Uranium in Groundwater at the Canonsburg Disposal Site

Uranium concentrations in 2011 were considerably below the established ACL (Figure 3–2). With the exception of monitoring wells 0412 and 0413, uranium concentrations in 2011 also were below the maximum concentration limit.

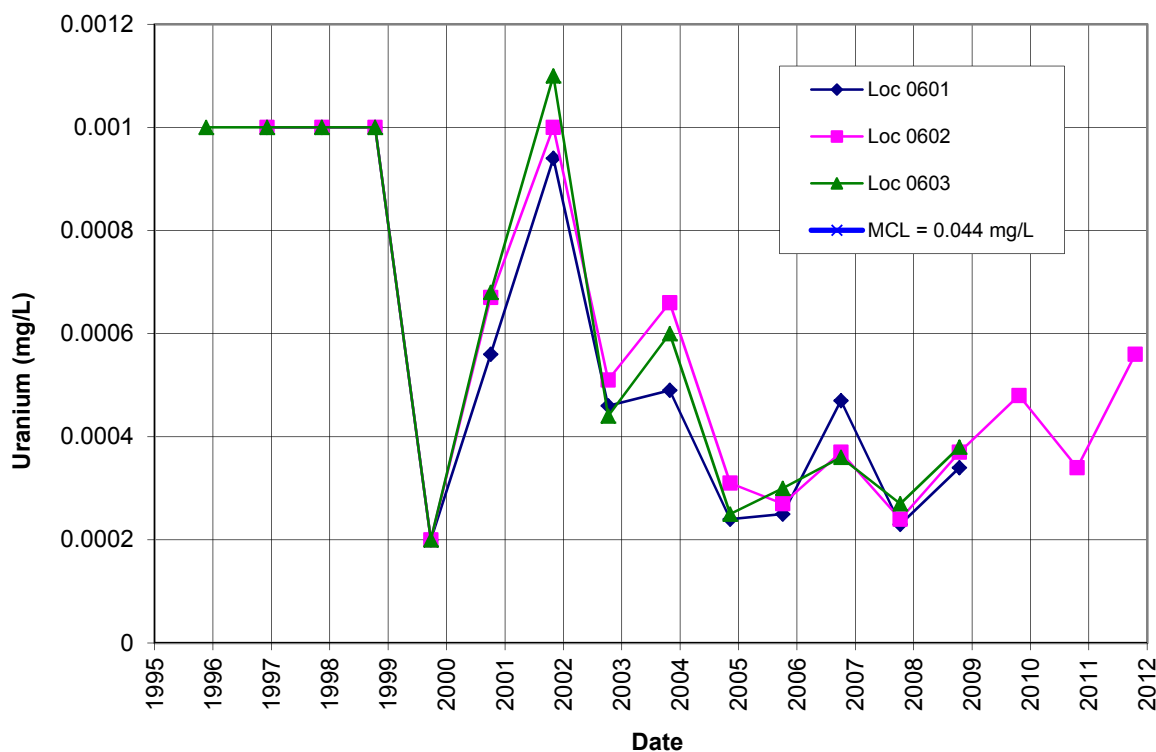
Figure 3-3. Time-Concentration Plot of Uranium in Surface Water at the Canonsburg Disposal Site

Only one surface water location (0602) is sampled under the revised LTSP. The uranium concentration of surface water at location 0602 in 2011 remained below the target concentration of 0.01 mg/L (Figure 3–3).

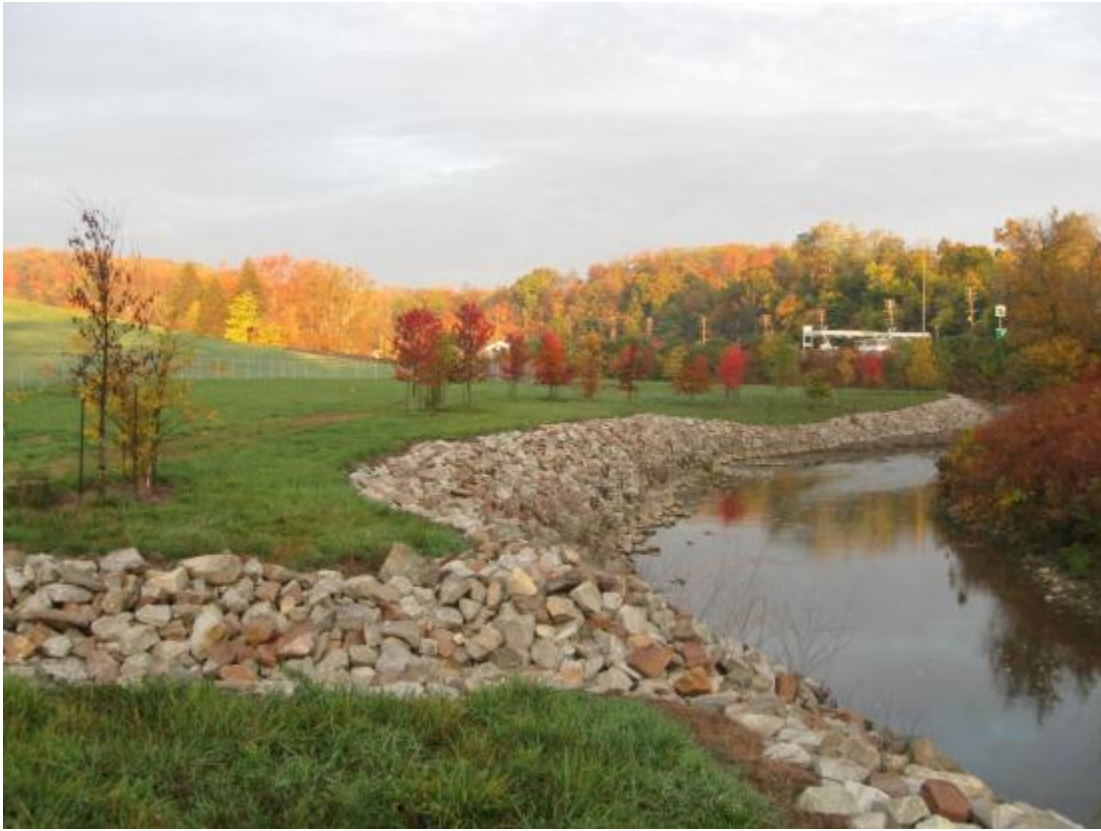
In 2001, the Chartiers Creek bank along Area C was reconstructed to stop slumping. In 2004, inspectors found that floodwater eroded the stream bank. Approximately 100 feet of reconstructed stream bank was damaged downstream from the Strabane Avenue Bridge, and 200 feet was damaged upstream from the railroad bridge. Floodwater cut laterally into the bank and scoured behind the riprap and fabric in places. DOE notified NRC, performed a follow-up inspection of the damage, and developed recommendations for creek bank repair along Area C. NRC concurred on the recommendations, and in April 2005, repairs were made (scoured areas along Area C were filled with riprap to restore the creek bank profile). Shrub and forb seed was broadcast to further stabilize the bank with vegetation. In 2006, the area between perimeter signs P7 and P8 was stabilized, and in 2008, the area between perimeter sign P8 and Strabane Avenue Bridge was stabilized. The stabilization work consisted of cutting back the slope of the creek bank and armoring the toe with riprap keyed into bedrock. Geotextile fabric underlies the riprap. Above the riprap, stabilization matting and new plantings of live fascines protect the slope.

CAN 10/2012. PL-1. Riprap-armored stream bank.

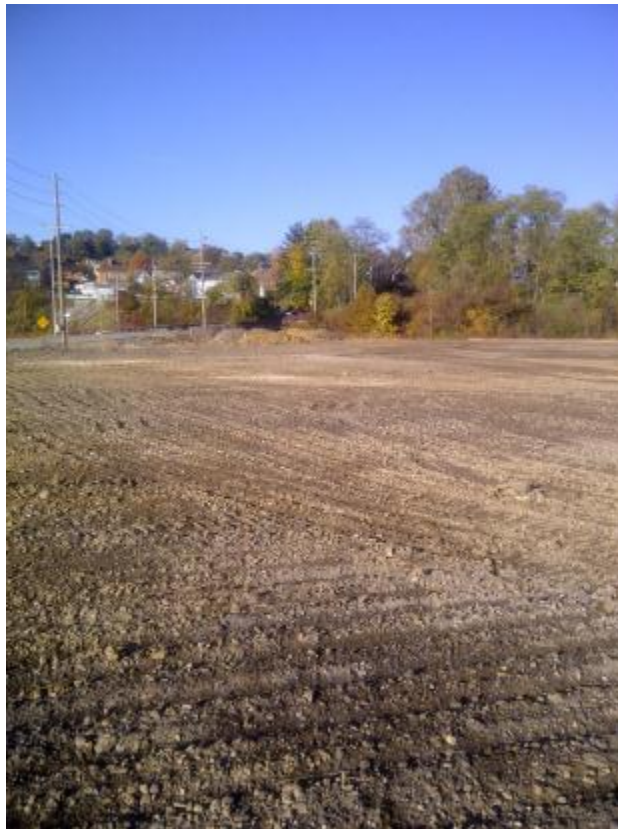
The land owner of Area C and former Tract 117 has elevated the land surface of both areas through the placement and grading of clean fill material (PL-2). This does not violate institutional controls. DOE owns two groundwater monitoring wells on Area C and former Tract 117. The land owner has taken excellent steps to provide adequate access to both wells, and to protect the integrity of both wells by grading the fill in a manner that should not result in surface water pooling around the base of the well pads (PL-3).

CAN 10/2012. PL-2. Looking northwest across Area C.

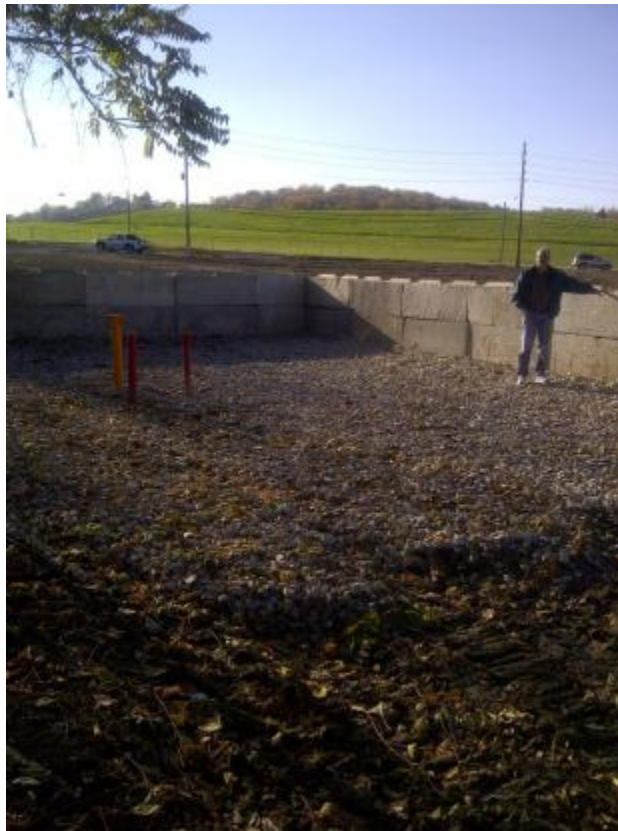
CAN 10/2012. PL-3. Area around monitoring well 0414B.

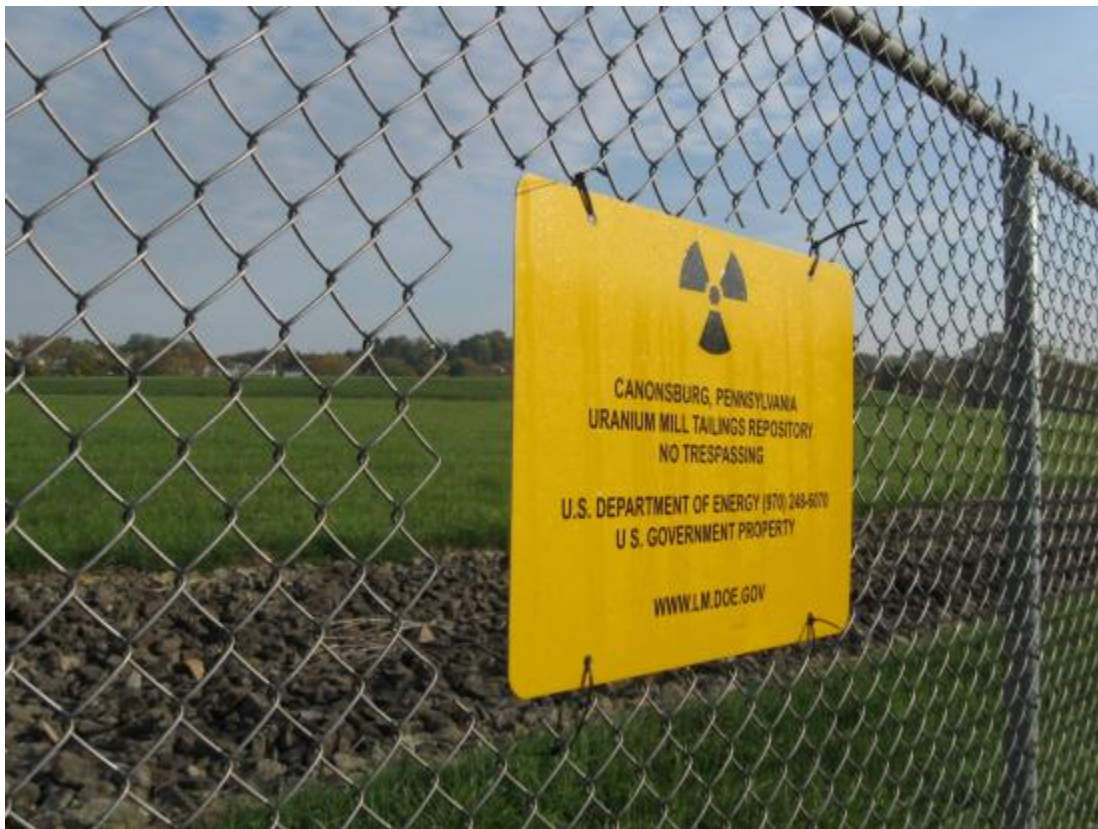
The security fence was in excellent condition with the exception of a small hole in the fence at perimeter sign P2. In 2011, for unknown reasons, someone cut perimeter sign P2 from the fence and left a small hole in its place. A new sign was installed to cover the hole in the fence (PL-4). A vegetation-free buffer zone is being maintained around the entire site security fence (PL-5). The 11 perimeter signs were in good condition.

CAN 10/2012. PL-4. Fence repair at perimeter sign P2.

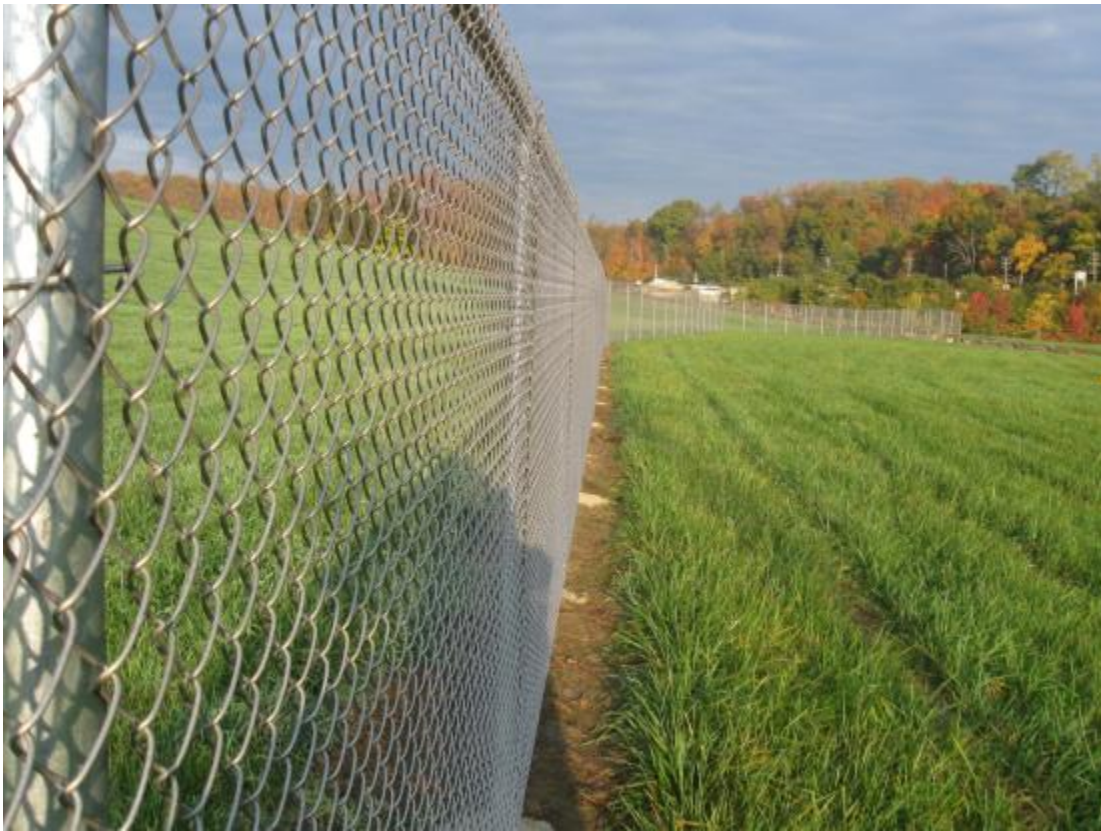
CAN 10/2012. PL-5. Fence line, northeast of disposal cell.

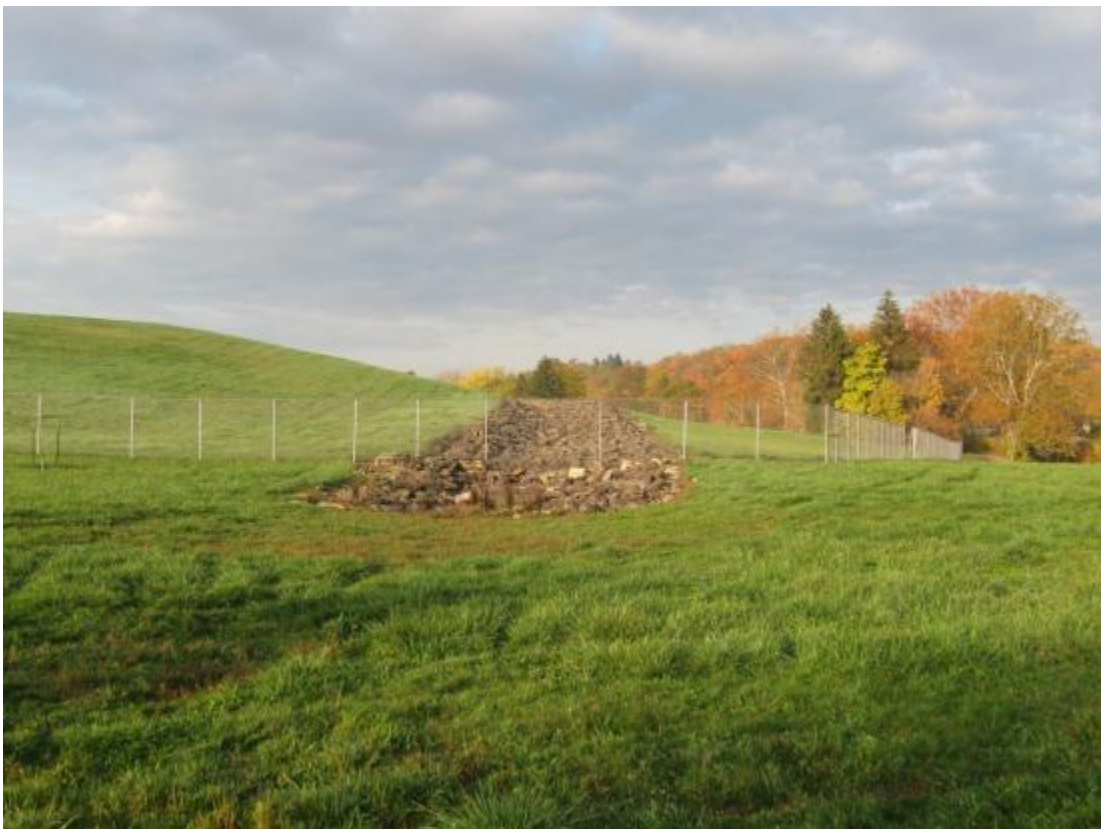
Diversion channels around the disposal cell and the perimeter ditch along the south side of the site are armored with riprap and were in excellent condition (PL-6). No indications of diminished rock durability were noted. Woody vegetation in the diversion ditches continues to be controlled by cutting and spraying.

CAN 10/2012. PL-6. Looking west down riprap-armored diversion ditch.

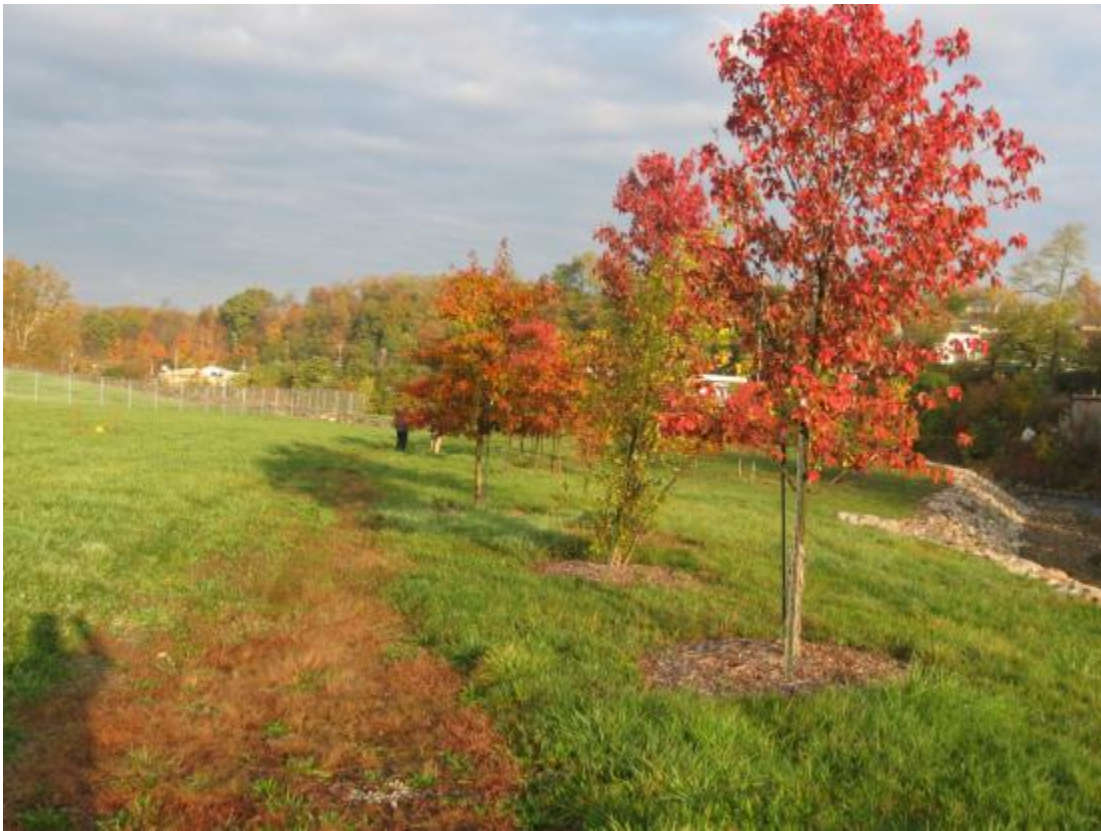
In 2009, reseeding and the planting of large saplings (greater than 2 inches in diameter) took place within the area that was regraded in 2008 as part of a stream bank stabilization project. The trees were planted under a third-party DOE Office of Legacy Management grant. Several of the trees planted in 2009 did not survive and were replaced with healthy trees in 2010, which continue to do well (PL-7). The stream bank stabilization project dramatically changed the look of the site. There is a sharp contrast between the riprap-armored south bank of Chartiers Creek (where vegetation growth is managed) and the unarmored north bank (where vegetation growth is not managed).

CAN 10/2012. PL-7. Floodplain northeast of disposal cell.
