3.0 Canonsburg, Pennsylvania, Disposal Site

3.1 Compliance Summary

The Canonsburg, Pennsylvania, Uranium Mill Tailings Radiation Control Act (UMTRCA) Title I Disposal Site was inspected on October 4, 2011. The disposal cell and all associated surface water diversion and drainage structures were in excellent condition and functioning as designed. No other maintenance needs or cause for a follow-up or contingency inspection was identified.

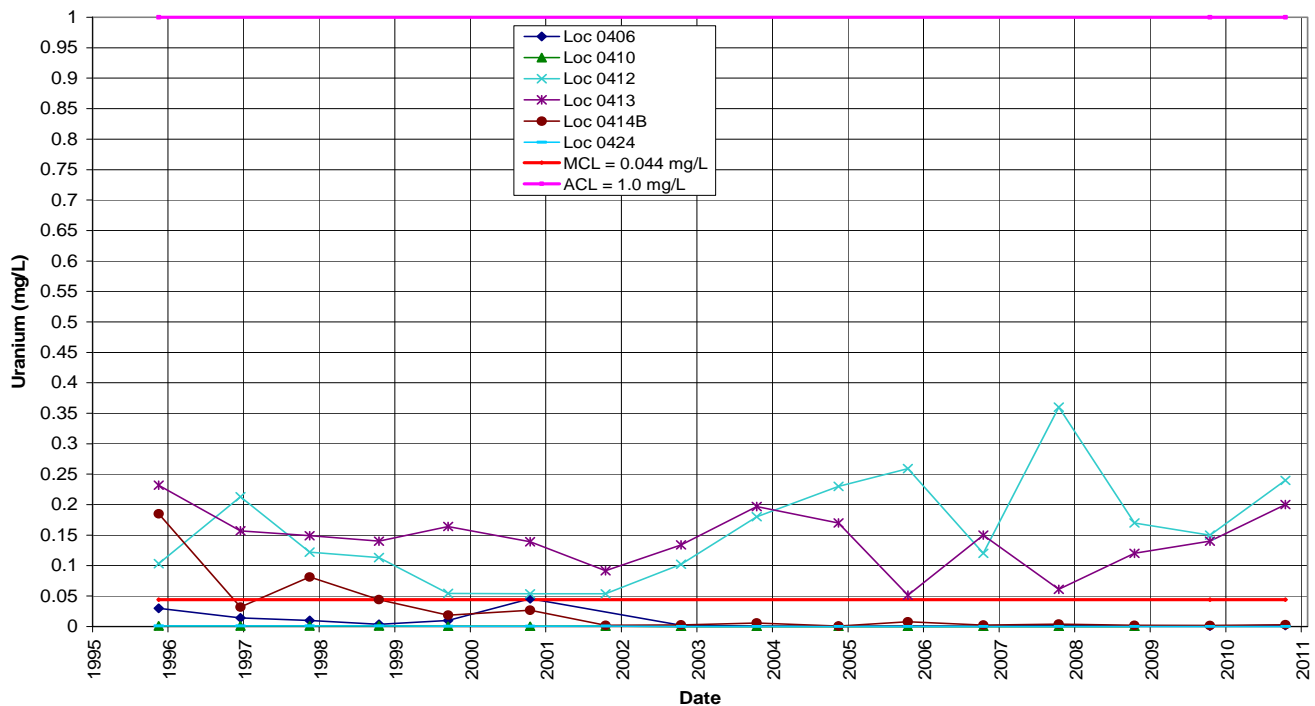
Figure 3-2. Time-Concentration Plot of Uranium in Groundwater at the Canonsburg Disposal Site

Groundwater—Uranium concentrations in 2010 were considerably below the established ACL (Figure 3–2). With the exception of monitoring wells 0412 and 0413, uranium concentrations in 2010 also were below the MCL.

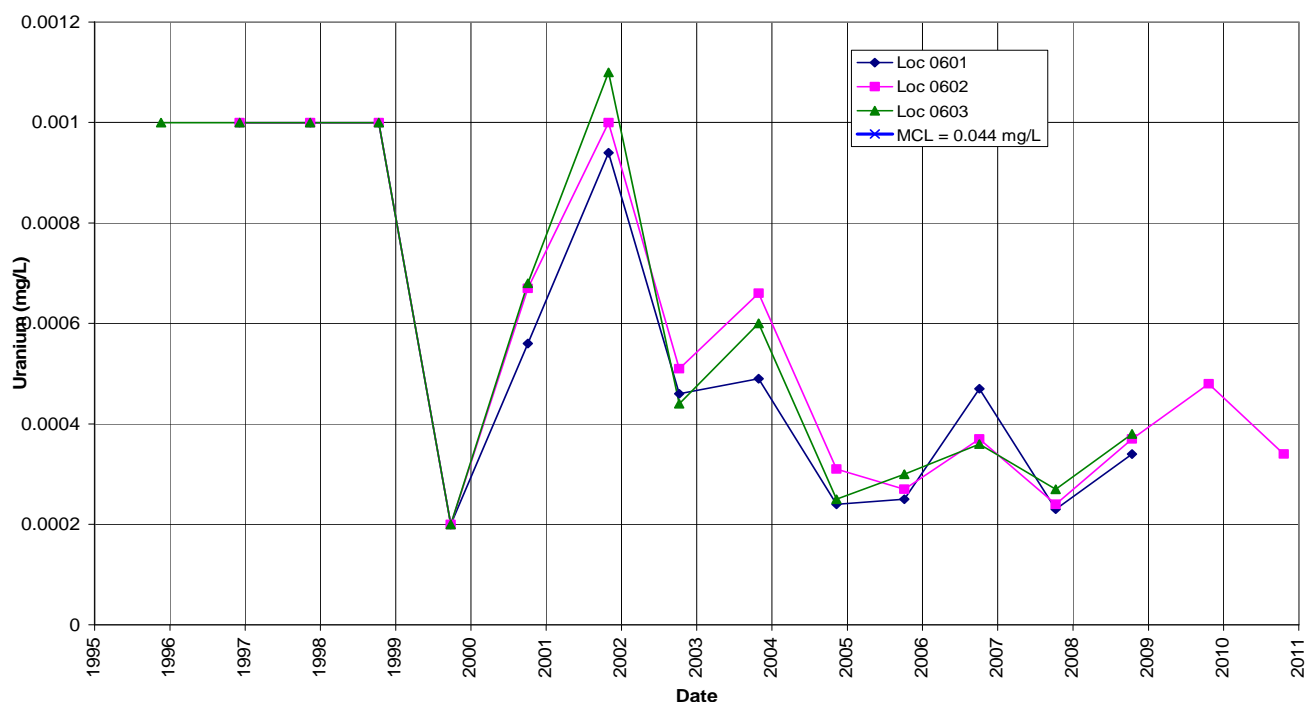
Figure 3-3. Time-Concentration Plot of Uranium in Surface Water at the Canonsburg Disposal Site

Surface Water—Only one surface water location (0602) is sampled under the revised LTSP. The uranium concentration of surface water at location 0602 in 2010 remained below the target concentration of 0.01 mg/L (Figure 3-3).

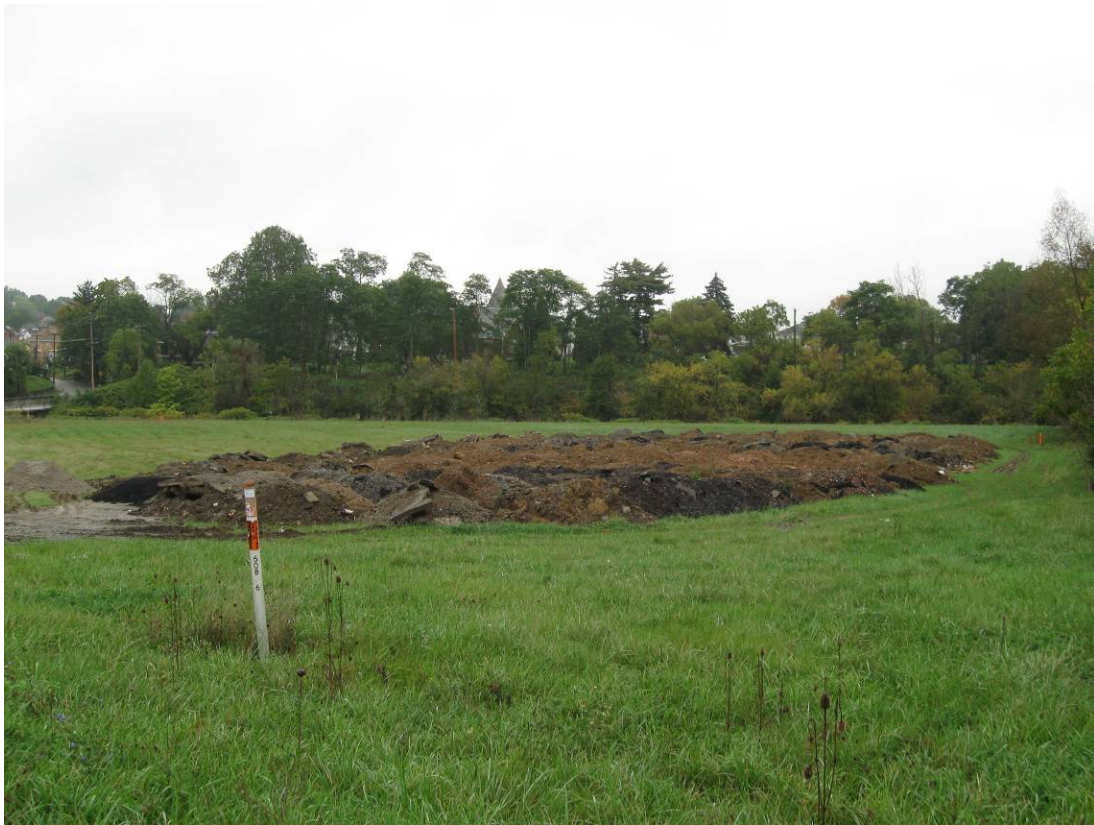
Large piles of fill material have been placed on Area C by the property owner within the last year (photograph location [PL]–1). The placement of the fill does not violate any institutional controls connected with the property. A minimum of 20 feet of clearance is being maintained to DOE groundwater monitoring wells. Post-inspection discussions with the property owner indicate that the placement of additional fill material on the property is not anticipated at this time.

It was noted during the inspection that large piles of fill material had been placed on Area C by the property owner. The placement of the fill does not violate any institutional controls connected with the property. A minimum of 20 feet of clearance is being maintained to DOE

groundwater monitoring wells. Post-inspection discussions with the property owner indicate that the placement of additional fill material on the property is not anticipated at this time.

CAN 10/2011. PL-1. Fill material on Area C property.

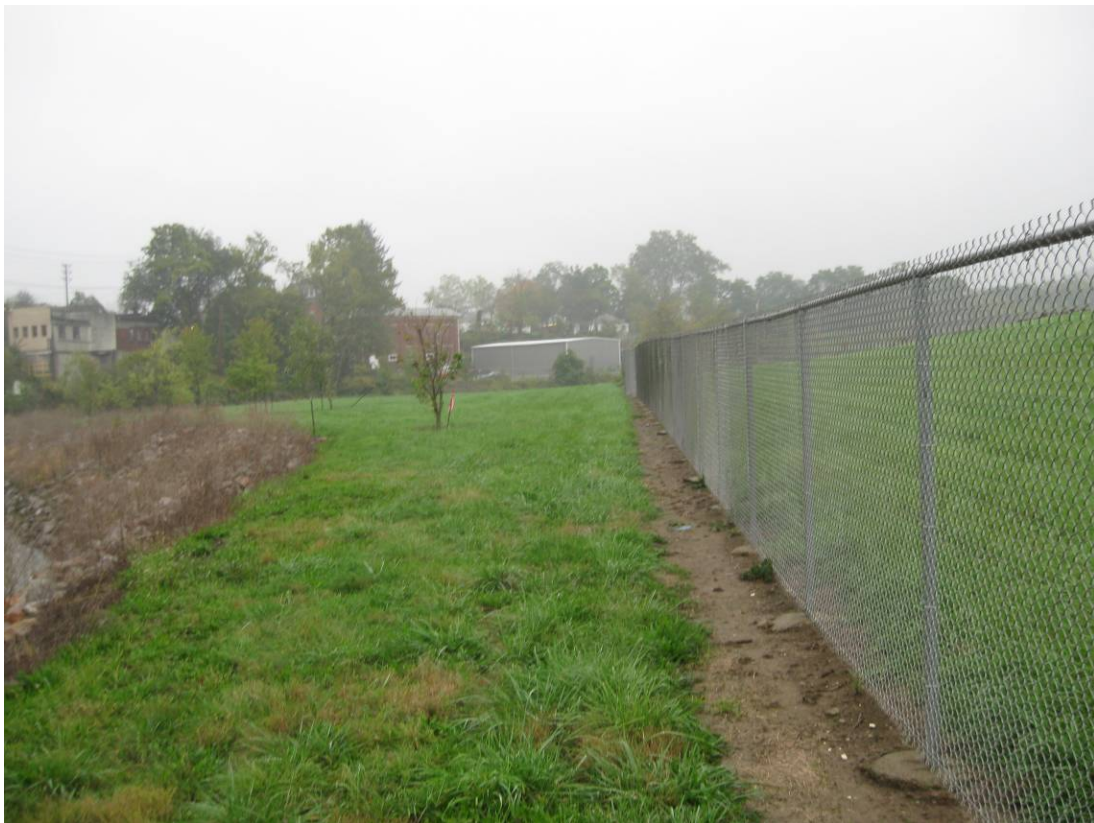
Access, Gates, Fence, and Signs—Access to the site is directly from Strabane Avenue, a public right-of-way within the Borough of Canonsburg in Washington County, Pennsylvania. The security fence and all four site gates were in excellent condition. A vegetation-free buffer zone is being maintained around the entire site security fence (PL–2). The entrance sign and 11 perimeter signs were in good condition.

CAN 10/2011. PL-2. Vegetation-free corridor along base of perimeter fence.

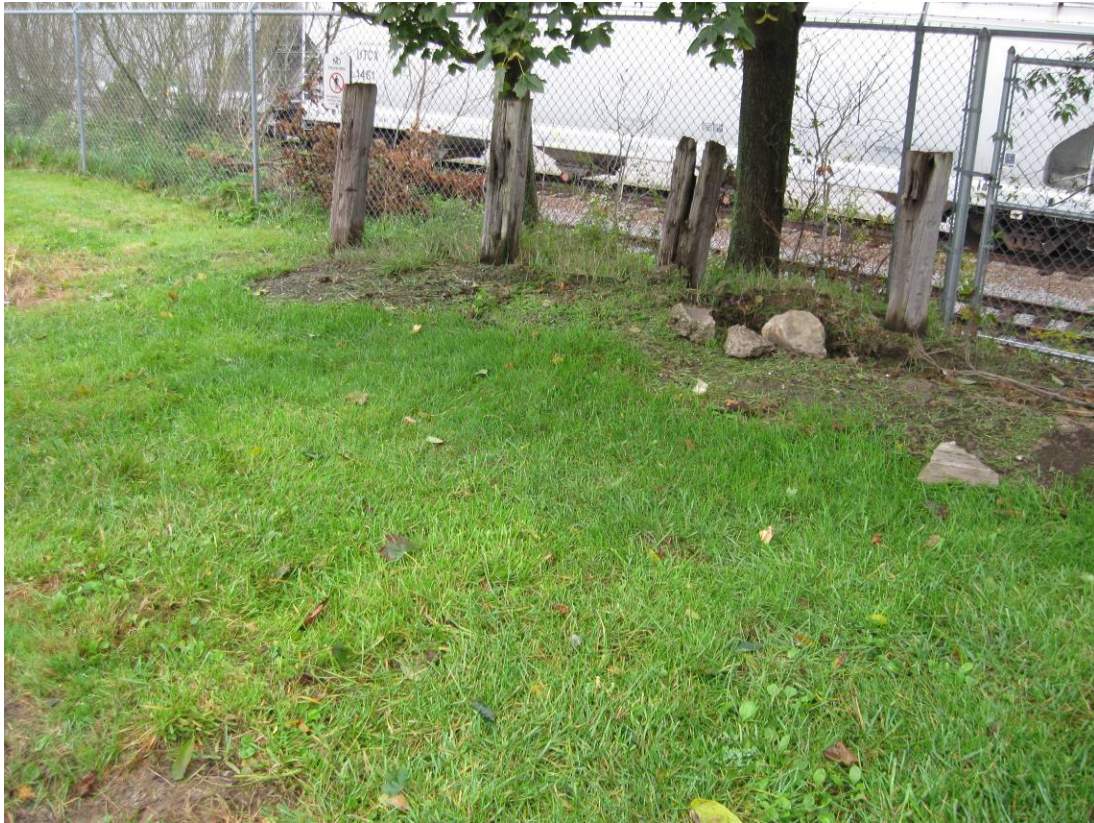
All of the monitoring wells were in excellent condition. Monitoring well 0410 (a background well that was no longer used) was safely plugged and abandoned on September 12, 2011, in accordance with the Pennsylvania Water Well Drillers License Act (Act 610). The site of the abandoned well was in excellent condition (PL-3).

CAN 10/2011. PL-3. Prior location of monitoring well 0410.

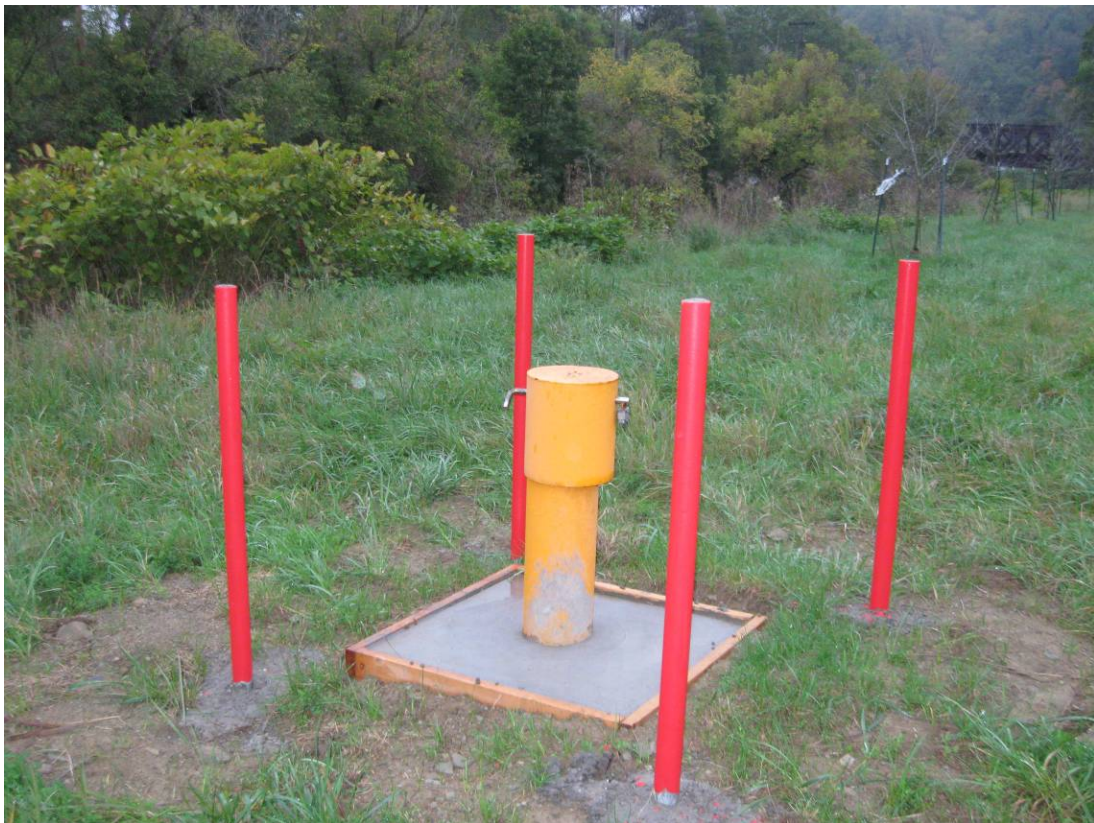
- Drain holes were installed in the protective casings of wells 0406A, 0412, and 0413.
- A brass identification tag was installed on well 0413.
- A concrete pad and protective bollards were installed at well 0413 (PL-4).
- Protective bollards were repaired or installed at wells 0414B and 0424.

CAN 10/2011. PL-4. Monitoring well 0413.

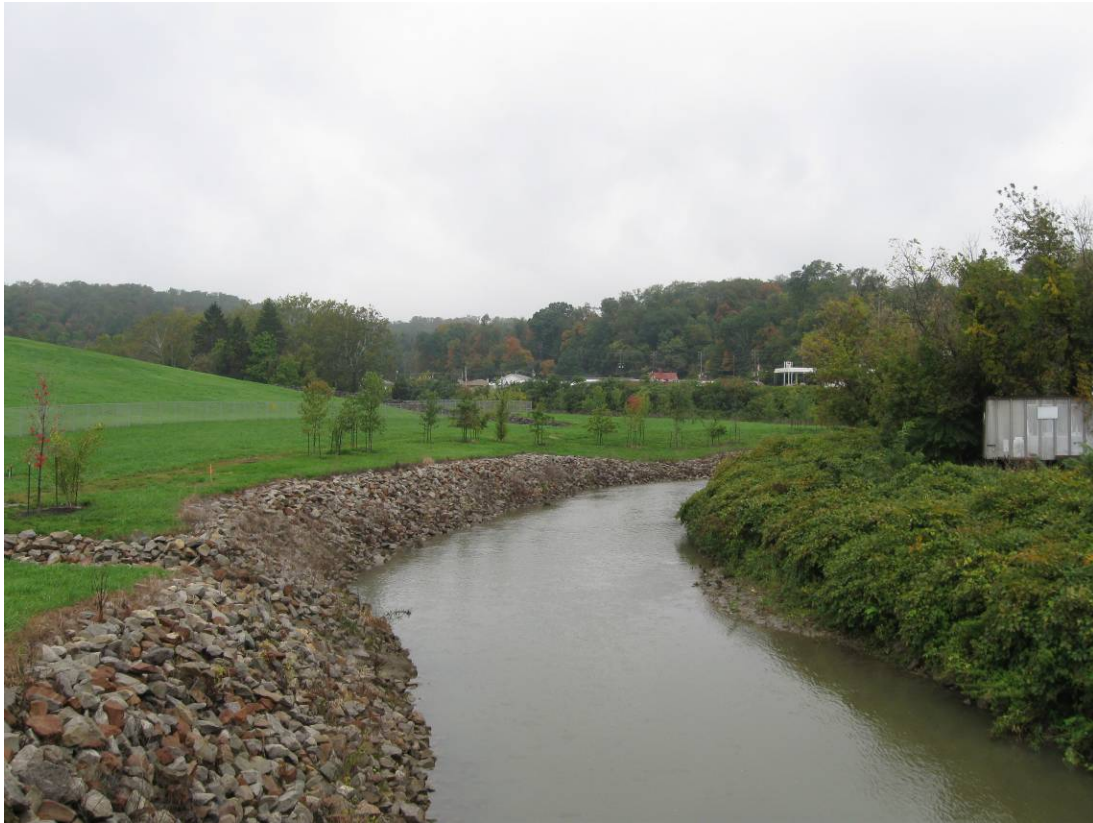
In 2009, reseeding and the planting of large saplings (greater than 2 inches in diameter) took place within the area that was regraded in 2008 as part of a stream bank stabilization project. The trees were planted under a third-party DOE Office of Legacy Management grant. Several of the trees planted in 2009 did not survive and were replaced with healthy trees in 2010, which continue to do well. The stream bank stabilization project dramatically changed the look of the site. There is a sharp contrast between the riprap-armored south bank of Chartiers Creek (where vegetation growth is managed) and the unarmored north bank (where vegetation growth is not managed) (PL-5).

CAN 10/2011. PL-5. Contrast between riprap stream bank, where vegetation is managed, and non-riprap stream bank, where vegetation is not managed.
