3.0 Canonsburg, Pennsylvania, Disposal Site

3.1 Compliance Summary

The Canonsburg, Pennsylvania, Uranium Mill Tailings Radiation Control Act (UMTRCA) Title I Disposal Site was inspected on October 20, 2010. The disposal cell and all associated surface water diversion and drainage structures were in excellent condition and functioning as designed. No other maintenance needs or cause for a follow-up or contingency inspection was identified.

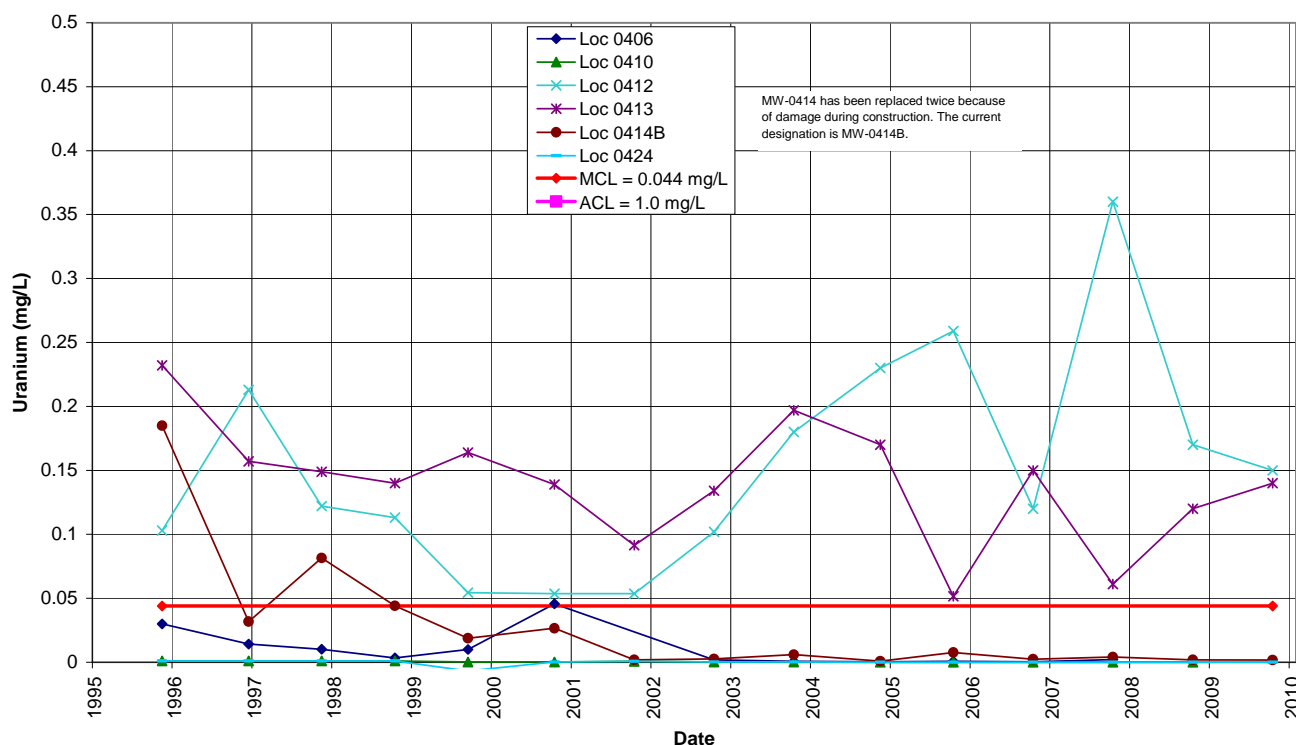
Figure 3–2. Time-Concentration Plot of Uranium in Groundwater at the Canonsburg Disposal Site

Groundwater—Uranium concentrations in 2009 were considerably below the established ACL (Figure 3–2). With the exception of monitoring well MW–0412 and monitoring well MW–0413, uranium concentrations in 2009 were also below the MCL.

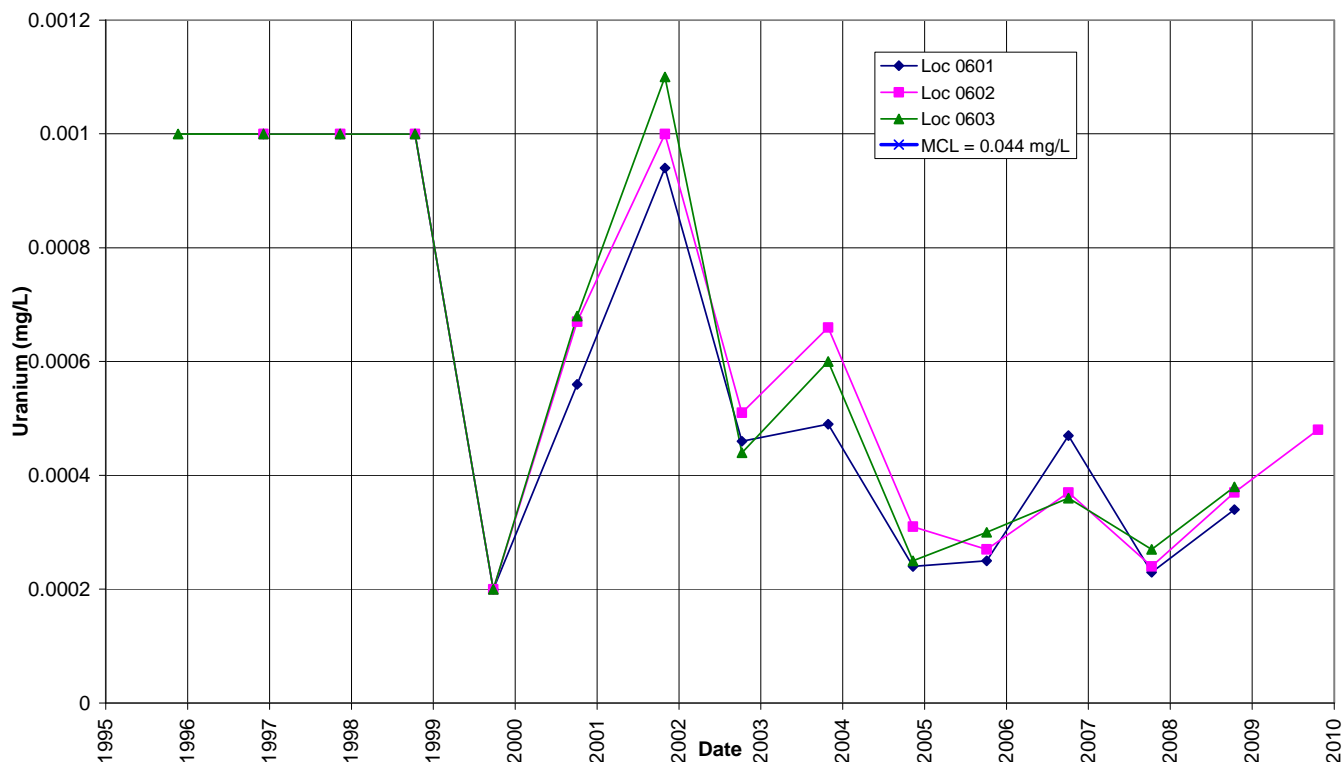
Figure 3-3. Time-Concentration Plot of Uranium in Surface Water at the Canonsburg Disposal Site

Surface Water—Only one surface water location (SW–0602) is sampled under the revised LTSP. The uranium concentration of surface water at location SW–0602 in 2009 remained below the target concentration of 0.01 mg/L (Figure 3–3).

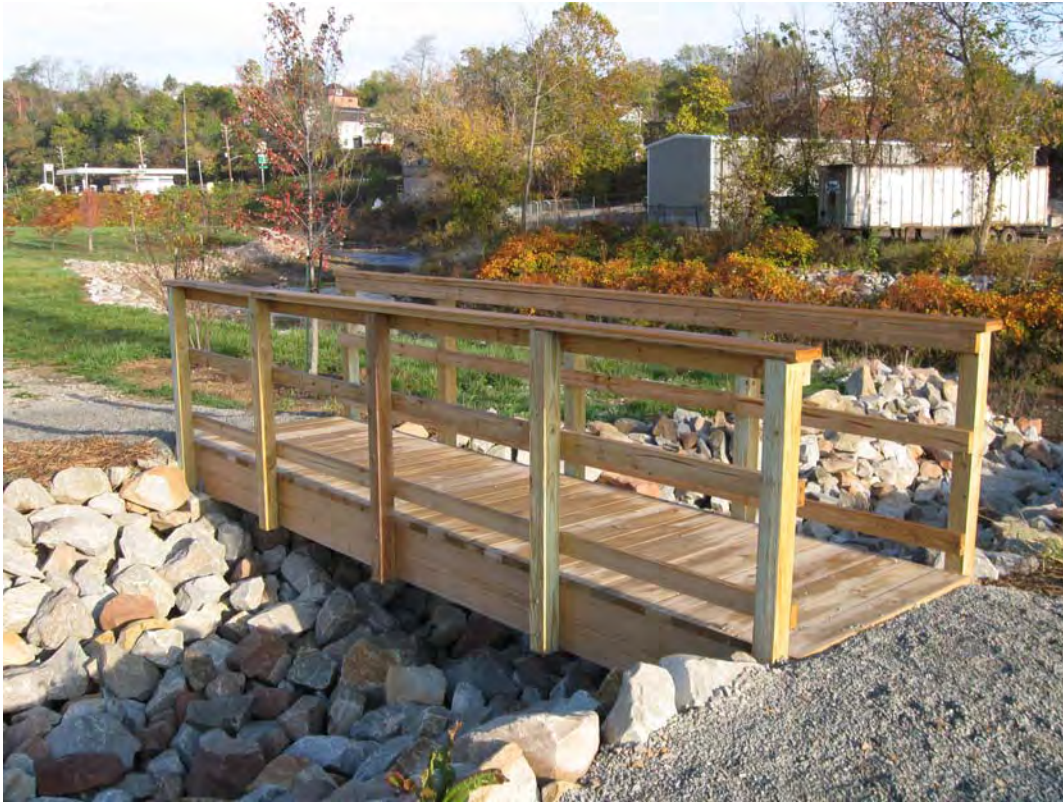
A small footbridge was installed north of the disposal cell in 2010, improving access to an unfenced portion of the site (PL–1). The footbridge provides a safer way for the public to cross a riprap-lined diversion ditch (PL–2). The footbridge was in excellent condition.

CAN 10/2010. PL-1. Newly installed footbridge across a riprap armored diversion ditch.

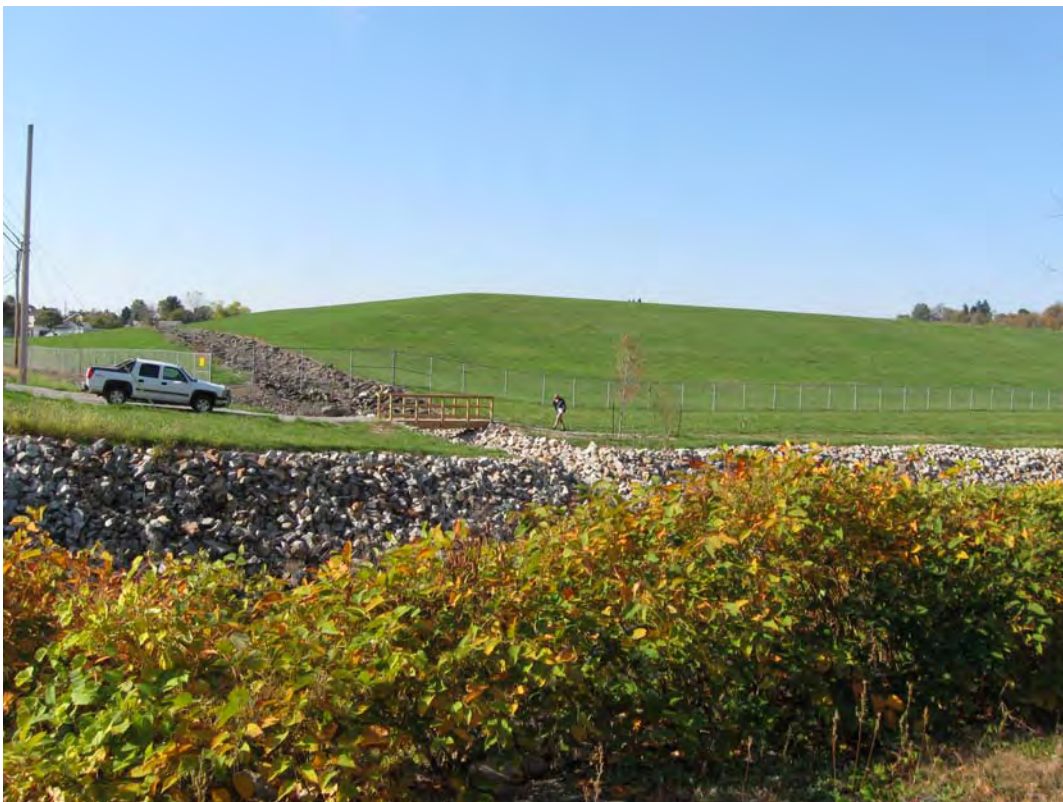
CAN 10/2010. PL-2. Footbridge across a riprap armored diversion ditch.

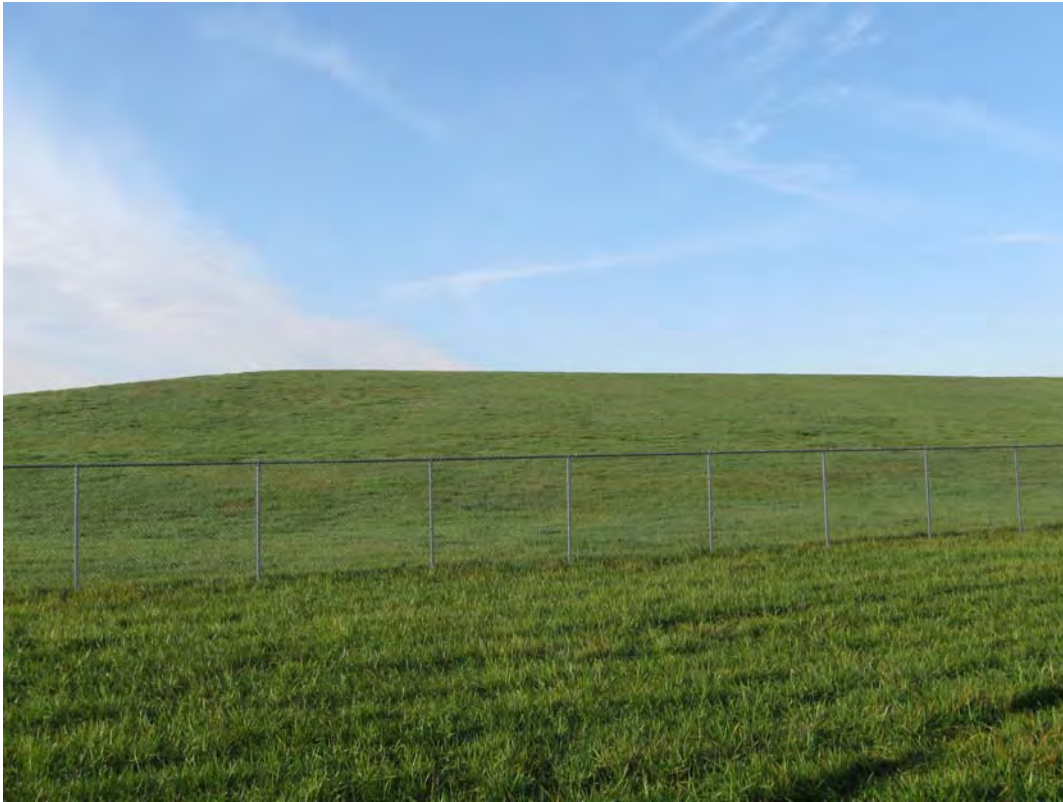
- 3B **Disposal Cell**—The grass-covered disposal cell surface was in excellent condition (PL-3). There was no evidence of slumping, settling, erosion, or other modifying processes. The grass is mowed and mulched in accordance with the LTSP. DOE continued to successfully control noxious and invasive weeds through a combination of mowing and spot-spraying.

CAN 10/2010. PL-3. North side slope of disposal cell.

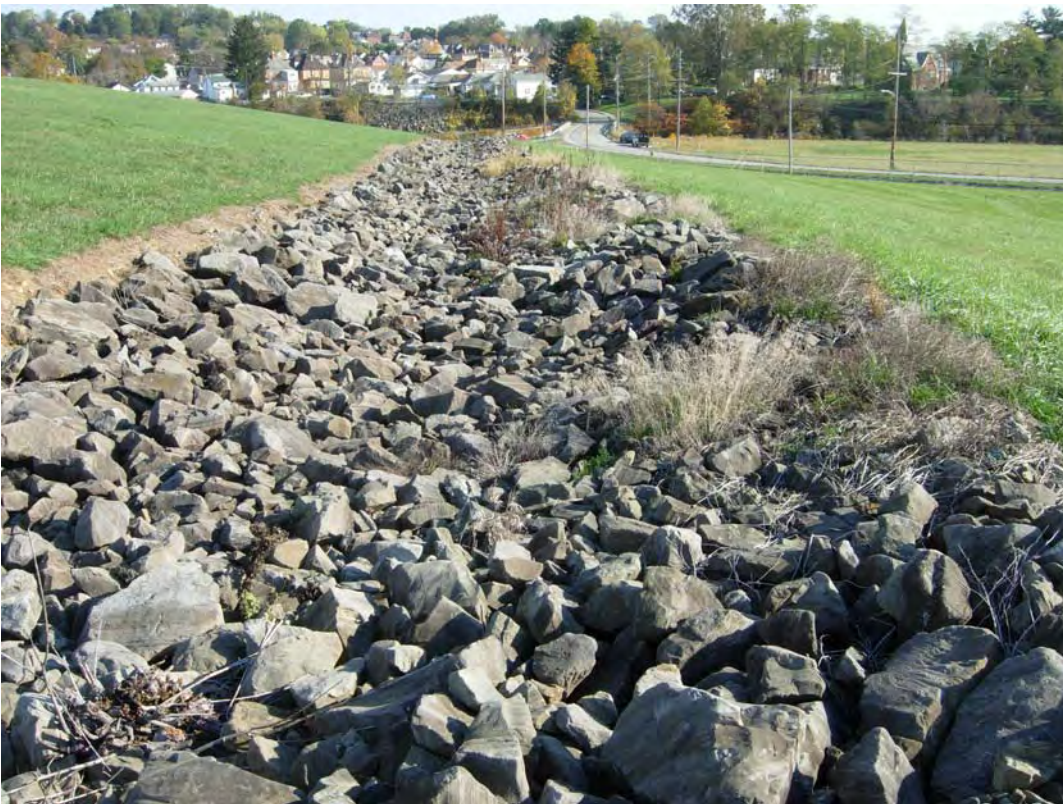
Diversion Channels and Perimeter Ditch—Diversion channels around the disposal cell, and the perimeter ditch along the south side of the site, are armored with riprap and were in good condition (PL-4, PL-5, and PL-6). No indications of diminished rock durability were noted. Woody vegetation in the diversion ditches continues to be controlled by cutting and spraying.

CAN 10/2010. PL-4. Riprap armored diversion ditch.

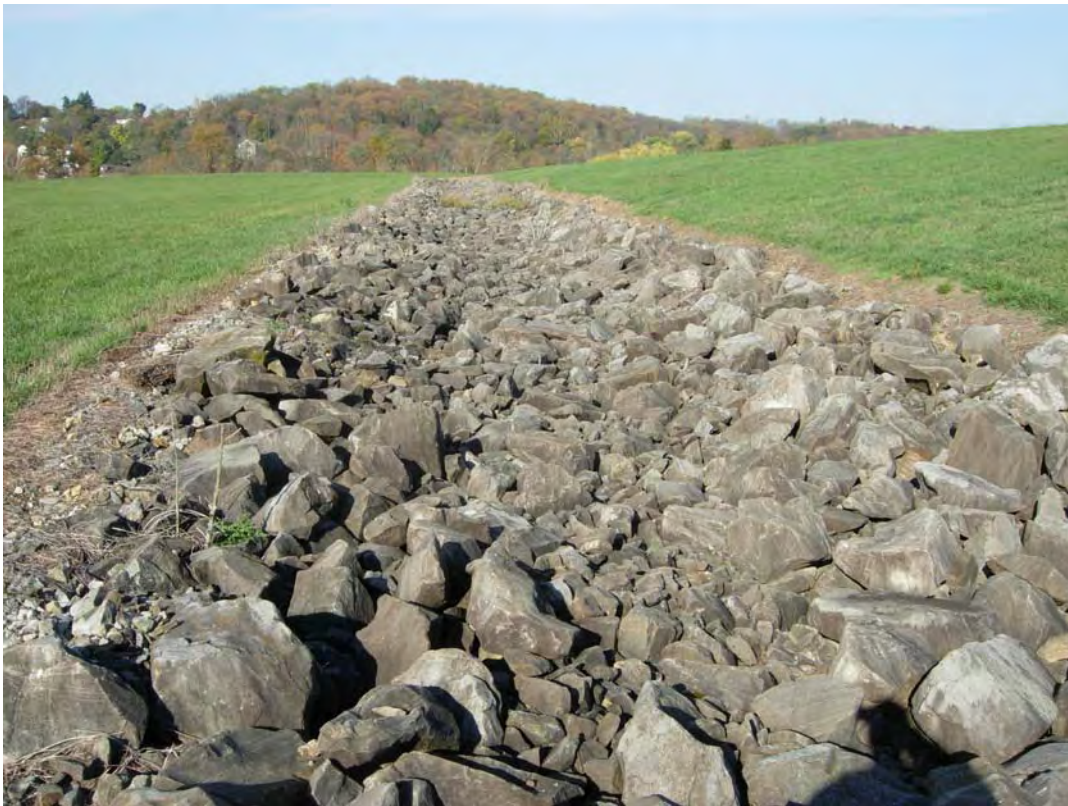
CAN 10/2010. PL-5. Riprap armored diversion ditch.

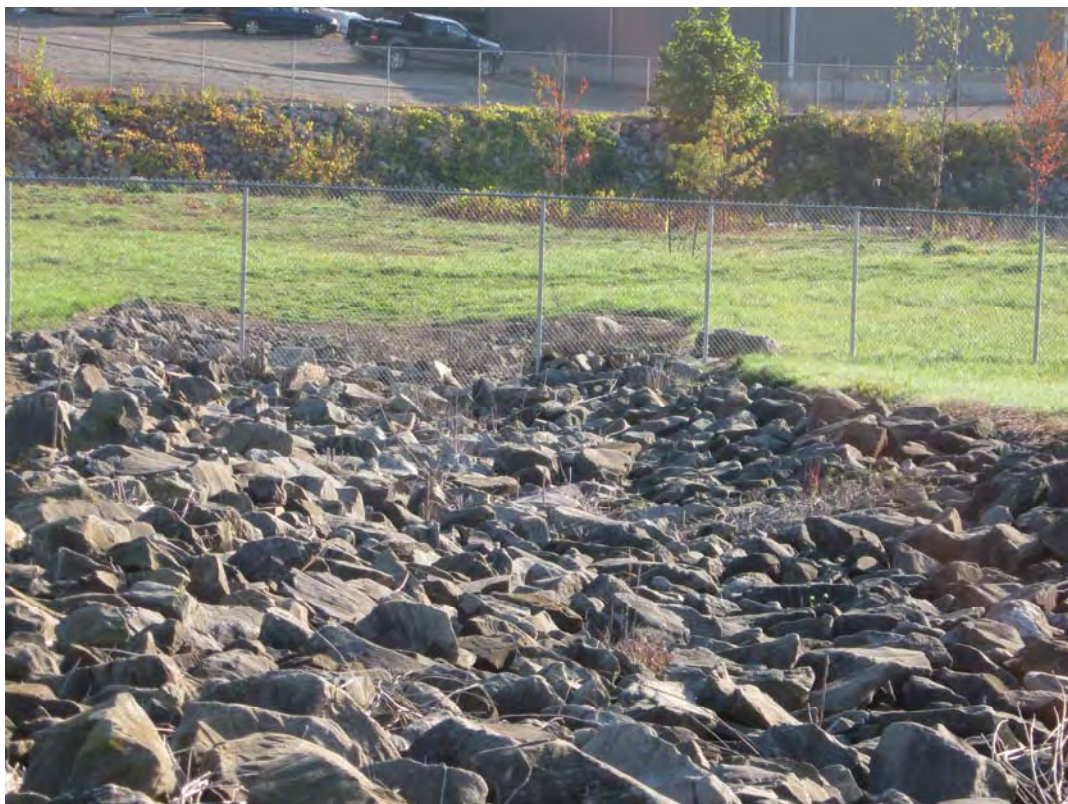
CAN 10/2010. PL-6. Looking down channel of a riprap armored diversion ditch.

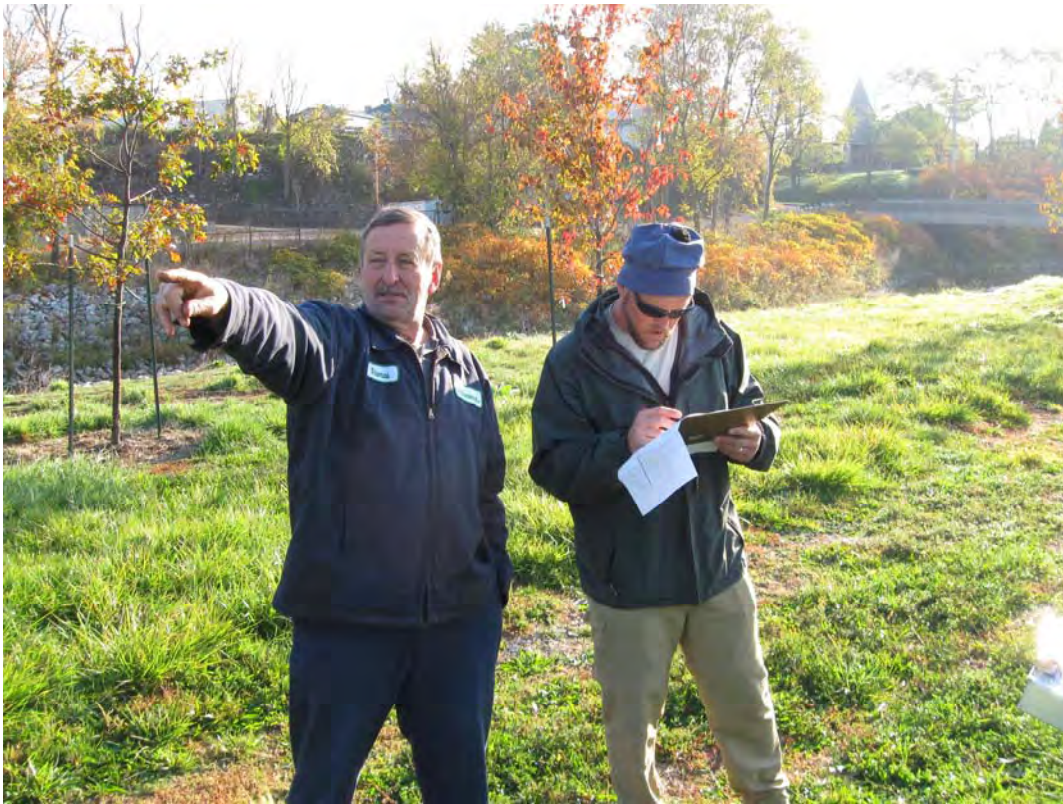
continuous improvements to the herbaceous cover at the site. In-the-field discussions with vegetation management personnel during the inspections continue to improve the efficiency and effectiveness of vegetation management activities (PL-7).

CAN 10/2010. PL-7. In-the-field lessons-learned session.

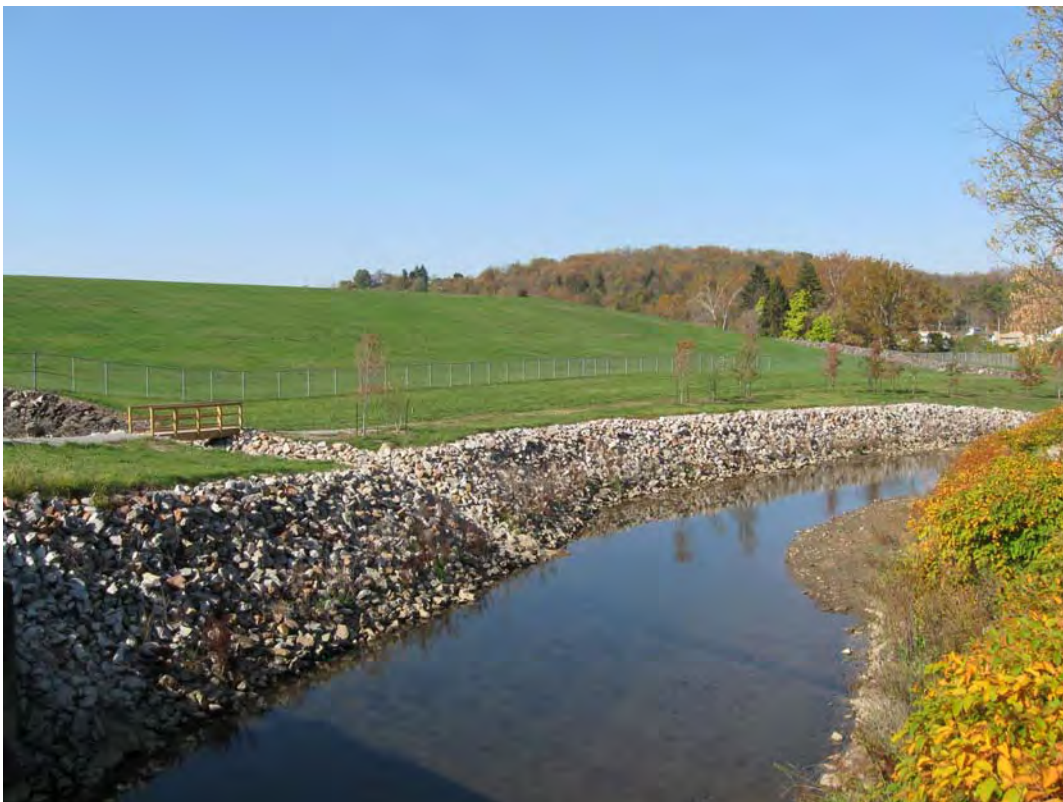
In 2009, reseeding and the planting of large (greater than 2-inch diameter saplings took place within the area that was regraded in 2008 as part of a Stream Bank Stabilization Project (PL-8). The trees were planted under a third-party Office of Legacy Management grant. Several of the trees planted in 2009 did not survive and were replaced with healthy trees in 2010.

CAN 10/2010. PL-8. Riprap armored stream bank along floodplain area.
