3.0 Canonsburg, Pennsylvania, Disposal Site

3.1 Compliance Summary

The Canonsburg, Pennsylvania, Uranium Mill Tailings Radiation Control Act (UMTRCA) Title I Disposal Site was inspected on October 21, 2009. The disposal cell and all associated surface water diversion and drainage structures were in excellent condition and functioning as designed.

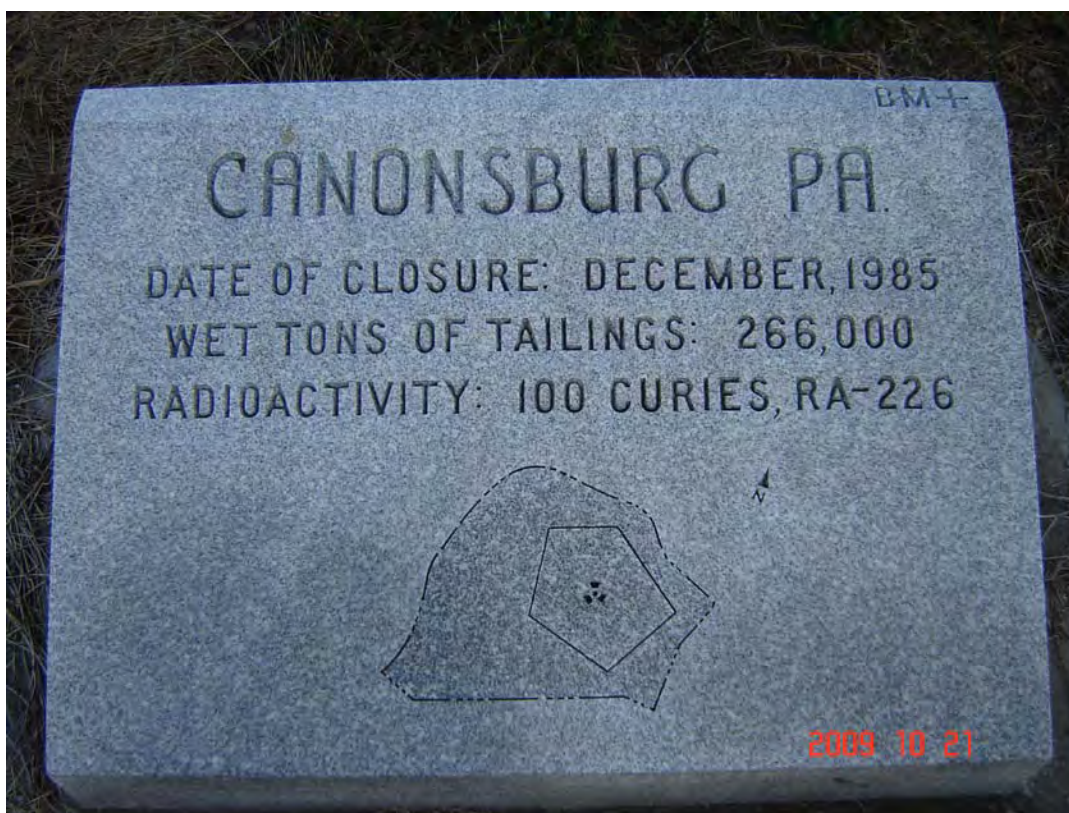
CAN 10/2009. PL-1. Site marker SMK-1.

Both site markers are in excellent condition (PL–1). Four pairs of erosion control markers were initially installed along the bank of Chartiers Creek. One of these markers, ECM–4A, was lost to erosion in 1997; erosion control marker ECM–4 has been used for reference. Stream bank stabilization work is complete, and erosion control marker ECM–4A will be replaced. All remaining erosion control markers were in excellent condition.

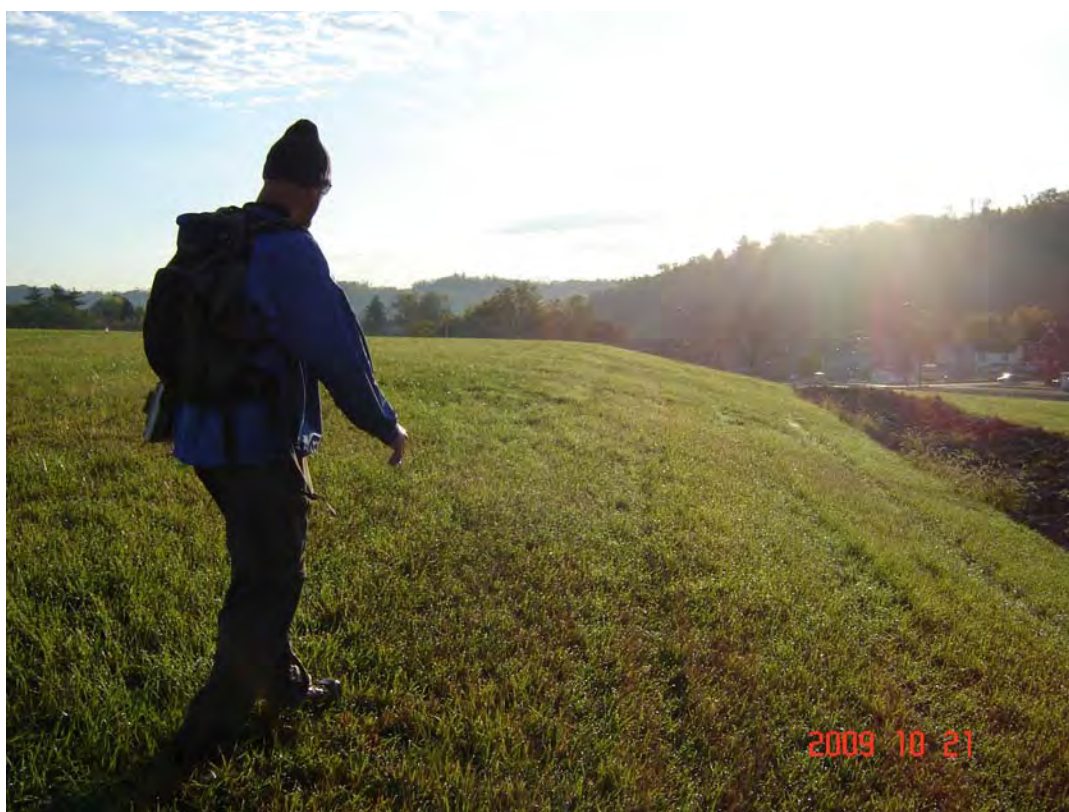
CAN 10/2009. PL-2. Southwest side of the disposal cell.

3A Disposal Cell—The grass-covered disposal cell surface was in excellent condition (PL–2); there was no evidence of slumping, settling, erosion, or other modifying processes. The grass is mowed and mulched in accordance with the LTSP. DOE continued to control Canada thistle and poison hemlock through a combination of mulching and spot-spraying with herbicide, which has greatly reduced the extent of these listed noxious and invasive weeds.

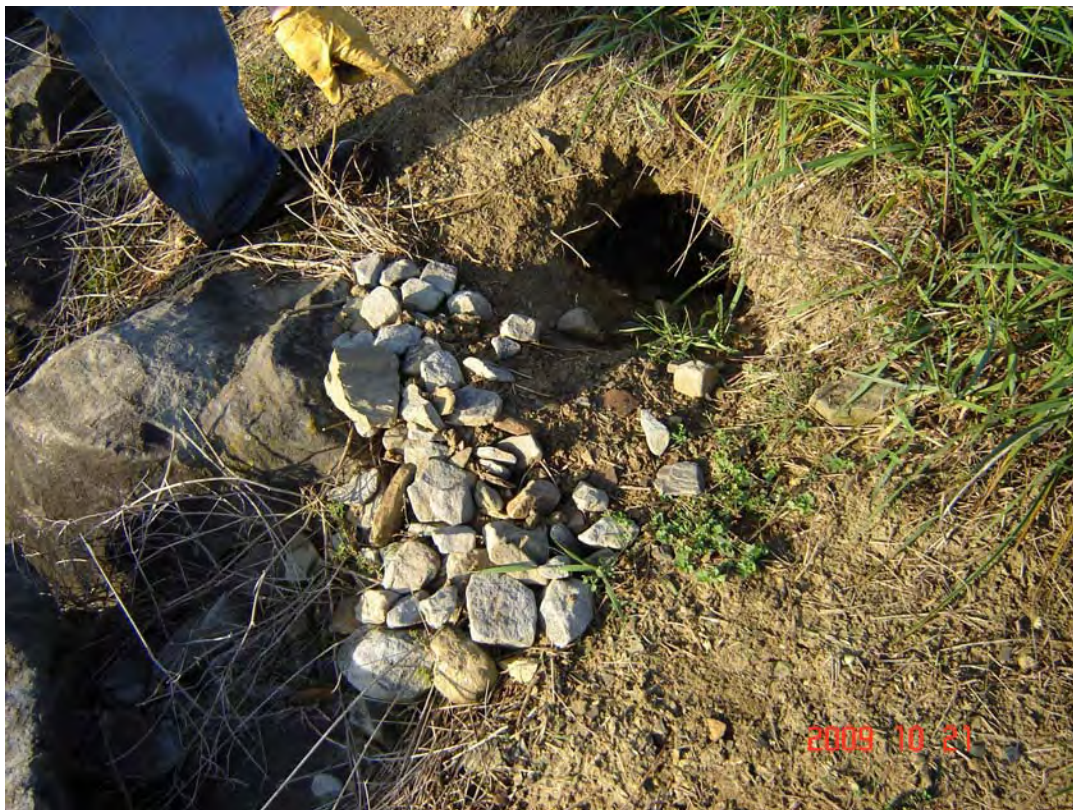
CAN 10/2009. PL-3. Animal burrow on the disposal cell.

3B Animal burrows continue to be observed on the cell cover. Because a 36-inch-thick clay layer (radon barrier), an 18-inch-thick rock layer, and a 12-inch-thick topsoil layer overlie the buried tailings at this site, biointrusion into the tailings is unlikely, and such burrows should not pose a risk to the disposal cell’s integrity or the public’s health. In 2009, a deep burrow that appears to have gone down to the top of the rock layer (PL–3) was discovered. The location, level of activity, and significance of burrows on the cell cover will continue to be monitored.

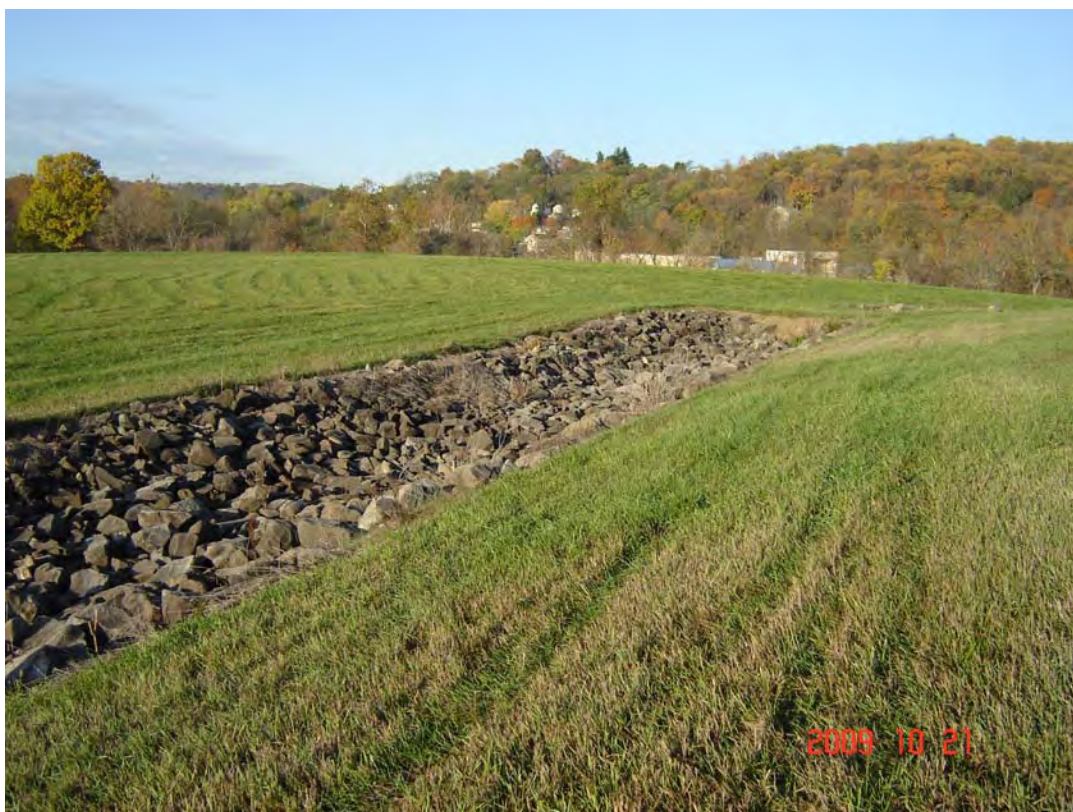
CAN 10/2009. PL-4. Riprap-armored diversion ditch.

Diversion Channels and Perimeter Ditch—Diversion channels around the disposal cell, and the perimeter ditch along the south side of the site, are armored with riprap and were in good condition (PL–4). No indications of diminished rock durability were noted. Woody vegetation that is becoming established in the diversion ditches continues to be controlled by cutting and spraying.

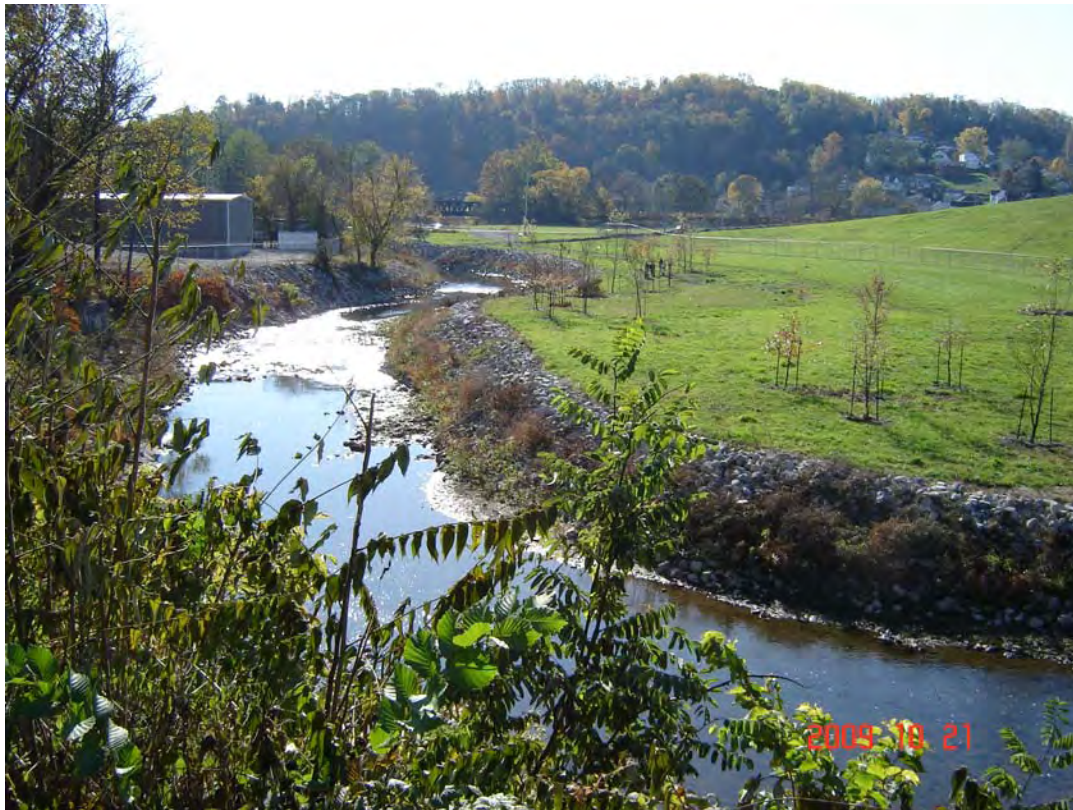
CAN 10/2009. PL-5. New trees planted north of the disposal cell.

- 3D In 2009, re-seeding and the planting of large (greater than 2-inch caliper) saplings took place within the area that was re-graded in 2008 as part of a Stream Bank Stabilization Project (PL-5). The trees were planted under a third-party LM grant.
