## 3.0 Canonsburg, Pennsylvania, Disposal Site

### 3.1 Compliance Summary

The Canonsburg, Pennsylvania, Uranium Mill Tailings Radiation Control Act (UMTRCA) Title I Disposal Site (site) was inspected on October 11, 2018. No changes were observed on the disposal cell or in the associated drainage features. Inspectors identified several minor maintenance needs.

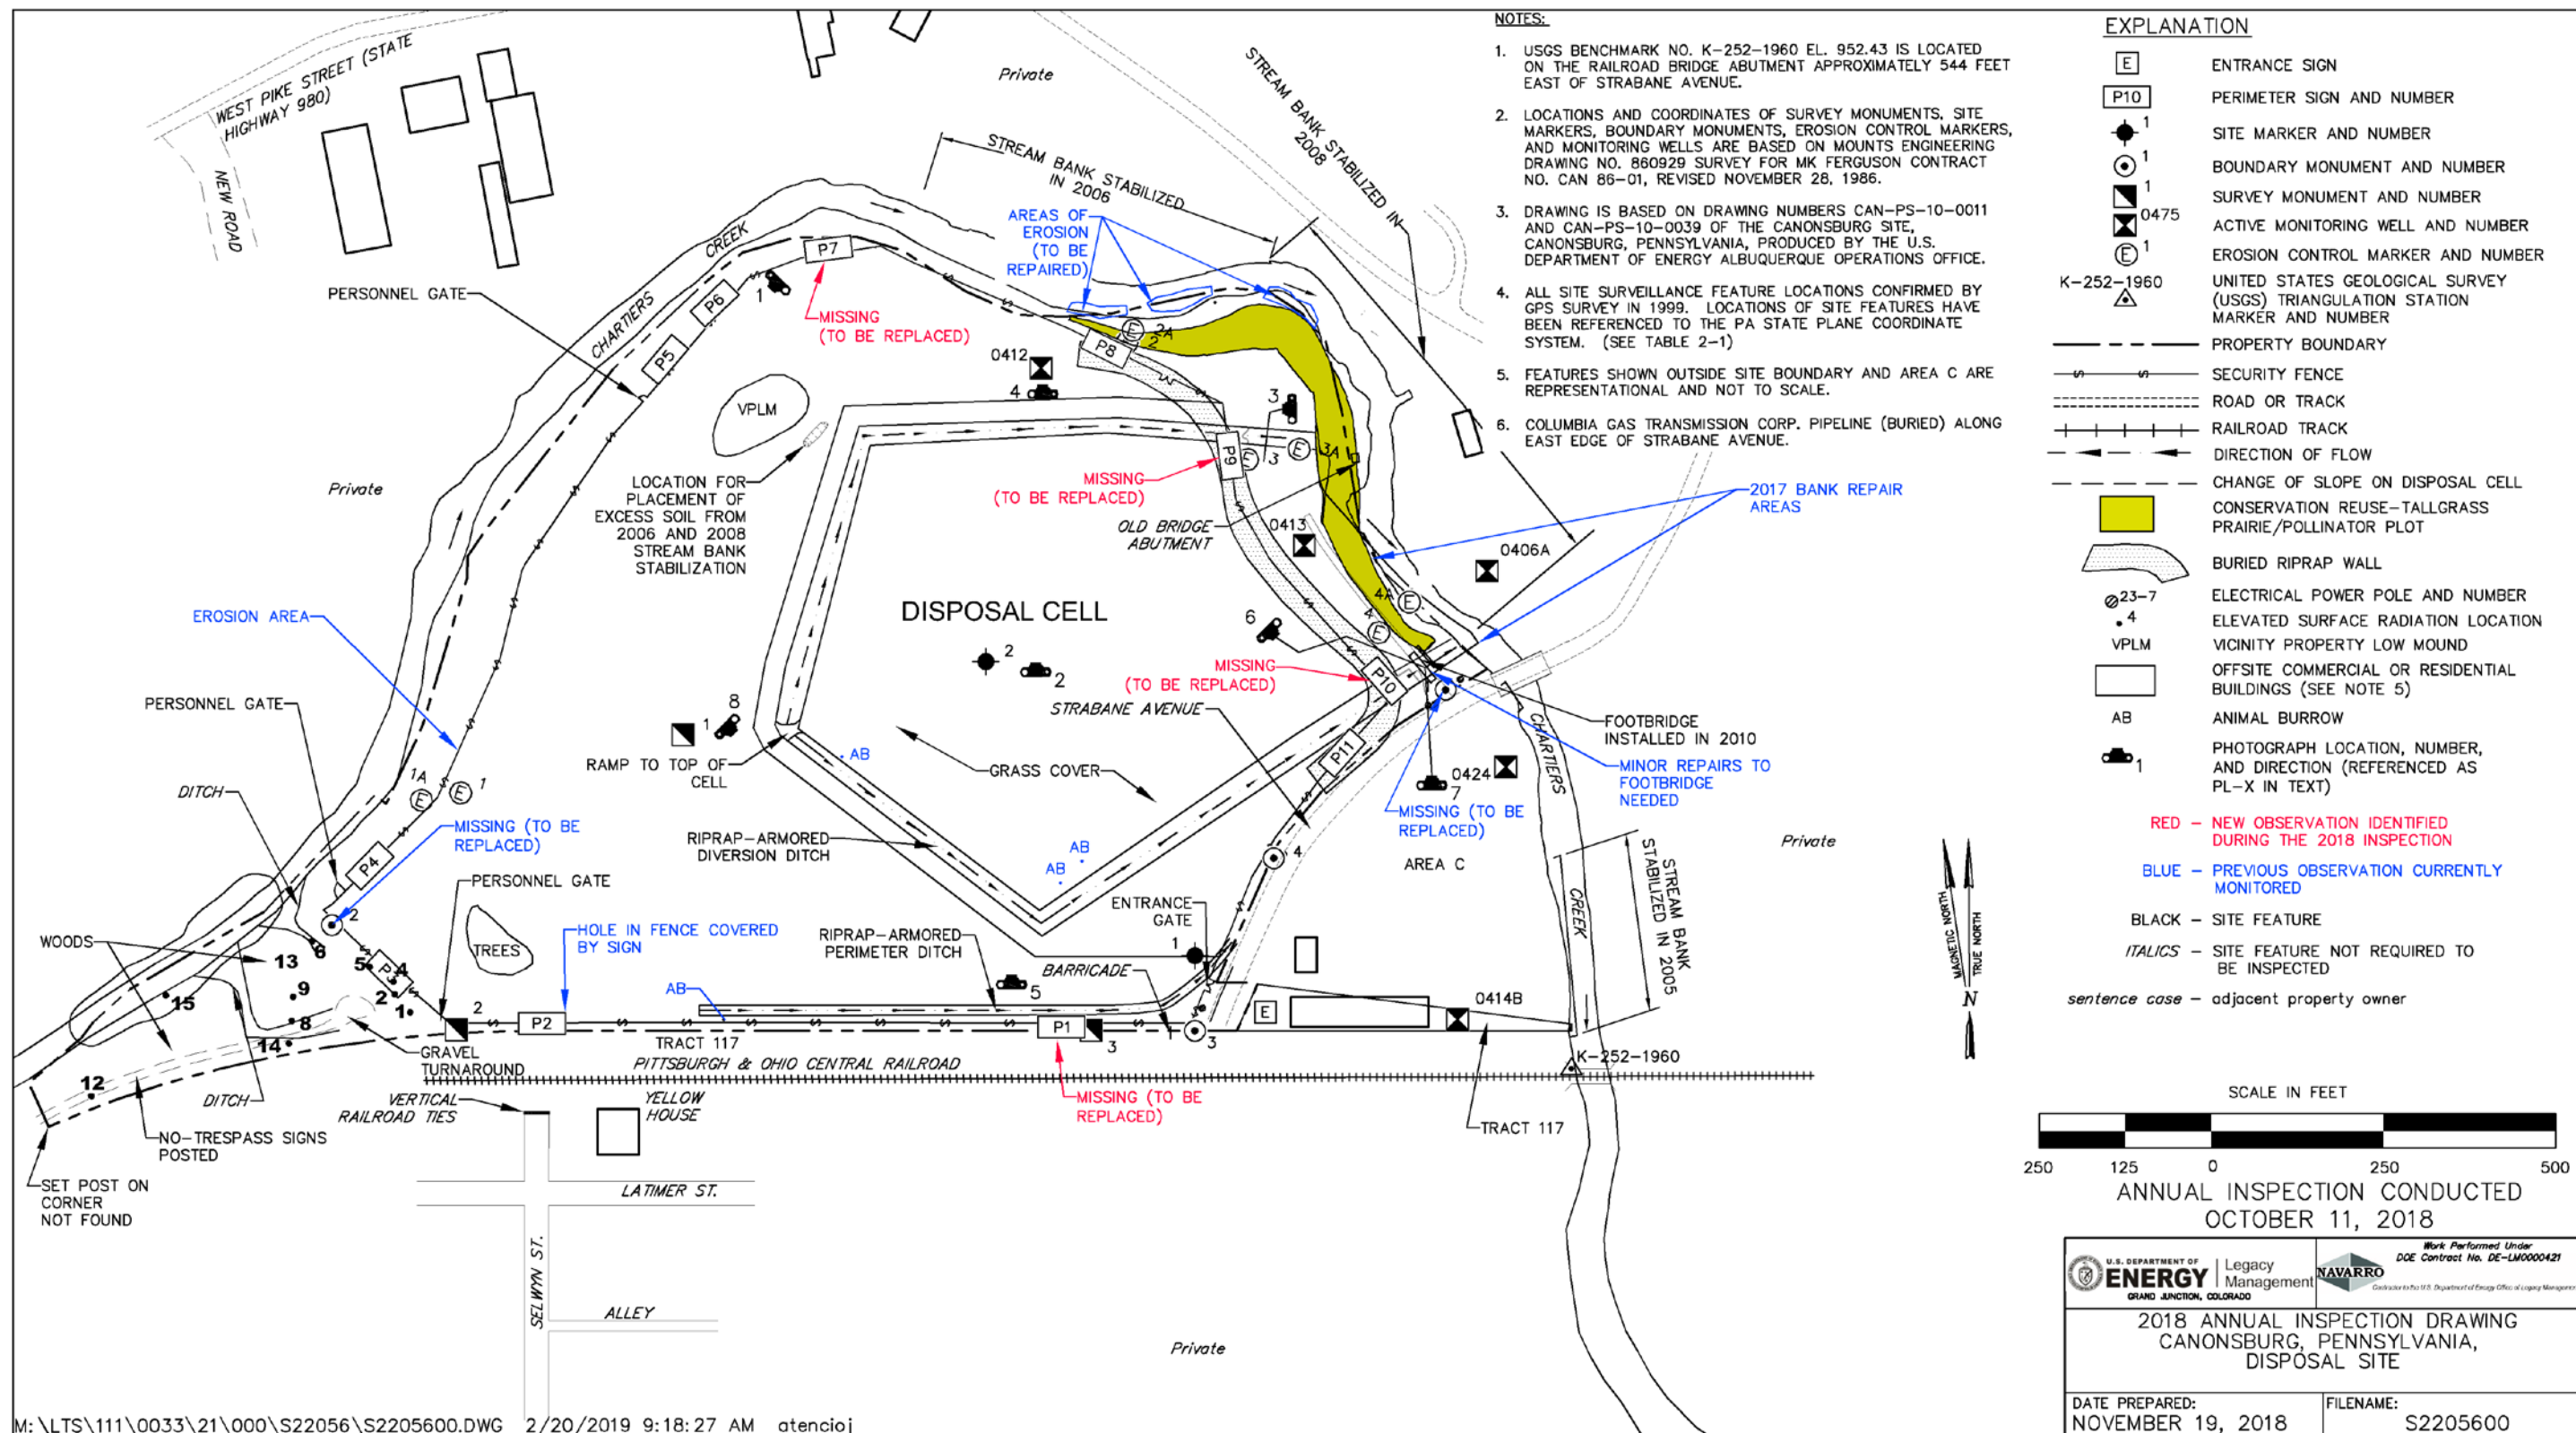
Figure 3-1. 2018 Annual Inspection Drawing for the Canonsburg, Pennsylvania, Disposal Site

Figure 3-1 shows the locations of site features in black, including site surveillance features and inspection areas. Site features that are present but not required to be inspected are shown in italic font. Observations from previous inspections that are currently monitored are shown in blue text, and new observations identified during the 2018 annual inspection are shown in red. Inspection results and recommended maintenance activities associated with site surveillance features are included in the following subsections. Photographs to support specific observations are identified in the text and in Figure 3-1 by photograph location (PL) numbers. The photographs and photograph log are presented in Section 3.10.

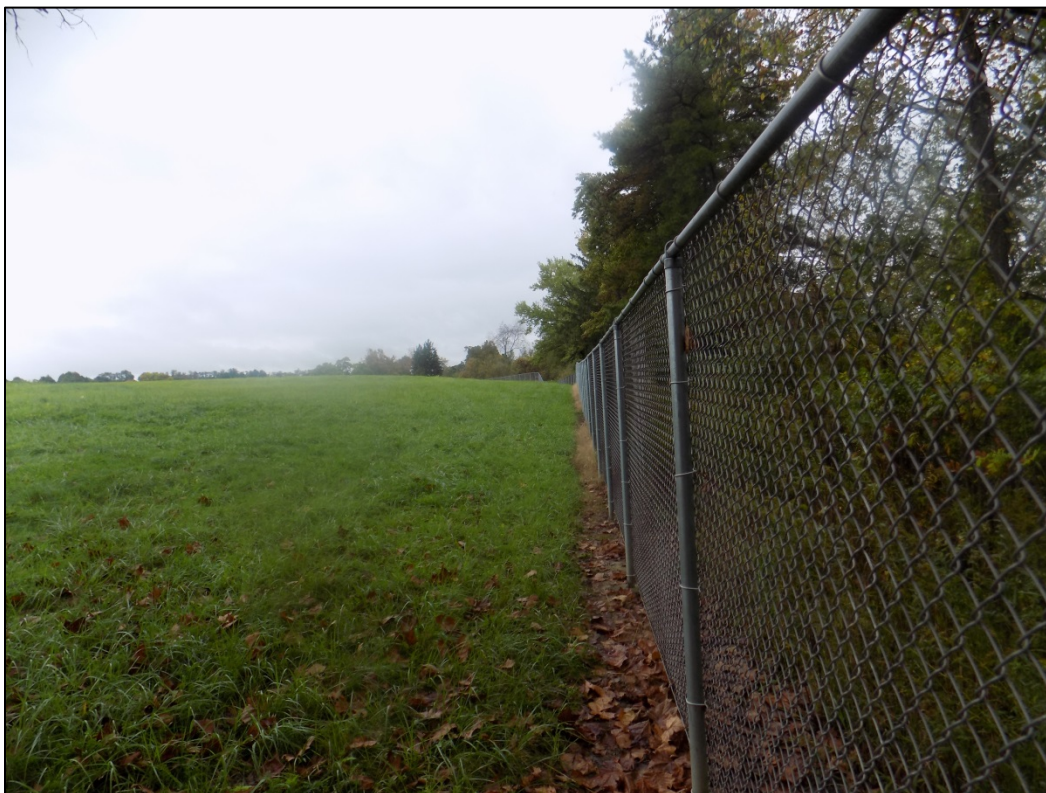
A chain-link security fence encloses most of the site. A vegetation-free buffer zone is maintained around the entire security fence (PL-1). An area of erosion under the west security fence remains. The area appears to be stable and has not grown in several years. For added security, slats were installed in 2016 across the area beneath the fence to help fill in the gap.

*PL-1. Security Fence Line*

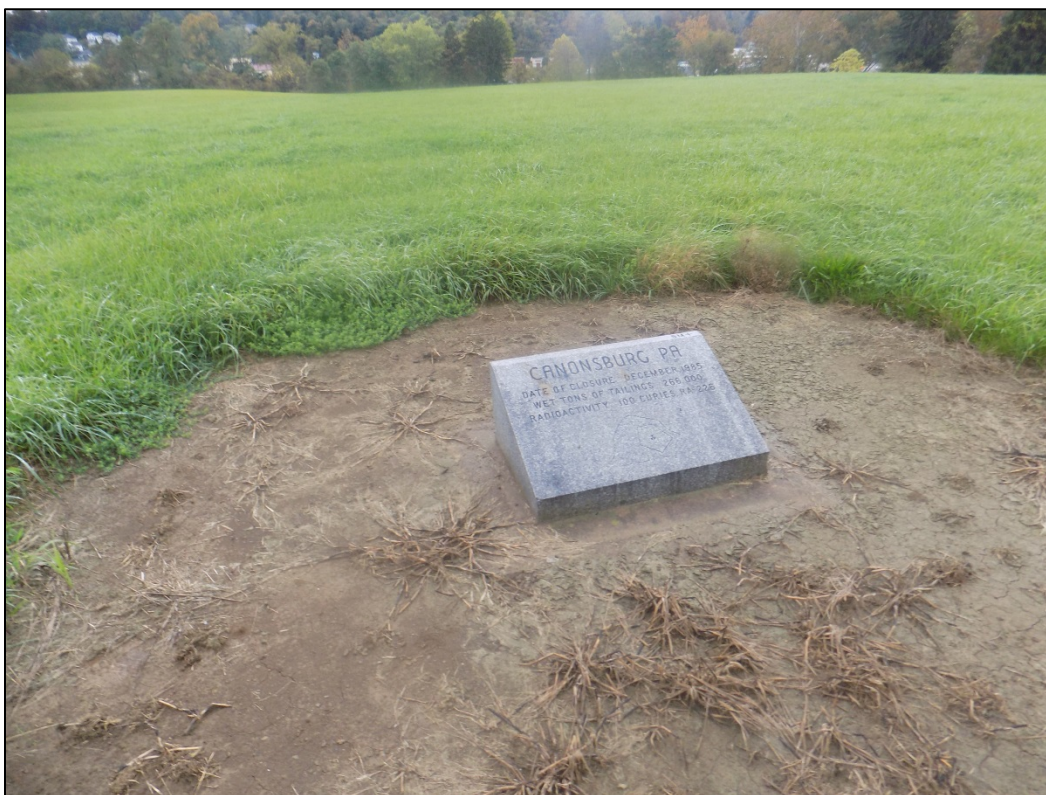
The site has two granite site markers. Site marker SMK-1 is just inside the main entrance gate, and site marker SMK-2 is on the top slope of the disposal cell (PL-2). No maintenance needs were identified.

*PL-2. Site Marker SMK-2*

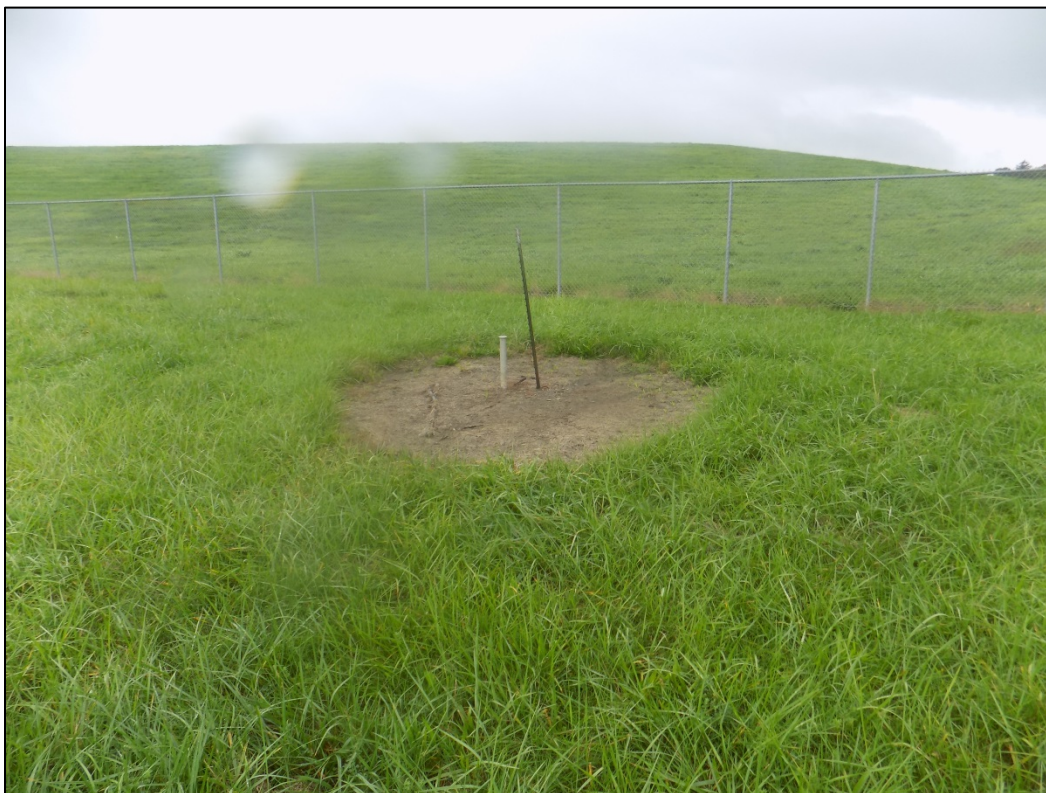
The site has four pairs of erosion control markers along the bank of Chartiers Creek (PL-3). No maintenance needs were identified.

*PL-3. Erosion Control Marker EC-3*

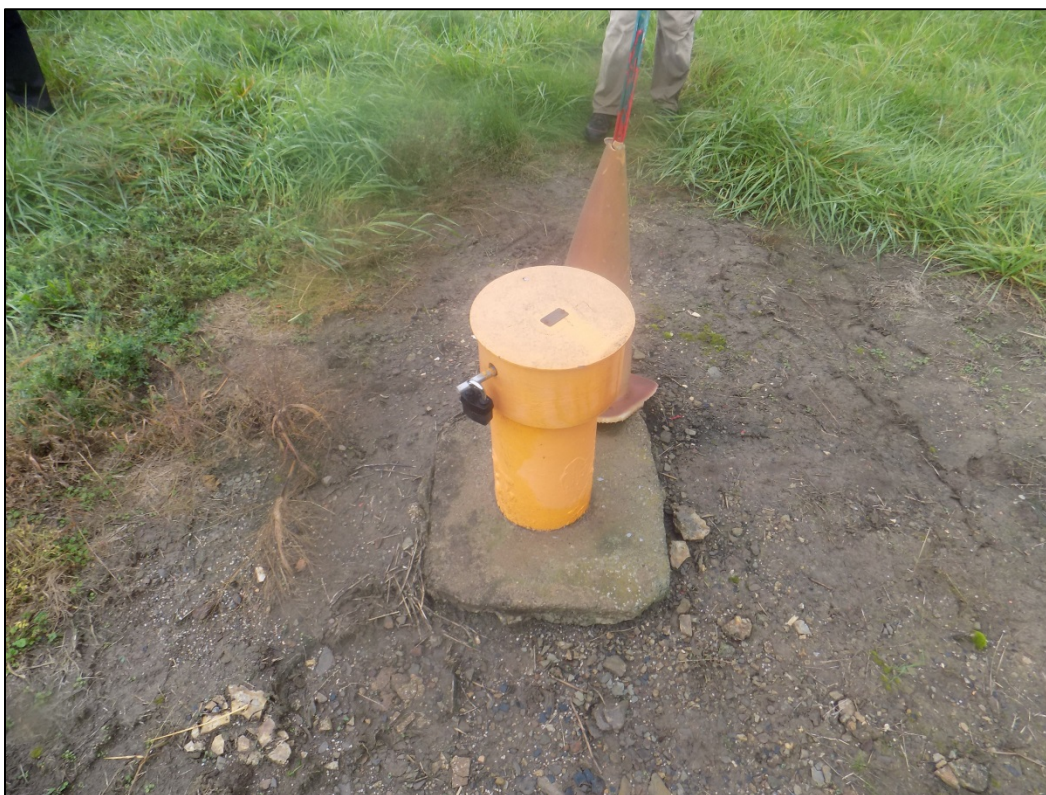
The site has five groundwater monitoring wells that are inspected when they are sampled (PL-4). Monitoring wells were sampled and inspected in October 2018. All wellhead protectors that were observed during the inspection were undamaged and locked. No maintenance needs were identified.

*PL-4. Monitoring Well 0412*

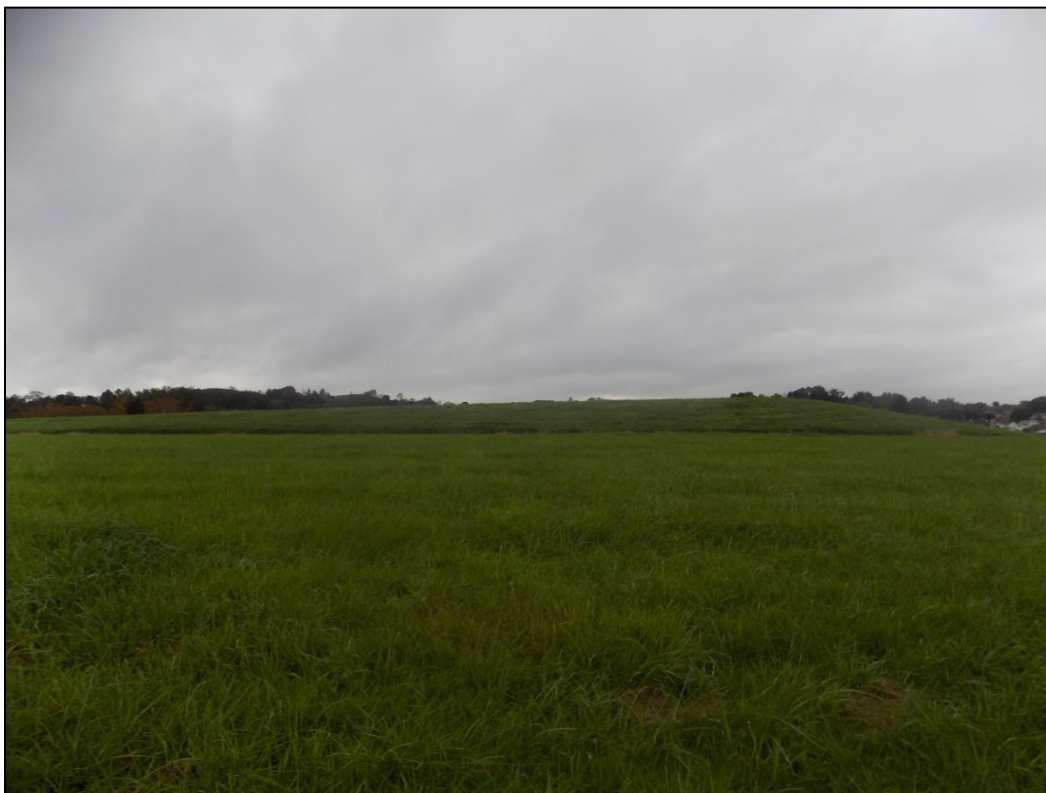
The disposal cell, completed in 1985, occupies 6.8 acres and is covered in grass (PL-5). There was no evidence of erosion, settling, slumping, or other modifying processes that might affect the integrity of the disposal cell. Animals burrow on the disposal cell cover, but such burrows should not pose a risk to disposal cell integrity or public health because the buried tailings are overlain by a 36-inch-thick clay layer (radon barrier), an 18-inch-thick rock layer, and a 12-inch-thick topsoil layer. Biointrusion down to or through the radon barrier is unlikely. Inspectors will continue to monitor the location and the significance of burrows. No new significant burrows were noted on the disposal cell during the inspection. No maintenance needs were identified.

*PL-5. Southeast Corner of Disposal Cell*

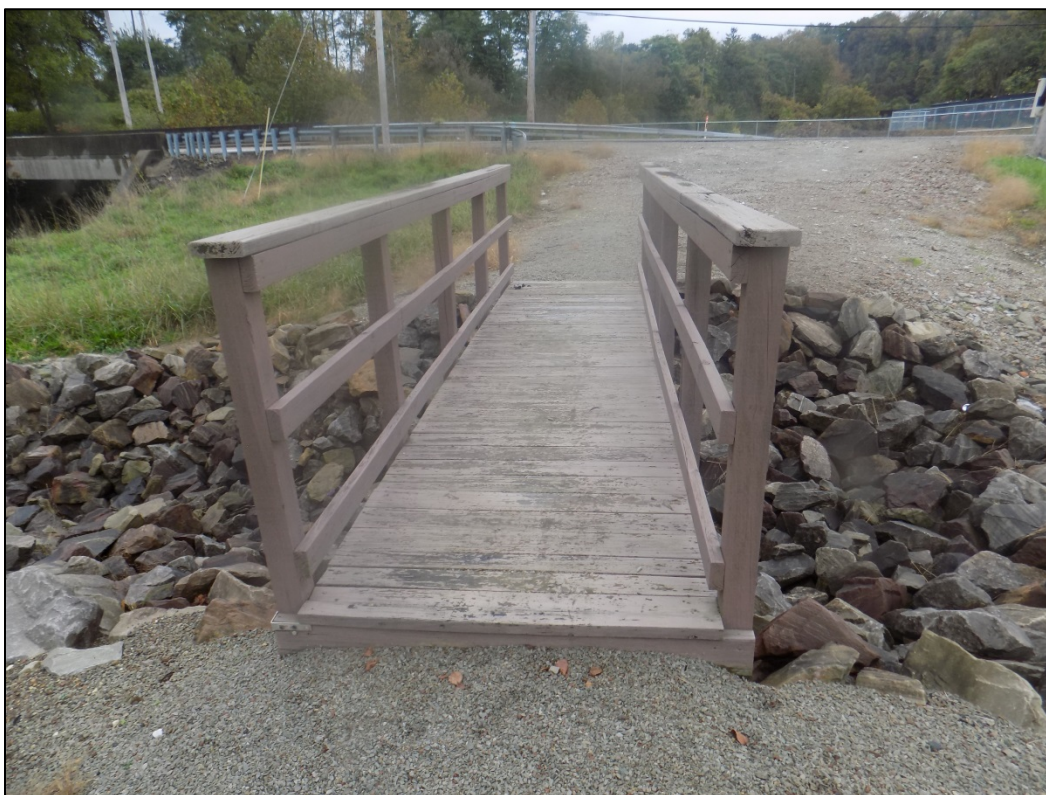
A small pedestrian bridge was installed northeast of the disposal cell in 2010 (PL-6). Minor repairs to the bridge are needed. A loose vertical handrail support was temporarily repaired in 2017 but requires a more permanent fix (PL-7), and the west end of the south handrail is beginning to rot. These repairs will be made at a later date pending budget and schedule. No other maintenance needs were identified.

*PL-6. Pedestrian Footbridge*

Additionally, repairs will be made to erosion along Chartiers Creek in summer 2019. Minor repairs to the pedestrian bridge will be made at a later date pending budget and schedule. No other maintenance needs were identified.

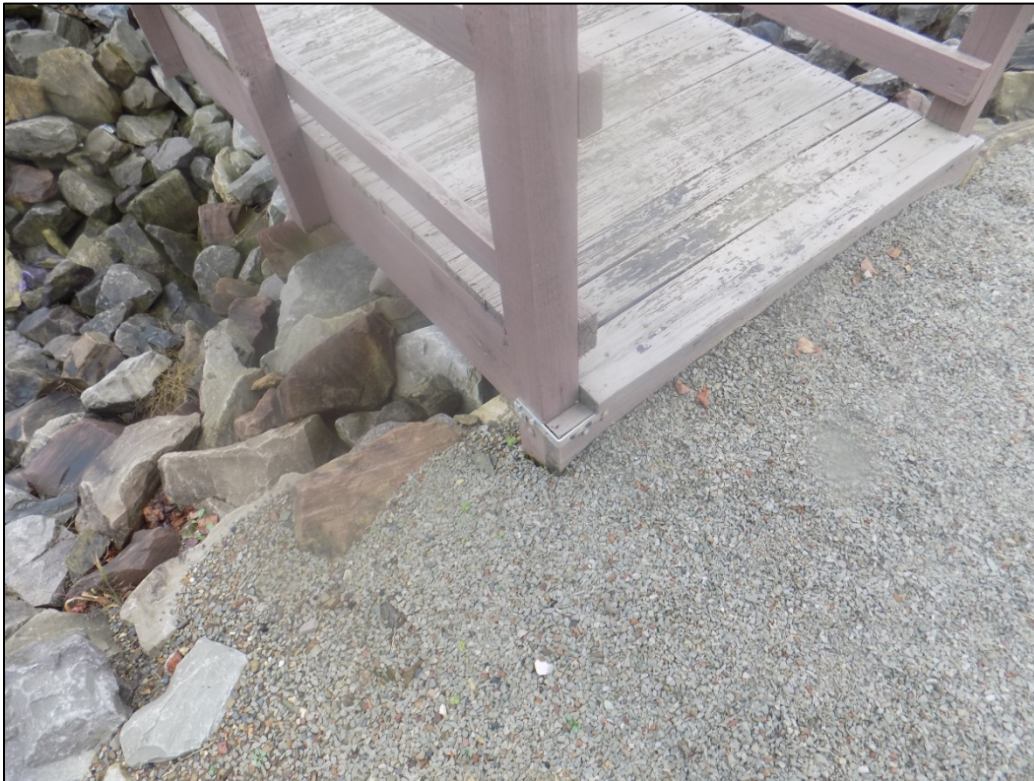
*PL-7. Temporary Repair to Pedestrian Footbridge Rail Support*

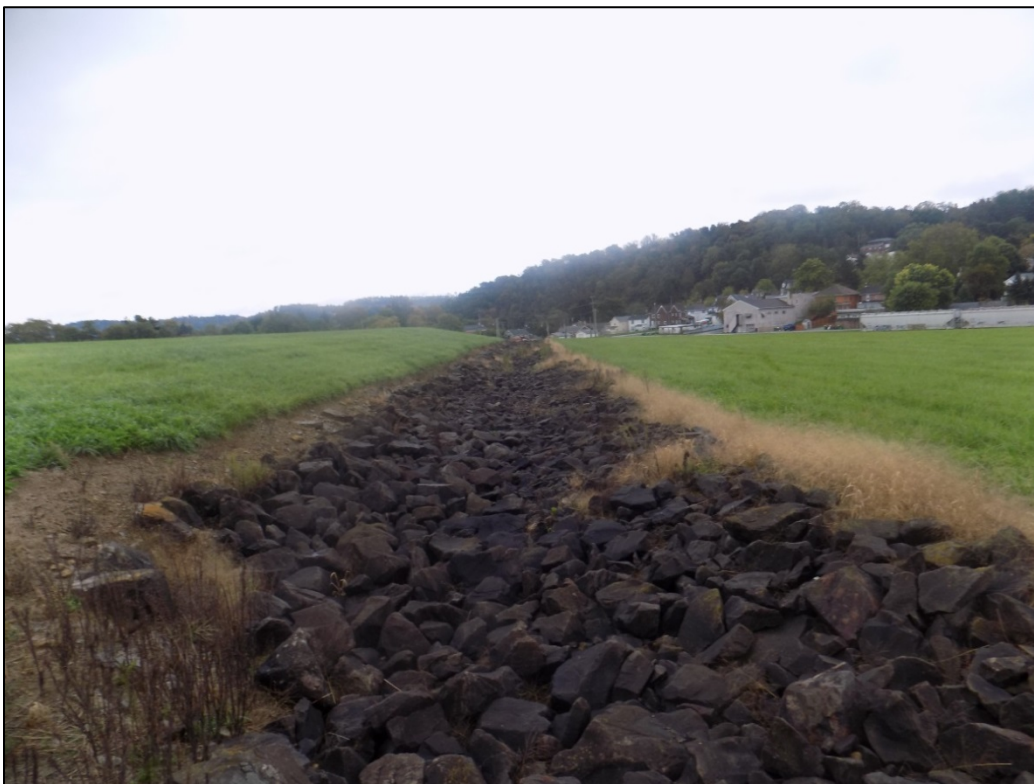
There was no evidence of rock deterioration or woody vegetation in the diversion channels and perimeter ditches (PL-8). Periodic physical removal and spot herbicide applications have been effective at reducing woody vegetation and will continue to be conducted as needed. No maintenance needs were identified.

*PL-8. Riprap-Armored Diversion Ditch*
