5.0 Falls City, Texas, Disposal Site

5.1 Compliance Summary

The Falls City, Texas, Uranium Mill Tailings Radiation Control Act (UMTRCA) Title I Disposal Site, was inspected on January 15, 2008. The disposal cell and all associated surface water diversion and drainage structures were in excellent condition and functioning as designed. Control of deep-rooted woody vegetation on the top and side slopes of the disposal cell continues. Grass continues to be cut and baled on site, including on the disposal cell cover. Minor fence repair were performed and one missing perimeter sign was replaced. Groundwater monitoring was performed; generally, historical trends continue, although the uranium concentration in well MW-0880 decreased significantly. NRC concurrence in the revised LTSP was received after the annual inspection was conducted; however, changes to the monitoring program were implemented. No maintenance needs or cause for a follow-up or contingency inspection was identified.

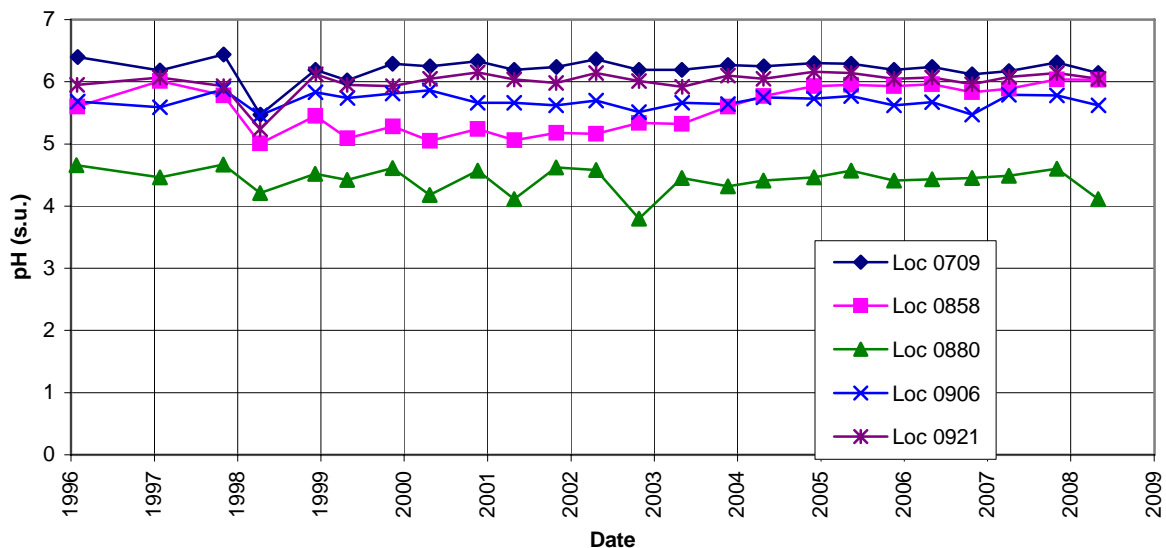
Figure 5-3. pH in Groundwater at Cell Performance Monitoring Locations at the Falls City Disposal Site

At the cell performance wells, pH levels have historically been within approximately 1 to 2 standard units of measurement, with no significant upward or downward trends evident. In 2008, the pH levels for the cell performance wells remained within the historical range (Figure 5-3), although a slight long-term decline may be occurring.

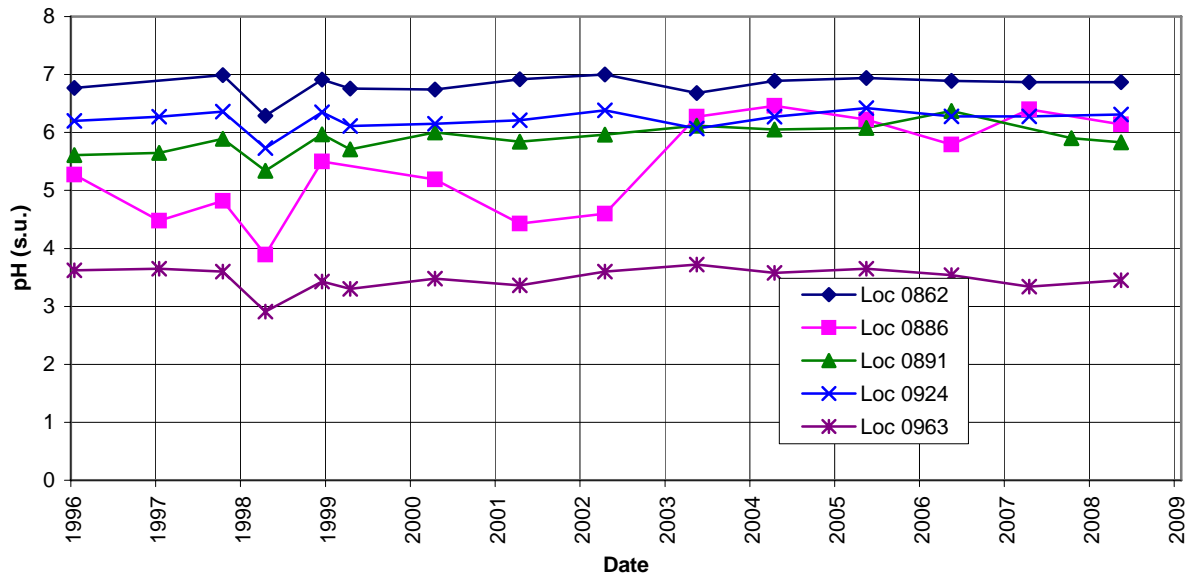
Figure 5-4. pH in Groundwater at Compliance Monitoring Locations at the Falls City Disposal Site

At the compliance monitoring wells, pH levels have historically been within approximately 2 to 3 standard units of measurement, with no significant upward or downward trends evident. In 2008, the pH levels for the compliance monitoring wells all were stable and within the historical range (Figure 5-4).

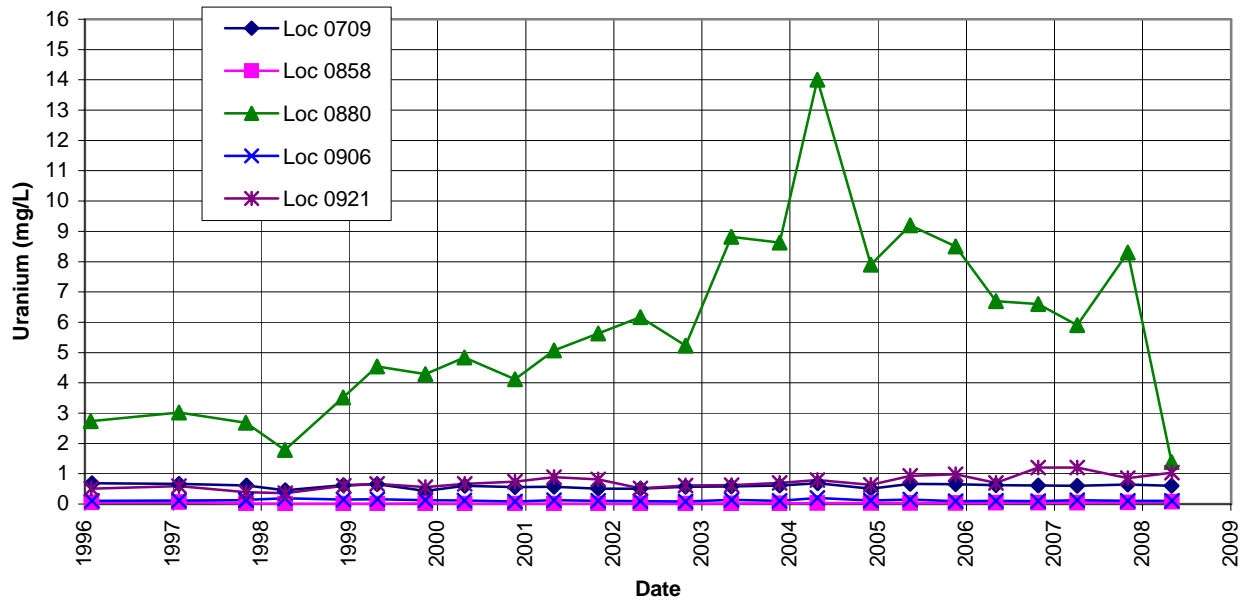
Figure 5-5. Uranium in Groundwater at Cell Performance Monitoring Locations at the Falls City Disposal Site

The uranium concentrations in the cell performance network remained stable and within the historical range, approximately 1.0 milligrams per liter (mg/L), or less, with one exception. At well MW-0880, uranium has varied from which rose to a high concentration of 14 mg/L in 2004 and to a low of 1.38 mg/L in 2008 (Figure 5-5). Historically, the concentration of uranium in this well has been variable and, until 2008, substantially greater than the uranium concentrations reported historically in the other site wells. In 2008, the uranium concentration in well MW-0880 decreased significantly and was comparable with the other wells in the cell performance network. Because pH at this location has not fallen significantly, the uranium concentrations reported historically are most likely the result of the natural redistribution of uranium mineralization. However, although the pH at this location has not fallen significantly, it has been lower than at other nearby wells, which may indicate that legacy, contamination persists at well MW-0880.

The explanation for the previously higher concentrations of uranium displayed in this well is not entirely clear, but it may be a result of (1) transient drainage from the disposal cell (i.e., tailings pore water), (2) residual processing-site-related contamination (i.e., historical), or as mentioned above (3) the natural redistribution of uranium mineralization. Additionally, the reason for the variation and the relatively higher concentration of uranium in well MW-0880, as compared with concentrations in other wells, is ambiguous and difficult to explain because tailings pore water is very similar chemically to the processing-site-related contamination, and groundwater at other monitor wells nearby does not show this historical variability or similarly elevated concentrations of uranium.

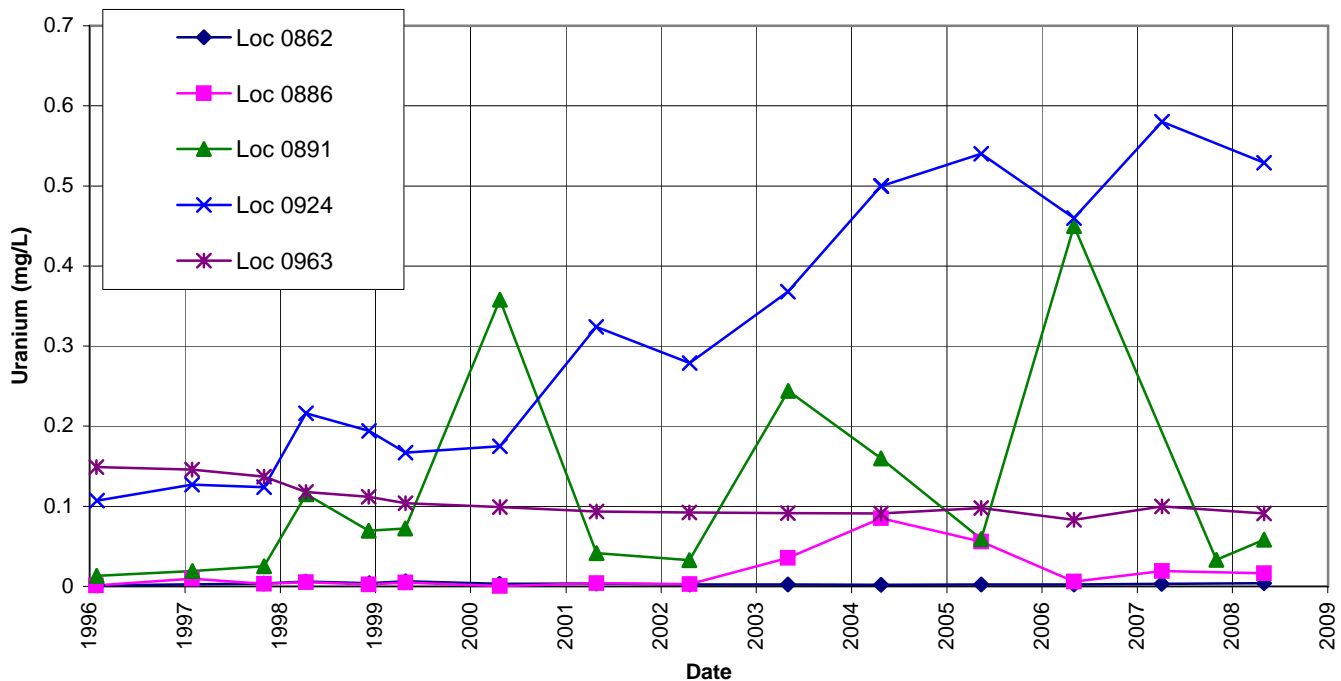
Figure 5-6. Uranium in Groundwater at Compliance Monitoring Locations at the Falls City Disposal Site

The concentration of uranium in groundwater within the compliance monitoring network displays three distinct trends: stable (wells MW-0862, MW-0886, and MW-0963), variable

(well MW-0891), and upward (well MW-0924) (Figure 5-6). Well MW-0924 continues to have the highest concentration of uranium in the compliance monitoring network. The concentrations at MW-0891 continue to fluctuate with no discernable trend; however, after reaching a historical high in 2006 (0.45 mg/L), the concentration declined to 0.033 mg/L in 2007 and 0.058 mg/L in 2008. In 2007 and 2008, the uranium concentrations reported in the remaining three compliance monitoring network wells were all within the historical range (less than 0.15 mg/L), with no significant trends evident.

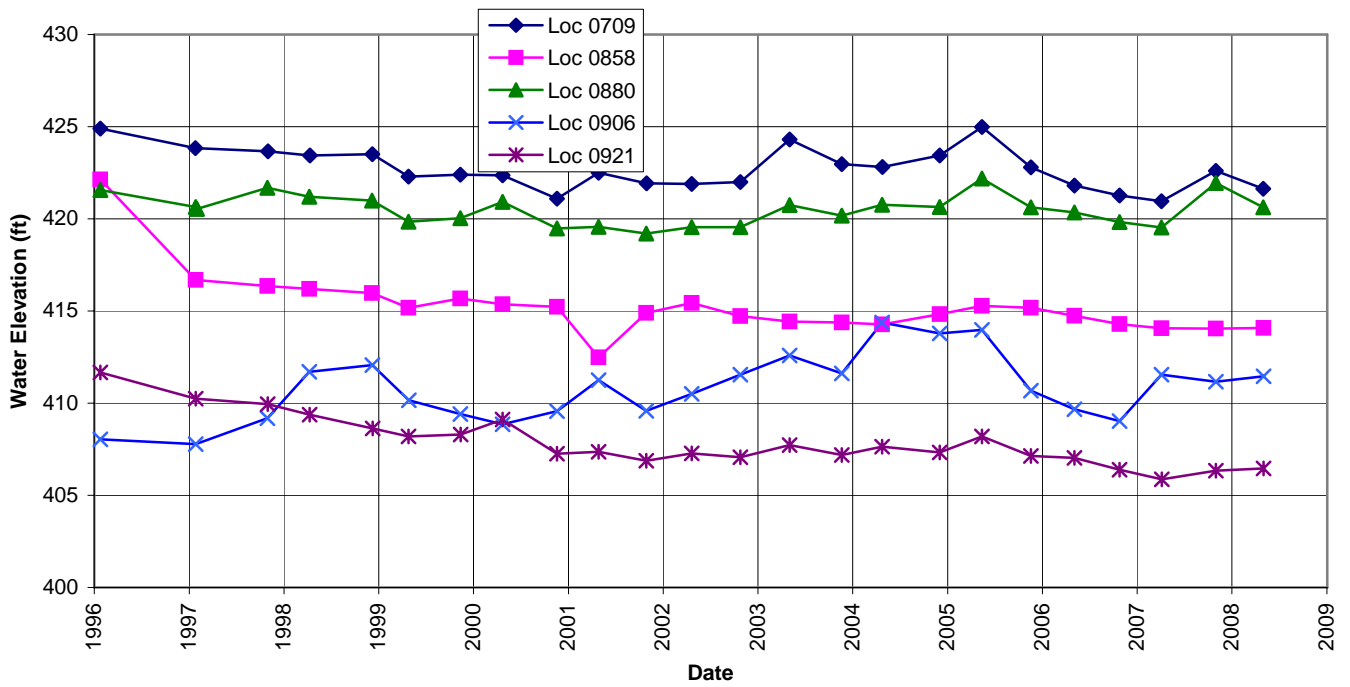
Figure 5–7. Water-Level Measurements at Cell Performance Monitoring Locations at the Falls City Disposal Site

Groundwater Level Monitoring Results—Groundwater levels in the disposal cell performance network wells displayed a decreasing trend with one exception: well MW-0906, which (although variable) showed an overall increasing trend. The fluctuation does not appear to be seasonal, nor does the water level track with the other wells in the network. The 2007–2008 levels were within the historical values and appear to be stabilizing (Figure 5-7). Monitor well MW-0906 is located directly down slope of the disposal cell, and the historical fluctuation may be the result of the infiltration of water shed by and conveyed away from the disposal cell, reflecting variations in annual precipitation. Other contributors that may influence local groundwater levels include (1) dissipation of the processing-site-related groundwater mound beneath the disposal cell, and (2) dissipation of transient drainage from the disposal cell.

Two cell performance monitor wells, MW-0908 and MW-0916, are not shown on Figure 5-7. These wells, designated for groundwater level monitoring only, are completed in the unsaturated zone of the Conquista Sandstone and have been dry since 1996.

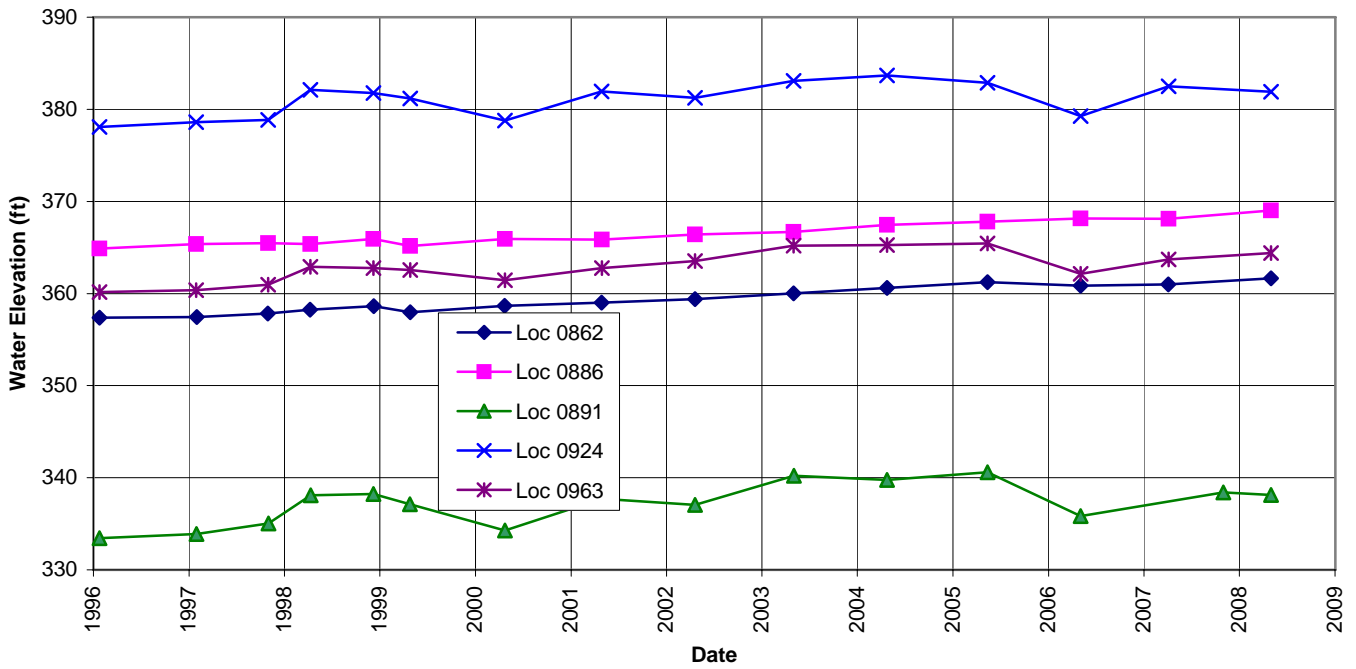
Figure 5–8. Water-Level Measurements at Compliance Monitoring Locations at the Falls City Disposal Site

In contrast, water levels in the groundwater compliance monitoring network wells have all steadily increased several feet since monitoring began in 1996, indicating a regional effect (Figure 5-8). Water levels in 2007 and 2008 continue trending upward, although the increase has been gradual, only a few feet over more than 20 years.

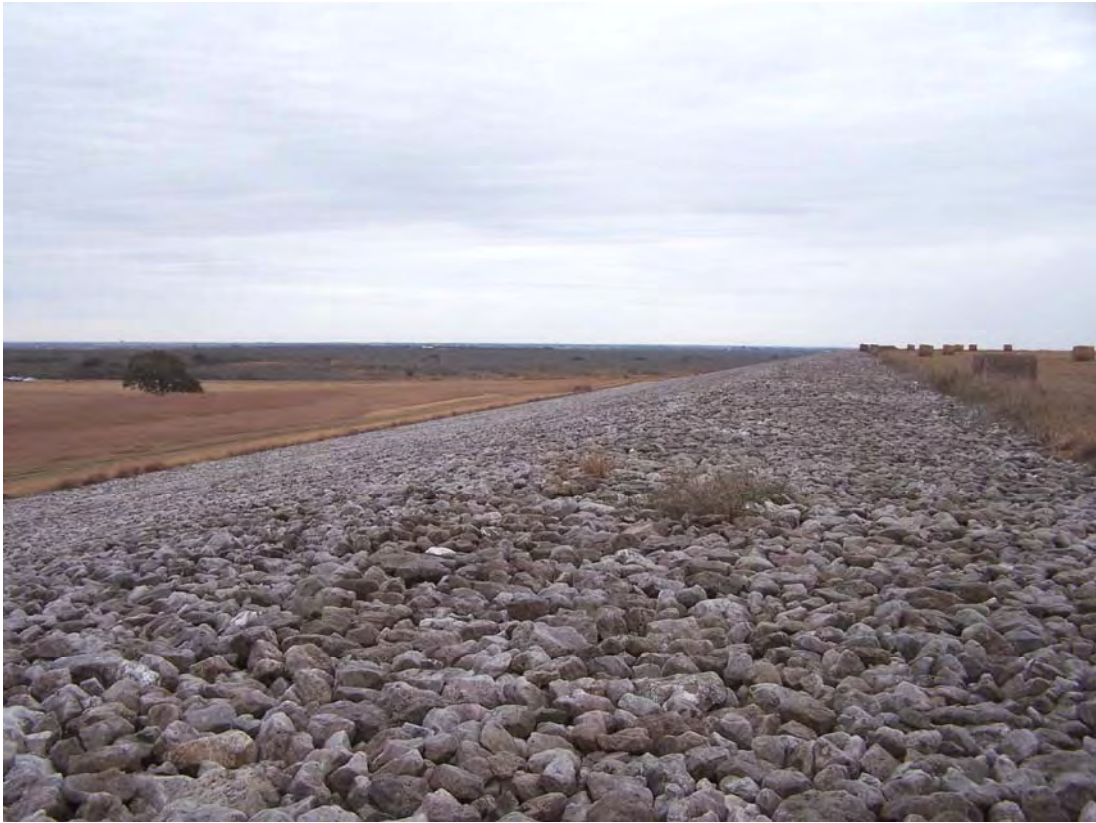
Top and Side Slopes of the Disposal Cell—The top of the disposal cell is covered with well-established grass and was in good condition; there was no indication of settlement, rock degradation, erosion, or other sign of instability. A local rancher cuts and bales hay each year from the disposal site, including the top of the cell (PL-1). The grass on the cell top had been cut short to control the risk of fire. Deep-rooted vegetation that encroaches on the disposal cell is controlled in accordance with the LTSP. Deep-rooted vegetation is of concern because it can penetrate the radon barrier. There was a minor amount of deep-rooted vegetation found on top of the disposal cell at the time of the inspection.

FCT 1/2008. PL-1. Northwest side slope of the disposal cell; hay bales on cell top.

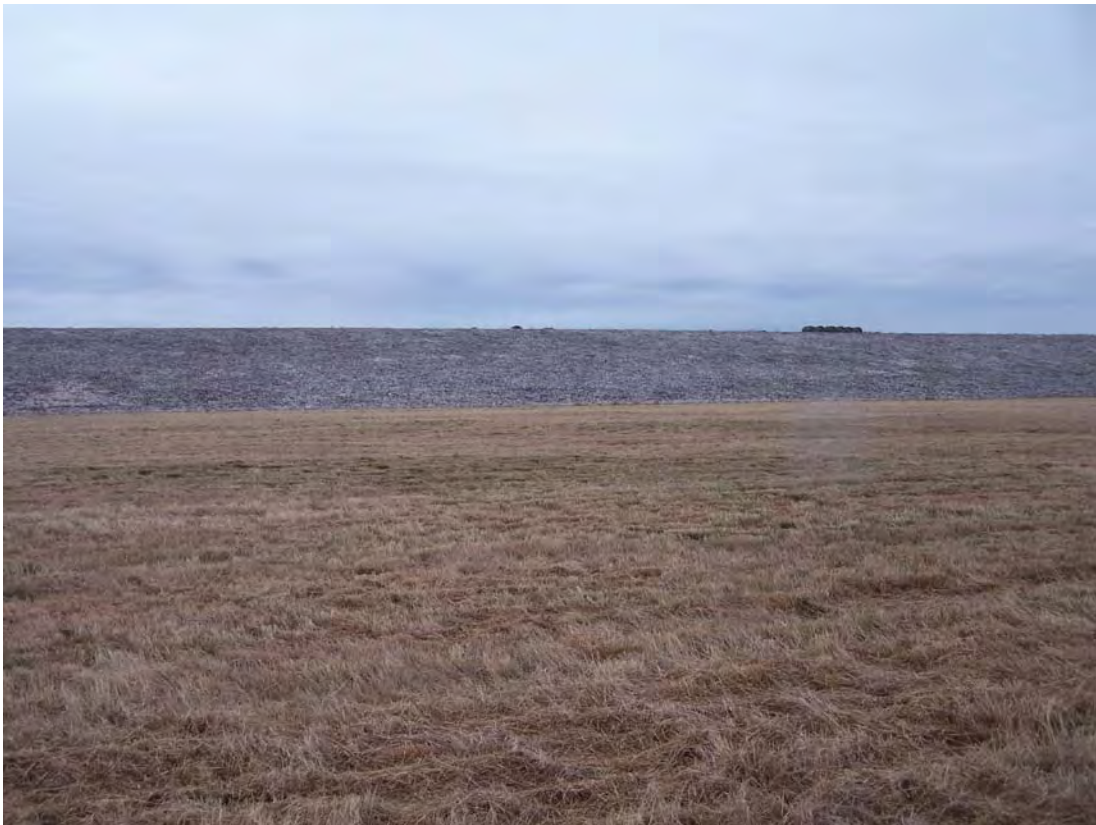
The side slopes are covered with riprap and are in good condition (PL-2). As noted during previous inspections, minor amounts of fractured riprap were observed along the side slopes. The fractured riprap apparently is an artifact of the quarrying and placement of the rock. Monitoring locations were established with T-posts, and reference photos will be taken during inspections (PL-3). This monitoring is not a requirement of the LTSP, but it is being conducted to demonstrate that the riprap is not deteriorating. During the 2008 inspection, no evidence was found to suggest that the riprap is degrading.

Site Perimeter—The area between the perimeter fence and the toe of the disposal cell is covered with well-established grass. The grass-covered areas between the disposal cell and the property line were cut short to reduce the risk of fire (PL-2).

FCT 1/2008. PL-2. Southeast side slope of the disposal cell.

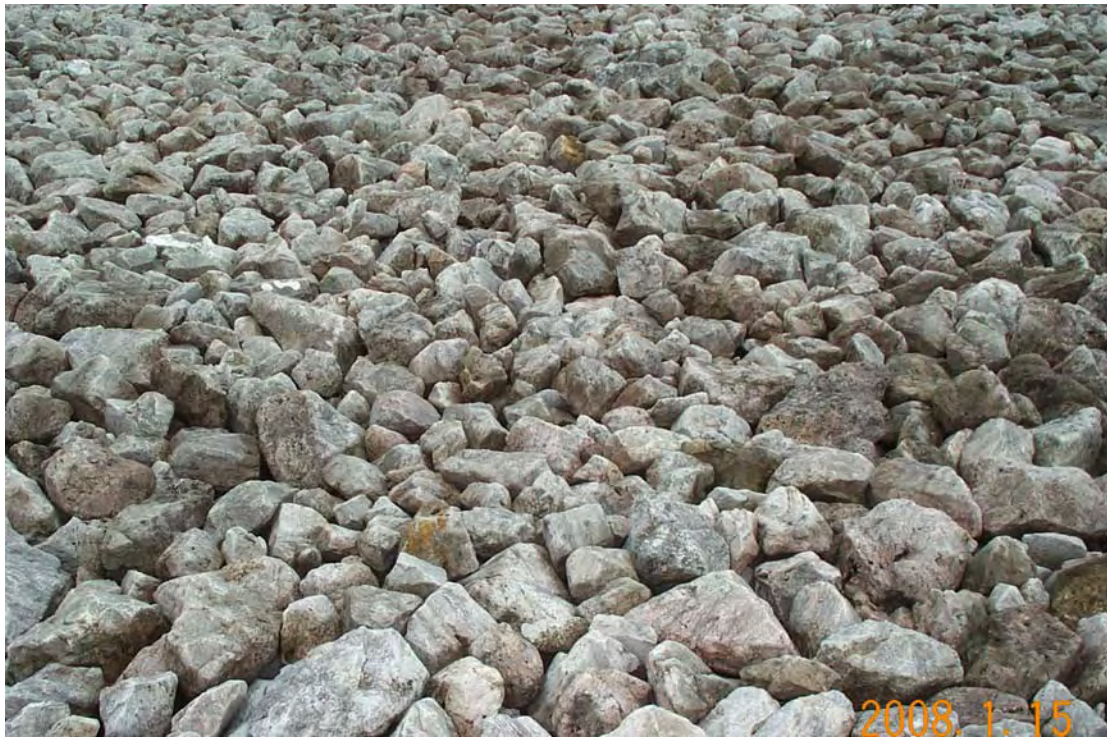
FCT 1/2008. PL-3. Reference photo of riprap adjacent to disposal cell access ramp.

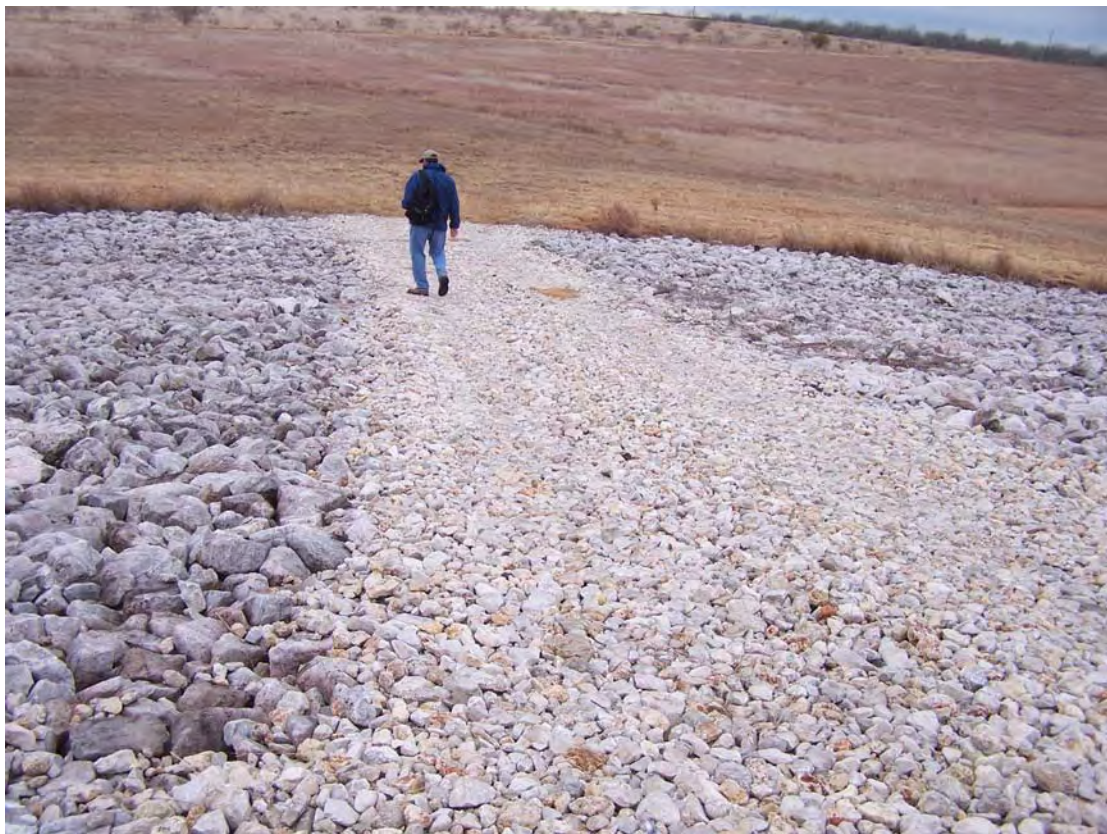
An access ramp was installed at the west corner of the side slope. No changes in the access ramp or the side slope were observed (PL-4).

FCT 1/2008. PL-4. Aggregate ramp on the west corner of the disposal cell.

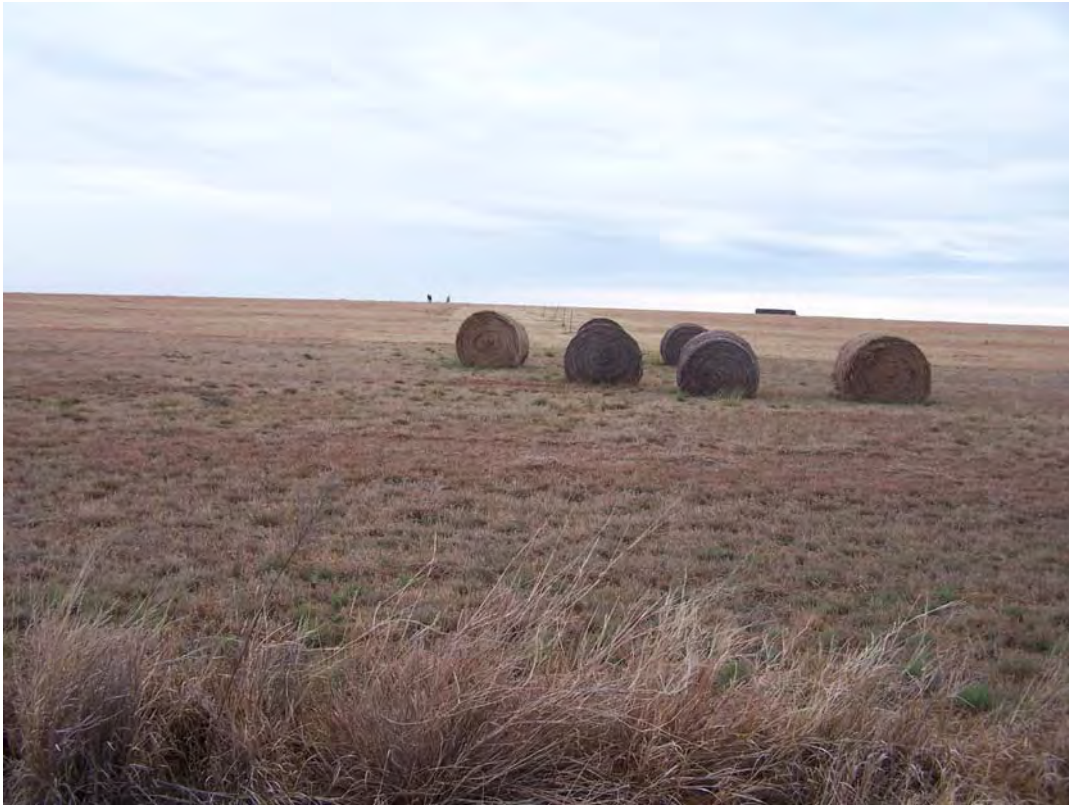
Vegetation management on the top of the cell (PL-5) and side slopes (PL-2) was excellent. Much of the vegetation seen on the side slopes was dead or dormant grass. DOE anticipates that the control of undesirable vegetation on the side slopes will be ongoing.

FCT 1/2008. PL-5. Vegetation management on the disposal cell top.

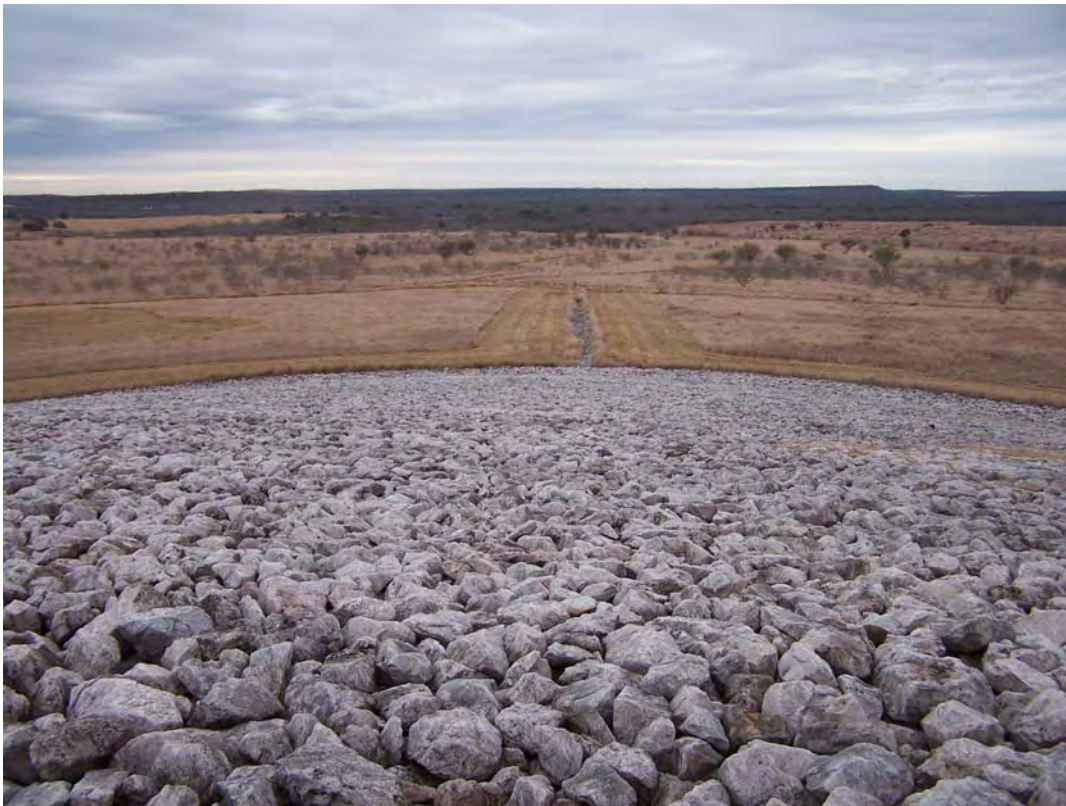
No water was observed flowing in the north or south rock drains, and the drains appeared to be functioning as designed (PL-6). Grass growing in both drains (as noted in previous inspections) is not sufficient to impede the flow of water draining from the cell apron. The apron outfall, midway along the northeast side slope, is not yet affected by grass encroachment. Grass in the rock drains may actually assist in dissipating the energy of site runoff, and may, therefore, be a desirable feature. No willows were noted this year in the drainage ditch running from the south corner of the disposal cell (PL-6). Vegetation needs to be removed from the culvert northeast of perimeter sign P50.

FCT 1/2008. PL-6. South side slope of the disposal cell; south rock drain in the background.
