COMPLETION OF DECONTAMINATION OF GILMAN HALL, UNIVERSITY OF CALIFORNIA AT BERKELEY

RADIOLOGICAL SURVEY AND REMEDIAL ACTIONS

GILMAN HALL, UNIVERSITY OF CALIFORNIA, BERKELEY

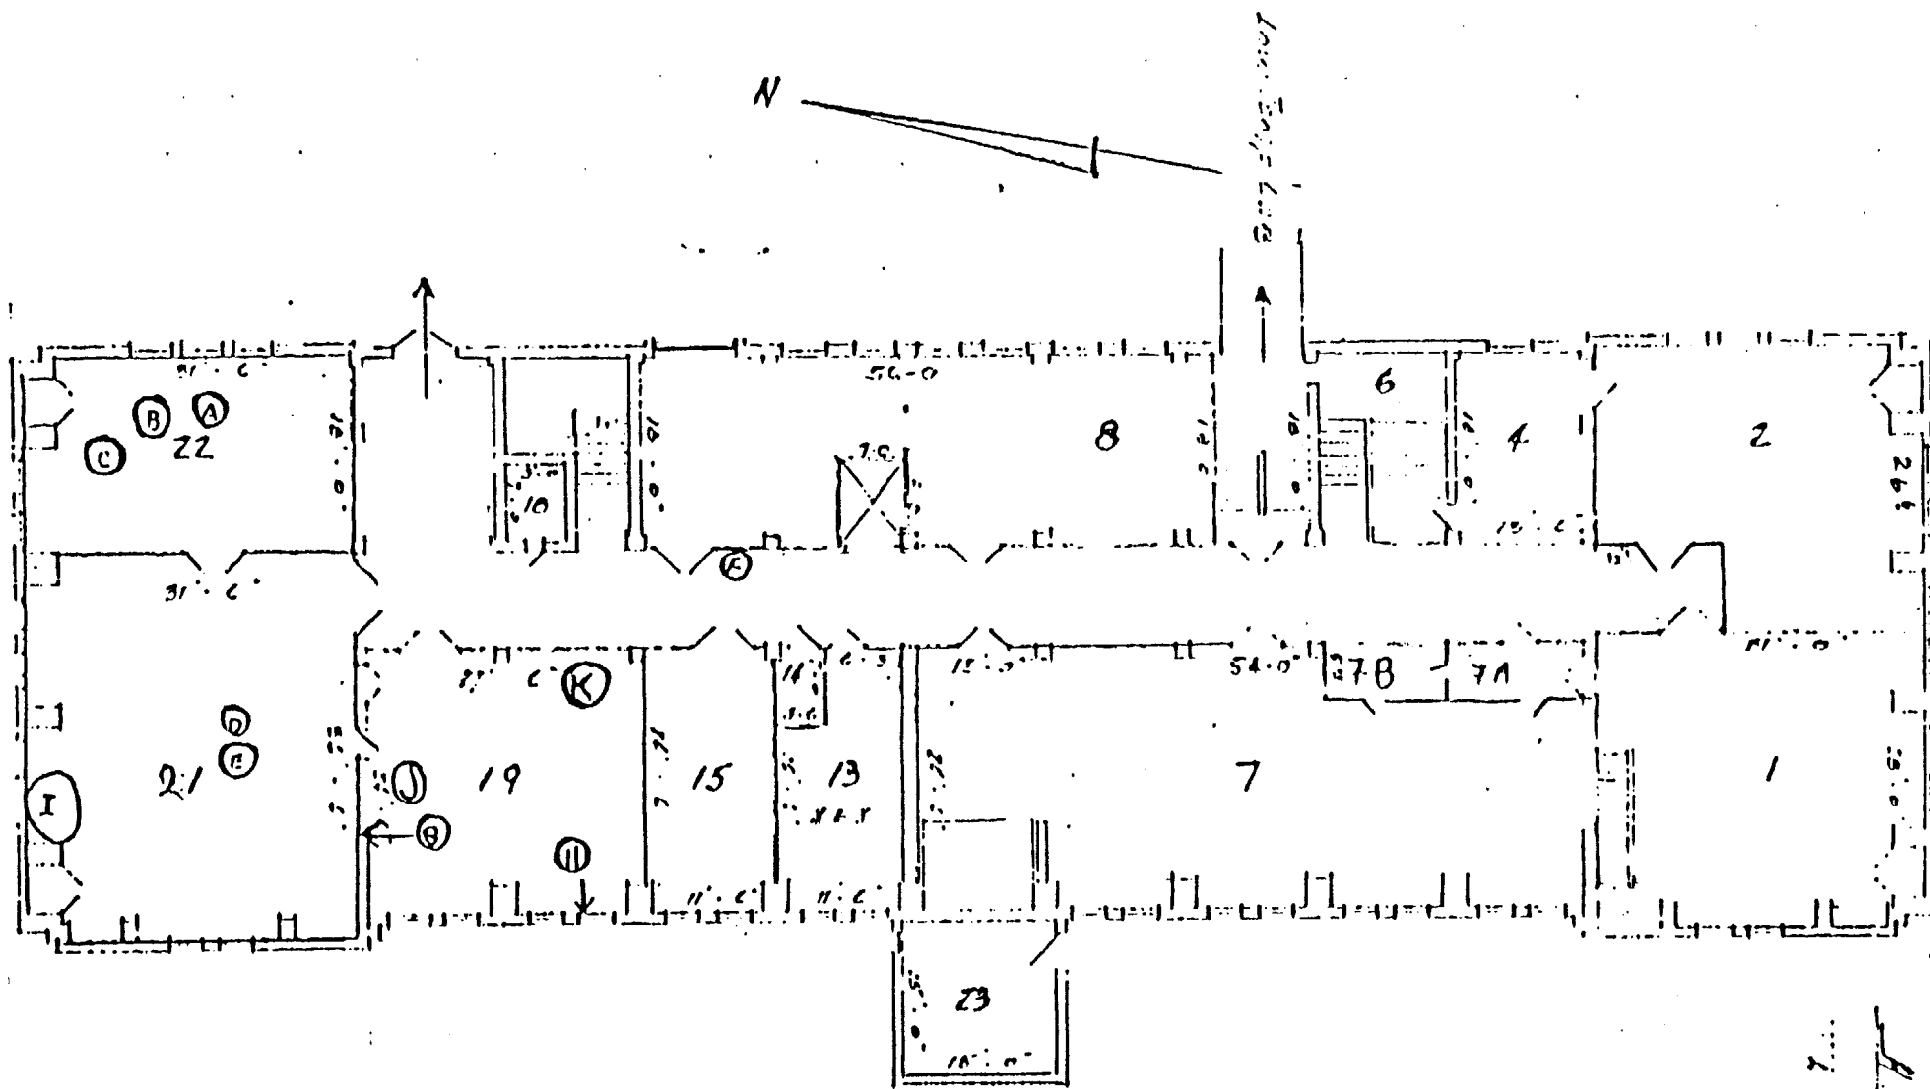
BASEMENT FLOOR

<u>Location</u>	<u>Contact Dose Rate (millirem/hour)</u>	<u>Alpha Rate (dpm)</u>	<u>Removable dpm/100 cm²</u>	<u>Comments</u>
Sub-basement	(no contamination)			
Basement (ground floor)				
A, floor, rm 22	.2	-	-	covered
B, floor, rm 22	.2	-	-	covered
C, floor, rm 22	.2	-	-	covered
D, floor, rm 21	.2	-	-	removed
E, floor, rm 21	.4	-	-	removed
F, floor, hall	.4	10,000	-	removed
G, wall, rm 19	.2	-	-	removed
H, wall, rm 19	.2	-	-	removed
I, floor, wall, rm 21	2.6	-	-	from DOE survey (1976), partially removed, refilled
J, floor, rm 19	.2	-	-	from DOE survey (1976), partially removed, refilled
K, floor, rm 19	.4	-	-	from DOE survey (1976), partially removed, refilled
First Floor				
A, floor, rm 121	.2	-	-	covered
B, floor, rm 121	.2	-	-	covered
C, floor, rm 121	.3	4,000	-	covered by bench or flooring
D, floor, rm 121	.2	-	-	covered
E, floor, rm 121	.2	-	-	covered
F, floor, rm 120	.2	-	-	covered
G, floor, rm 120	.2 to 3	-	-	several spots, all covered

1. Remove spot near Room 8 and replace floor (F).

Room 22

1. Cover floor (A-C).

Room 21

1. Remove contamination and replace floor at D and E.
2. Evaluate cross-hatched area near north wall (137Cs) and decide whether to remove or shield.

Room 19

1. Remove spots on north and west wall and replace wall (G and E).
2. Evaluate cross-hatched area near north and east walls (137Cs) and decide whether to remove or shield.

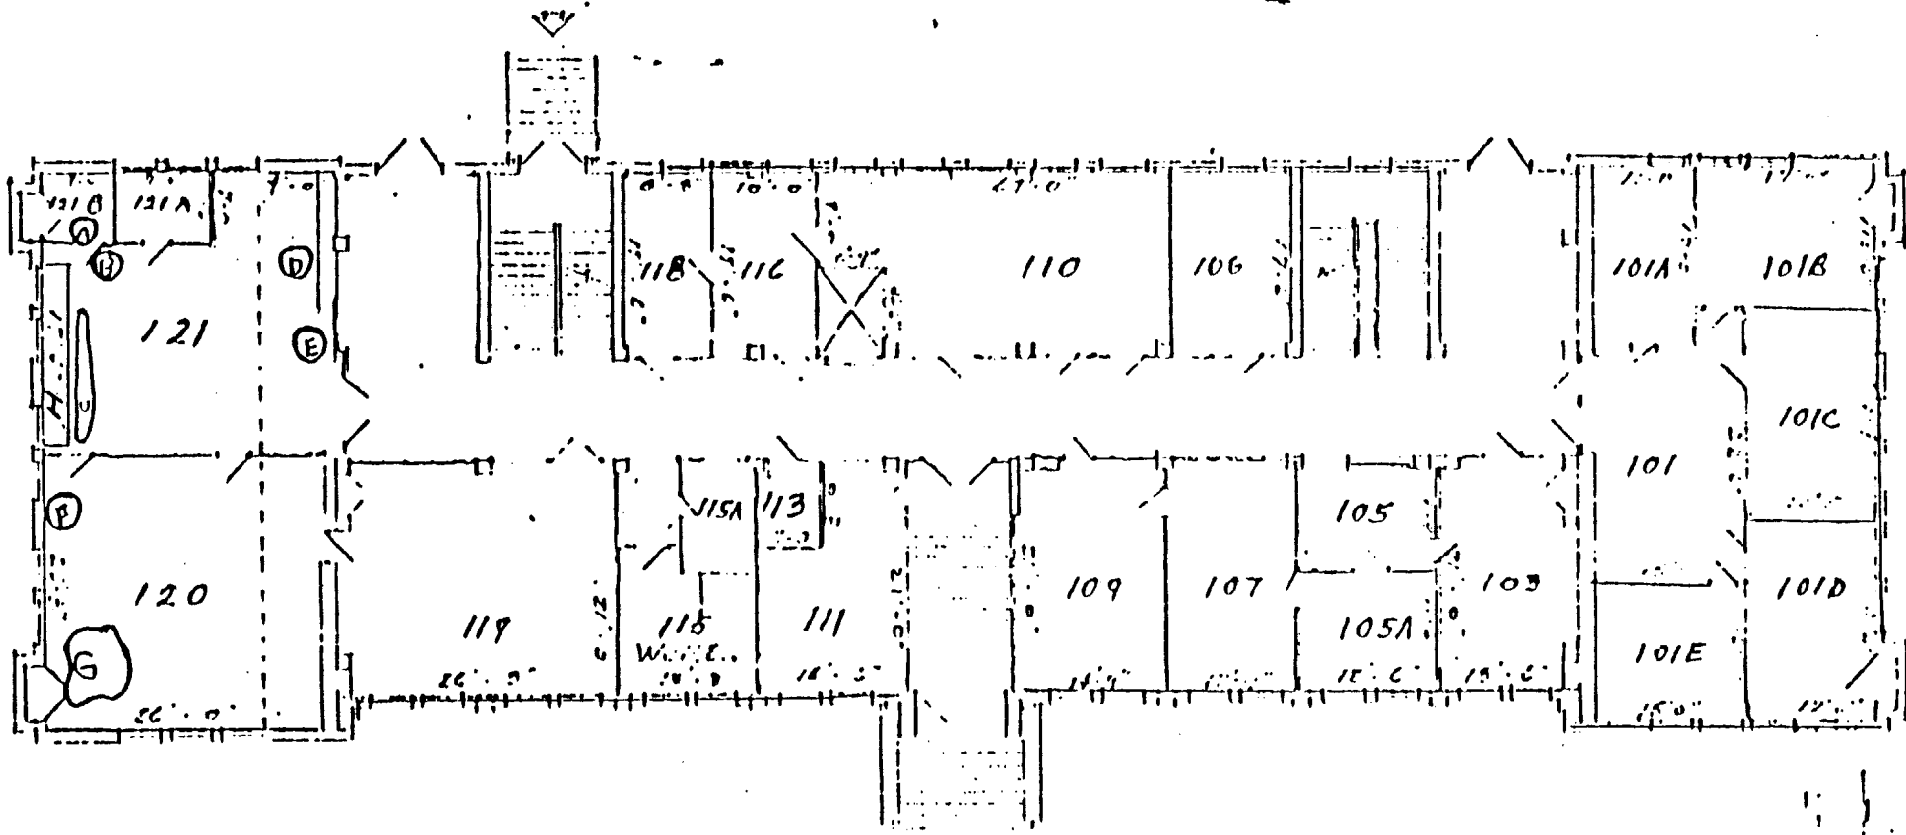
FIRST FLOOR

H, bench, rm 121	.2	-	-	bench top, doors, facing removed
Second Floor				
A-C, G-J, floor, rm 221	.2 to .4	-	-	covered
D-F, floor, rm 22	1.5 to 5	5,000 to 10,000	200	removable from joints between slabs; all covered
K-M, floor, hall	.2	-	-	removed

Room 121B

1. Cover floor (A).

Room 121

1. Remove and replace lab bench on north wall (E).
2. Cover floor (B-E).

Room 121C

1. Cover floor (F and G).

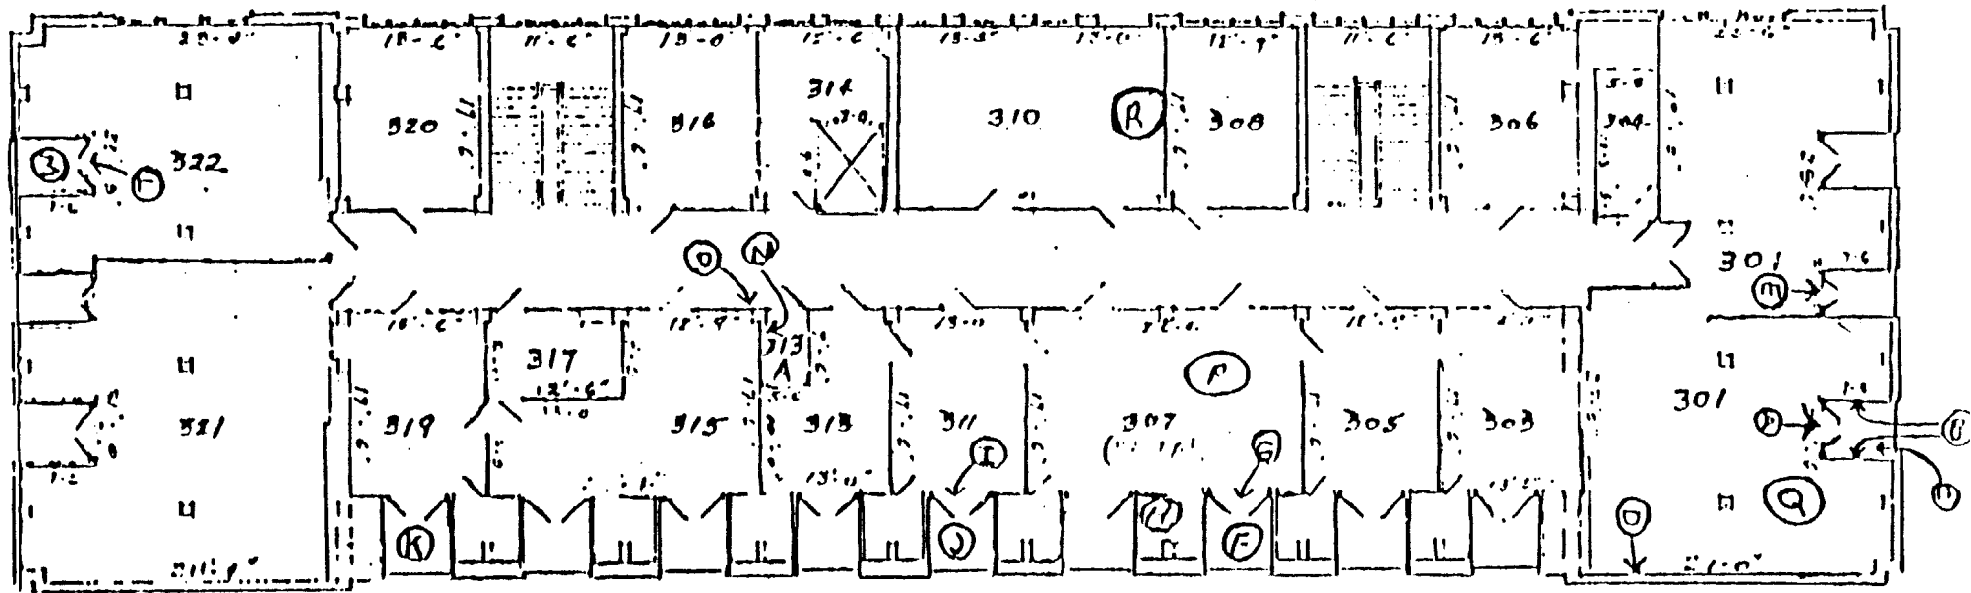
THIRD FLOOR

<u>Location</u>	<u>Contact Dose Rate (millirem/hour)</u>	<u>Alpha Rate (dpm)</u>	<u>Removable dpm/100 cm²</u>	<u>Comments</u>
Third Floor				
A, sill & alcove door, rm 301	.3	2,000	-	removed
B, walls, alcove, rm 301	3.5	10,000	200	removed
C, floor, alcove, rm 301	.4	-	-	covered
D, baseboard, wall, rm 301	.2	-	-	removed
E, sill to alcove, rm 301	.2	-	-	removed
F, floor, table, walls, piping, of alcove, rm 307	.2 to .4	-	-	floor covered; table, walls, piping removed
G, sill, alcove, rm 307	.2	-	-	removed
H, floor, closet, rm 307	.3	-	-	some gamma, covered with lead
I, sill, alcove, rm 311	.2	-	-	removed
J, floor, alcove, rm 311	.3	-	-	covered
K, floor, alcove, rm 319	.2	-	-	covered
L, sill, alcove, rm 322	.2	-	-	removed
M, floor, alcove, rm 322	.2	-	-	covered
N, floor, rm 313A	.3	-	-	covered
O, floor, hall	.2	-	-	removed
P, floor, rm 307	-	-	-	DOE survey (1976), no action needed
Q, floor, rm 301	-	-	-	DOE survey (1976), no action needed

R, wall, floor under removed bench, rm 310	3.0	4,000	500	Survey A, wall removed, floor contamination partially removed, covered

Room 301

1. Remove and replace outside walls of west alcove (Items B and C on diagram).
2. Remove and replace wood sills leading to both alcoves (A and E).
3. Remove and replace baseboard on west wall (D).

Room 307

1. Cover floor of south alcove (F).
2. Remove and replace wood sill leading to south alcove (G).
3. Cover floor of small closet between the two alcoves (H).

Room 311

1. Remove and replace wood sill leading to alcove (I).
2. Cover floor of alcove (J).

Room 313A

1. Cover floor (N).

Corridor near Room 313A

1. Remove spot on floor and replace floor (O).

Room 322

1. Remove and replace wood sill (L).
2. Cover floor (M).
