**2014 Annual Land-Use Covenant  
Inspection Report  
for DOE Areas at the Laboratory  
for Energy-Related Health  
Research/Old Campus Landfill  
Superfund Site  
University of California, Davis**

**January 2015**

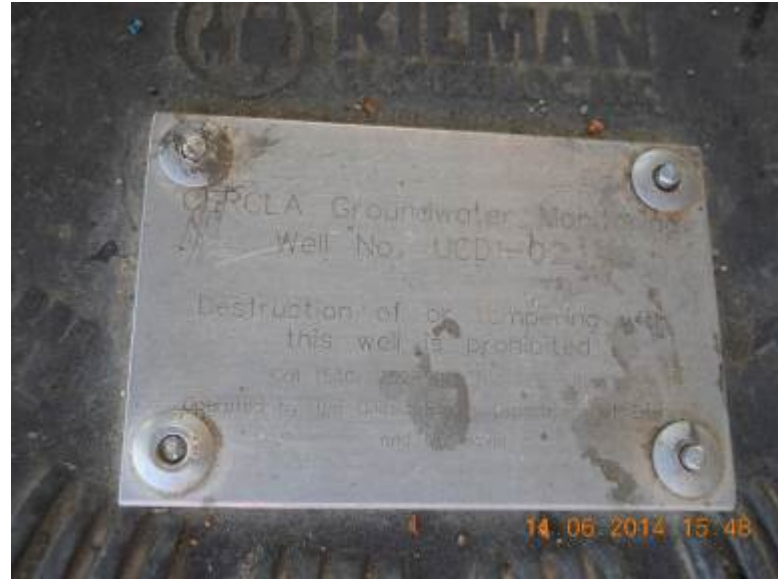
Well UCD1-021 has surface cracks and chips in the cement pad, but the underlying structural cement around the vault appears to be sound. The cement pad at the base of the standpipe at well UCD1-070 has a crack but the standpipe is sound. Cement pads at the remainder of the DOE areas wells and at the background wells were structurally sound with no surface damage.

*UCD1-021 Wellhead.*

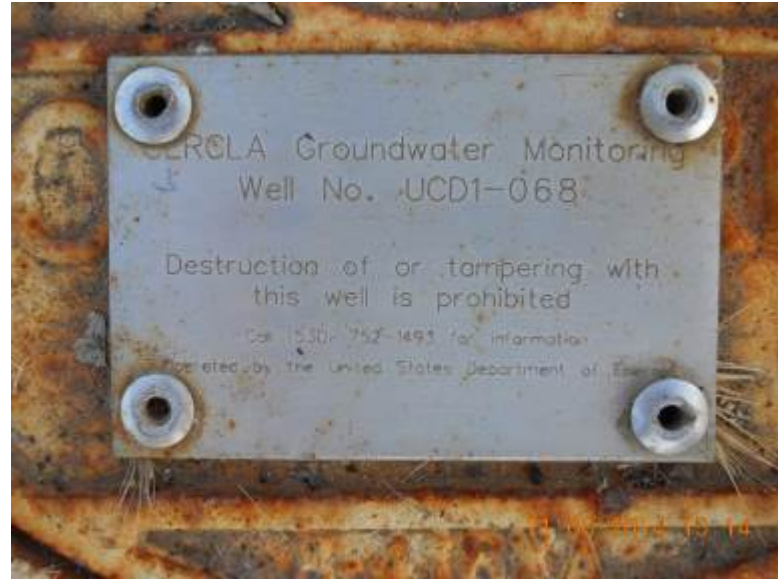
- Vault lid bolts were difficult to fasten to the anchorage threads at wells UCD1-068 and UCD1-071.
- The casing cap in well UCD1-069 was missing a stopper in the water level measurement port.

UCD1-068 Wellhead (photo of completed maintenance in Appendix E).

Appendix E provides photographs of the well repairs. Appendix A provides a copy of the field activity log.

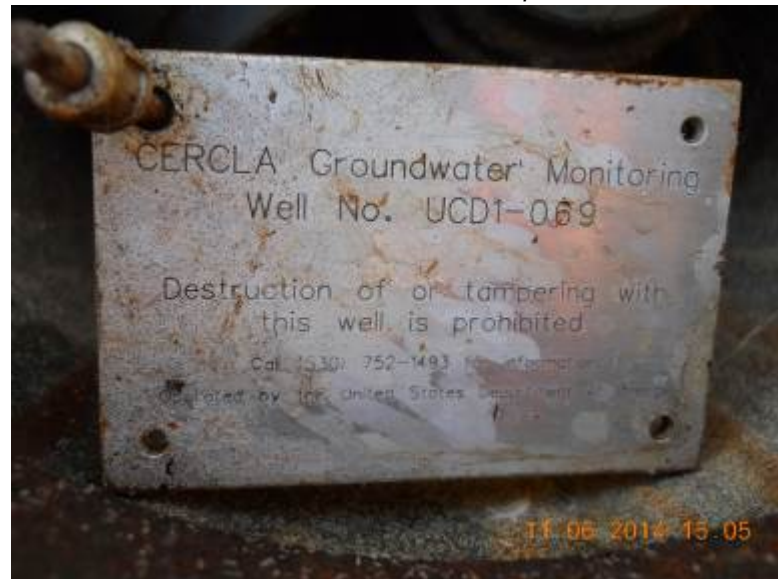
UCD1-069 Interior (photo of completed maintenance in Appendix E).

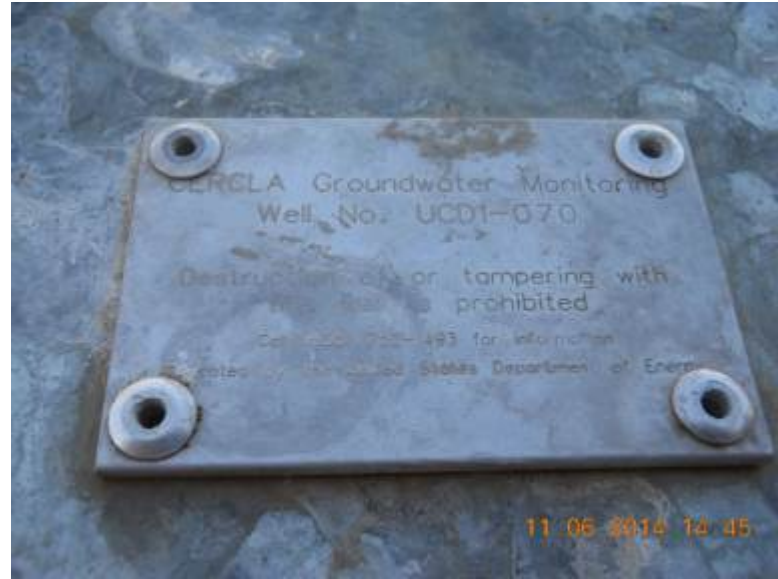
*UCD1-070 Wellhead.*
