**2015 Annual Land-Use Covenant
Inspection Report
for DOE Areas at the Laboratory
for Energy-Related Health
Research/Old Campus Landfill
Superfund Site
University of California, Davis**

January 2016

U.S. DEPARTMENT OF
ENERGY

Legacy
Management

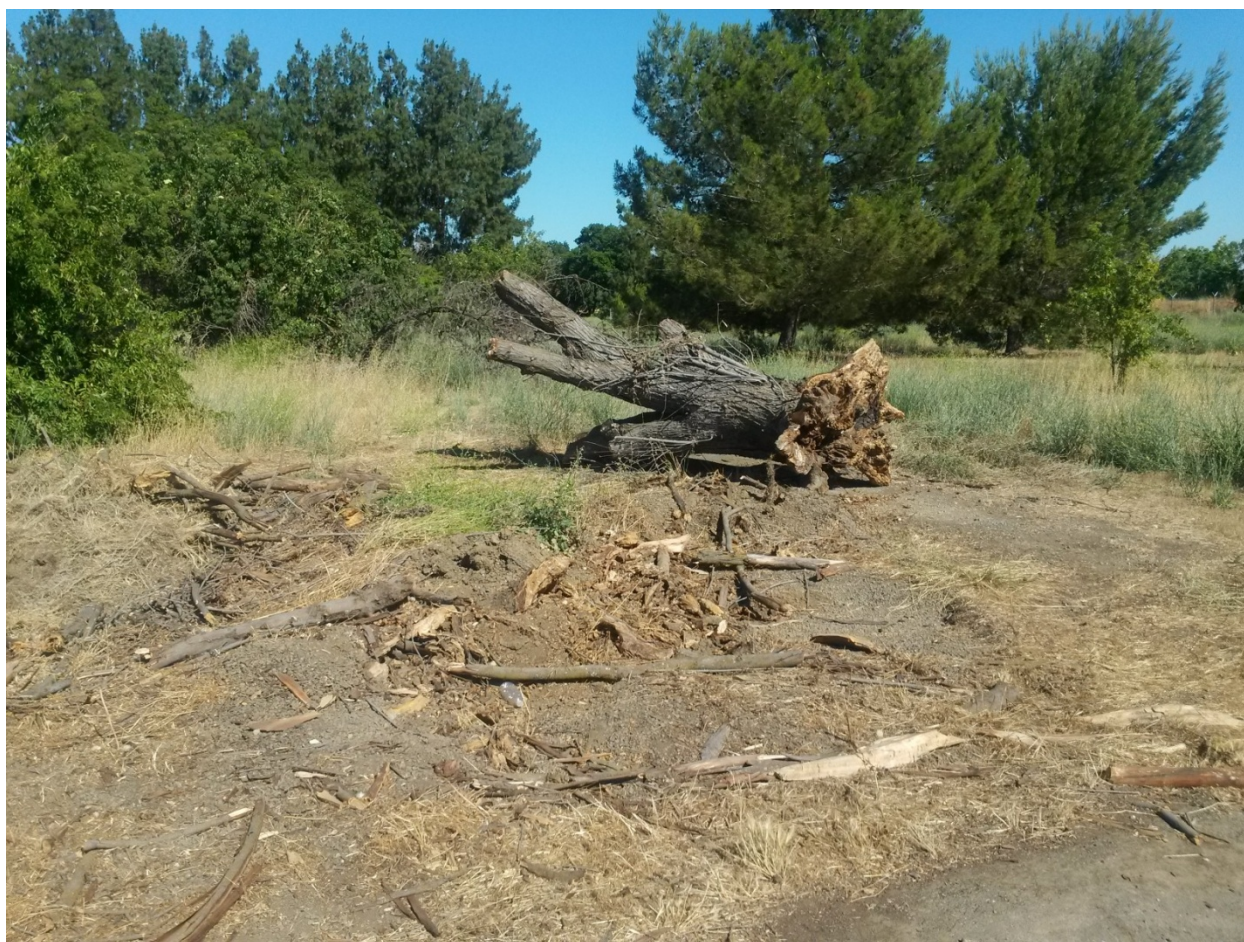
On June 16, 2015, between 10:14 a.m. and 2:23 p.m. and November 3, 2015, between 8:42 a.m. and 3:07 p.m., Tim Utterback of Weiss performed walk-through inspections of the DOE areas subject to land-use restrictions to look for signs of soil disturbance. Minor soil disturbance associated with a fallen tree was observed in the northwest corner of the EDPs during both inspections. Before the tree fell, it was located outside the west boundary of the EDPs as shown in the surveyors map prepared in 1998 (Figure 5). Easting and northing coordinates obtained from the surveyors map indicate that the trunk was originally located approximately 8 to 10 feet west (outside) of the EDPs fence. The tree was dead when it fell to the northeast into the northwest corner of the EDPs. The UC Davis grounds crew removed branches from the tree and moved the trunk approximately 15–20 feet southeast of its original location. In the process of performing this work, the grounds equipment disturbed a shallow area of soil. The area of disturbed soil is approximately 1–2 inches deep by 25 feet long by 22 feet wide as shown on Figure 3. Less than 3 cubic yards of soil was mounded near the center of the scraped area. The trunk of the fallen tree was lying about 5 feet south of the scraped area. As shown on Figure 4, the tree sheared at its base and did not bring soil or roots to the surface.

Figure 4. View South of Fallen Tree with Disturbed Soil in Foreground and Relocated Fallen Tree Stump Behind (photo taken June 12, 2015)

The volume and depth of the EDPs soil disturbance were less than the quantities that would require a permit according to the specifications in the Soil Management Plan in Appendix A of the *Remedial Design/Remedial Action Work Plan* (DOE 2010) (disturbed depths less than 1 foot and soil displaced less than 5 cubic yards). No soil disturbance events that would require a permit have occurred during the reporting period. Appendix A provides the November 3, 2015, inspection checklist, and Appendix C provides photographs documenting the inspection. The checklist and photographs from the June 16, 2015, inspection were presented in Appendix D of the Draft First Five-Year Review for the LEHR Federal Facility (DOE 2015).

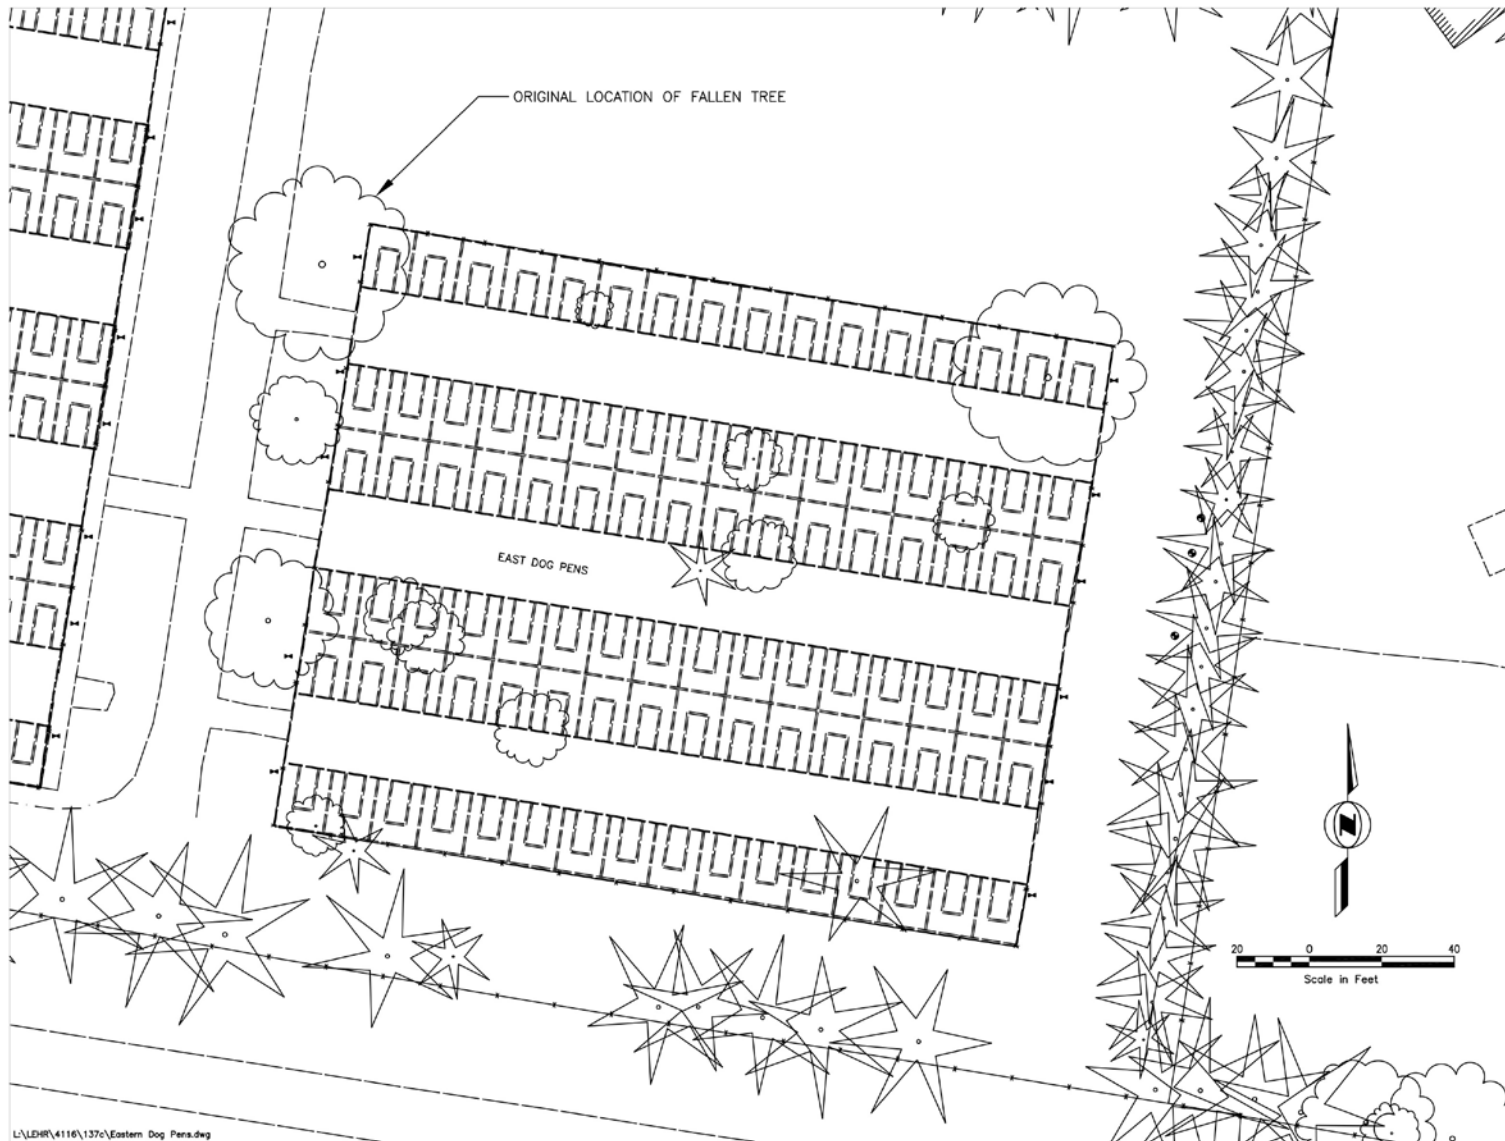
Figure 5. 1998 Survey Map Showing Original Location of Fallen Tree

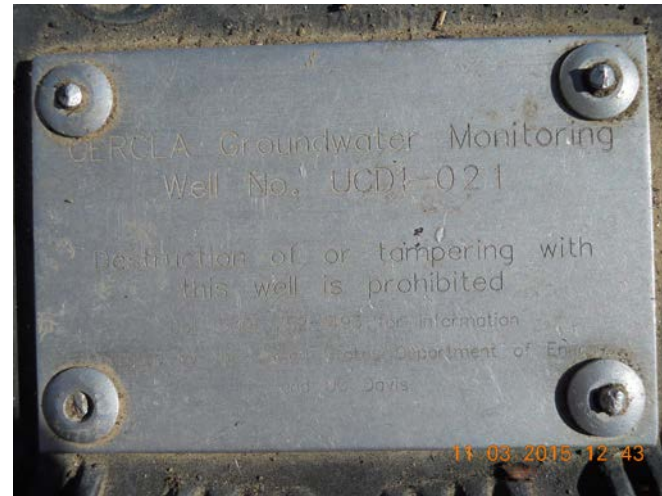
UCD1-021 Wellhead Plaque (photo No. 2918).

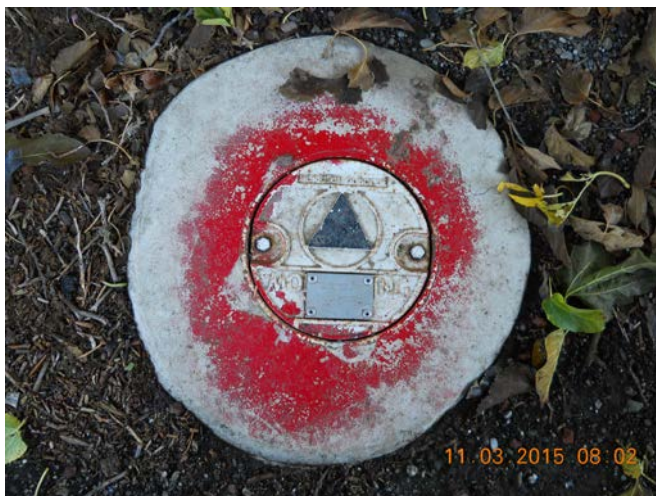
UCD1-071 Wellhead (photo of gasket replacement in Appendix E) (photo No. 2821).

On September 1, 2015, a new plaque was installed on the lid of well UCD1-069. On November 3, 2015, a new vault gasket was installed at well UCD1-071. Appendix E provides photographs of the reinstalled plaque and replaced gasket. Well plaques will be cleaned if coatings or residues worsen. The vault gasket in well UCD1-068 will be replaced if its condition continues to deteriorate.

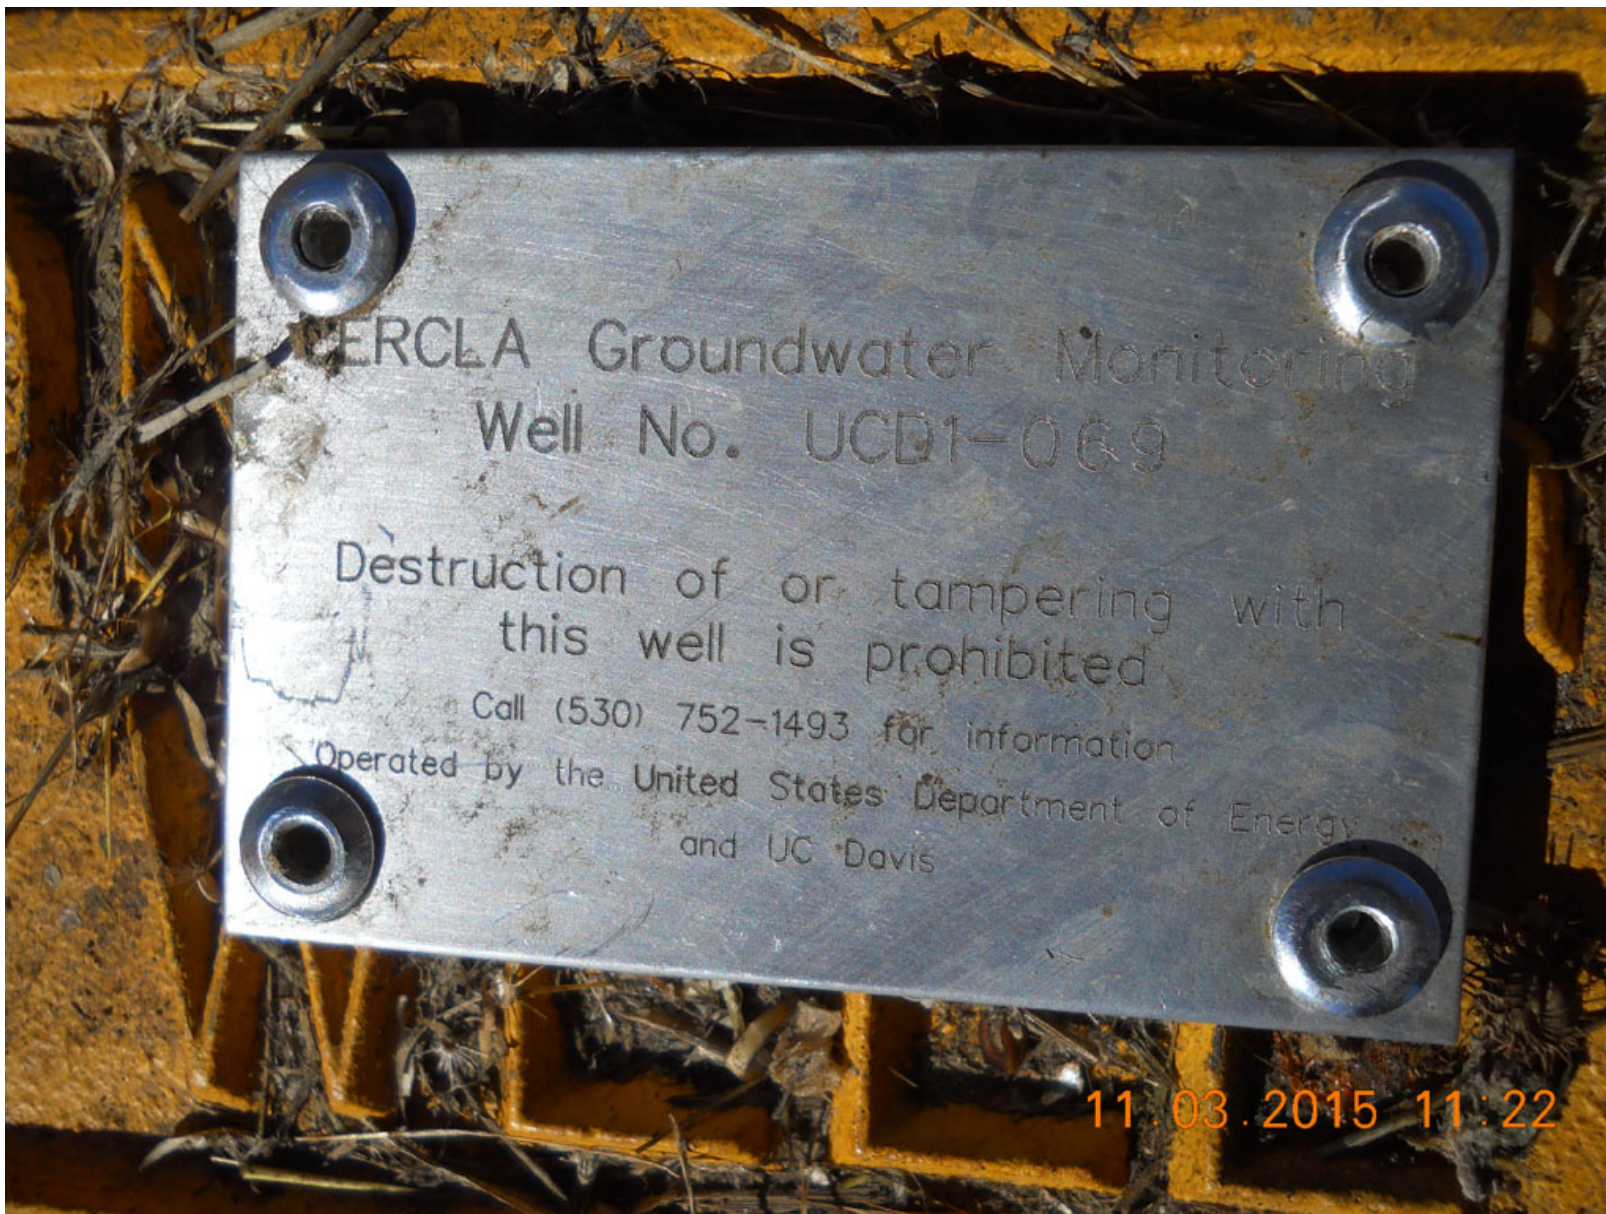
- The plaque on the lid of well UCD1-069 was missing due to vault replacement. The vault was replaced due to damage from grounds maintenance equipment.
- Well UCD1-071 required a new vault gasket.

UCD1-069: new plaque on well vault lid.

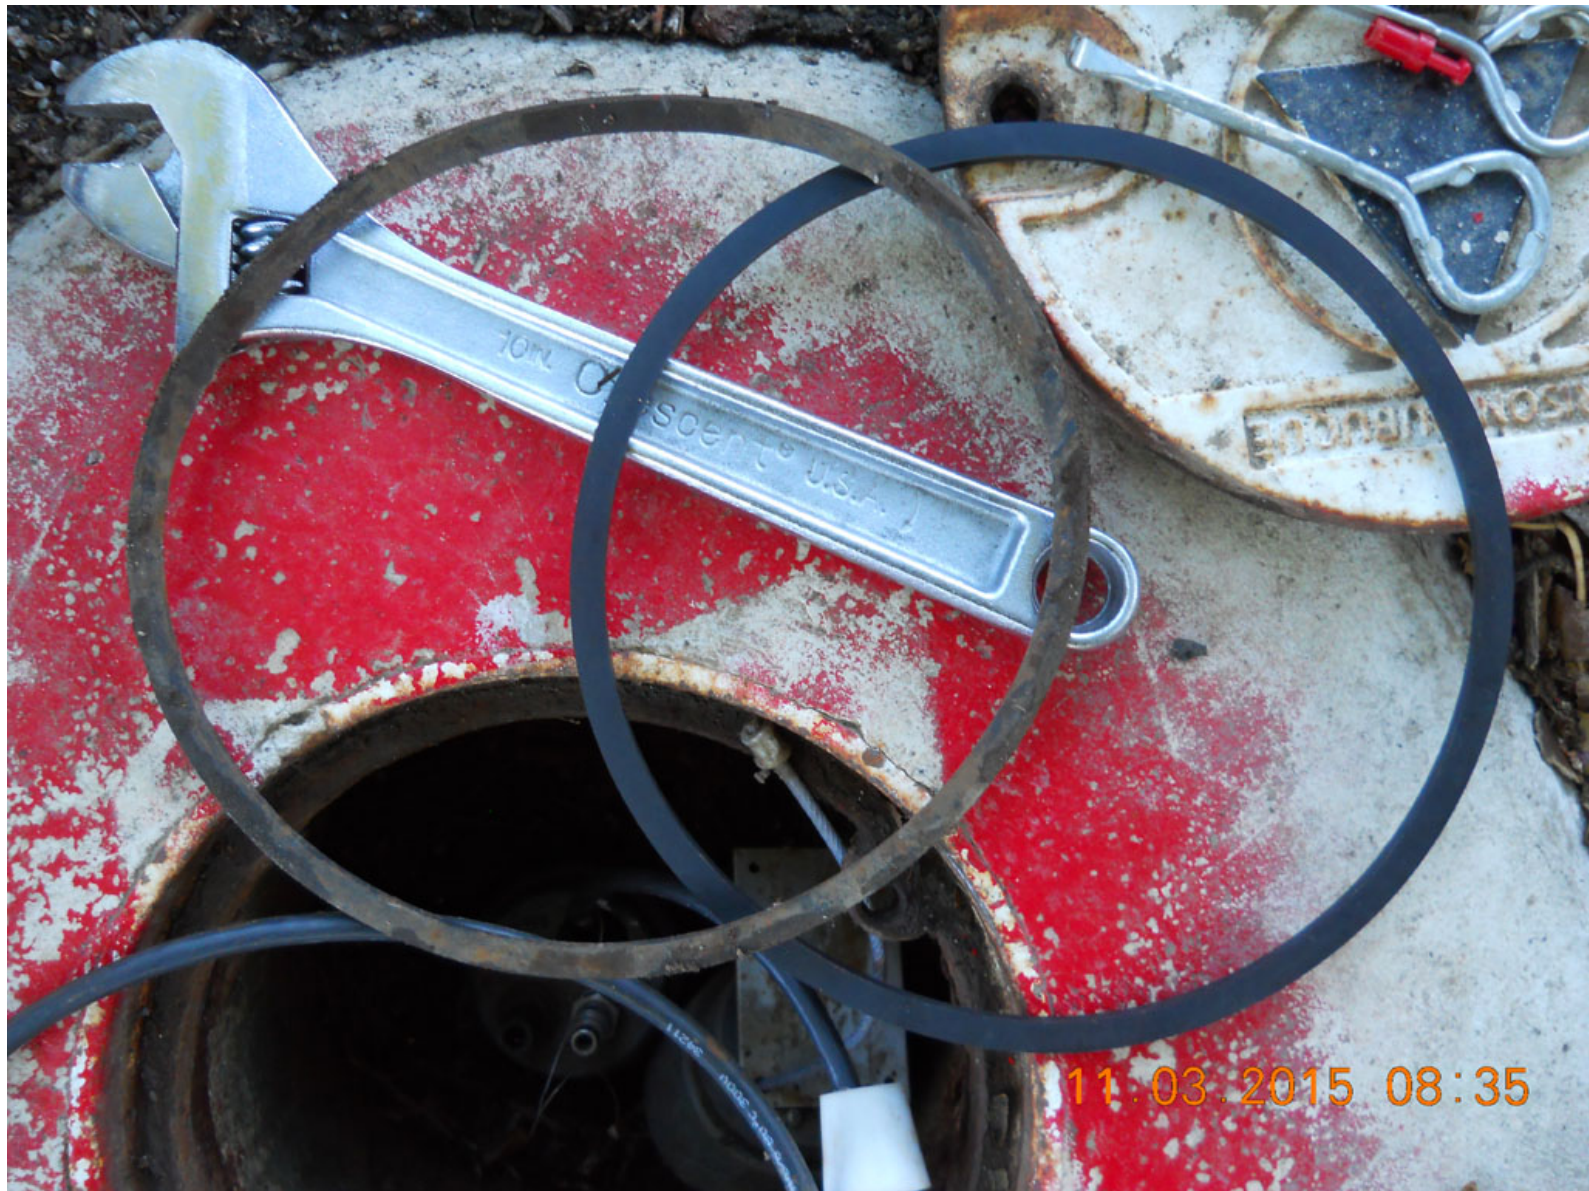
UCD1-071: vault lid gasket replacement.
