**2016 Annual Land-Use Covenant
Inspection Report
for DOE Areas at the Laboratory
for Energy-Related Health
Research/Old Campus Landfill
Superfund Site
University of California, Davis**

January 2017

U.S. DEPARTMENT OF
ENERGY

Legacy
Management

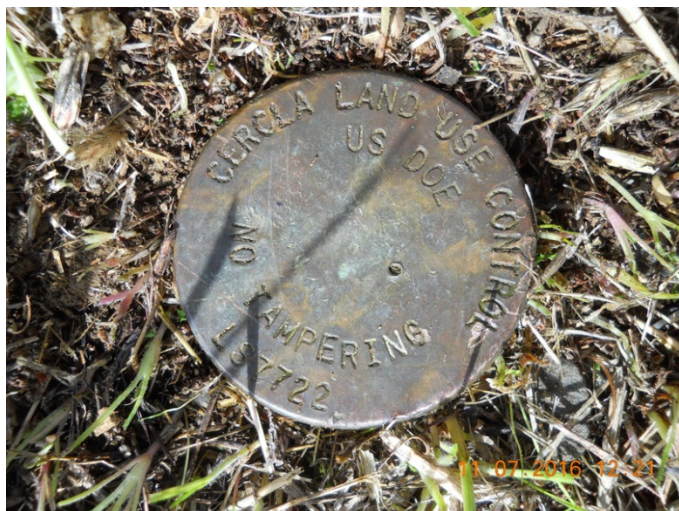
All 24 monuments were found in good condition during the November 3, 2016, inspection, except monument 22 at the southeast corner of the EDPs Area was not found that day. On November 7, 2016, Tim Utterback and Brian Bandy of Weiss performed a detailed search for monument 22 using a tape measure, rake, shovel, and metal detector. Brian Bandy of Weiss found monument 22 with the metal detector, and Tim Utterback of Weiss inspected the monument. Monument 22 was in good condition at the time of inspection. Appendix A provides the inspection checklists completed on November 3 and 7, 2016, and Appendix B provides the photographs of the monuments.

Monument 22: southeast corner of Eastern Dog Pens Area
(photo No. 3261).

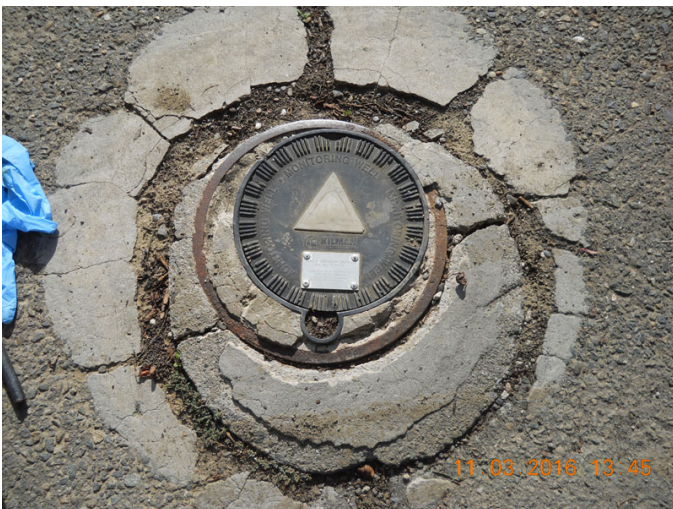
Well UCD1-021 is located in a paved driveway, and part of the concrete apron surrounding the well vault is broken. The break may leave the well vulnerable to stress from motor vehicle loads. DOE plans to repair the well vault in 2017. The cement pad at the base of the standpipe at well UCD1-070 has a crack, but the standpipe is sound. DOE plans to repair the cracked pad in 2017. Cement pads at the remainder of the DOE areas wells and at the background wells were structurally sound with no surface damage.

UCD1-021 Wellhead (photo No. 3218).

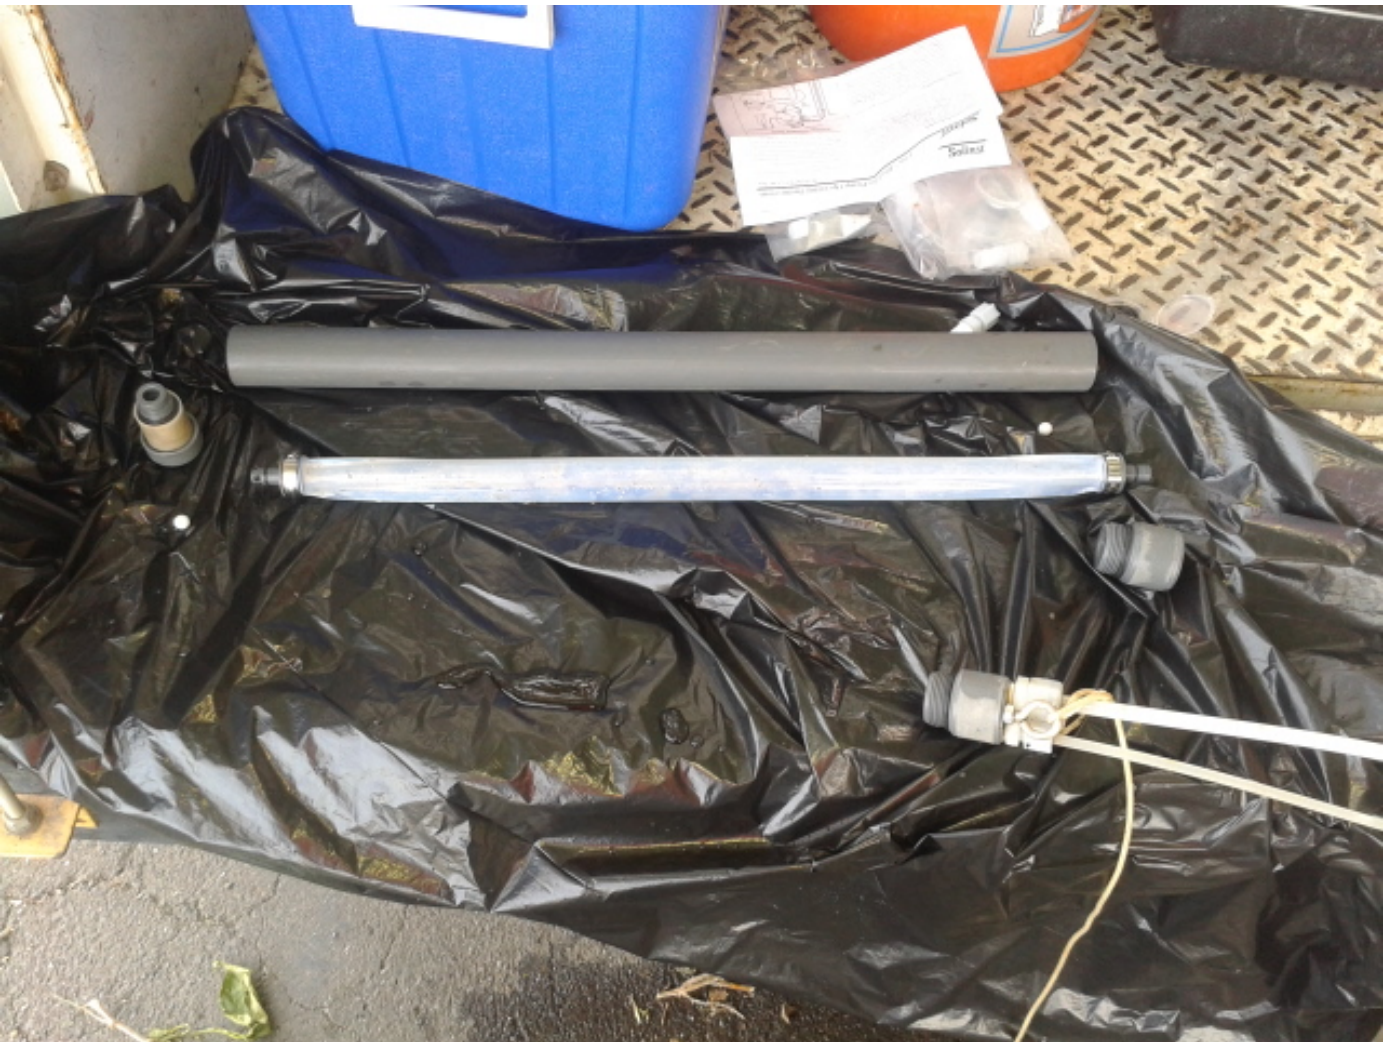
UCD1-071: Replacement of pump O-rings and check-valve balls.
