**2017 Annual Land-Use Covenant
Inspection Report
for DOE Areas at the Laboratory
for Energy-Related Health
Research/Old Campus Landfill
Superfund Site
University of California, Davis**

January 2018

U.S. DEPARTMENT OF
ENERGY

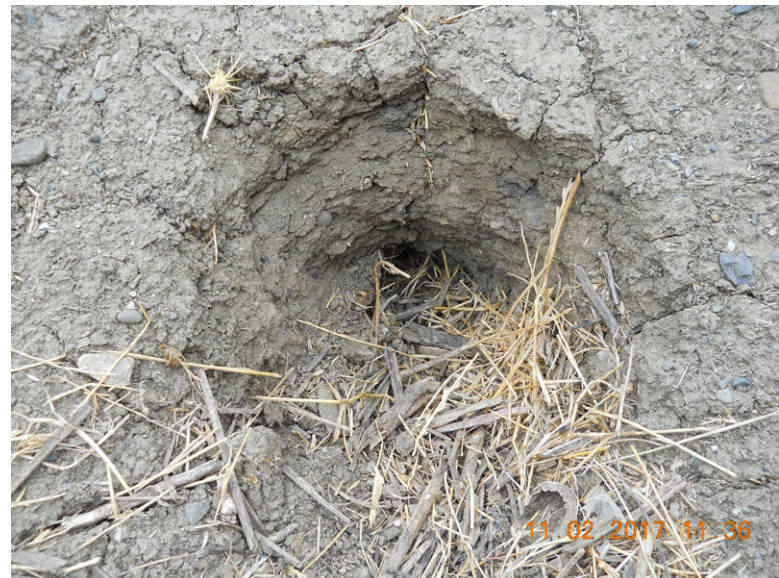
During the November 2, 2017, walkthrough inspection, Tim Utterback of Weiss observed and photographed one small animal burrow in the Ra/Sr Treatment Systems Area and three small animal burrows in the EDPs Area (photographs 3353, 3354, and 3425 in Appendix C). The volume of material displaced in each area is less than a cubic foot, indicating the soil disturbance is not likely an exposure risk to site workers or the public.

Radium/Strontium Treatment Systems Area: Burrowing animal hole in southeast corner of unpaved courtyard (photo No. 3353).

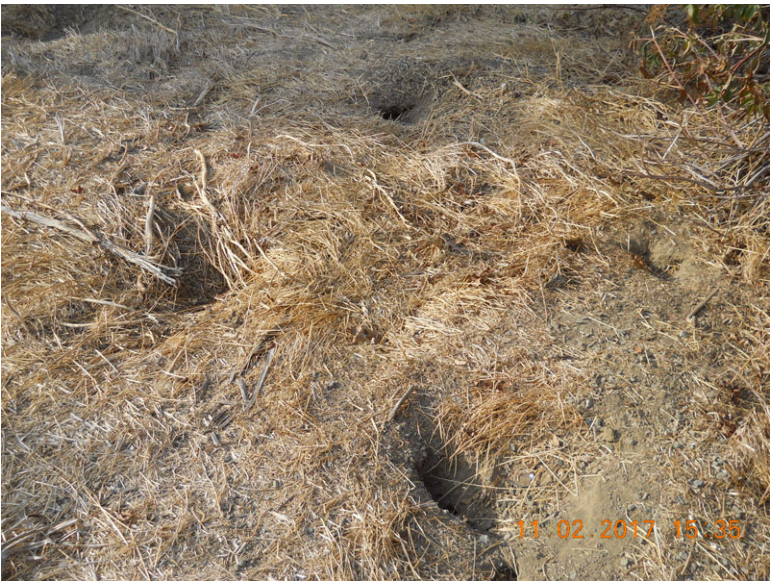
Burrowing animal holes in Southwest region of Eastern Dog Pens Area (photo No. 3425).

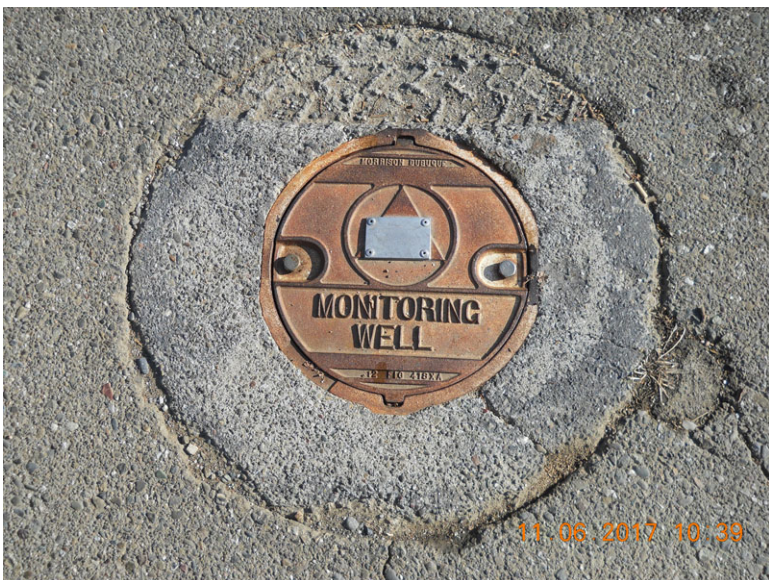
UCD1-054 Wellhead (photo No. 3427).

Wells UCD1-054 and UCD1-071 were missing pump discharge port plugs. DOE plans to replace the missing discharge plugs and install plugs in the pump air ports.

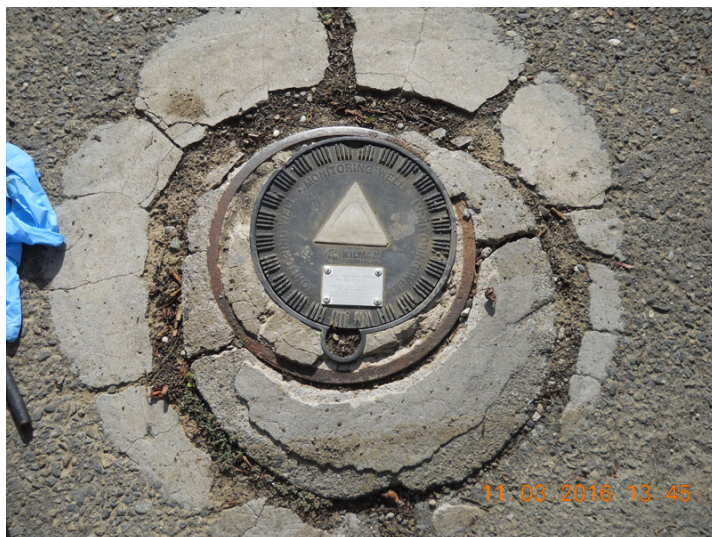
*Well UCD1-021 wellhead before vault replacement
(photo No. 3218 from 2016 inspection report).*

On April 6 and 7, 2017, the vault was replaced at well UCD1-021 and the concrete apron was replaced at well UCD1-070 as recommended in the 2016 Land-Use Covenant Inspection Report (DOE 2017a). Appendix E provides photographs of the wellhead repairs.

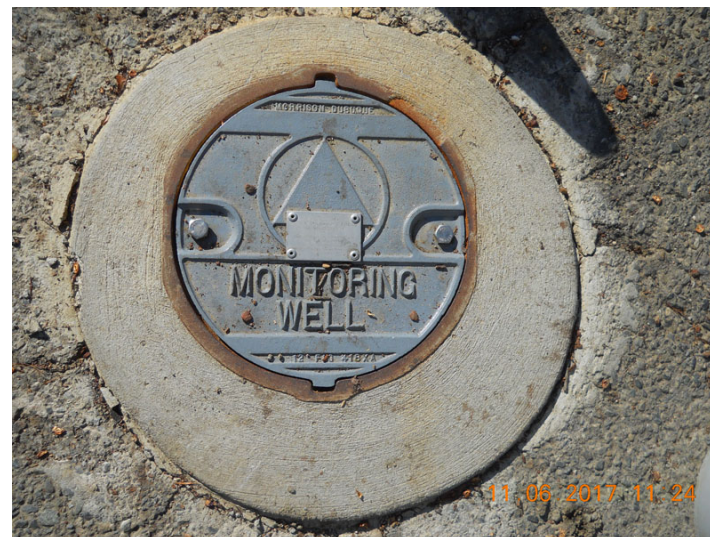
*Well UCD1-021 wellhead after vault replacement
(photo No. 3437).*

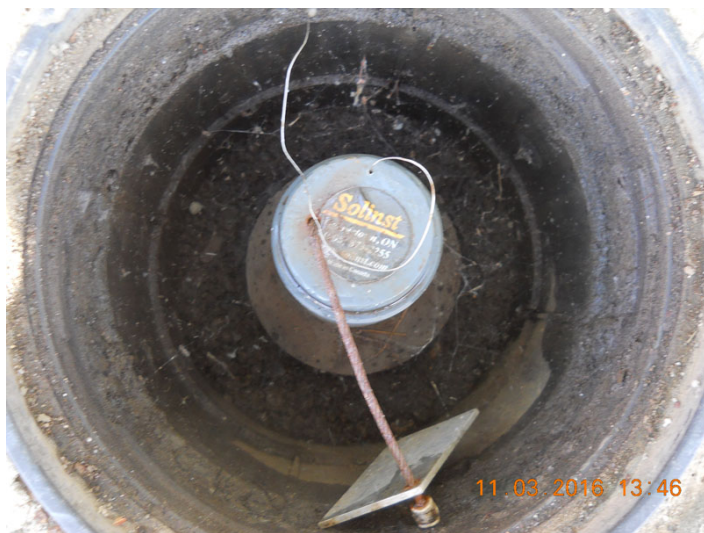
*Well UCD1-021 vault interior before replacement (
photo No. 3220 from 2016 inspection report).*

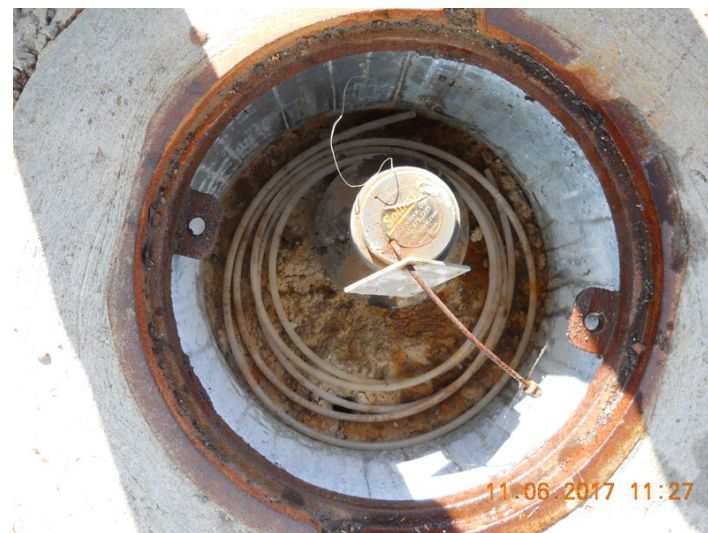
*Well UCD1-021 vault interior after replacement
(photo No. 3440).*

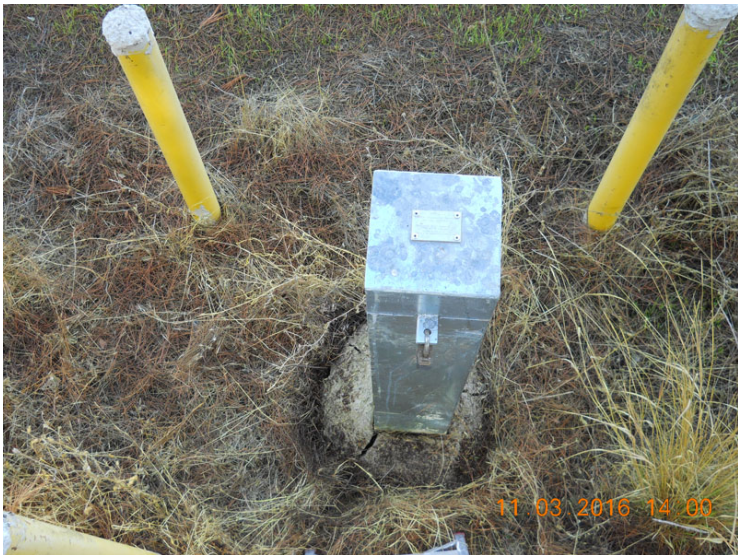
*Well UCD1-070 before concrete apron replacement
(photo No. 3222 from 2016 inspection report).*

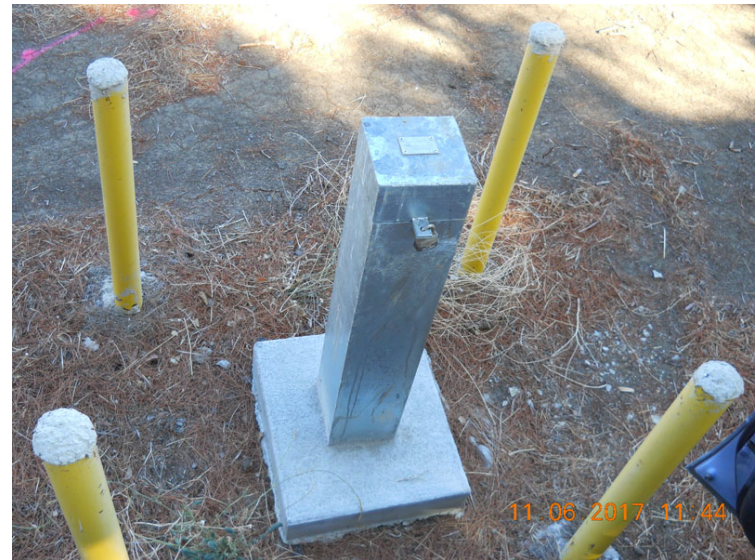
*Well UCD1-070 after concrete apron replacement
(photo No. 3443).*
