**2018 Annual Land-Use Covenant
Inspection Report
for DOE Areas at the Laboratory
for Energy-Related Health
Research/Old Campus Landfill
Superfund Site
University of California, Davis**

January 2019

U.S. DEPARTMENT OF
ENERGY

Legacy
Management

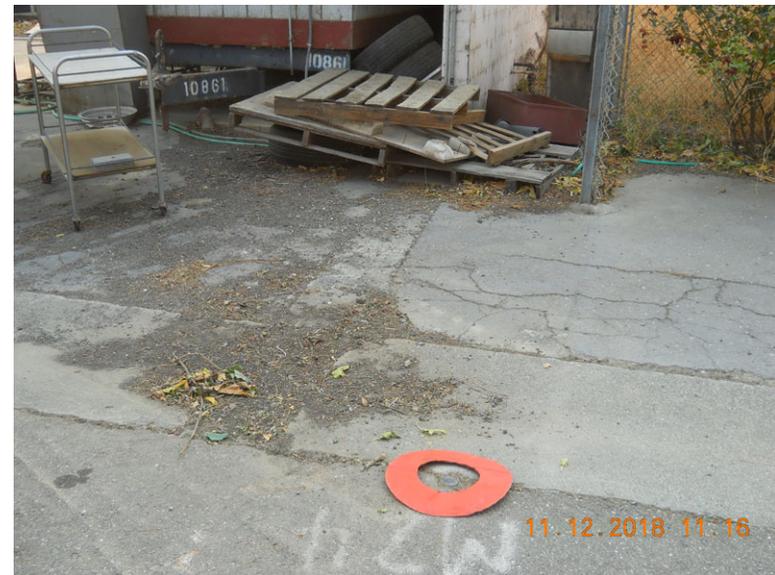
A total of 23 survey monuments were found in good condition during the November 7, 2018, inspection. A dumpster was located on top of Survey Monument 24, making it inaccessible for inspection. The dumpster was moved, and on November 12, 2018, Survey Monument 24 was inspected and found to be in good condition. Figure 3 shows the locations of the survey monuments, Appendix A provides the survey monument inspection checklists completed on November 7 and 12, 2018, and Appendix B provides the photographs of the survey monuments.

View south: Survey Monument 24, within orange ring on edge of concrete swale; trailer storage unit behind survey monument (photo No. 3733).

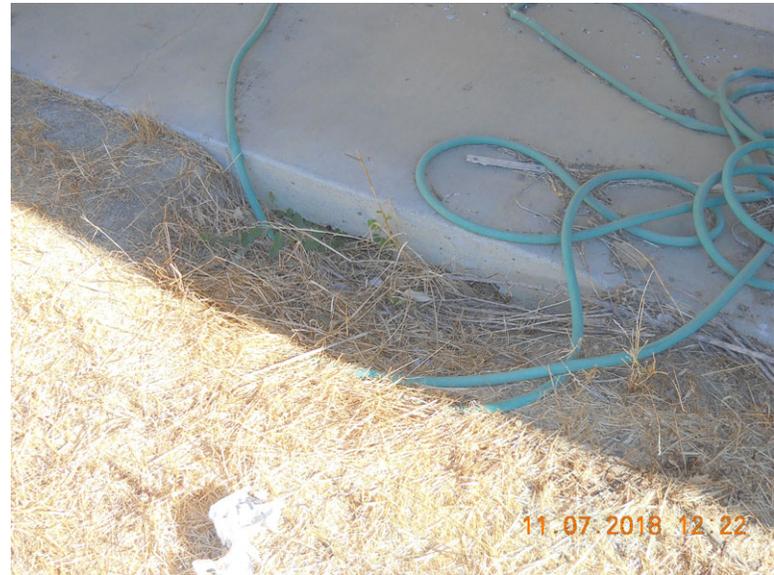
During the November 7, 2018, walkthrough inspection, Tim Utterback of Weiss observed and photographed one small animal burrow and one small area of soil subsidence in the Ra/Sr Treatment Systems Area (photographs 3693 and 3694 in Appendix C). The animal burrow was photographed in 2017. Comparison of 2017 and 2018 photographs indicates no change to the burrow and no soil disturbance between photographs. Animal burrows photographed in the EDPs area during the 2017 inspection were not found in the 2018 inspection. The area of soil subsidence in the Ra/Sr Treatment Systems Area does not indicate soil removal, but that a small area of ground surface has subsided slightly. A pile of asphalt not previously observed within the Eastern Dog pens was observed during the November 7, 2018, walkthrough inspection, but no soil disturbance due to the asphalt placement was observed. Thus, no soil disturbance was observed in 2018 other than the permitted activity described above.

Small subsidence adjacent to sidewalk at east end of unpaved courtyard of Radium/Strontium Treatment Systems Area (photo No. 3694).

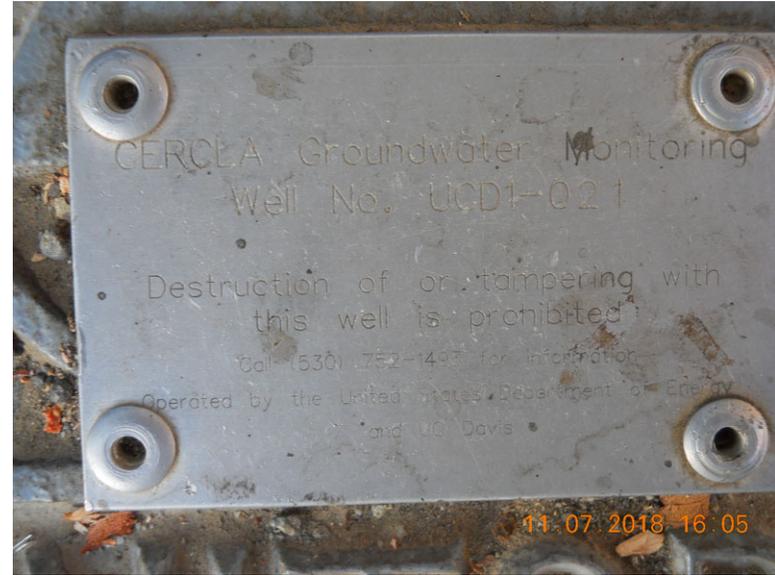
UCD1-021 Wellhead plaque (photo No. 3718).

Cable connections between the cap and plaque inside wells UCD1-021 and UCD1-068 were rusted and frayed or broken. DOE plans to replace these cables.

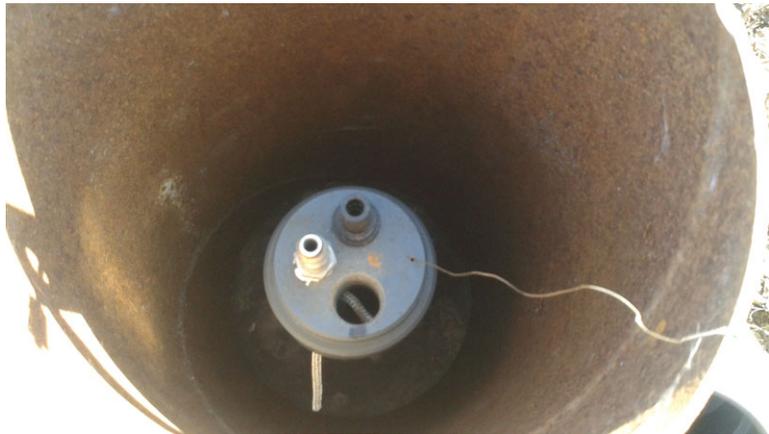
On February 21, 2018, because of diminished pump performance observed during flow rate tests in 2017, new pumps were installed in wells UCD1-018, UCD1-023, and UCD1-071. Appendix E provides photographs of the well vault interiors before and after pump replacement.

Well UCD1-018 vault before pump replacement.

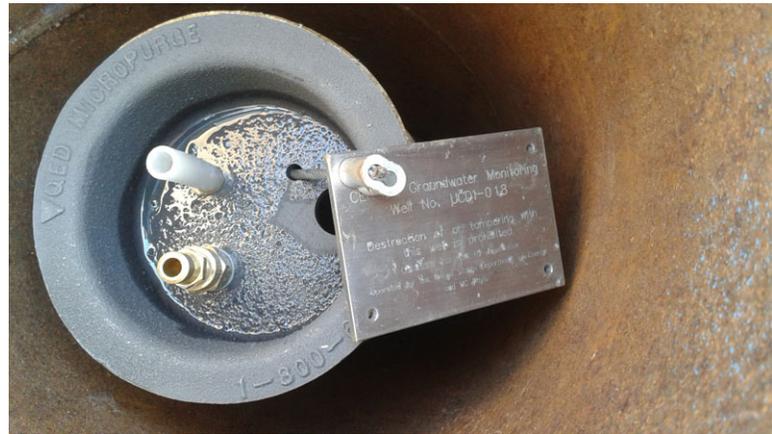
Well UCD1-018 vault after pump replacement.

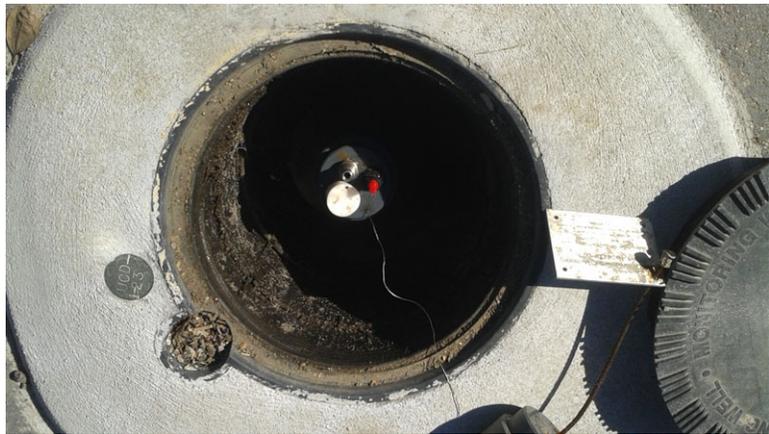
Well UCD1-023 vault before pump replacement.

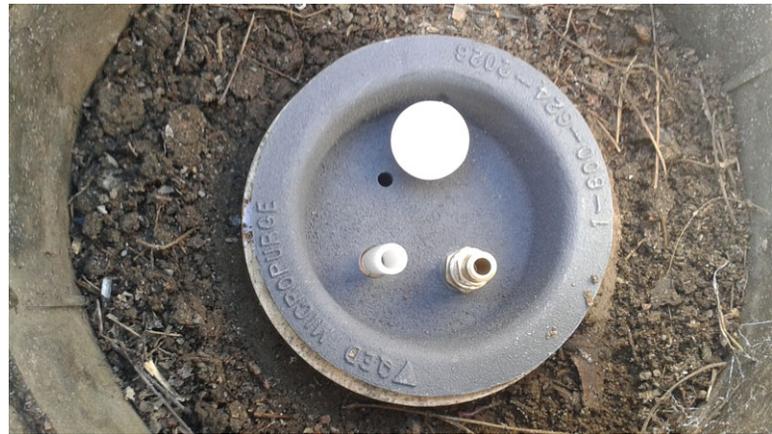
Well UCD1-023 vault after pump replacement.

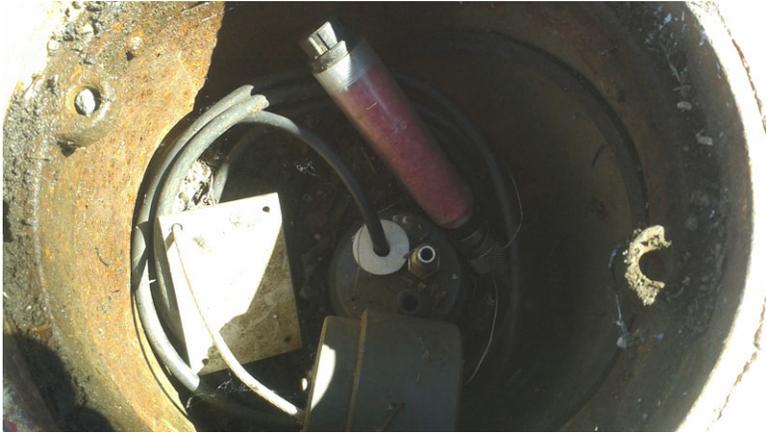
Well UCD1-071 vault before pump replacement.

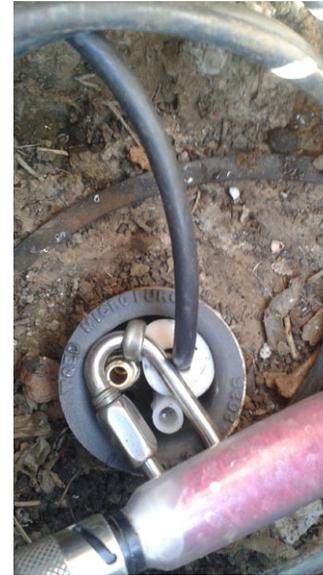
Well UCD1-071 vault after pump replacement.
